**Ty Brynseion,  
Dowlais, Merthyr Tydfil**

## **Bat and Nesting Bird Survey Report**

**July 2025**

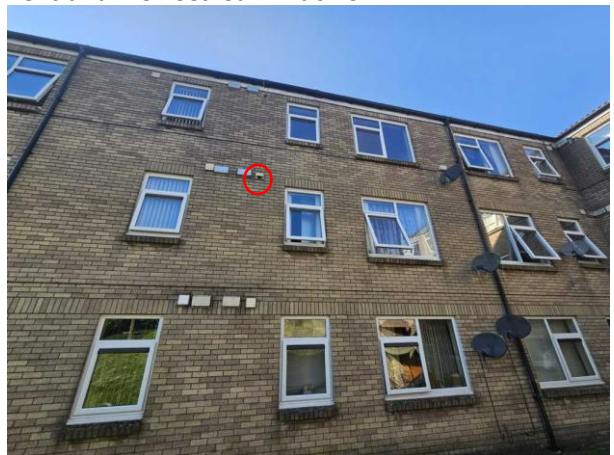
Photo 4: South-east elevation, example of broken vent and well-sealed windows

| Vents | There are multiple vents across all floors on the southern and eastern elevations. Vent stacks are also present on all roof sections. Many vents are damaged or missing (Photos 4 and 10). |

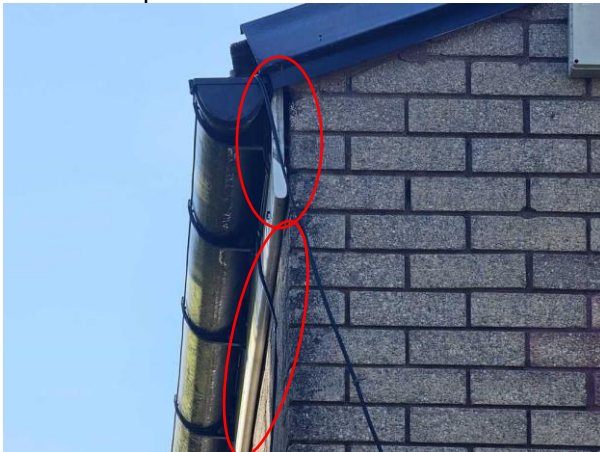
Photo 5: Gaps behind fascia boards

| Soffits, Fascias and Bargeboards | The barge boards and fascias across all elevations have visible gaps beneath or are missing entirely (Photo 5). |

Four new exterior fascia boards will be set off the face of the newly rendered walls to provide 'crawling bat access' underneath. The gap will be approximately 20mm wide off the face of the wall and will run throughout the fascia's length to provide roosting provision without access to the interior or loft space. They should not be placed directly above windows or close to artificial lighting. The proposed location can be found in Plan 6.

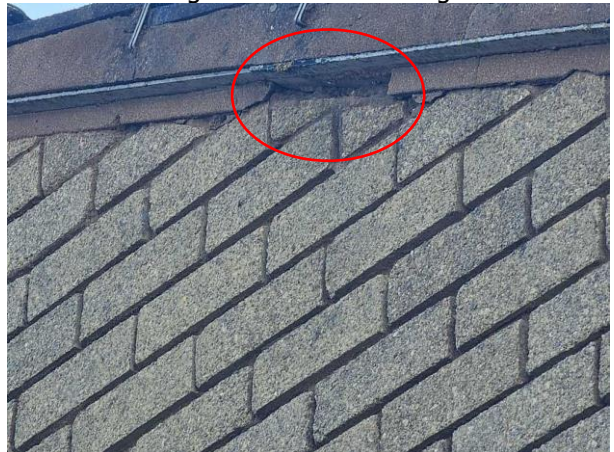
Photo 6: Missing mortar on western gable

| Roof | The roof is multi-pitched, with interlocking curved tiles in good condition and few visible gaps overall. Plastic anti-wildlife spikes are installed along the edge of each tile run; however, some are bent or missing, creating gaps that may allow access between the roofing felt and tiles, potentially leading into the roof void (Photos 7 and 9). Notably, there are additional gaps at the apex on the southern elevation pitch, and a large section of missing mortar along the edge of the western elevation, compromising the tile seal in that area (Photos 6 and 8). |

- **PRF 1:** Gaps created by missing mortar along the edge of the roof tiles and at the roof apexes, which may provide access beneath the tiles (Photos 6 and 8).
- **PRF 2:** Bent or missing anti-wildlife spikes along the roof tile runs, potentially allowing entry to the space between tiles and the 1F bitumen roof lining (Photo 7).
- **PRF 3:** Gaps beneath bargeboards and fascias, which could lead into crevice spaces suitable for bat roosting (Photo 5).
- **PRF 4:** Missing or damaged vents on the southern and eastern elevations, which may provide entry into the wall cavities or other enclosed spaces (Photo 10).

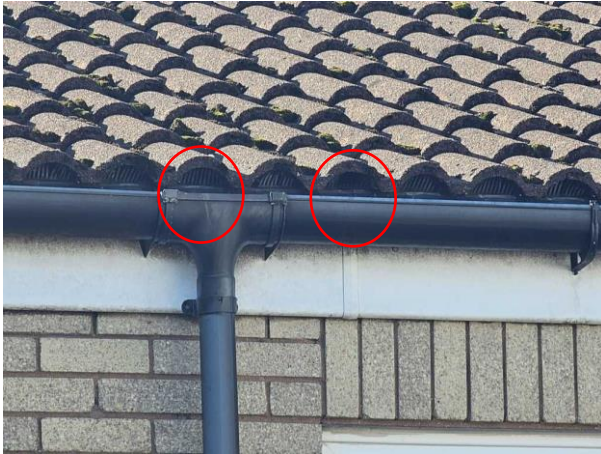
Photo 7: Interlocking tiles with missing wildlife spikes

- Gaps created by bent or missing plastic anti-wildlife spikes along the roof tile runs (Photos 7 and 9);
- Missing mortar along the edge of the western elevation roof tiles (Photo 6);
- Gaps beneath or around bargeboards and fascias on all elevations (Photo 5);
- Lifted lead flashing at the joint of the single-storey extension on the north-east elevation and around vent stacks (Photo 9);
- Damaged or missing vents across the southern and eastern elevations (Photos 4 and 10); and
- Gaps within the brickwork due to missing mortar on all elevations (Photos 6, 8 and 11).

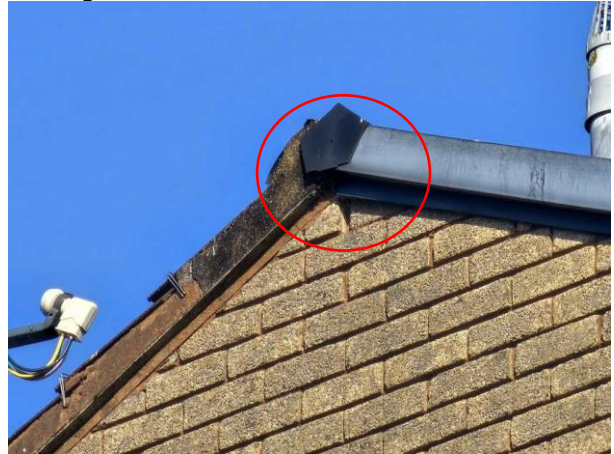
Photo 8: Gap at apex on southern elevation and missing mortar between bricks

| External Walls | External walls are constructed of brick and mortar across all elevations, gaps due to missing mortar are present within the brickwork on all elevations (Photos 8 and 11). |

- **PRF 5:** Lifted lead flashing around the vent stacks and at the north-east elevation joint, creating small gaps (Photo 9).
- **PRF 6:** Gaps in masonry caused by missing mortar in the brickwork, along all elevations (Photos 8 and 11).

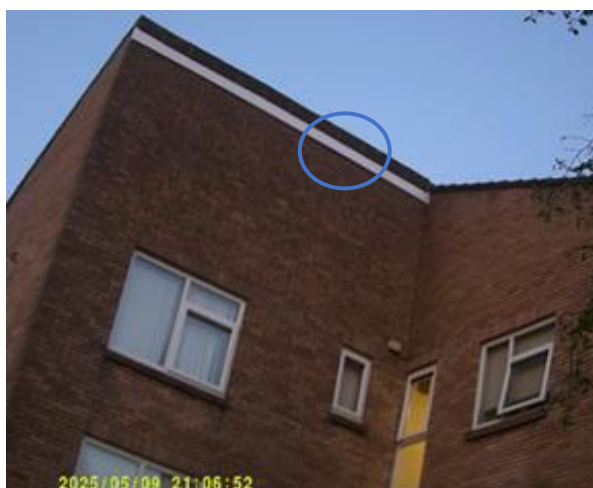
Photo 15: Photo showing common pipistrelle roost location on the western elevation

= common pipistrelle roost location

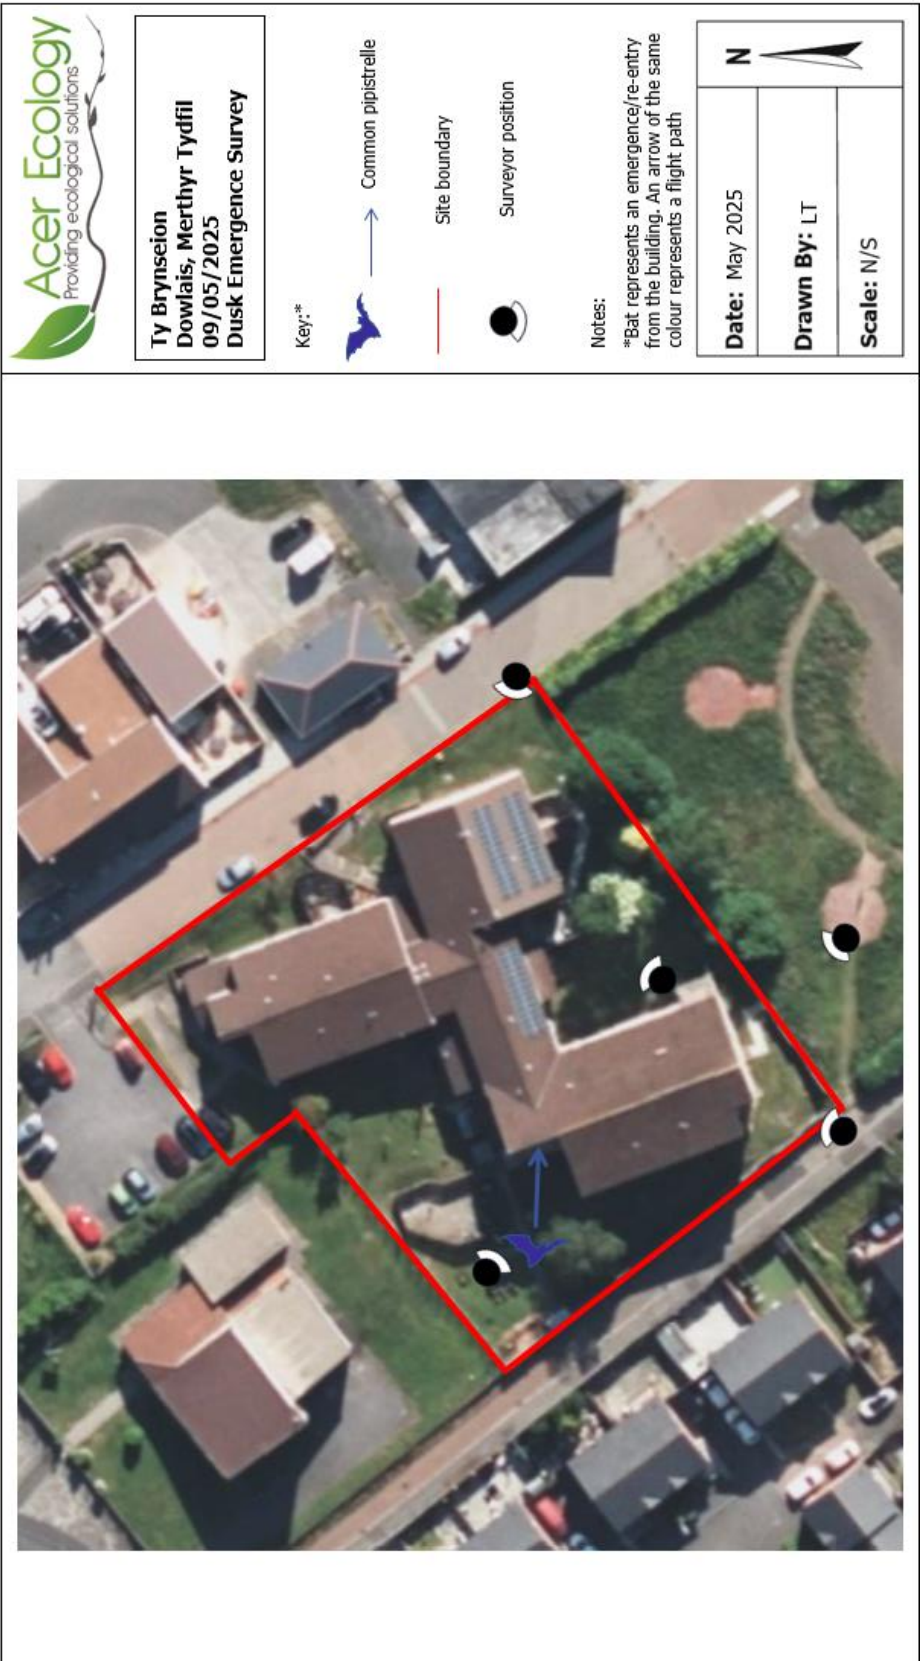
Plan 5: Dusk Emergence Survey Results

Survey 1B: 09/05/2025

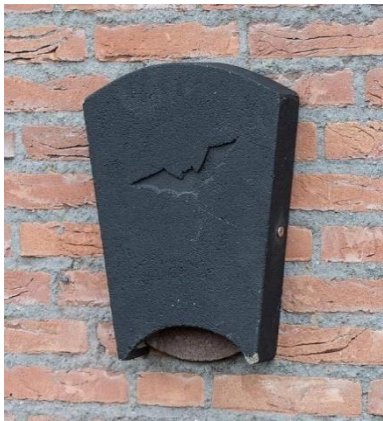
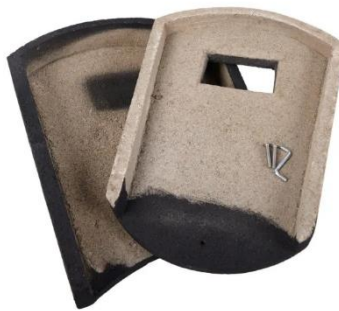
## Appendix 8: Beaumaris Woodstone Bat Box

This bat box is made entirely from woodstone, a robust material comprising concrete and wood fibres. This means that, not only does the box have excellent insulating properties maintaining a more consistent temperature throughout the year, it also provides excellent protection from predators. The Beaumaris box has a single narrow cavity which makes it suitable for crevice roosting bats such as the common pipistrelle, soprano pipistrelle, Nathusius' pipistrelle, Brandt's bat and whiskered bat. The interior of the box has a rough surface for bats to cling to and the front of the box features a subtle but attractive imprint of a bat in flight.

Suitable for attaching to external walls and should be sited as high up on the façade as possible, at a height of at least 3m from the ground. Avoid siting under artificial lights. Bats prefer to change roosts to benefit from varying ambient temperatures, so bat boxes should ideally be clustered in small groups.

- Height: 39cm
- Width: 29cm
- Depth: 6cm
- Weight: 4.4kg

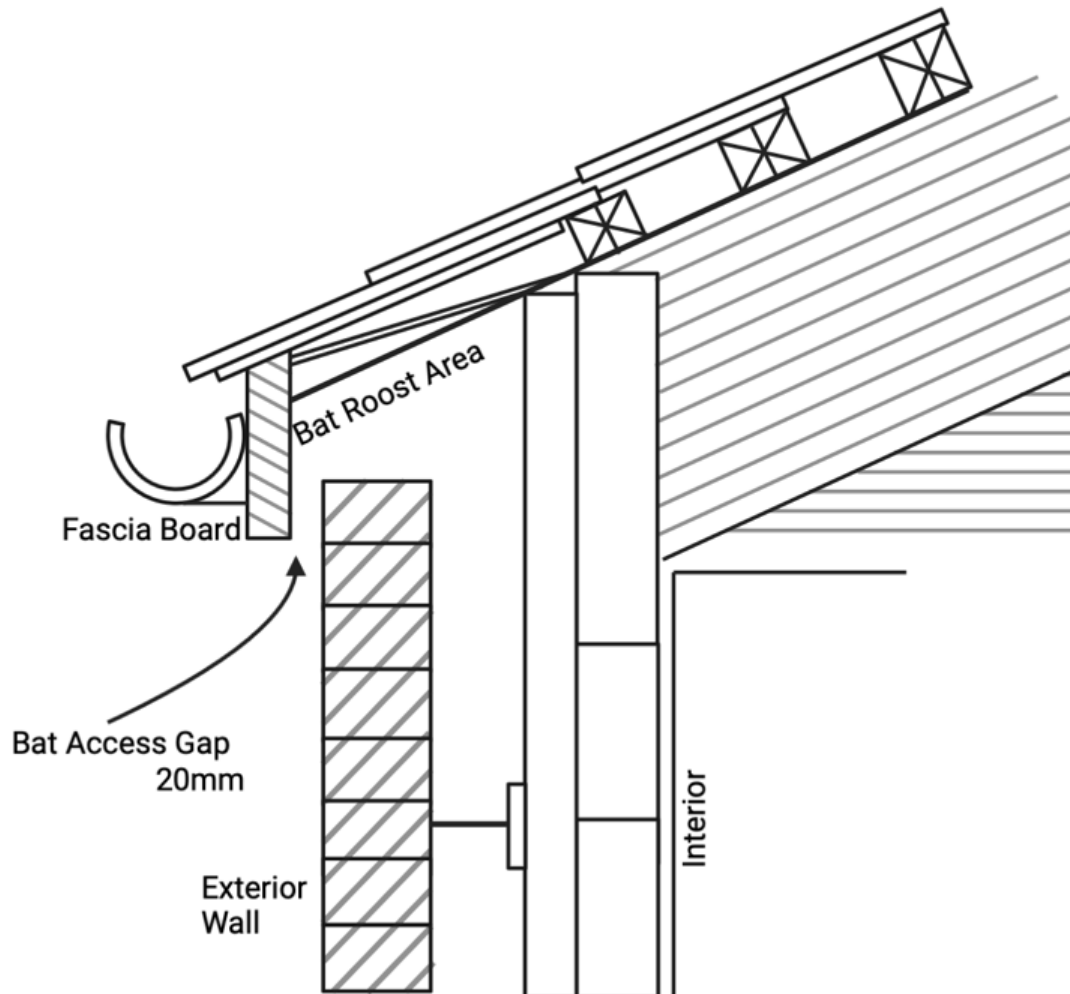
## Appendix 9A: Raised Fascia Boards

Closed design, without access into roof void.

- 
- Insulation and rough rendering will be placed on the outside of the external brick wall as part of the proposed works, with the fascia offset 20mm from the exterior edge.
- Bat access gaps should be located away from windows, doors and other light sources.
- The new fascia will be made of timber or if uPVC plastic is used, the underside will be lined with timber.

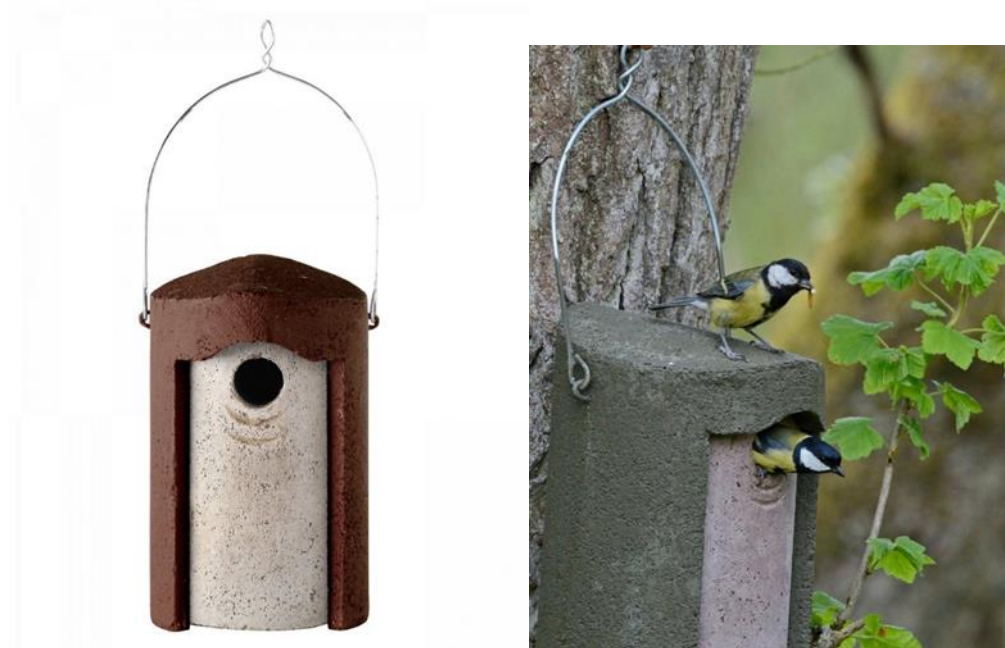
## Appendix 10: Schwegler 1B General Small Bird Box

The Schwegler 1B Woodcrete nest box is available with different entrance hole sizes to attract a wide range of species and prevent competition between birds. The nest box can be attached to the tree or wall using an aluminium nail or by hanging over a branch. The nest box has removable front panel to aid inspection and cleaning.

- **32mm entrance hole** will attract great, blue, marsh, coal and crested tit, redstart, nuthatch, collared and pied flycatcher, wryneck, tree and house sparrow and bats.
- **26mm entrance hole** suits blue, marsh, coal and crested tit and possibly wren. All other species are prevented from using the nest box due to the smaller entrance hole.
- **Oval entrance hole** (29 x 55mm) suits redstarts because more light enters the brood chamber. It is also suitable for all other species which nest in the 32mm boxes

The Schwegler 1B general small bird box will be preferably mounted on a stable tree trunk, rather than on branches which will sway. The mounting location will not be heavily shaded. Boxes should be mounted vertically on the tree.

Boxes will be mounted a minimum of 2m, and preferably 3m, above the ground, and as far as possible placed on the SE- or SW-facing surfaces of the tree trunks.
