# Technical Note

Job name: Ffos y Fran Restoration Strategy

Ref. **Note on storage shed suitability for roosting bats**

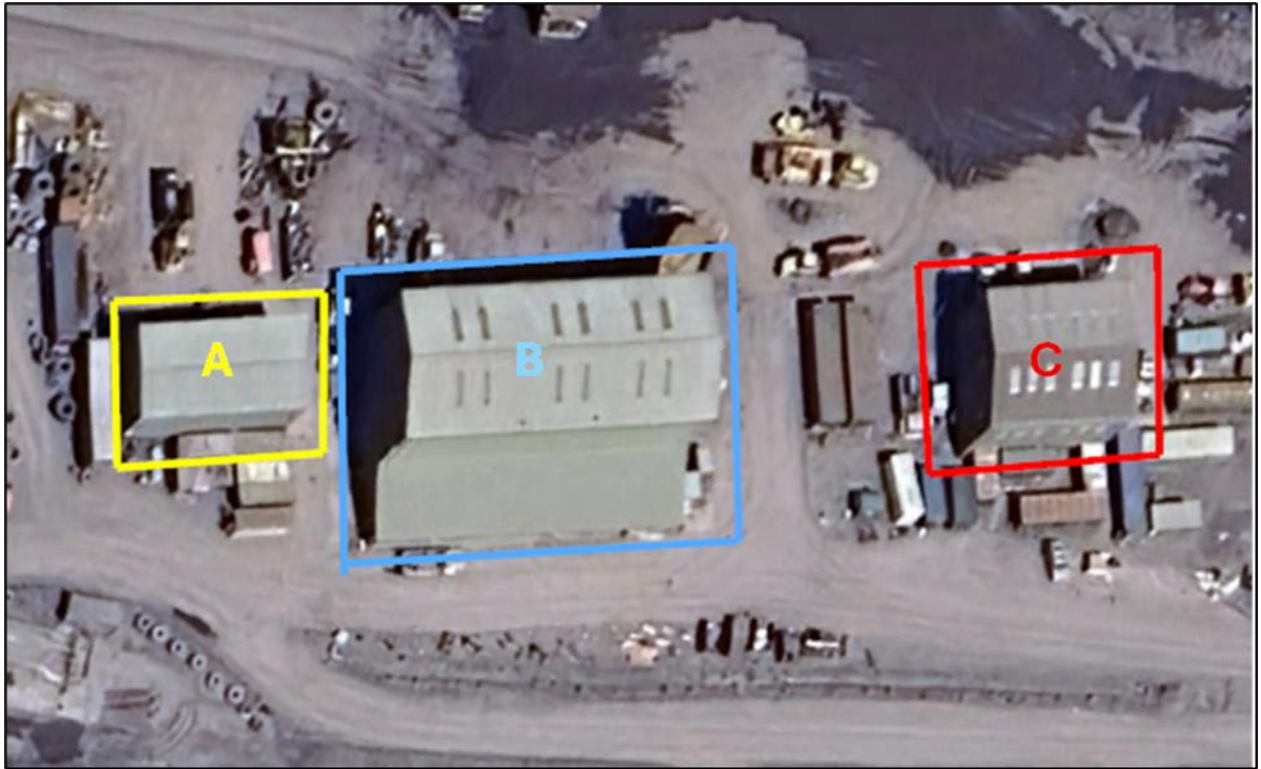
**Figure 1.** The three sheds with arbitrary reference letters (A-C) corresponding to photographs in Table 1.

There are three storage and/or workshop sheds on this central area of the site that lie north of Bogey Road and used during the operational phase of the mine for servicing vehicles and materials storage (**sheds A-C; Figure 1**). The sheds comprise single-storey steel portal-frame industrial storage buildings with profiled metal wall and roof cladding (including rooflight panels on sheds B and C), set on a concrete slab and accessed via large roller shutter doors and a personnel door.

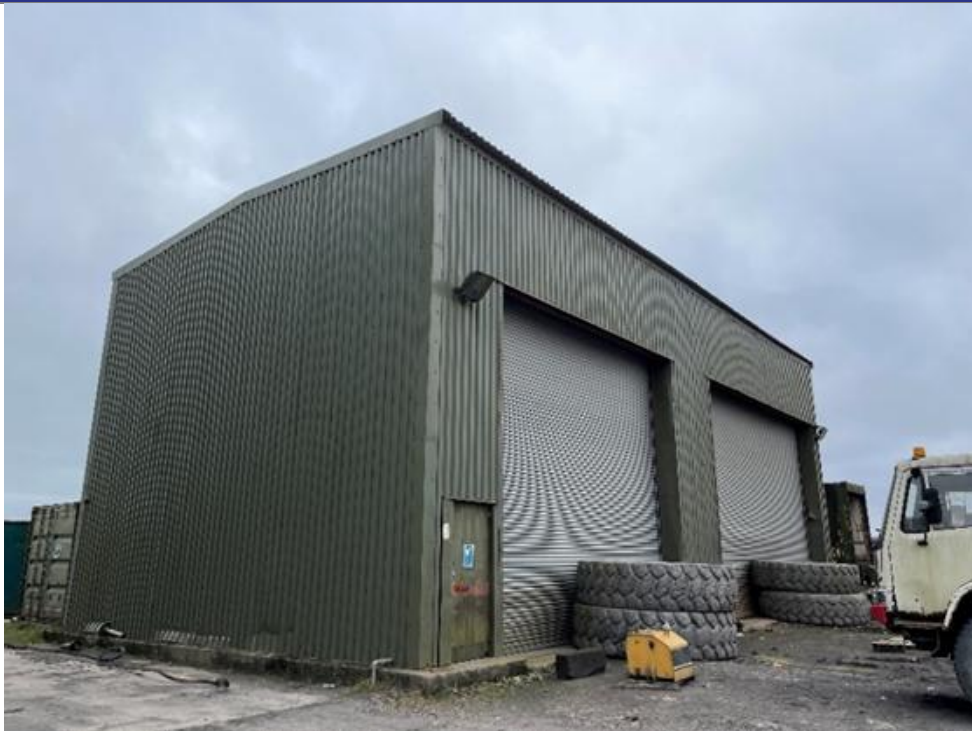
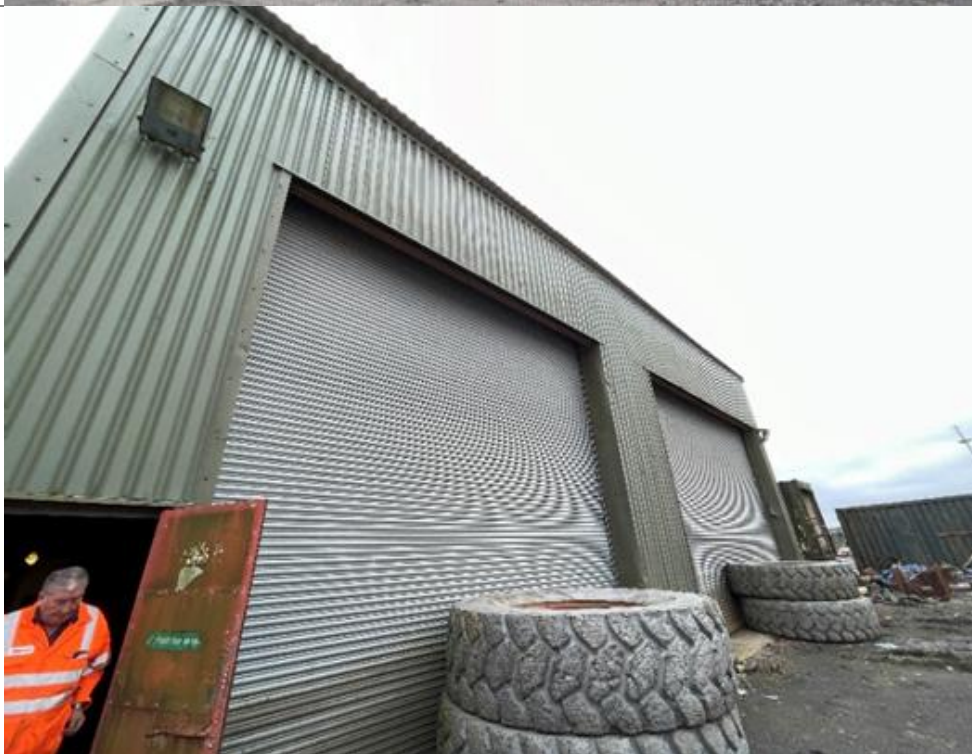
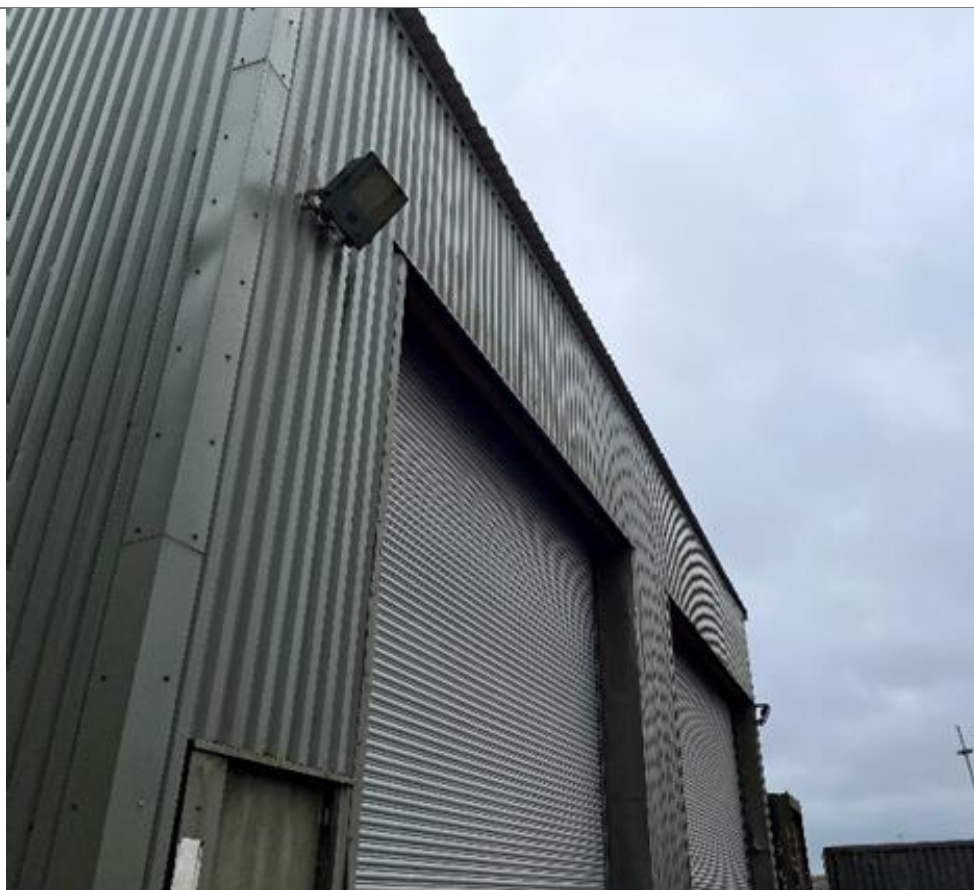
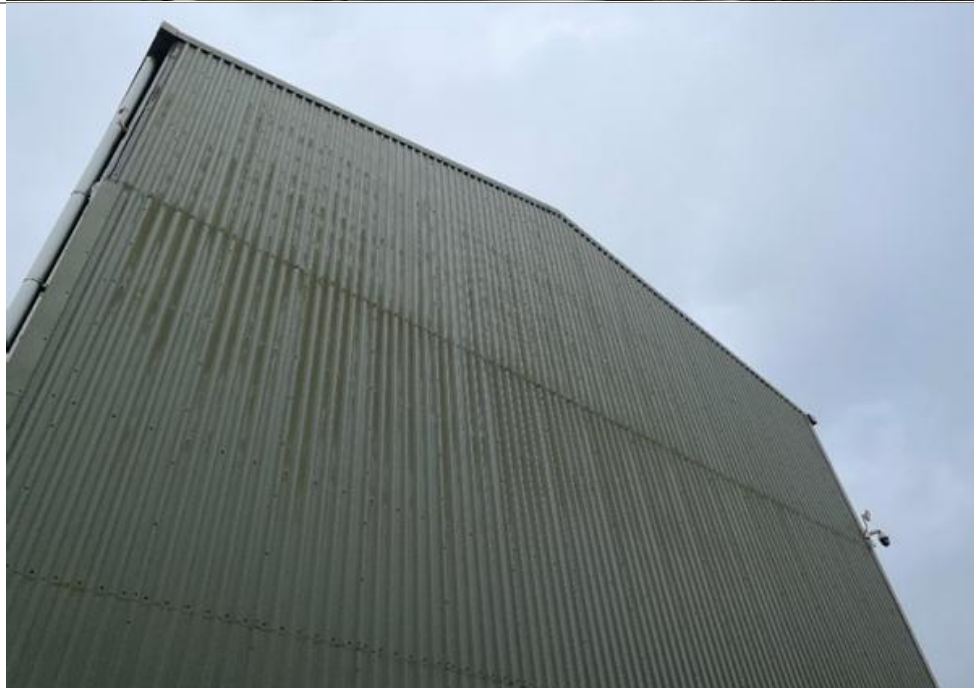
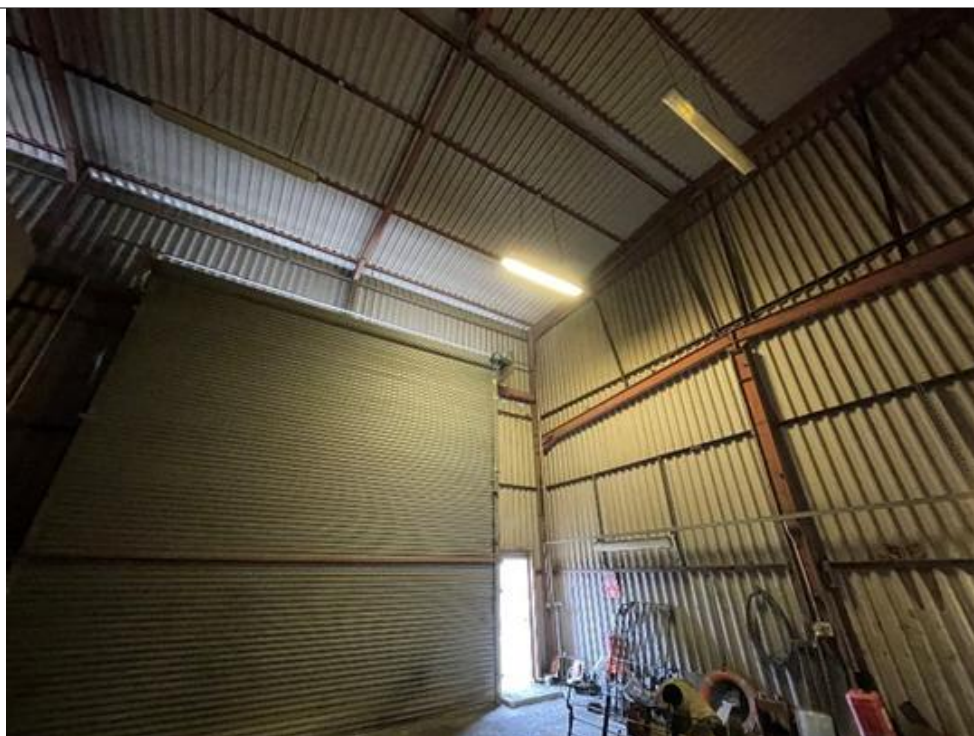
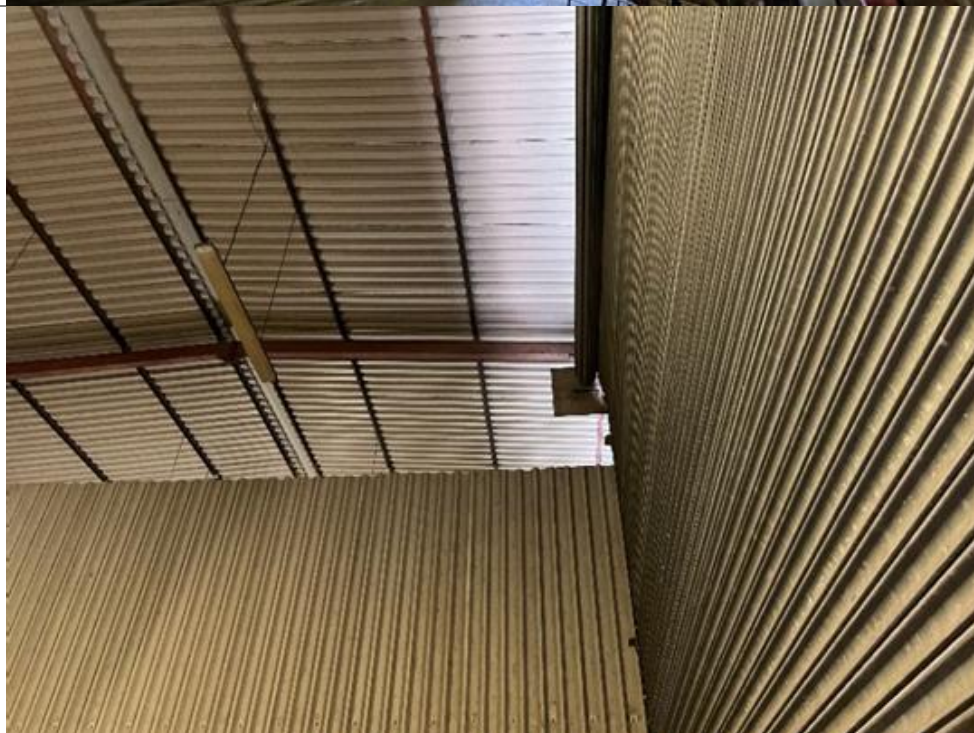
**Shed A**

Roosting bats in the UK typically select buildings that provide sheltered cracks/crevices, small openings and roof voids, with a favourable and relatively stable microclimate, and (for many species) low levels of artificial lighting around roost access points. In contrast, modern metal-clad portal-frame sheds of this type generally offer few suitable roosting features (e.g., a lack of tiled roofs, soffits and complex junctions that create concealed crevices), and any minor gaps that do occur are more likely to be exposed to draughting and rapid temperature fluctuation due to the thin metal envelope and large door openings, making them less suitable for maintaining the stable conditions bats tend to use. In addition, as equipment stores, they are typically subject to regular human activity, vehicle/machinery movements and lighting, and guidance<sup>3</sup> notes that lighting in the vicinity of roosts/access points can disturb bats and deter use where alternative roosts are available. On this basis, the three sheds are considered to have negligible potential to support roosting bats.
