## **PRELIMINARY BUILDING INSPECTION IN RESPECT OF BATS:**

**148 High St  
Merthyr Tydfil  
CF47 8DP  
SEPTEMBER 2024**

Preliminary Building Inspection in Respect of Bats

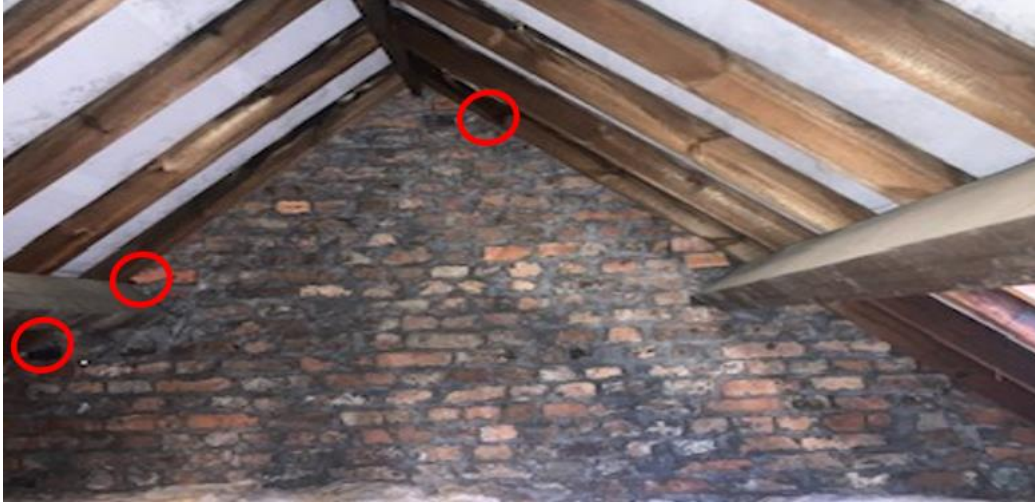
Figure 4.

- 1) Between the roof beams and west facing wall. (Figure 4).
- 2) Bat droppings and feeding remains. (Figure 5).

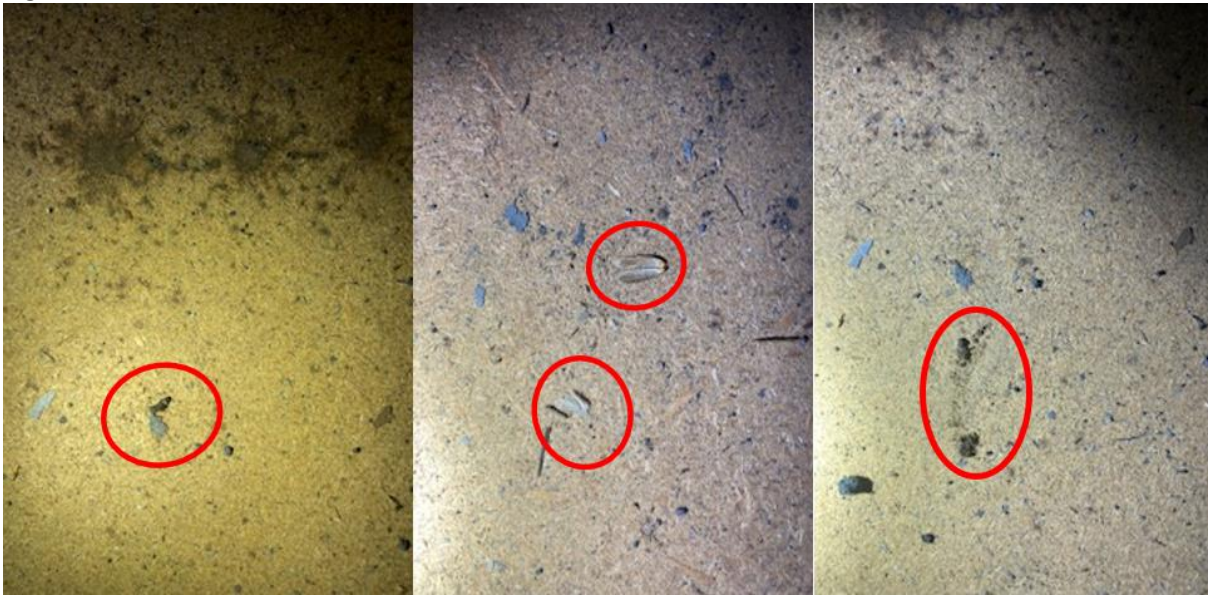
Figure 5.

No bats were observed during the internal survey, but evidence of bats was observed in the loft space. Potential roost sites were identified:

The potential access points on the northern edge of the west facing wall and multiple potential access points on the western and eastern facing walls of the neighbouring property to the south that has open spaces in the loft that connects both neighbouring properties and the evidence of bat dropping and feeding remains proves that there are bats using the loft space.

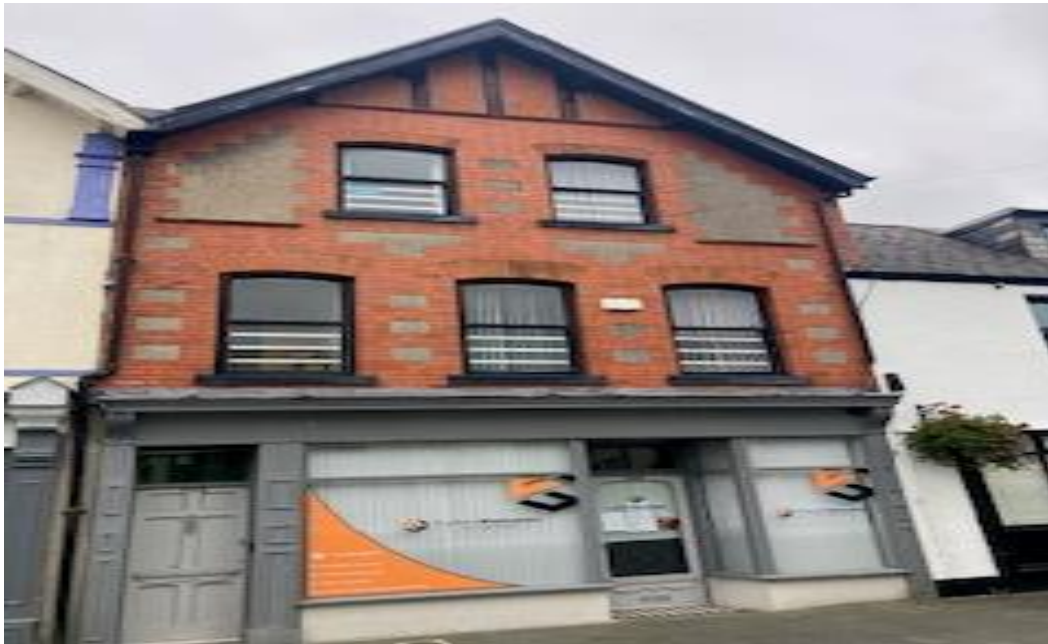
Plate 1 –Eastern (Front) elevation

The property (**Plates 1 - 3**) is a three-storey structure of brick construction under a Marley Mendip style concrete tiled roof, the ridge of which is oriented generally east-west. There are no chimneys. The roof has a Velux window in the southeastern corner allowing for daylight to enter which lights up the eastern part of the loft during daytime hours.

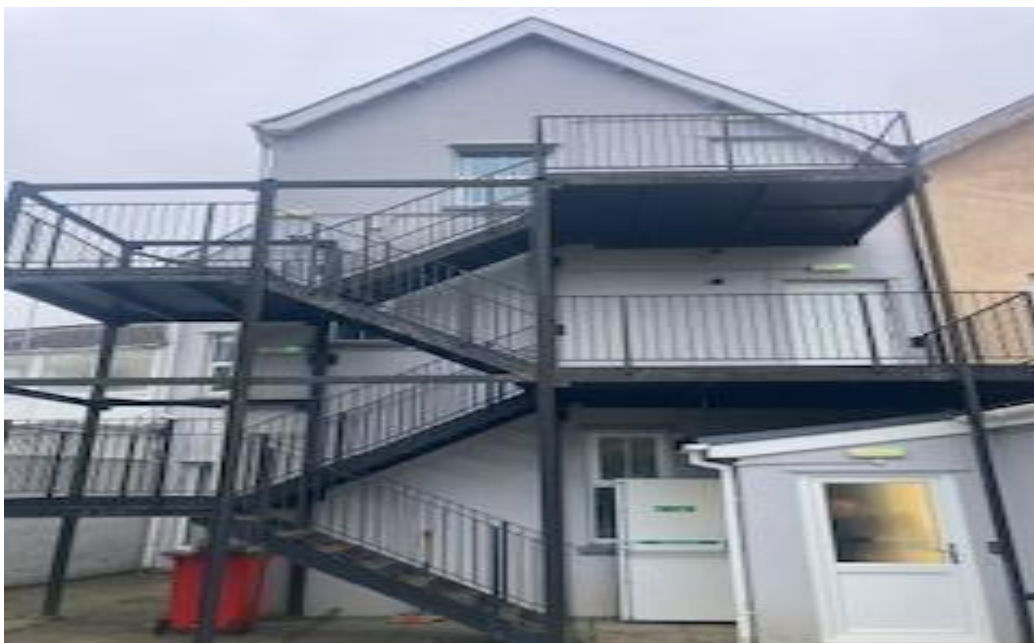
Plate 2 – Western (Rear) elevation

The west facing wall of the property has a open fire escape covering all 3 levels.

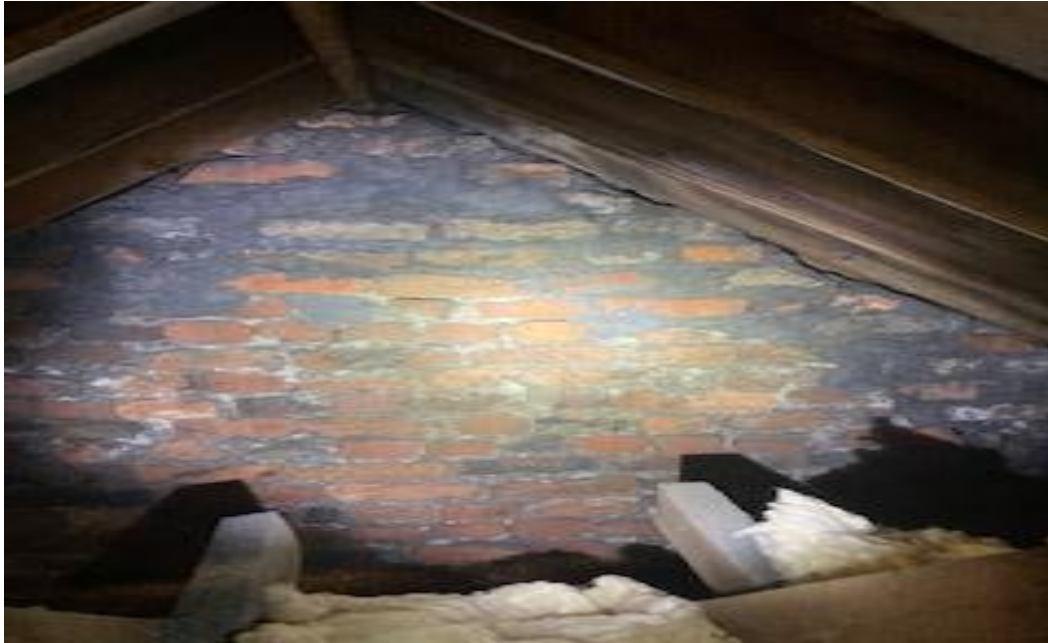
*Preliminary Building Inspection in Respect of Bats*  
Plate 5 – Internal view of western wall in loft

The loft space has large cavities connecting to the adjoining properties both south and north. The roof beams are exposed with felt lining in between. The floor is partially covered by wood to allow use for storage and the uncovered areas have exposed insulation.

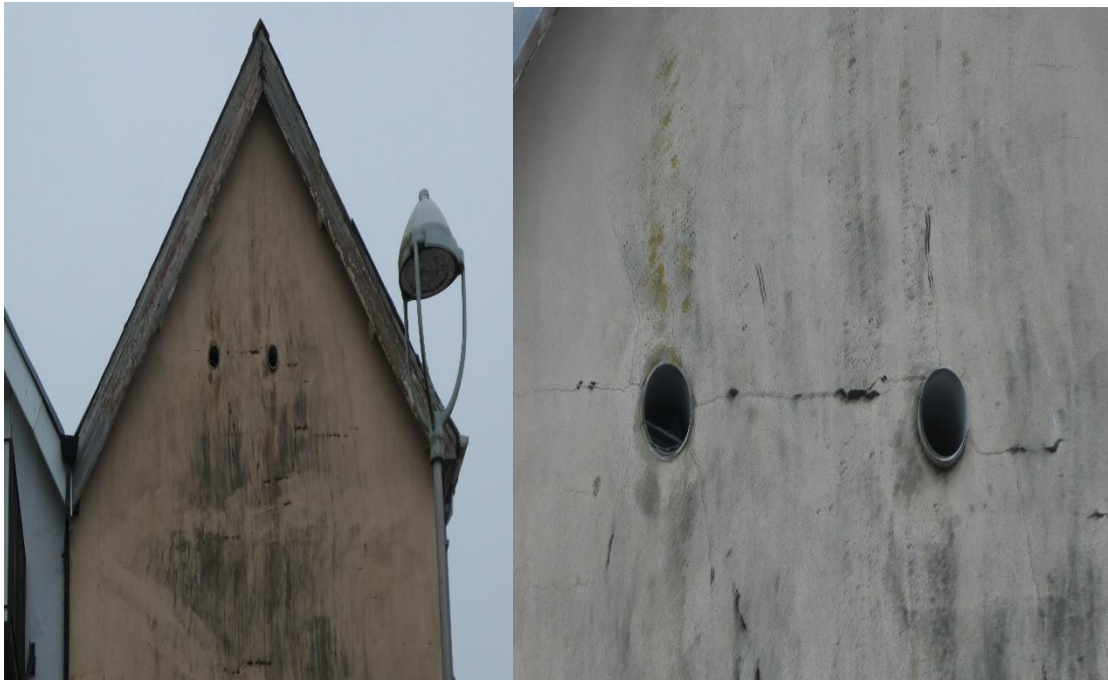
Plate 11 – View of neighbouring property to southern end rear wall with openings to loft

Due to there being no access to the roof spaces of the neighbouring Southern and Northern properties and potential bat access points, I recommend that a minimum of 3 dusk activity surveys are carried out that should include the neighbouring properties East and West facing aspects so that the classification of the building can be determined accurately. Also, internal monitoring by static cameras is recommended to confirm use of loft space as for transit by bats or indeed as a roosting space.
