## Bat Survey: 26 Courtland Terrace, Merthyr Tydfil, CF47 0DT

Instructed by: Lee Pickett

Reported by: Ecological Services Ltd  
10 Mount Pleasant, Llanelly Hill, Abergavenny, Monmouth NP7 0NT

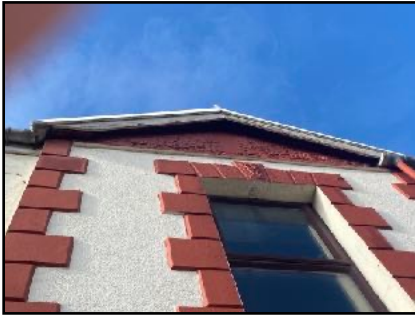
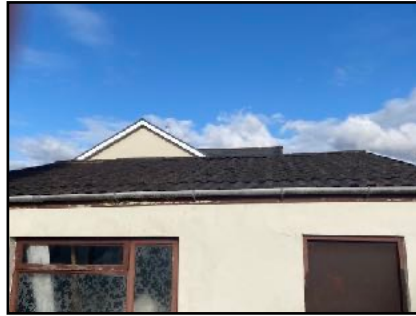
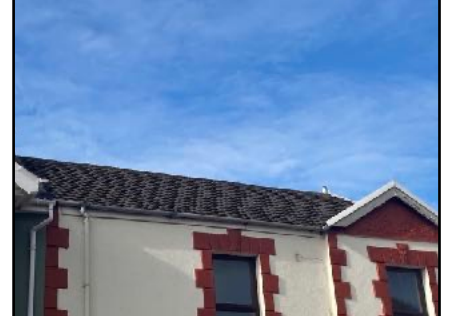
**6.3 There is limited potential for bats to access and use both buildings**

**6.4 Gaps along the roofline and under cement tiles did offer moderate potential for bat access.**

**6.5 No droppings or evidence of bats were discovered on any external features.**

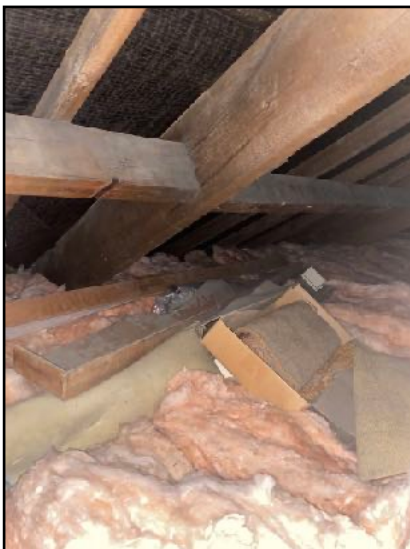
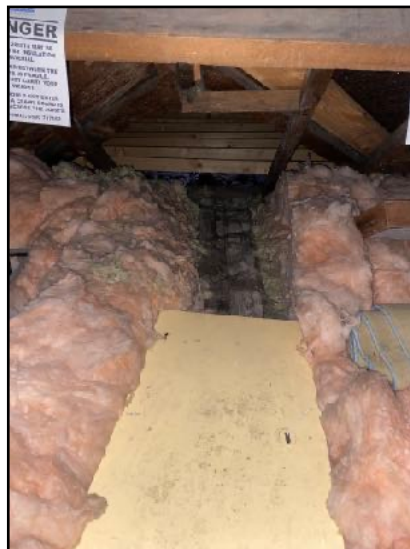
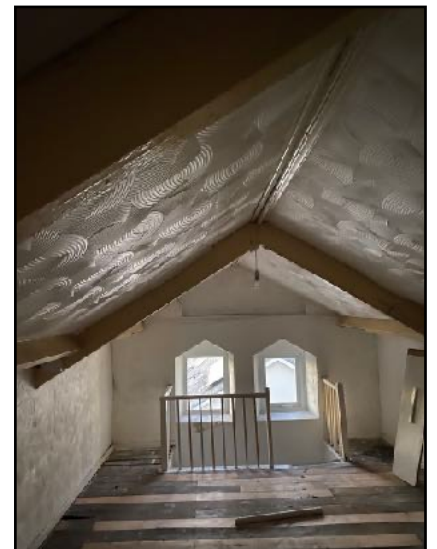
**7.2 The upper floor also occupies the internal roof space.**

**7.3 There were limited roof voids.**

**7.4 No bat droppings were discovered during the search of the attic space.**

**7.8 There was no external light visible from the internal attic space.**

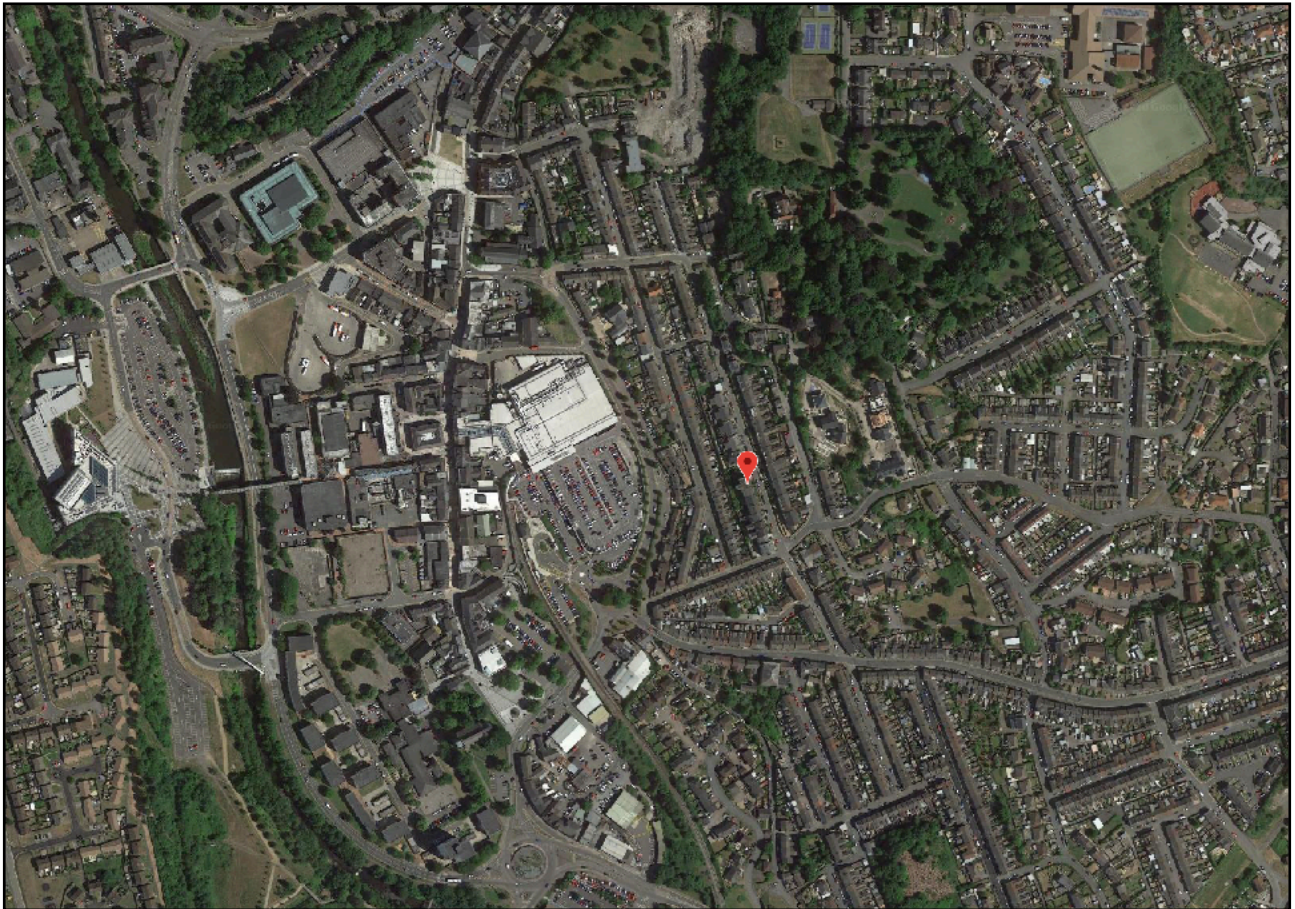
### **Aerial Photos**

**The site in its wider environment showing relatively good connectivity to surrounding habitat.**
