## Feeder Pipe Bridge Replacement, Abercynon Invasive Species Survey

Our ref: T7028

Client: Rhondda Cynon Taff Borough  
CouncilDate: 10<sup>th</sup> March 2023cc: Jess Clitheroe, Principal Ecologist  
jess.clitheroe@templegroup.co.uk

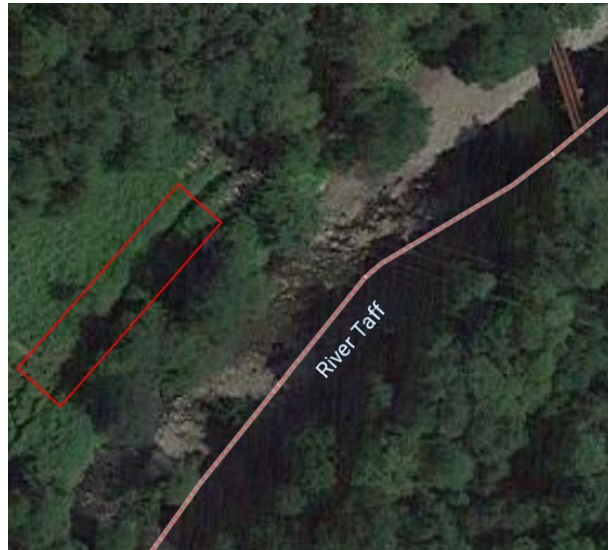
Image 1

A stand of Japanese Knotweed *Reynoutria japonica* syn. *Fallopia japonica* was recorded in a number of locations. The main 2 stands that are within the works area are a small stand found growing within woodland approximately 15 metres from the river, on the northwest bank of the site, and a larger area stretching along the northwest bank of the river between the two areas of Ancient Woodland (Appendix 2, Photographs 1 - 3).

Location of main stand of Japanese Knotweed, on the northwest bank. This is the area where the current access track will pass through.

A specialist contractor should be contacted to advise on the most suitable method of treatment for the site.

For vehicle and pedestrian access through the site a zone should be created for wheel washing and boot washing/scrubbing, which will need to be strictly observed to avoid the potential movement of any Japanese knotweed from the area into the wider site.

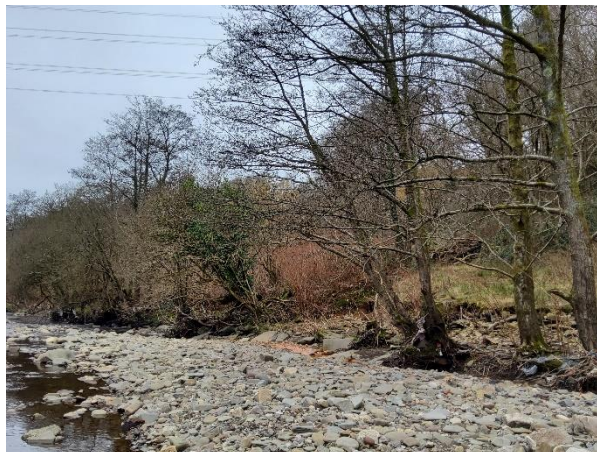
Image 2

Japanese Knotweed, *Reynoutria japonica* syn. *Fallopia japonica*, on the northwest bank. View from river bank by bridge

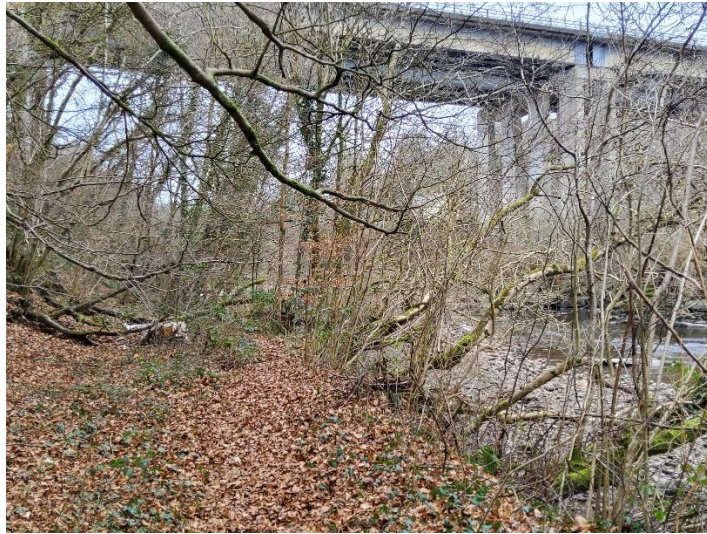
Image 4  
Japanese  
Knotweed on  
bank above river  
upstream from the  
bridge on the  
northern side
