**TYLA-GLAS FARM, BEDLINOG, MERTHYR TYDFIL**

**BAT SURVEY**

**ISSUE 1, VERSION B**

**OCTOBER 2022**

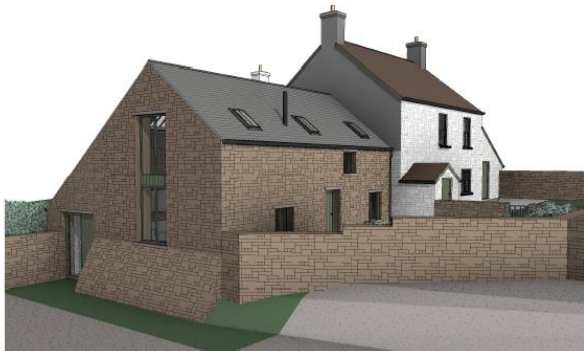
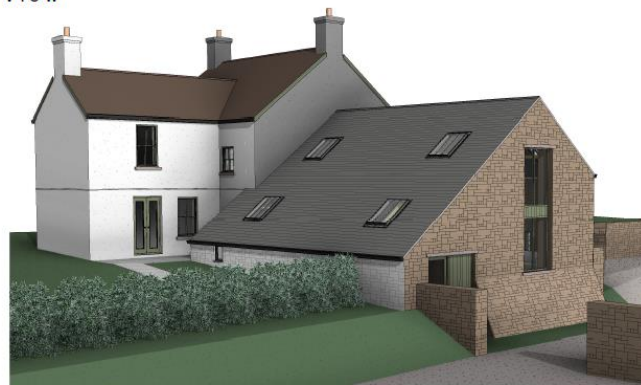
**DRAWING TITLE**  
Perspective Views as Proposed

**SUBJECT**  
Proposed barn conversion to form a  
residential dwelling

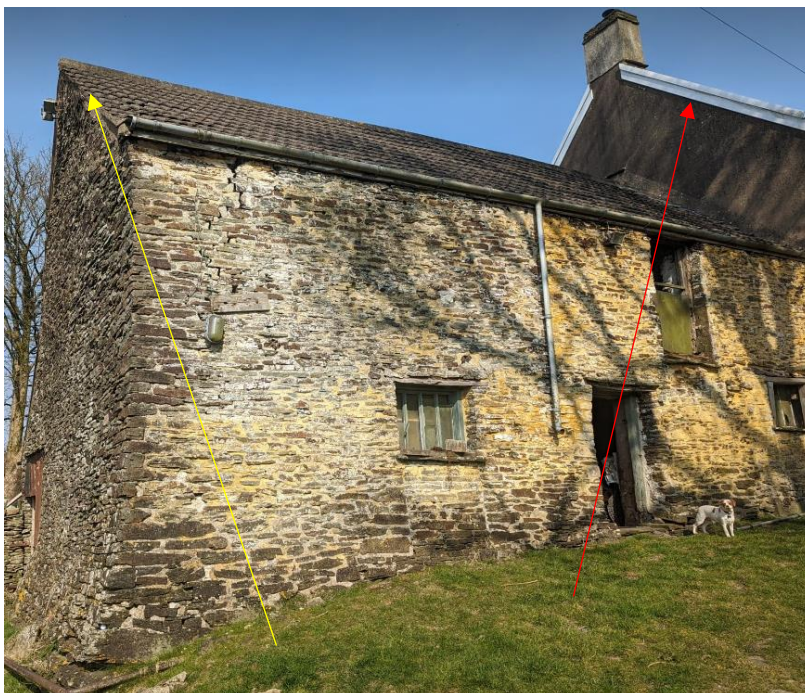
Figure 4: Common pipistrelle emergence points

The first bat call heard was a common pipistrelle bat, heard at 21:40, the bat was seen emerging from the barge board of the attached farm house before commuting east (figure 4, arrowed red). This was shortly followed by a further one common pipistrelle bat, all of which commuted north and east.

Immediately after this, two common pipistrelle bats were seen emerging from a gap in the stone work above the right hand wall plate of the south west gable of the barn (figure 4, arrowed yellow).

The first bat heard was a common pipistrelle approximately 10 minutes post sunrise, the bat was seen emerging from the same location it had done on the previous survey (figure 4, arrowed red)

The pipistrelle roosts will be mitigated for by creating four crevices within the stone work of the building on the south western gable. In addition to this a 10mm gap will be left between the stone wall and the barge board on the south western gable.

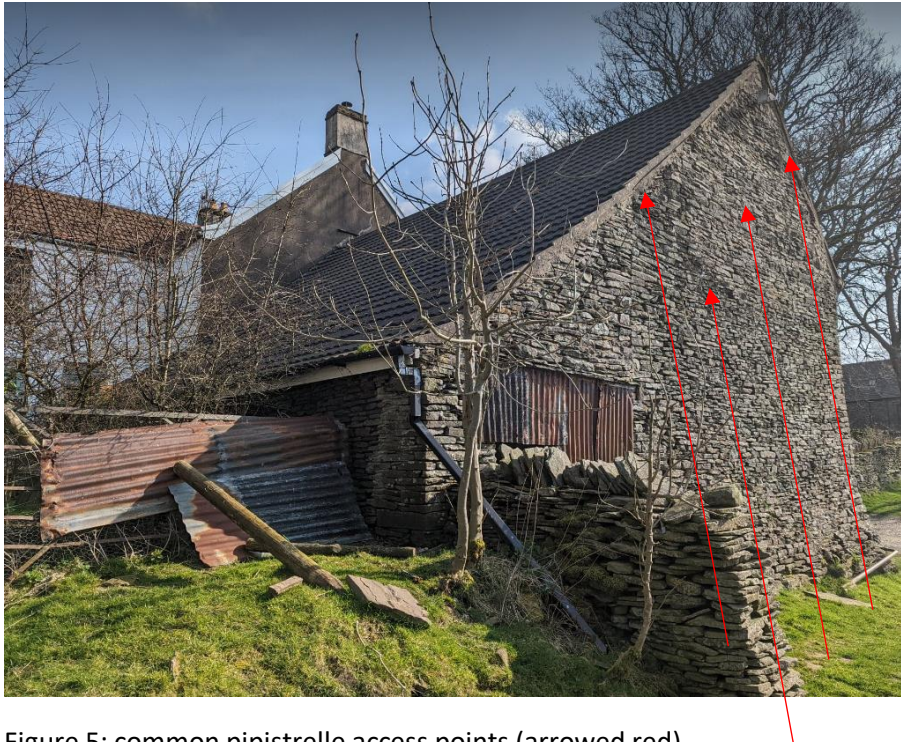
Figure 5: common pipistrelle access points (arrowed red)

Four common pipistrelles emerged from the barn under survey before commuting east (figure 5, arrowed red).

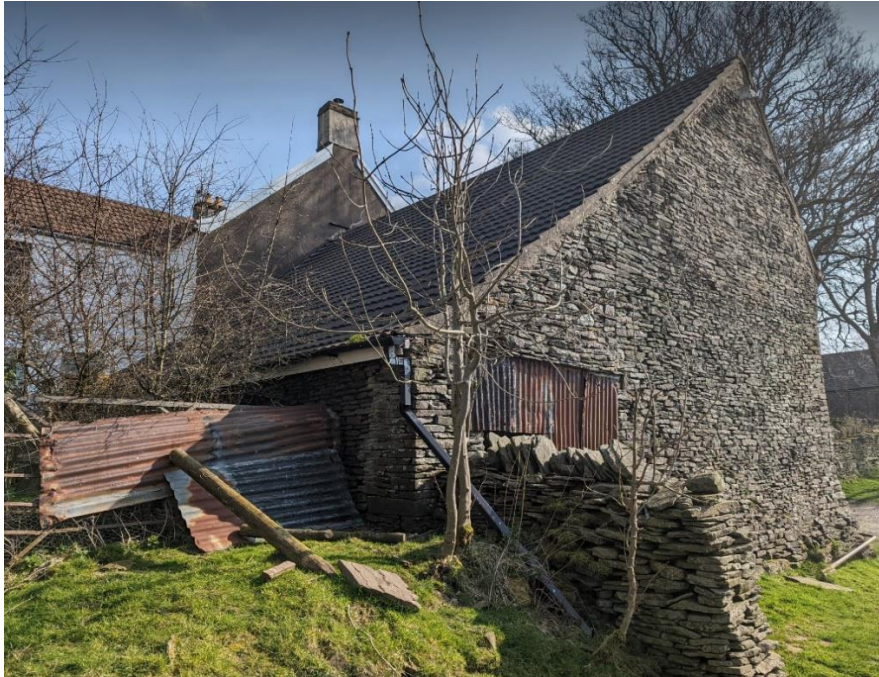
**Plate 1- south western gable and rear**

The survey carried out by BE Ecological Ltd revealed no droppings or evidence of bats on the exterior of the building. A number of access points were noted:

- Small number of potentially slipped tiles
- Gaps at the ridge
- Gaps above ill fitting windows and doors
- Gaps above wall plates of gables
- Gaps beneath fascias
- Gaps in cracked stonework

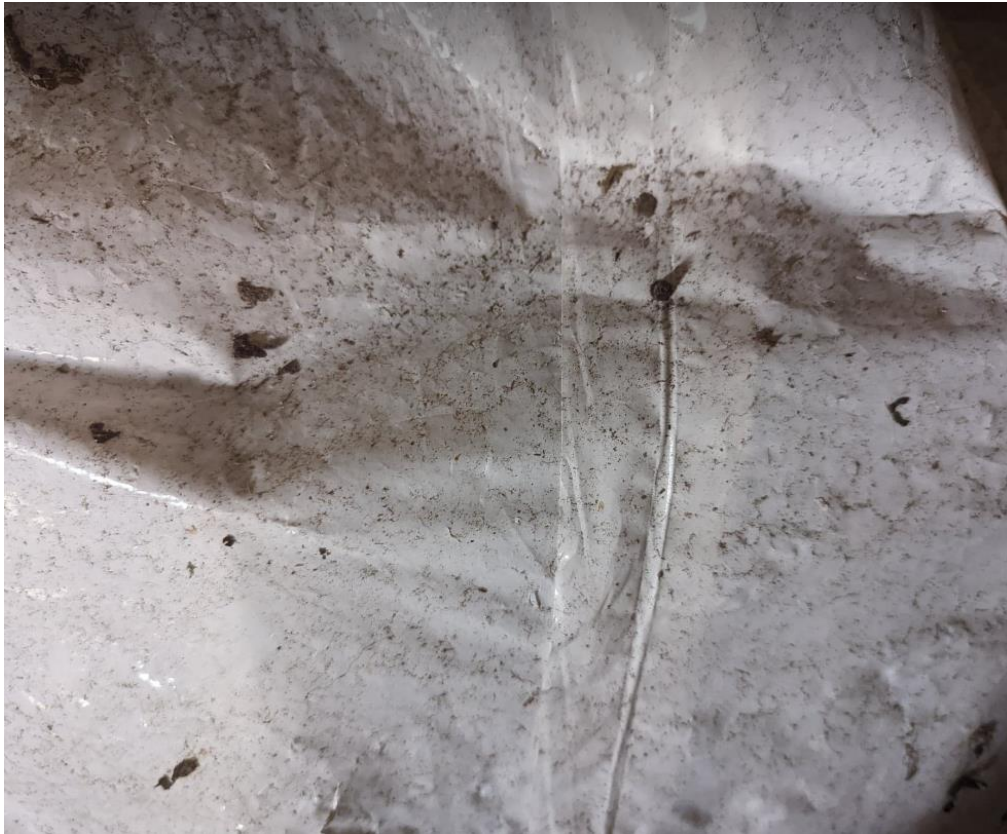
**Plate 11- photograph of individual dropping (bottom left corner)**

A scattering of droppings commensurate with a pipistrelle species was found throughout the barn (individual droppings on storage items). A single aggregation of droppings possibly commensurate with a brown long-eared species was found in the south western end of the barn below the ridge beam.
