**SARDIS CHAPEL, STATION TERRACE, BEDLINOG**

**BAT ACTIVITY SURVEY**

**ISSUE 1, VERSION B**

**SEPTEMBER 2024**

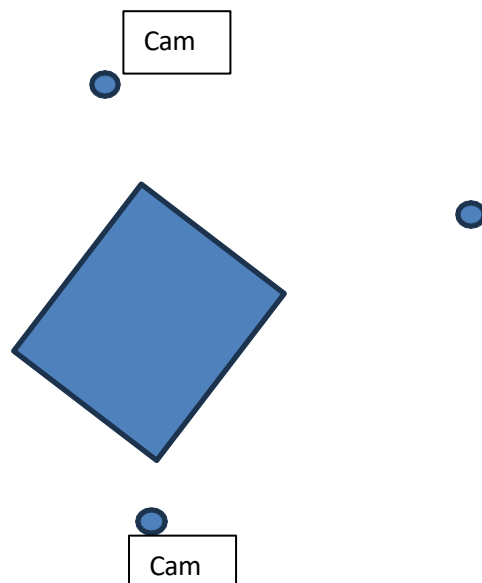
**Figure 1: Approximate surveyor locations**

Surveyor location dotted blue

Please note, it was not possible to erect a camera on the north eastern corner during the first survey. An attempt was made, however, due to the road being extremely narrow, there was a lot of traffic present that evening, with a lot of parked cars and surveyors were being harassed for putting a camera in the way. The decision was made to not use the camera and replace the camera with a surveyor. The sides of the property are only accessed via a very narrow pathway again making camera placement difficult. The rear of the building has a sheer drop present which is covered in vegetation, again making camera placement extremely difficult. It can only be accessed from the left hand side of the chapel.

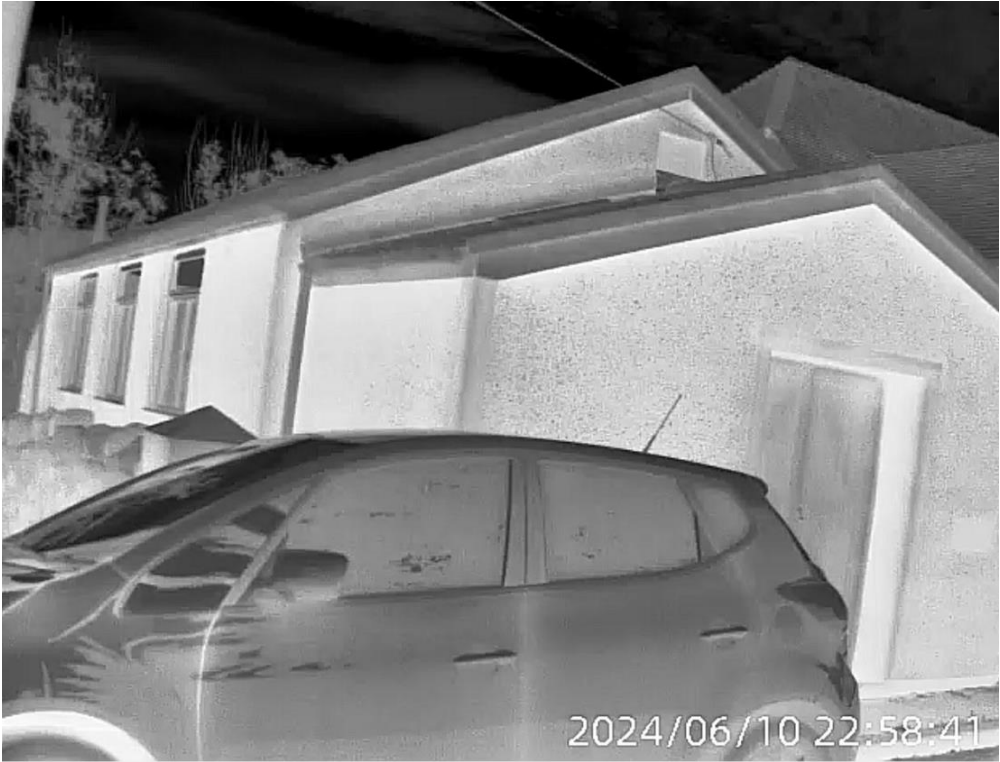
Figure 4- Thermal Guide camera view 10<sup>th</sup> June 2024

A survey was undertaken on 10<sup>th</sup> June 2024 as above, however due to a quieter street and less parking, a camera was able to be placed on the north eastern corner

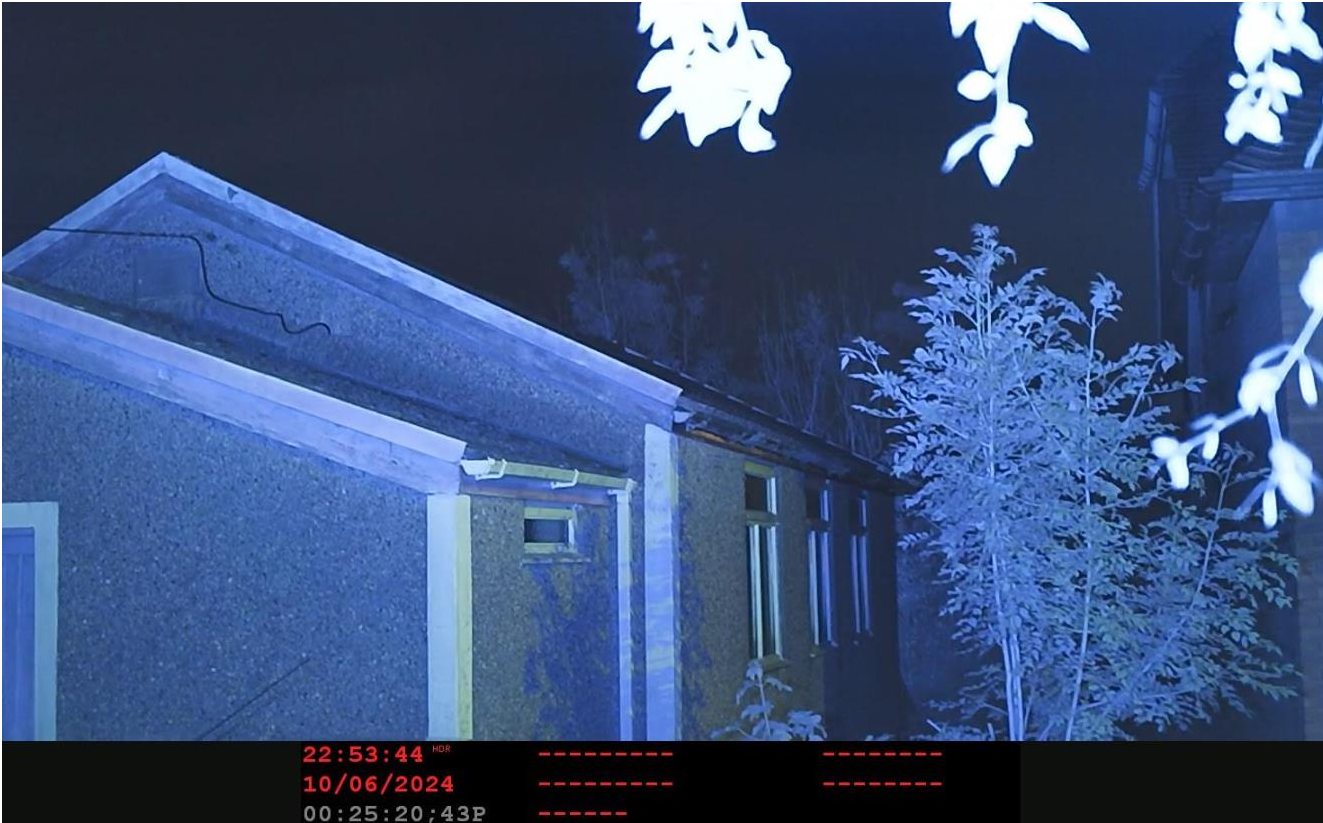
Figure 5- Sionyx colour night vision 10<sup>th</sup> June 2024

Brambles had grown up towards the rear of the property following a period of rainfall. The rear of the bank was also extremely slippery, so a decision not to place a camera at this location was made due to not being able to gain the correct angle and due to not being able to walk further afield as a result of health and safety. As much of the rear as possible was covered by a surveyor only.

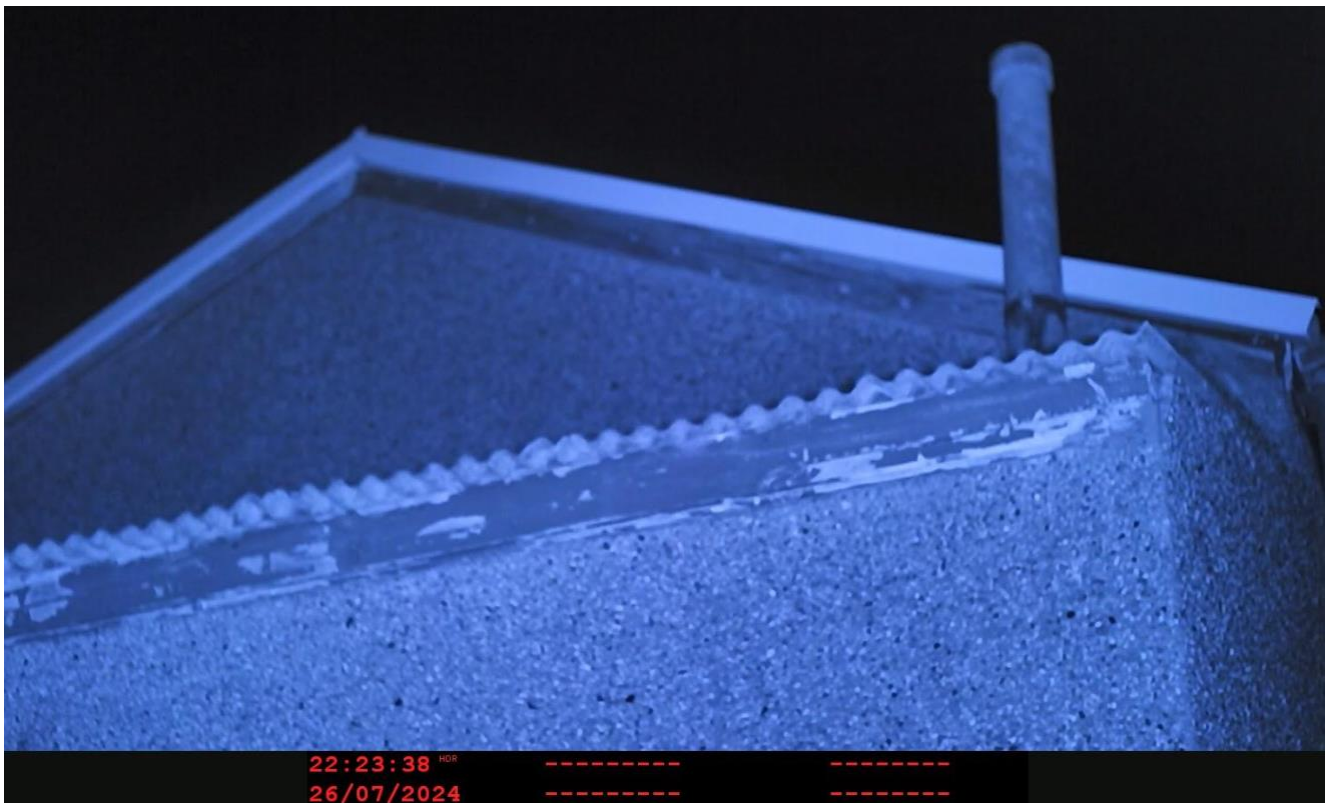
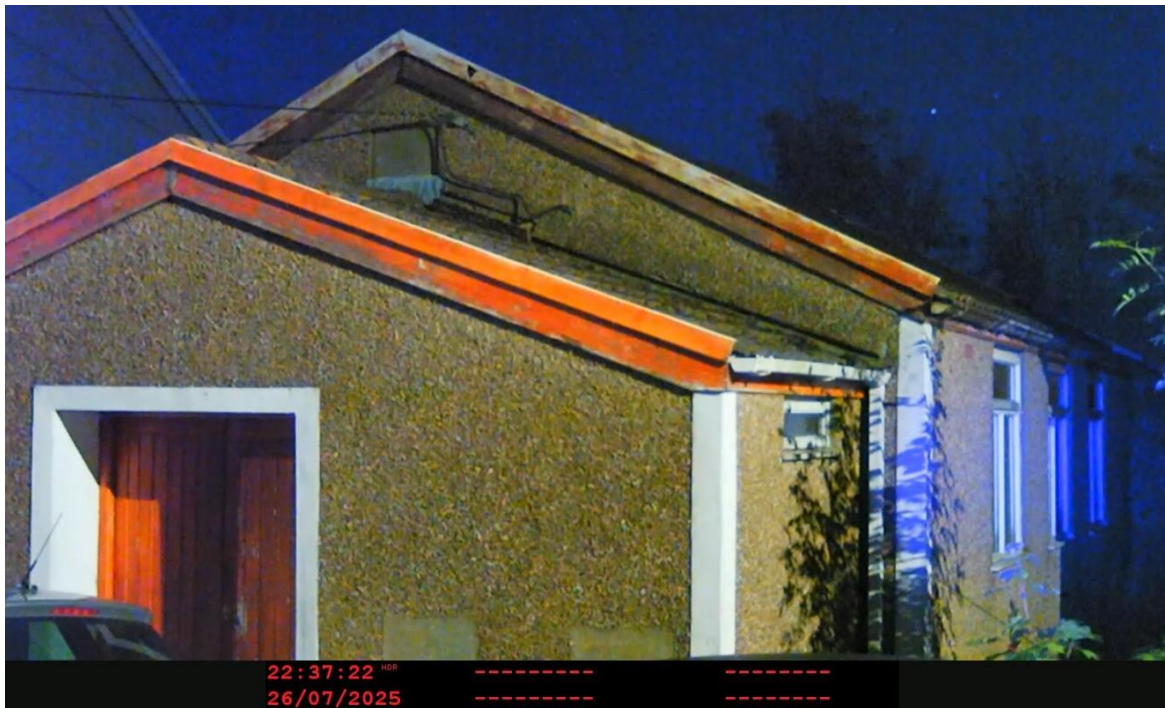
Figure 6: Sionyx night vision colour 26/07/24

A survey was undertaken as per figure 1 above. This time the banking to the rear had dried up with some of the brambles were able to be pushed out of the way and a camera was again placed at the rear. A camera was again able to be placed on the north east corner.

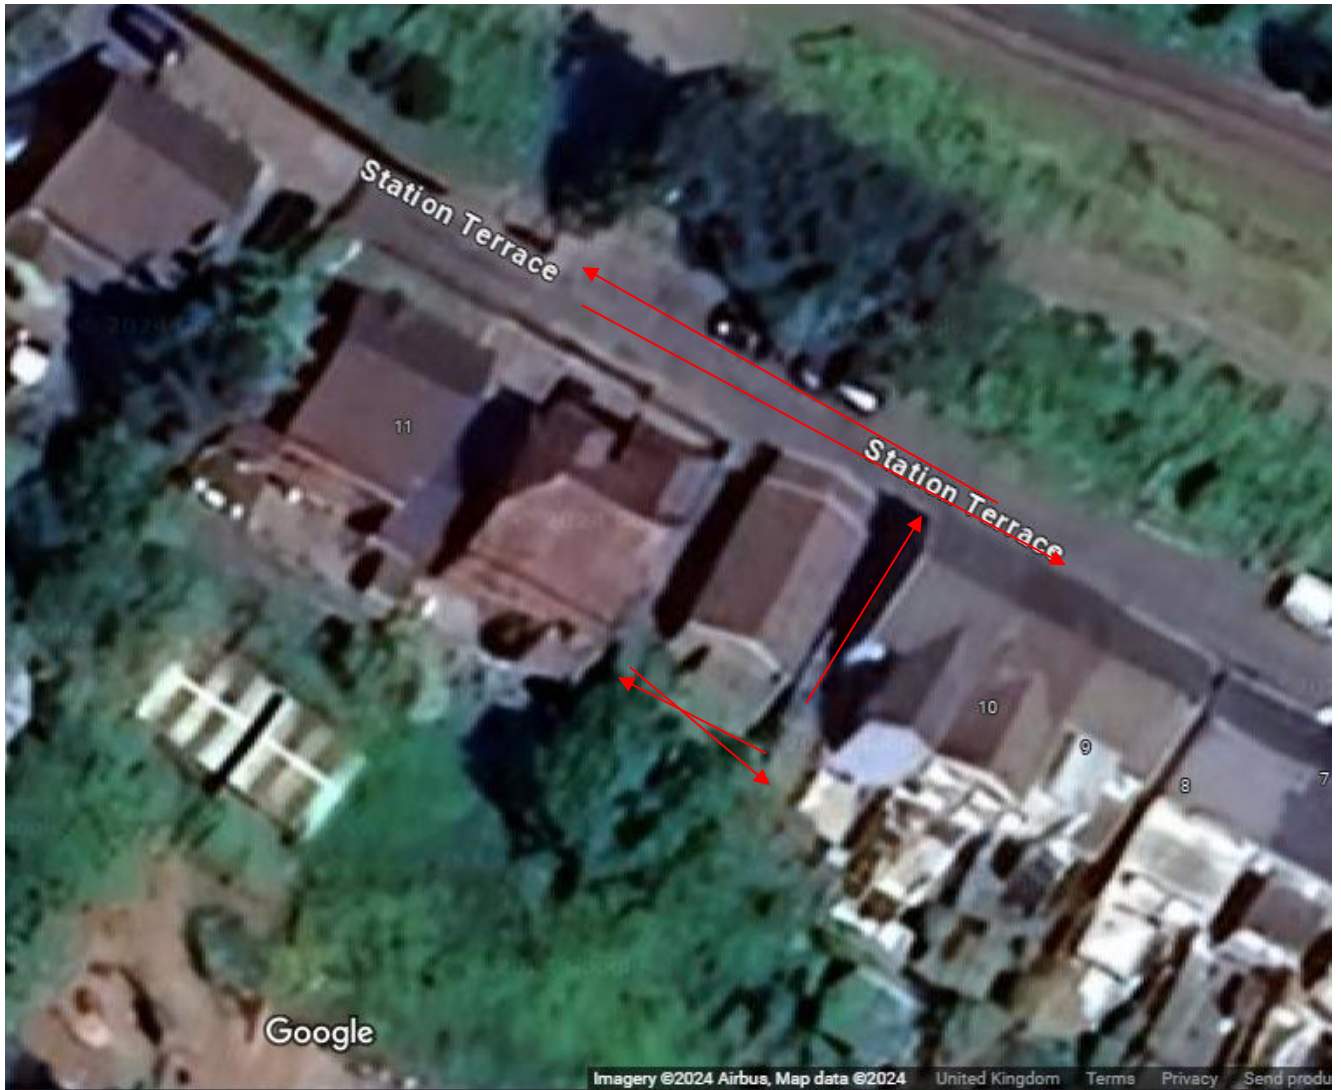
Figure 7: Locations of flight lines (arrowed red)

Again the only bat species heard on site were common pipistrelle, soprano pipistrelle and noctule. The first bat heard was a noctule approximately 20 minutes post sunrise. The bat was not seen. Again activity was very similar to that of the previous survey. No bats emerged from or interacted with the building on this date.

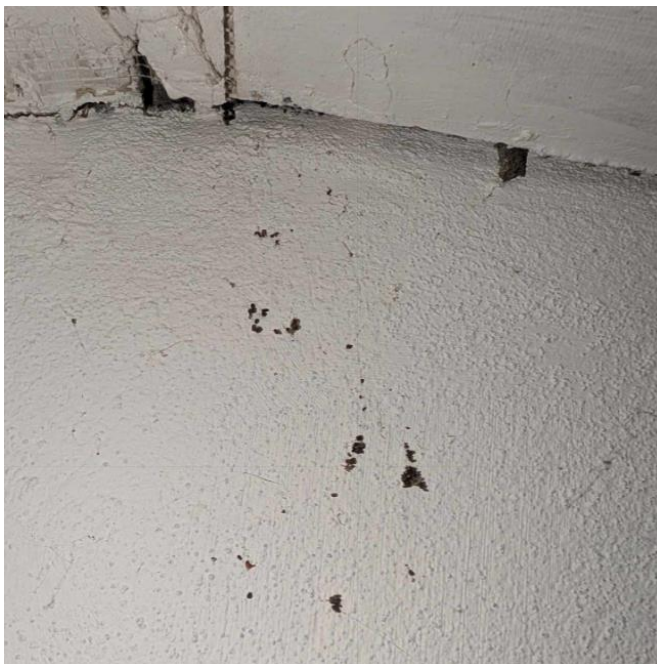
BE Ecological Ltd has since been to site to check the aggregation of droppings following a nil result from the surveys. It is unclear from what was present on the interior whether this aggregation was actually bat droppings. The “droppings” are too degraded should they be droppings to be able to send off for DNA analysis (not intact, swollen and very old debris). Please see below photographs and please cross reference photographs from Acer Ecology Report. The large clump present in the acer ecology report appeared to have fallen to the floor and broken up.

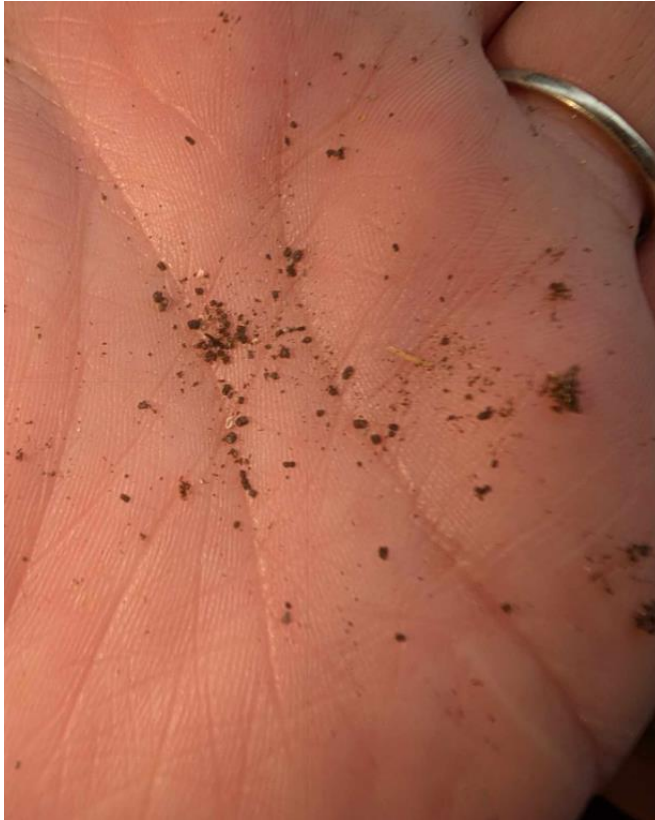
A lot of the debris that is there currently did not appear to be biological. When crumbled, those pieces that may have been (not intact or shaped like bat droppings) did break apart but they did not crumble into a fine dust as bat droppings usually would. A few of the pieces that were crumbled, crumbled to smaller fragments, some of which appeared to have occasional bits of vegetation present (please see yellow line in photograph below)

Having re-assessed the Acer ecology report, there is no convincing evidence from inside the building currently (close up of droppings etc) that this debris was in fact droppings. Please note, this was an easy misidentification and without further evidence (lack of bats during surveys, close up of droppings etc), BE Ecological Ltd would have possibly considered some of these to be droppings also in the first instance. It is noted that a licence cannot be granted due to insufficient evidence of a roost or species or numbers present. Static bat detectors cannot be placed above ceiling level due to lack of access and it would not be considered to be proportional to ask the client to undertake further surveys given the survey effort already undertaken at the site.

The client is happy to carry out the works at the least sensitive timing for bats (spring and autumn) and the client is happy to provide mitigation within the on site building. Mitigation would be no less than what the bats have access to currently. As a result it is proposed that the works are undertaken in line with a non-licensed method statement and ecological supervision. If at any point bats or evidence of bats are found, all works will cease, with NRW consulted. Further surveys and/or a licence may be required prior to works re-commencing.
