**56 PANTERGERDYNEN, SWANSEA ROAD, MERTHYR TYDFIL**

**BAT ACTIVITY SURVEY**

**Bat Survey Report**

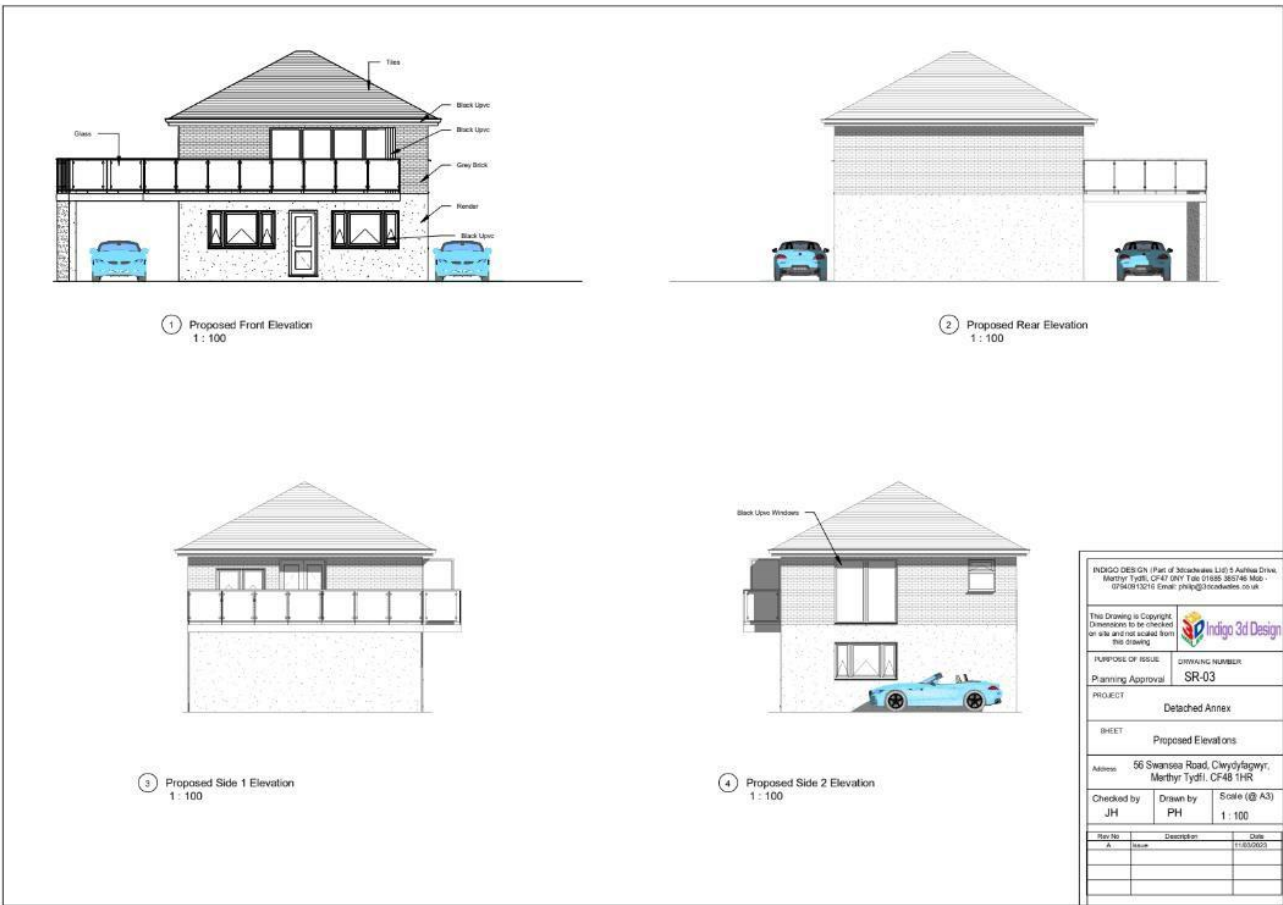
1.3 Proposed development

The development proposals involve Change of use of garage to create a one bedroom annex with external balcony.

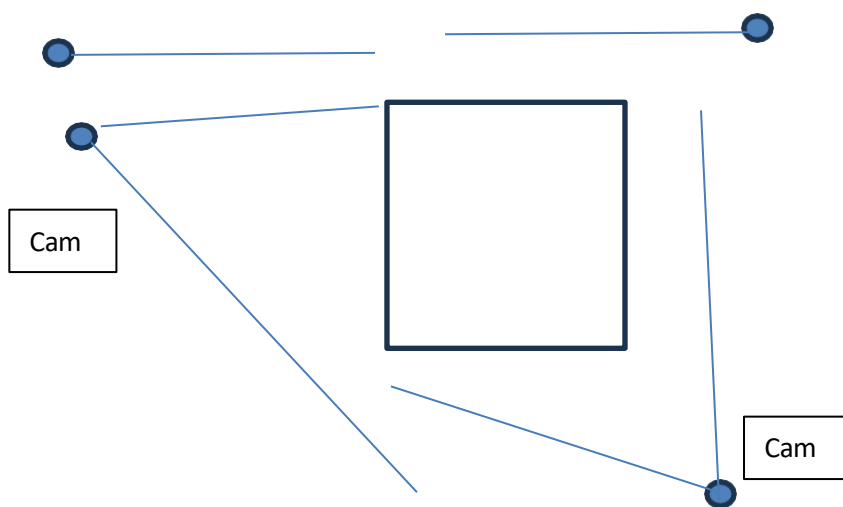
**Figure 1: Approximate surveyor locations**

A dusk survey was carried out on 24th June 2024 using surveyors positioned in such a way that as much of the building was visible to surveyors as possible. Surveyors were equipped with Batlogger M detectors and NVAs.

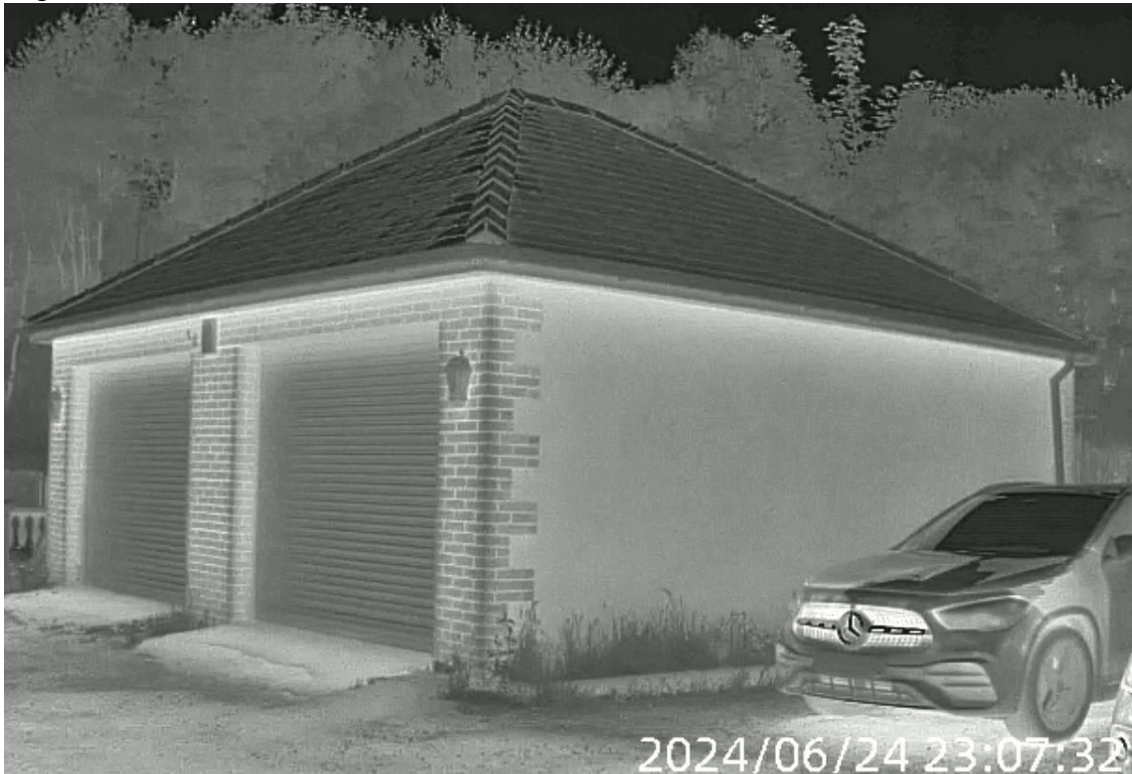
Figure 1: Thermal Guide camera view 24/06/24

None of the bats interacted with the building in any way and no bats emerged from the building on this date.

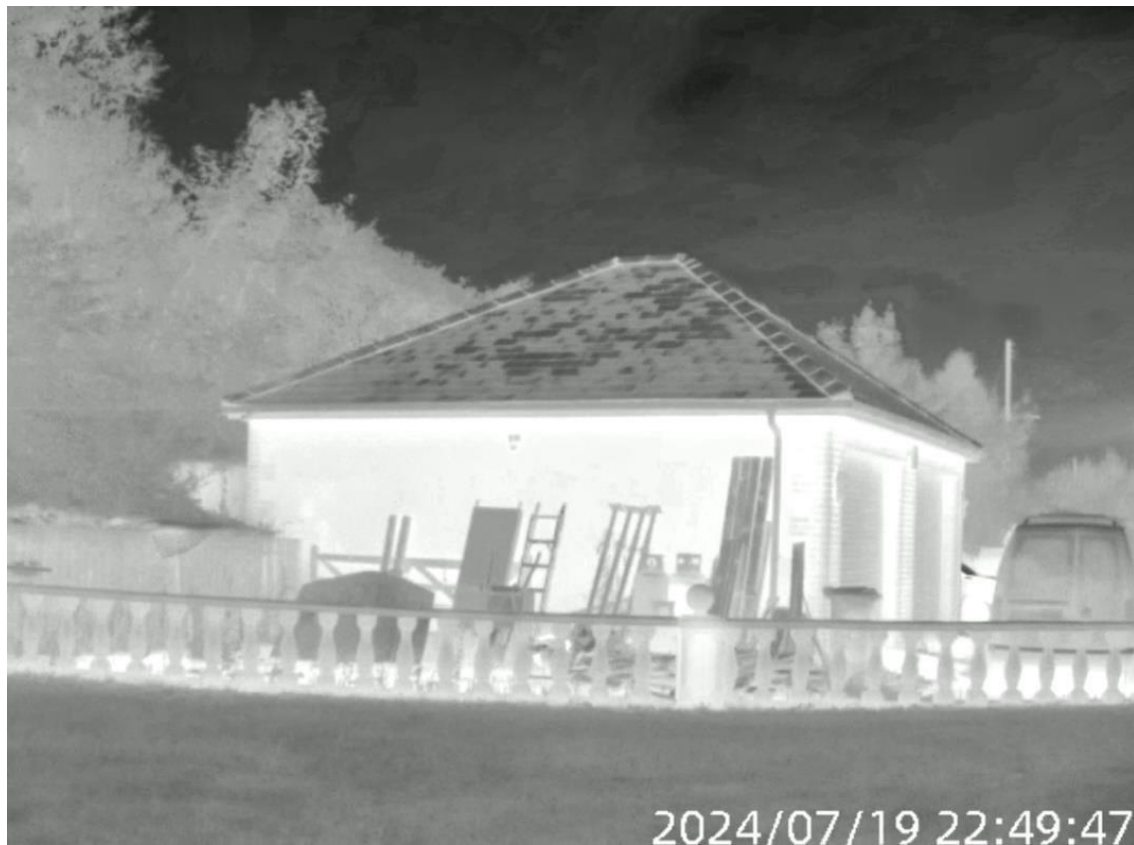
Figure 4- Thermal Guide camera view 19<sup>th</sup> July 2024

None of the bats interacted with the building in any way and no bats emerged from the building on this date.

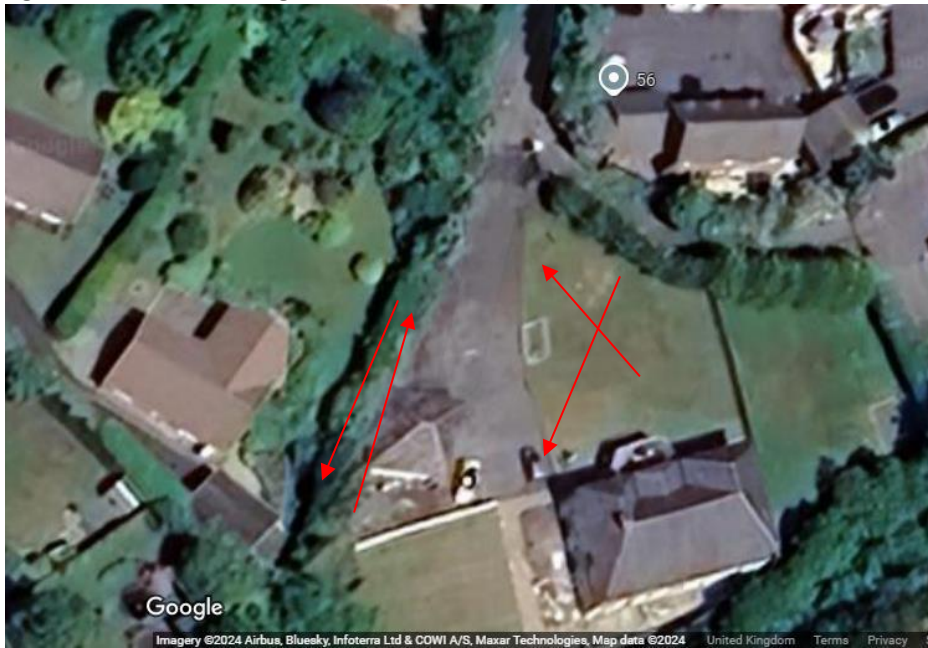
Figure 7: Locations of flight lines (arrowed red)

Species heard on site include common pipistrelle, noctule and soprano pipistrelle. The first bat heard was a common pipistrelle bat, heard at approximately 20 minutes post sunrise. The bat was seen flying along the hedgerow to the west from south to north. The noctule bat was heard at 22:10 and observed flying high above the building from north to south. A small number of common pipistrelle and soprano pipistrelle bats (approximately 7) were seen commuting back and forth over the hedgerow to the rear of the building from south to north and north to south with the occasional bat foraging over the garden of the property.

Species heard on site again include common pipistrelle and soprano pipistrelle. The first bat heard was a common pipistrelle bat, heard at 21:34. The bat was seen flying high over head from east to west. A small number of bat calls (less than 20 were heard throughout the night, intermittently). The occasional common pipistrelle was observed foraging over the garden at the front of the property and commuting again back and forth the hedgerow to the rear.
