**THE GRIFFIN (CWMBRIAN HOUSE) , GEORGETOWN,  
MERTHYR TYDFIL**

**INITIAL BAT INSPECTION SURVEY**

**Bat Survey Report**

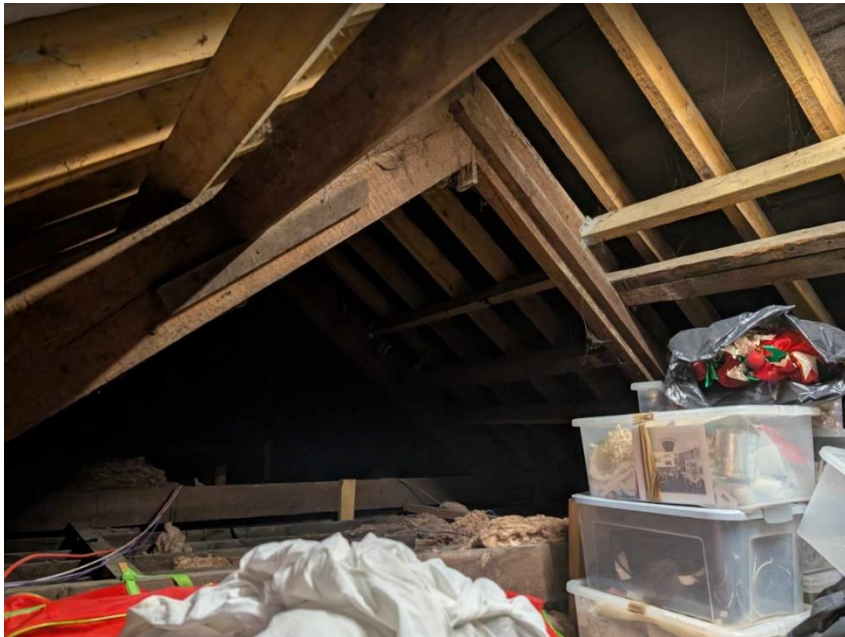
Plate 1- photograph of roof space

Internally there is a medium sized roof space above the property. The area is lined with bitumen felt and some breathable membrane and insulated at joist level with fiberglass insulation. The area is relatively clean. There is one light ingress into the roof, however, this is from the roof light. No bats or evidence of bats was observed in the roofspace.

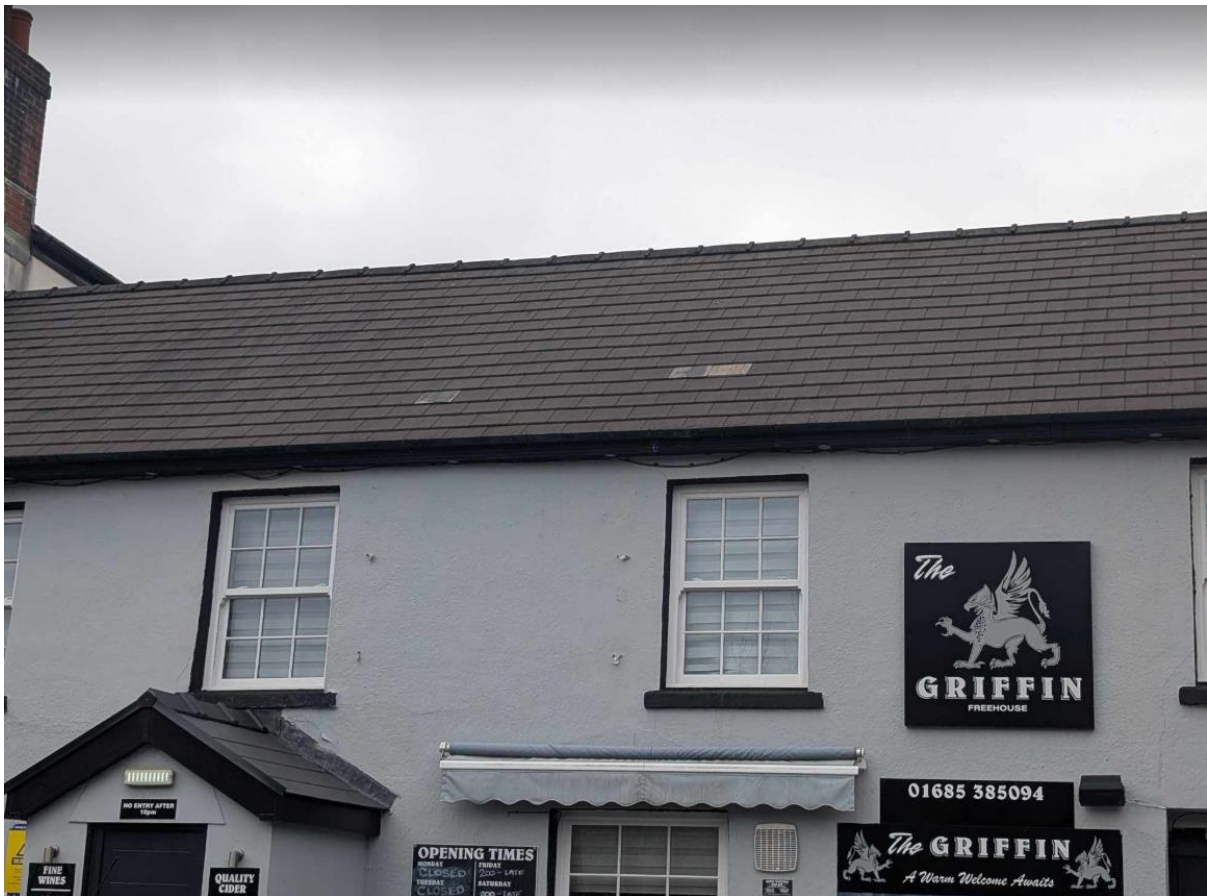
Plate 2- photograph of tight fitting slates on front elevation

The slates on the property appear to be flush with no missing or lifted areas. The ridge does not appear to be lifted to allow ingress at this location. There appeared to be a gap beneath the apex of the south eastern gable, however, on closer inspection this appeared to be blocked, including from the inside.

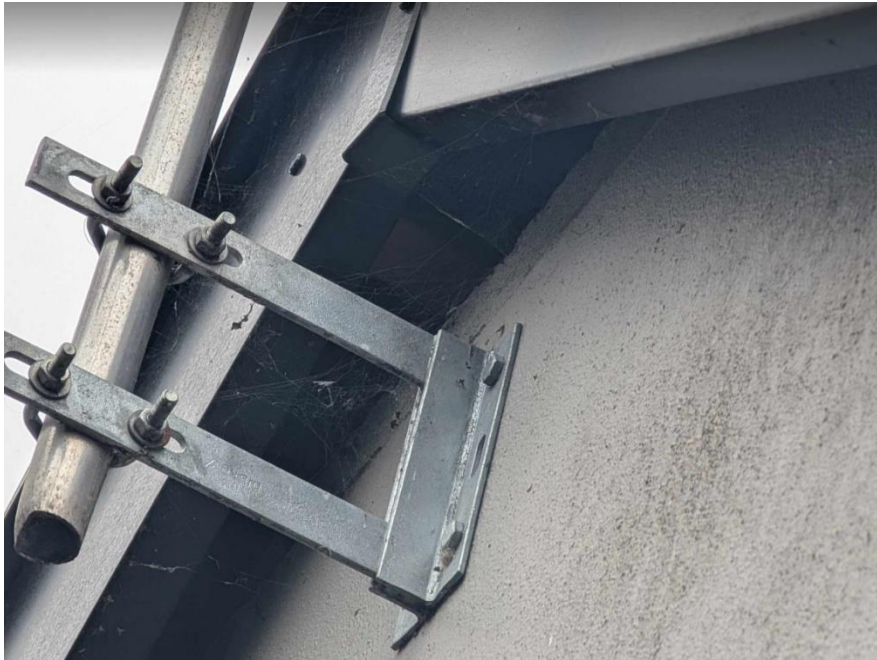
**Plate 5- photograph of south eastern gable (appears to be a hole, on further inspection it does not lead anywhere and it is foamed up on the inside)**
