# The Old Sawmill, Court Street, Merthyr Tydfil

## Initial Bat Inspection Survey Report

March 2026 | Issue 1B

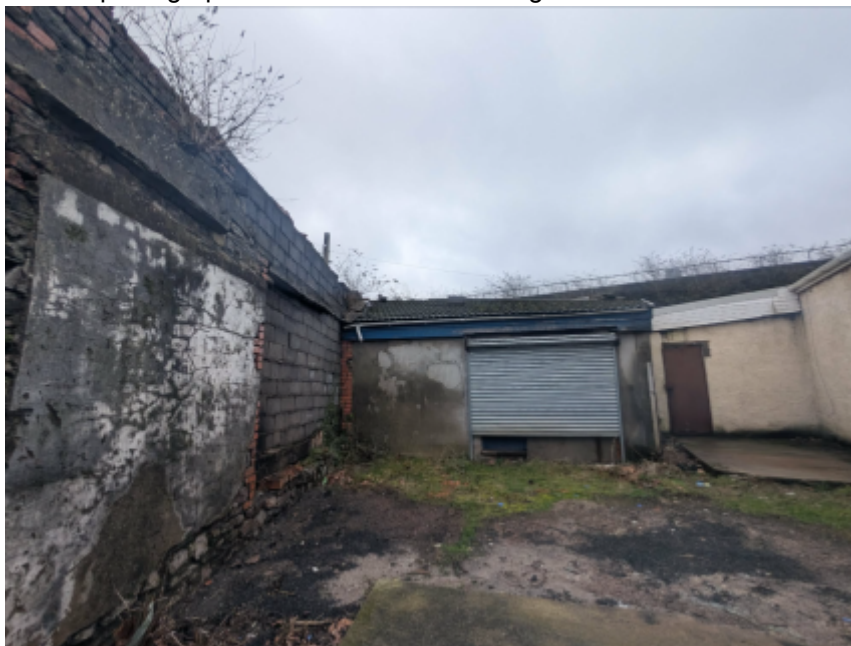
Whilst there are some ridge tiles missing on the small tiled unit, there does not appear to be many gaps into the roof via tiles.

Plate 1- photograph of small tiled roof building

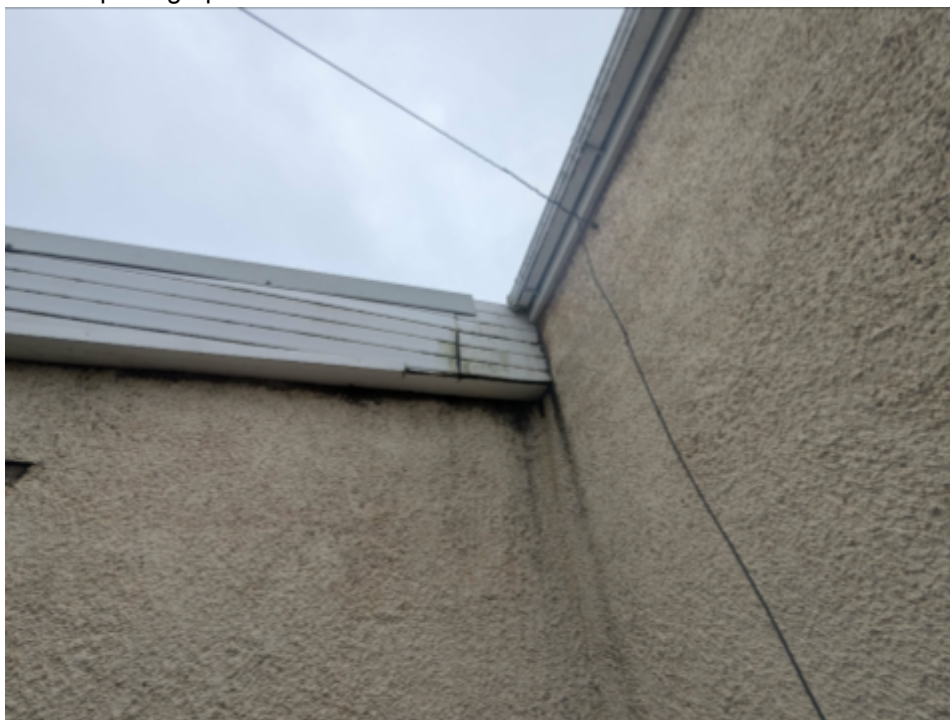
Whilst there are a small number of gaps into the buildings (above shutter doors, beneath metal sheets etc) the wall plates can be viewed. The building is draughty and clean. There is a small amount of ivy present on the rear elevation, however, the ivy is too young to provide appropriate roosting conditions. Generally fascias and soffits do not have gaps beneath them.

Plate 2- photograph of sealed fascias and soffits

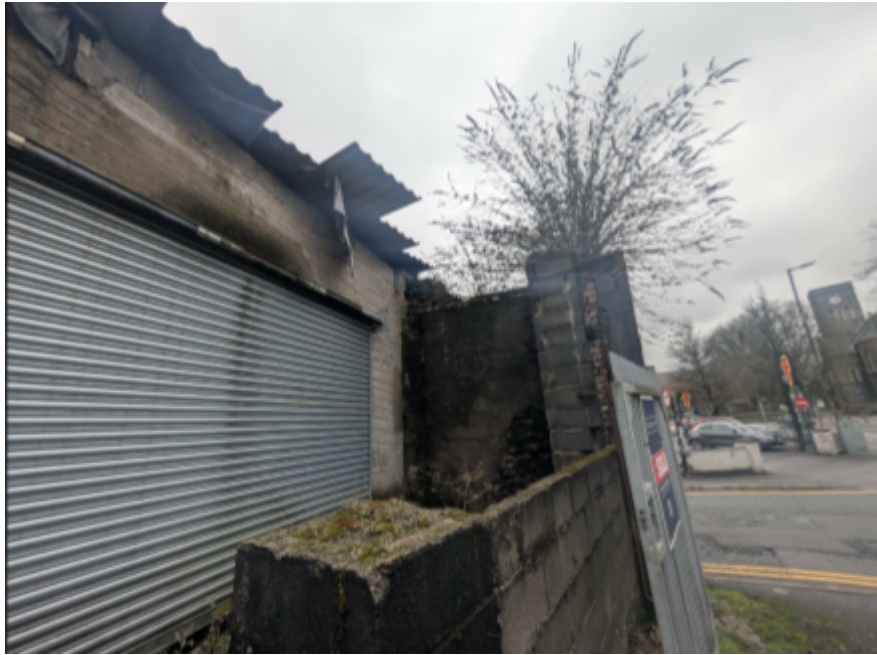
Plate 3- photograph of entrance and front of units

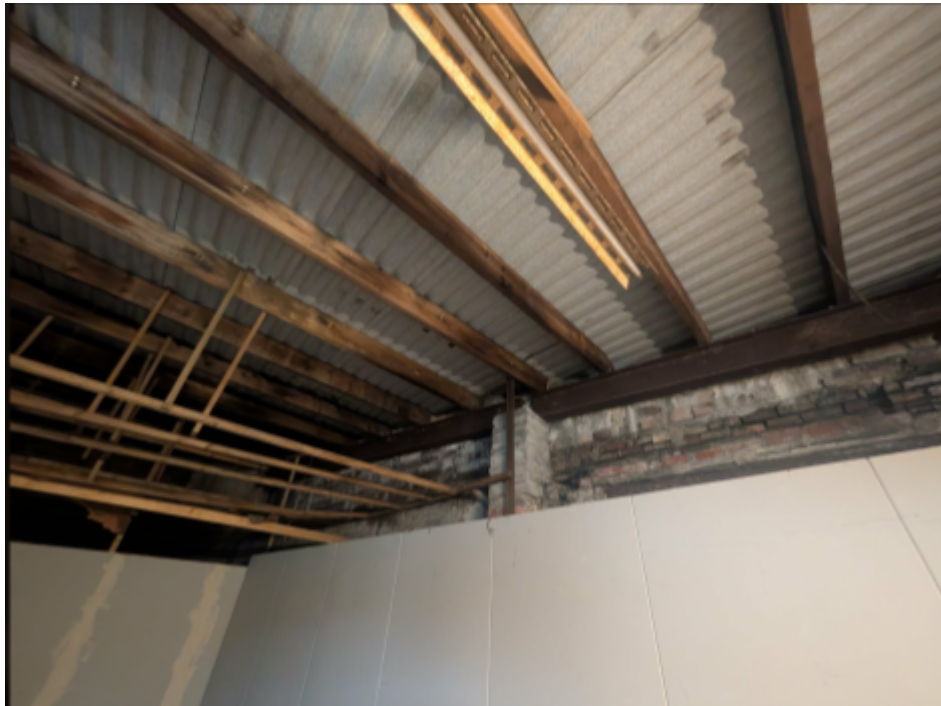
Whilst joined, the buildings are split into separate areas. There is no roof space present within the building with the tile roof. There are no light ingress' within this part of the building at wall plate level. The area to the north east is entirely lined with corrugated metal that is sat on timber joists. There are some gaps to the exterior beneath the metal but the wallplates are exposed and can be viewed. There are numerous unbroken cobwebs around wall plates. No evidence or potential for bats was found in the interior of the building. No evidence of nesting birds was found within the interior of the building.

Plate 4- interior of units

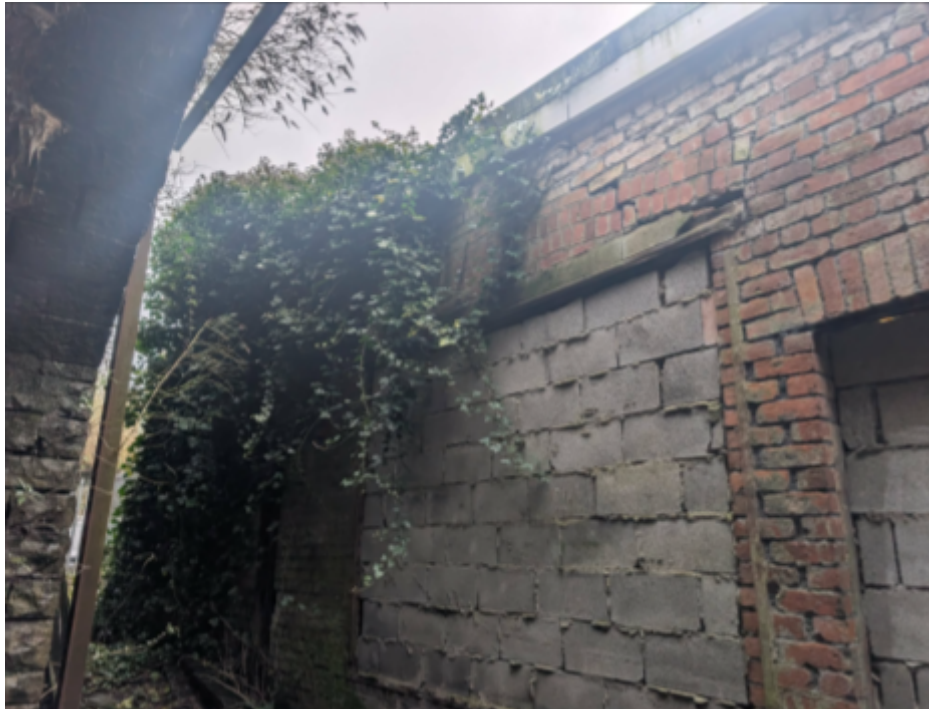
Plate 5- rear of units

3. Before any work commences, the ivy on the exterior of the building will be checked by the ecologist for the presence of bats and birds.
4. All suitable bat roosting features will need to be removed by hand (metal sheets) and inspected by the onsite bat ecologist.

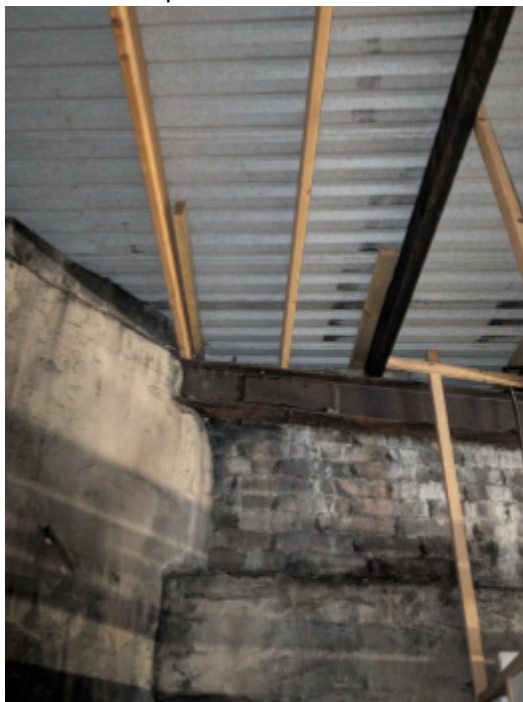
Plate 6- example of interior

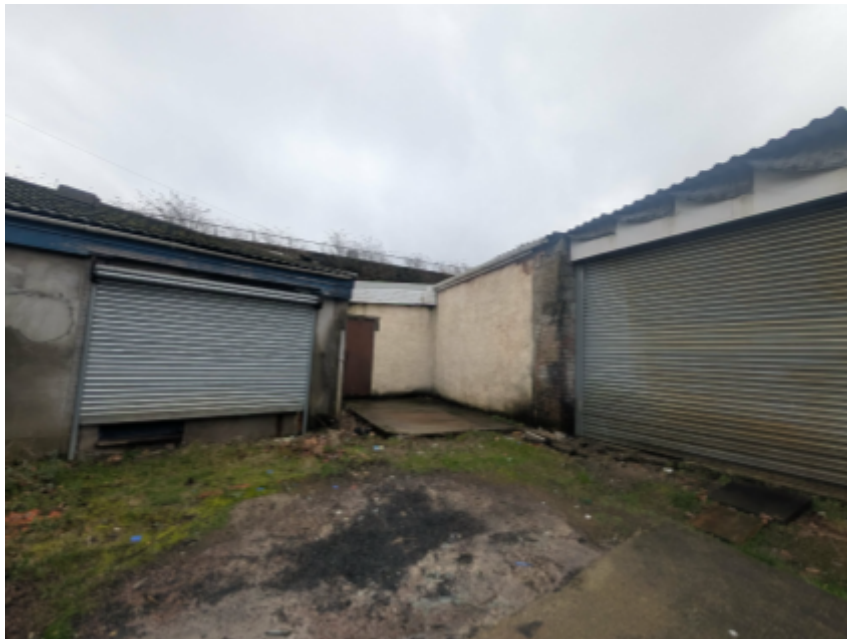
Plate 7- front of property

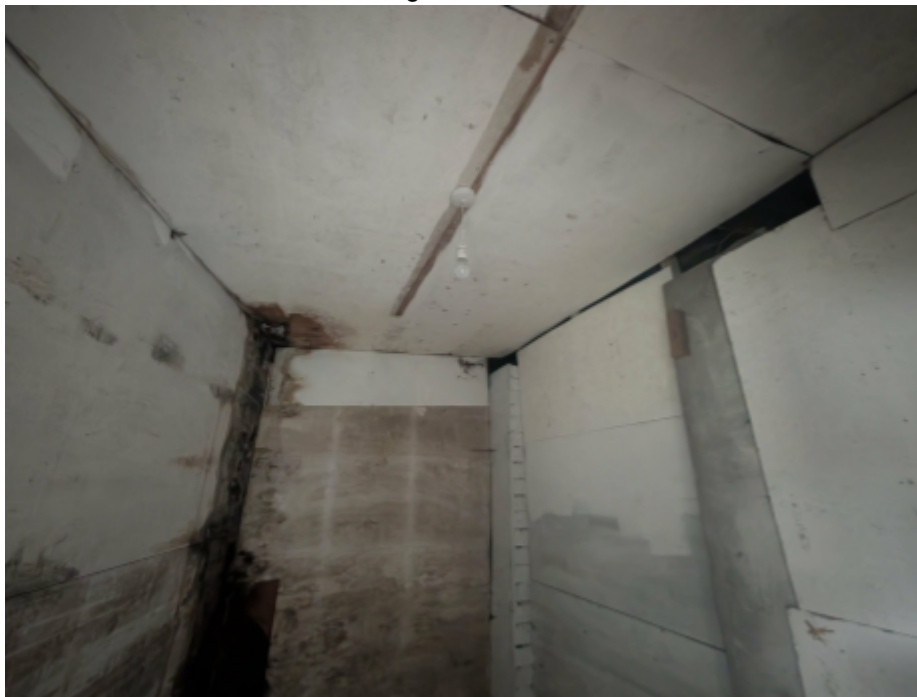
Plate 8- interior of tiled roof building
