**THE RAILWAY INN, HIGH STREET, BEDLINOG, TREHARRIS**

**INITIAL BAT INSPECTION SURVEY**

**ISSUE 1, VERSION B**

**JULY 2020**

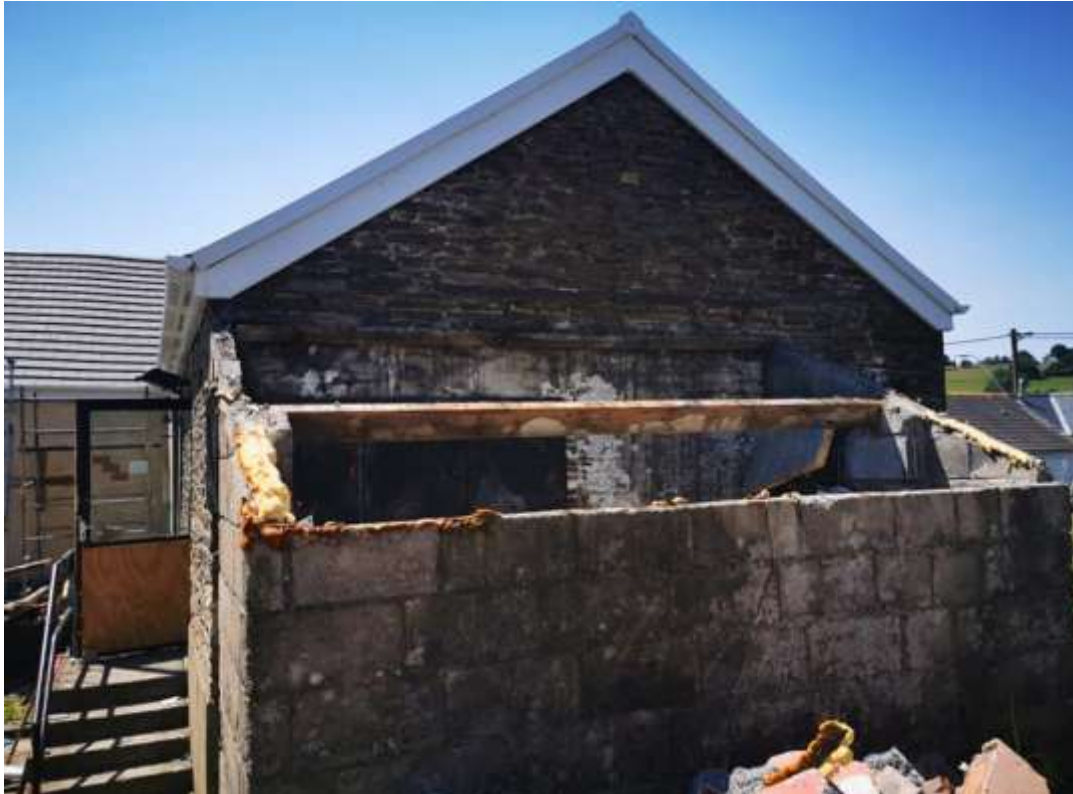
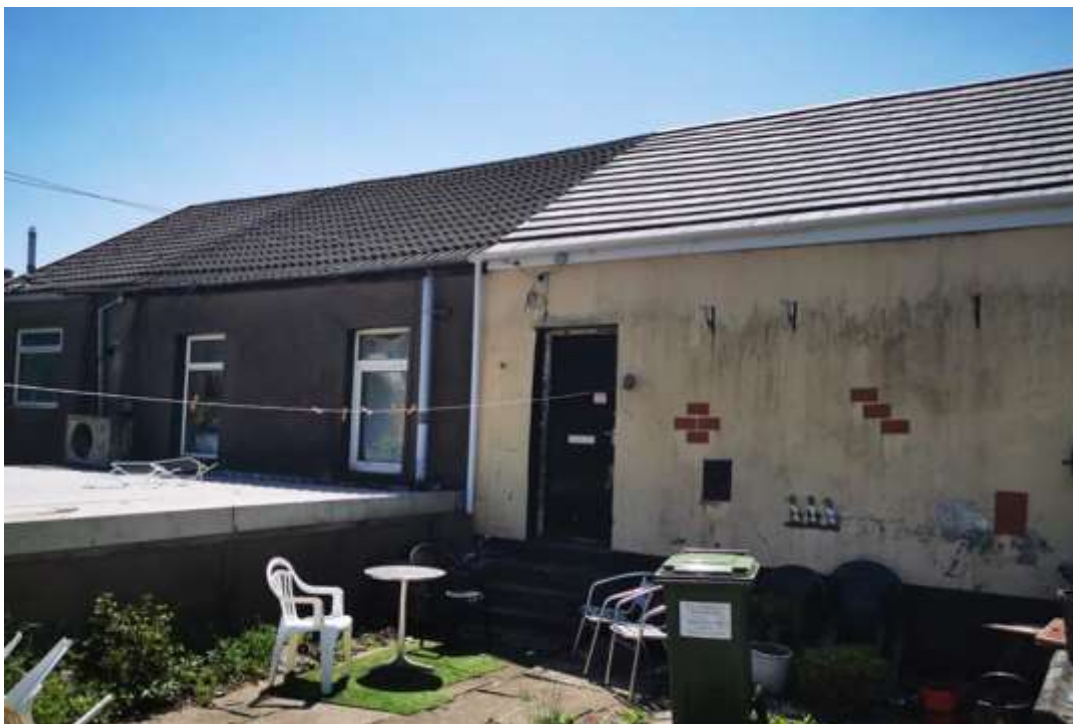
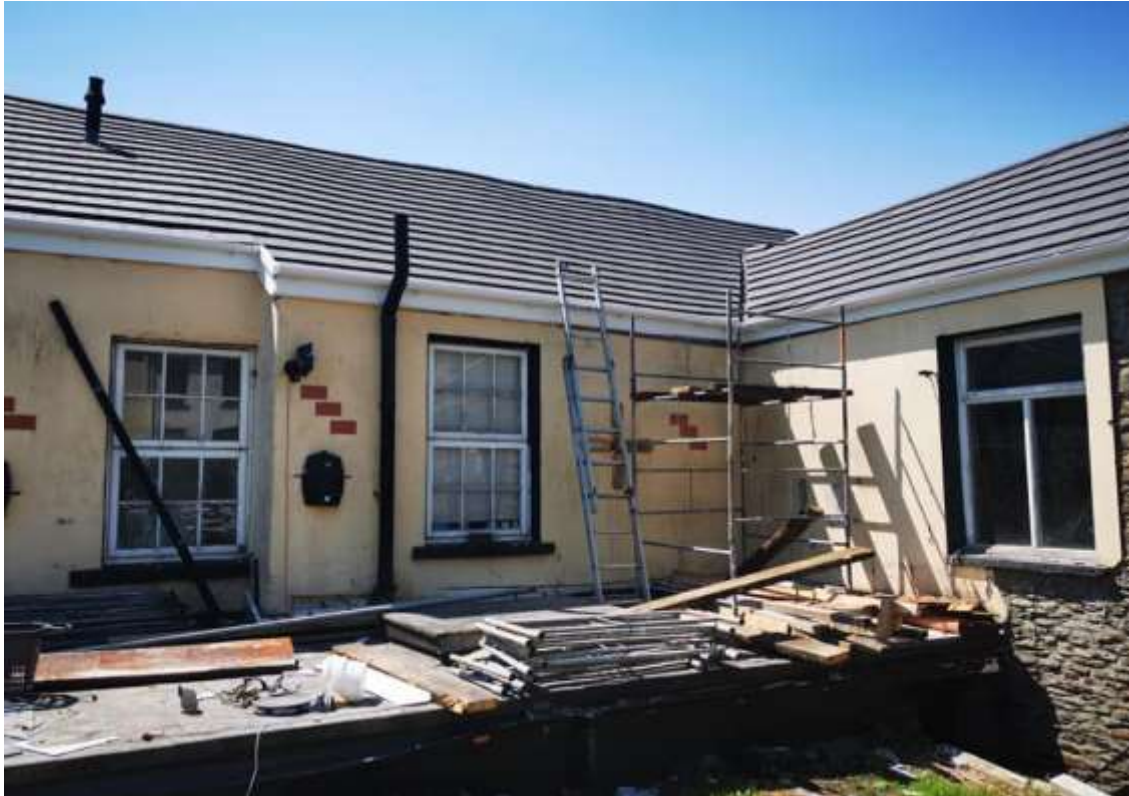
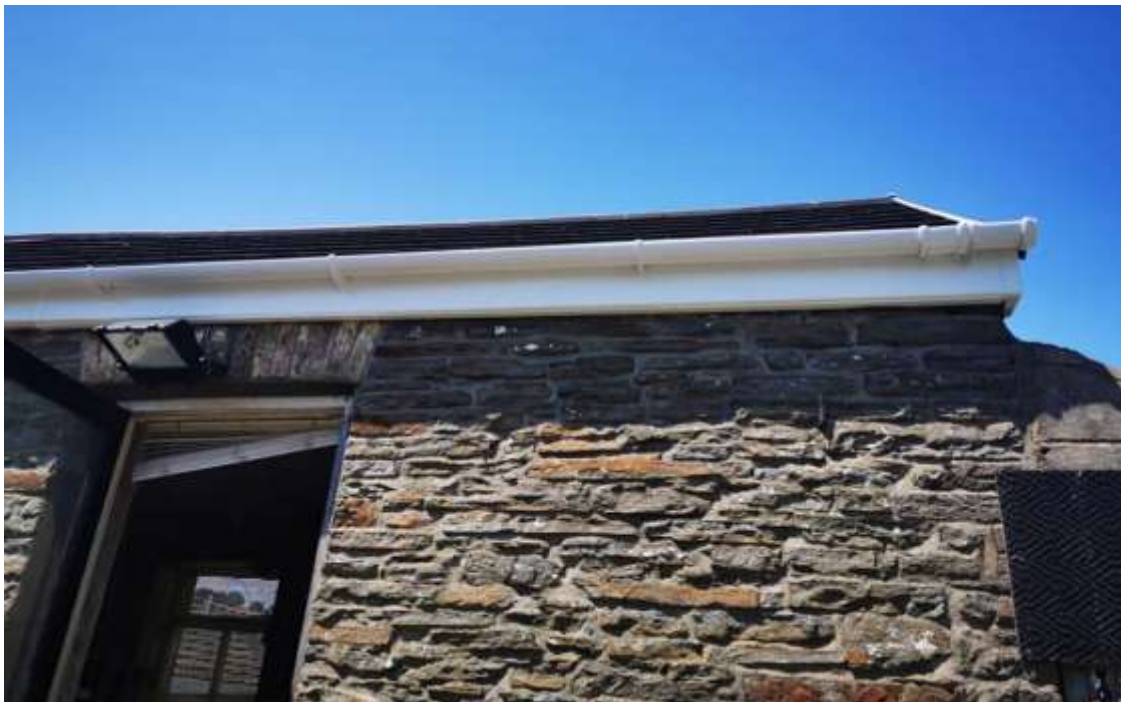
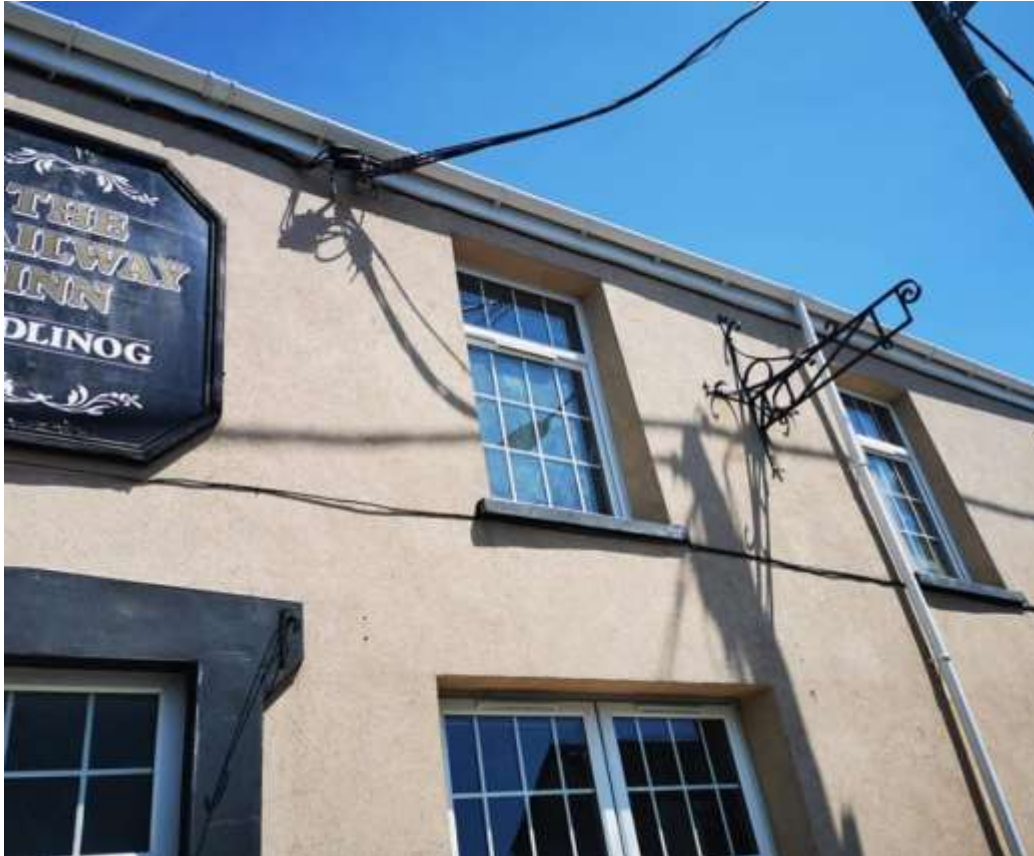
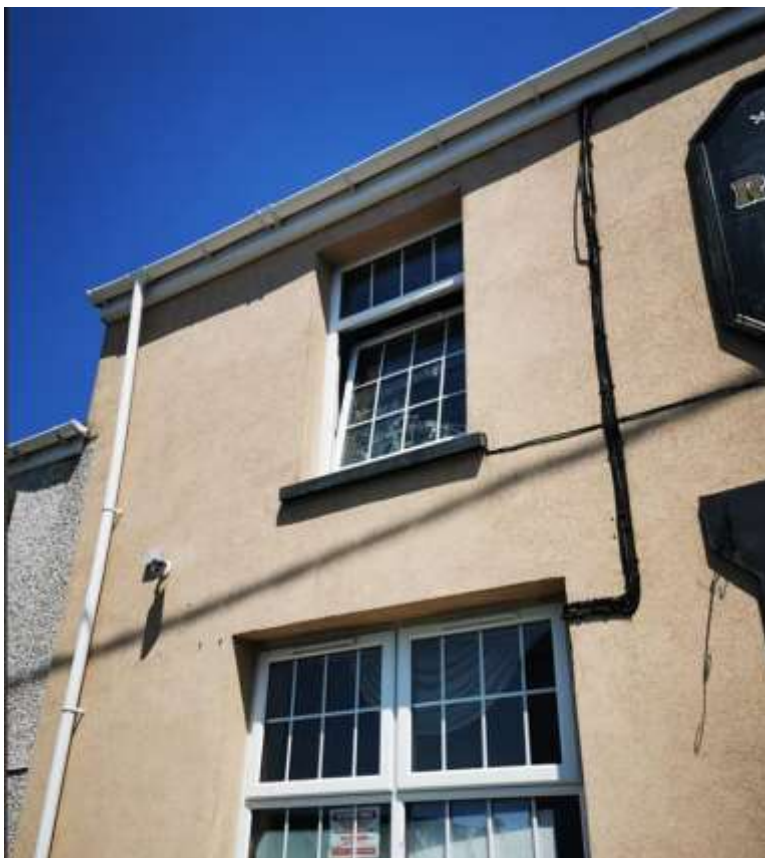
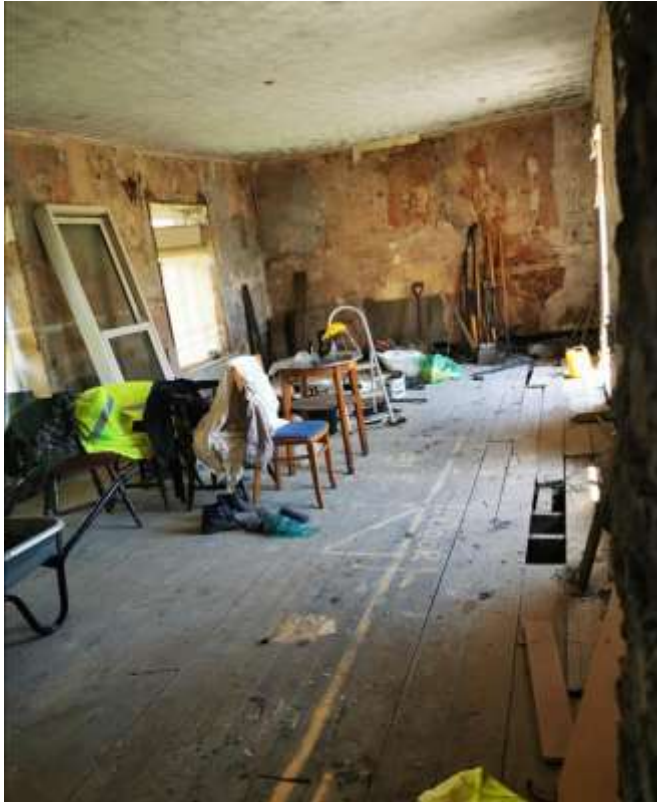
## APPENDIX A- PHOTOGRAPHS

The survey carried out by BE Ecological Ltd revealed no droppings or evidence of bats on the exterior of the buildings. However, a number of potential access points were noted including:

- Gaps beneath newly fitted fascias and barge boards
- Gaps beneath newly fitted ridge tiles

No evidence of nesting birds was seen on the exterior. No birds were seen or heard on the site during the time of survey.
