*Report No. BC/MB/06.19.05.*

# **Mining Risk Assessment: Land at Plymouth House, Merthyr Tydfil.**

***Mr and Mrs D. Rees***

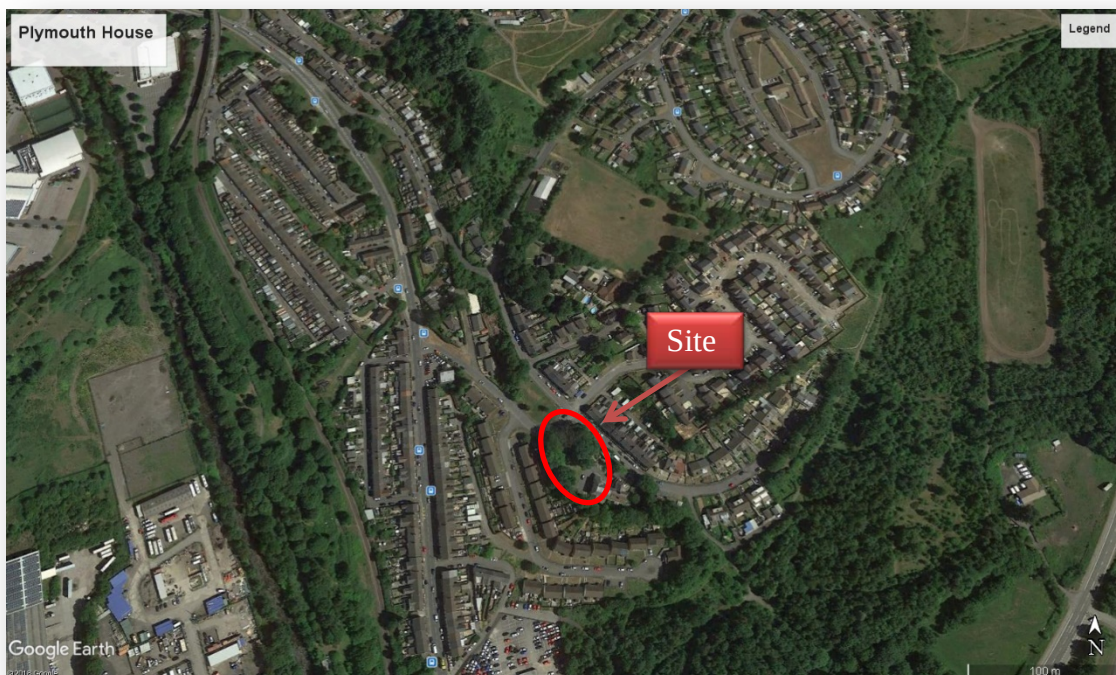
**Figure 1**  
**Aerial View of Site**

The parcel of land that is the subject of this report ('the Site') is located at the southern margins of the town of Merthyr Tydfil; it is approximately 1 km south-east of the centre of the town (see Figure 1 and *General Location Plan, drawing no. BC/MB/06.19.05.01*). The Site is located near the floor of the Taff Valley and is at an approximate elevation of 176m aod: it occupies an area of approximately 0.13 hectares (see *Detailed Location Plan, drawing no. BC/MB/06.19.05.03*). The Site lies within a mixed residential area where houses and bungalows are a mixture of terraced, semi-detached and detached.

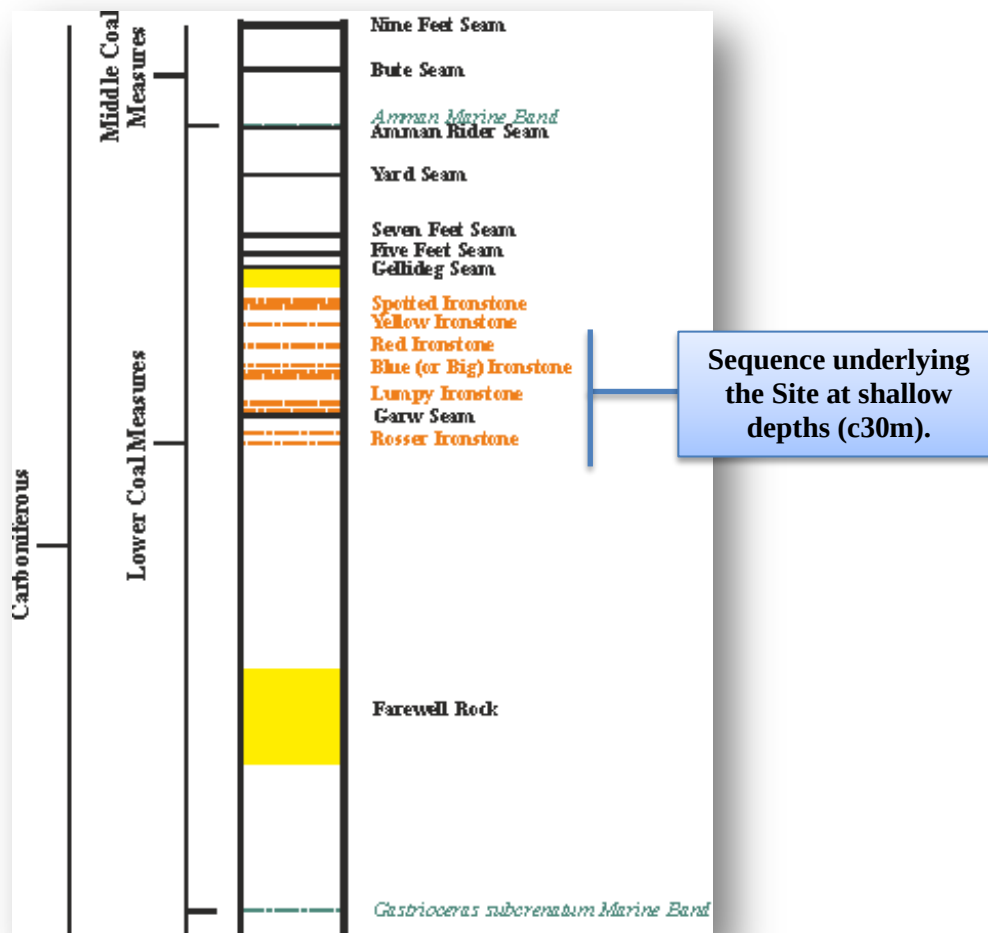
**Figure 1**  
**Part of the Stratigraphic Column.**  
 Scale: Not to Scale.

NE and SO 00 SE), shows the inferred position of the outcrop of the Gellideg Seam to be present approximately 70m east of the Site and upslope from it (see *Geology Plan, drawing no. BC/MB/06.19.05.02*). Beneath the Gellideg Seam in the geological sequence are a series of five ironstone veins, the Garw Coal Seam and then the Rosser Ironstones (see Figure 2, Part of the Stratigraphic Column). The regional dip of the coal measures in this area is 1 in 12 towards the south-west such that the sequence containing the ironstone veins and the Garw Seam underlie the Site at shallow depths.

The locality has experienced extensive mining operations for both coal and ironstone and the Site lies within an area that could be affected by underground mining in one the ironstone veins at shallow depth. It is recommended that a programme of exploration boreholes is drilled on the Site with a view to determining the depth and nature of any shallow mine workings that may be present.

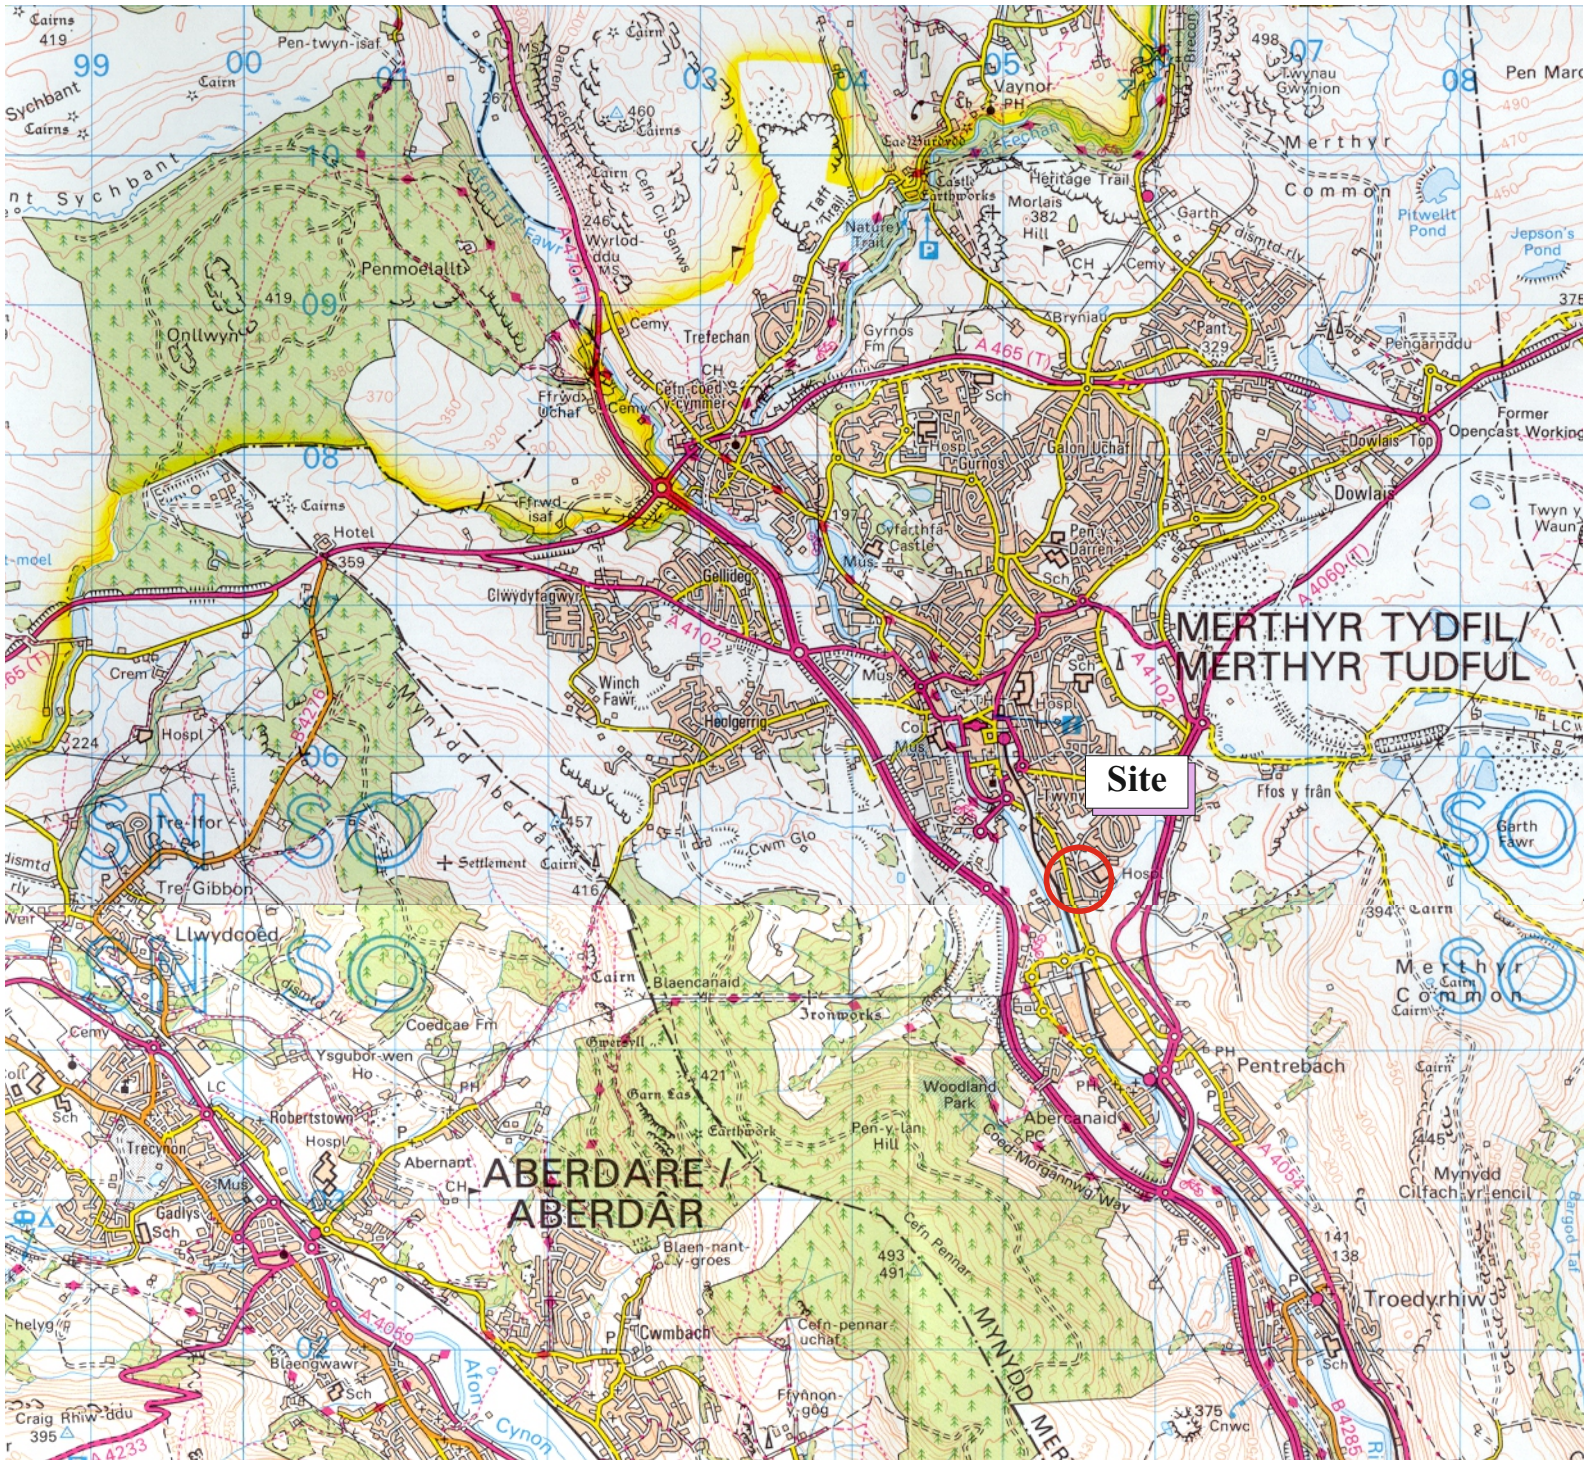
*Geology Plan.*

The published geological sheet shows the Site to be covered with glacial deposits of river alluvium and with Made Ground that is almost certainly colliery spoil. We have no details of the thickness or engineering properties of the Alluvium or of the Made Ground that are present on the Site. The published geological sheet also shows that the Site is not affected by landslip conditions.
