*Report No. BC/MB/08.09.01.*

# **MINING RISK ASSESSMENT:**

**Land South of Winchfawr Park,  
Heolgerrig, Merthyr Tydfil.**

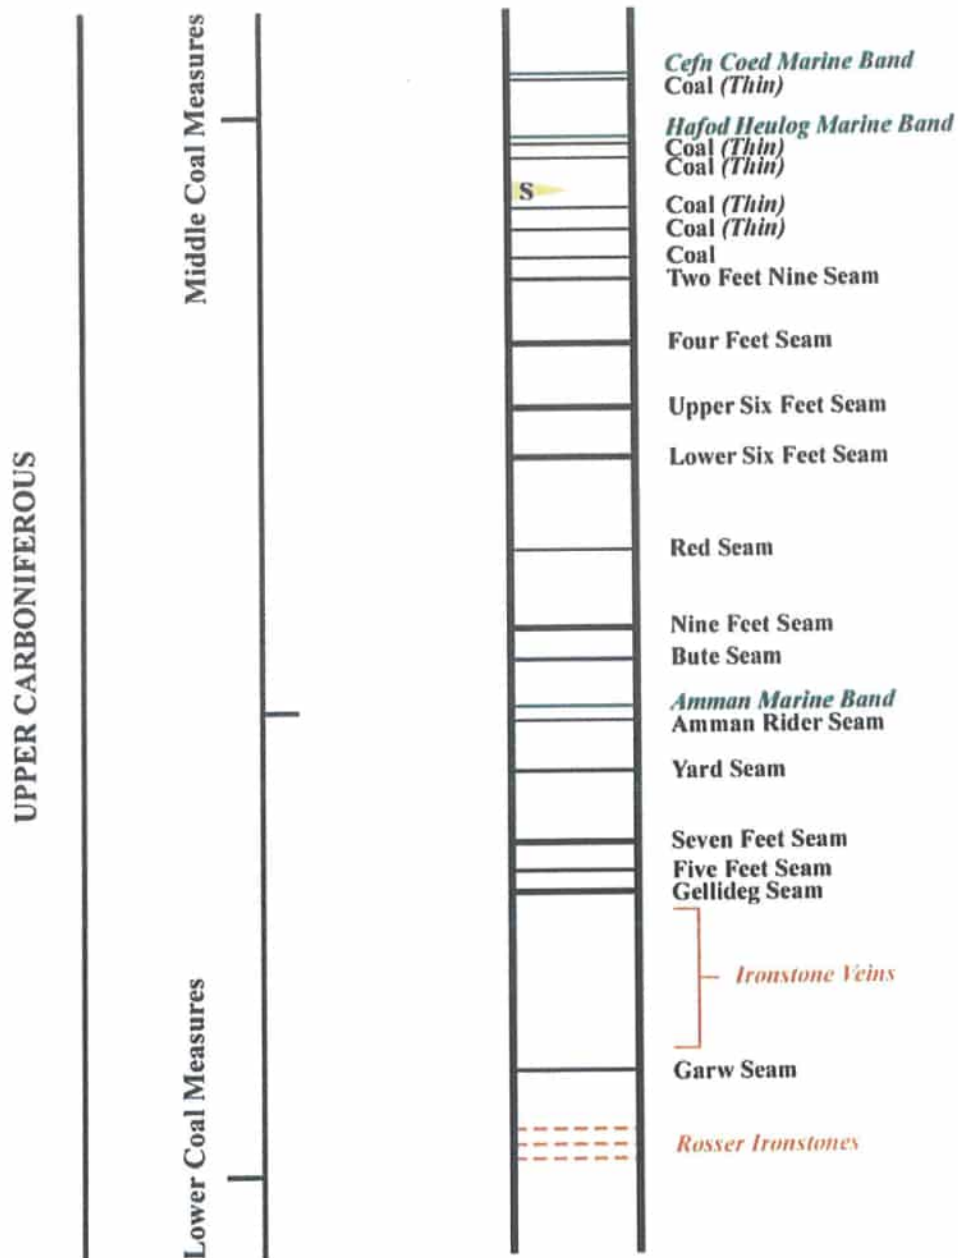
## Part of the Stratigraphic Column.

When both sets of records are taken together it is apparent that the Six Feet Seam outcrops within the confines of the Site and the Nine Feet Seam outcrops a relatively short distance to the north of it so that the Six Feet Seam underlies much of the Site at very shallow

depths and the Nine Feet Seam underlies the whole of the Site at relatively shallow depths. A thin coal seam, the Red Seam, is sometimes present between the above two seams, but its presence has not been confirmed in this area. Exploratory drilling carried out in the surrounding area indicates that the Upper and Lower Six Feet Seams are two separate seams in some areas of Heolgerrig and elsewhere are one, thick, composite seam. Exploratory drilling within this Site suggests that the Six Feet Seam is there represented by the two separate seams, the Upper Six Feet Seam and the Lower Six Feet Seam. The Red Seam was not identified in exploratory drilling within the Site and the Nine Feet Seam was not encountered, being deeper than the maximum depth of the boreholes (30m).

Other coal seams underlie the Site at increasing depths, the principal ones, in descending order, are the Bute, Yard, Seven Feet, Five Feet/Gellideg and the Garw Seams (see *Part of the Stratigraphic Column*, above); there are also a number of ironstone veins below the Five Feet/Gellideg Seam.

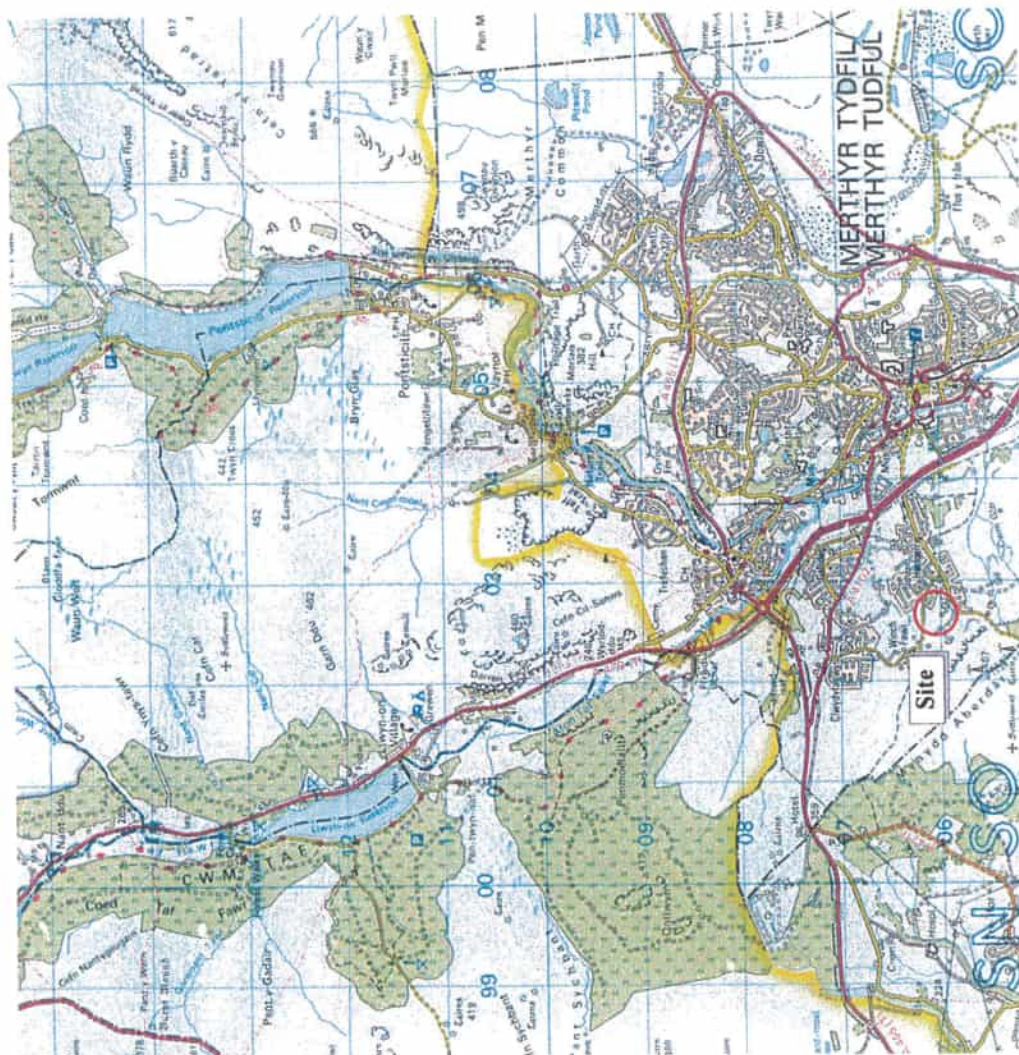
Drawing No: BC/MB/08.09.01.01.

The coal measures of the South Wales Coalfield have been affected by large faults. In the Heolgerrig area these large faults have a slightly sinuous trace at the surface and an average trend towards the north-west. The published geological sheet indicates that the Site is not affected by large scale faulting.

The published geological sheet also indicates that the coal measures locally are overlain with deposits of glacial boulder clay and that a lenticular area at the south-western end of the Site is occupied with made ground, likely to be colliery spoil. Ground investigation carried out on the Site by Terra Firma confirmed the presence of both soils. Published geological records indicate that the Site is not affected by landslip.

There are no features associated with the solid geology of the Site that would require any particular measures to be included in the design and construction of the foundations for the proposed dwelling. It is recommended that no further action is required in this respect.

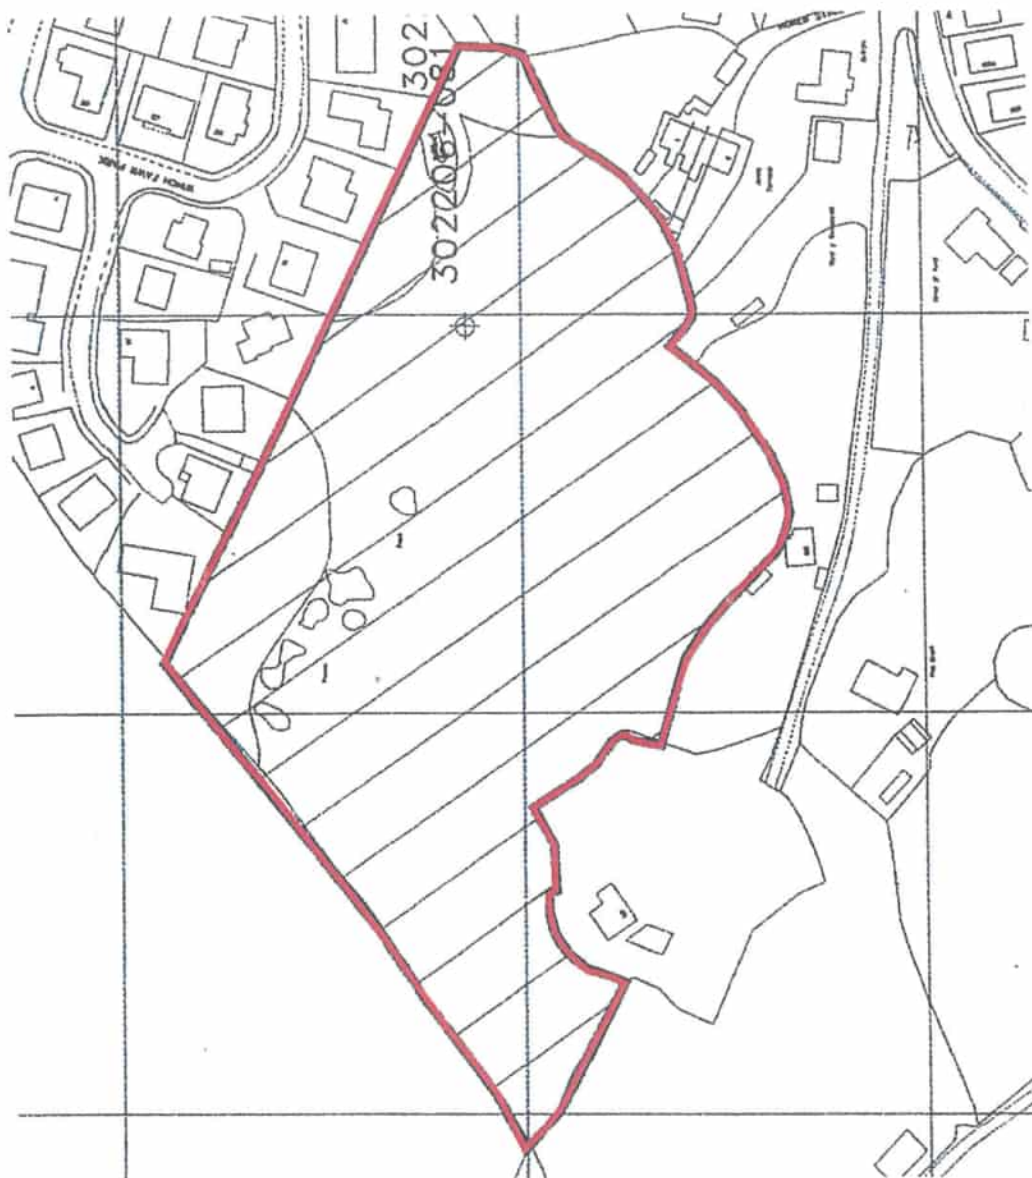
Drawing No: BC/MB/08.09.01.03.

deeper coal seams and ironstone veins and there are a large number of disused shafts and adits in the locality. Air shafts were also sunk in order to provide ventilation to the underground mining operations. Our search of mining records found the Site to be underlain by old workings in a number of coal seams and ironstone veins, many of which are at considerable depths beneath the Site.
