## INSTALLATION OF NEW SKYLIGHTS/VELUX WINDOWS

JAH-JIREH CARE HOME, A465 MERTHYR

### BUILDING INSPECTION REPORT (PROTECTED SPECIES)

Document Ref: E25136001 Doc 01 September 2025

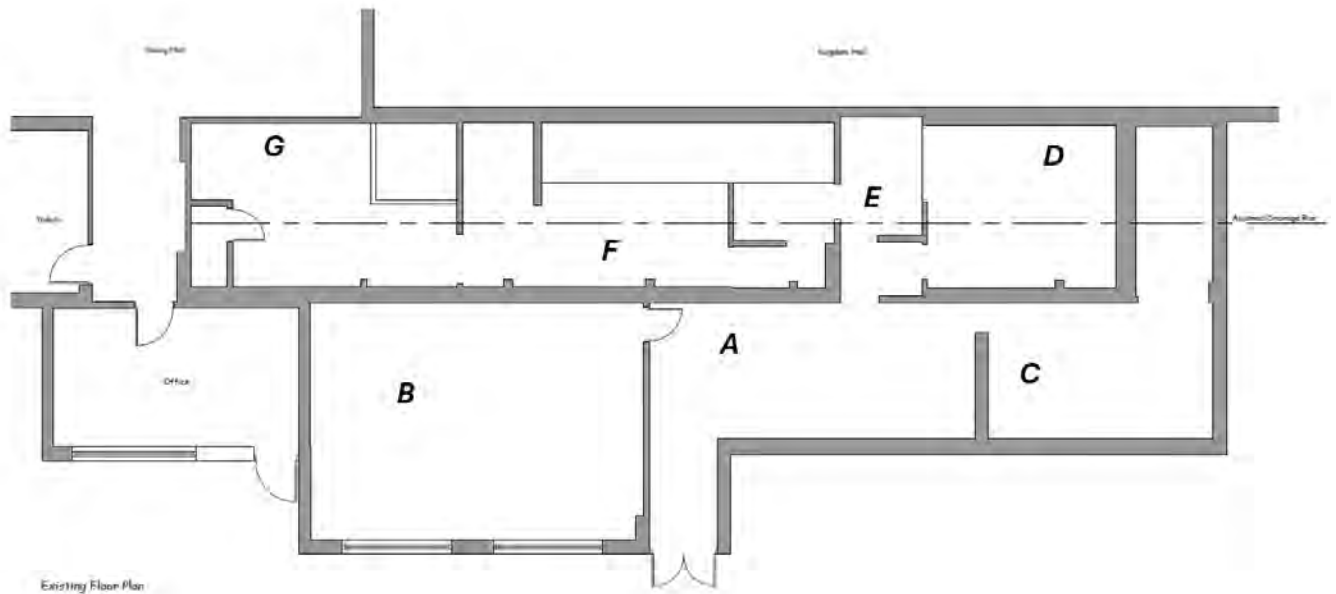
**Figure 1-Existing Internal Room Layout-Area Surveyed**

3.9 The section of the building that is included in the proposed works area was previously used as toilets/bar area. Figure 1 illustrates the internal room layout of the surveyed area. There are 7 separate rooms (referred to as A-G).

3.10 The door was locked upon entry and the window located in room B was open. Rooms A-C are largely located within the flat roof area and no accessible roof space is present (Room C is partially located in the pitched roof section of the building). Recent works include the installation of ceiling insulation boards in room A,B and C. There were no signs of bat droppings on any surfaces within these rooms.

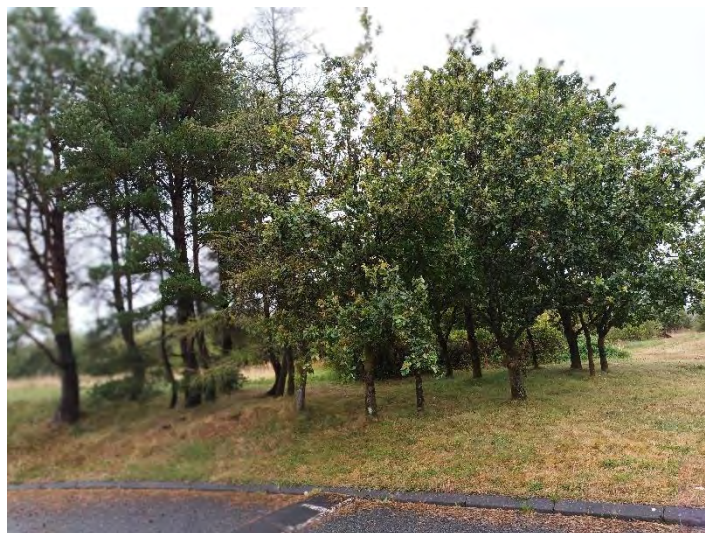
**Plate 5-View Looking North Eastwards Towards Boundary Vegetation**

- 3.13 There is a car park immediately adjacent to the building with some ornamental planting present and a single Willow *Salix sp.* noted. There is a small area of grassland with trees bordering the north/eastern part of the site. Species include Oak *Quercus robur*, Scots Pine *Pinus sylvestris*, Alder *Alder glutinosa* and Willow *Salix*. (Plate 5).

There is a large conifer plantation 50m to the west of the site.

- 3.14 The habitats contained within the care home grounds would be suitable for common reptiles and amphibians - although these areas would not be directly impacted by the roofing works consideration of site compound or storage areas would be appropriate to minimise any risk to these groups.
