**Tree condition survey on land adjacent to 80 Westwood Drive,  
Treharris CF46 5BL**

**Date:**  
4<sup>th</sup> December 2019

**Document ref:**  
PC19-192

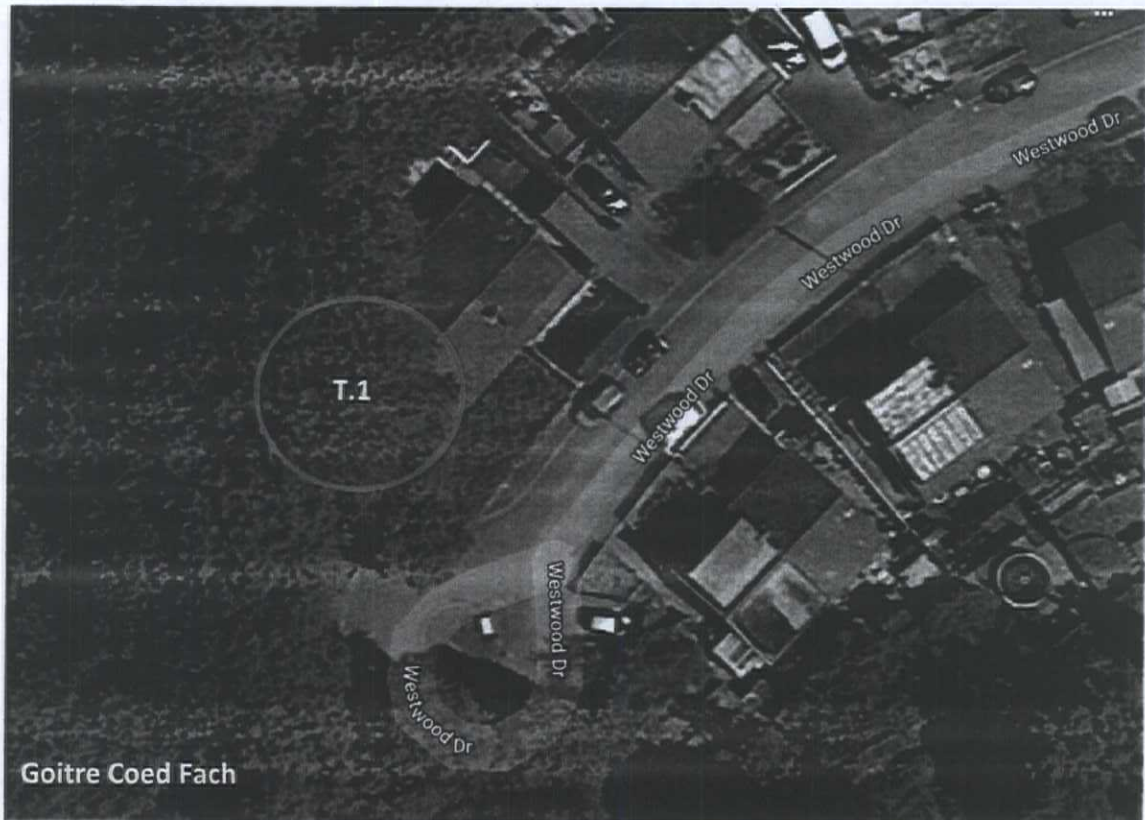
### Tree Location Plan

| Tree number | Species | Comments | Failure foreseeable? | Intervention required? | Within what timeframe? |
|---|---|---|---|---|---|
| T.1 | Beech | <p>A high value mature tree growing on steeply sloping ground adjacent to property boundary. Single stem dividing into 4 significant stems at 1.5m. Building materials from property's driveway construction tipped around base and ground levels altered; top layer of ground easily displaced. East half of crown extends over property of 80 Westwood Drive. Deadwood in crown, 75mm diameter x 4.5m long, and snapped hung-up branch over driveway. Good bud density throughout crown with some foliage in autumn colour still attached. No critical defects observed, tree appears healthy with good vitality.</p> <p><b>Specific target:</b> 80 Westwood Drive occupants and visitors</p> | <p>Yes – deadwood and snapped branch only</p> <p><b>Risk of harm:</b><br/>Low</p> | <p>Yes</p> <p>Remove deadwood and snapped branch</p> <p>Clear building materials away from trees</p> | 12 months |

To ease the intimidation, reduce the concerns and help prevent future safety issues arising, we recommend the branches overhanging the bungalow and drive are reduced by approximately 4m (from 12.5m to 8.5m). Finished cuts to be made at viable growth points, with pruning wounds no larger than 50mm diameter to help prevent significant damage to the tree's health.
