Project: Merthyr Synagogue
Job No: 9684
Subject: Comments on further investigations
Made by: JB
Date: 20/02/24
Ref: 9684_SK10
Rev: A

8.3.1 Existing Steps at the Rear - Options Assessment

Project No: **Merthyr Synagogue**
Potential Approaches to Rear Area
Project: **9684**Engineer: **Joshua Bird**Date of Issue: **15/01/2024**Revision: **A**

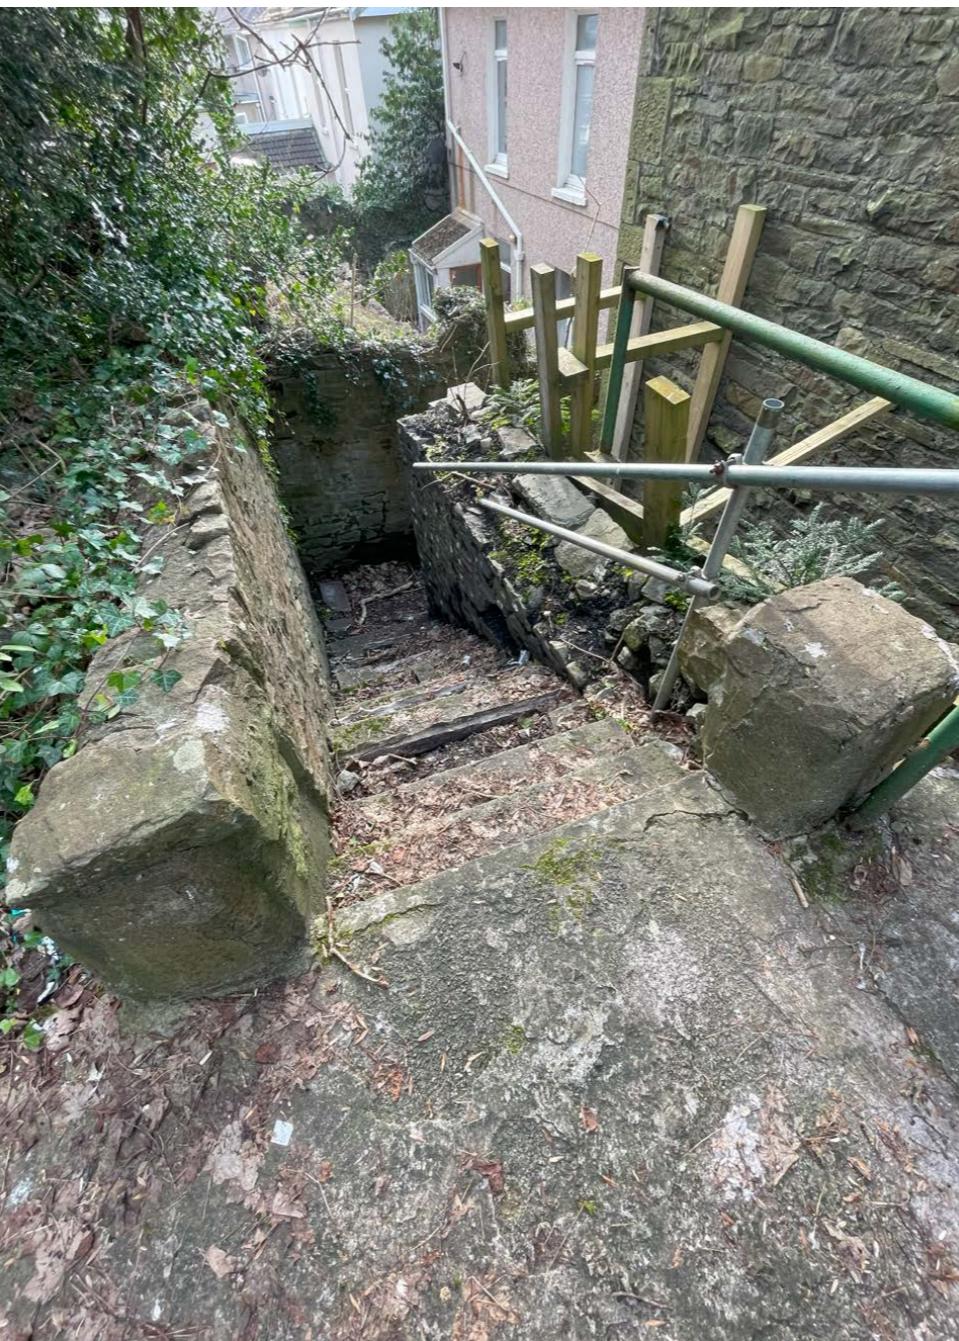
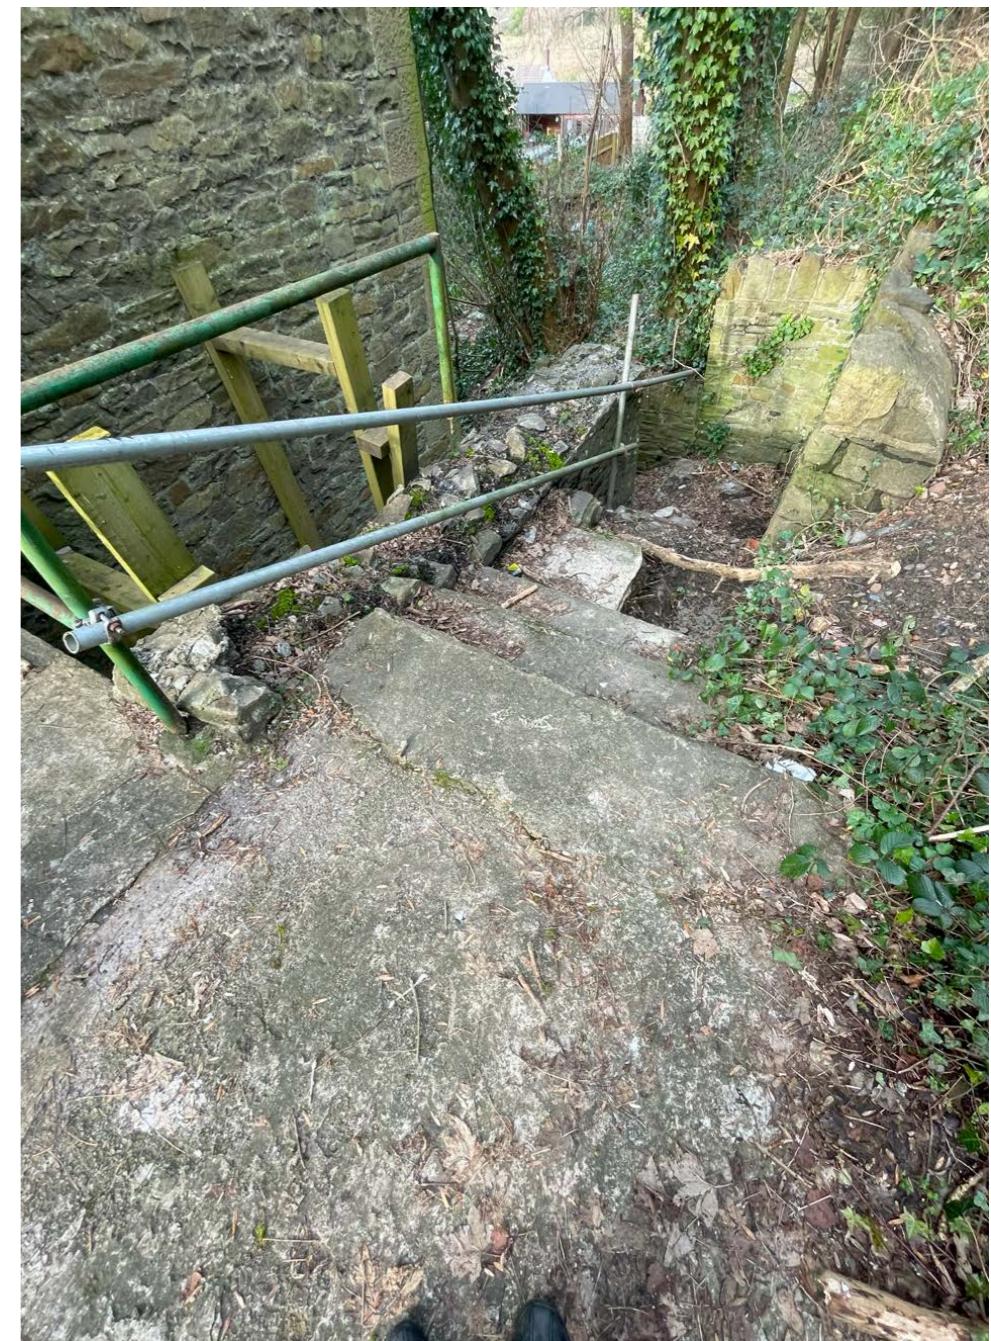
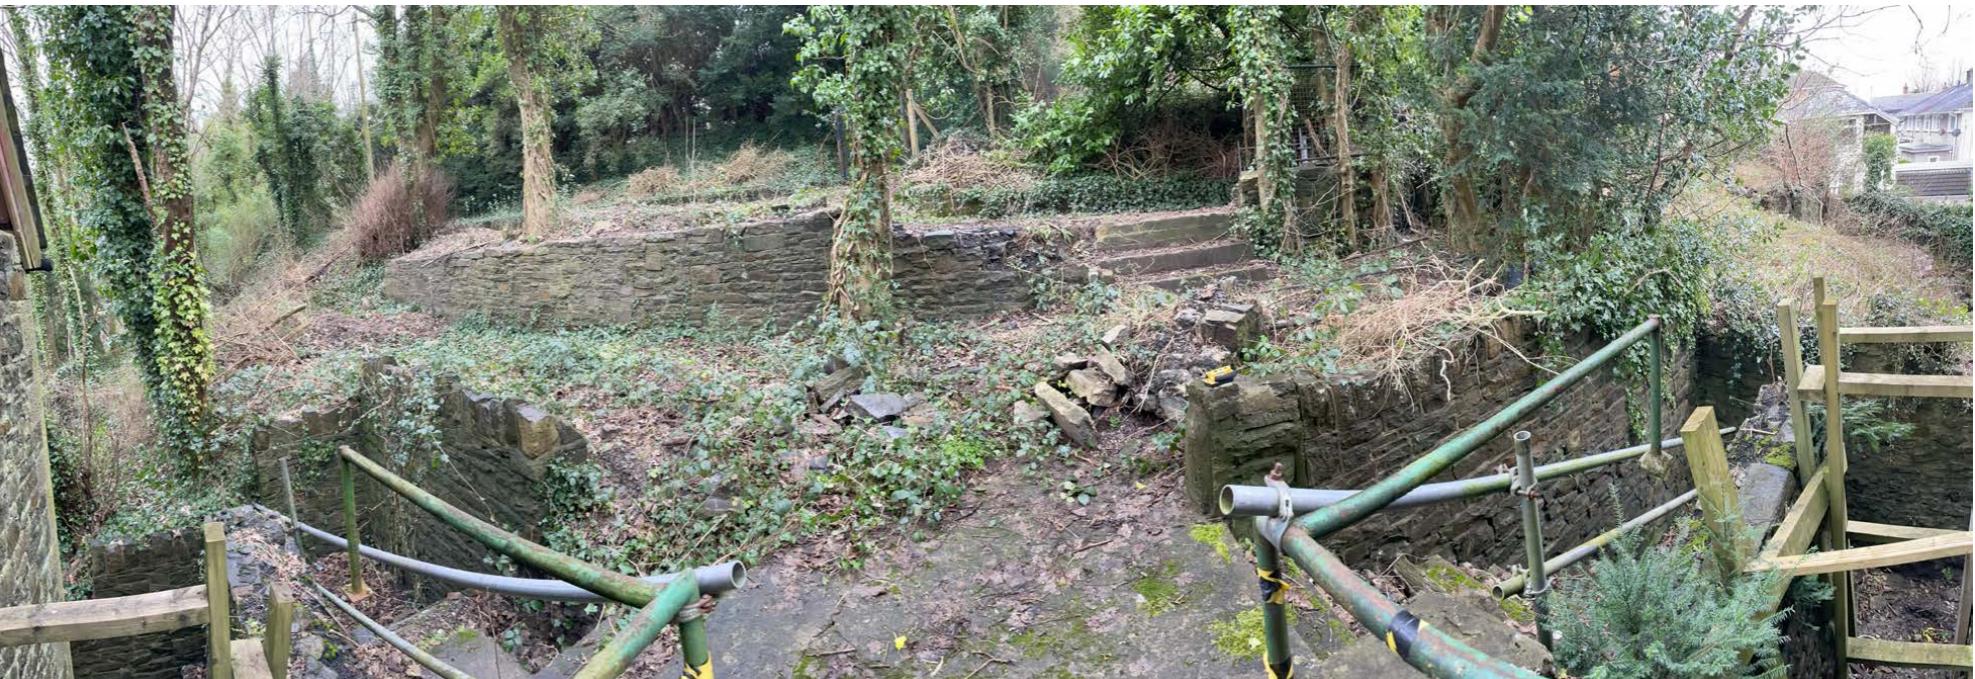
Drainage - As part of the inspections we undertook a quick exercise to try and establish whether the drains still run. This was done by pouring water into holes created in the upper ends of the pipe (on the upper landing) and inspecting whether flow was visible at the bottom.

The North pipe is notably flowing well however there was some evidence of silts within the pipe which may have restricted the flow.

The South pipe flows however at a noticeably slower rate therefore we suspect there may be some localised trapped materials / vegetation which may be restricting the flow.

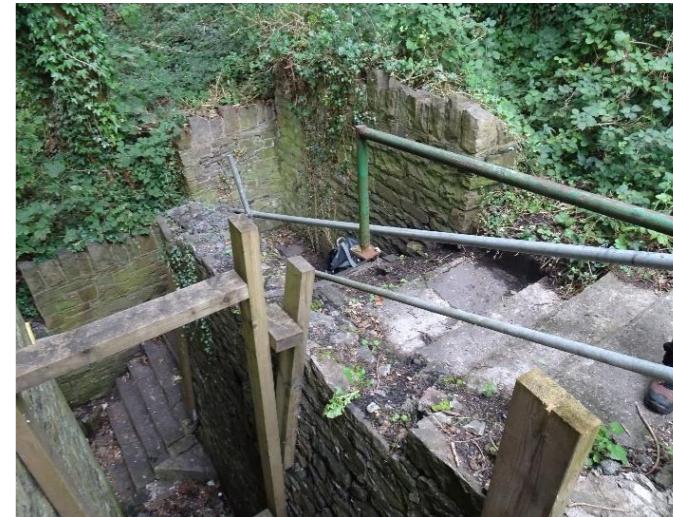
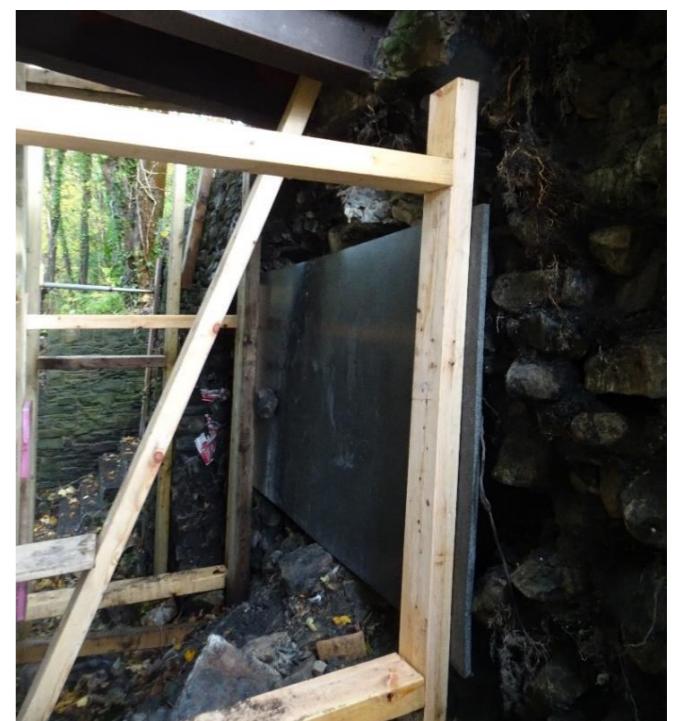
- 2.1 The steps and landings generally are in very poor condition, with most of the original treads either significantly damaged, missing or improperly supported.

- 2.2 The rear wall is generally in reasonable condition and sound, with no obvious evidence of distress or significant deterioration. However, trial pits have revealed that it is not founded at depth; the base of the wall is just below the level of the adjacent steps. The newer concrete slab and bridge are also in reasonable condition currently with no evidence of spalling or exposed reinforcement observed during the inspection.

- 2.3 The inner masonry wall is in very poor condition and has a large collapsed area in the centre. A scheme of temporary propping was undertaken in 2020 to stabilise the wall and mitigate further collapses which could have compromised the remaining integrity of the wall.
