RHONDDA  
GEOTECHNICAL  
SERVICES

COAL MINING RISK ASSESSMENT  
MERTHYR TYDFIL C.B.C.  
DEVELOPMENT AT  
MERTHYR MOTOR AUCTIONS  
PANT ROAD  
DOWLAIS  
MERTHYR TYDFIL  
CF48 3SH  
18/01/2021

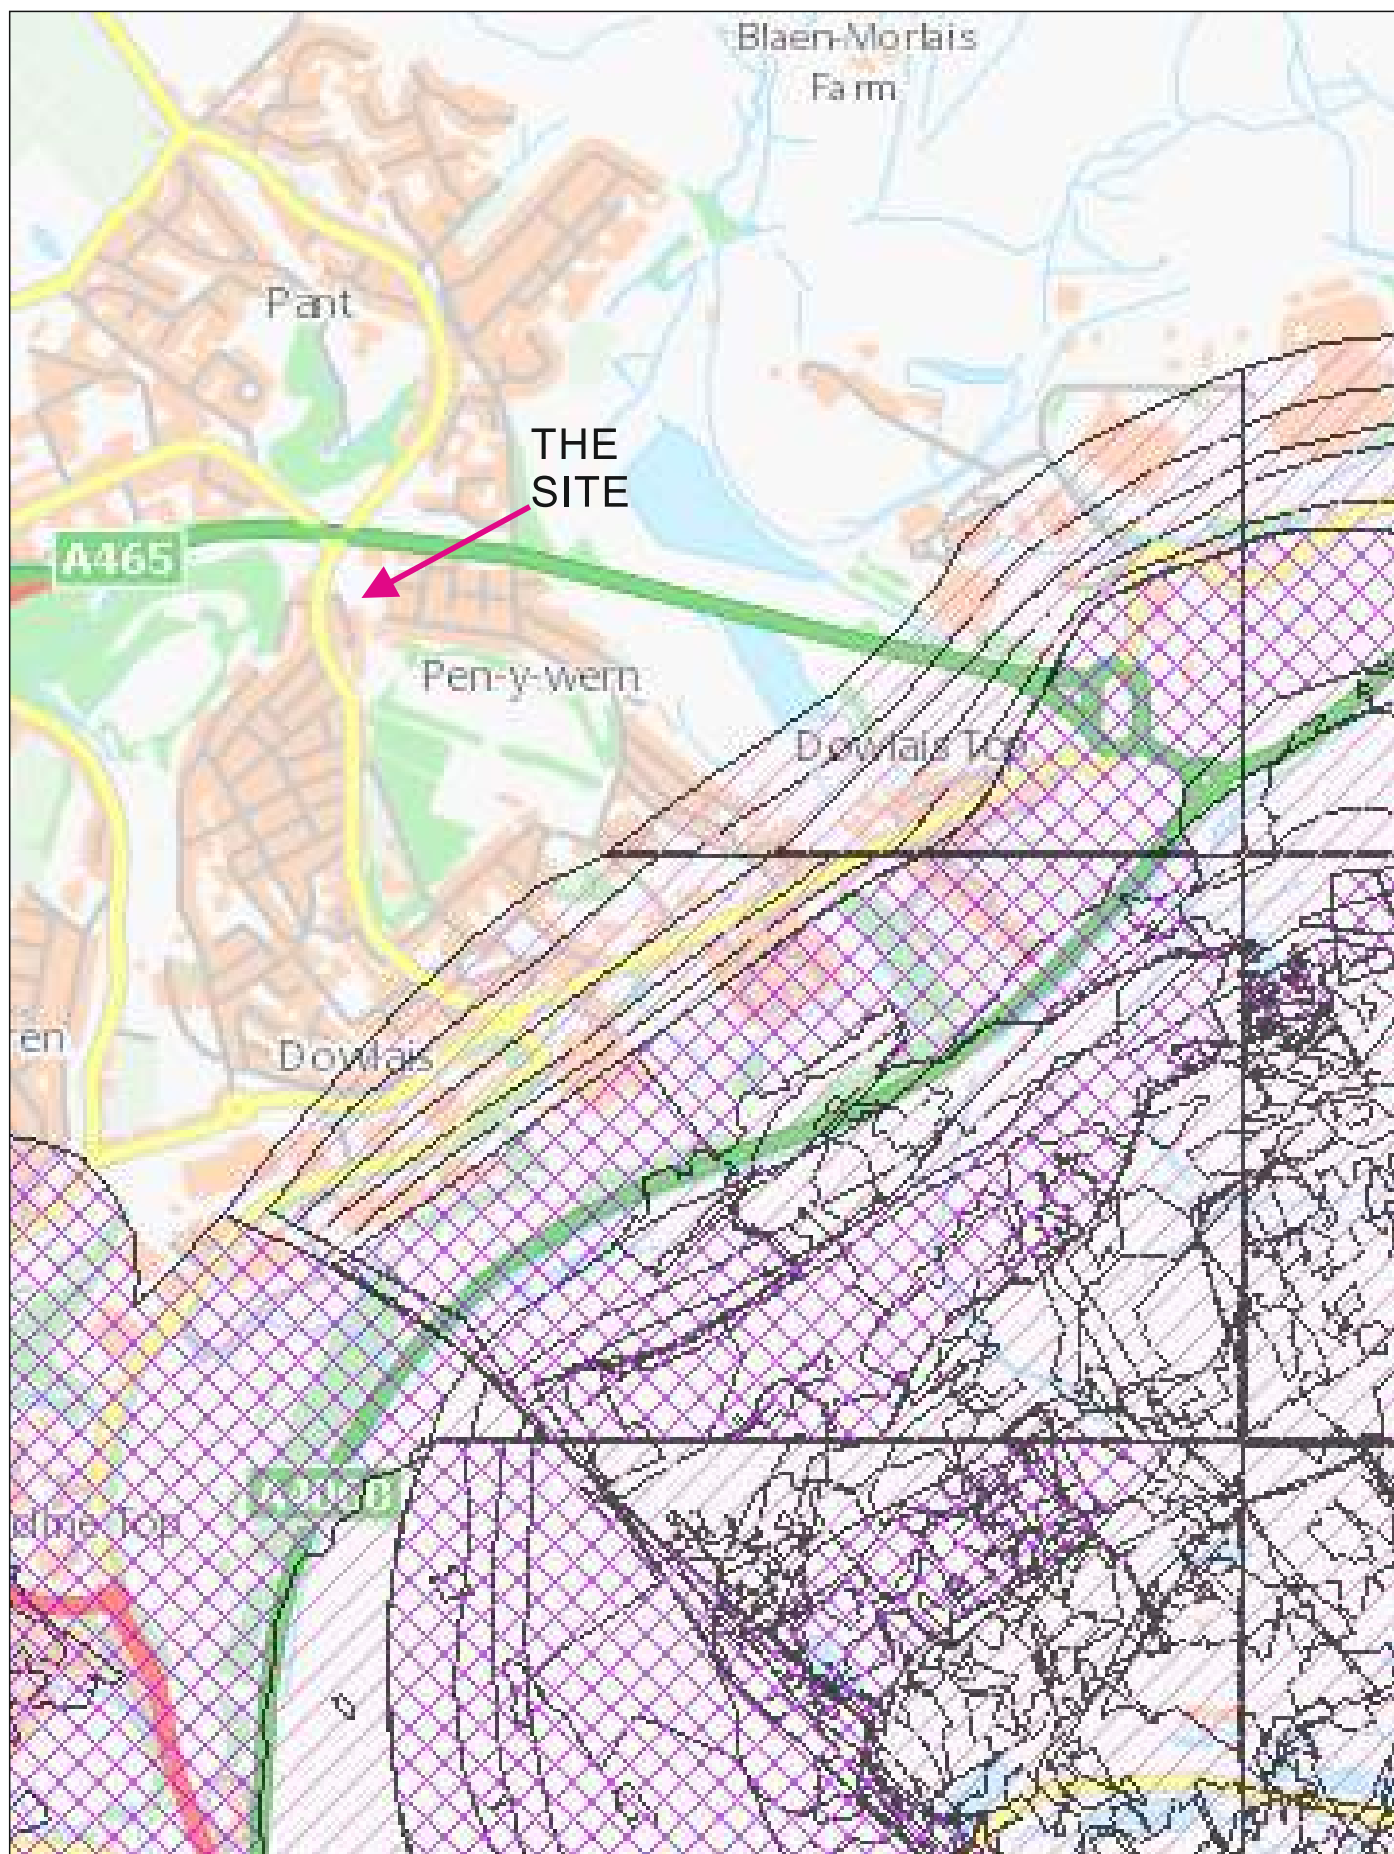
FIGURE 5  
C.A. INTERACTIVE VIEWER, MINING DATA WINDOW.  
THE DIAGONAL HATCHING COVERS AREAS OF RECORDED MINING,  
THE CROSS HATCHING COVERS AREAS OF PROBABLE MINING.

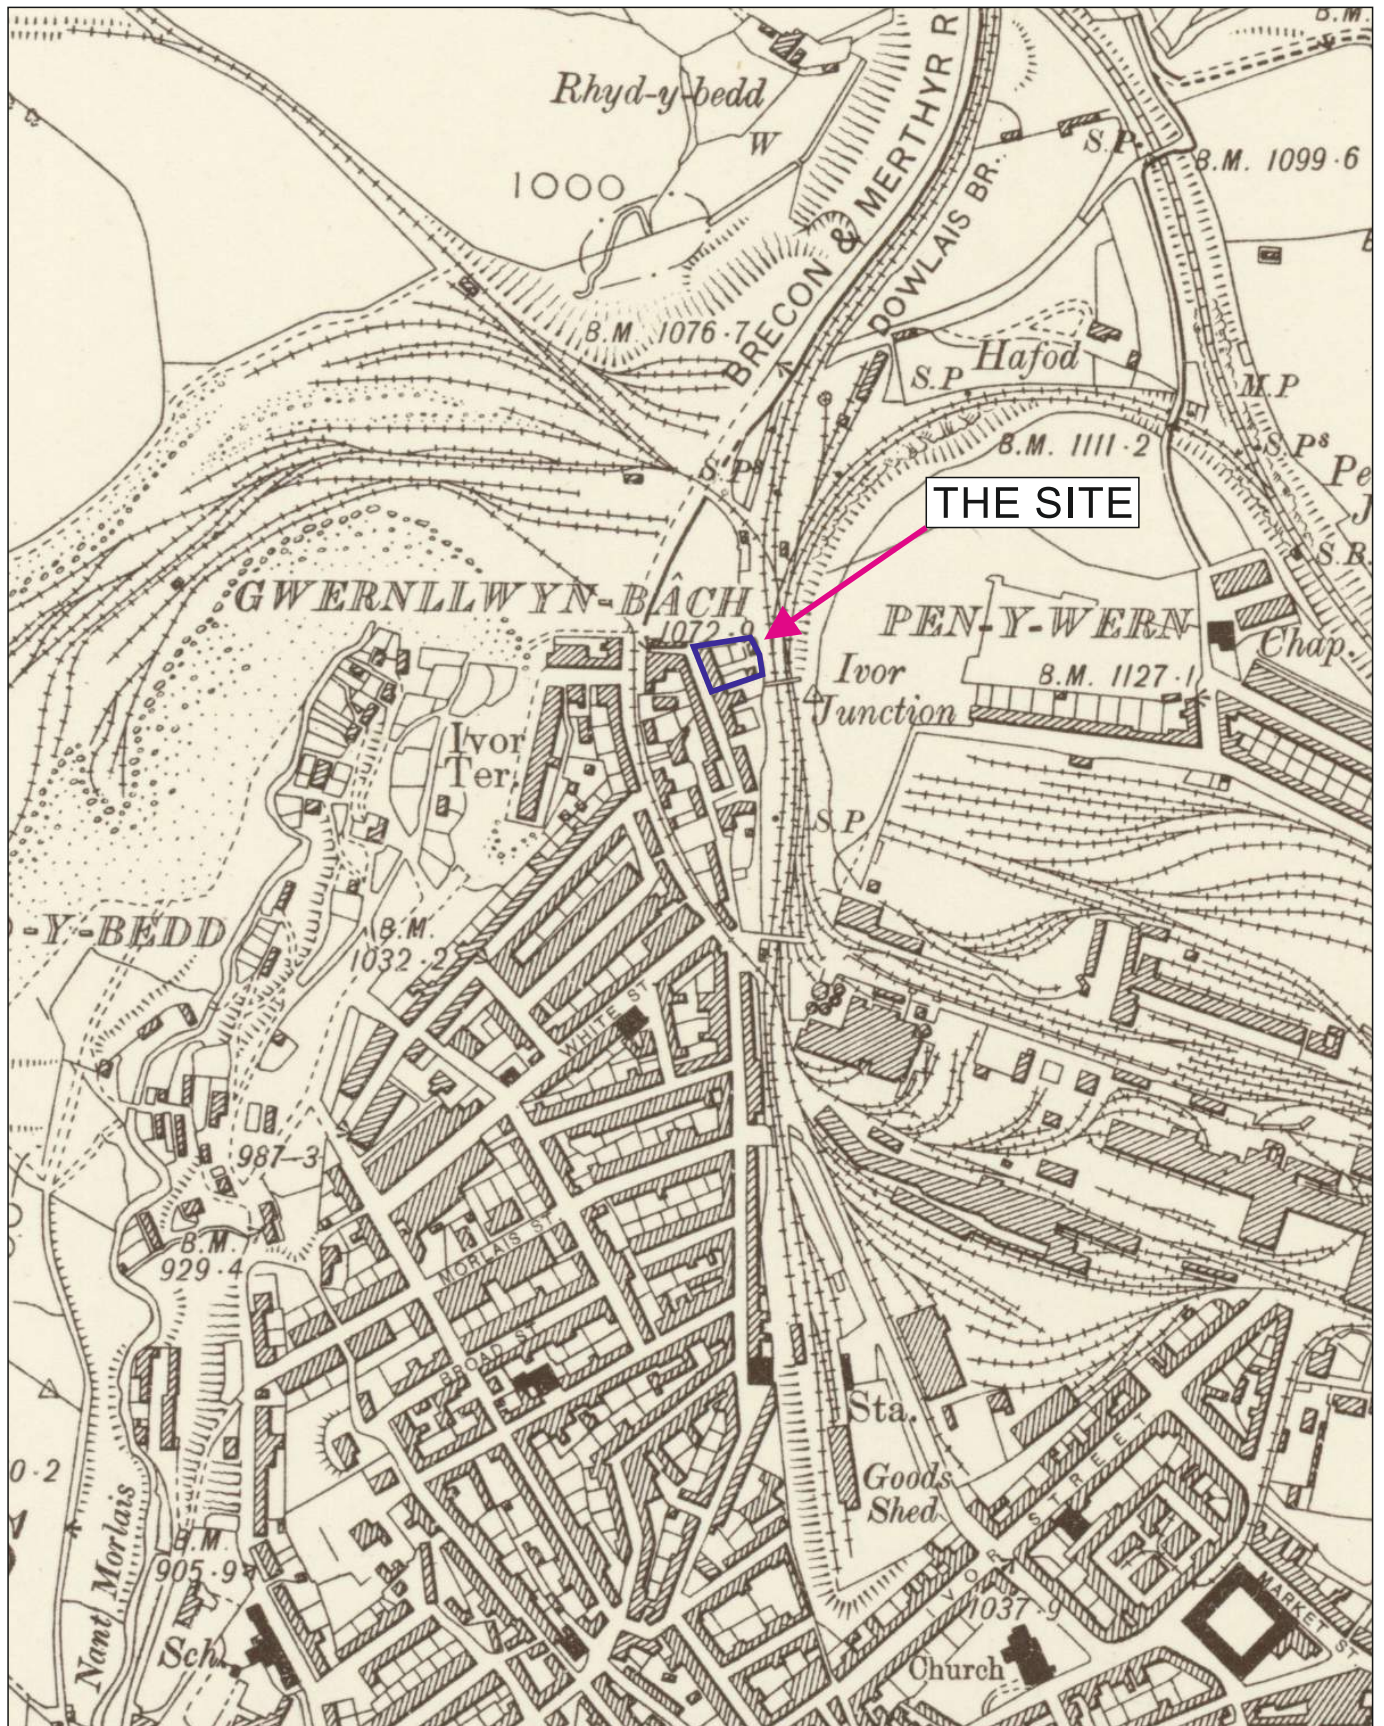
FIGURE 8

1899 O.S. MAP SHOWING THE MASSIVE RAIL COMPLEX SERVING THE IVOR IRONWORKS. THE SITE IS HIGHLIGHTED IN BLUE, OCCUPIED BY TERRACED HOUSING AND GARDENS.
