Site: Flat 1 Rechabite Hall Crescent Street, Merthyr Vale, CF48 4RH

Flat 2 Rechabite Hall, Crescent Street, Merthyr Vale, CF48 4RH

**Contact:** Chris Jones  
**Customer:** Merthyr Council  
**Project No:** S19-01384

**Issue Number:** 1  
**Survey Start Date:** 16 July 2019  
**Report Issue Date:** 22 July 2019

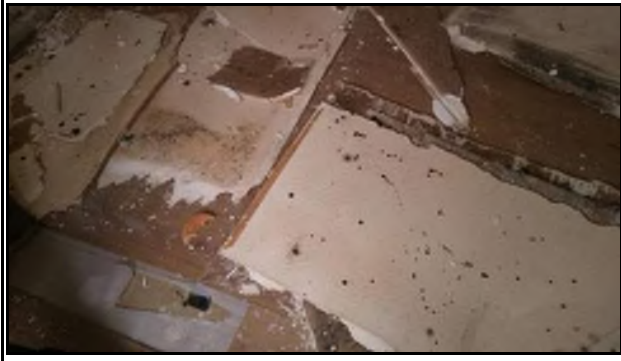
| <b>Room No.</b> | 001 |

| <b>Room ID</b> | lounge |
| <b>Item Description</b> | Textured Coating Floor |
| <b>Material</b> | Textured Coating |

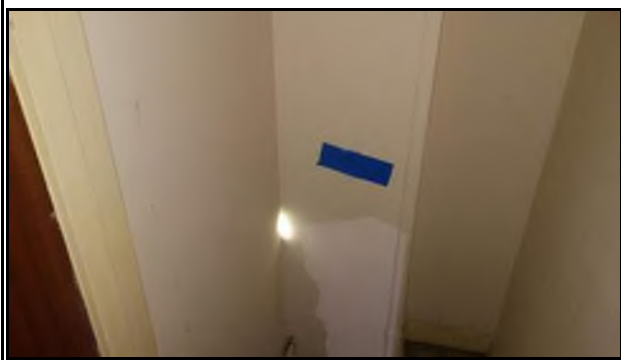
| <b>Room No.</b> | 002 |

| <b>Room ID</b> | Hallway cupboard |
| <b>Item Description</b> | Insulating Board Boxing |
| <b>Material</b> | Insulating Board |

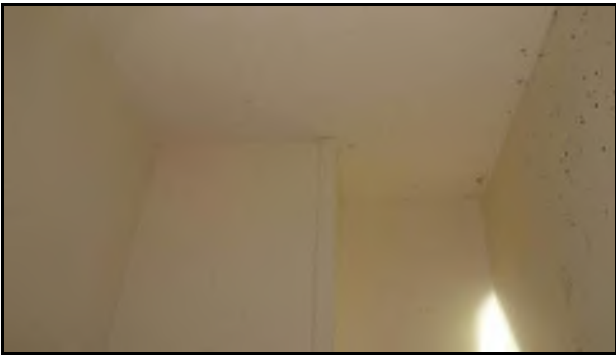
| <b>Room No.</b> | 002 |

| <b>Room ID</b> | Hallway cupboard |
| <b>Item Description</b> | Textured Coating Ceiling |
| <b>Material</b> | Textured Coating |

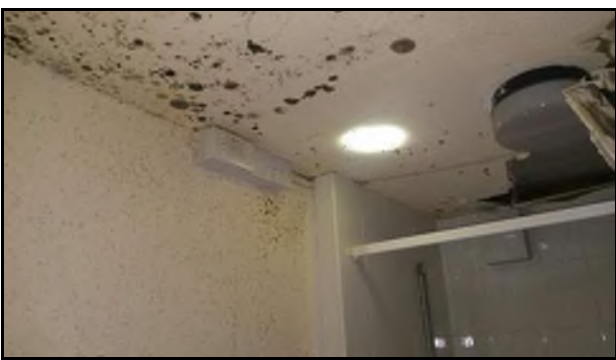
| <b>Room No.</b> | 003 |

| <b>Room ID</b> | Bathroom |
| <b>Item Description</b> | Textured Coating Ceiling |
| <b>Material</b> | Textured Coating |

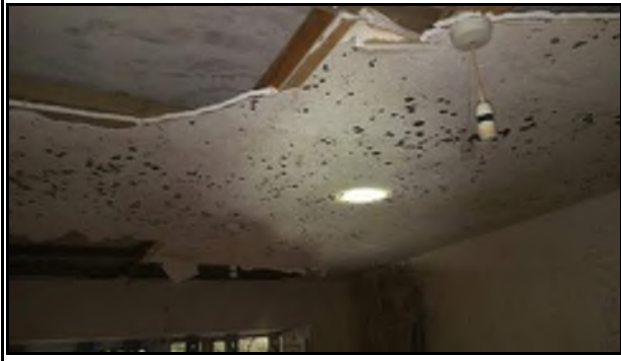
| <b>Room No.</b> | 004 |

| <b>Room ID</b> | Bedroom 1 |
| <b>Item Description</b> | Textured Coating Ceiling |
| <b>Material</b> | Textured Coating |

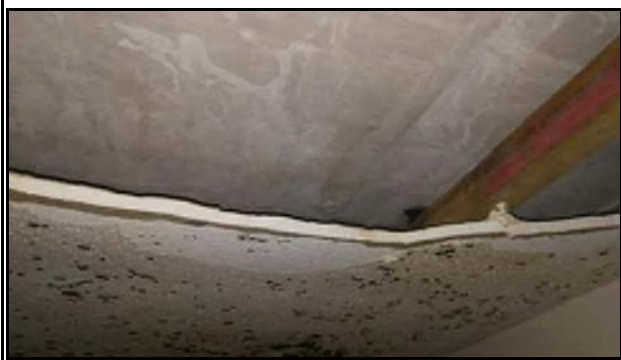
| <b>Room No.</b> | 004 |

| <b>Room ID</b> | Bedroom 1 |
| <b>Item Description</b> | Cement Product Ceiling |
| <b>Material</b> | Cement Product |

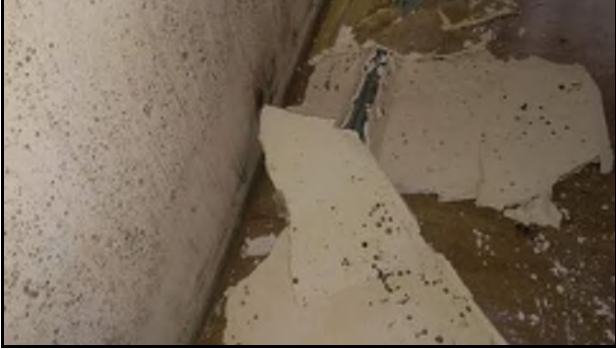
| <b>Room No.</b> | 004 |

| <b>Room ID</b> | Bedroom 1 |
| <b>Item Description</b> | Textured Coating Floor |
| <b>Material</b> | Textured Coating |

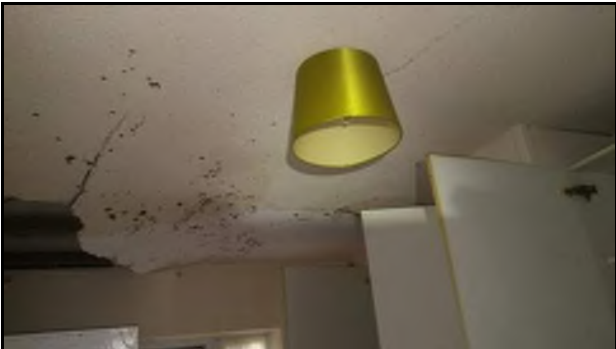
| <b>Room No.</b> | 005 |

| <b>Room ID</b> | Kitchen |
| <b>Item Description</b> | Textured Coating Ceiling |
| <b>Material</b> | Textured Coating |

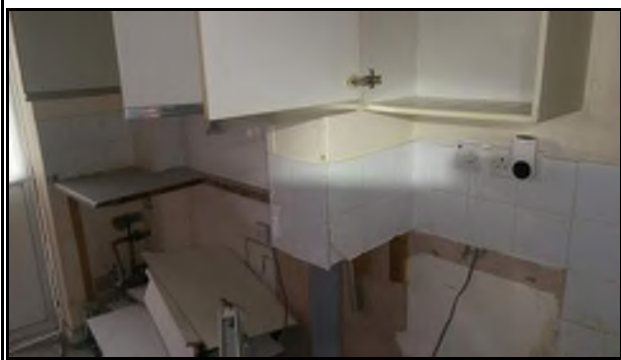
| <b>Room No.</b> | 005 |

| <b>Room ID</b> | Kitchen |
| <b>Item Description</b> | Insulating Board Boxing |
| <b>Material</b> | Insulating Board |

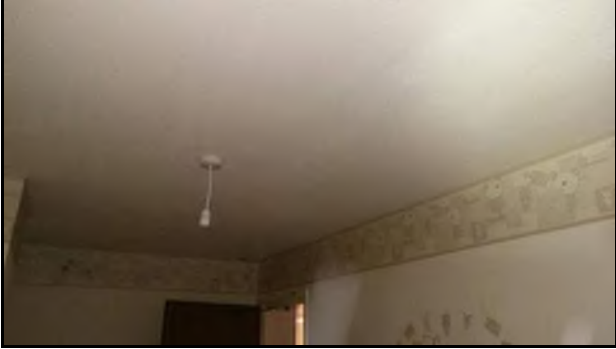
| <b>Room No.</b> | 006 |

| <b>Room ID</b> | Bedroom 2 |
| <b>Item Description</b> | Textured Coating Ceiling |
| <b>Material</b> | Textured Coating |

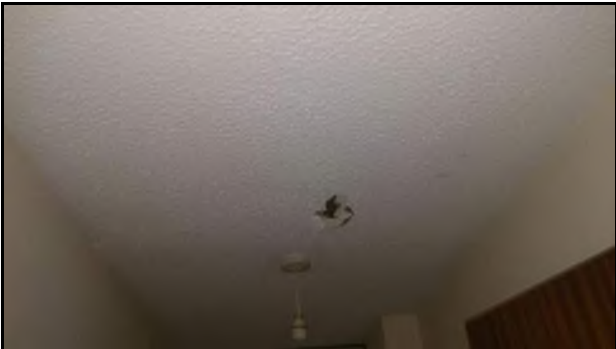
| <b>Room No.</b> | 007 |

| <b>Room ID</b> | Store |
| <b>Item Description</b> | Textured Coating Ceiling |
| <b>Material</b> | Textured Coating |

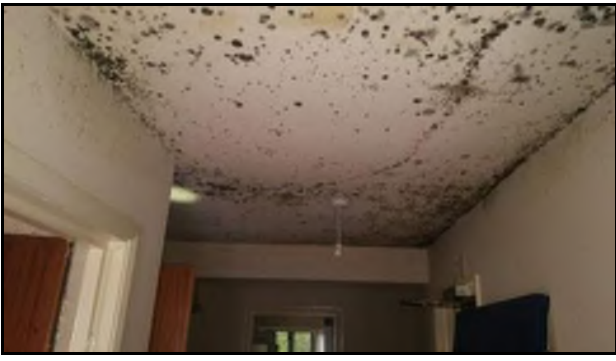
| <b>Room No.</b> | 008 |

| <b>Room ID</b> | Hallway |
| <b>Item Description</b> | Textured Coating Ceiling |
| <b>Material</b> | Textured Coating |

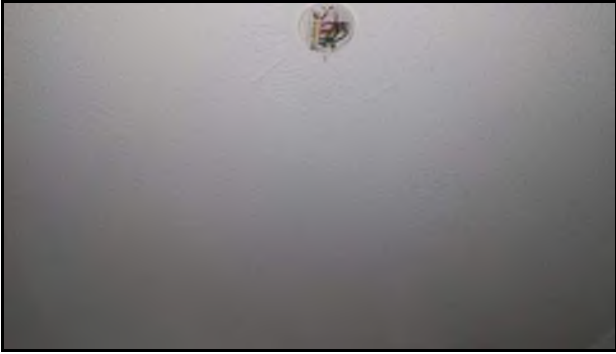
| <b>Room No.</b> | 001 |

| <b>Room ID</b> | Bedroom 1 |
| <b>Item Description</b> | Textured Coating Ceiling |
| <b>Material</b> | Textured Coating |

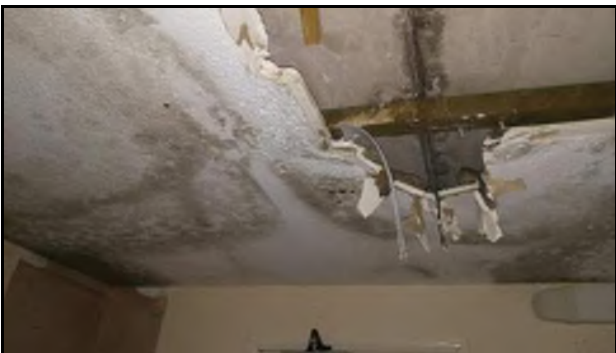
| <b>Room No.</b> | 002 |

| <b>Room ID</b> | Kitchen |
| <b>Item Description</b> | Textured Coating Ceiling |
| <b>Material</b> | Textured Coating |

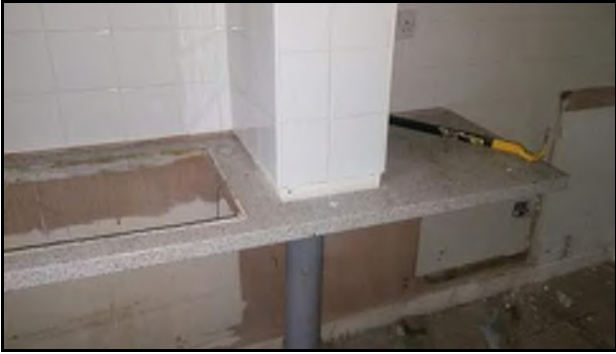
| <b>Room No.</b> | 002 |

| <b>Room ID</b> | Kitchen |
| <b>Item Description</b> | Insulating Board Boxing |
| <b>Material</b> | Insulating Board |

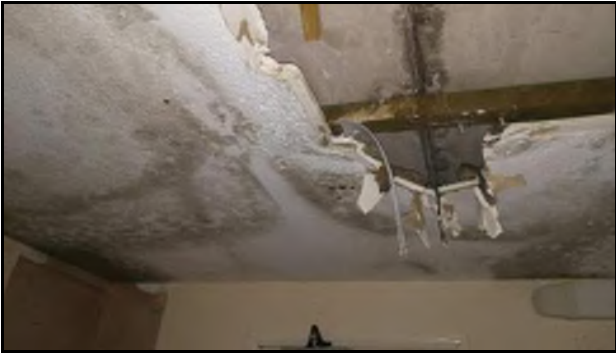
| <b>Room No.</b> | 002 |

| <b>Room ID</b> | Kitchen |
| <b>Item Description</b> | Debris Floor |
| <b>Material</b> | Debris |

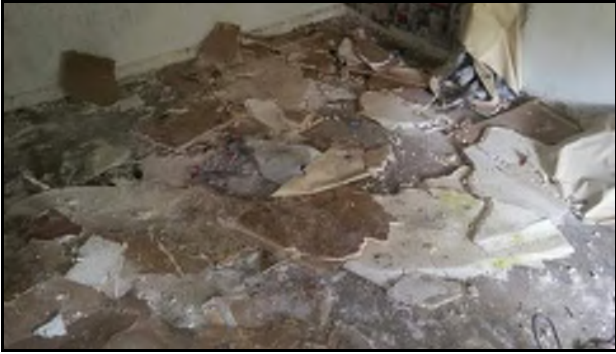
| <b>Room No.</b> | 003 |

| <b>Room ID</b> | Bedroom 2 |
| <b>Item Description</b> | Debris Floor |
| <b>Material</b> | Debris |

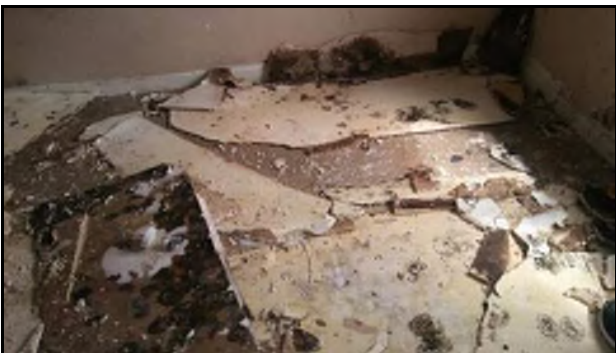
| <b>Room No.</b> | 004 |

| <b>Room ID</b> | Lounge |
| <b>Item Description</b> | Debris Floor |
| <b>Material</b> | Debris |

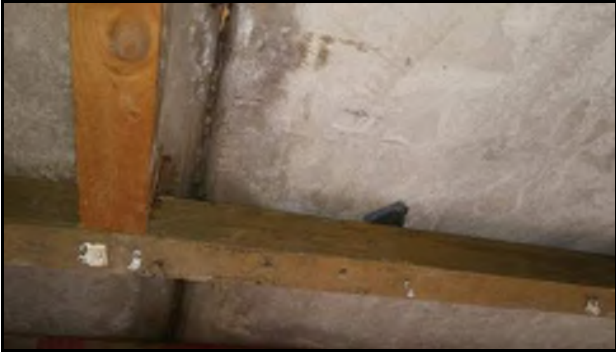
| <b>Room No.</b> | 004 |

| <b>Room ID</b> | Lounge |
| <b>Item Description</b> | Cement Product Ceiling |
| <b>Material</b> | Cement Product |

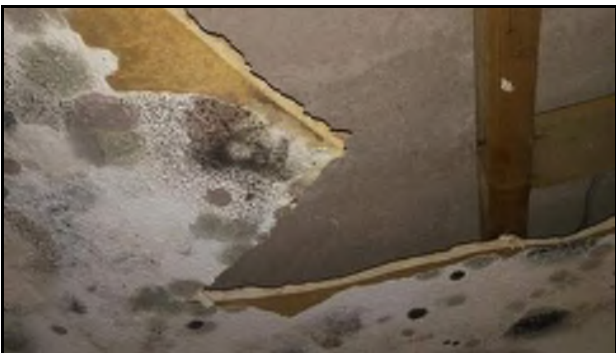
| <b>Room No.</b> | 005 |

| <b>Room ID</b> | Bathroom |
| <b>Item Description</b> | Textured Coating Ceiling |
| <b>Material</b> | Textured Coating |

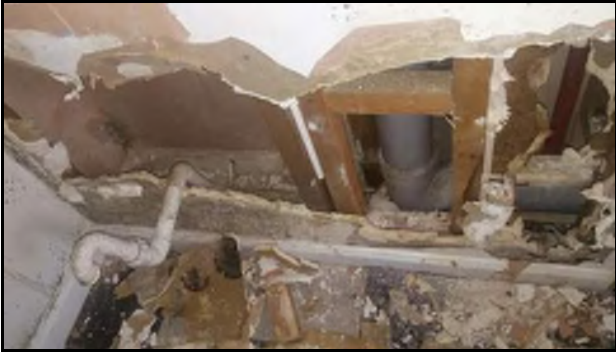
| <b>Room No.</b> | 005 |

| <b>Room ID</b> | Bathroom |
| <b>Item Description</b> | Insulating Board Boxing |
| <b>Material</b> | Insulating Board |

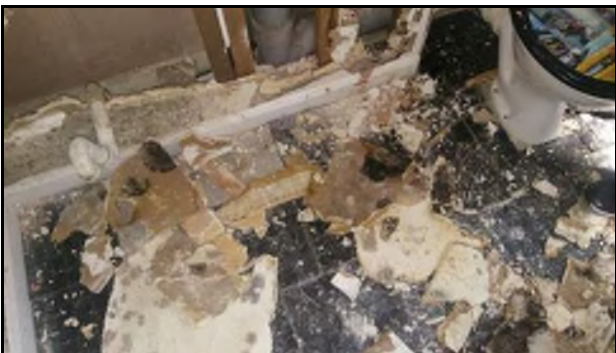
| <b>Room No.</b> | 005 |

| <b>Room ID</b> | Bathroom |
| <b>Item Description</b> | Debris Floor |
| <b>Material</b> | Debris |

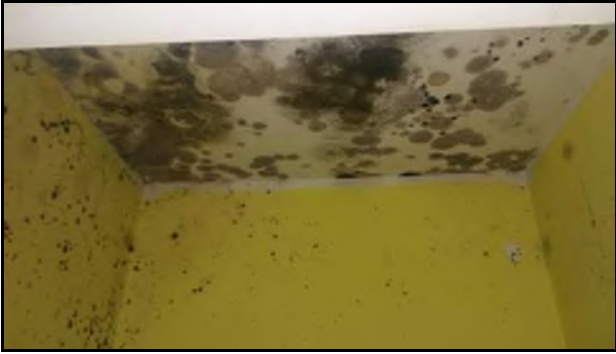
| <b>Room No.</b> | 006 |

| <b>Room ID</b> | Hallway cupboard |
| <b>Item Description</b> | Textured Coating Ceiling |
| <b>Material</b> | Textured Coating |

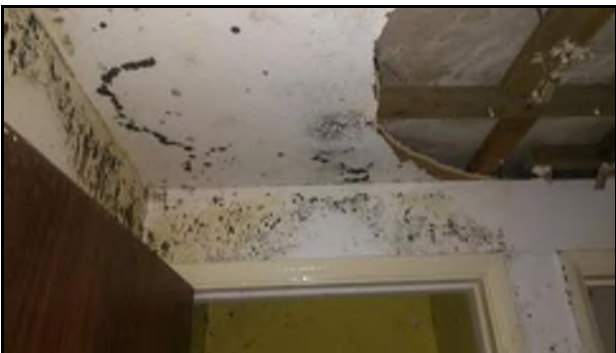
| <b>Room No.</b> | 007 |

| <b>Room ID</b> | Hallway |
| <b>Item Description</b> | Textured Coating Ceiling |
| <b>Material</b> | Textured Coating |

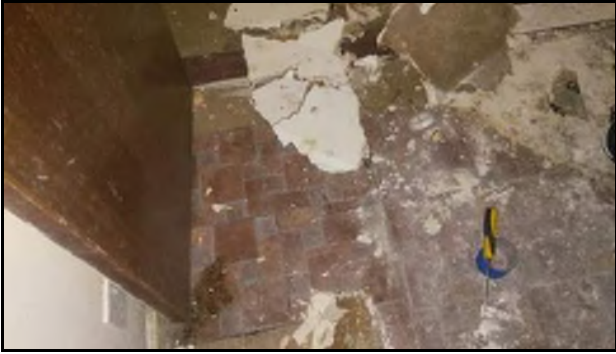
| <b>Room No.</b> | 007 |

| <b>Room ID</b> | Hallway |
| <b>Item Description</b> | Debris Floor |
| <b>Material</b> | Debris |

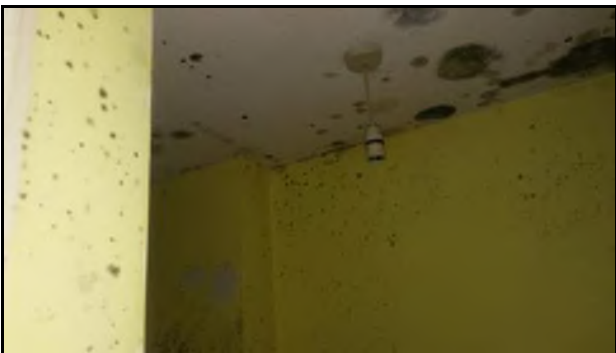
| <b>Room No.</b> | 008 |

| <b>Room ID</b> | Store Cupboard |
| <b>Item Description</b> | Textured Coating Ceiling |
| <b>Material</b> | Textured Coating |

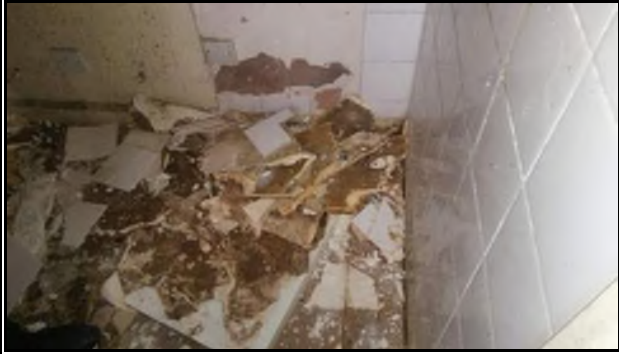
| <b>Room No.</b> | 001 |

| <b>Room ID</b> | Kitchen |
| <b>Item Description</b> | Debris to the Floor |
| <b>Material</b> | Debris |

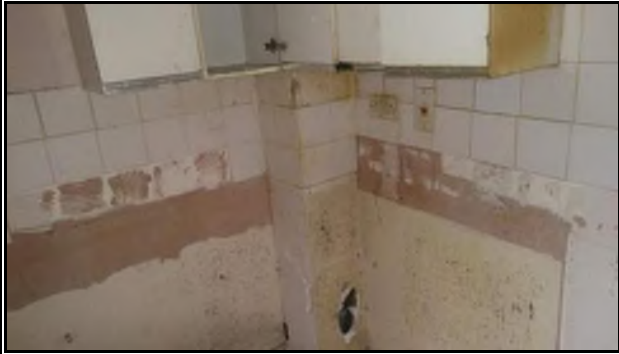
| <b>Room No.</b> | 001 |

| <b>Room ID</b> | Kitchen |
| <b>Item Description</b> | Insulating Board Boxing |
| <b>Material</b> | Insulating Board |

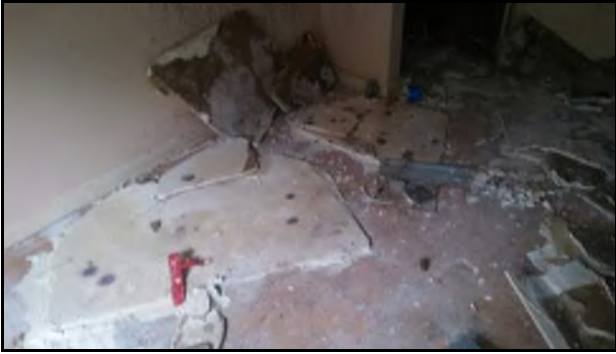
| <b>Room No.</b> | 002 |

| <b>Room ID</b> | Lounge |
| <b>Item Description</b> | Debris to the Floor |
| <b>Material</b> | Debris |

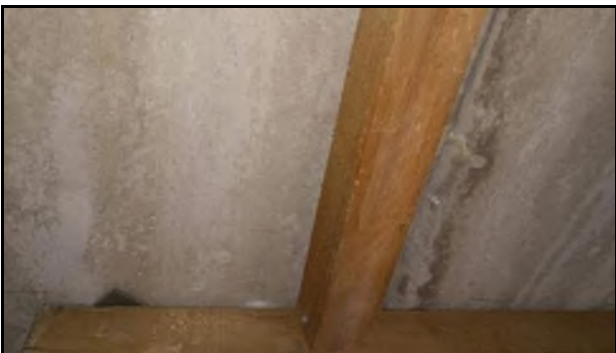
| <b>Room No.</b> | 002 |

| <b>Room ID</b> | Lounge |
| <b>Item Description</b> | Cement Product Ceiling |
| <b>Material</b> | Cement Product |

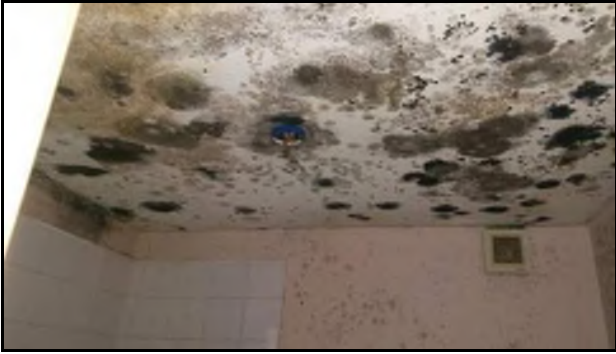
| <b>Room No.</b> | 003 |

| <b>Room ID</b> | Bathroom |
| <b>Item Description</b> | Textured Coating Ceiling |
| <b>Material</b> | Textured Coating |

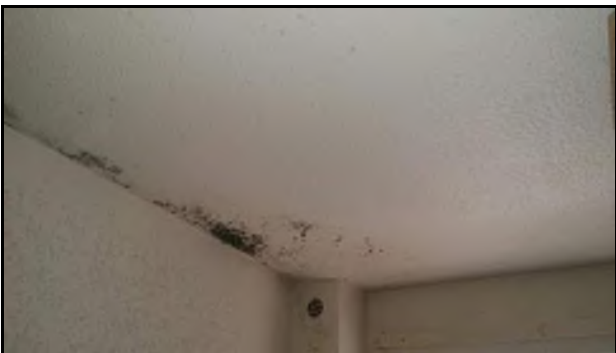
| <b>Room No.</b> | 004 |

| <b>Room ID</b> | Bedroom |
| <b>Item Description</b> | Textured Coating Ceiling |
| <b>Material</b> | Textured Coating |

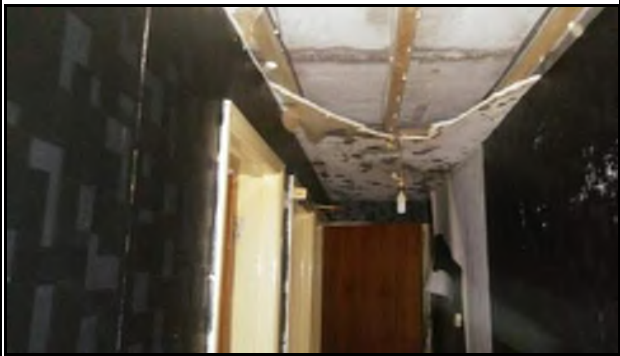
| <b>Room No.</b> | 005 |

| <b>Room ID</b> | Hallway |
| <b>Item Description</b> | Textured Coating Ceiling |
| <b>Material</b> | Textured Coating |

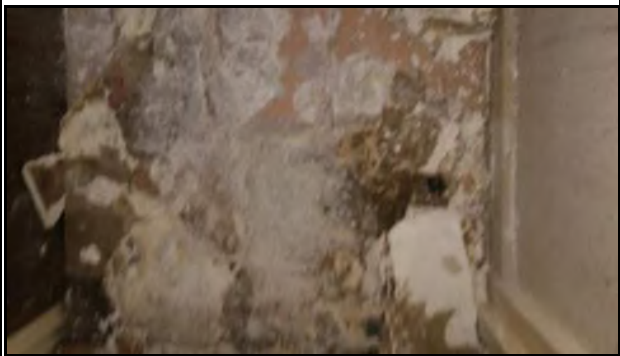
| <b>Room No.</b> | 005 |

| <b>Room ID</b> | Hallway |
| <b>Item Description</b> | Textured Coating to the Floor |
| <b>Material</b> | Textured Coating |

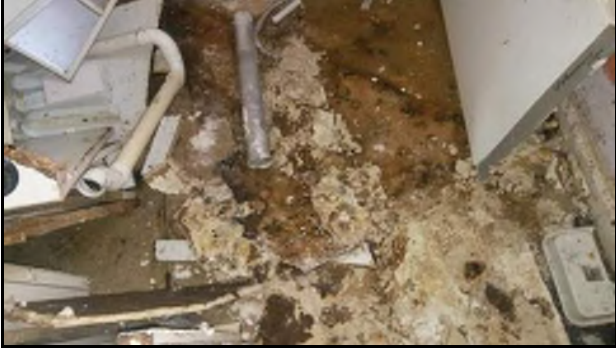
| <b>Room No.</b> | 001 |

| <b>Item Description</b> | Floor |
| <b>Material</b> | Debris |

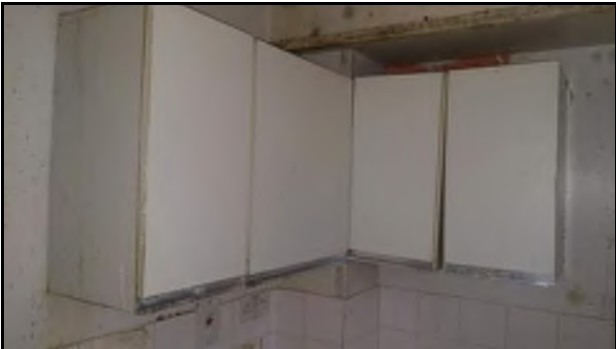
| <b>Room No.</b> | 001 |

| <b>Item Description</b> | Boxing |
| <b>Material</b> | Insulating Board |

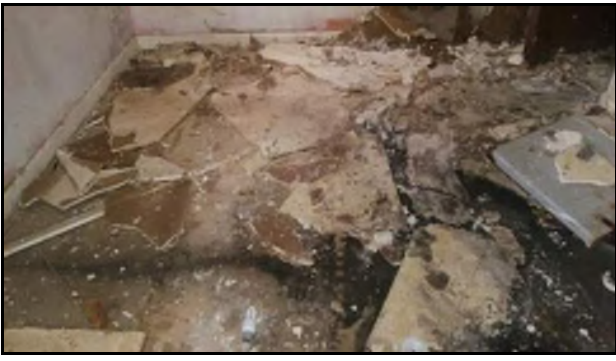
| <b>Room No.</b> | 002 |

| <b>Item Description</b> | Floor |
| <b>Material</b> | Debris |

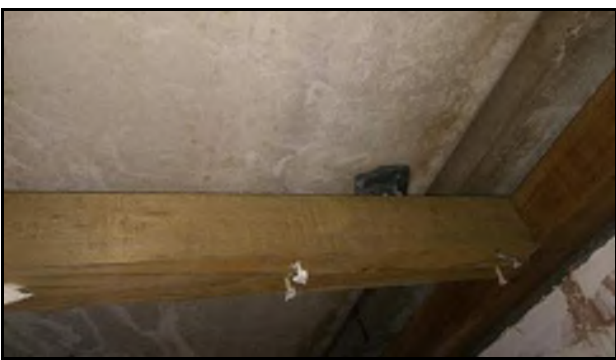
| <b>Room No.</b> | 002 |

| <b>Item Description</b> | Ceiling |
| <b>Material</b> | Cement Product |

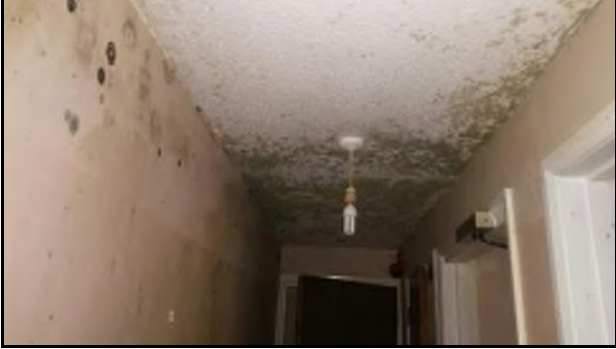
| <b>Room No.</b> | 003 |

| <b>Item Description</b> | Ceiling |
| <b>Material</b> | Textured Coating |

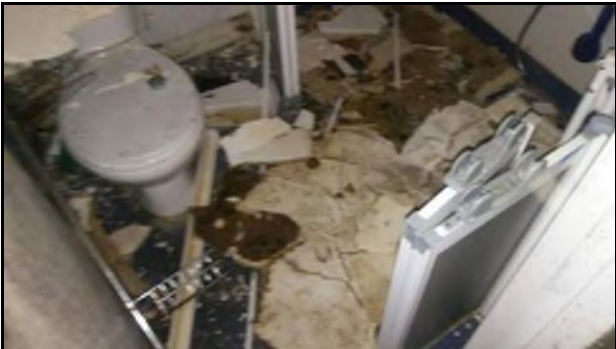
| <b>Room No.</b> | 004 |

| <b>Item Description</b> | Floor |
| <b>Material</b> | Debris |

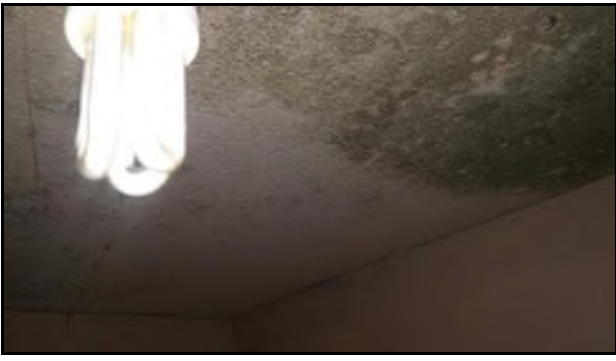
| <b>Room No.</b> | 005 |

| <b>Item Description</b> | Ceiling |
| <b>Material</b> | Textured Coating |

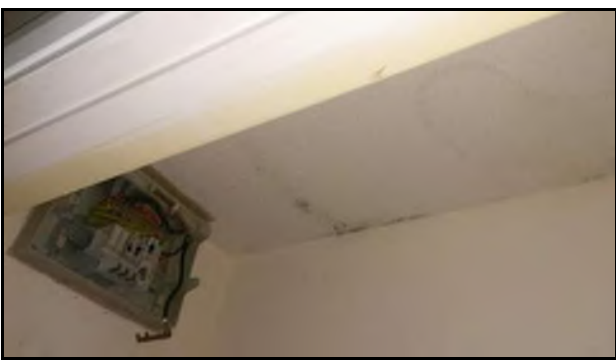
| <b>Room No.</b> | 006 |

| <b>Item Description</b> | Ceiling |
| <b>Material</b> | Textured Coating |

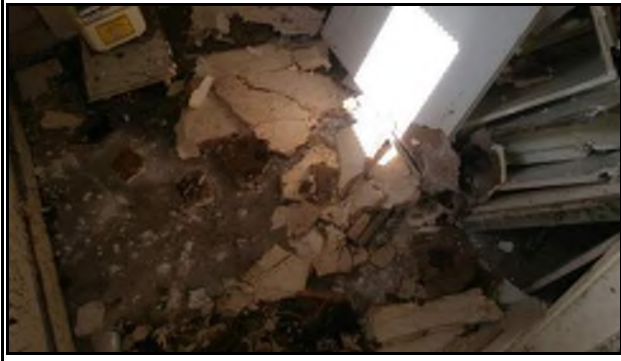
| <b>Room No.</b> | 001 |

| <b>Item Description</b> | Floor |
| <b>Material</b> | Debris |

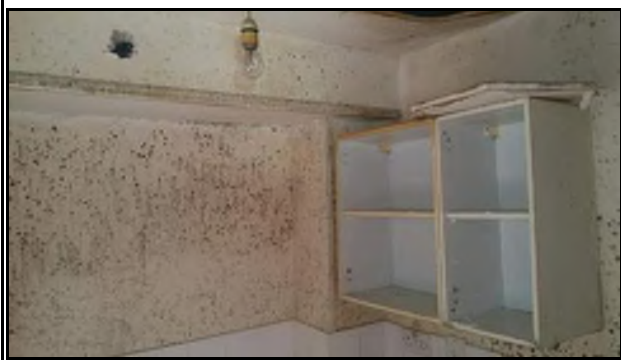
| <b>Room No.</b> | 001 |

| <b>Item Description</b> | Boxing |
| <b>Material</b> | Insulating Board |

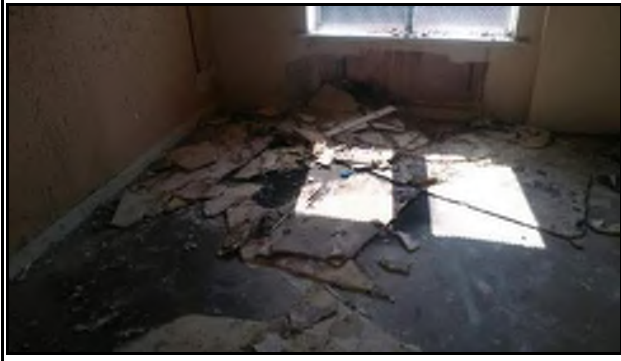
| <b>Room No.</b> | 002 |

| <b>Item Description</b> | Floor |
| <b>Material</b> | Debris |

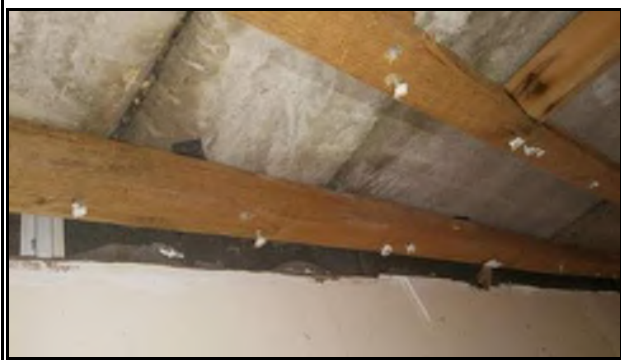
| <b>Room No.</b> | 002 |

| <b>Item Description</b> | Ceiling |
| <b>Material</b> | Cement Product |

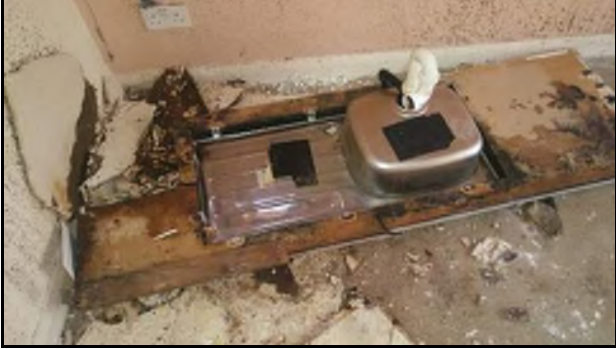
| <b>Room No.</b> | 002 |

| <b>Item Description</b> | Sink pad (s) |
| <b>Material</b> | Bituminous Products |

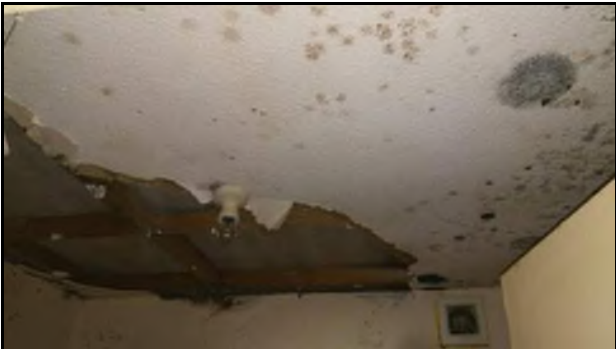
| <b>Room No.</b> | 003 |

| <b>Item Description</b> | Ceiling |
| <b>Material</b> | Textured Coating |

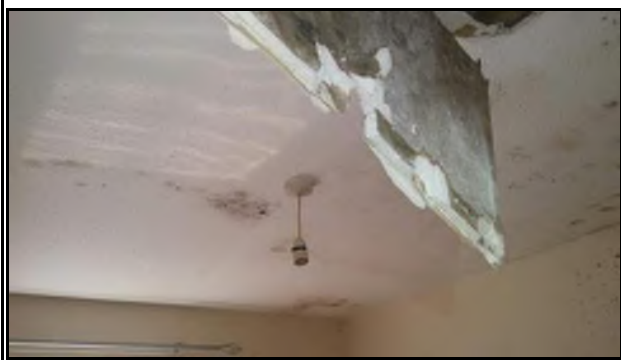
| <b>Room No.</b> | 004 | | |

| | | <b>Item Description</b> | Ceiling |
| | | <b>Material</b> | Textured Coating |
| | | <b>Asbestos Type</b> | No Asbestos Detected |

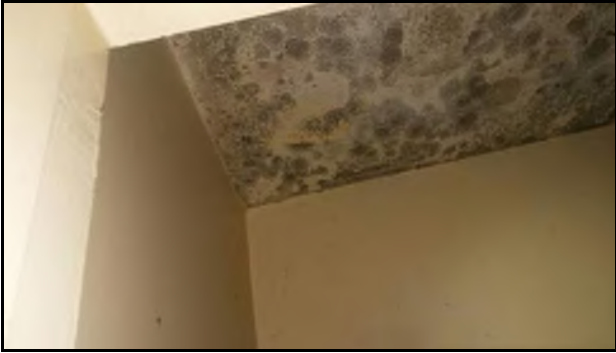
| <b>Room No.</b> | 005 |

| <b>Item Description</b> | Ceiling |
| <b>Material</b> | Textured Coating |

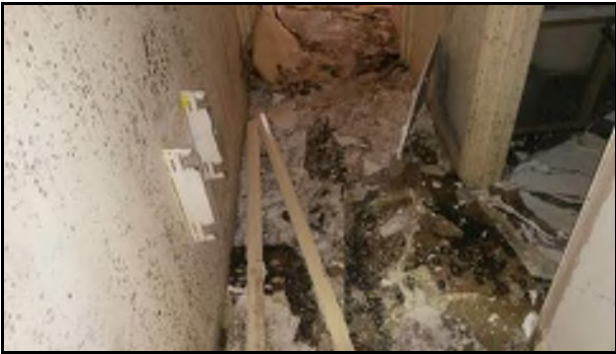
| <b>Room No.</b> | 006 |

| <b>Item Description</b> | Floor |
| <b>Material</b> | Debris |

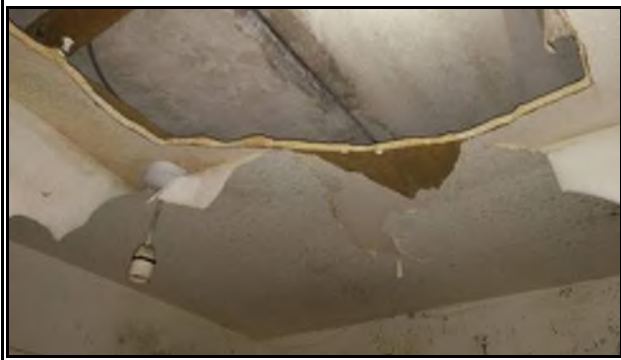
| <b>Room No.</b> | 001 |

| <b>Item Description</b> | Textured Coating Ceiling |
| <b>Material</b> | Textured Coating |

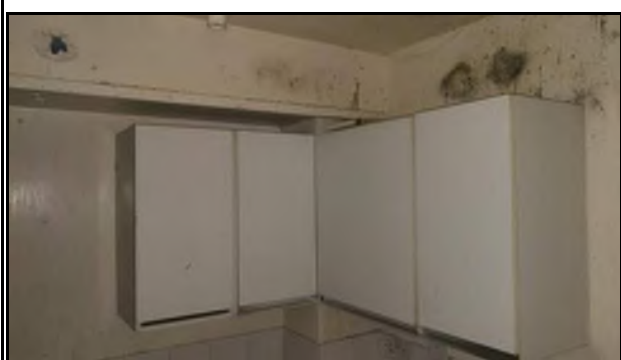
| <b>Room No.</b> | 001 |

| <b>Item Description</b> | Insulating Board Boxing |
| <b>Material</b> | Insulating Board |

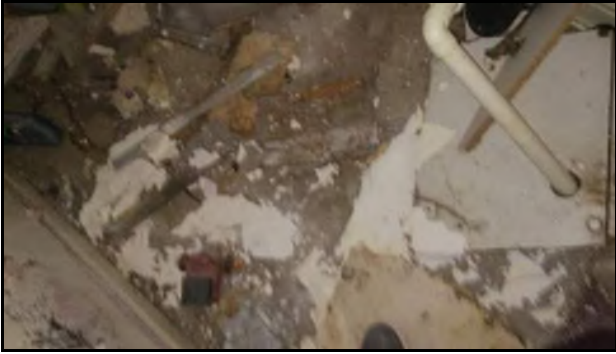
| <b>Room No.</b> | 001 |

| <b>Item Description</b> | Textured Coating to the Floor |
| <b>Material</b> | Textured Coating |

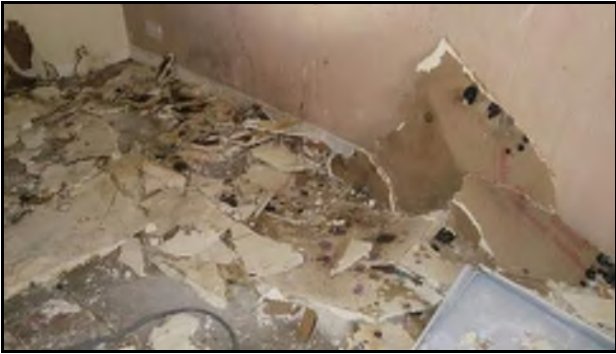
| <b>Room No.</b> | 002 |

| <b>Item Description</b> | Debris to the Floor |
| <b>Material</b> | Debris |

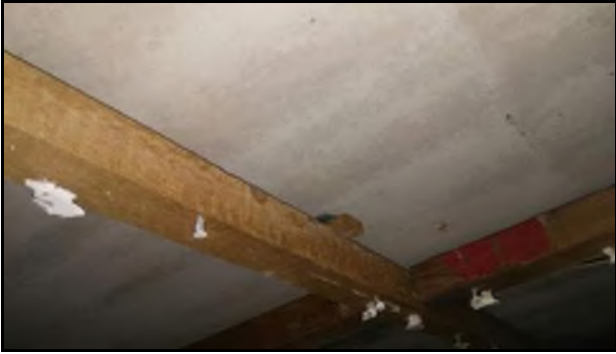
| <b>Room No.</b> | 002 |

| <b>Item Description</b> | Cement Product Ceiling |
| <b>Material</b> | Cement Product |

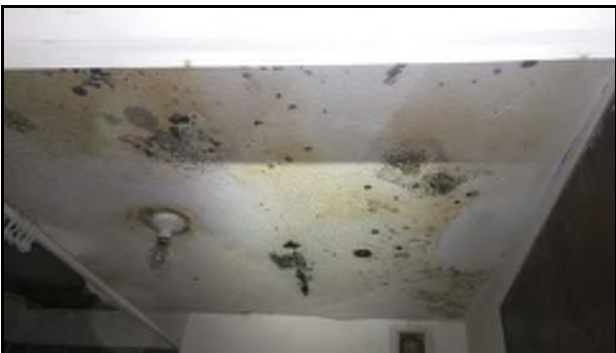
| <b>Room No.</b> | 003 |

| <b>Item Description</b> | Textured Coating Ceiling |
| <b>Material</b> | Textured Coating |

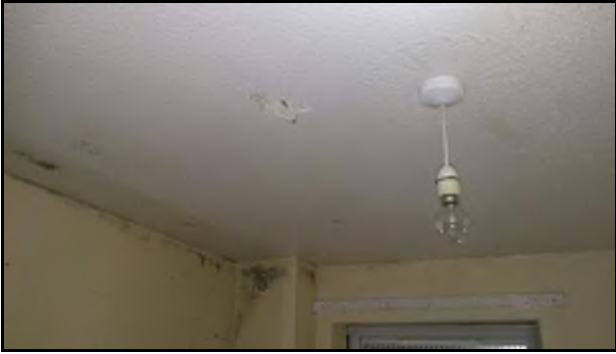
| <b>Room No.</b> | 004 |

| <b>Item Description</b> | Textured Coating Ceiling |
| <b>Material</b> | Textured Coating |

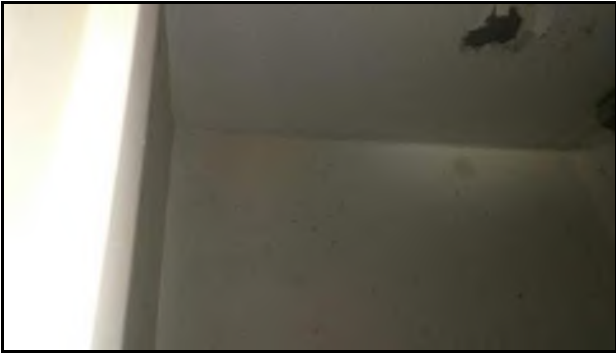
| <b>Room No.</b> | 005 |

| <b>Item Description</b> | Textured Coating Ceiling |
| <b>Material</b> | Textured Coating |

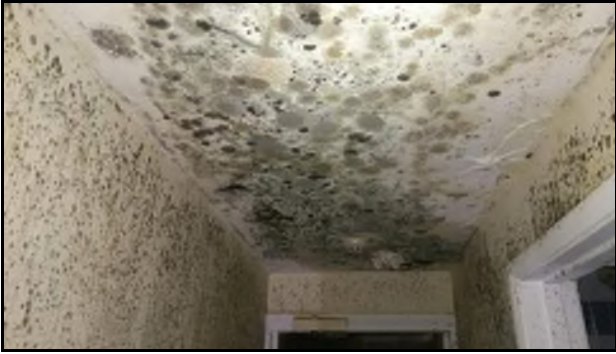
| <b>Room No.</b> | 006 | | |

| | | <b>Item Description</b> | Textured Coating Ceiling |
| | | <b>Material</b> | Textured Coating |
| | | <b>Asbestos Type</b> | No Asbestos Detected |

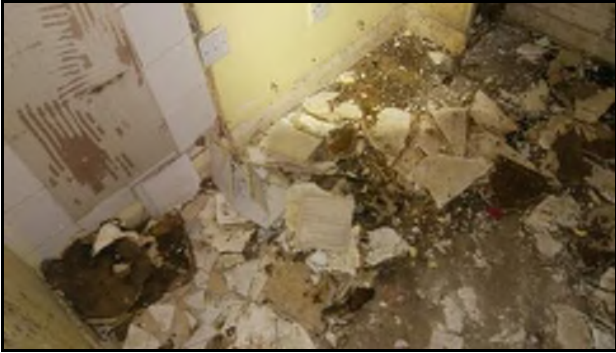
| <b>Room No.</b> | 001 |

| <b>Item Description</b> | Floor |
| <b>Material</b> | Debris |

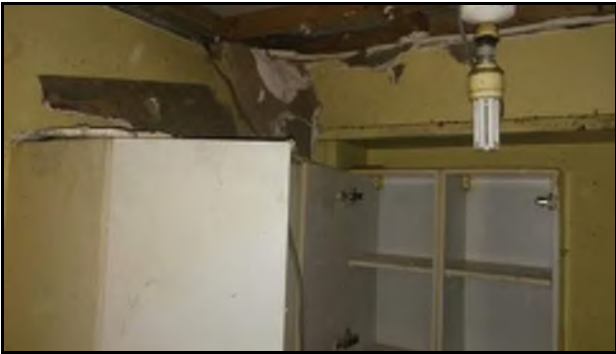
| <b>Room No.</b> | 001 |

| <b>Item Description</b> | Boxing |
| <b>Material</b> | Insulating Board |

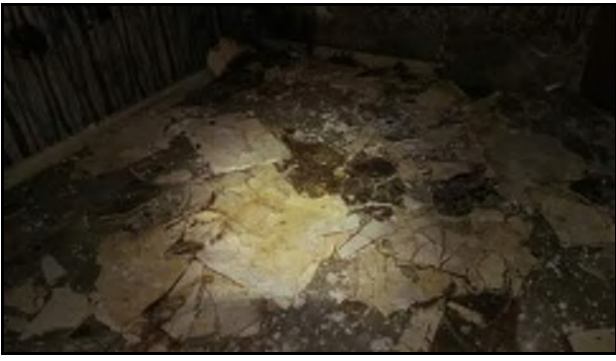
| <b>Room No.</b> | 002 |

| <b>Item Description</b> | Floor |
| <b>Material</b> | Debris |

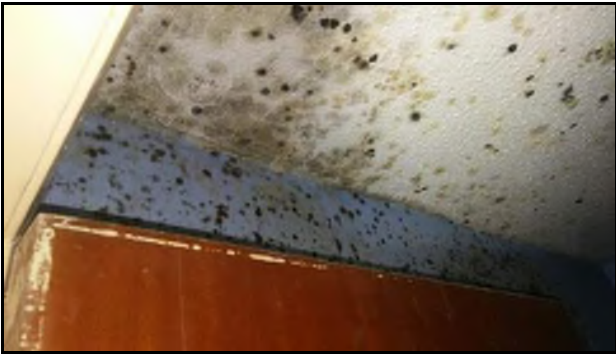
| <b>Room No.</b> | 003 |

| <b>Item Description</b> | Ceiling |
| <b>Material</b> | Textured Coating |

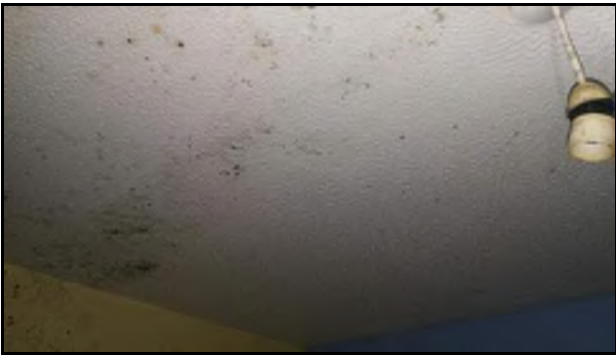
| <b>Room No.</b> | 004 |

| <b>Item Description</b> | Ceiling |
| <b>Material</b> | Textured Coating |

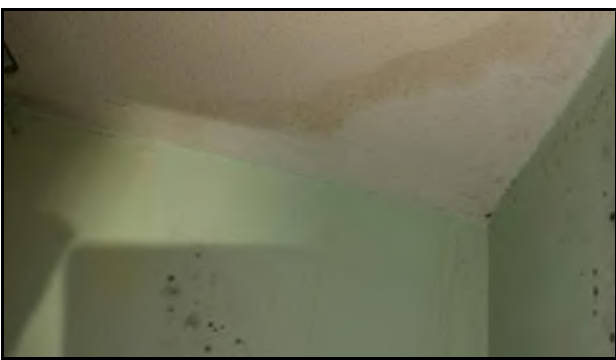
| <b>Room No.</b> | 005 |

| <b>Item Description</b> | Ceiling |
| <b>Material</b> | Textured Coating |

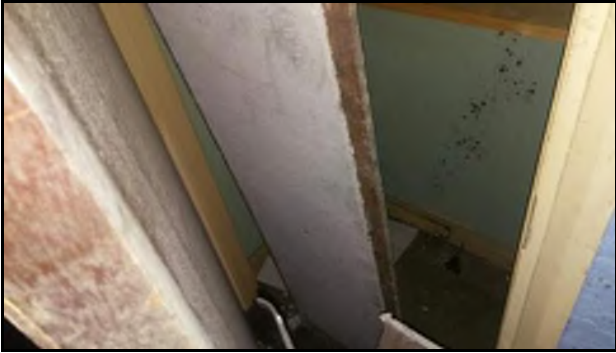
| <b>Room No.</b> | 005 |

| <b>Room ID</b> | Hallway Cupboard |
| <b>Item Description</b> | Floor |
| <b>Material</b> | Insulating Board |

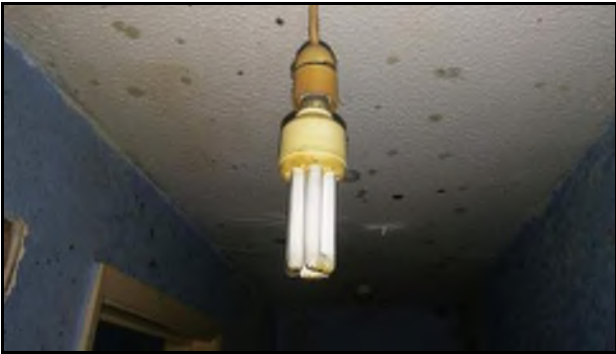
| <b>Room No.</b> | 006 |

| <b>Room ID</b> | Hallway |
| <b>Item Description</b> | Ceiling |
| <b>Material</b> | Textured Coating |

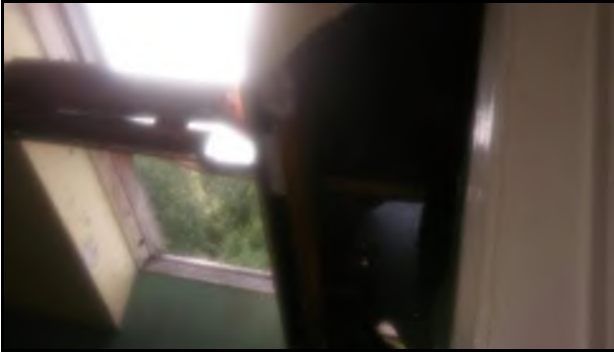
| <b>Room No.</b> | 001 |

| <b>Room ID</b> | Kitchen |
| <b>Item Description</b> | Ceiling |
| <b>Material</b> | Textured Coating |

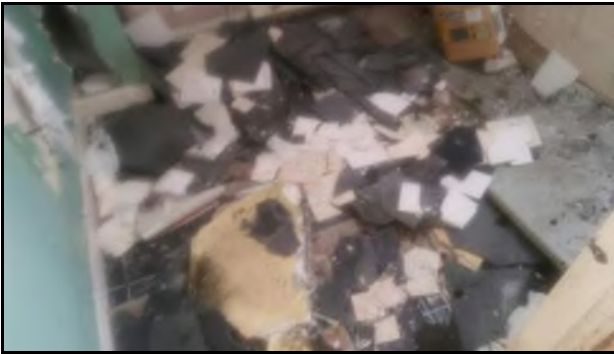
| <b>Room No.</b> | 001 |

| <b>Room ID</b> | Kitchen |
| <b>Item Description</b> | Floor |
| <b>Material</b> | Textured Coating |

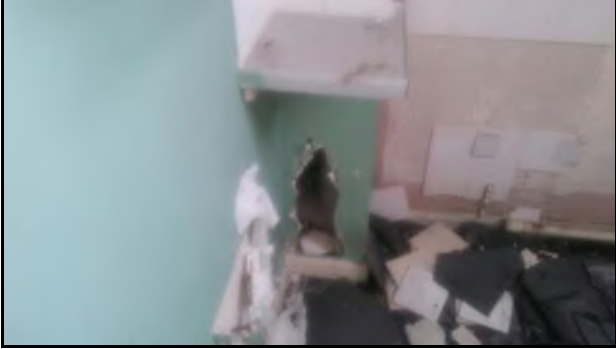
| <b>Room No.</b> | 001 |

| <b>Room ID</b> | Kitchen |
| <b>Item Description</b> | Boxing |
| <b>Material</b> | Insulating Board |

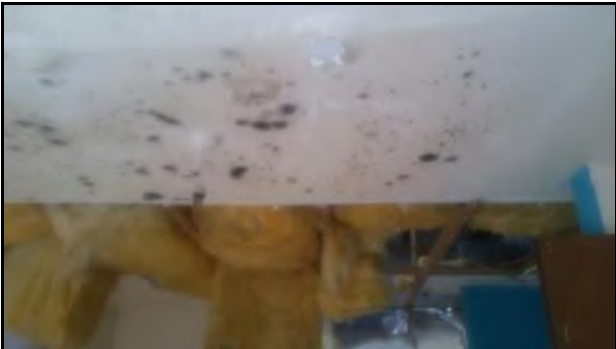
| <b>Room No.</b> | 002 |

| <b>Room ID</b> | Lounge |
| <b>Item Description</b> | Ceiling |
| <b>Material</b> | Textured Coating |

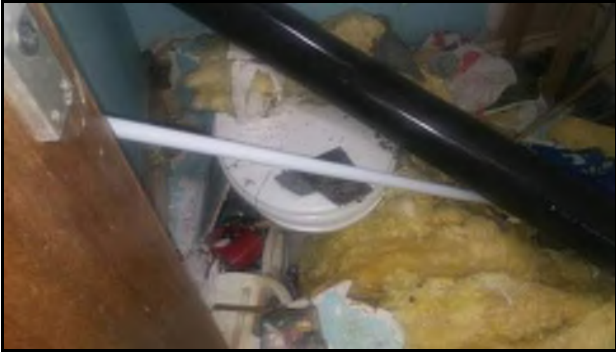
| <b>Room No.</b> | 003 |

| <b>Room ID</b> | Bathroom |

| <b>Item Description</b> | Floor |
| <b>Material</b> | Textured Coating |

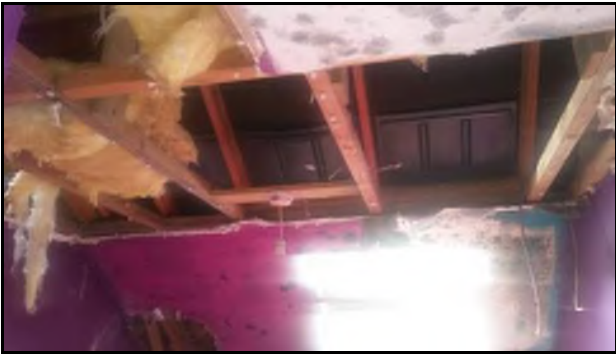
| <b>Room No.</b> | 004 |

| <b>Room ID</b> | Bedroom |

| <b>Item Description</b> | Ceiling |
| <b>Material</b> | Textured Coating |

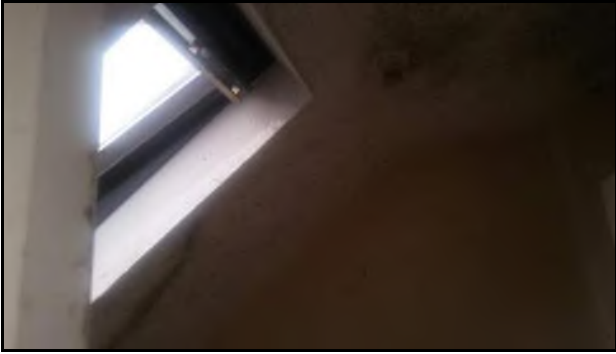
| <b>Room No.</b> | 001 |

| <b>Room ID</b> | Kitchen |
| <b>Item Description</b> | Textured Coating Ceiling |
| <b>Material</b> | Textured Coating |

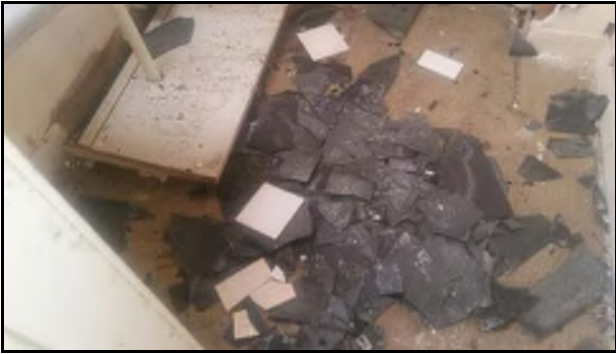
| <b>Room No.</b> | 001 |

| <b>Room ID</b> | Kitchen |
| <b>Item Description</b> | Debris to Floor |
| <b>Material</b> | Debris |

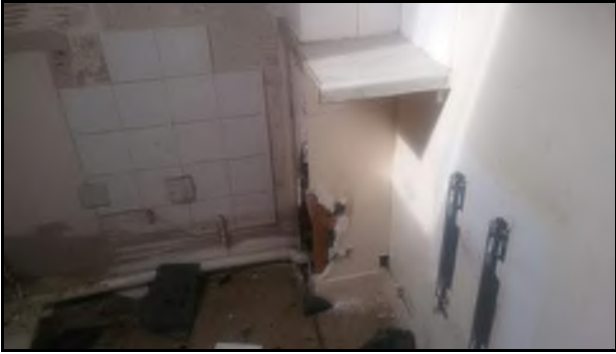
| <b>Room No.</b> | 001 |

| <b>Room ID</b> | Kitchen |
| <b>Item Description</b> | Insulating Board Boxing |
| <b>Material</b> | Insulating Board |

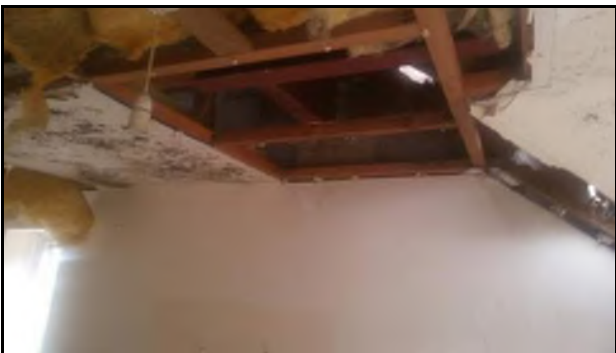
| <b>Room No.</b> | 002 |

| <b>Room ID</b> | Lounge |
| <b>Item Description</b> | Textured Coating Ceiling |
| <b>Material</b> | Textured Coating |

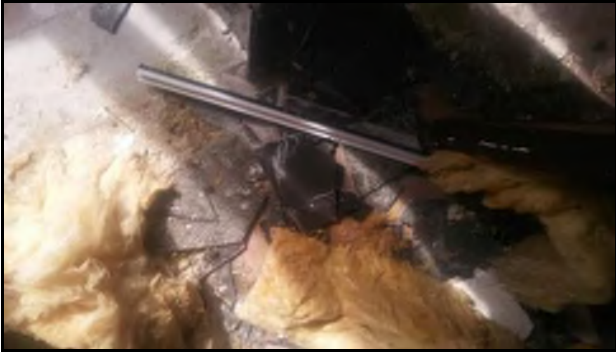
| <b>Room No.</b> | 002 |

| <b>Room ID</b> | Lounge |
| <b>Item Description</b> | Debris to Floor |
| <b>Material</b> | Debris |

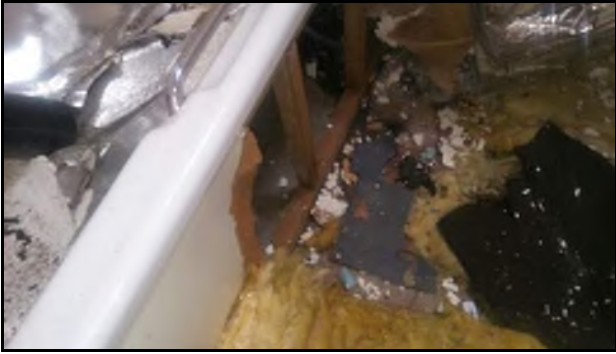
| <b>Room No.</b> | 003 |

| <b>Room ID</b> | Bathroom |
| <b>Item Description</b> | Debris to Floor |
| <b>Material</b> | Debris |

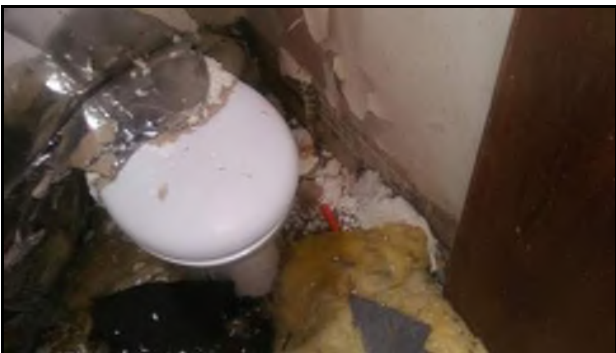
| <b>Room No.</b> | 003 |

| <b>Room ID</b> | Bathroom |
| <b>Item Description</b> | Textured Coating to Floor |
| <b>Material</b> | Textured Coating |

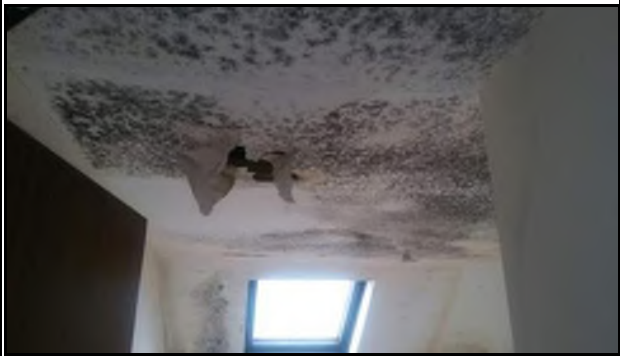
| <b>Room No.</b> | 004 |

| <b>Room ID</b> | Bedroom |
| <b>Item Description</b> | Textured Coating Ceiling |
| <b>Material</b> | Textured Coating |

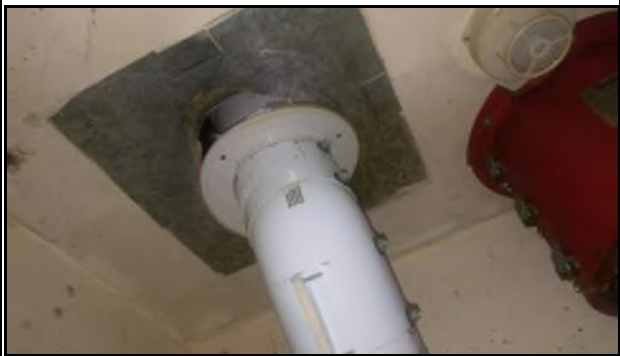
| <b>Room No.</b> | 005 |

| <b>Room ID</b> | Hallway cupboard |
| <b>Item Description</b> | Insulating Board Ceiling |
| <b>Material</b> | Insulating Board |

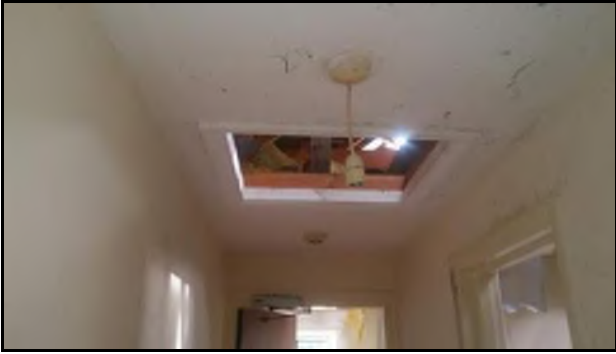
| <b>Room No.</b> | 006 | | | | |

| <b>Room ID</b> | Hallway | | | | |
| | | <b>Item Description</b> | Textured Coating Ceiling | | |
| | | <b>Material</b> | Textured Coating | | |
| | | <b>Asbestos Type</b> | No Asbestos Detected | | |
