**Water connections at Crescent Street and Taff Street, Merthyr Vale, Merthyr Tydfil**

## **APPENDIX H - DRAINAGE CCTV PLAN AND REPORT**

Pre-Demolition Inspection Report

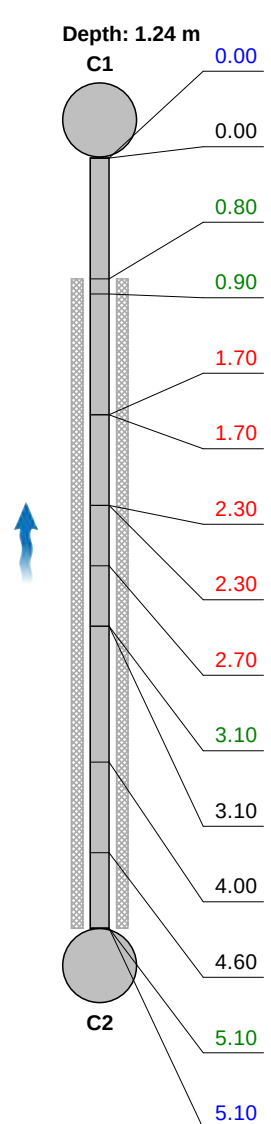
| Scale: | 1:50 | Position [m] | Code | Observation | Photo | Grade |
|---|---|---|---|---|---|---|
| | | 1.70 | FC | Fracture, circumferential, from 5 to 5 o'clock | 1 | 3 / 2 |
| | | 2.30 | FLJ | Fracture, longitudinal at joint, at 11 o'clock | 2 | 3 / 2 |
| | | 2.30 | FMJ | Fracture, multiple at joint, from 7 to 5 o'clock | 3 | 4 / 2 |
| | | 2.70 | FM | Fracture, multiple, from 7 to 5 o'clock | | 4 / 2 |

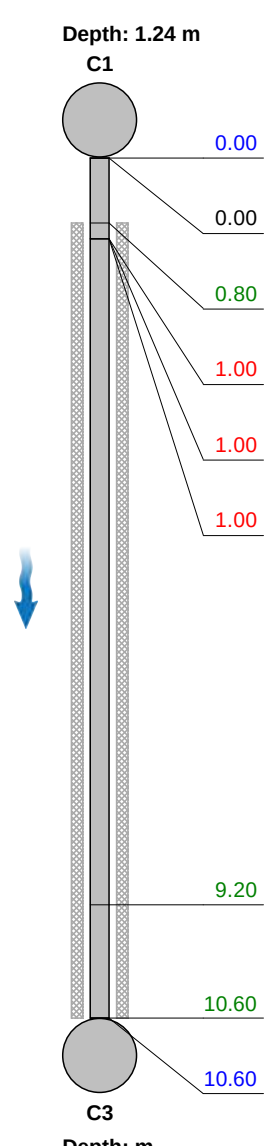
| Scale: 1:93 | Position [m] | Code | Observation | Photo | Grade |
|---|---|---|---|---|---|
| | 1.00 | BJ | Broken pipe at joint, from 3 to 5 o'clock | | 4 |
| | 1.00 | FMJ | Fracture, multiple at joint, from 7 to 5 o'clock | | 4 / 2 |

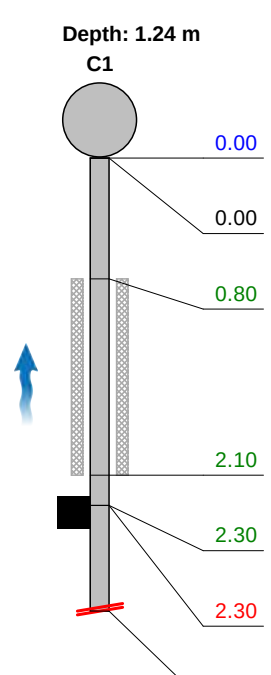
| Scale: | 1:50 | Position [m] | Code | Observation | Photo | Grade |
|---|---|---|---|---|---|---|
| | | 2.30 | FLJ | Fracture, longitudinal at joint, at 3 o'clock | | 3 / 2 |

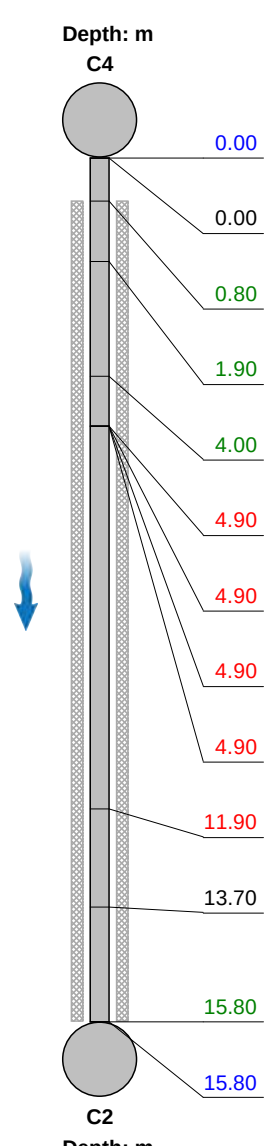
| Scale: 1:138 | Position [m] | Code | Observation | Photo | Grade |
|---|---|---|---|---|---|
| | 4.90 | FLJ | Fracture, longitudinal at joint, at 9 o'clock | | 3 / 2 |
| | 4.90 | FLJ | Fracture, longitudinal at joint, at 3 o'clock | | 3 / 2 |
| | 4.90 | FLJ | Fracture, longitudinal at joint, at 10 o'clock | | 3 / 2 |
| | 4.90 | FCJ | Fracture, circumferential at joint, from 7 to 5 o'clock | | 3 / 2 |
| | 11.90 | FCJ | Fracture, circumferential at joint, from 10 to 2 o'clock | 1 | 3 / 2 |

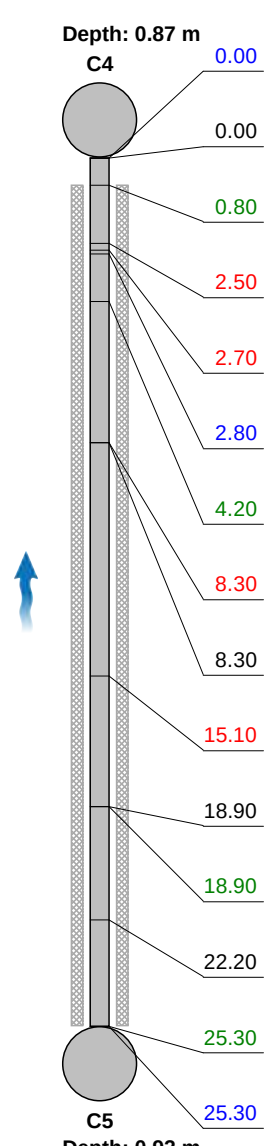
| Scale: 1:220 | Position [m] | Code | Observation | Photo | Grade |
|---|---|---|---|---|---|
| | 2.80 | VV | Void visible beyond defect | | |
| | 8.30 | FCJ | Fracture, circumferential at joint, from 8 to 3 o'clock | | 3 / 2 |
| | 15.10 | CL | Crack, longitudinal, at 4 o'clock | | 2 / 2 |

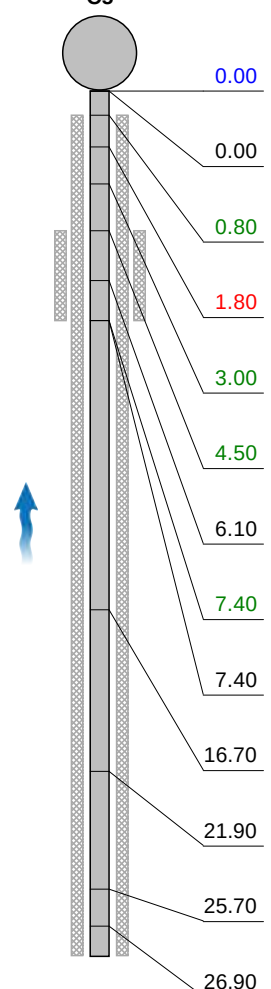
| Scale: 1:243 | Position [m] | Code | Observation | Photo | Grade |
|---|---|---|---|---|---|
| | 1.80 | FCJ | Fracture, circumferential at joint, from 8 to 11 o'clock | 1 | 3 / 2 |

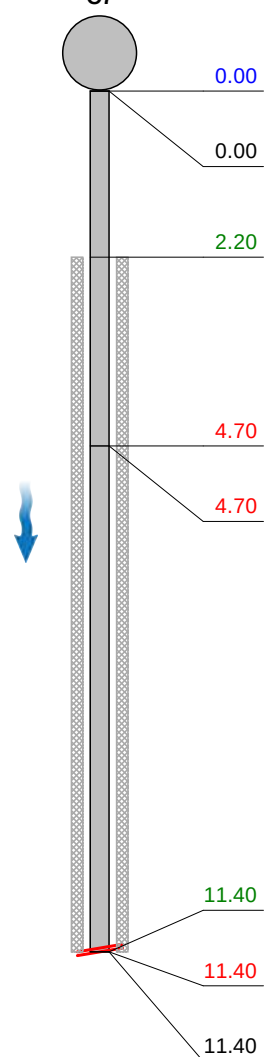
| Scale: 1:100 | Position [m] | Code | Observation | Photo | Grade |
|---|---|---|---|---|---|
| 4.70 | | FCJ | Fracture, circumferential at joint, from 10 to 2 o'clock | | 3 / 2 |
| 4.70 | | FLJ | Fracture, longitudinal at joint, at 11 o'clock | | 3 / 2 |

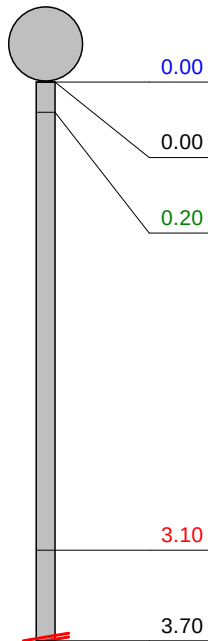
<table><tr><th>Position [m]</th><th>Code</th><th>Observation</th><th>Grade</th></tr><tr><td>3.10</td><td>FC</td><td>Fracture, circumferential, from 10 to 2 o'clock</td><td>3 / 2</td></tr></table>

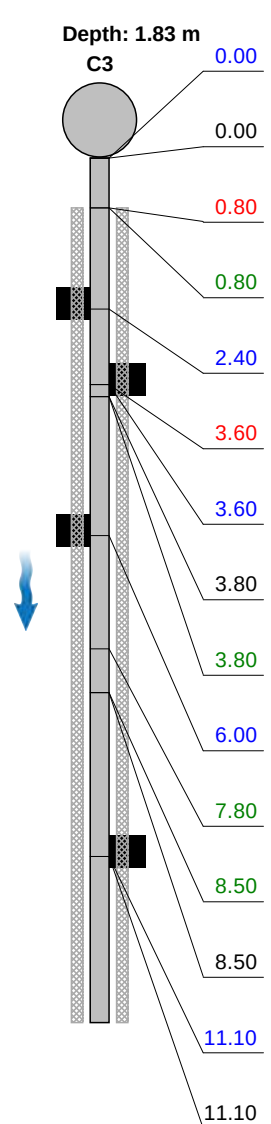
| Scale: 1:120 | Position [m] | Code | Observation | Photo | Grade |
|---|---|---|---|---|---|
| | 0.80 | FCJ | Fracture, circumferential at joint, from 7 to 5 o'clock | | 3 / 2 |
| | 3.60 | BJ | Broken pipe at joint, from 10 to 2 o'clock | | 4 |

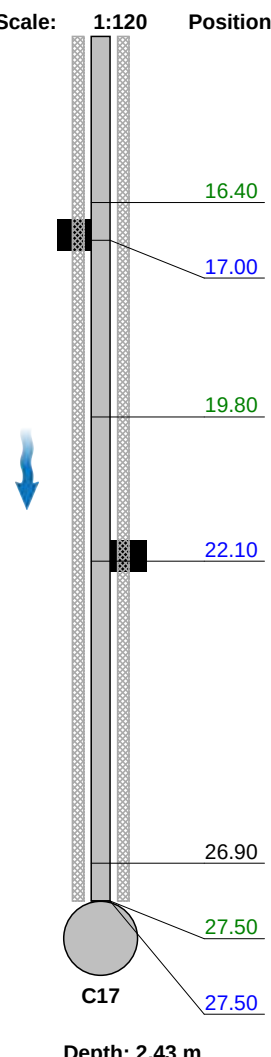
| Scale: | 1:120 | Position [m] | Code | Observation | Photo | Grade | | | |
|---|---|---|---|---|---|---|---|---|---|
| | 19.80 | DEX | Settled deposits, other, 20% cross-sectional area loss: UNDER FLOW | | | 4 | | | |

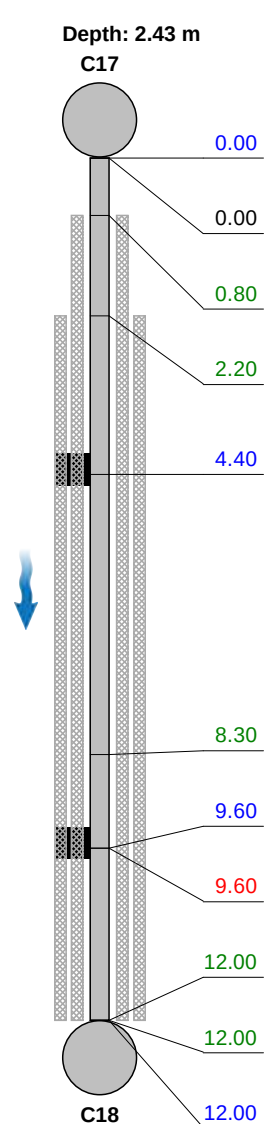
| Scale: 1:105 | Position [m] | Code | Observation | Photo | Grade |
|---|---|---|---|---|---|
| | 8.30 | DEX | Settled deposits, other, 10% cross-sectional area loss: BROKEN PIECE OF PIPE | | 3 |
| | 9.60 | FCJ | Fracture, circumferential at joint, from 7 to 5 o'clock | | 3 / 2 |

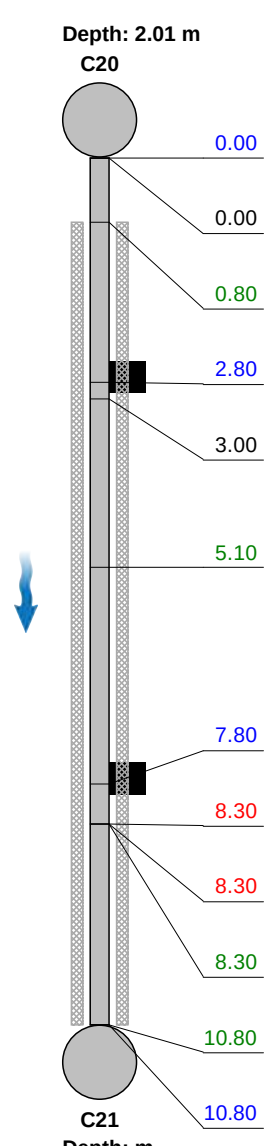
| Scale: 1:94 | Position [m] | Code | Observation | Photo | Grade |
|---|---|---|---|---|---|
| | 8.30 | FCJ | Fracture, circumferential at joint, from 12 to 2 o'clock | | 3 / 2 |
| | 8.30 | FLJ | Fracture, longitudinal at joint, at 12 o'clock: WANDERS TO 8 | | 3 / 2 |
