*Report No. BC/MB/08.09.01.*

# **MINING RISK ASSESSMENT:**

**Land South of Winchfawr Park,  
Heolgerrig, Merthyr Tydfil.**

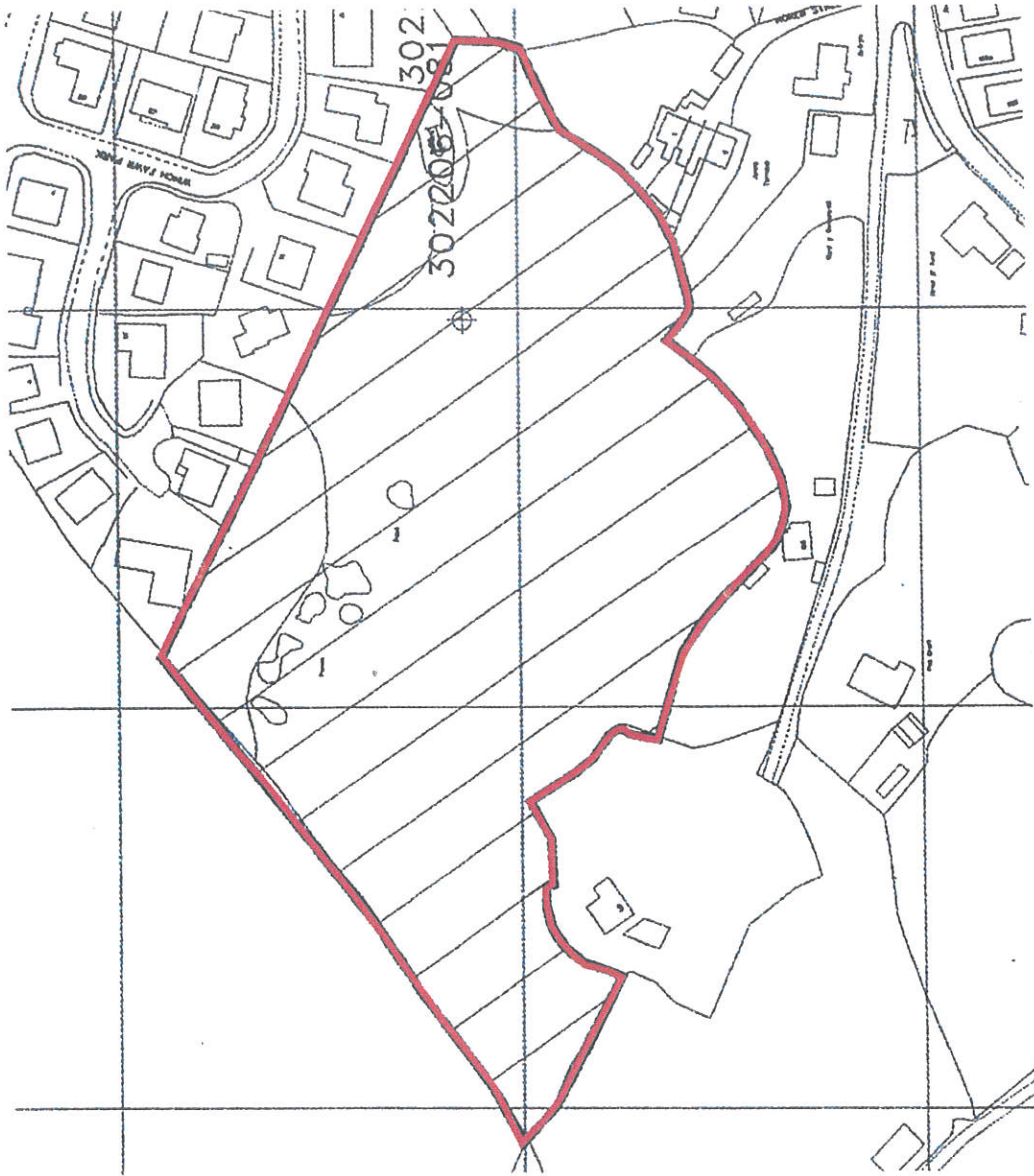
Drawing No: BC/MB/08.09.01.03.

When both sets of records are taken together it is apparent that the Six Feet Seam outcrops within the confines of the Site and the Nine Feet Seam outcrops a relatively short distance to the north of it so that the Six Feet Seam underlies much of the Site at very shallow

depths and the Nine Feet Seam underlies the whole of the Site at relatively shallow depths. A thin coal seam, the Red Seam, is sometimes present between the above two seams, but its presence has not been confirmed in this area. Exploratory drilling carried out in the surrounding area indicates that the Upper and Lower Six Feet Seams are two separate seams in some areas of Heolgerrig and elsewhere are one, thick, composite seam. Exploratory drilling within this Site suggests that the Six Feet Seam is there represented by the two separate seams, the Upper Six Feet Seam and the Lower Six Feet Seam. The Red Seam was not identified in exploratory drilling within the Site and the Nine Feet Seam was not encountered, being deeper than the maximum depth of the boreholes (30m).

## Extract from Mine Records Plan. - Six Feet Seam -
