**Heritage Impact Assessment:  
Treharris Library, Merthyr Tydfil**

Report No. 2143

Prepared for Merthyr Tydfil County Borough Council

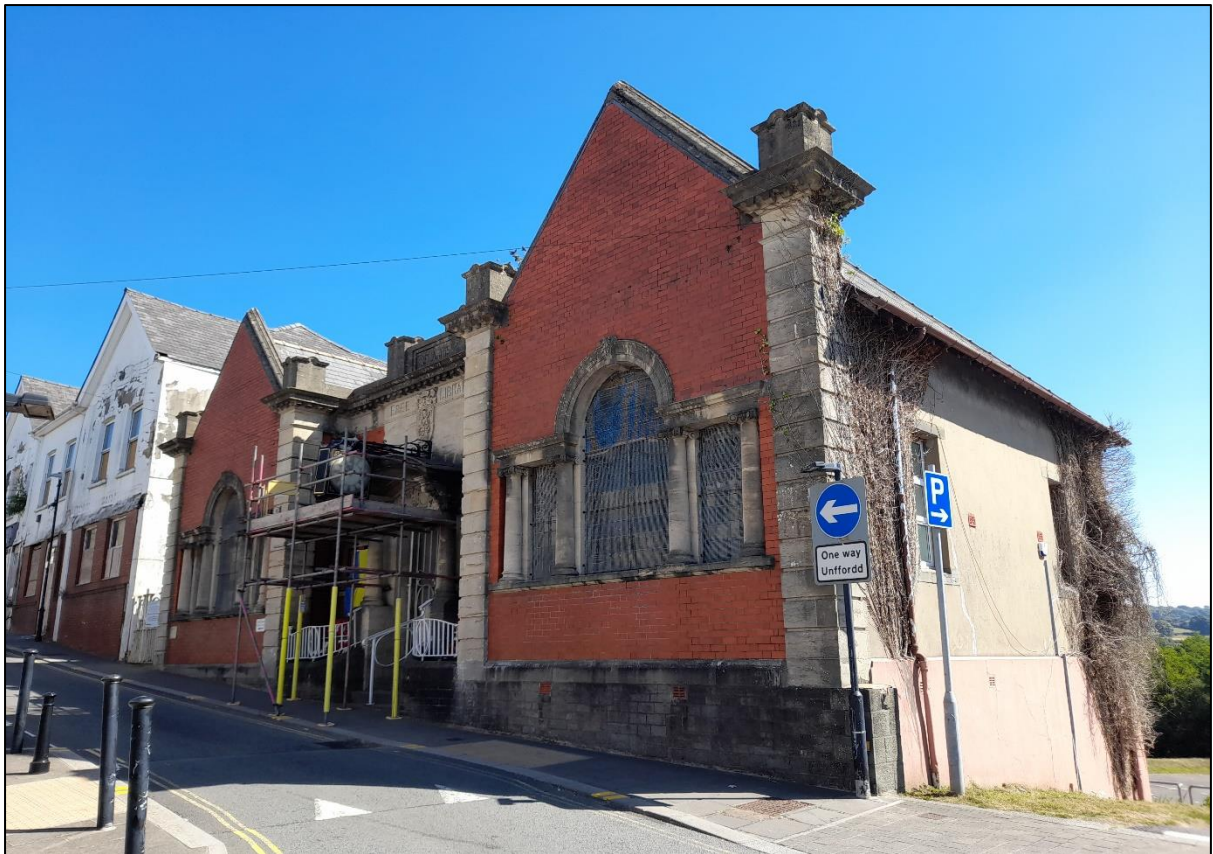
- 4.3.3. The outer bays of the front elevation, to the cross-gables, each have a large, recessed Palladian window with Ionic columns, moulded arch and cornice of Bath Stone (Plates 1 and 4). The glazing is decorative coloured leaded glass, with the large central panel having an arch design with a lamp above and the two side panels having wreaths. The windows are covered by galvanized metal grills.

*Plate 1: Front elevation of Treharris Public Library, looking north-east.*

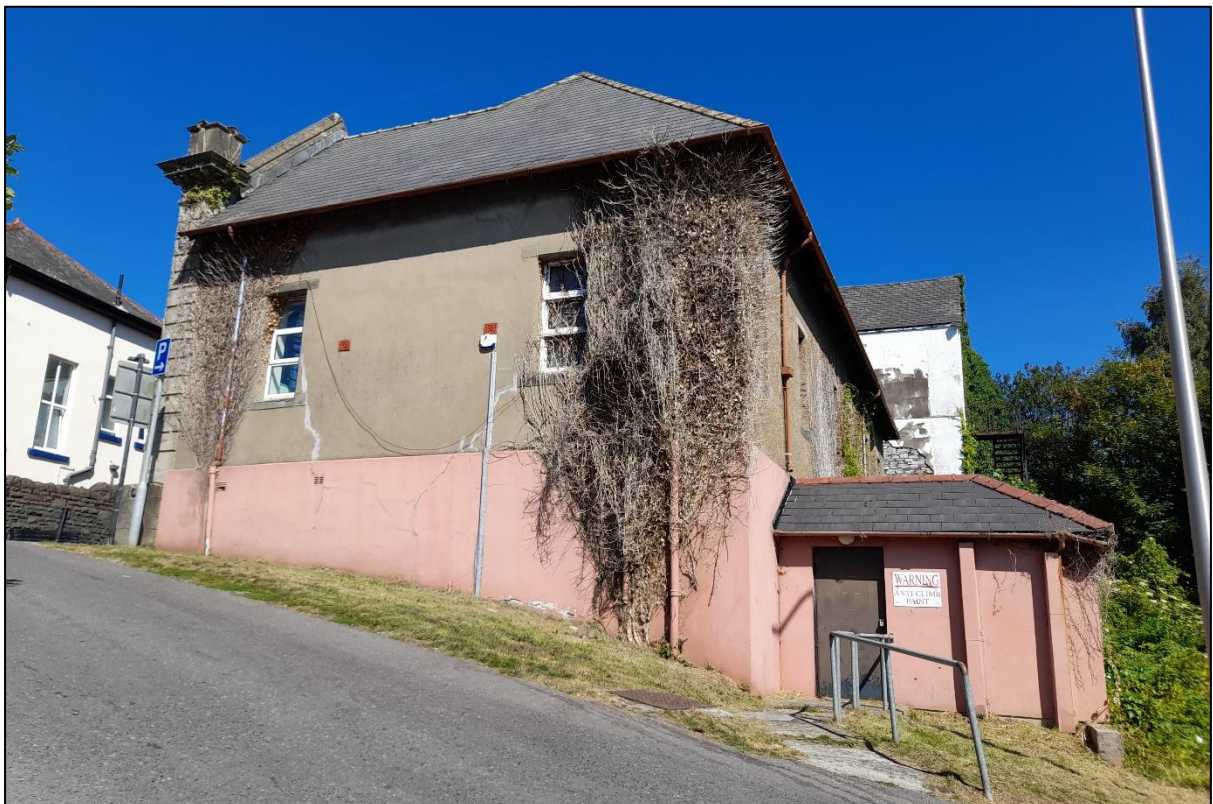
- 4.3.6. The south-facing elevation has two rectangular windows, slightly recessed with plain stone sills and lintels (Plate 2). The one to the right is a three light wooden framed casement window, while that to the left is a similar style uPVC unit. The historic photograph (Figure 4) shows that these would originally have been decorative stained glass. Two small, decorative ceramic vents to the interior of the windows also appear on the historic photo. The photo shows vents to the outside of the window. It is not clear if these still exist as the areas are covered by ivy. To the rear of the building, the extension has a modern solid wood door. It is approached by a concrete slab path with galvanised metal handrail.

*Plate 2. South-facing elevation of Treharris Public Library, looking north.*

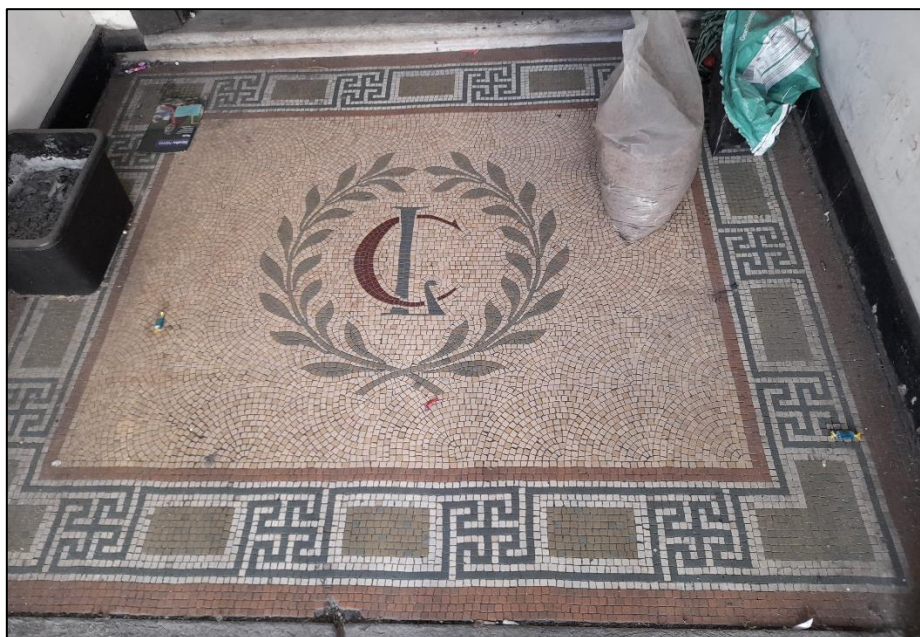
- 4.3.2. The main entrance is located to the centre of the front elevation. Low sandstone walls with iron railings curve up either side of four stone recessed steps to the recessed doorway (Plate 5). The surround is of Bath Stone and has Ionic columns supporting a segmental curved hood on acanthus carved brackets. Below the hood is a decoratively carved tympanum. Above the hood is a central shield flanked by the words Free Library. The war memorial clock projects from over the hood. It is currently supported by scaffolding. The door recess has a mosaic floor with a central wreath containing the initials CL for Carnegie Library (Plate 6).

*Plate 6. Mosaic to main entrance, bearing the initials CL, for Carnegie Library.*

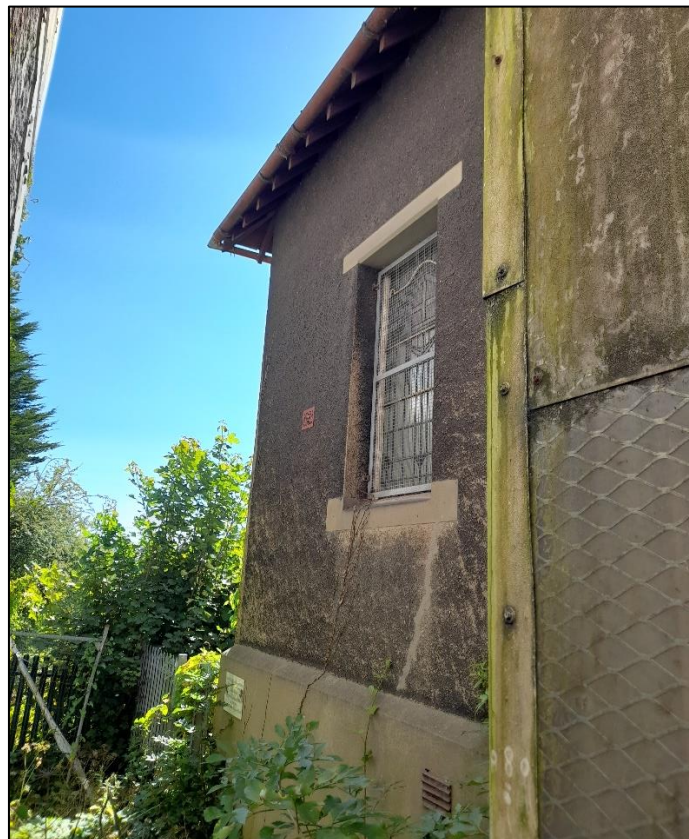
- 4.3.4. The north-facing elevation has a wooden door with four glazed panels, and a transom light above. There is a lean-to style entrance canopy over the door, which is wooden framed with opaque glazing and protective metal grill (Plate 7). The approach to the door is concrete, and there are concrete steps down to the side of the building to access the rear space. The three windows are all decorative stained glass with a crest design. They are slightly recess and have simple bevelled stone sills and lintels (Plate 8).

*Plate 8. Window to east end of north-facing elevation, looking south-east.*

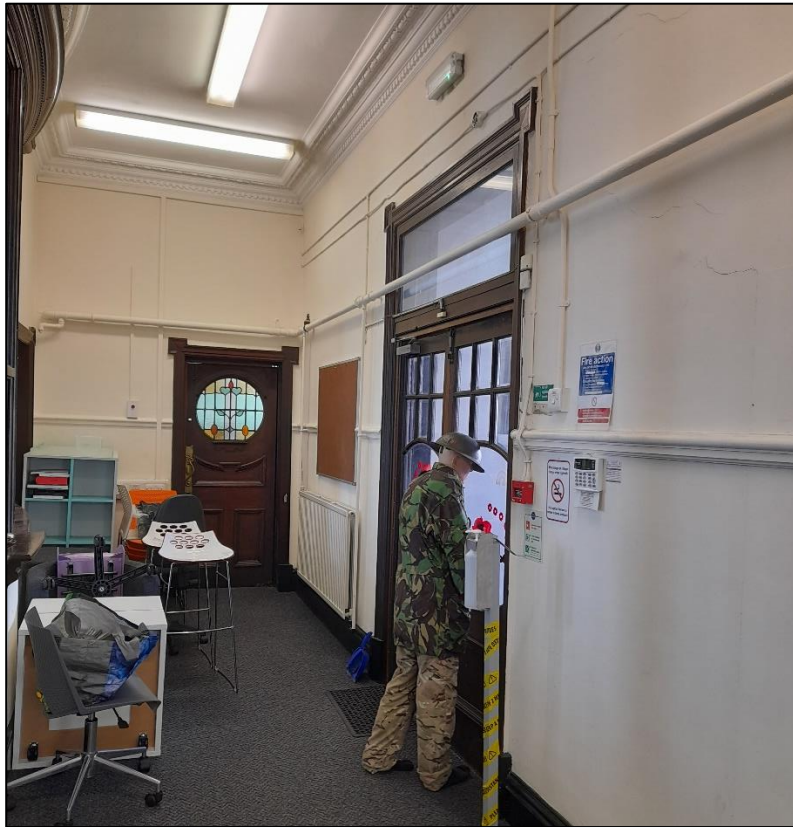
- 4.3.7. The interior of the Library retains many original features. The reception area is a rectangular room accessed by the front double doors (Plate 9). The doors are wooden framed with glazed panels to the upper part and a large transom light over. On the opposite wall is a gently curving bay with the original large reception window (Plate 10). The window has seven narrow rectangular decorative leaded glazed panels in a wooden frame with moulded cornice to the top. To the central panel is a small serving window. Three doors exit the reception into the main library, one to either side of the reception window on the east wall and one on the south wall. The doors are all wooden panel with a circular glazed panel to the upper with decorative glass. They have moulded surrounds with square details to the top corners. On the north wall is flat arch opening to the main library with the same style of surround as the doors. The reception room has a modern carpet, bull nose skirting boards, and decorative moulded coving.

*Plate 9. Reception area with main doors to right, looking south.*

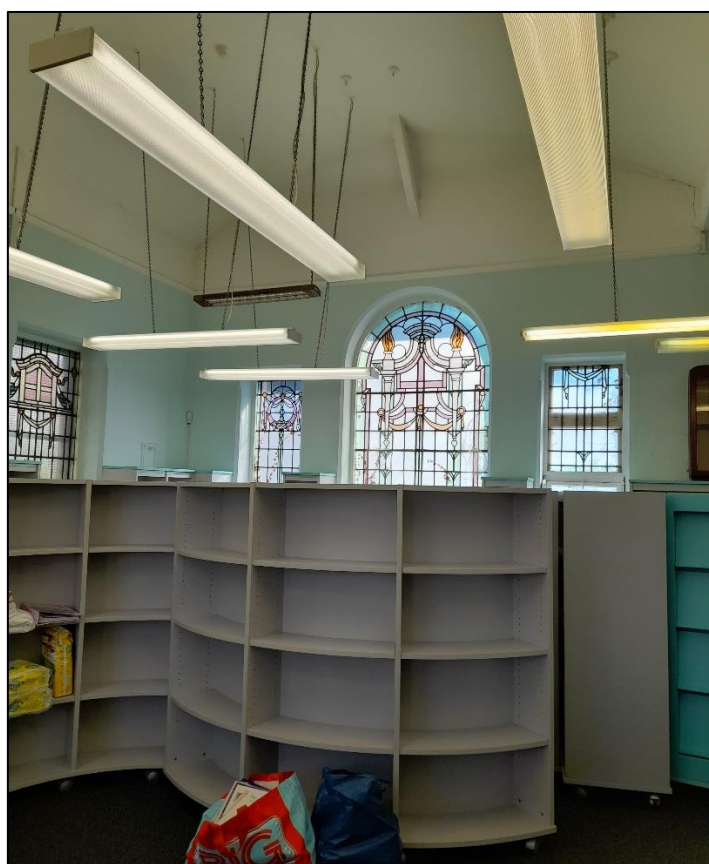
- 4.3.8. The main room is a U-shape with the projecting sections to the cross-gables at the front of the building. The ceiling in both of these sections is higher than that behind the reception, to the centre of the room. The northern section has a curved ceiling (Plate 11) while the southern is flat with sloped edges and exposed rafters (Plate 12). The southern section has a partition wall running north – south with a large square arch with glazed panels above.

added into a window opening, with the upper part of the window being retained as the transom above (Plate 15). The removed lower section has been used to repair one of the windows on the east wall (Plate 11).

*Plate 11. North end of main library room, looking east.*

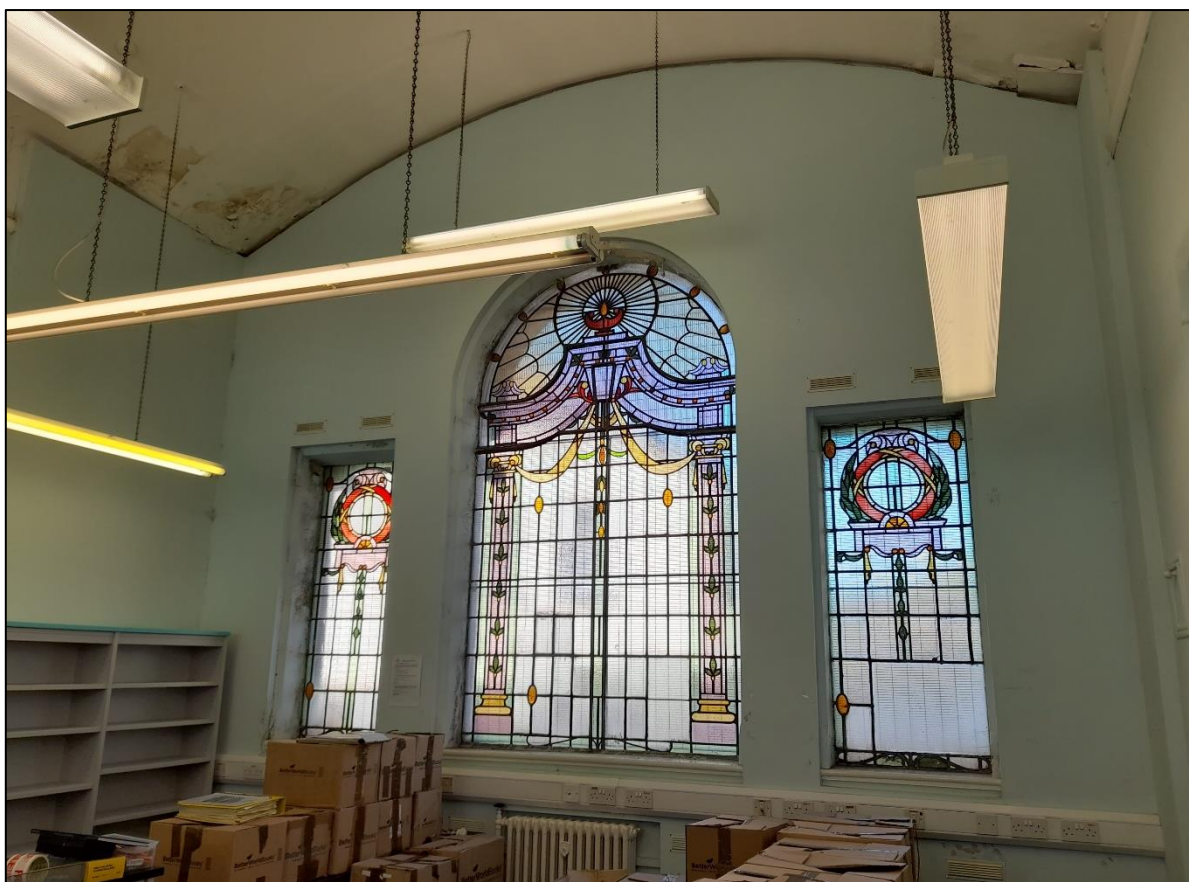
- 4.3.9. The windows are all recessed, with bevelled angles to their reveals and simple wooden sills (Plates 13 and 14). The door on the north wall appears to have been

*Plate 13. Decorative stained glass window on west wall of north end of the library, looking west.*

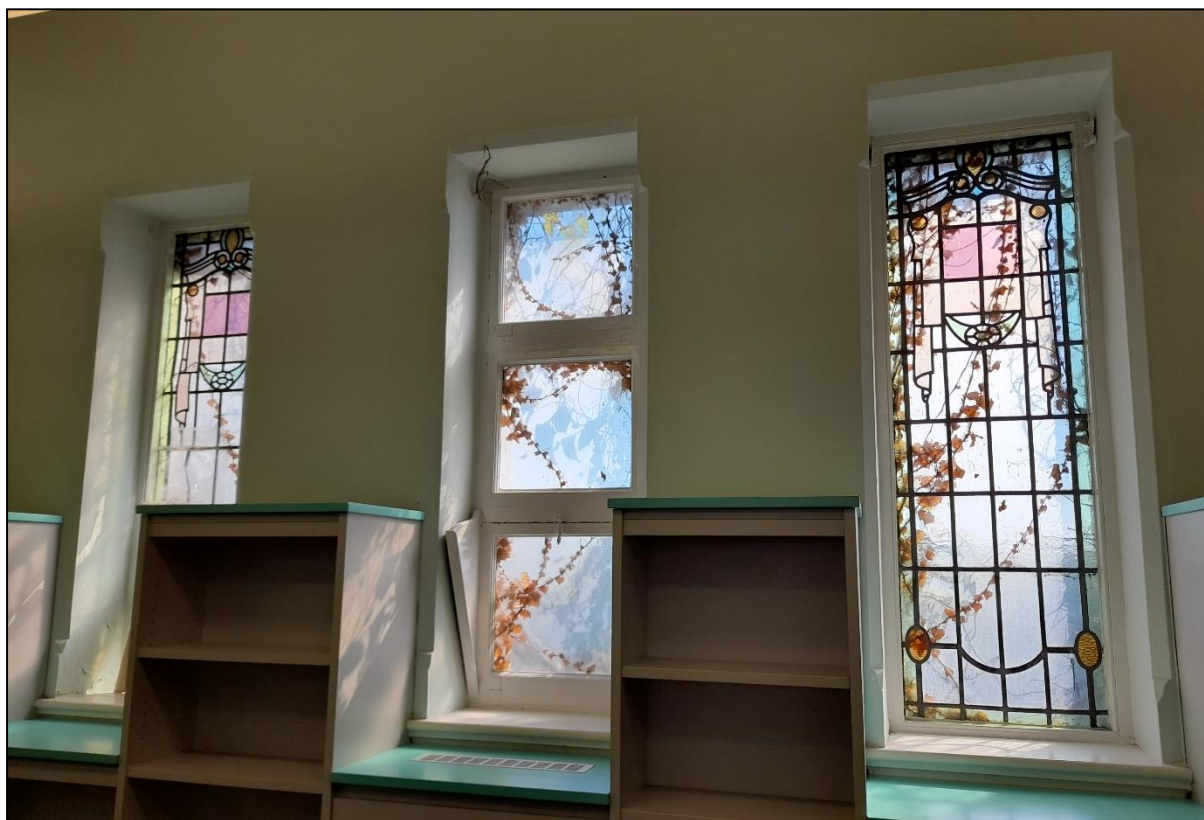
*Plate 14. Windows on the centre of the east wall of the library, central window is a later replacement.*

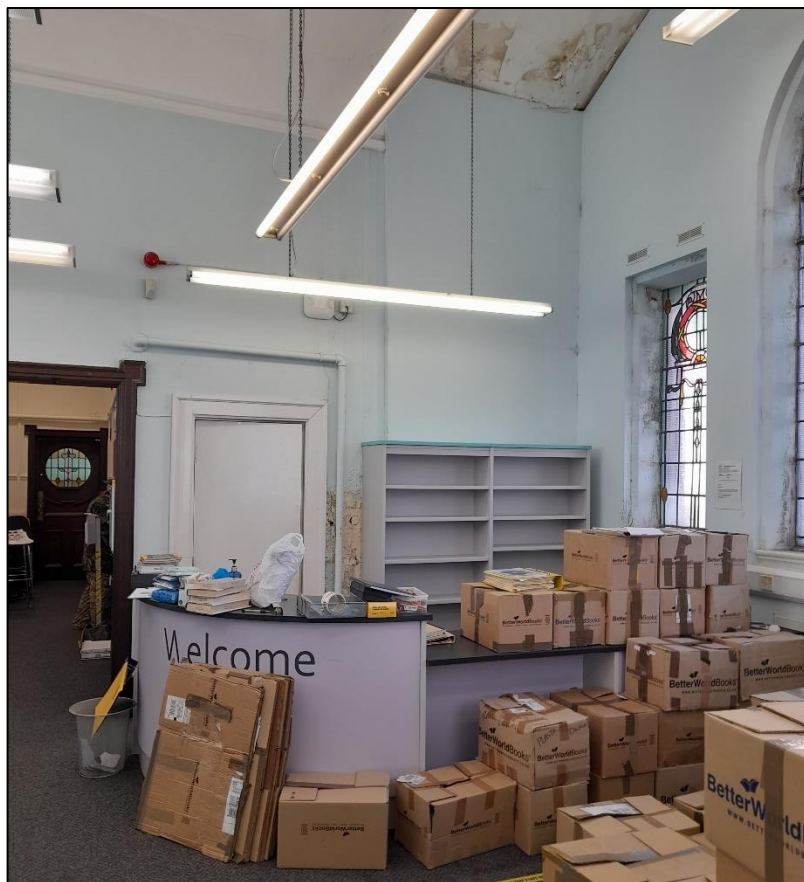
- 4.3.10. The existing reception area is in the north-west of the library (Plate 16). It has a modern curved desk with shelving behind. There is a door on the south wall that leads into a small kitchen area with modern fittings and fixtures. The door is not original, but it appears to have been fitted an original opening. The kitchen is in very poor condition with signs of damp.

*Plate 16. Existing reception area, looking south-west.*

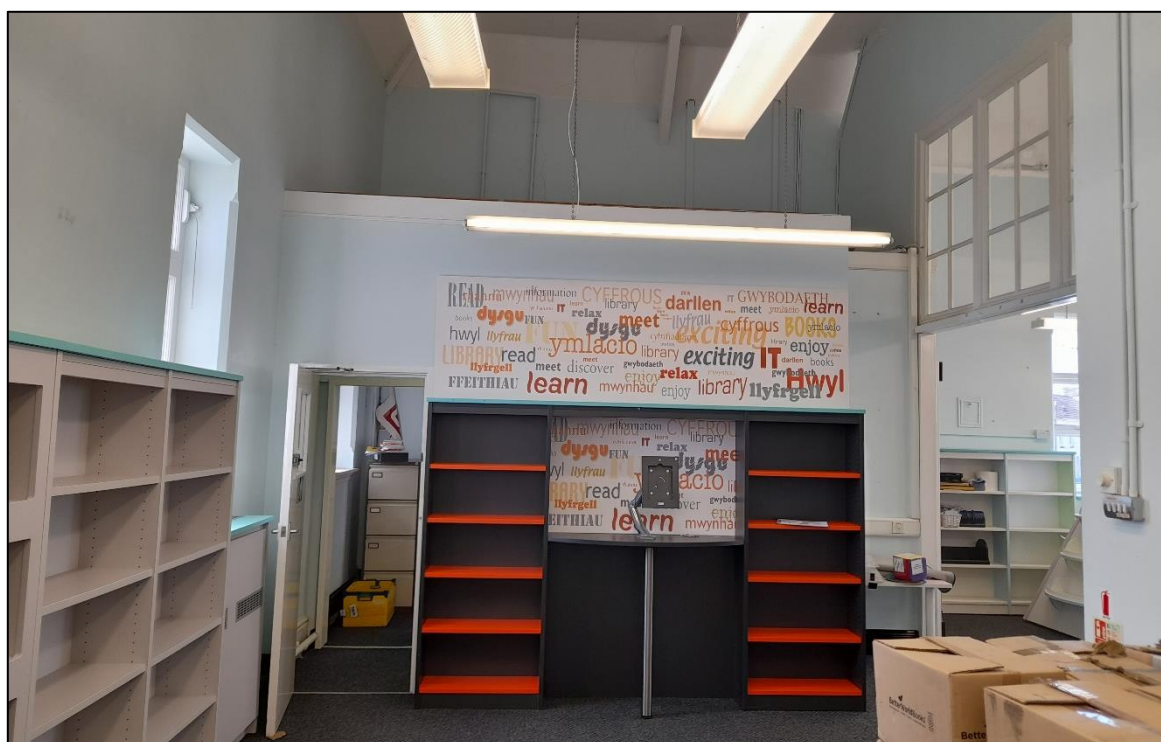
*Plate 18.*

- 4.3.11. In the south-east corner of the library is the stairwell to the basement and a narrow project room. The full height partition to the children's room forms the west wall, while the north wall does not extend to the ceiling (Plate 18). It appears to be a later partition and has a modern door in simple wooden frame. The project room has a painted wooden ceiling, and its north wall has glazed panelling which has been boarded over on the north side (Plate 19).

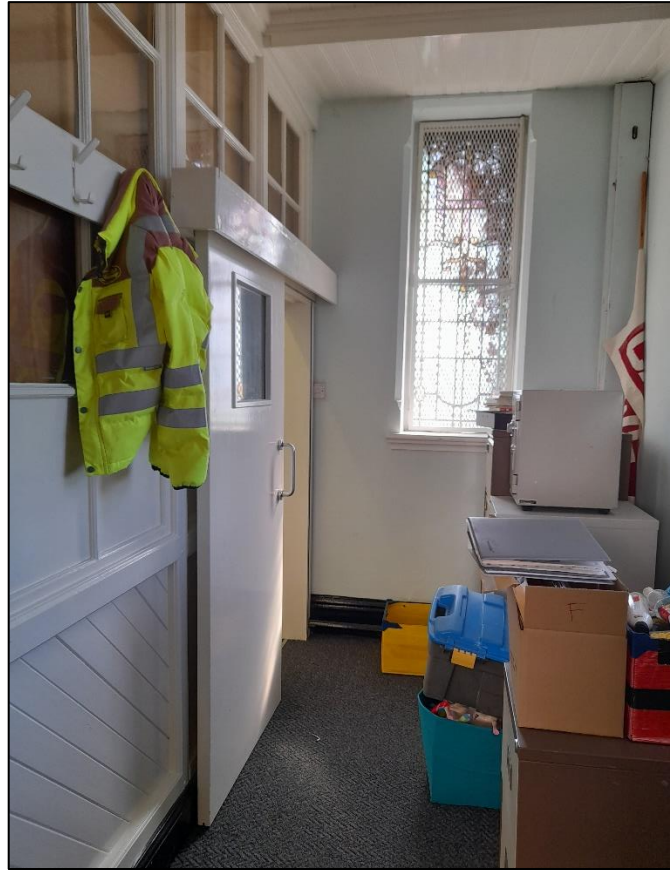
*Plate 19. Existing project room in south-east corner of the library, looking east.*

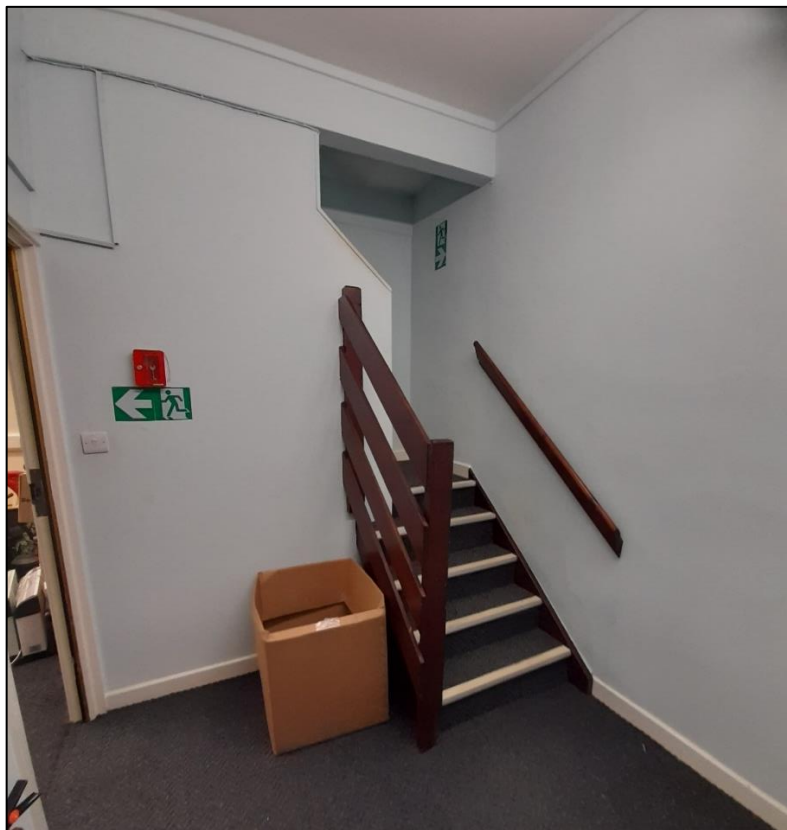
- 4.3.13. The basement has a small lobby at the bottom of the stairwell, all of which has modern fittings and decoration (Plate 22). There are two main rooms in the original basement area, the open learning room to the north (Plate 23) and training room to the south (Plate 24). There is fitted shelving along the west wall of the open learning room and a small cupboard in the north-west corner (Plate 25). These appear to be later, possibly mid 20<sup>th</sup> century, additions. Otherwise, the rooms have modern fittings and decoration, including doors and doors frames and uPVC windows.

*Plate 22. Basement small lobby at the bottom of the stairwell, looking south-west.*

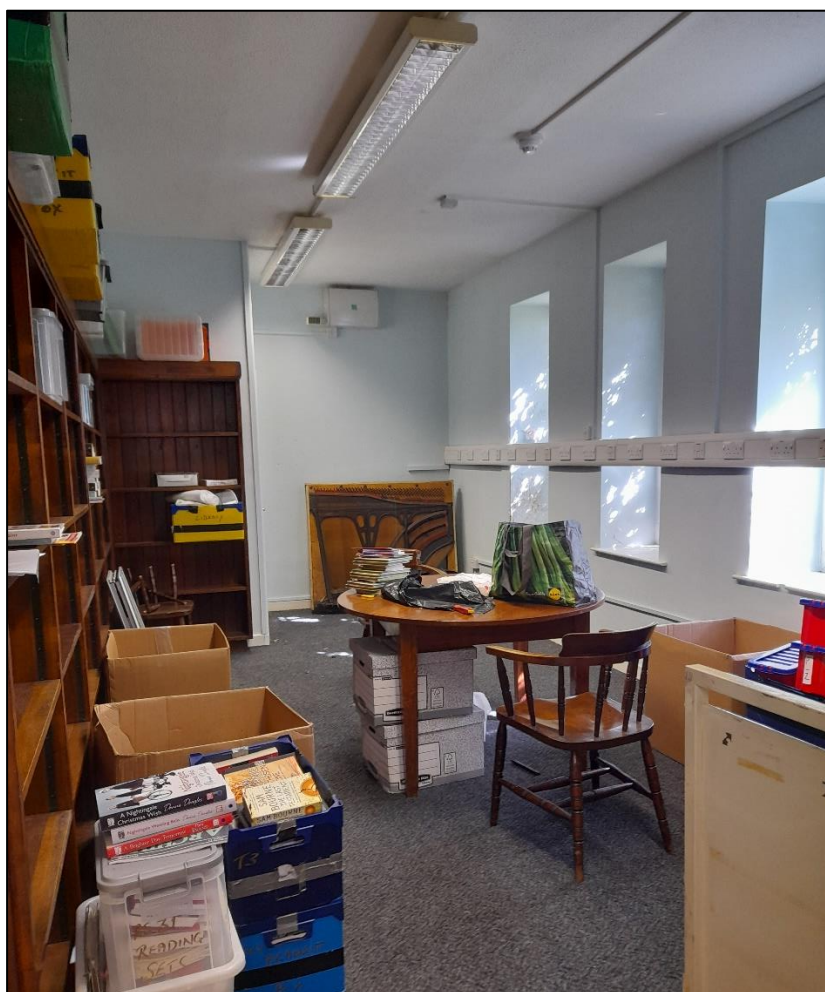
*Plate 23. Opening learning room in the basement, looking north.*

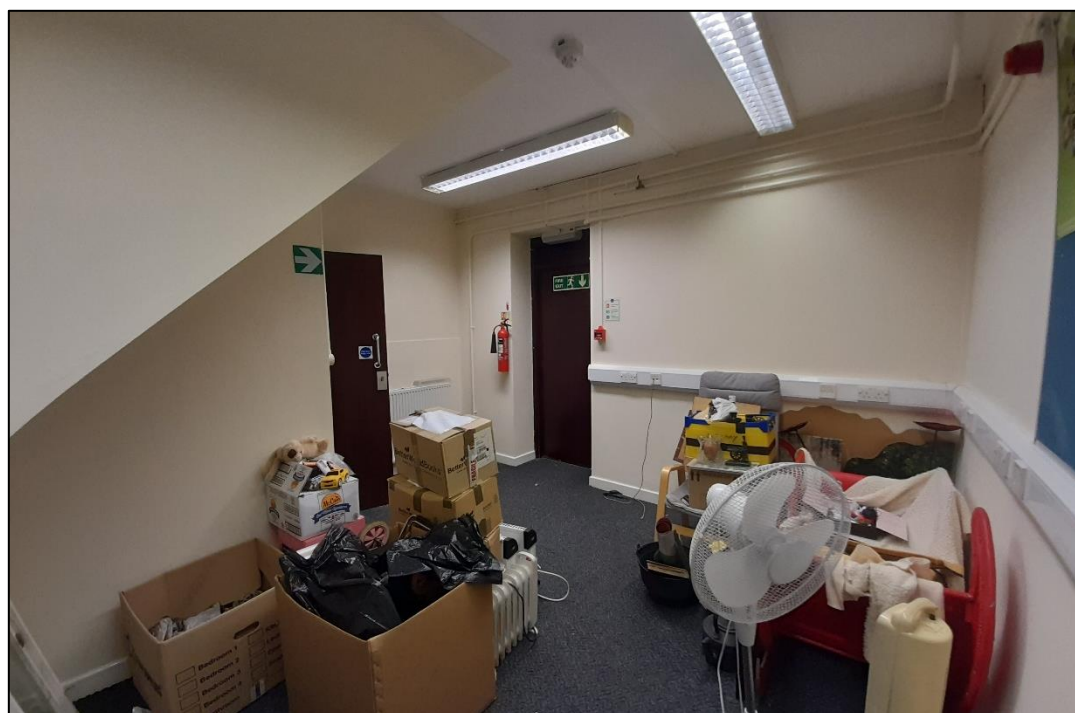
*Plate 24. Training room in basement, looking north-east.*
