RHONDDA  
GEOTECHNICAL  
SERVICES

GROUND STABILITY STATEMENT  
M.T.C.B.C. PLANNING APP. P/22/0088

PROPOSED RESIDENTIAL DEVELOPMENT  
WINCHFAWR ROAD  
WINCHFAWR  
MERTHYR TYDFIL  
CF48 1RD

18/11/2025

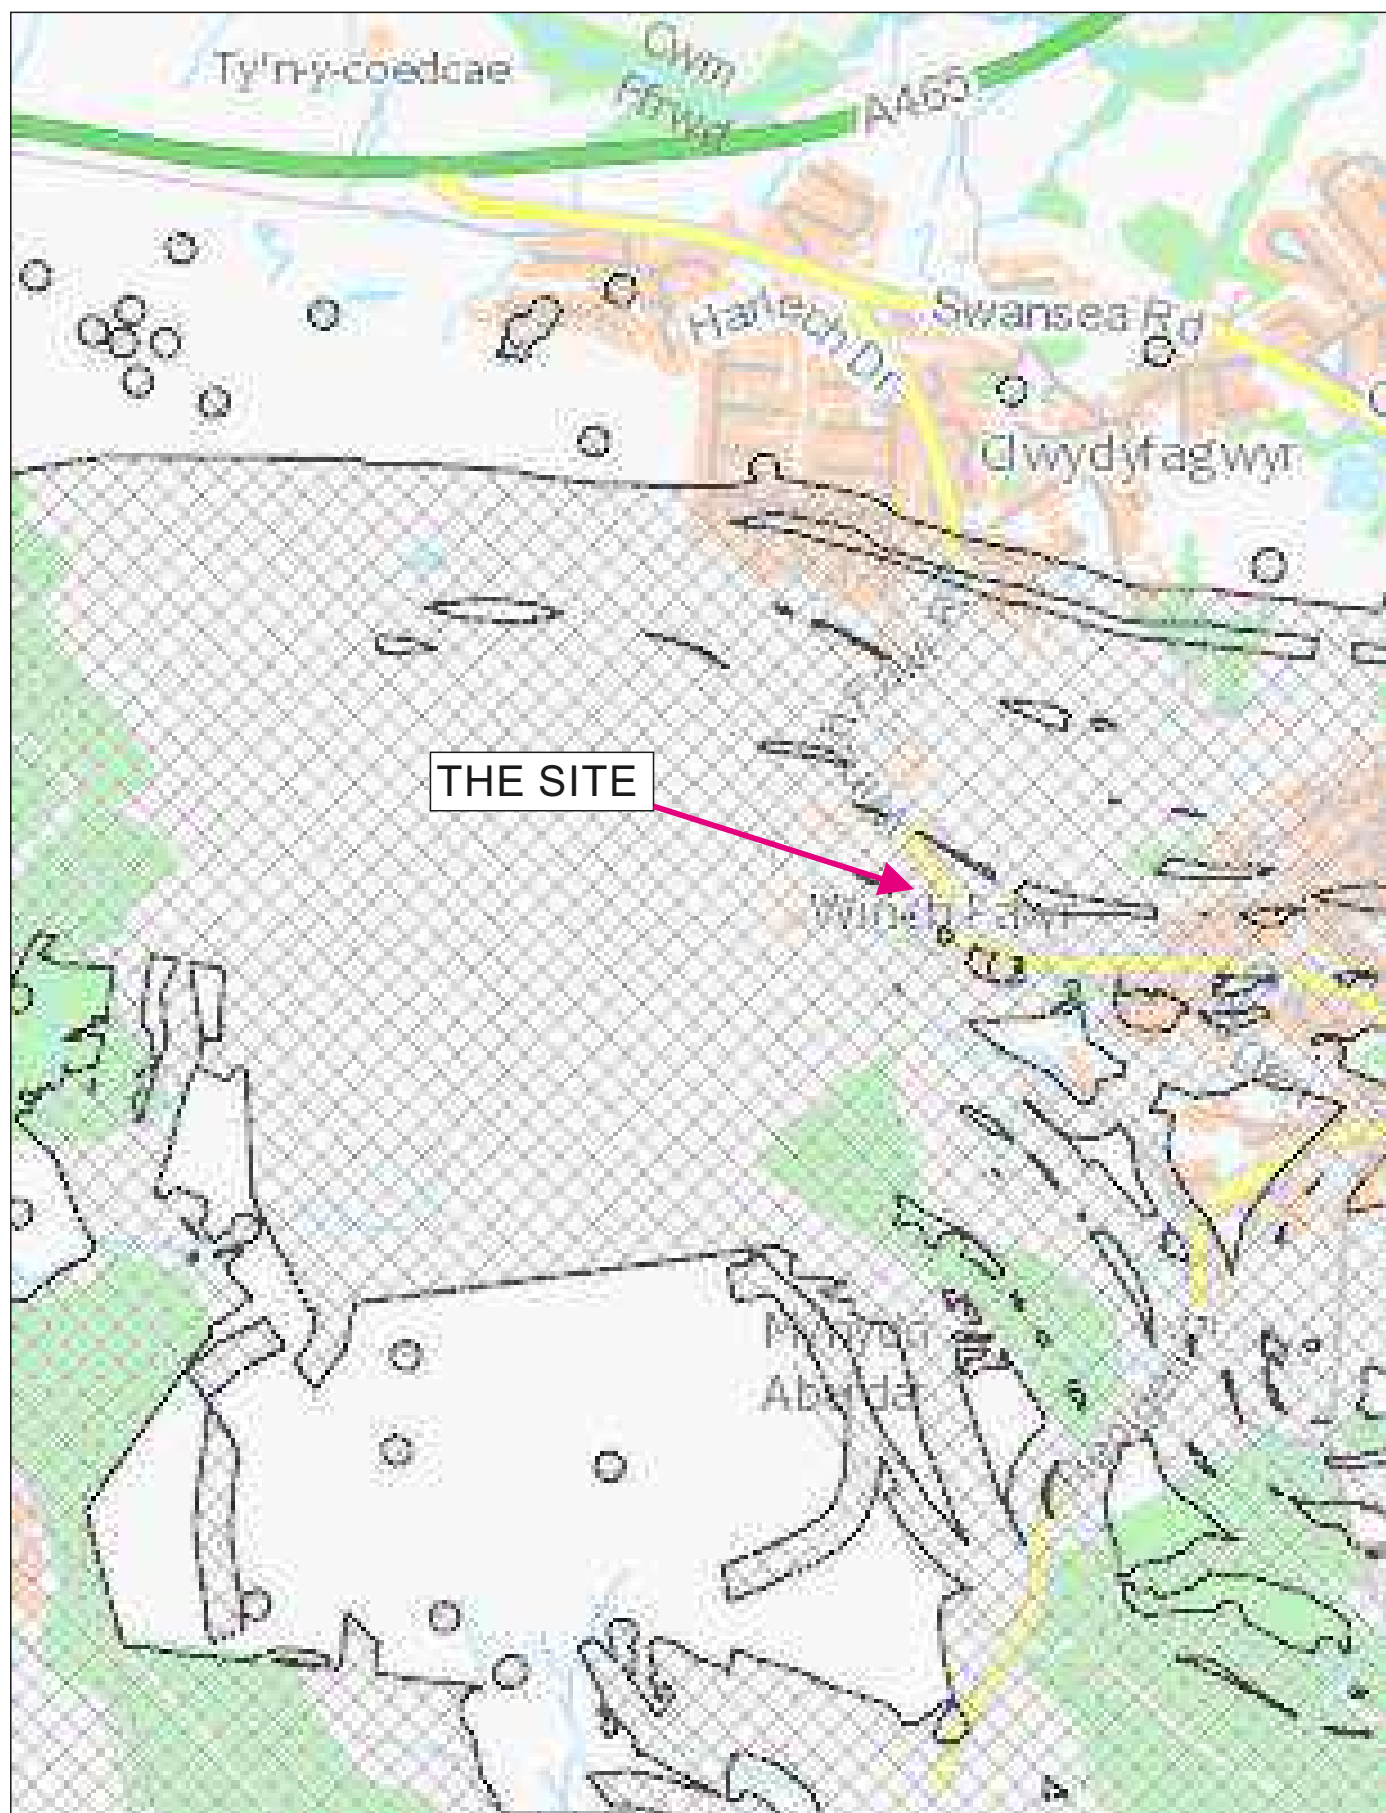
FIGURE 4  
COAL AUTHORITY INTERACTIVE VIEWER.  
GREY HATCHED AREAS ARE DEVELOPMENT HIGH RISK.

2b) The C.A. interactive viewer contains a vast amount of information from various sources, particularly on the mining data window. This always includes material not contained in the Consultants Report but which can be important to a fuller understanding of the geology and mining. An extract from the planning window can be seen in Figure 4. The entire site lies within a huge block of Development High Risk. From its unbroken appearance it would appear to be an area of suspected shallow workings, closely spaced outcrops, opencast mining or a combination of all three. The small isolated circular areas are 20m exclusion zones around mine entrances outside the Development High Risk Zone.

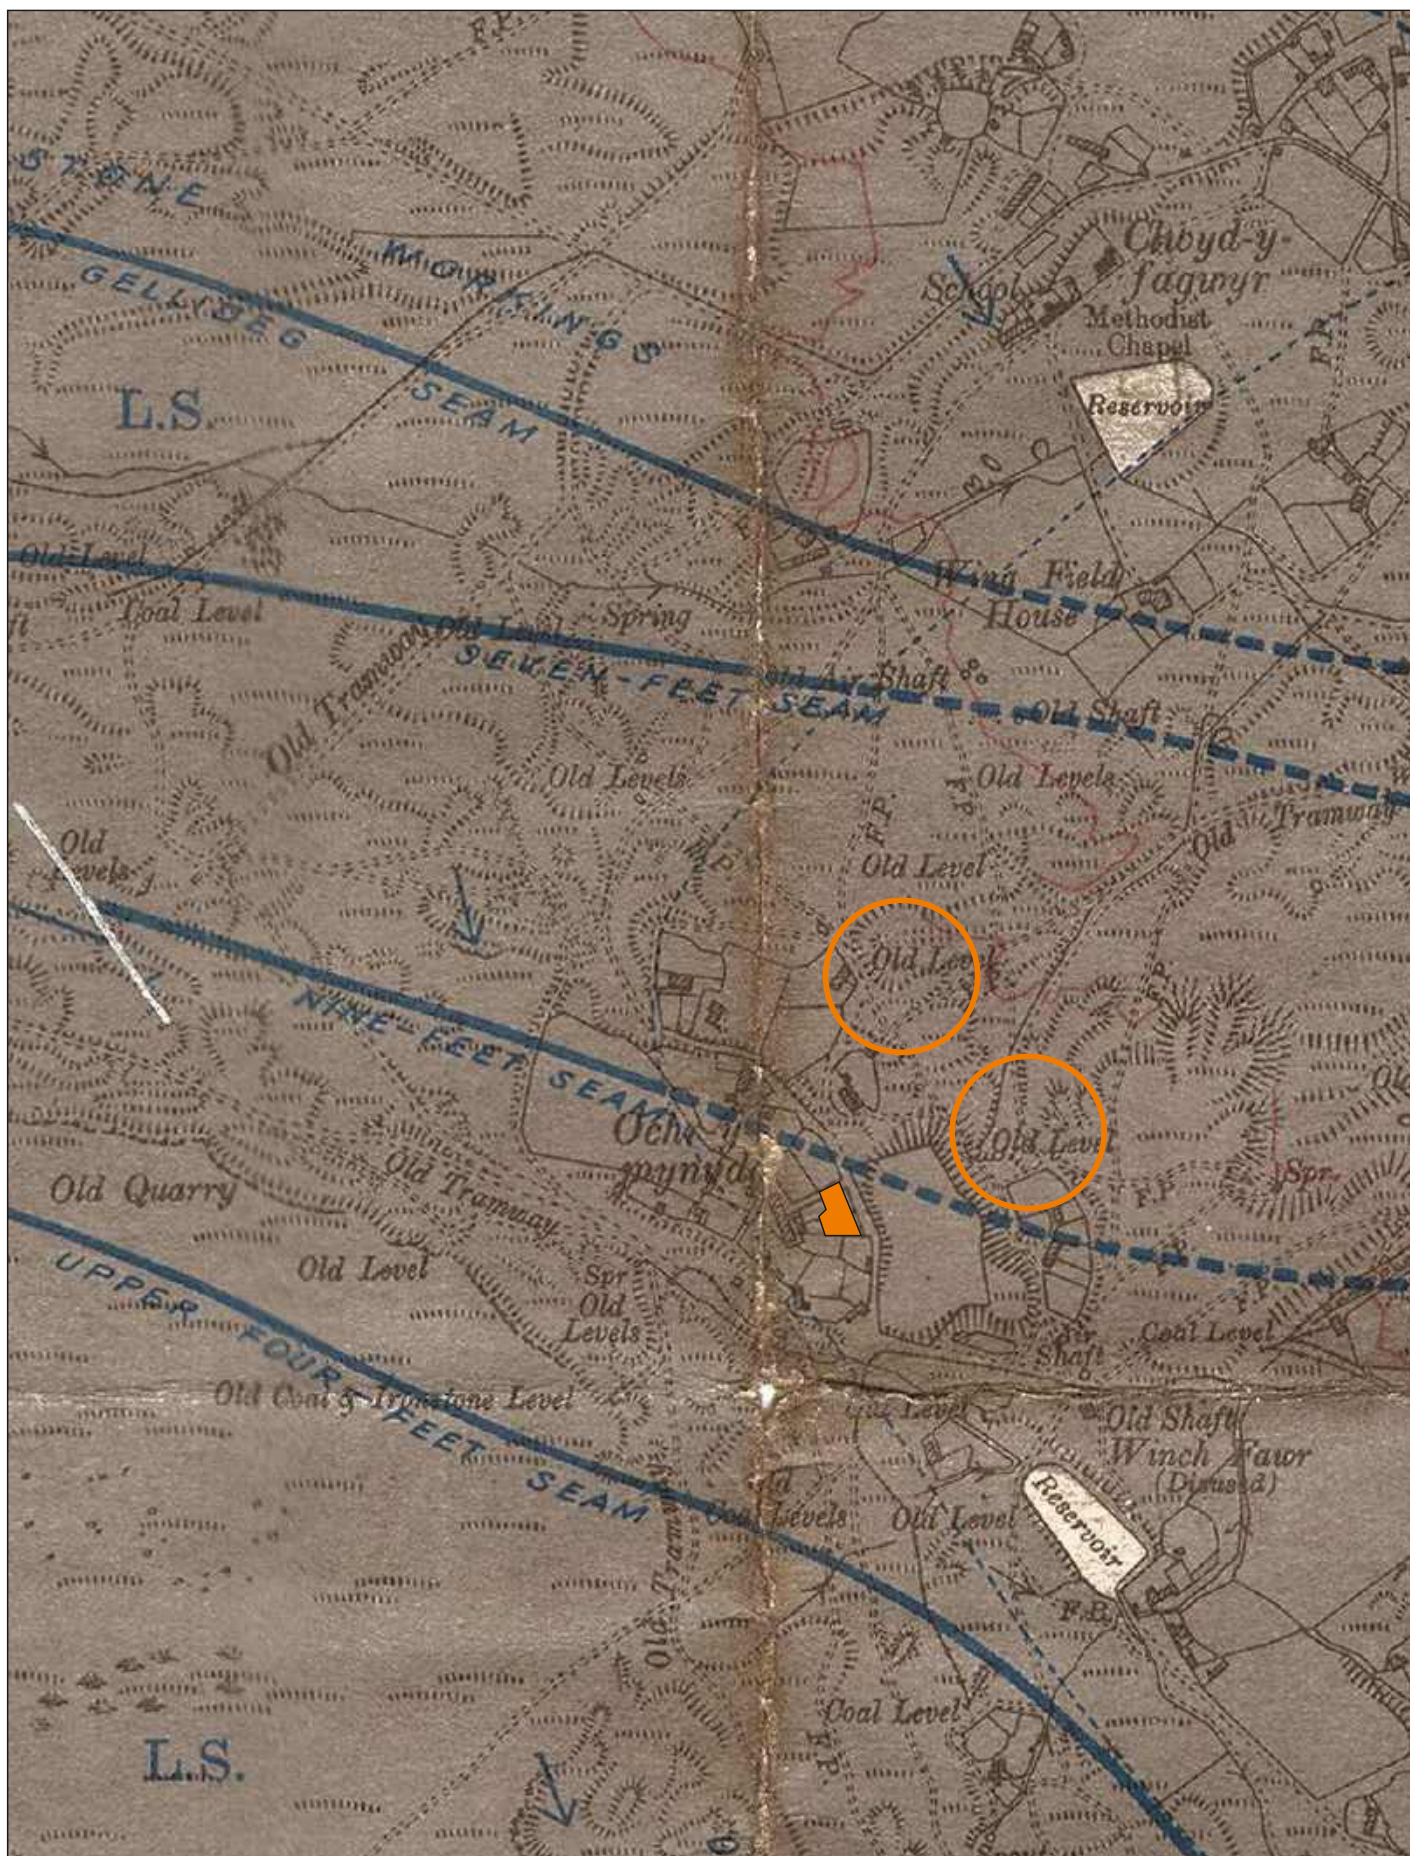
FIGURE 6B  
EXTRACT OF GEOLOGICAL SURVEY SHEET GLAM 11NE (1921).  
THE SITE IS HIGHLIGHTED IN ORANGE.

In Figure 6A the large areas of NW-SE cross hatching represent Made Ground from very extensive surface mining of Ironstone and Coal. The debris from this can be seen on the underlying base map. This is better seen in Figure 6B which has an older base map. Southwest of the site in Figure 6A is an area of SW-NE hatching. This represents opencast mining. The broad outcrop pattern is similar to Figure 5 but with fewer outcrops. This is because the Survey usually only shows the most important seams to avoid overcomplicating the map. In contrast, many of the outcrops on the C.A. Viewer are thin and unworkable. North of the site the entire Lower Coal Measures are exposed from the basal Garw Seam to the Amman Marine Band which marks the junction with the Middle Coal Measures. Only four coal seam outcrops are shown in the entire Lower Coal Measures. The Memoirs make it clear that there are other closely spaced coal seams underground with splits and recombination giving quite a complicated picture. There is a measured dip  $35^{\circ}$  along strike from the site. Further northwest is a second measured dip of  $12^{\circ}$ . This is a considerable difference over a relatively short distance. Strata dip is going to have a very important bearing on depth of seams below the site.

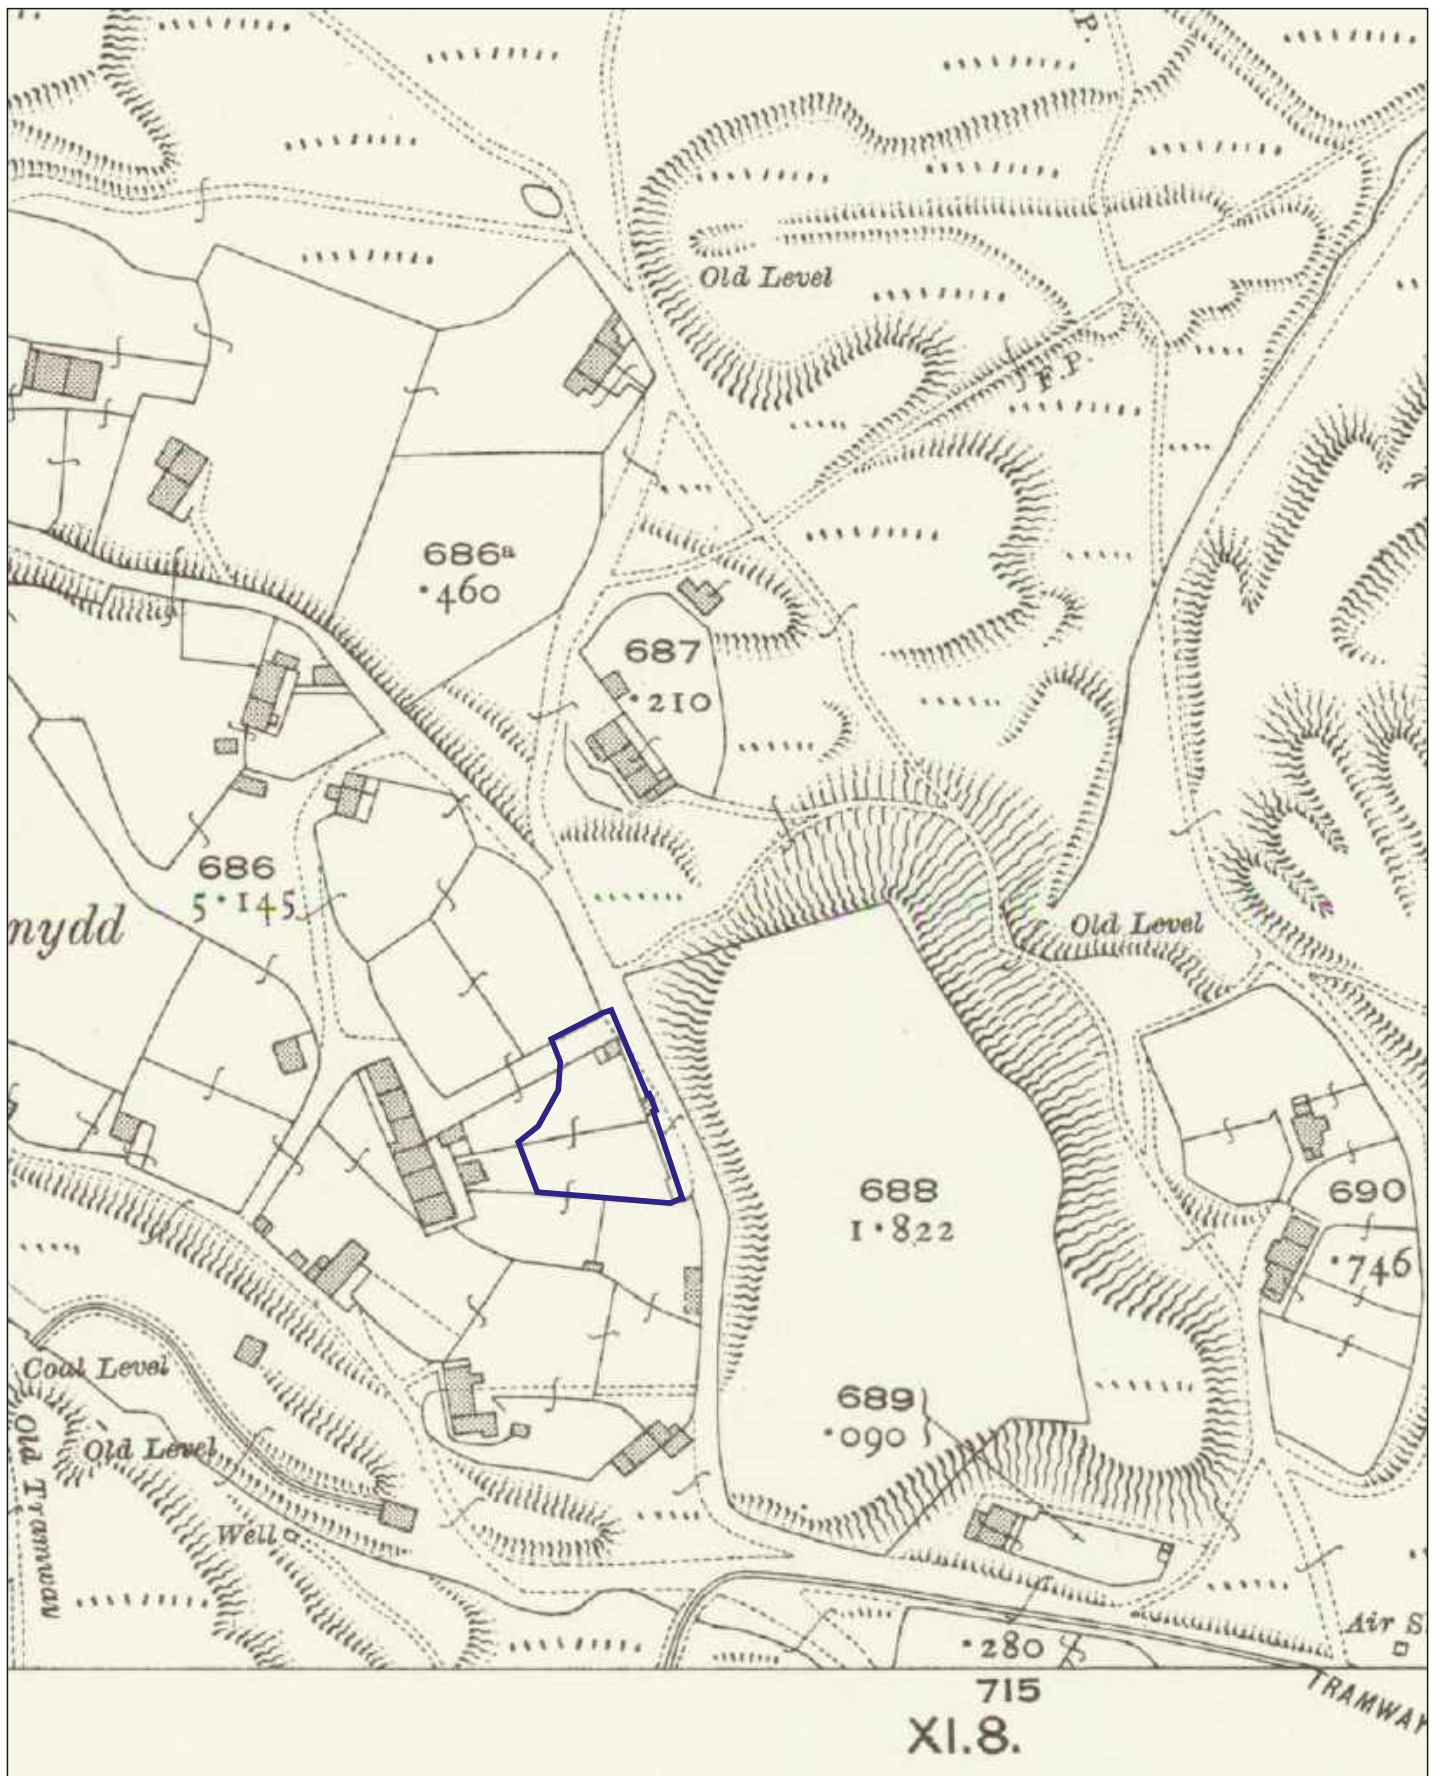
FIGURE 8  
THE SITE IN 1919 ON 1:2500 ORDNANCE SURVEY.

2f) Historical Ordnance Survey maps can prove invaluable in looking for evidence of coal mining activity. Since the first County Series maps were produced in the 1870's nearly all mining features have been recorded, even if they were considered "old" at that time. This is particularly true of the 1:1250 and 1:2500 scale maps. On the earliest 1885 map the area around the site is being intensively exploited by shallow mining. It is noticeable that most of the mining is labelled as ironstone, with coal production being of secondary importance. Ironstone was the primary mining target to supply the voracious Merthyr Ironworks, which at the time were the largest in the world. Figure 8 is from the 1919 revision at 1:2500 scale. and shows the area as an industrial wasteland in severe decline. The closest "old level" seen due east of the site is in the location of the No1 and No.2 Bute Levels and at this scale it is easier to appreciate the proximity to the site.

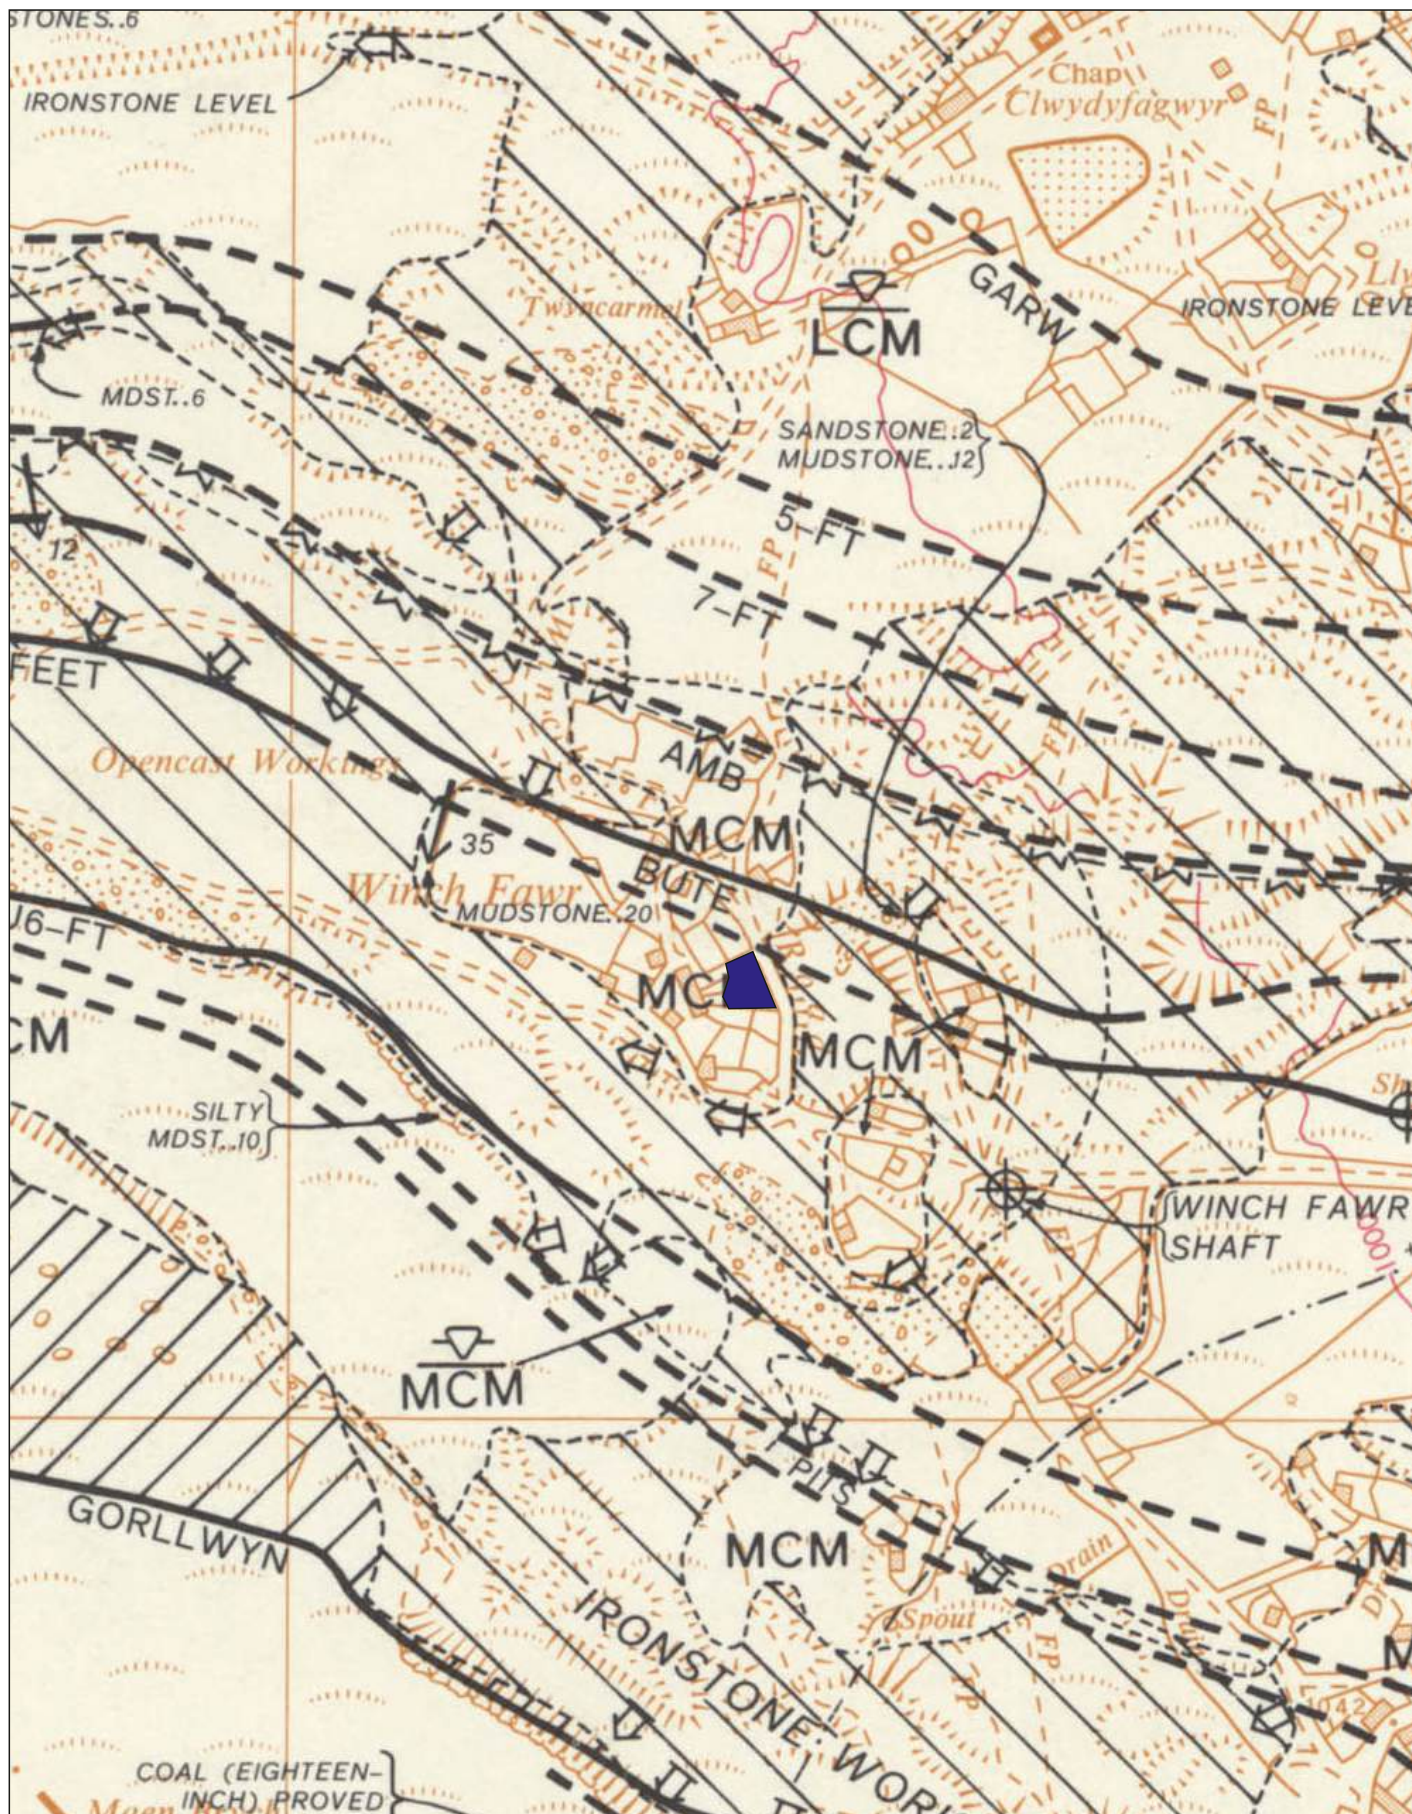
FIGURE 3  
EXTRACT OF GEOLOGICAL SURVEY SHEET SO 00NW.  
THE SITE IS HIGHLIGHTED IN BLUE.

In Figure 3 the large areas of NW-SE cross hatching represent Made Ground from very extensive surface mining of Ironstone and Coal. The debris from this can be seen on the underlying base map. This is better seen in Figure 5 which has an older base map. Southwest of the site in Figure 3 is an area of SW-NE hatching. This represents opencast mining. North of the site the entire Lower Coal Measures are exposed from the basal Garw Seam to the Amman Marine Band which marks the junction with the Middle Coal Measures. Only four coal seam outcrops are shown in the entire Lower Coal Measures. The Memoirs make it clear that there are other closely spaced coal seams underground with splits and recombination giving quite a complicated picture. There is a measured dip  $35^{\circ}$  along strike from the site. Further northwest is a second measured dip of  $12^{\circ}$ . This is a considerable difference over a relatively short distance. Strata dip is going to have a very important bearing on depth of seams below the site.

The site is shown underlain by the Middle Coal Measures. The Bute Seam is shown as a solid line. The Nine Foot is also shown as a solid line west and east of the site but in the vicinity of the site it is dashed. This means the outcrop is conjectural, not proven. It is evident the Bute and Nine Foot (if present) will both underlie the site at shallow depth. In the case of the Nine Foot, the outcrop is probably too close to the site to have sufficient rock cover. The broad arrow symbols are levels (sub-horizontal mine entries). The two closest to the site appear to be driven on the Bute outcrop. Further evidence including mine plans and large scale historical O.S. indicated there would be workings in the Bute Seam and the C.M.R.A. concluded the site would need to be drilled.
