*Report No. BC/MB/11.20.04.*

# **Preliminary Site Investigation: Land at Colliers Row, Merthyr Tydfil.**

**Maxiom Developments Ltd.**

# **Preliminary Site Investigation Report: Land at Colliers Row, Merthyr Tydfil.**

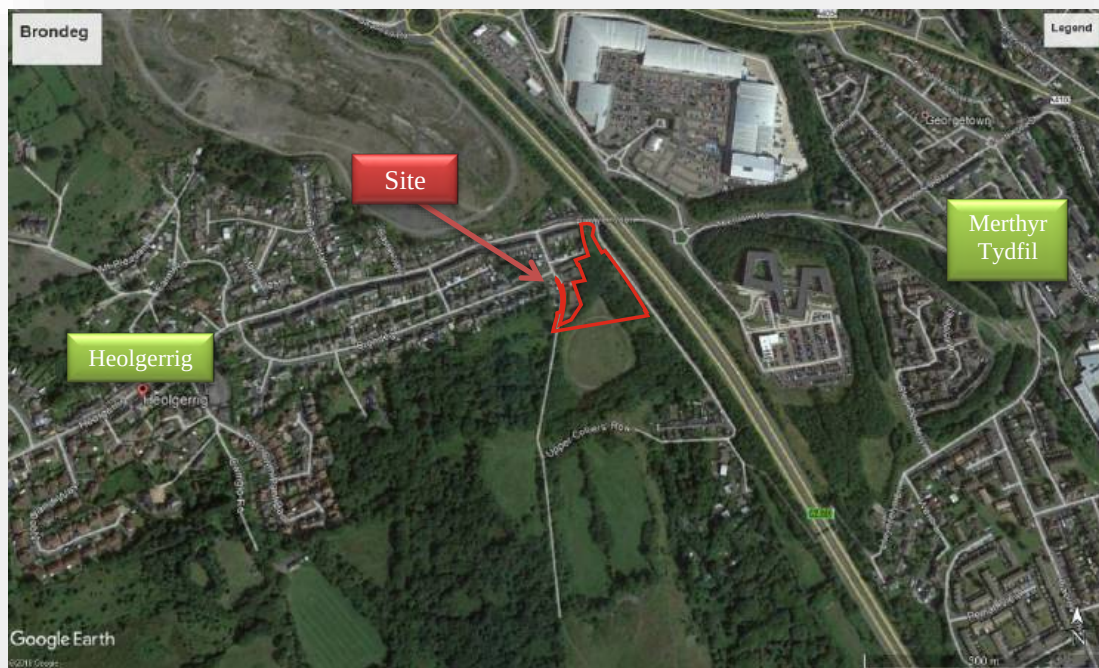
**Figure 1**  
**Aerial View of the Site**

The plot of land that is the subject of this report, 'the Site' is located on the western fringes of Merthyr Tydfil, approximately 700m west of the town centre; it is irregular in outline and occupies an area of approximately 0.82 hectares (see Figure 1 and *General Location Plan, drawing no. BC/MB/11.20.04.01*). The Site is located in a residential area on the fringes of the town and is bounded on its western side by residential dwellings and a lane; to the north is Aberdare Road and beyond it the Trago Mills retail site; to the east is the public highway serving Colliers Row, beyond which is the A 470 (T), and to the south there are a mixture of agricultural enclosures and open countryside.

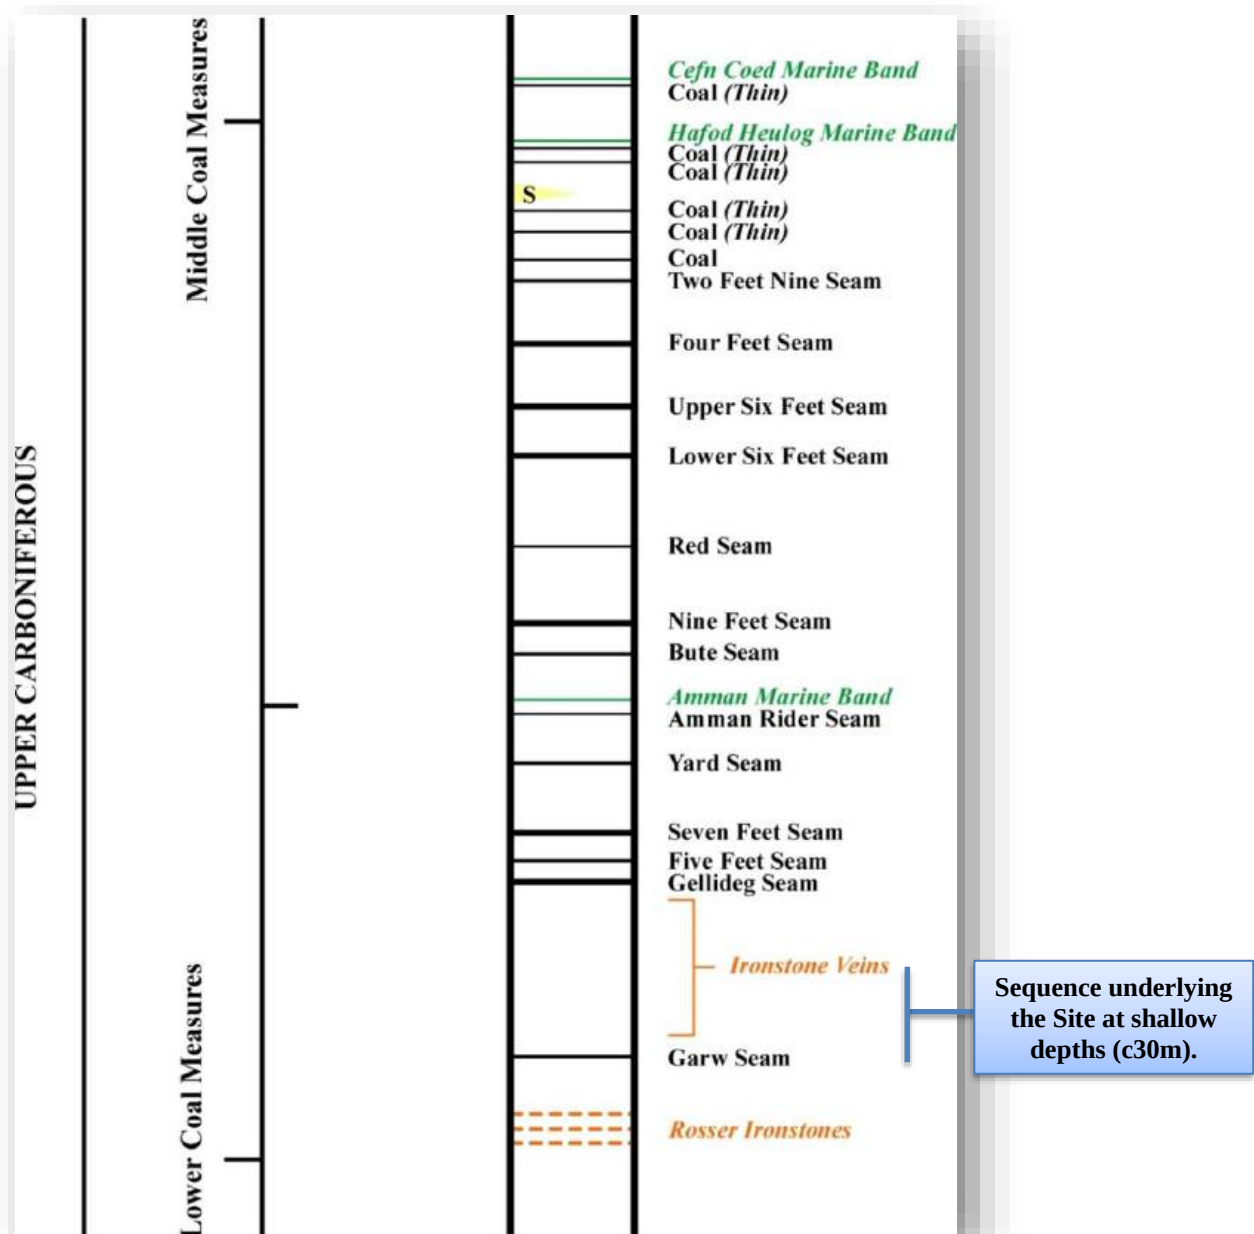
**Figure 2**  
**Part of the Stratigraphic Column.**

(SO 00 NW) shows the inferred positions of the outcrop of the Garw Seam to pass through the Site (see *Geology Plan*, drawing no. BC/MB/11.20.04.02). However, mining records indicate that the outcrops are south-east of the positions shown on the published geological sheet such that the outcrop of the Five Feet/Gellideg Seam passes through the south-west corner of the Site (see *Plan of Old Workings in the Five Feet/Gellideg Seam*, drawing no. BC/MB/11.20.04.04). A number of ironstone bands are present within the coal measures, occurring above and below the Garw Seam (see Figure 2, Part of the Stratigraphic Column).

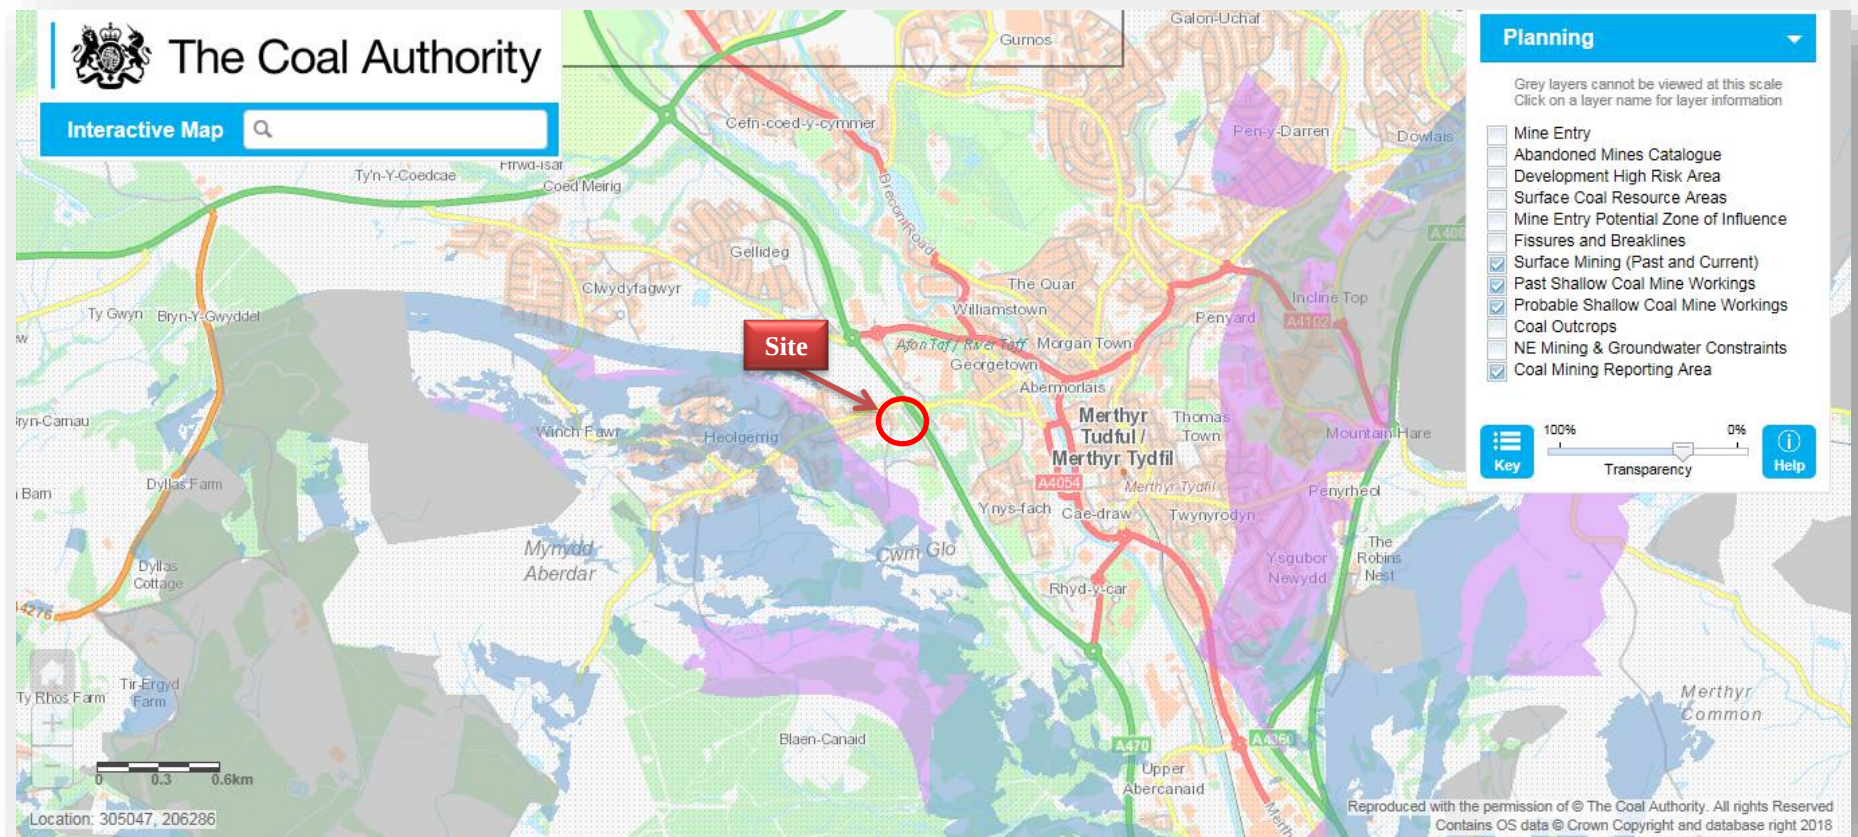
**Figure 3**  
**Print from The Coal Authority's Interactive Map**  
 (accessed 21<sup>st</sup> August 2019)

Coal Authority's interactive map identifies that the inclusion of the finger of land along the lane does not alter any of the findings of The Coal Authority's report.

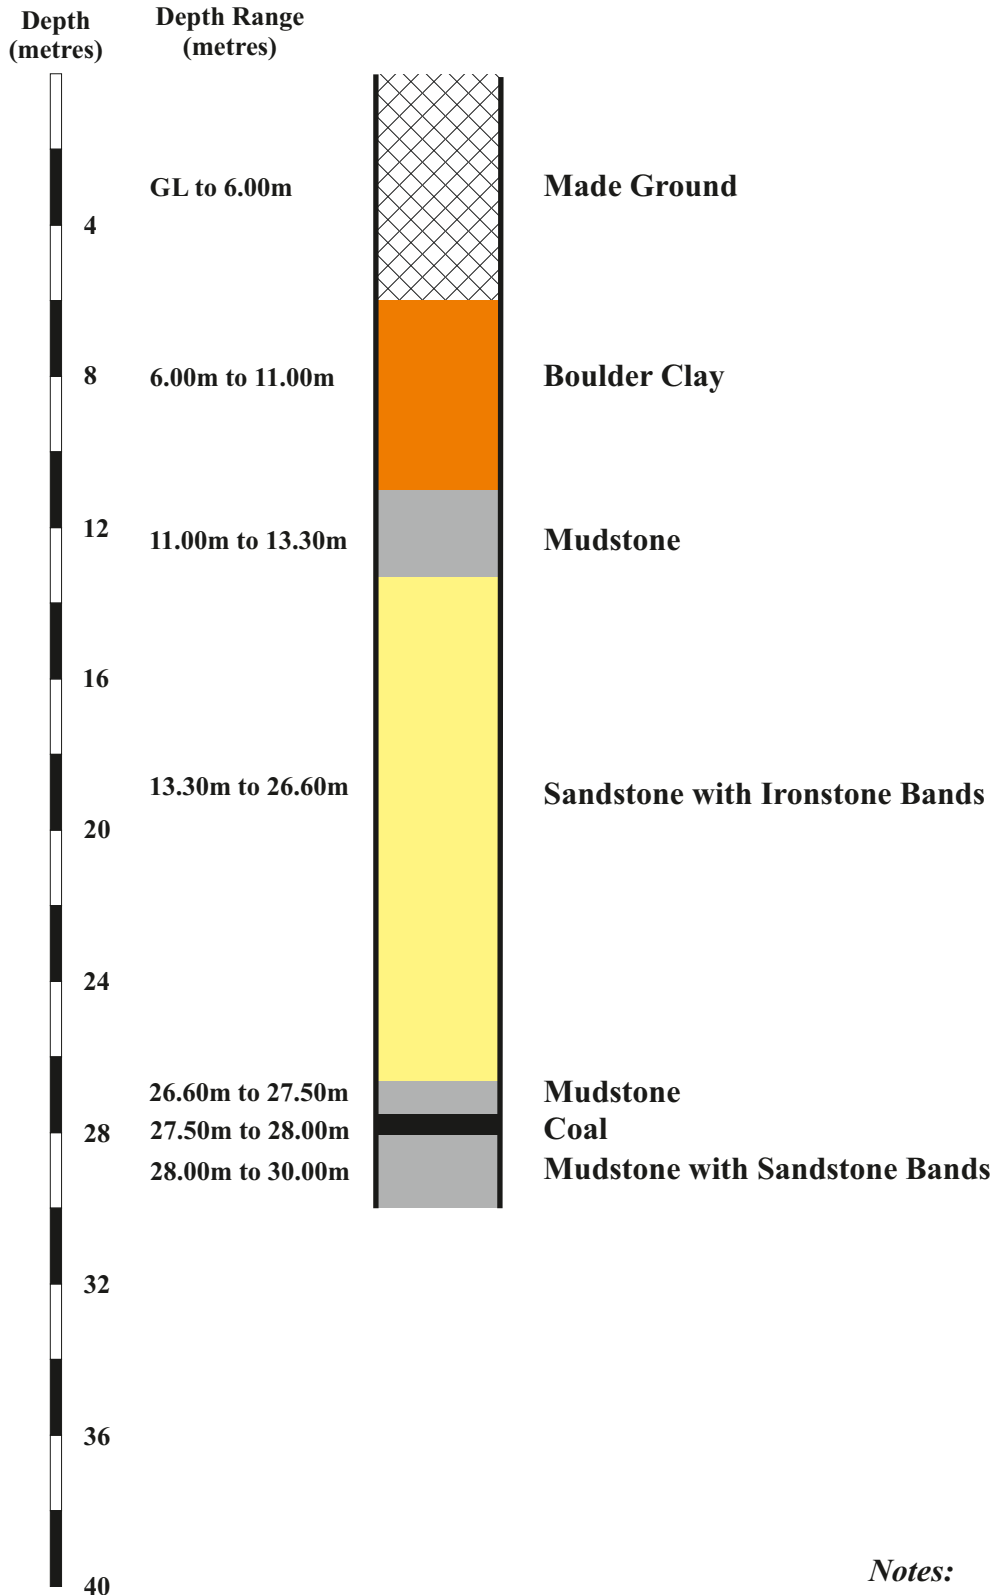
### *Borehole No. 1*

1. *Driller's Descriptions.*
2. *Borehole dry.*
3. *Total depth of borehole, 30.00m.*
4. *Cased 10.50m.*

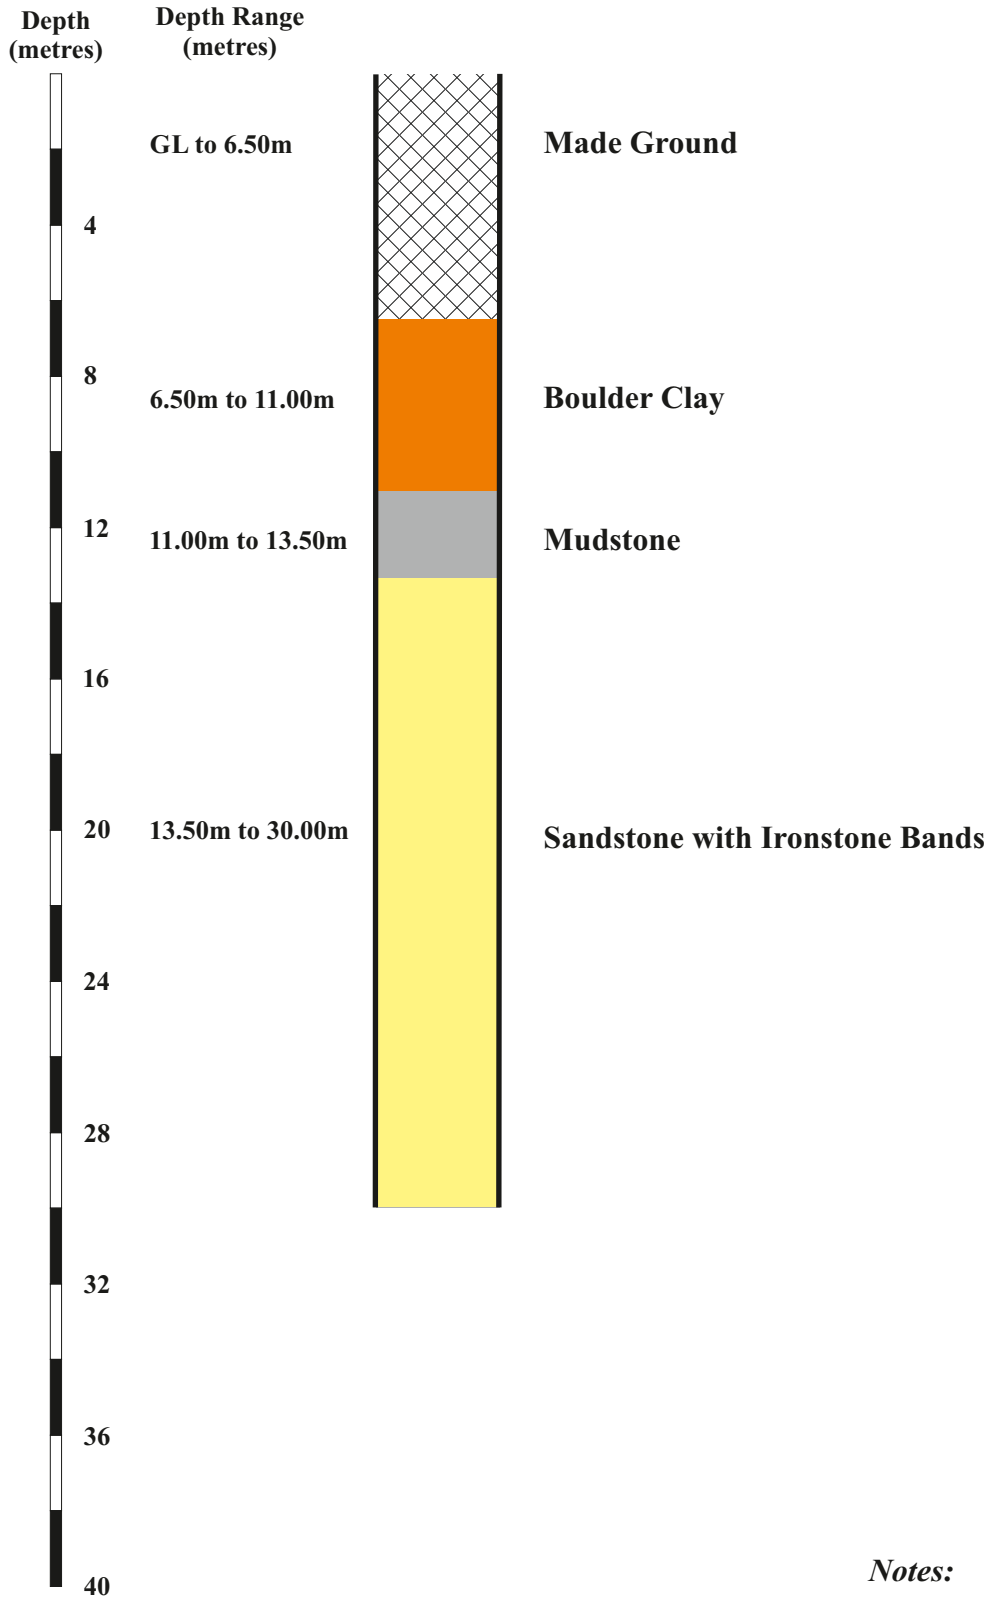
### *Borehole No. 3*

1. *Driller's Descriptions.*
2. *Borehole dry.*
3. *Total depth of borehole, 30.00m.*
4. *Cased 10.50m.*

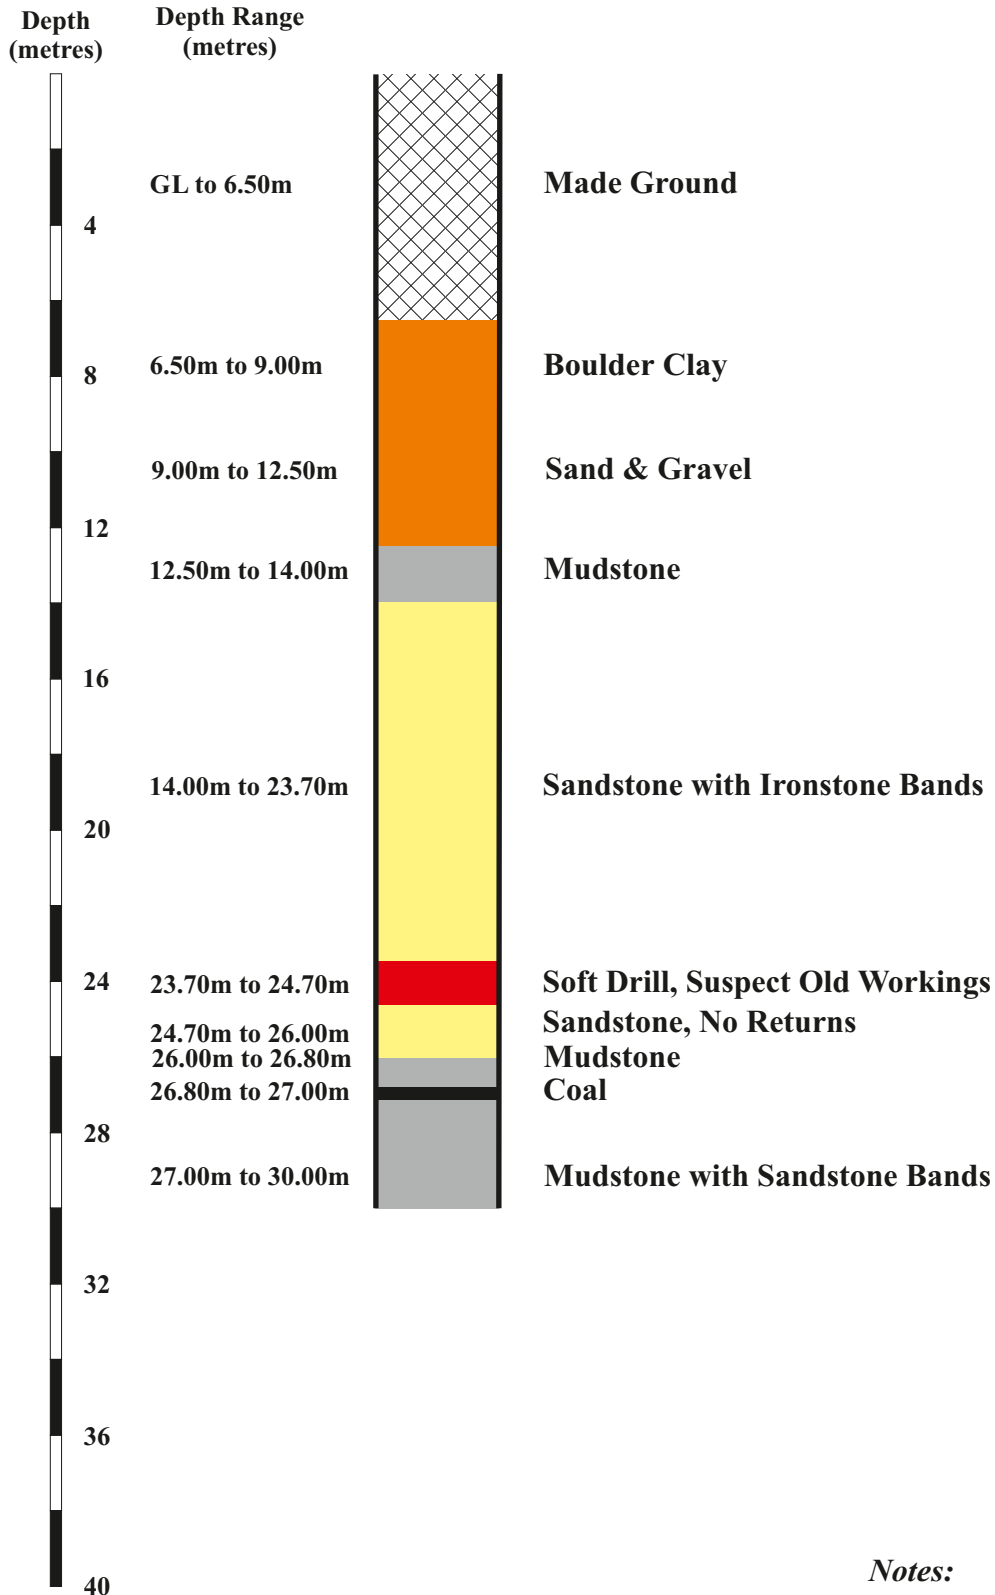
### Borehole No. 6

1. Driller's Descriptions.
2. Borehole dry.
3. Total depth of borehole, 30.00m.
4. Cased 13.00m.

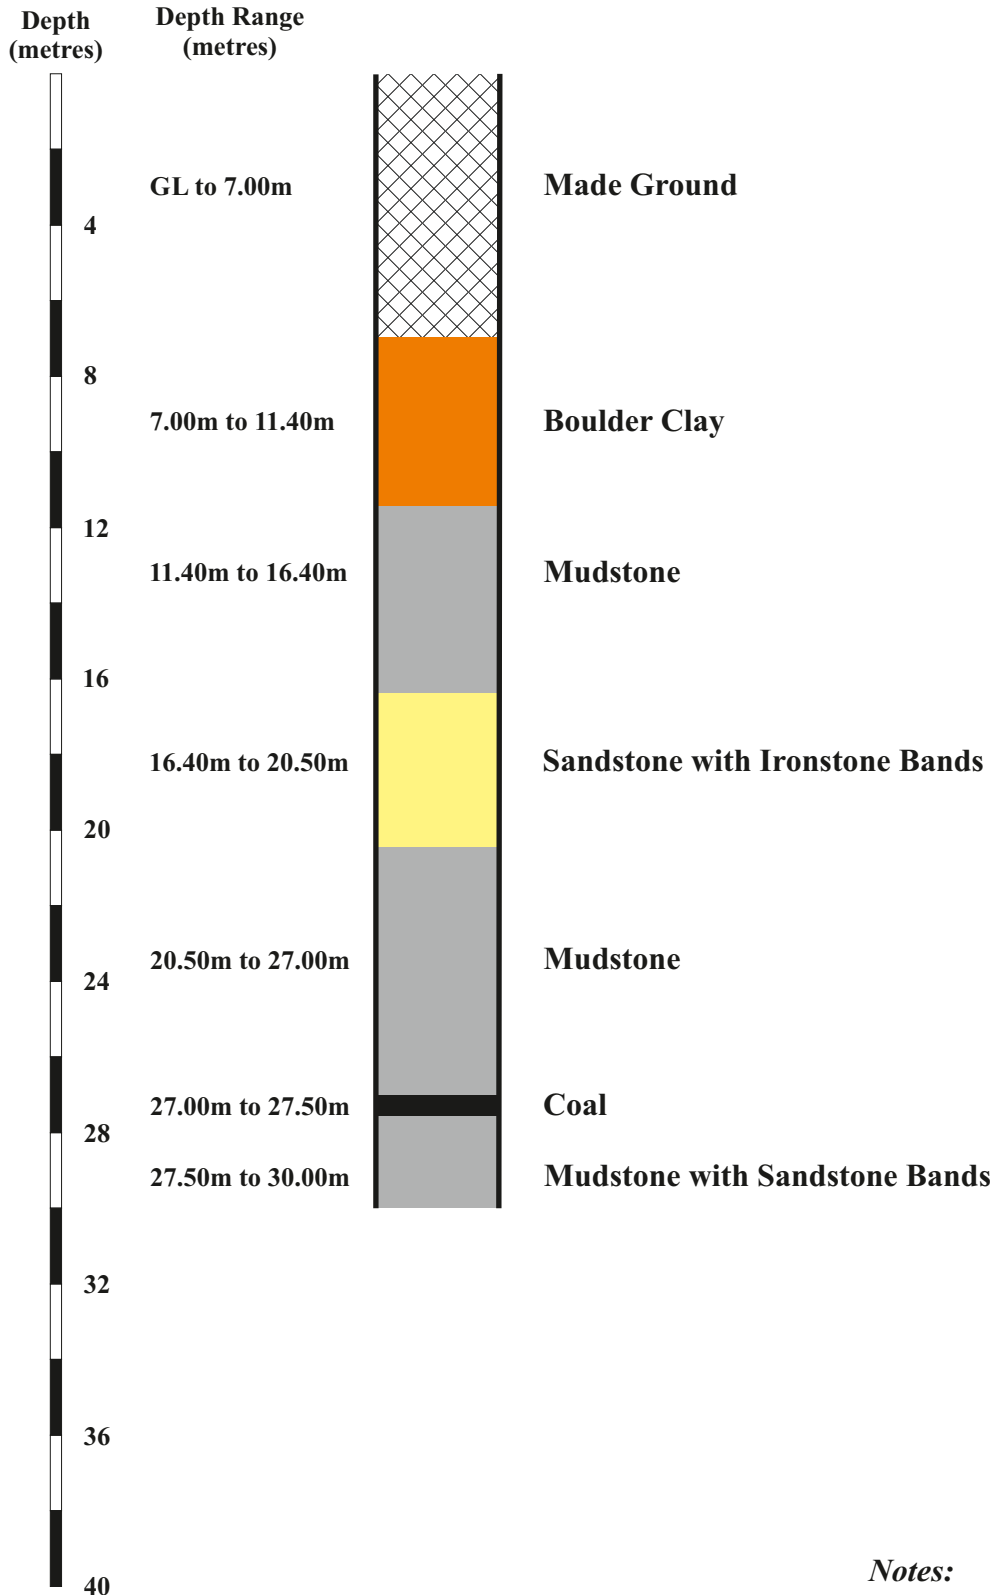
### *Borehole No. 7*

1. *Driller's Descriptions.*
2. *Borehole dry.*
3. *Total depth of borehole, 30.00m.*
4. *Cased 10.50m.*

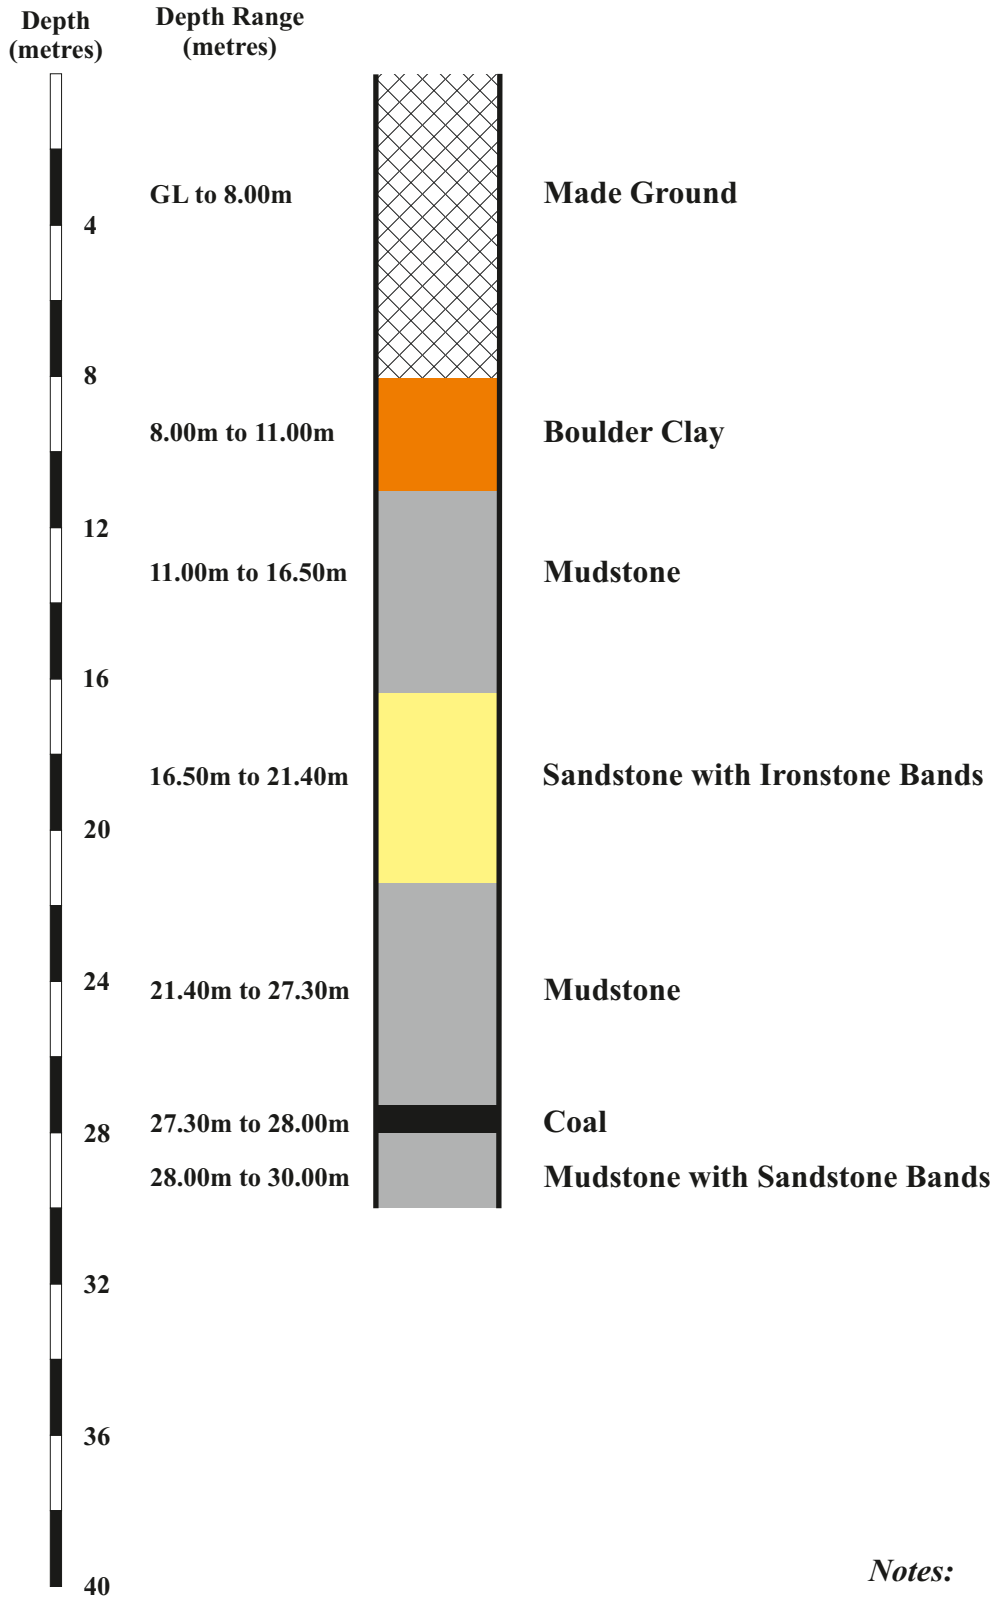
### Borehole No. 8

1. Driller's Descriptions.
2. Borehole dry.
3. Total depth of borehole, 30.00m.
4. Cased 10.50m.

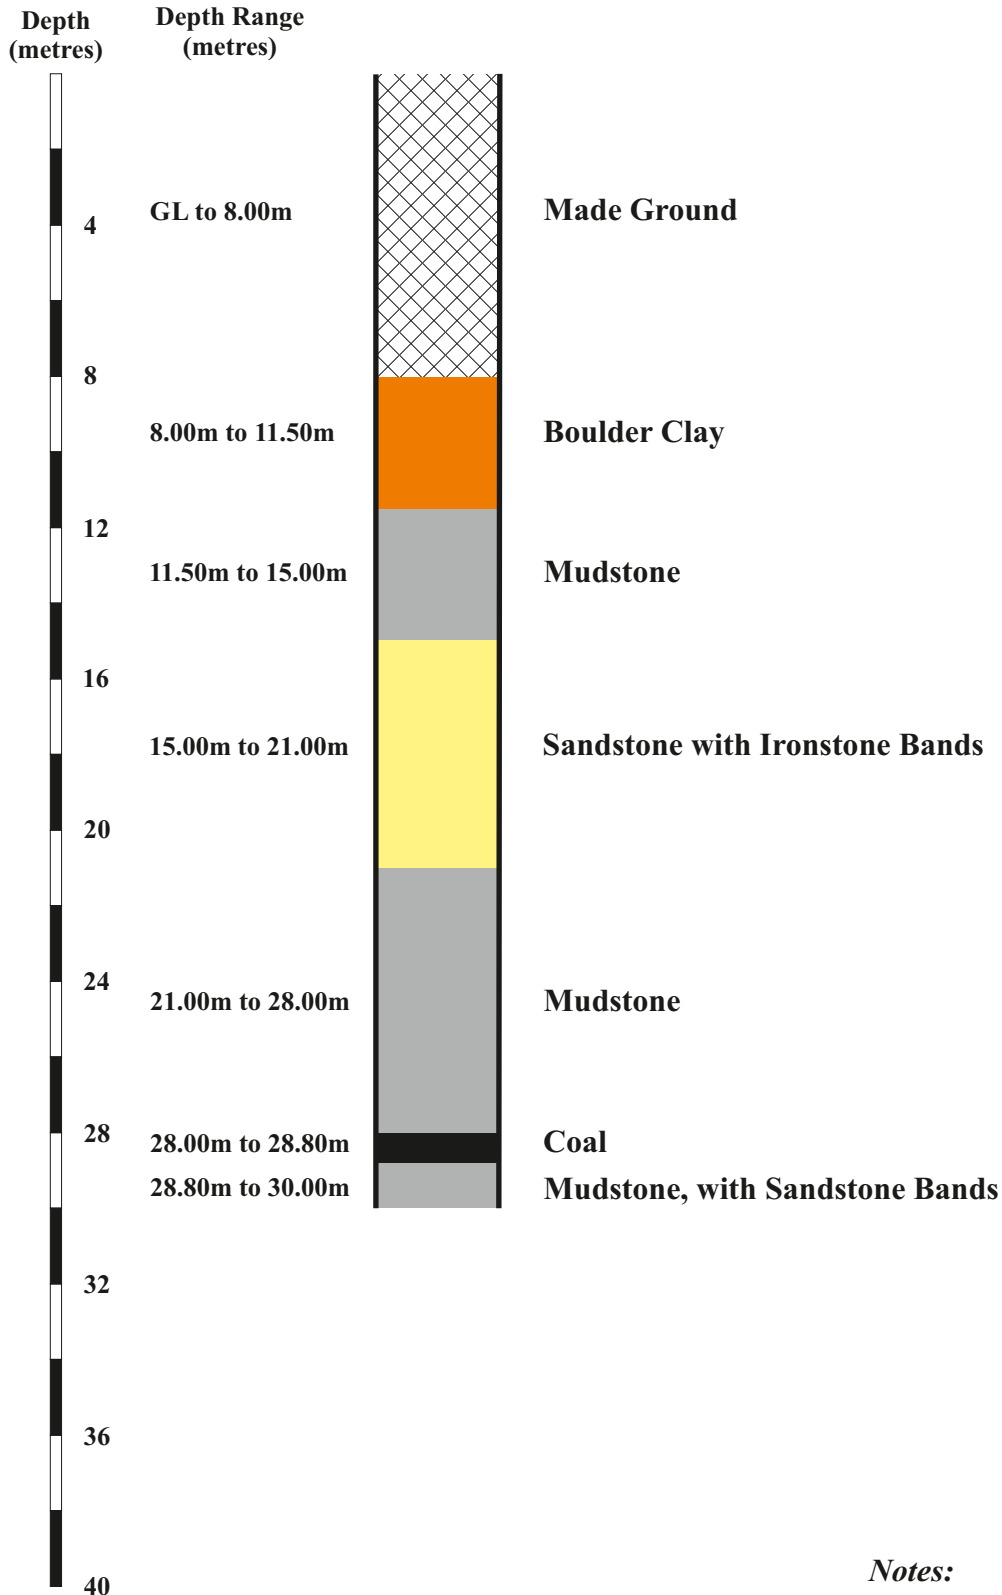
### Borehole No. 9

1. Driller's Descriptions.
2. Borehole dry.
3. Total depth of borehole, 30.00m.
4. Cased 10.50m.
