RHONDDA  
GEOTECHNICAL  
SERVICES

# VALIDATION REPORT

LAND ADJACENT TO

SIX BELLS ESTATE

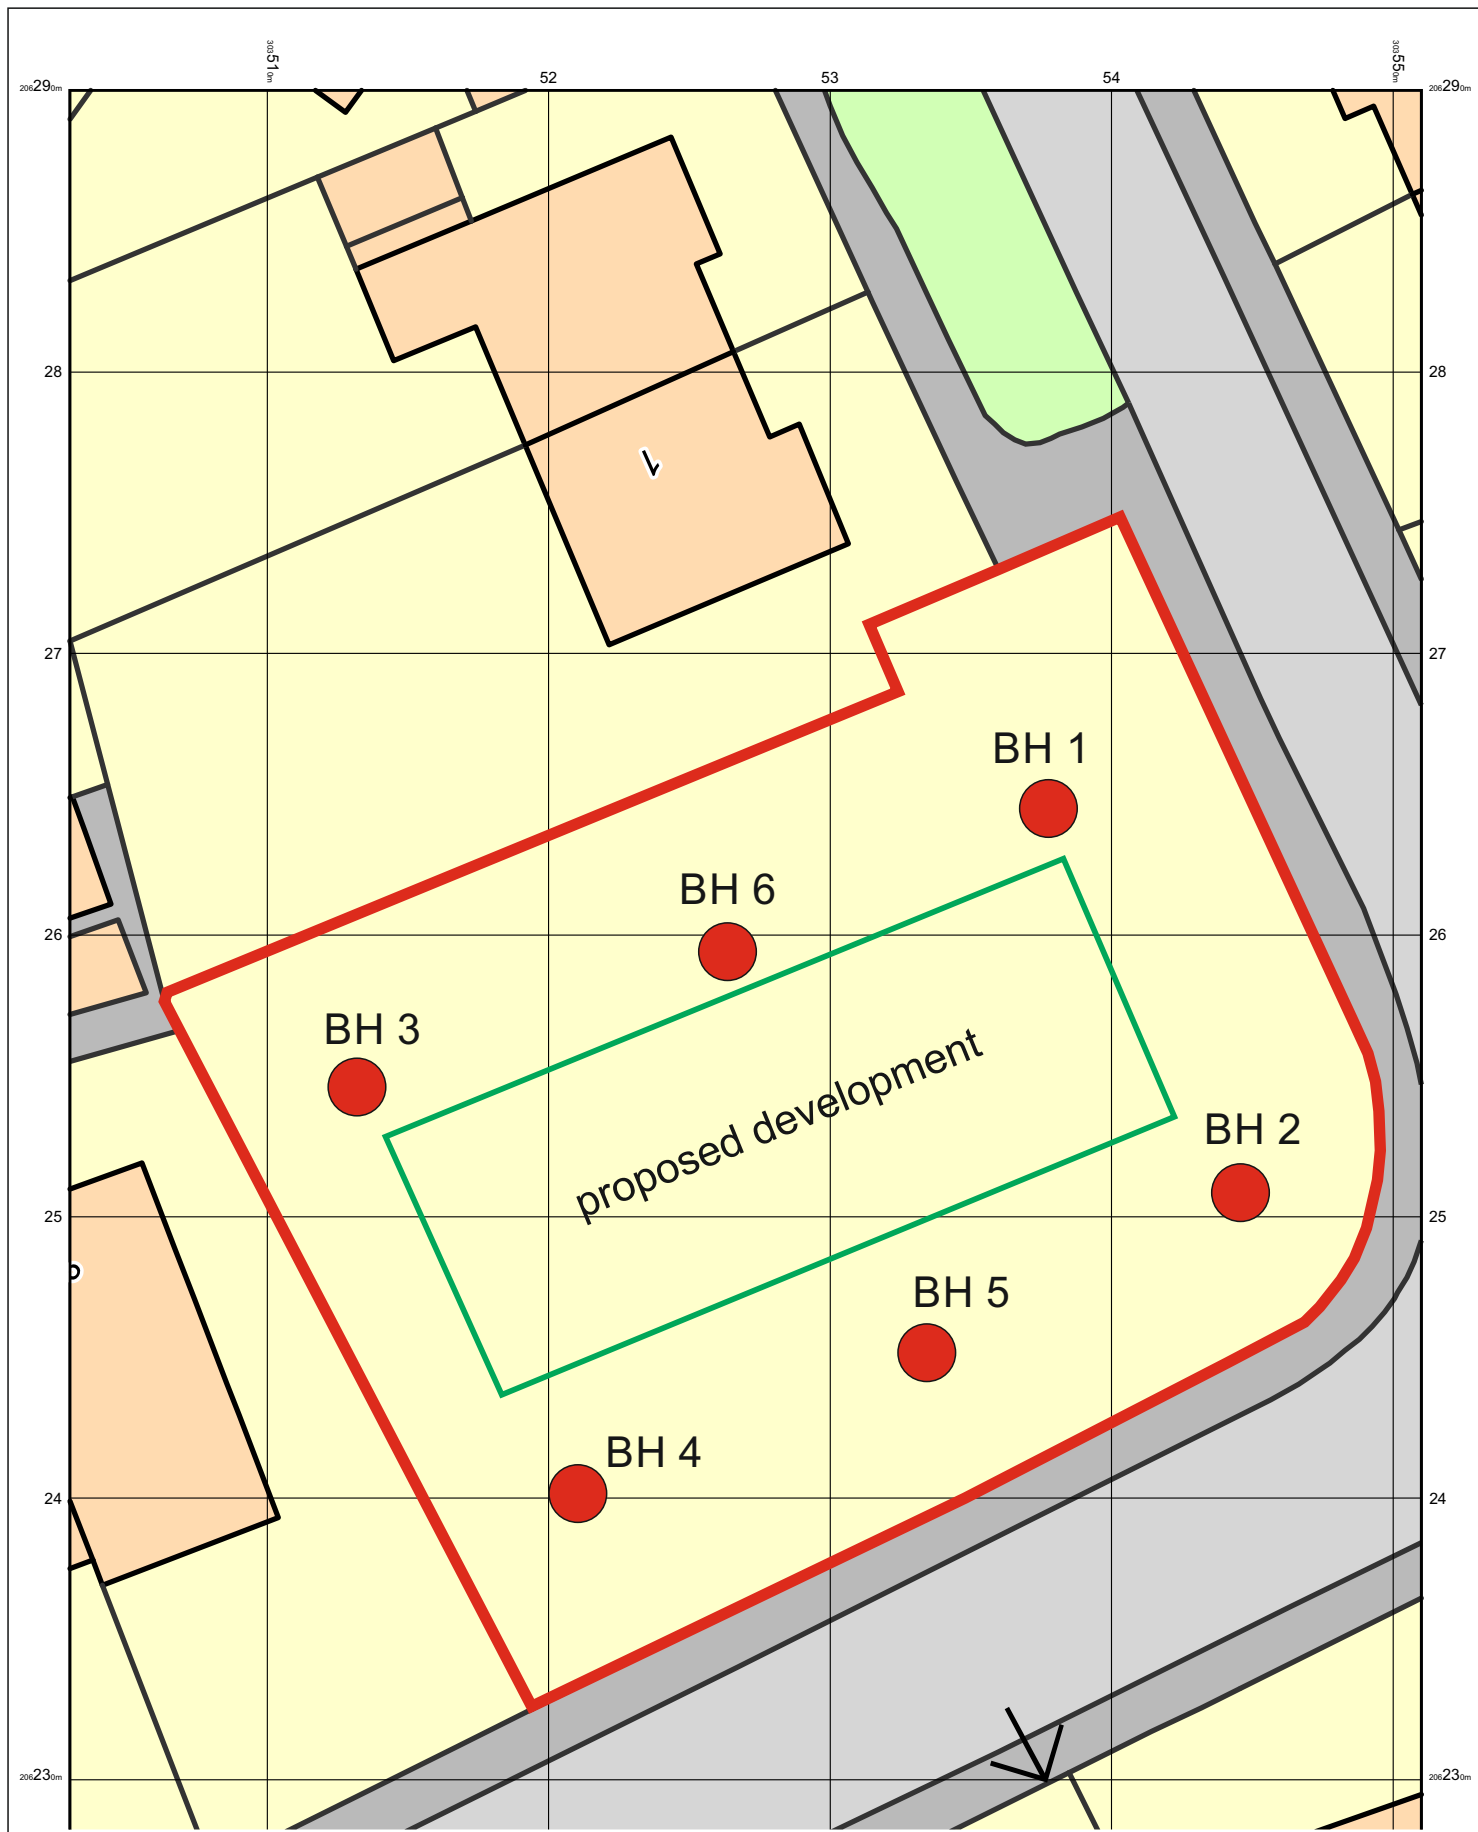
FIGURE 6  
BOREHOLE LOCATION PLAN AT SIX BELLS ESTATE  
(SUBJECT TO TRACING CULVERT)

The boreholes were drilled between 7-9/03/2023. Apex Drilling used a compact Beretta T44 rotary rig to drill the boreholes. All permit conditions were adhered to, with water flush being employed from rockhead after the superficial deposits were cased using air flush and Odex/Symatrex casing. Continuous gas monitoring at the rig, and regular monitoring in the surrounding area detected no mine gases. Full borehole logs are contained in Appendix 1. In summary, 10 boreholes were drilled to a maximum depth of 34m. The boreholes proved between 2.7m-5.3m of gravelly Glacial Drift. Some of this appeared to have been disturbed/tipped which was possibly linked to the culvert construction. The culvert is relatively modern and is constructed from spun concrete rings. Rockhead was grey mudstone in all boreholes. BH1 encountered workings/ broken ground at shallow depth (9.6m-13.0m). All flush was lost. Once a metre of solid rock was proven beneath the broken ground, the borehole was stopped because of the risk of jamming the drill string. BHs 2-6 were all drilled to 34m. No workings were encountered. Correlation between the boreholes was good. The Gellideg and Five Foot seams were clearly identified with depths thicknesses and spacings very much as described in the Geological Survey Memoirs. The Gellideg was apparently absent in BH2, but there was no suggestion it had been removed. Local seam washouts are a very common phenomenon in the Lower Coal Measures. The Garw Seam was not reached by any of the boreholes. Below the seatearth of the Gellideg the strata were predominantly mudstone. There were thin interbedded harder layers. These might well have been Ironstone Veins but with rotary open hole methods it is impossible to differentiate between Ironstone and thin sandstones with any certainty. After the initial six boreholes, BH7 encountered 2.2m of broken ground. There was a partial loss of flush, but the returns were sufficient to prove the base of the Five Foot Seam, the entire Gellideg Seam and drill on to 20m. It is likely that BH7 had been drilled through a pillar, hence the only partial loss of flush. Both BH1 and BH7

- The Five Foot and Gellideg were confidently identified by the S.I.
- The Gellideg was unworked.
- Workings in the Five Foot were confined to the southwest corner of the site. This is well away from the footprint of the proposed building. It would appear that the Five Foot was taken in preference to the Gellideg. The seam separation averaged 3m. This is too great to take both seams together as has been done elsewhere in the coalfield where the seam separation is much less. The seams could not have been mined separately. If the Gellideg was taken after the Five Foot, roof conditions would have been extremely hazardous. If the Five Foot was taken after the Gellideg the position would be reversed, with the floor prone to collapse. It is likely that the Five Foot was being worked back toward outcrop from one of the recorded levels in the area, possibly the Coedcae Level which is approximately 400m away. This is a hazardous practice. The mudstone roof is only 3m-4m thick over the workings in BHs 1 and 7. Buried glacial erosion features make it even more dangerous and it would appear the workings were halted at that point.

There is no risk to ground stability at the site due to mining legacy issues. No remediation is required, neither are specialist foundations. Foundation design will be entirely dependent on shallow ground conditions. Standard strip footings can be used if the soils at the site have sufficient bearing capacity. This will need to be checked on site and is outside the remit of this report.
