*Report No. BC/MB/06.19.03.*

# **Site Investigation Report on Land at Gethin House, Abercanaid**

# **Site Investigation Report: Land Adjacent to Gethin House, Abercanaid, Merthyr Tydfil.**

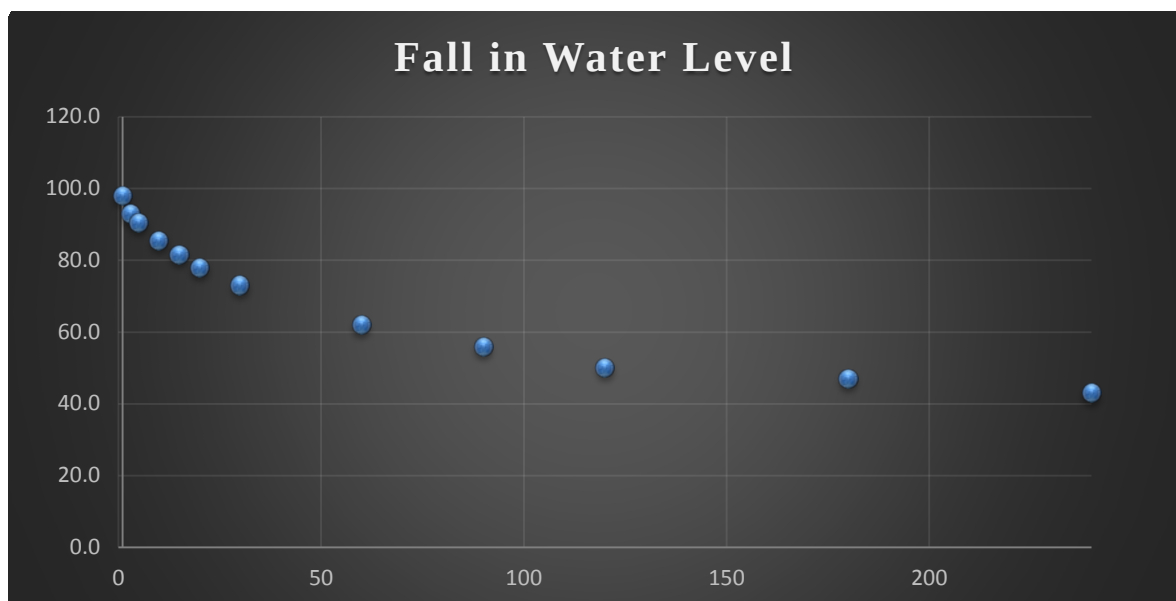
**Figure 6**

An infiltration test was carried out in Trial Pit 4 in accordance with BRE365 (2016). This location was selected because the south-east corner of the Site is sufficiently distant from the foundations of the proposed dwelling. The fall of the water level in the trial pit is displayed in the graph at Figure 6; the infiltration rate was found to be  $1.042 \times 10^{-4}$ .

**Attenuation Infiltration Area:** The soil infiltration test carried out in TP1 found the soils to have a relatively high infiltration rate leading to the conclusion that attenuation infiltration areas would be effective. The use of permeable paving surfaces on path and patio areas would prove useful.

**Shallow Base Soakaways:** The results of the infiltration test carried out indicates that Shallow Based Soakaway solution designed to BRE 365 specifications would be a viable option.
