Primrose Hill, Merthyr Tydfil

RECORD OF BUILDING AND CONDITION ASSESSMENT REPORT, WITH REPAIR PROPOSALS

.....
(449)2503-GVWP-A-HIS-P01

Date: 05.03.25

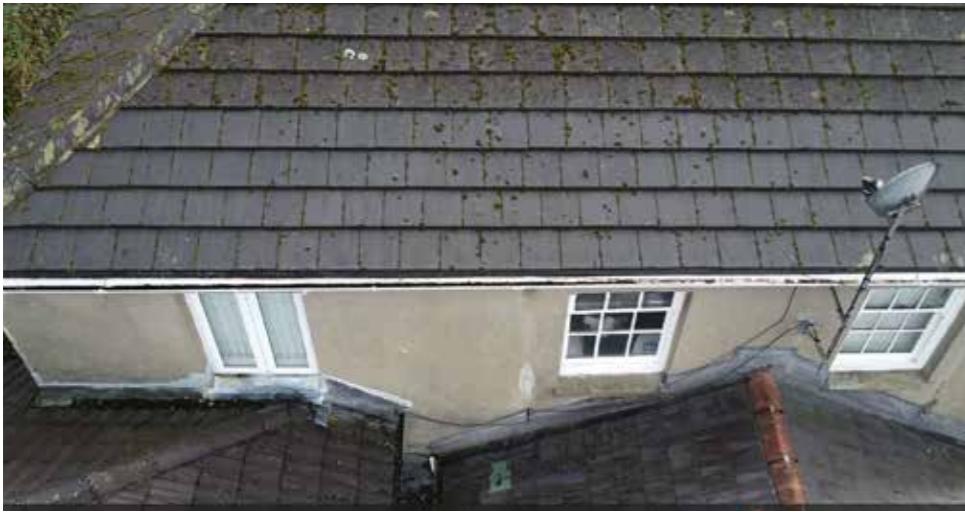
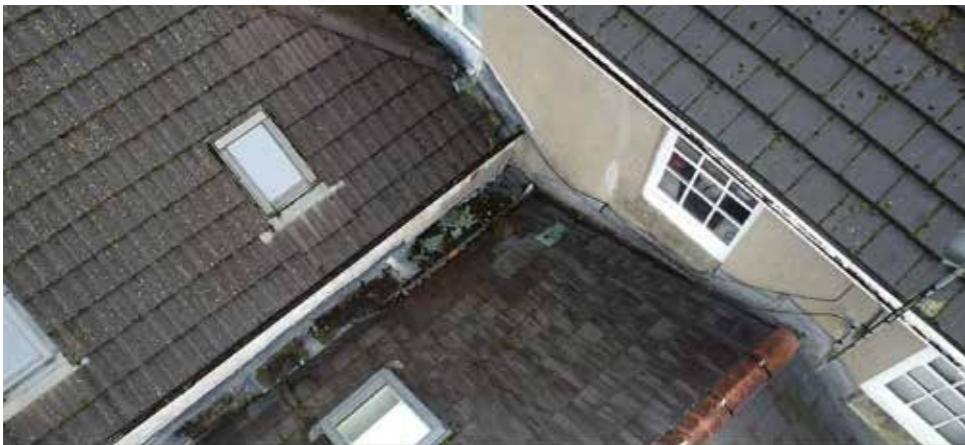
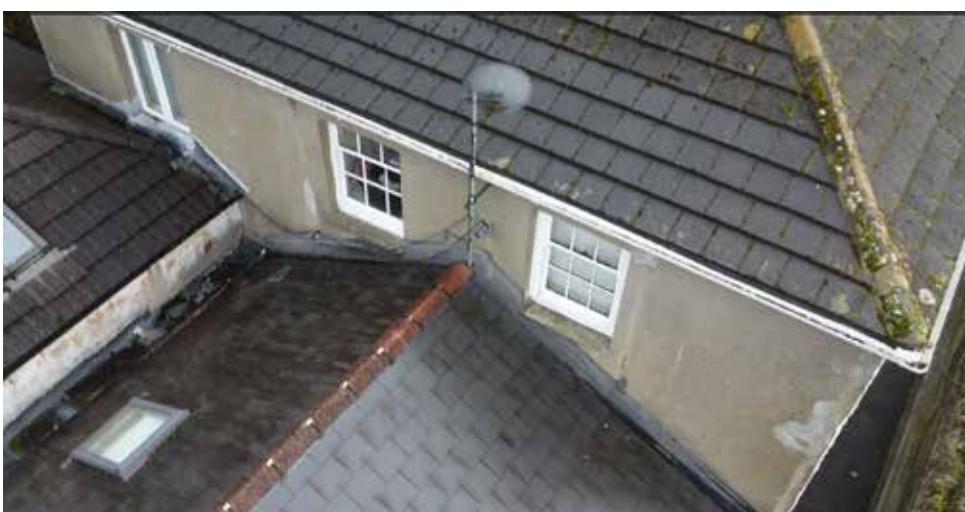
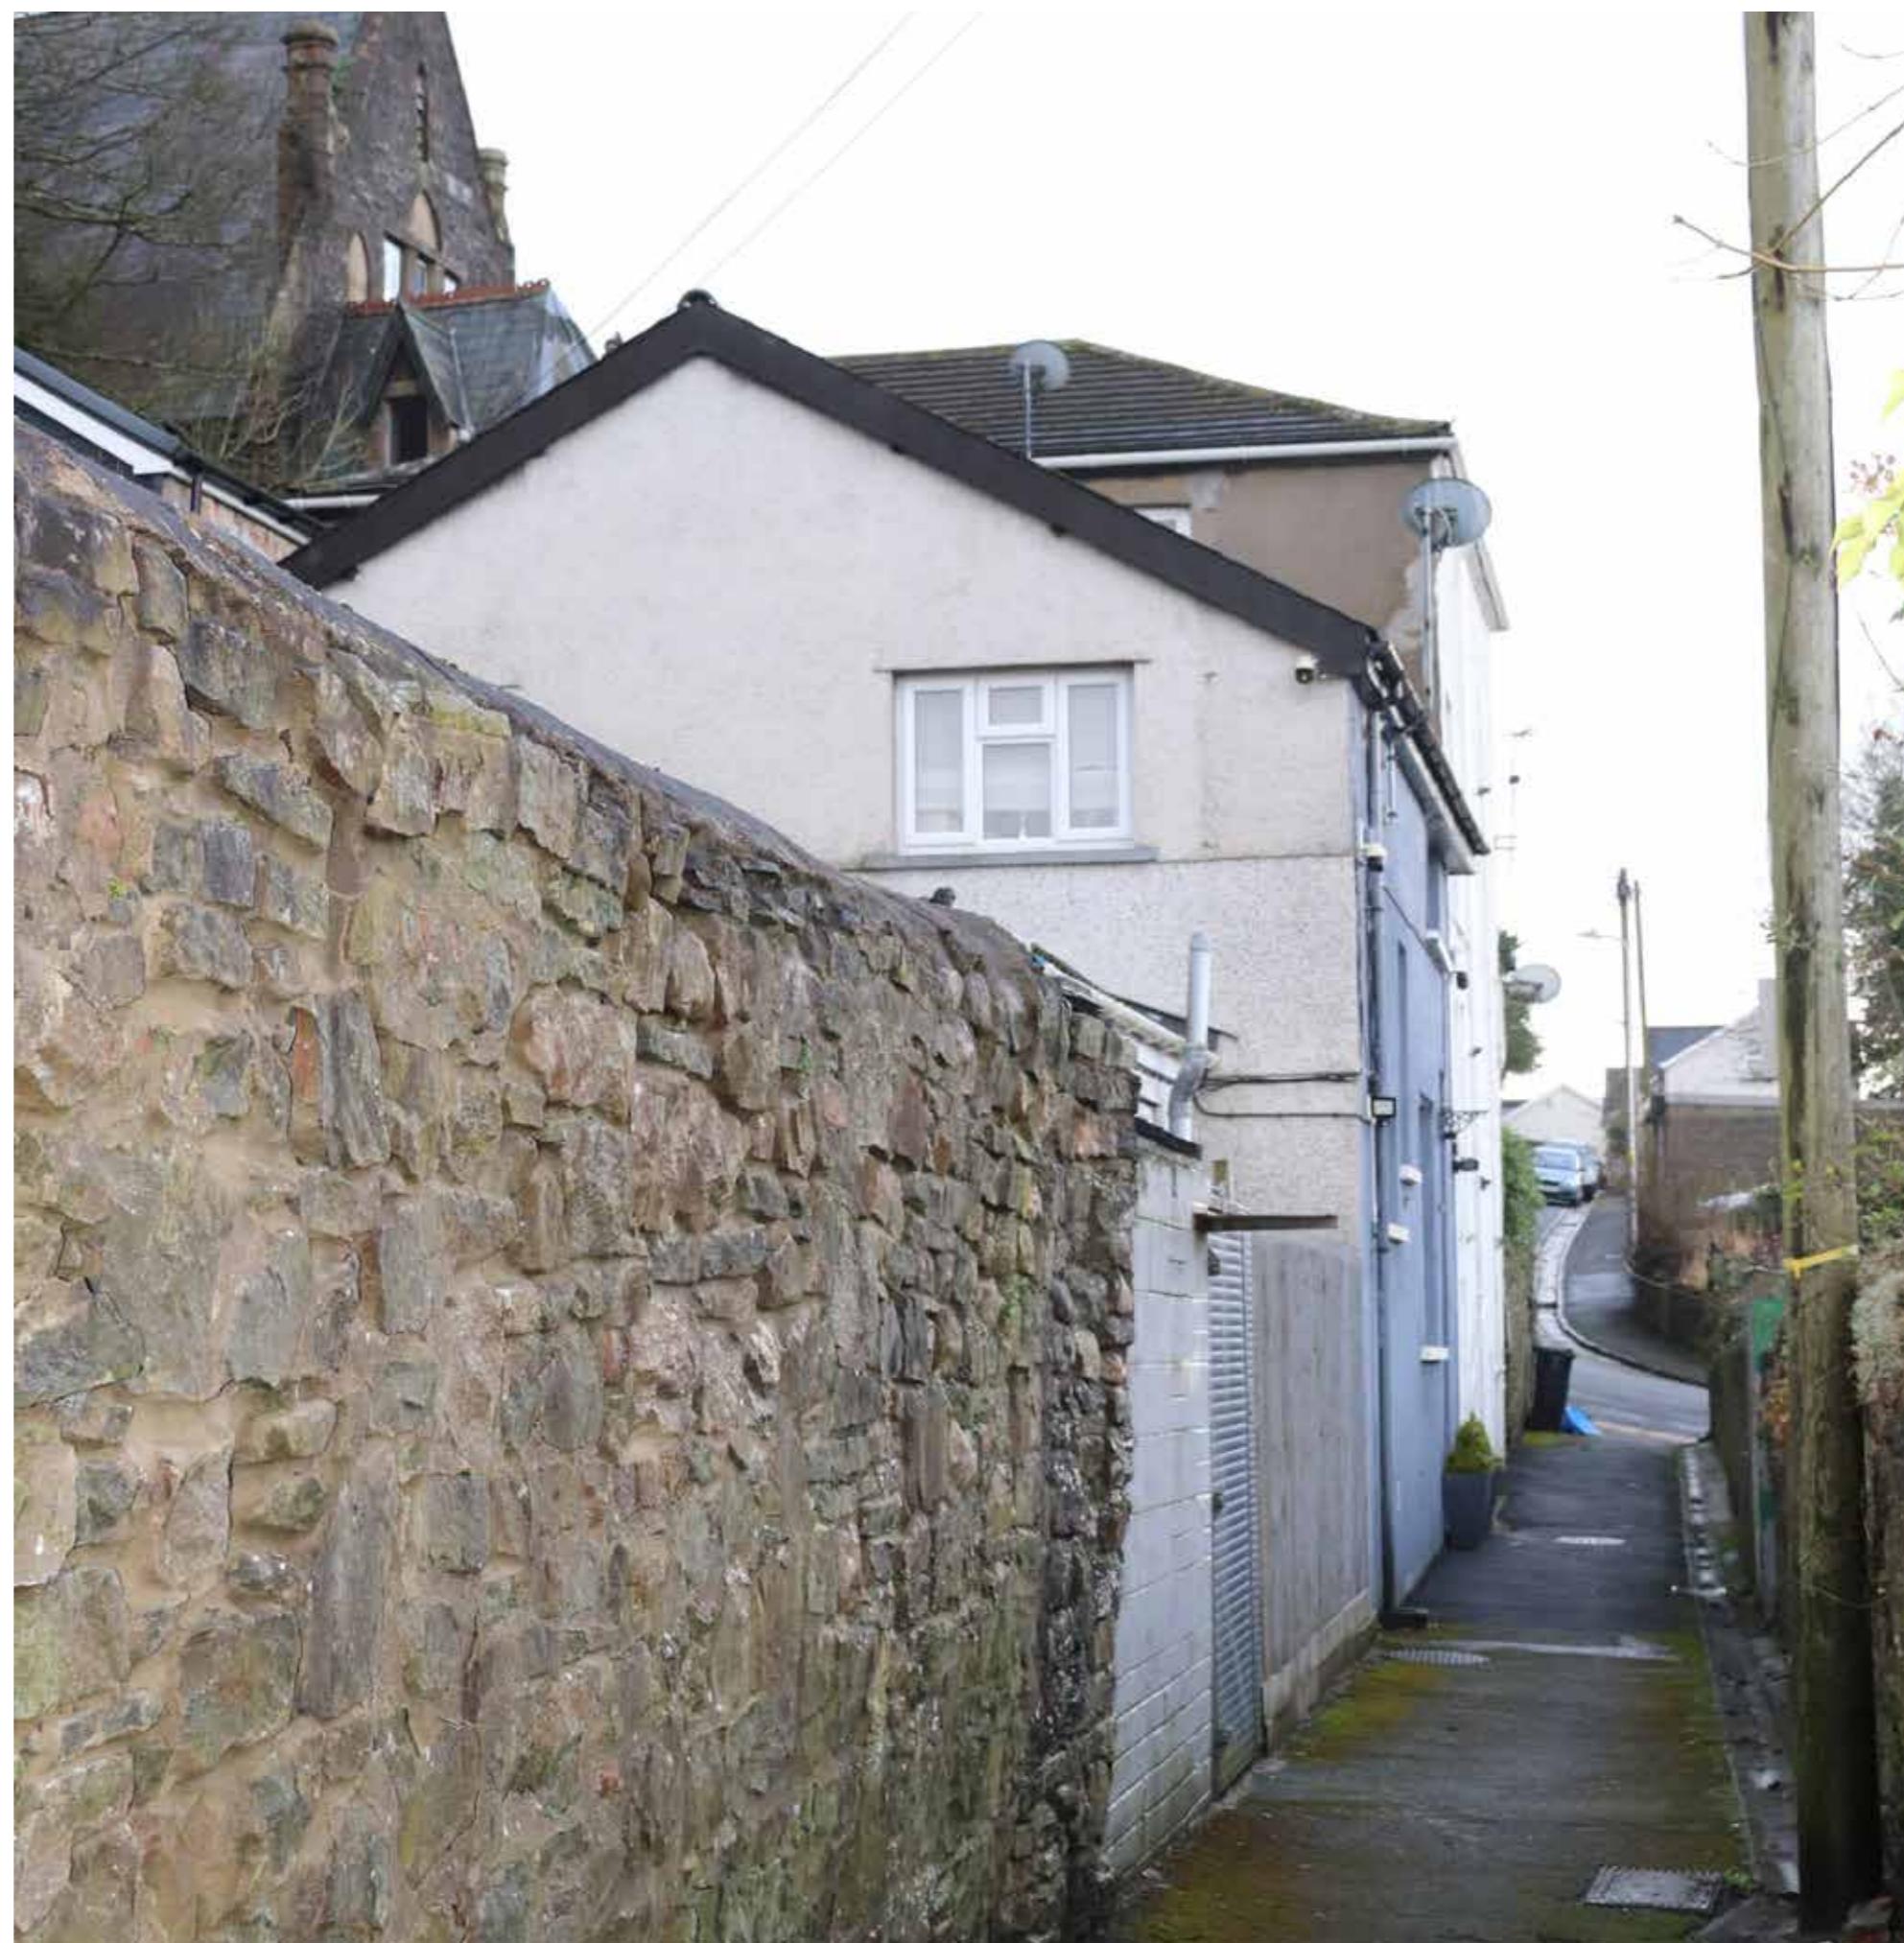
The majority of the north external wall is not internal, apart from the top section. The view of the top section of this rear elevation is so limited that no assessment can be made on it. The one thing that is apparent is that there has been some patch repair work undertaken to the render.

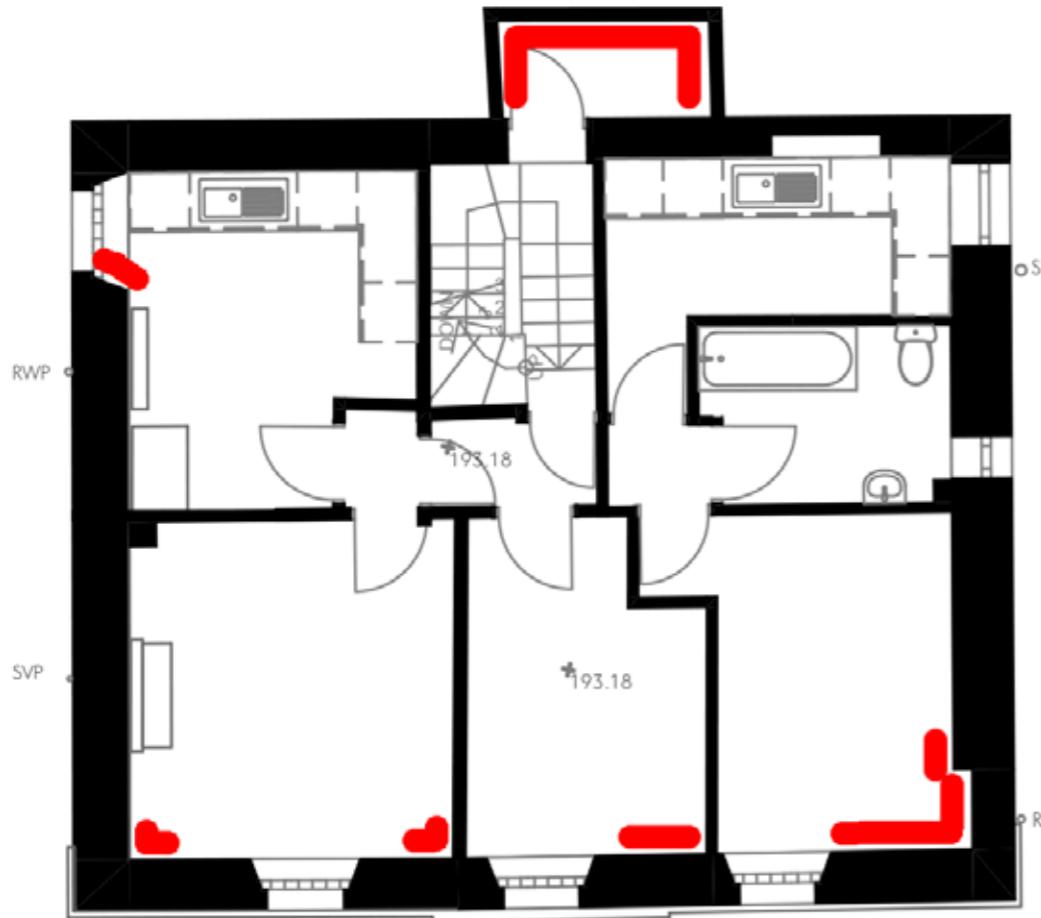
First Floor

Insofar as it might help determine where likely damp ingress issues are, on this page, in red on the plan below, we identify where damp is clearly apparent on the internal face of the external walls.

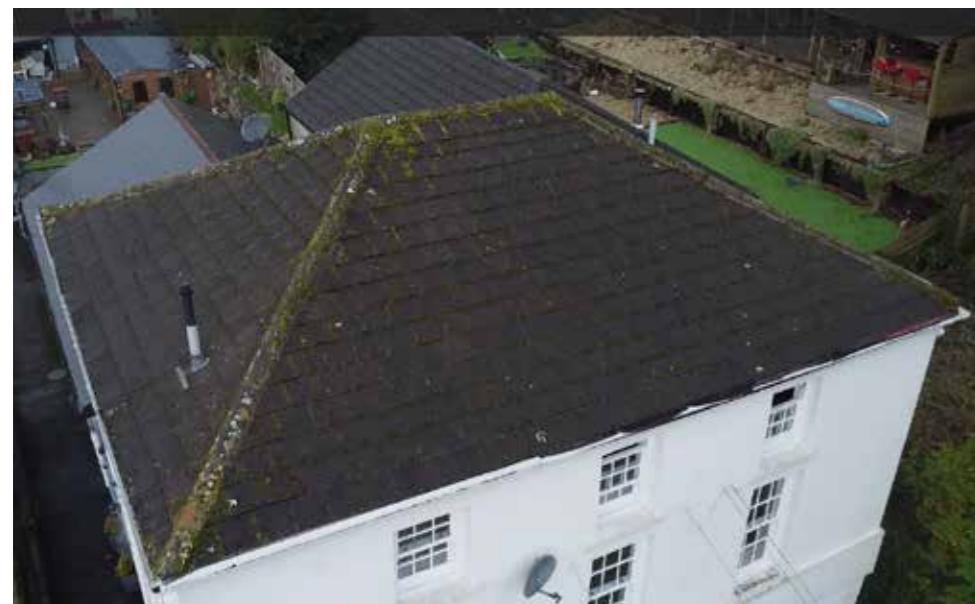
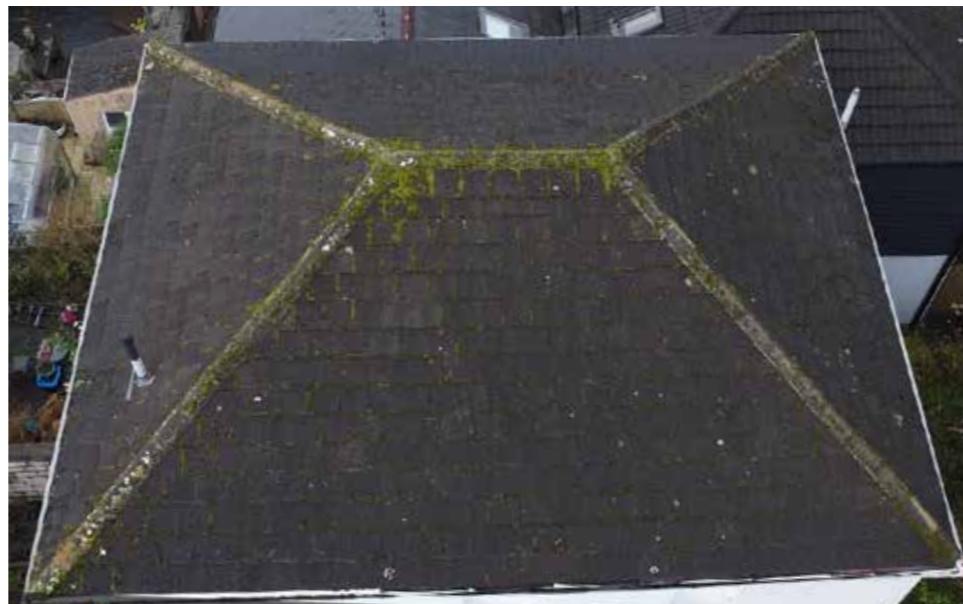
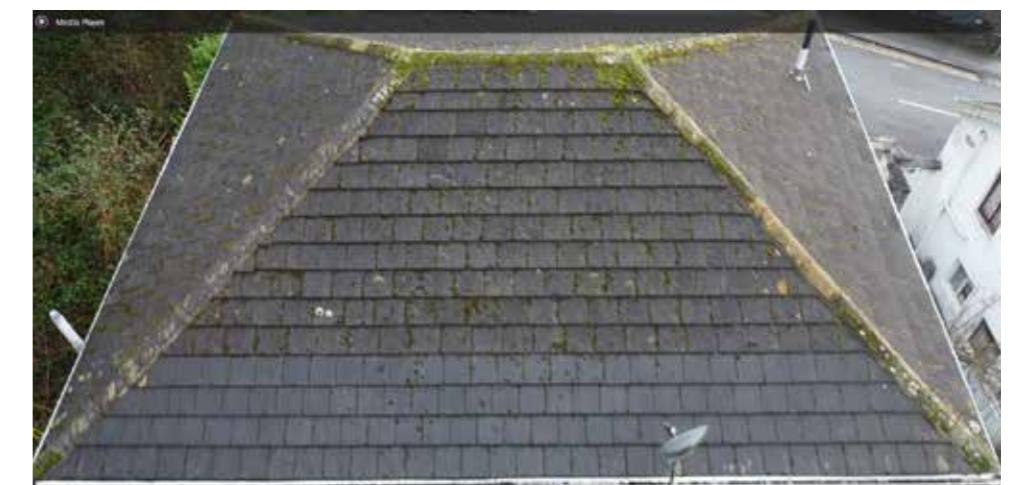
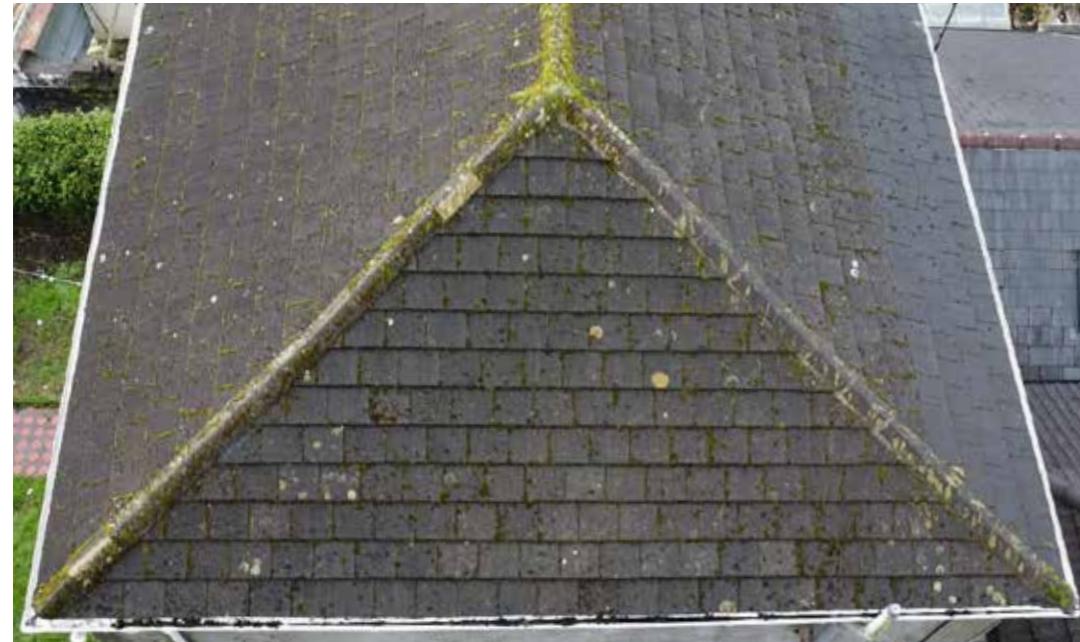
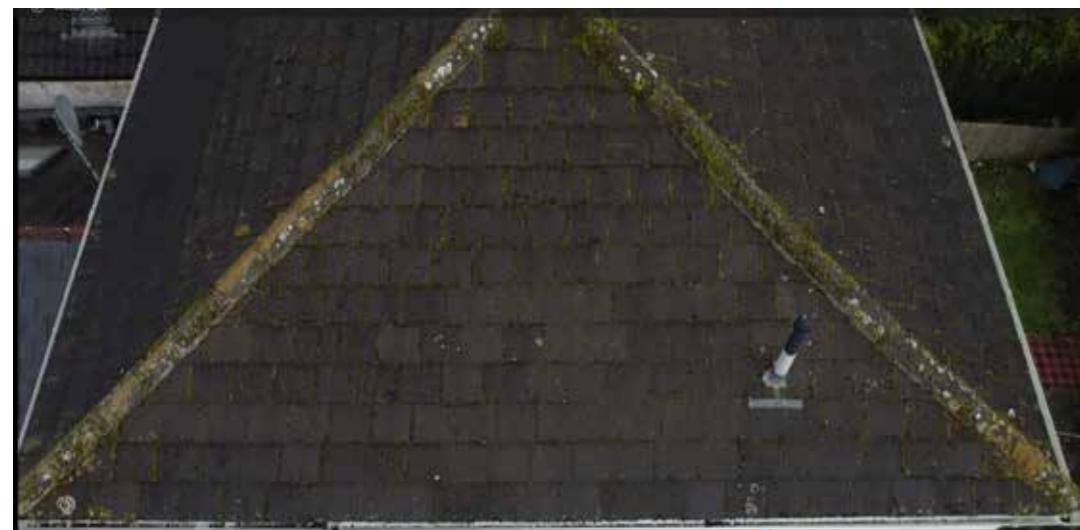
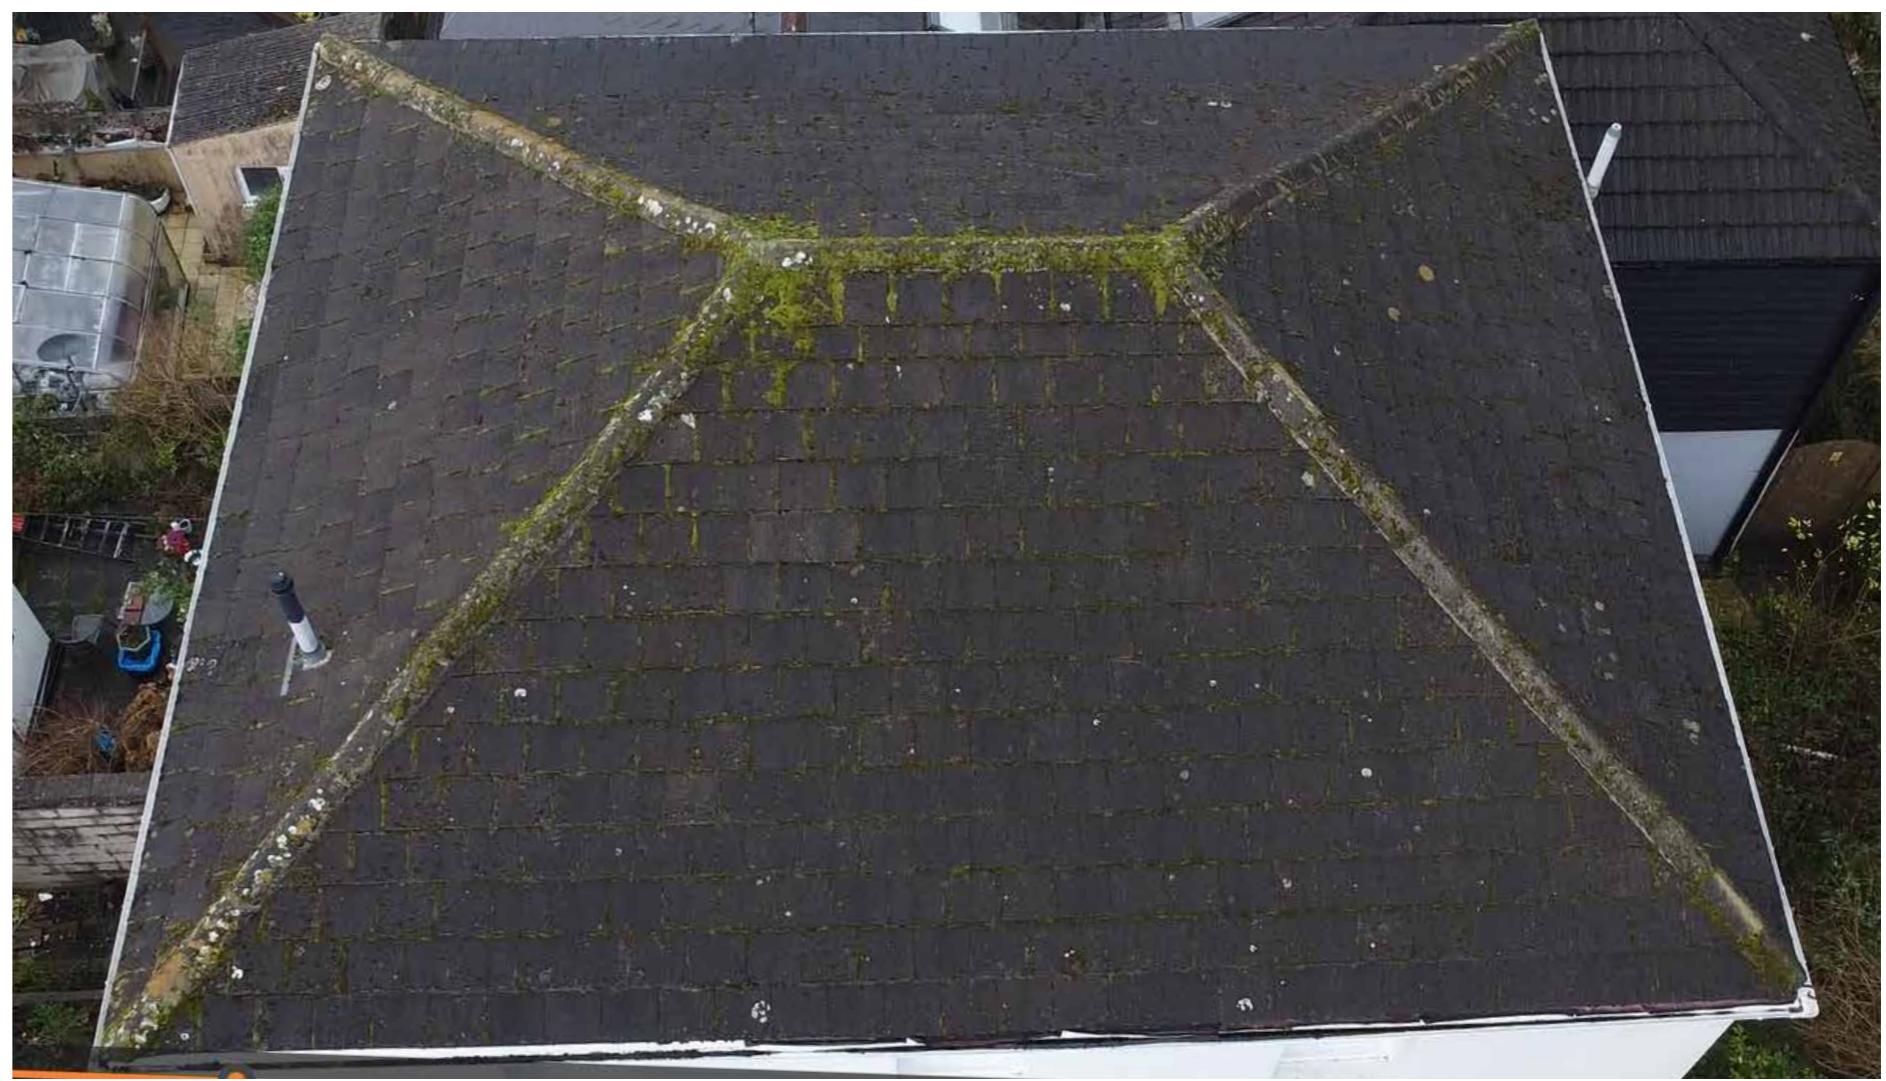
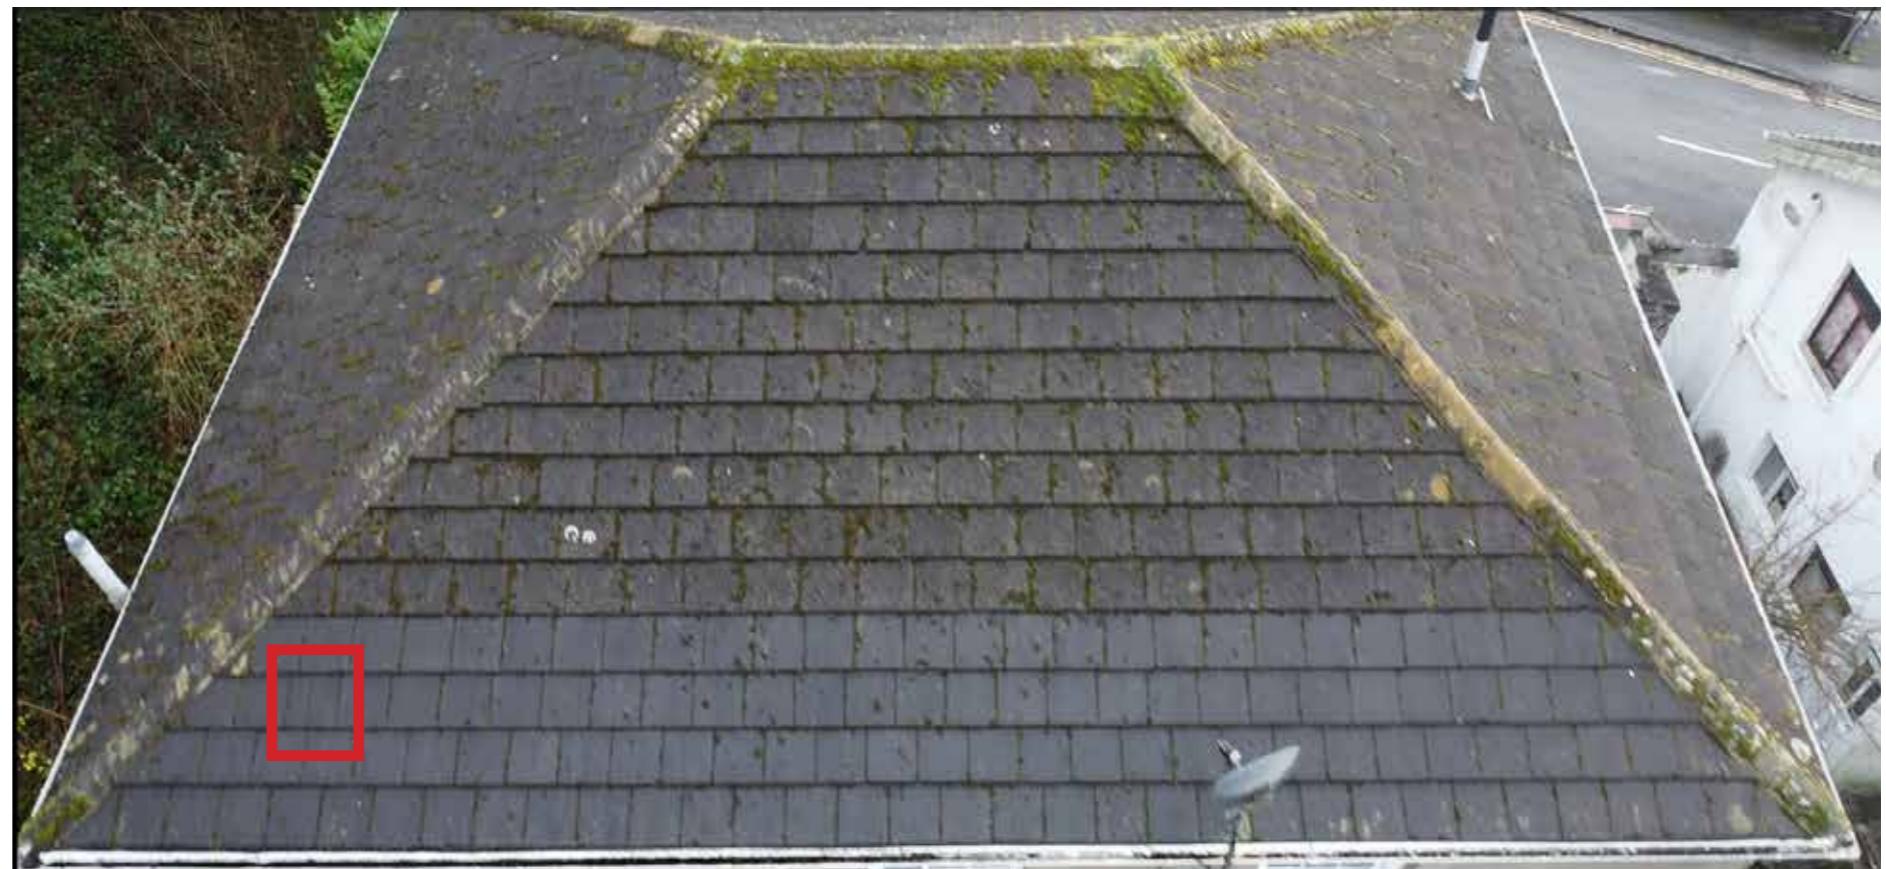
The roof is a simple rectangular hipped roof, covered in concrete tiles and rounded concrete ridge and hip tiles. The surface of the tiles is heavily mossed on the ridge and some hips. However, there do not appear to be any lost tiles, nor slipped tiles, and only a small number of broken tiles. In this regard, the roof covering appears to be in a reasonable condition. The roof would benefit from a clean of all the moss, and the edges of the roofing membrane cut back; but no significant work is suggested to the roof covering.

It is noticeable that there are no chimneys penetrating the roof. With several fireplaces inside, there would have been at least two chimneys, possible four, penetrating the roof. These have all been removed. It does not appear as though the tops of these flues have been vented since the chimneys were removed, which is a worrying sign. It is recommended that a vent is added into the external wall at each floor, to ventilate the flue.

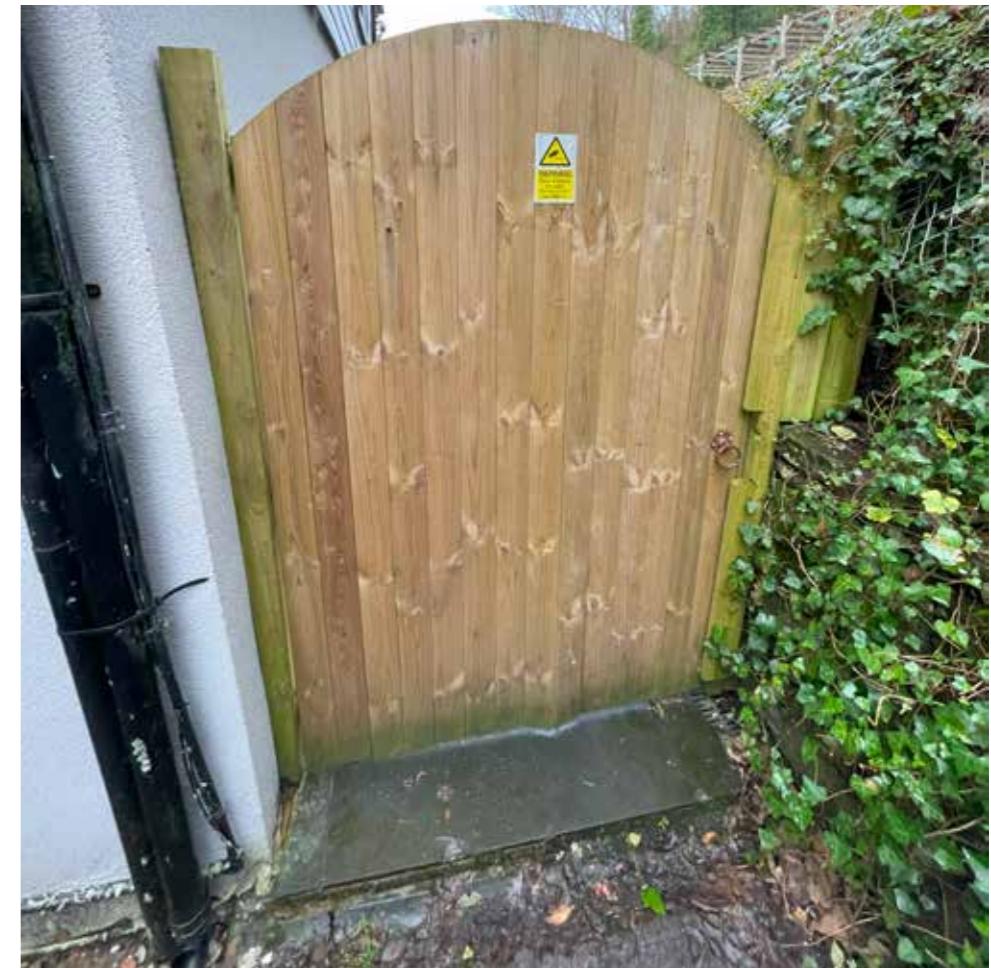
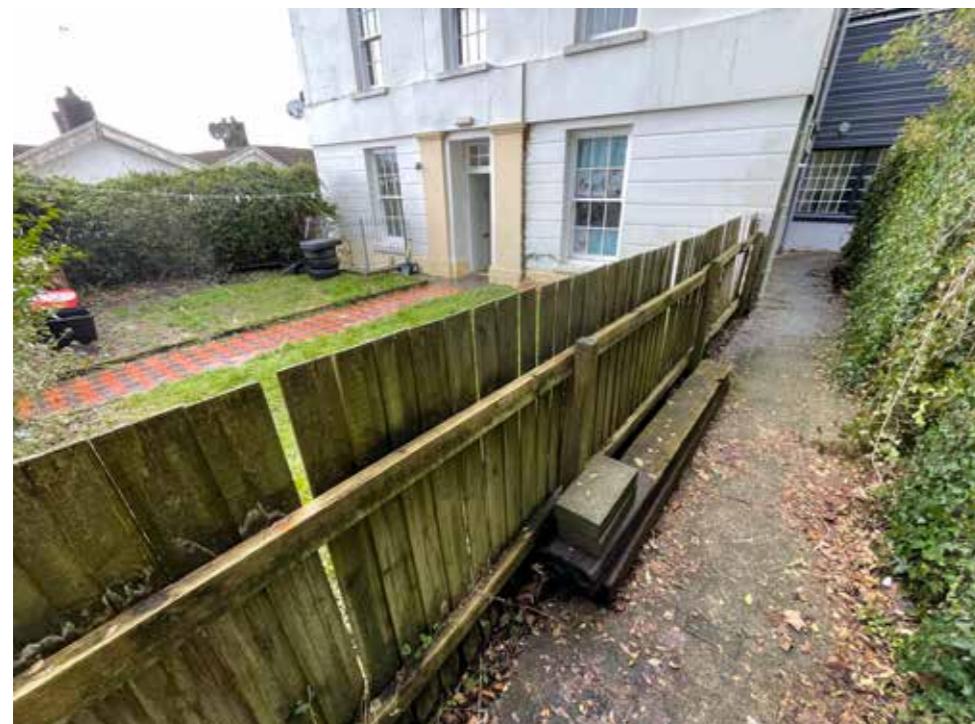
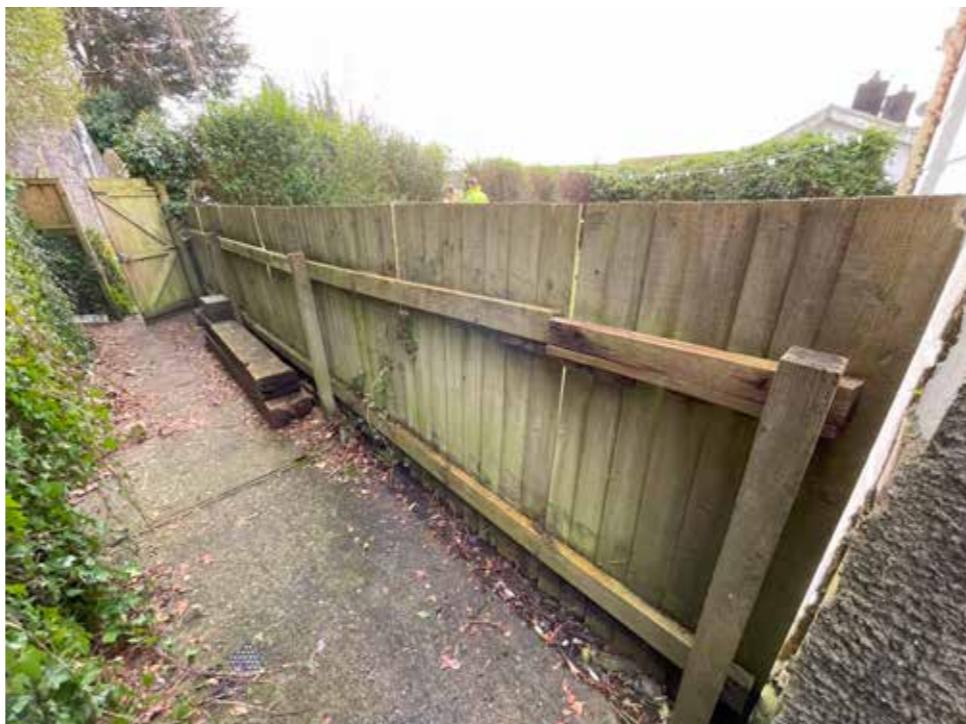
The side path has a concrete surface which appears to be in a reasonable condition.

There is a timber boarded fence between the path and the front garden to Primrose Hill.

This path constitutes a 'Right of Way' to the property behind and to the north of Primrose Hill, which is accessed via a timber boarded gate - see top right photo.

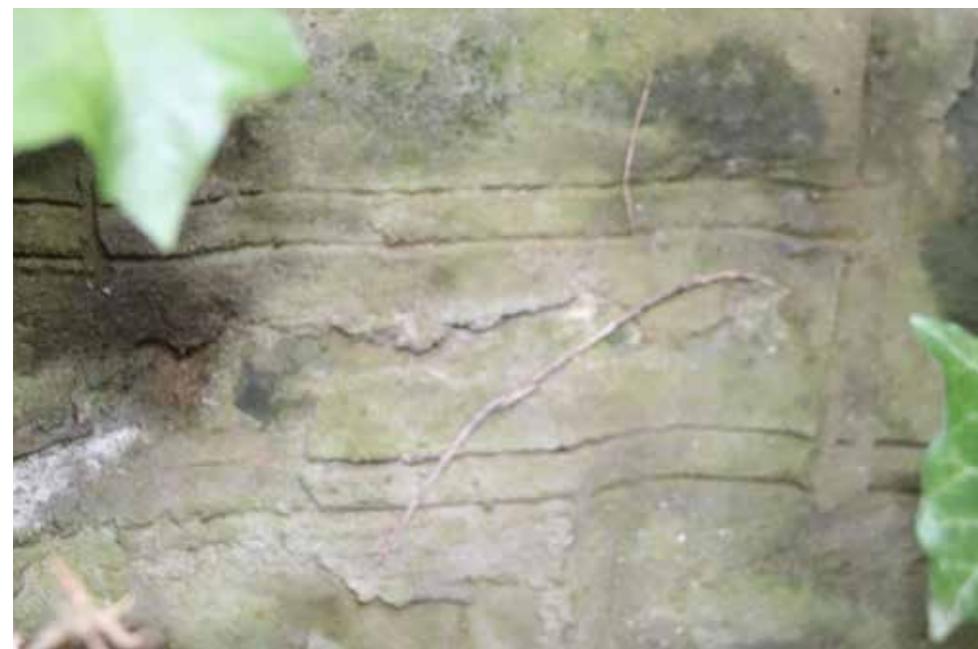
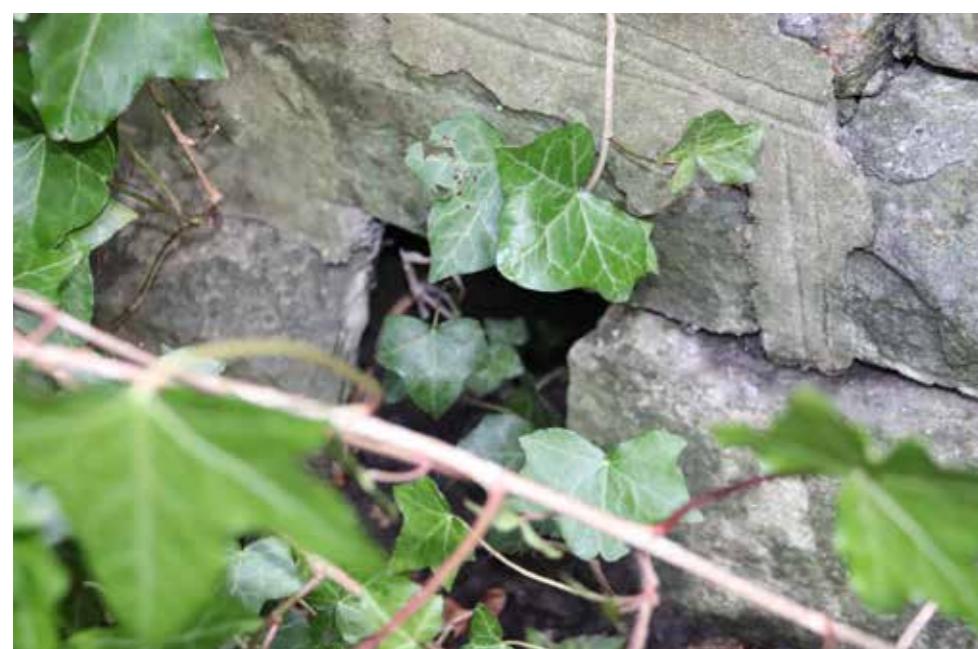
8.2 Retaining Wall

Covered by ivy and other vegetation, to the side of the path, east of Primrose Hill, is a retaining wall, approximately 3m high, made of rubble stonework. It is assumed that the stones are bedded on a lime mortar (albeit not confirmed) and that it used to be pointed in a lime mortar; however, it is apparent that the wall has more recently been pointed in a cementitious mortar, using a buttering / part rendering which has covered much of the stonework. The wall is covered in vegetation, to face and top, and so the wall could barely be inspected; however, there is concern about the use of cement for the pointing and for the restriction this will have put to the passage of moisture through the wall.

A 'makeshift' drainage hole was apparent at the base in one location; however, it is not clear whether there is a full drainage provision to this wall. That being said, percolation tests undertaken to the ground above suggests a good level of natural drainage in the ground above this wall.

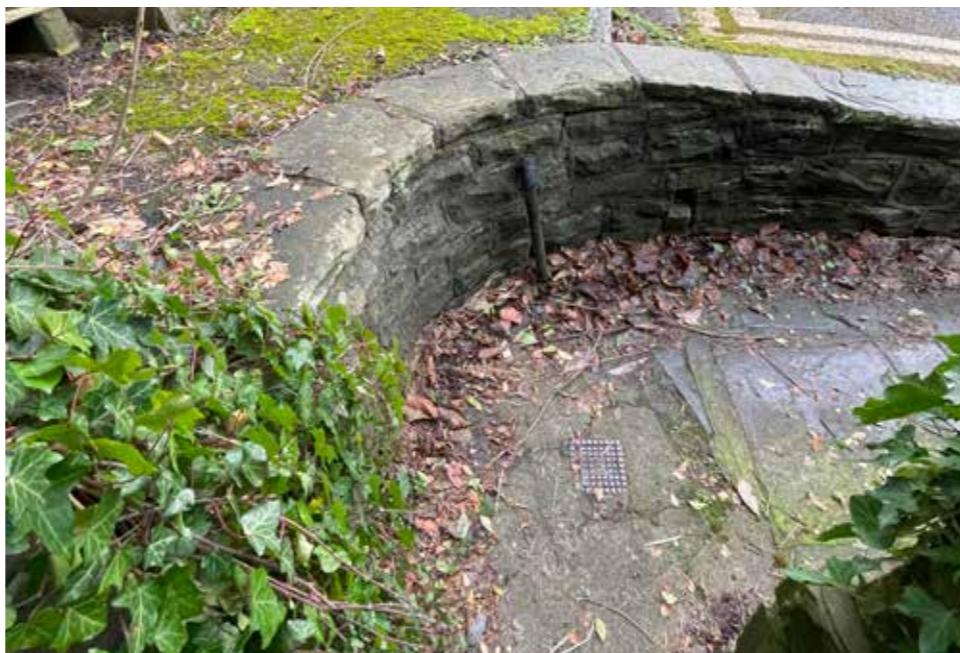
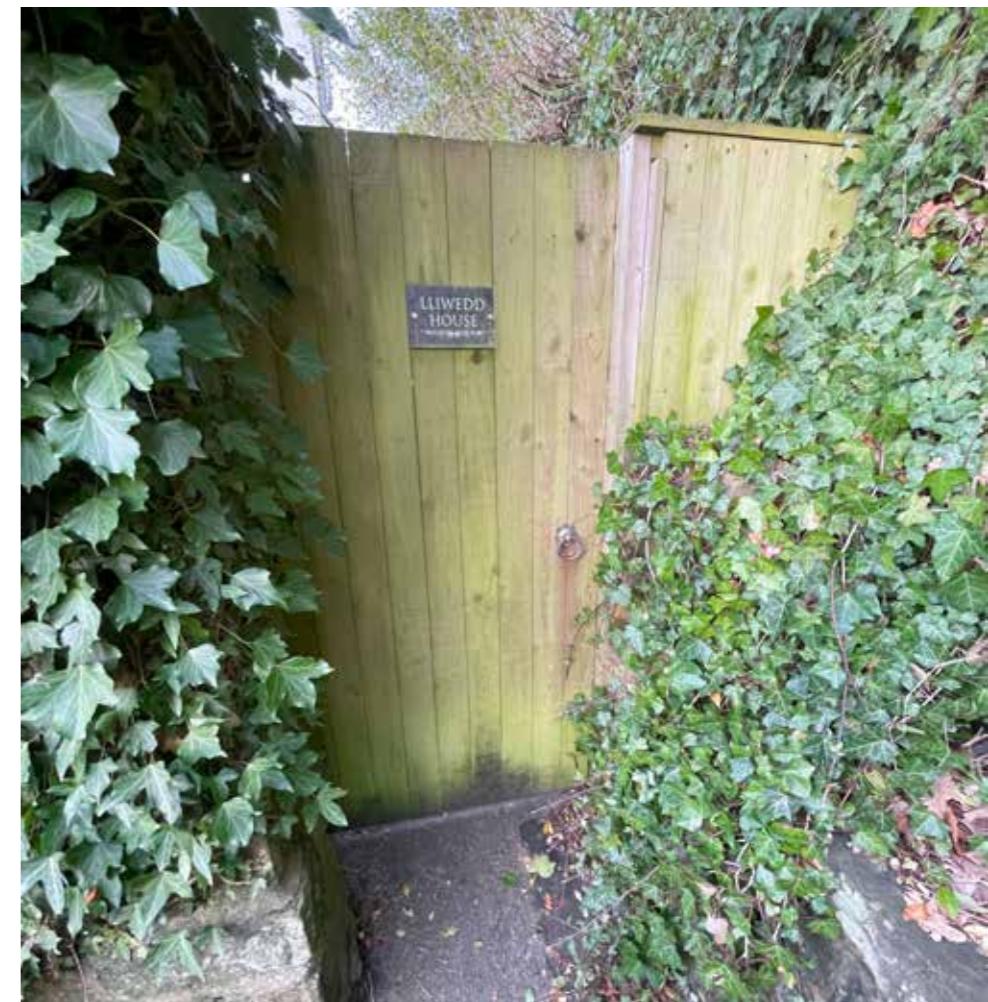
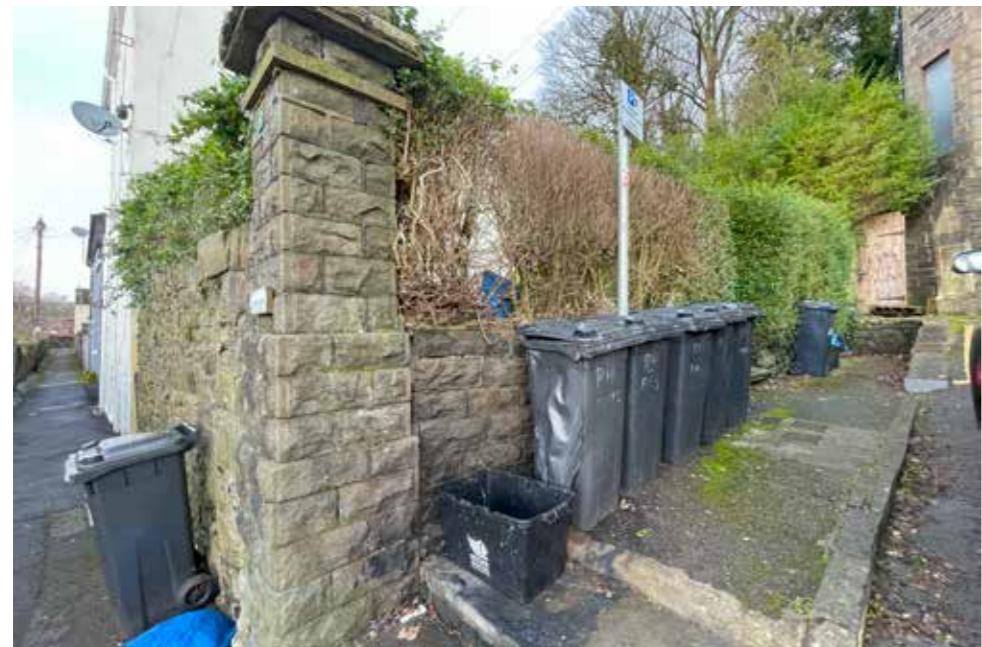
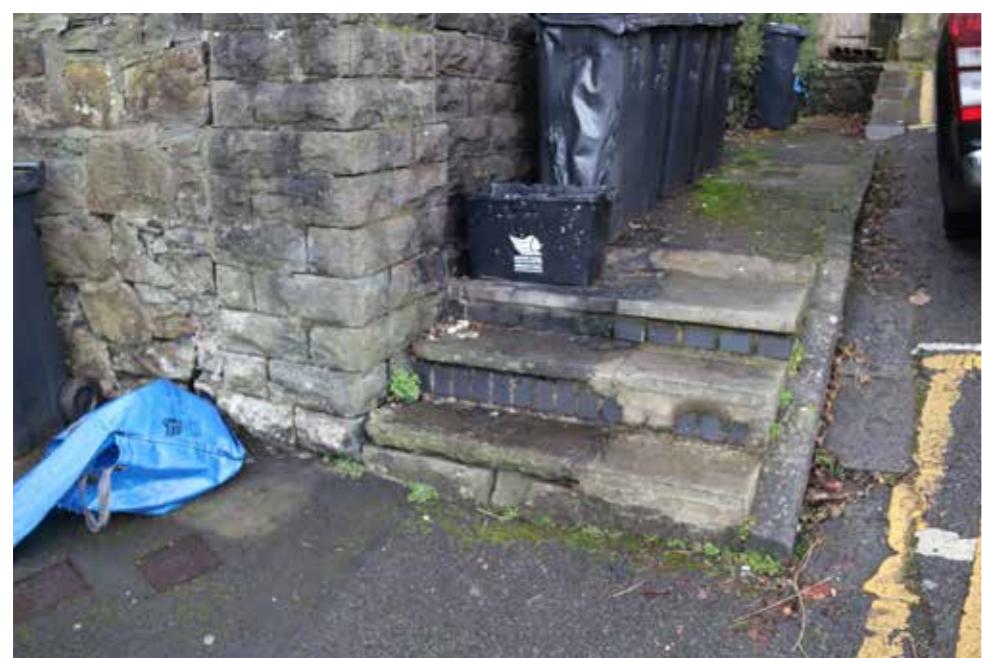
9.1 Front Pavement

Between the tarmac road and the front wall to Primrose Hill's front garden there is a row of coping stones and then a drop to an area of stone flag paving. The tarmac is sloped, whilst the flagging is level, with the stone-capped wall acting as a retaining wall for the sloped road. The retaining wall then curves around at the top, leading towards the Right of Way path. At the bottom of the path is a set of three stone steps faced on the risers in blue-black engineering brick.
