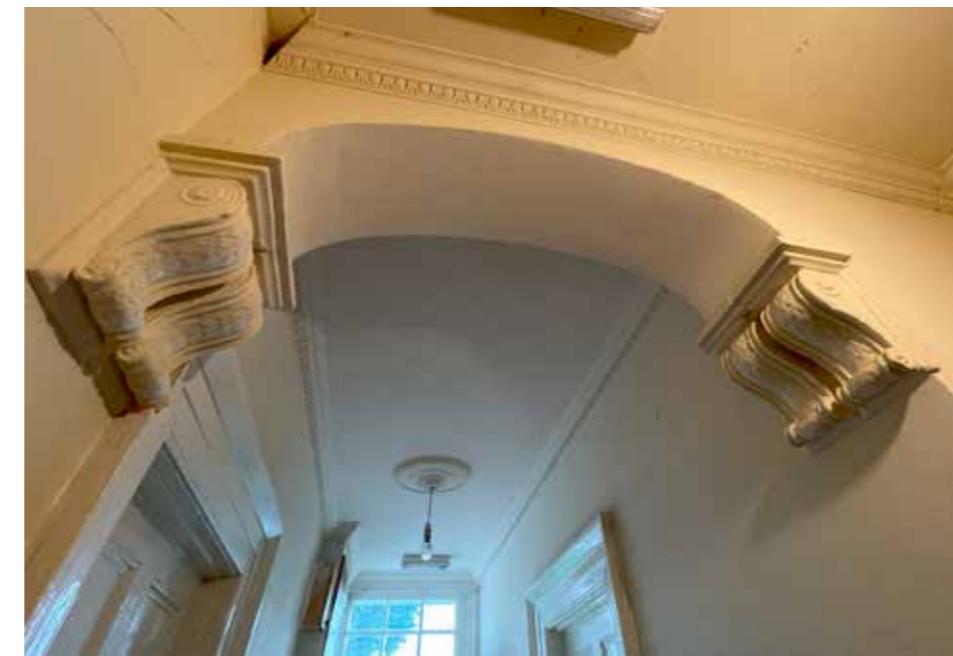
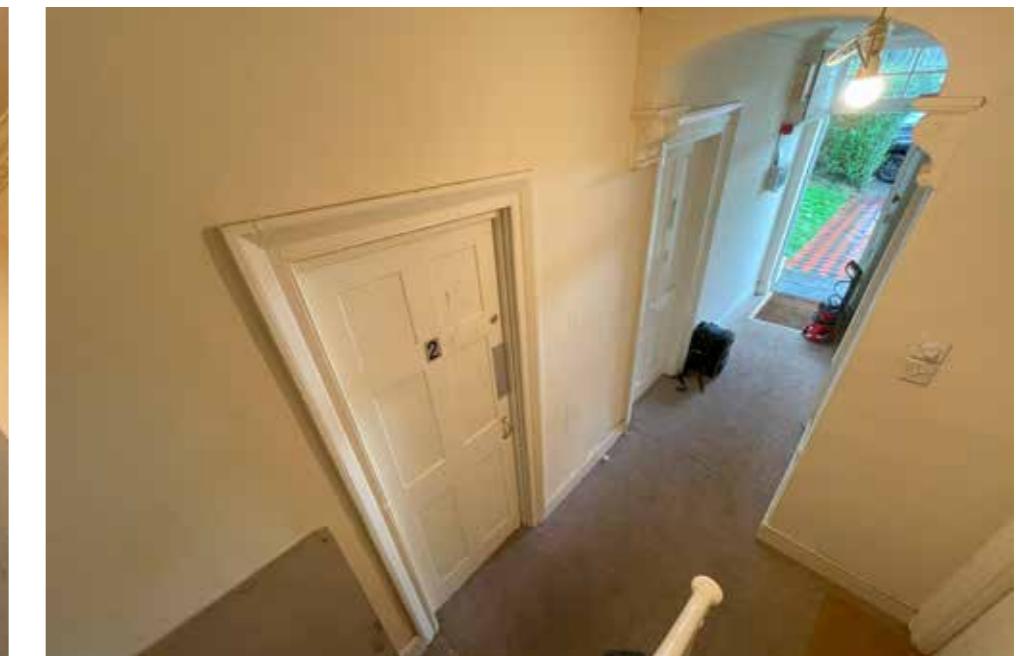
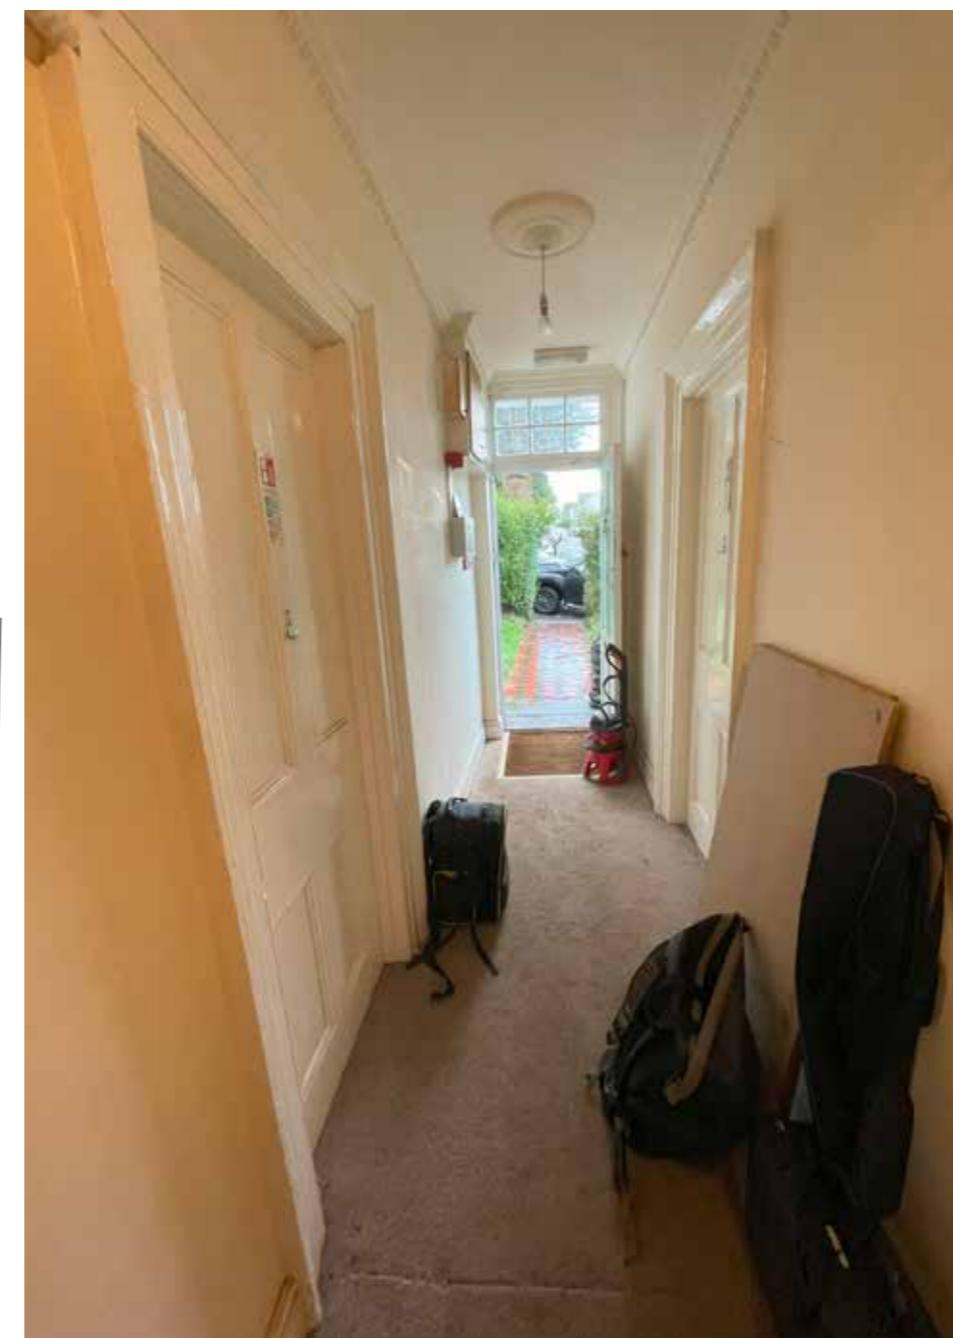
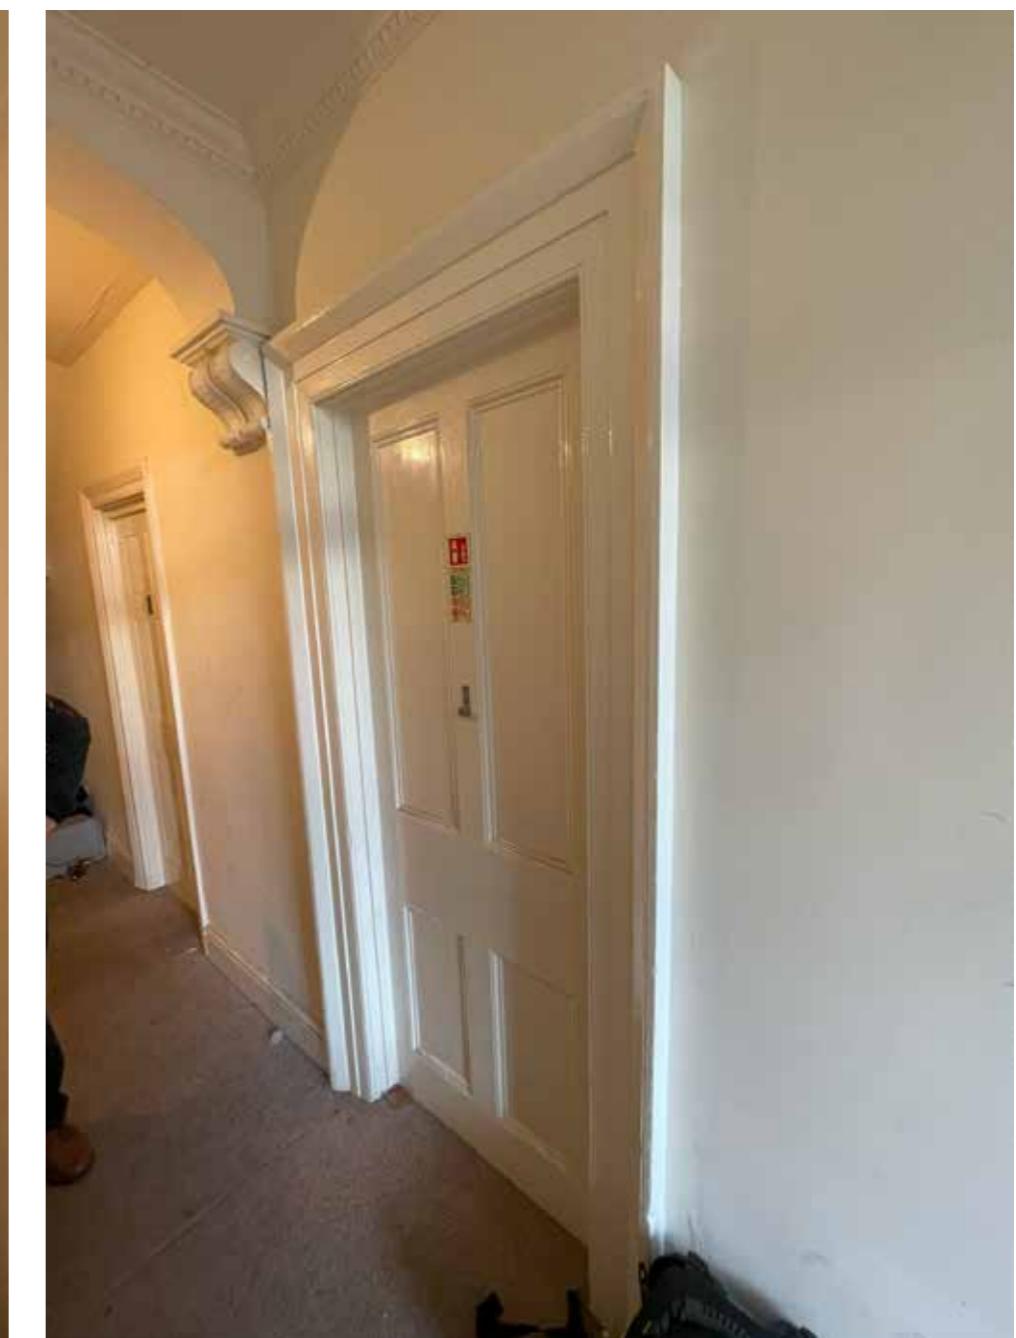
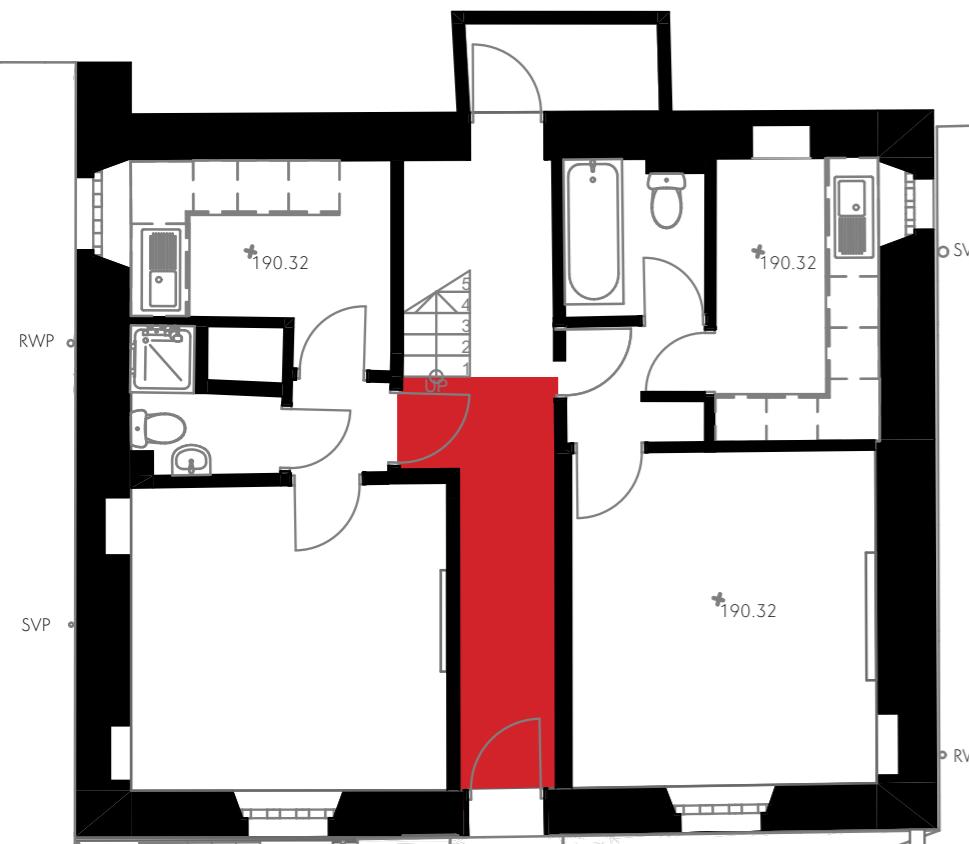
10.0 Interior - Ground Floor - Entrance Lobby

Where the entrance corridor becomes the stair lobby, an interesting arch flies over the junction, springing from twinned swirled corbels. The egg-and-dart cornice continues over the top.

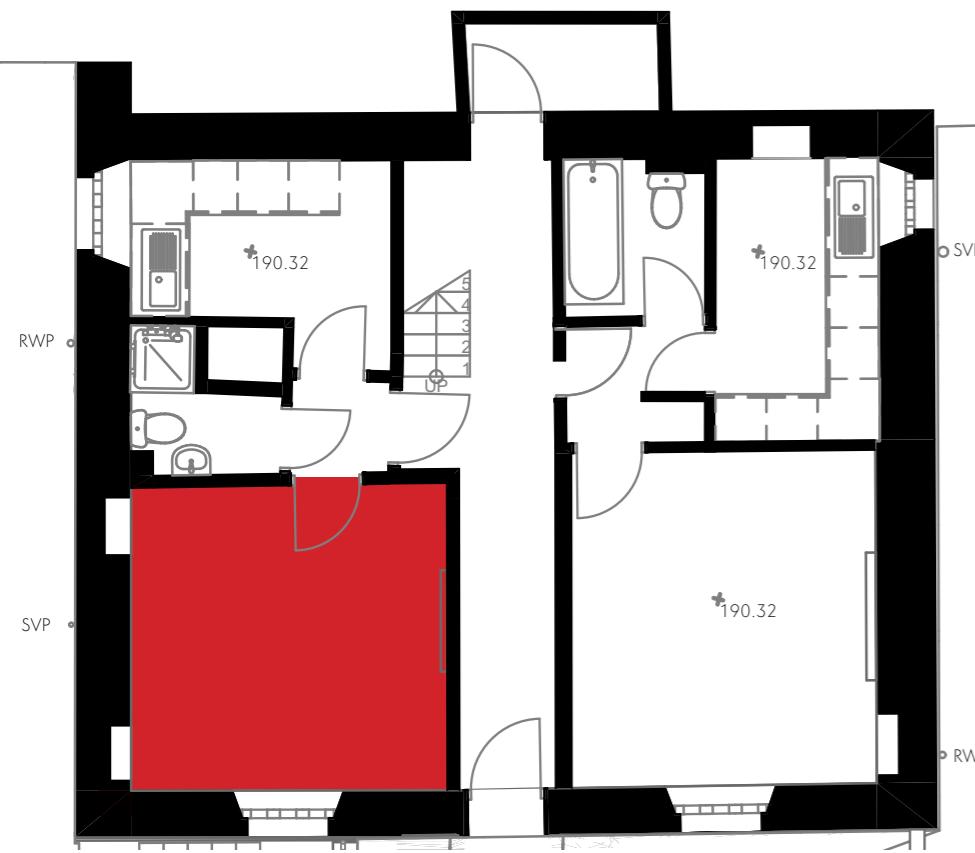
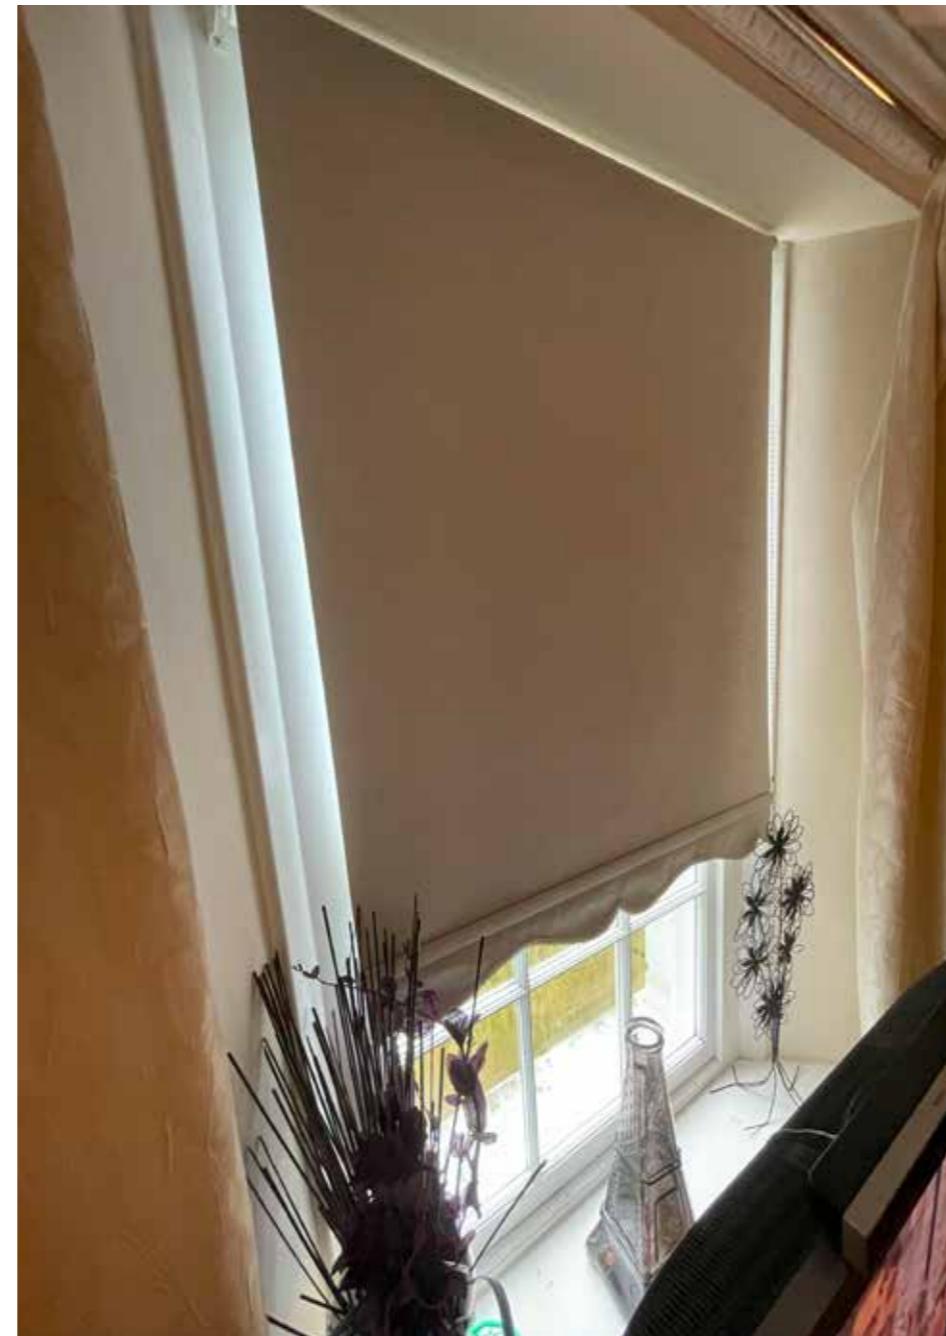
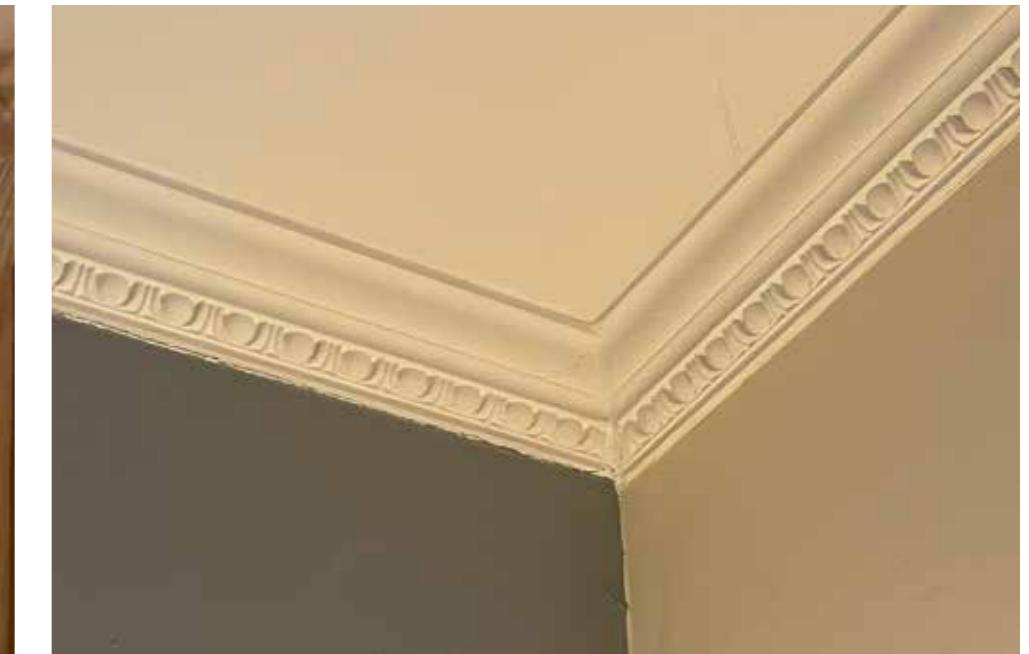
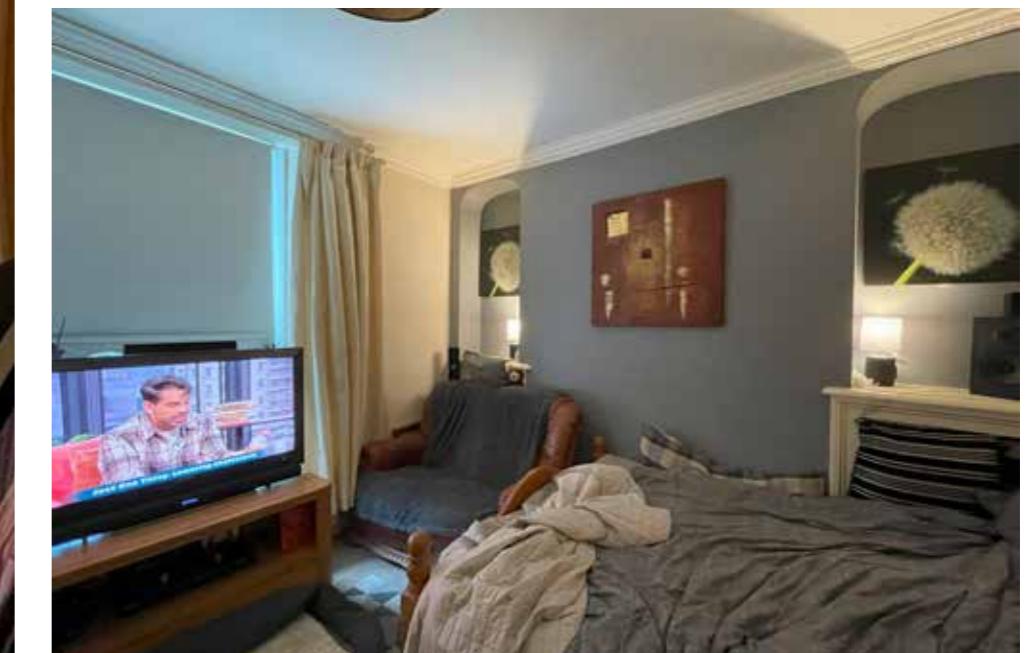
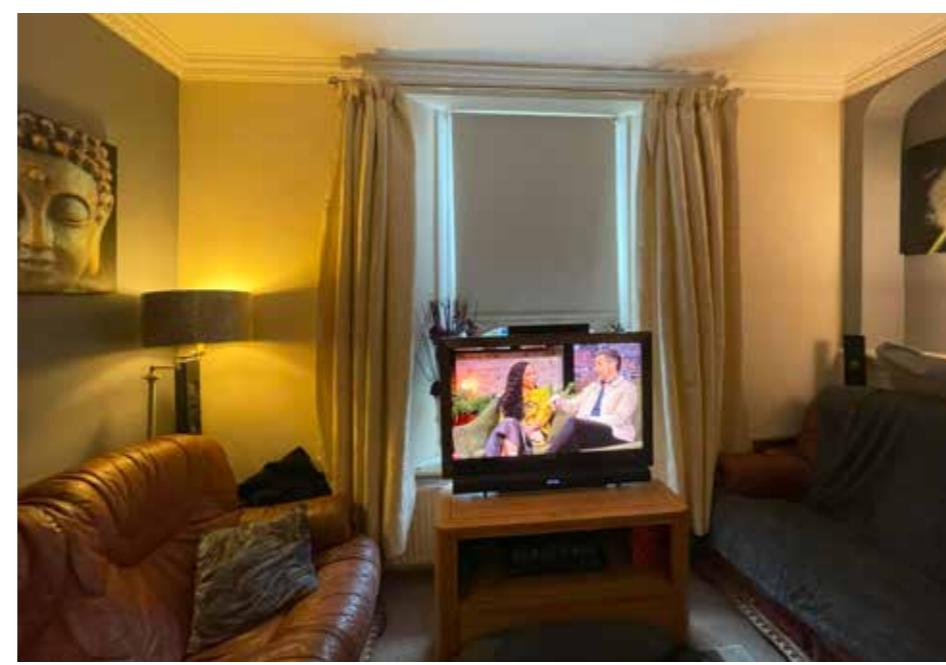
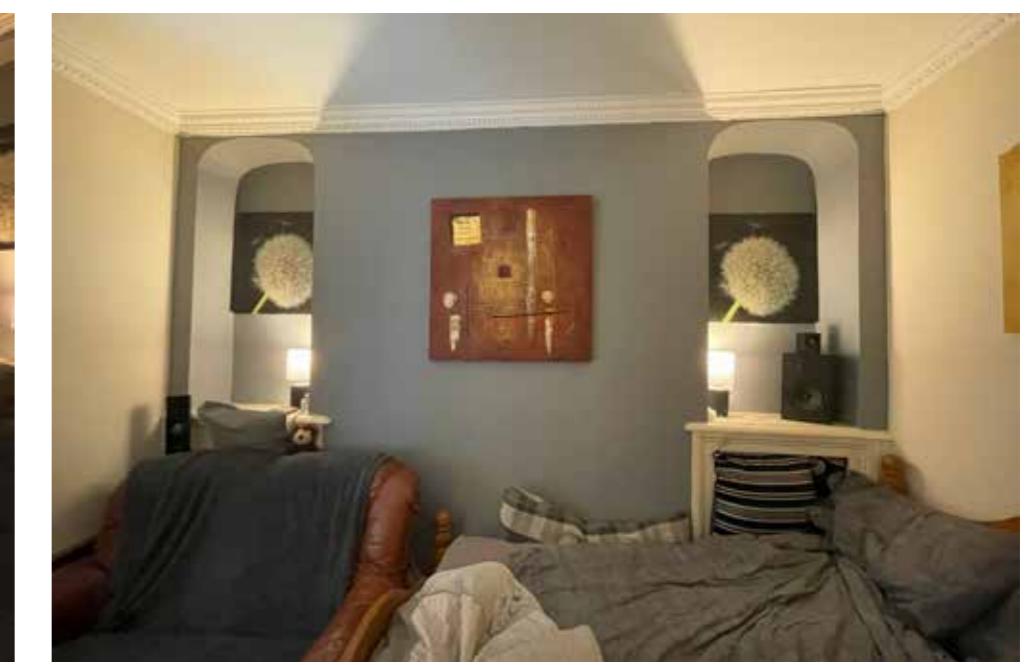
10.0 Interior - Ground Floor - West Flat Front Room

Much as the central entrance lobby, the front room to the West Flat is of painted plastered walls and ceilings with an egg-and-dart cornice and a ceiling rose. The floor is carpeted; the door is a painted four-panelled timber door and the window a painted timber window with double glazing. All appear to be in a good condition.

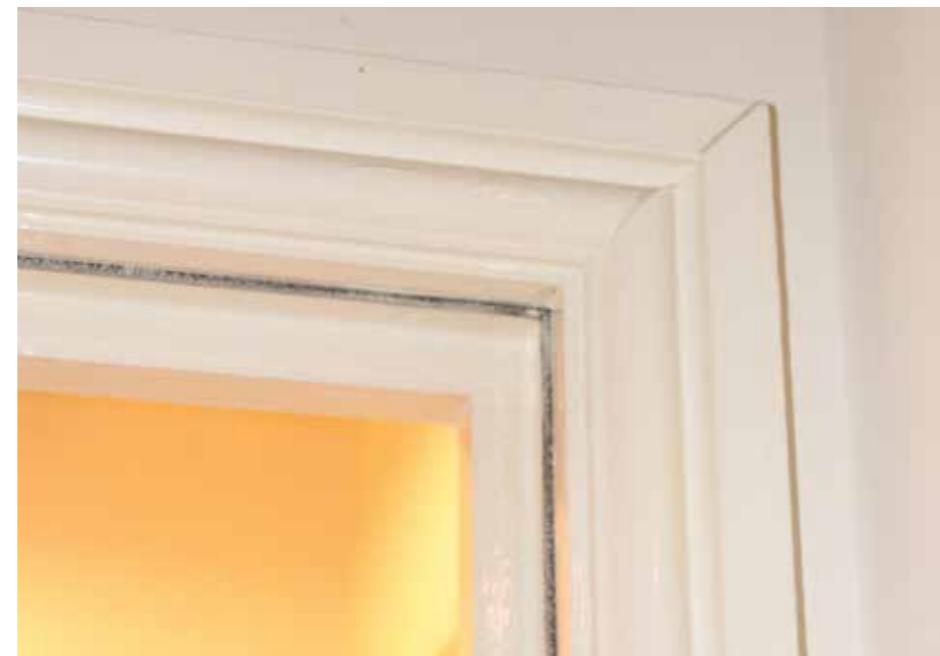
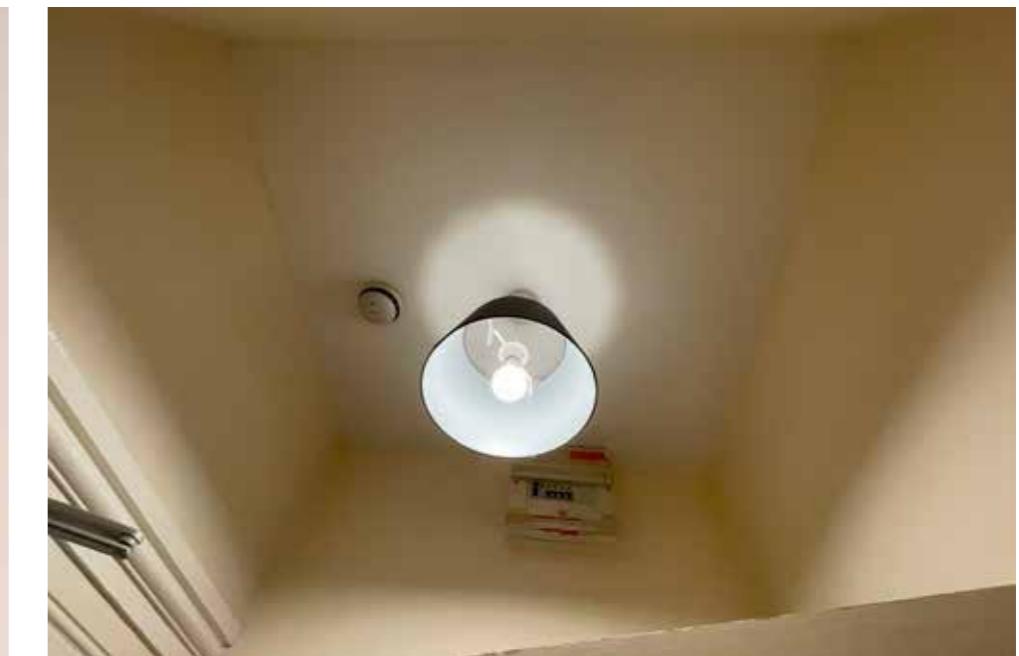
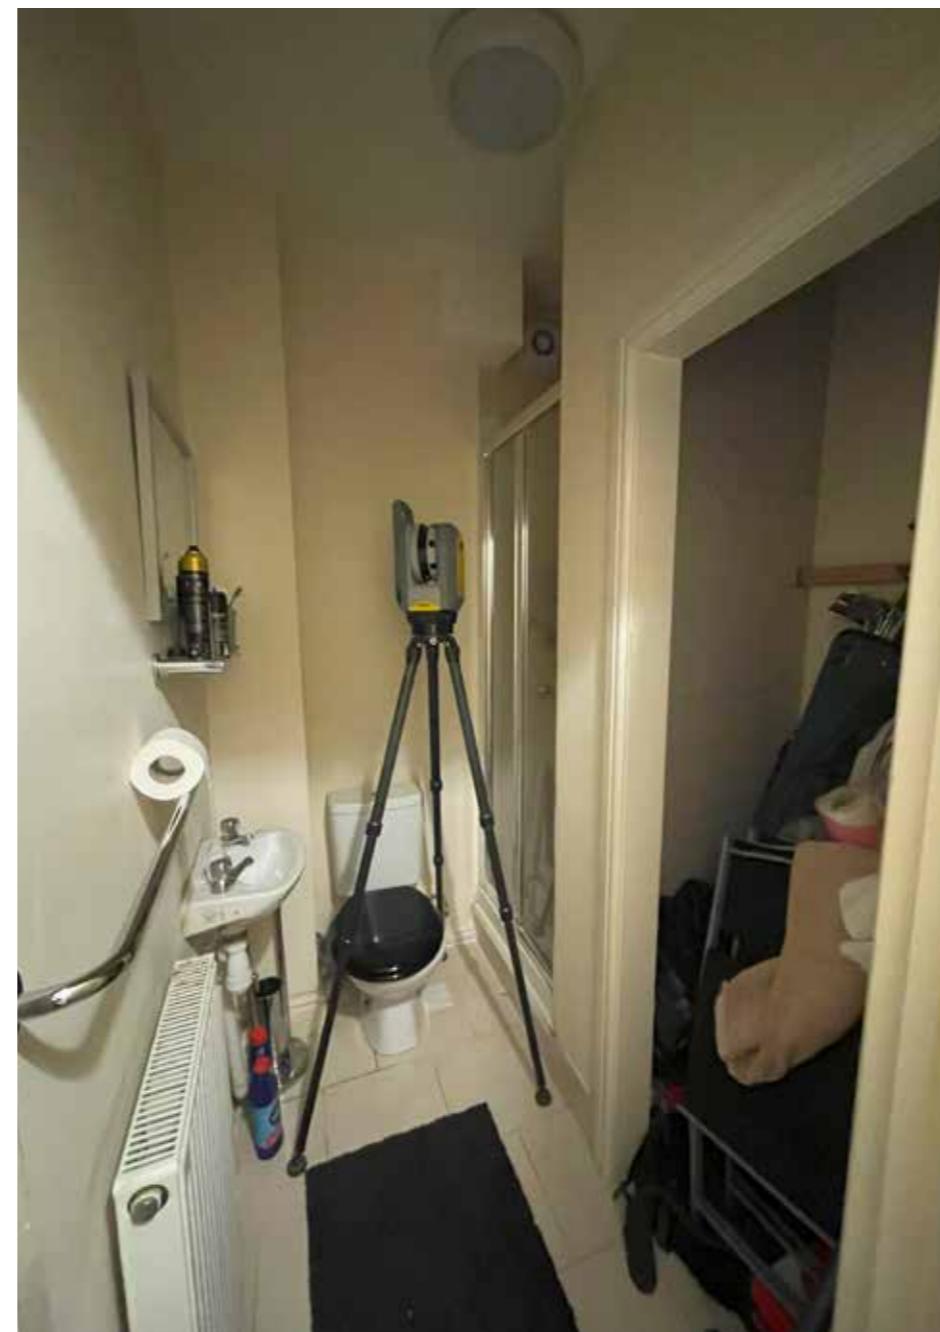
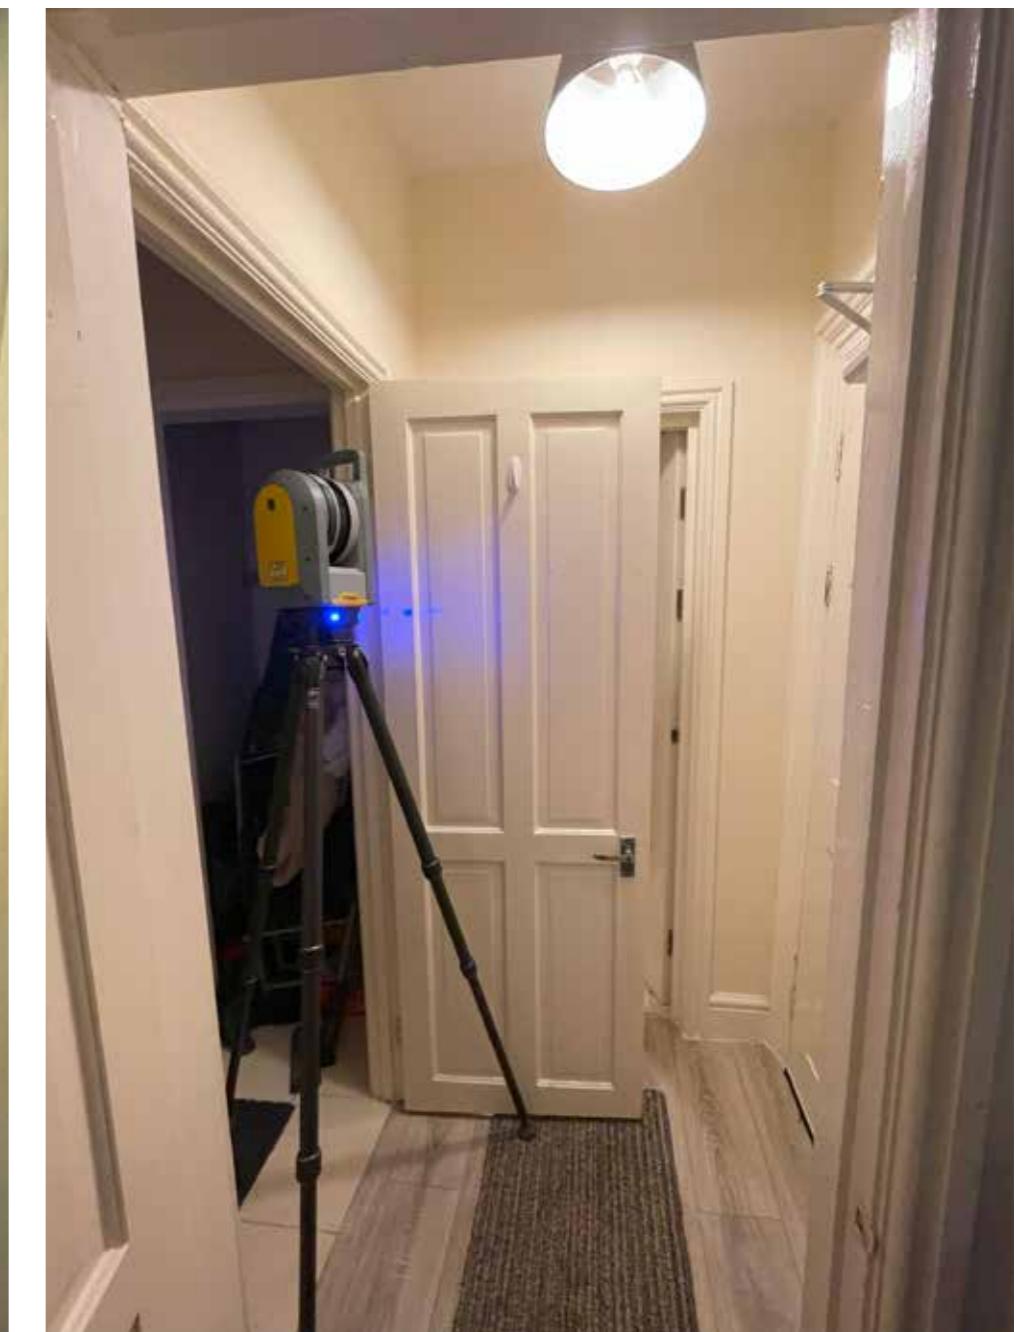
10.0 Interior - Ground Floor - West Flat Bathroom and Lobby

Also with painted plastered walls and ceilings (this time with no cornice), and timber four-panelled painted doors, the floor to the bathroom is of ceramic tiling and, to the lobby, of vinyl. All appears to be in a reasonable condition.

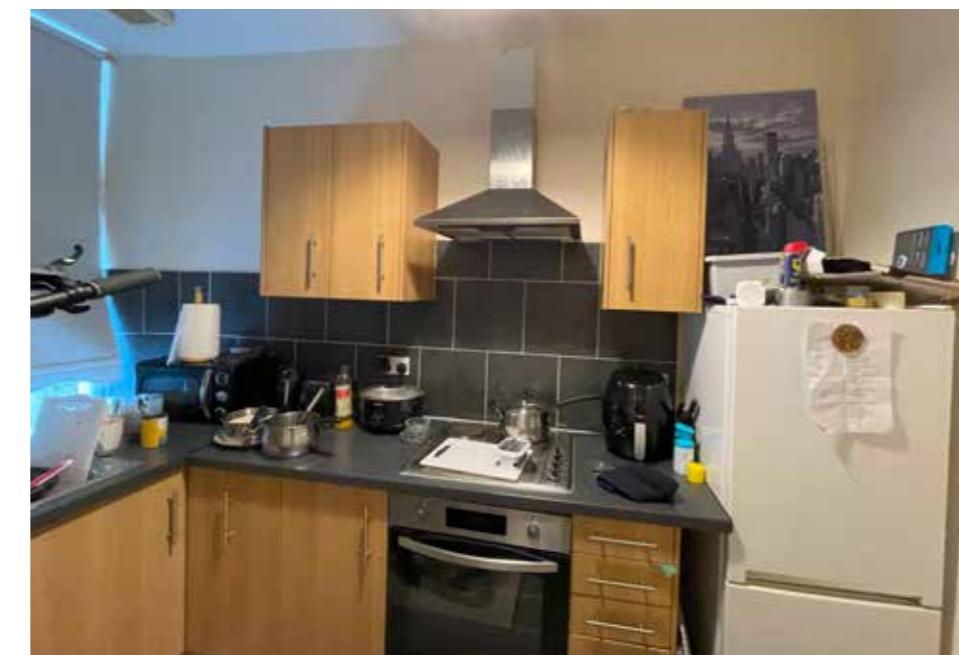
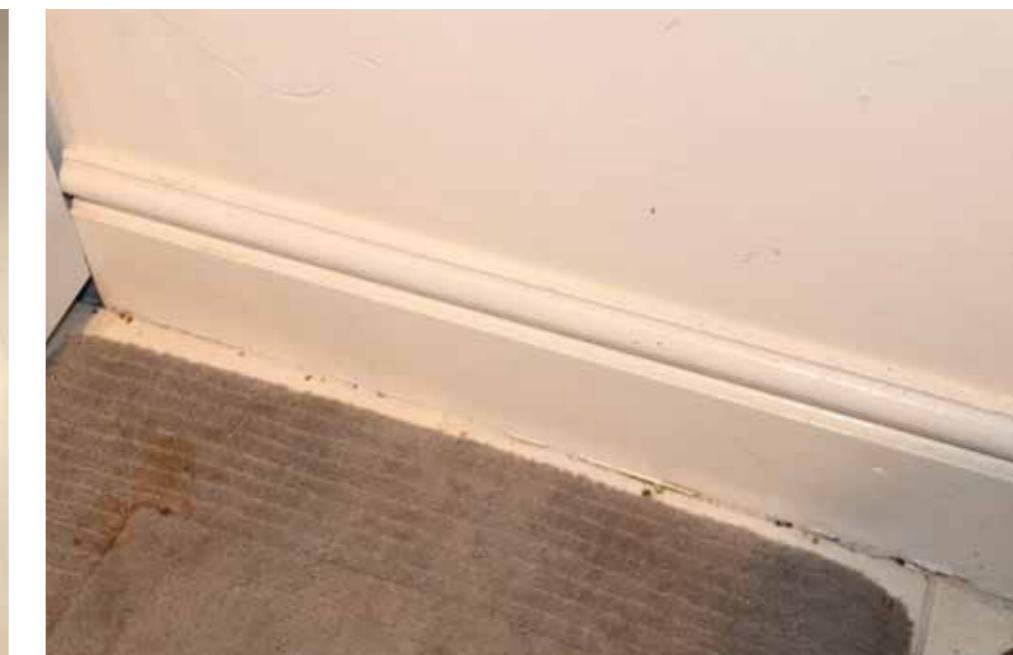
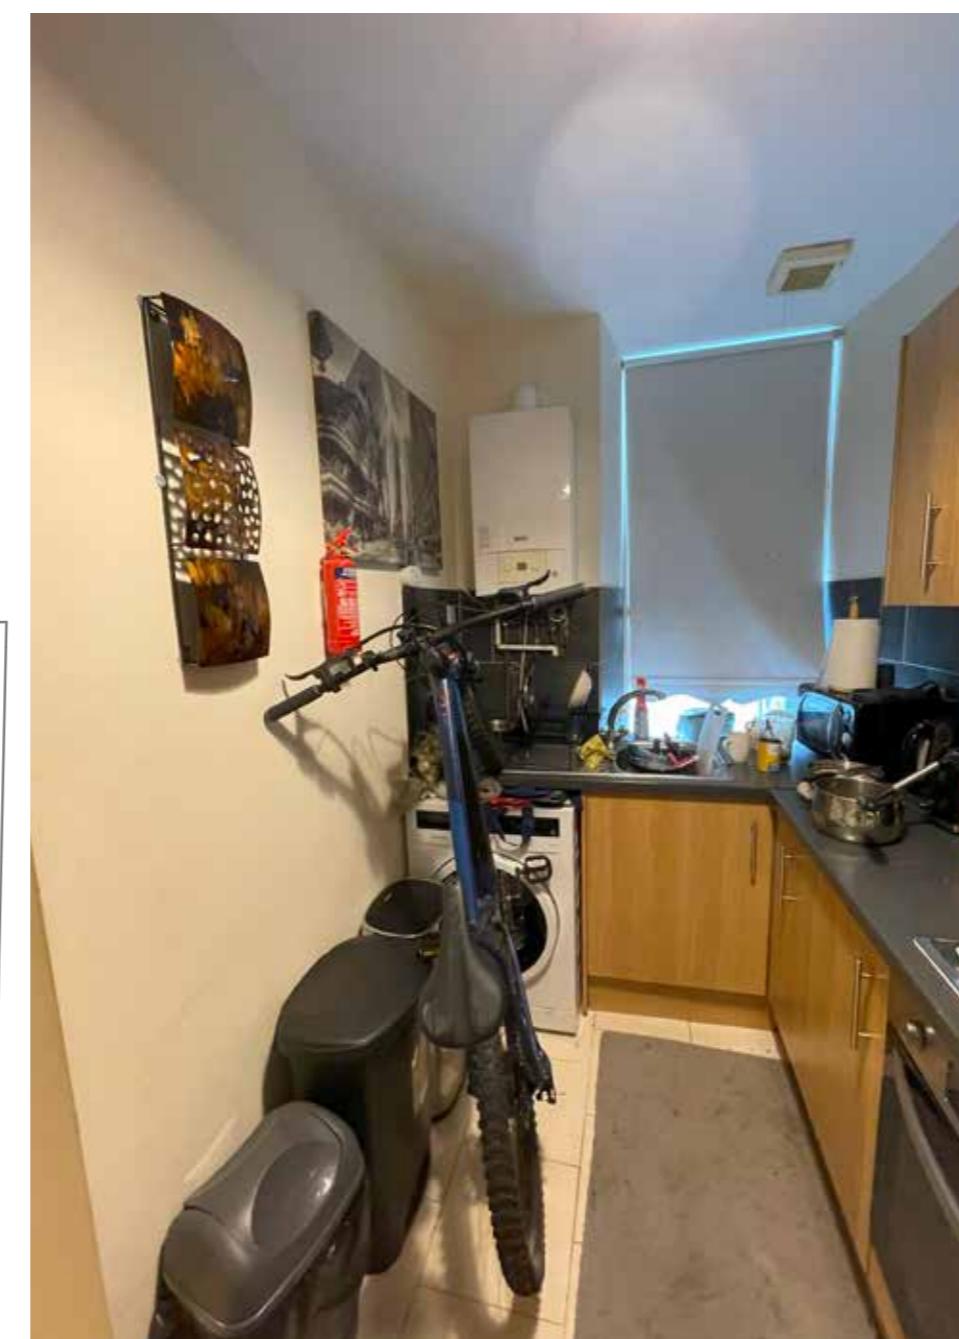
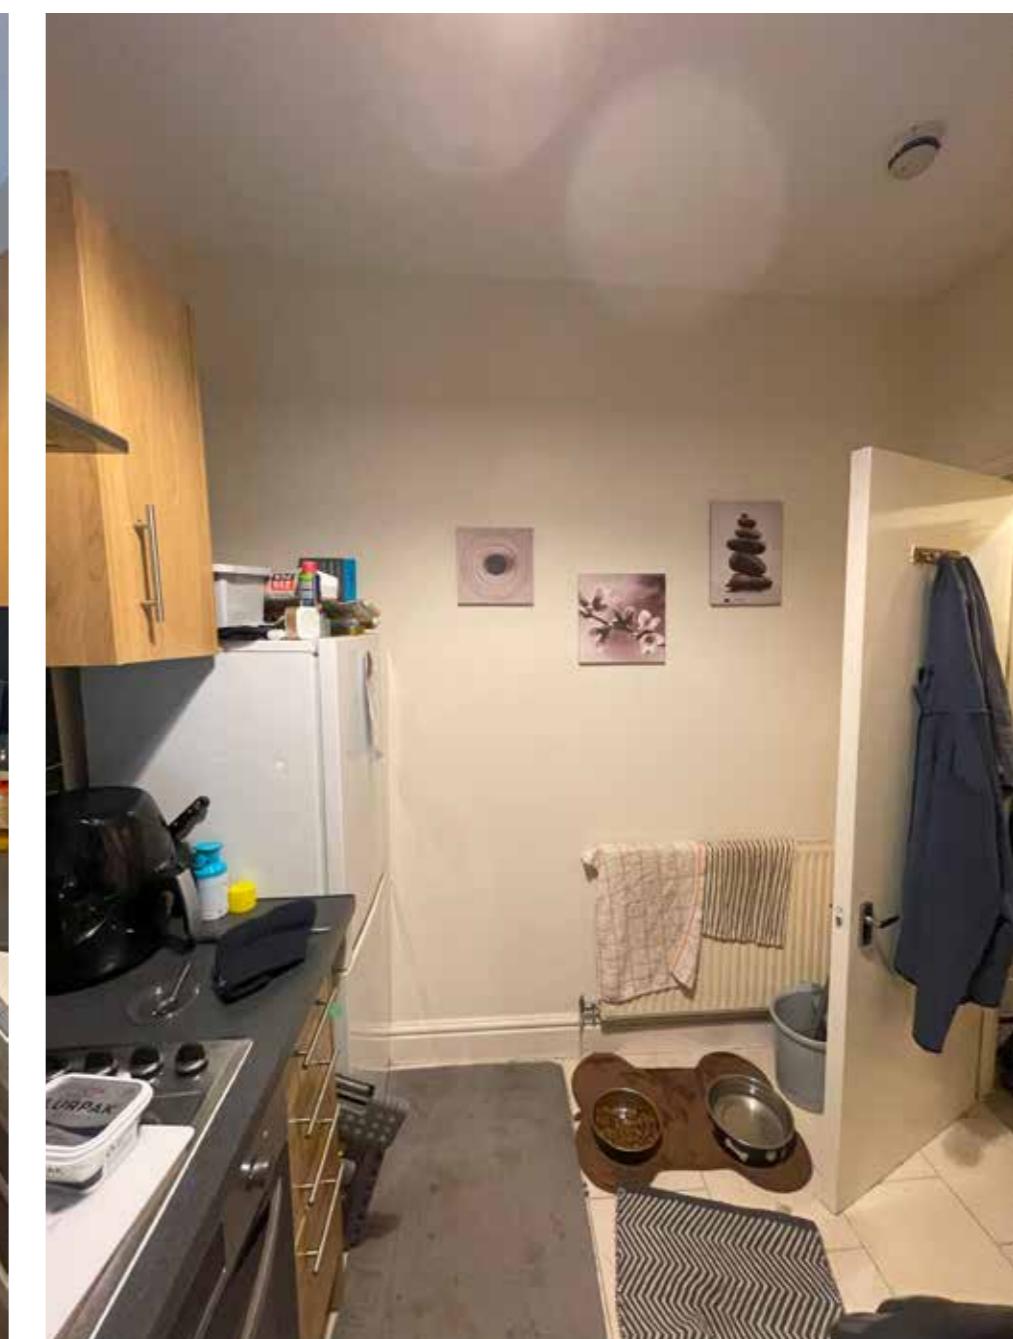
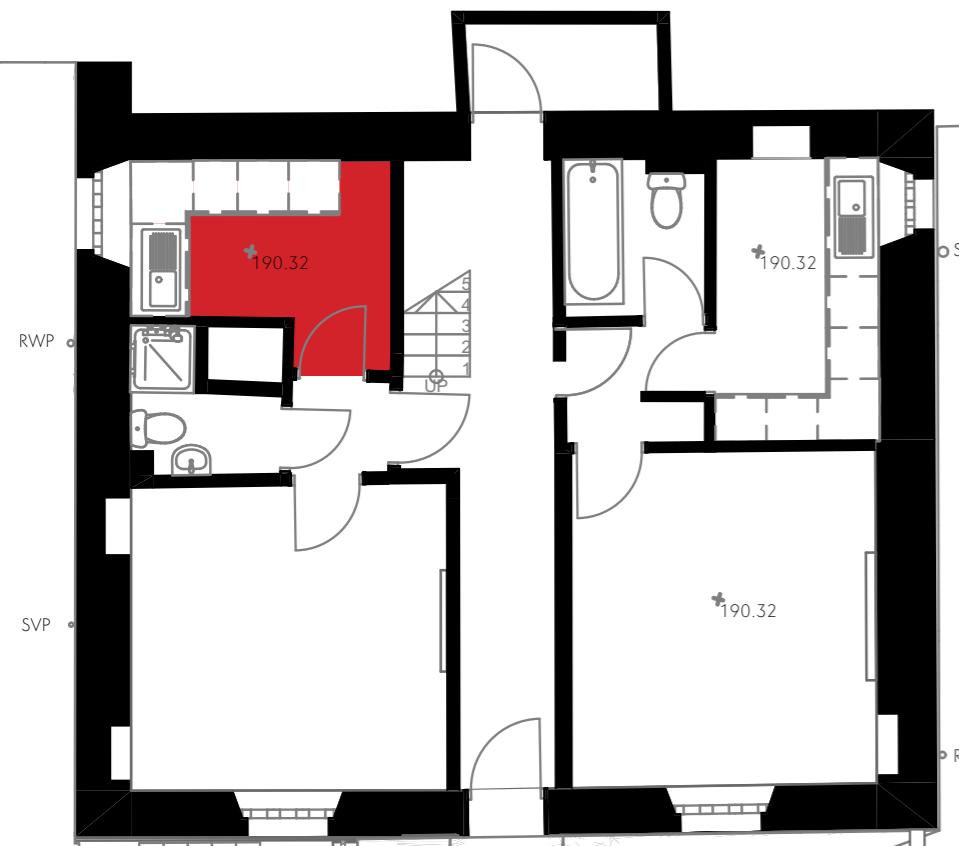
10.0 Interior - Ground Floor - Kitchen

With painted plastered walls and ceilings (again with no cornice), with some splashback tiling above the kitchen units, and a timber flush painted door, the floor to the kitchen is of ceramic tiling; and the window is timber-frame, single glazing. All appears to be in a reasonable condition.

The proposals replace the glass in the window with Slimline double glazing.
