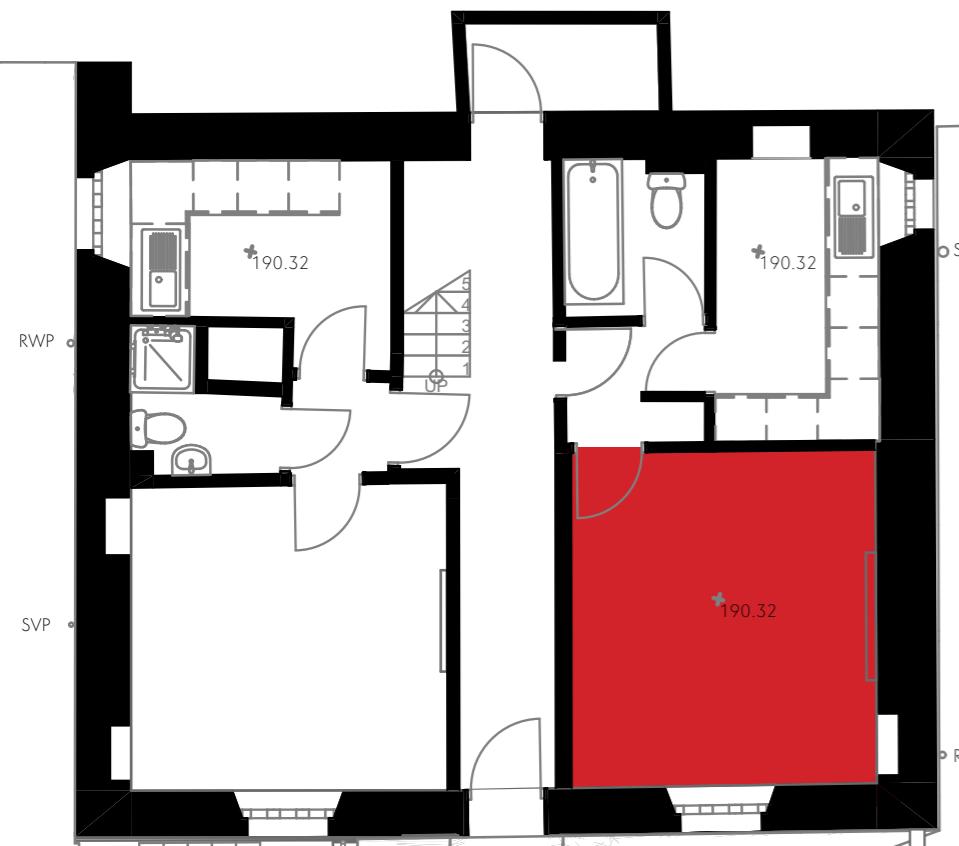
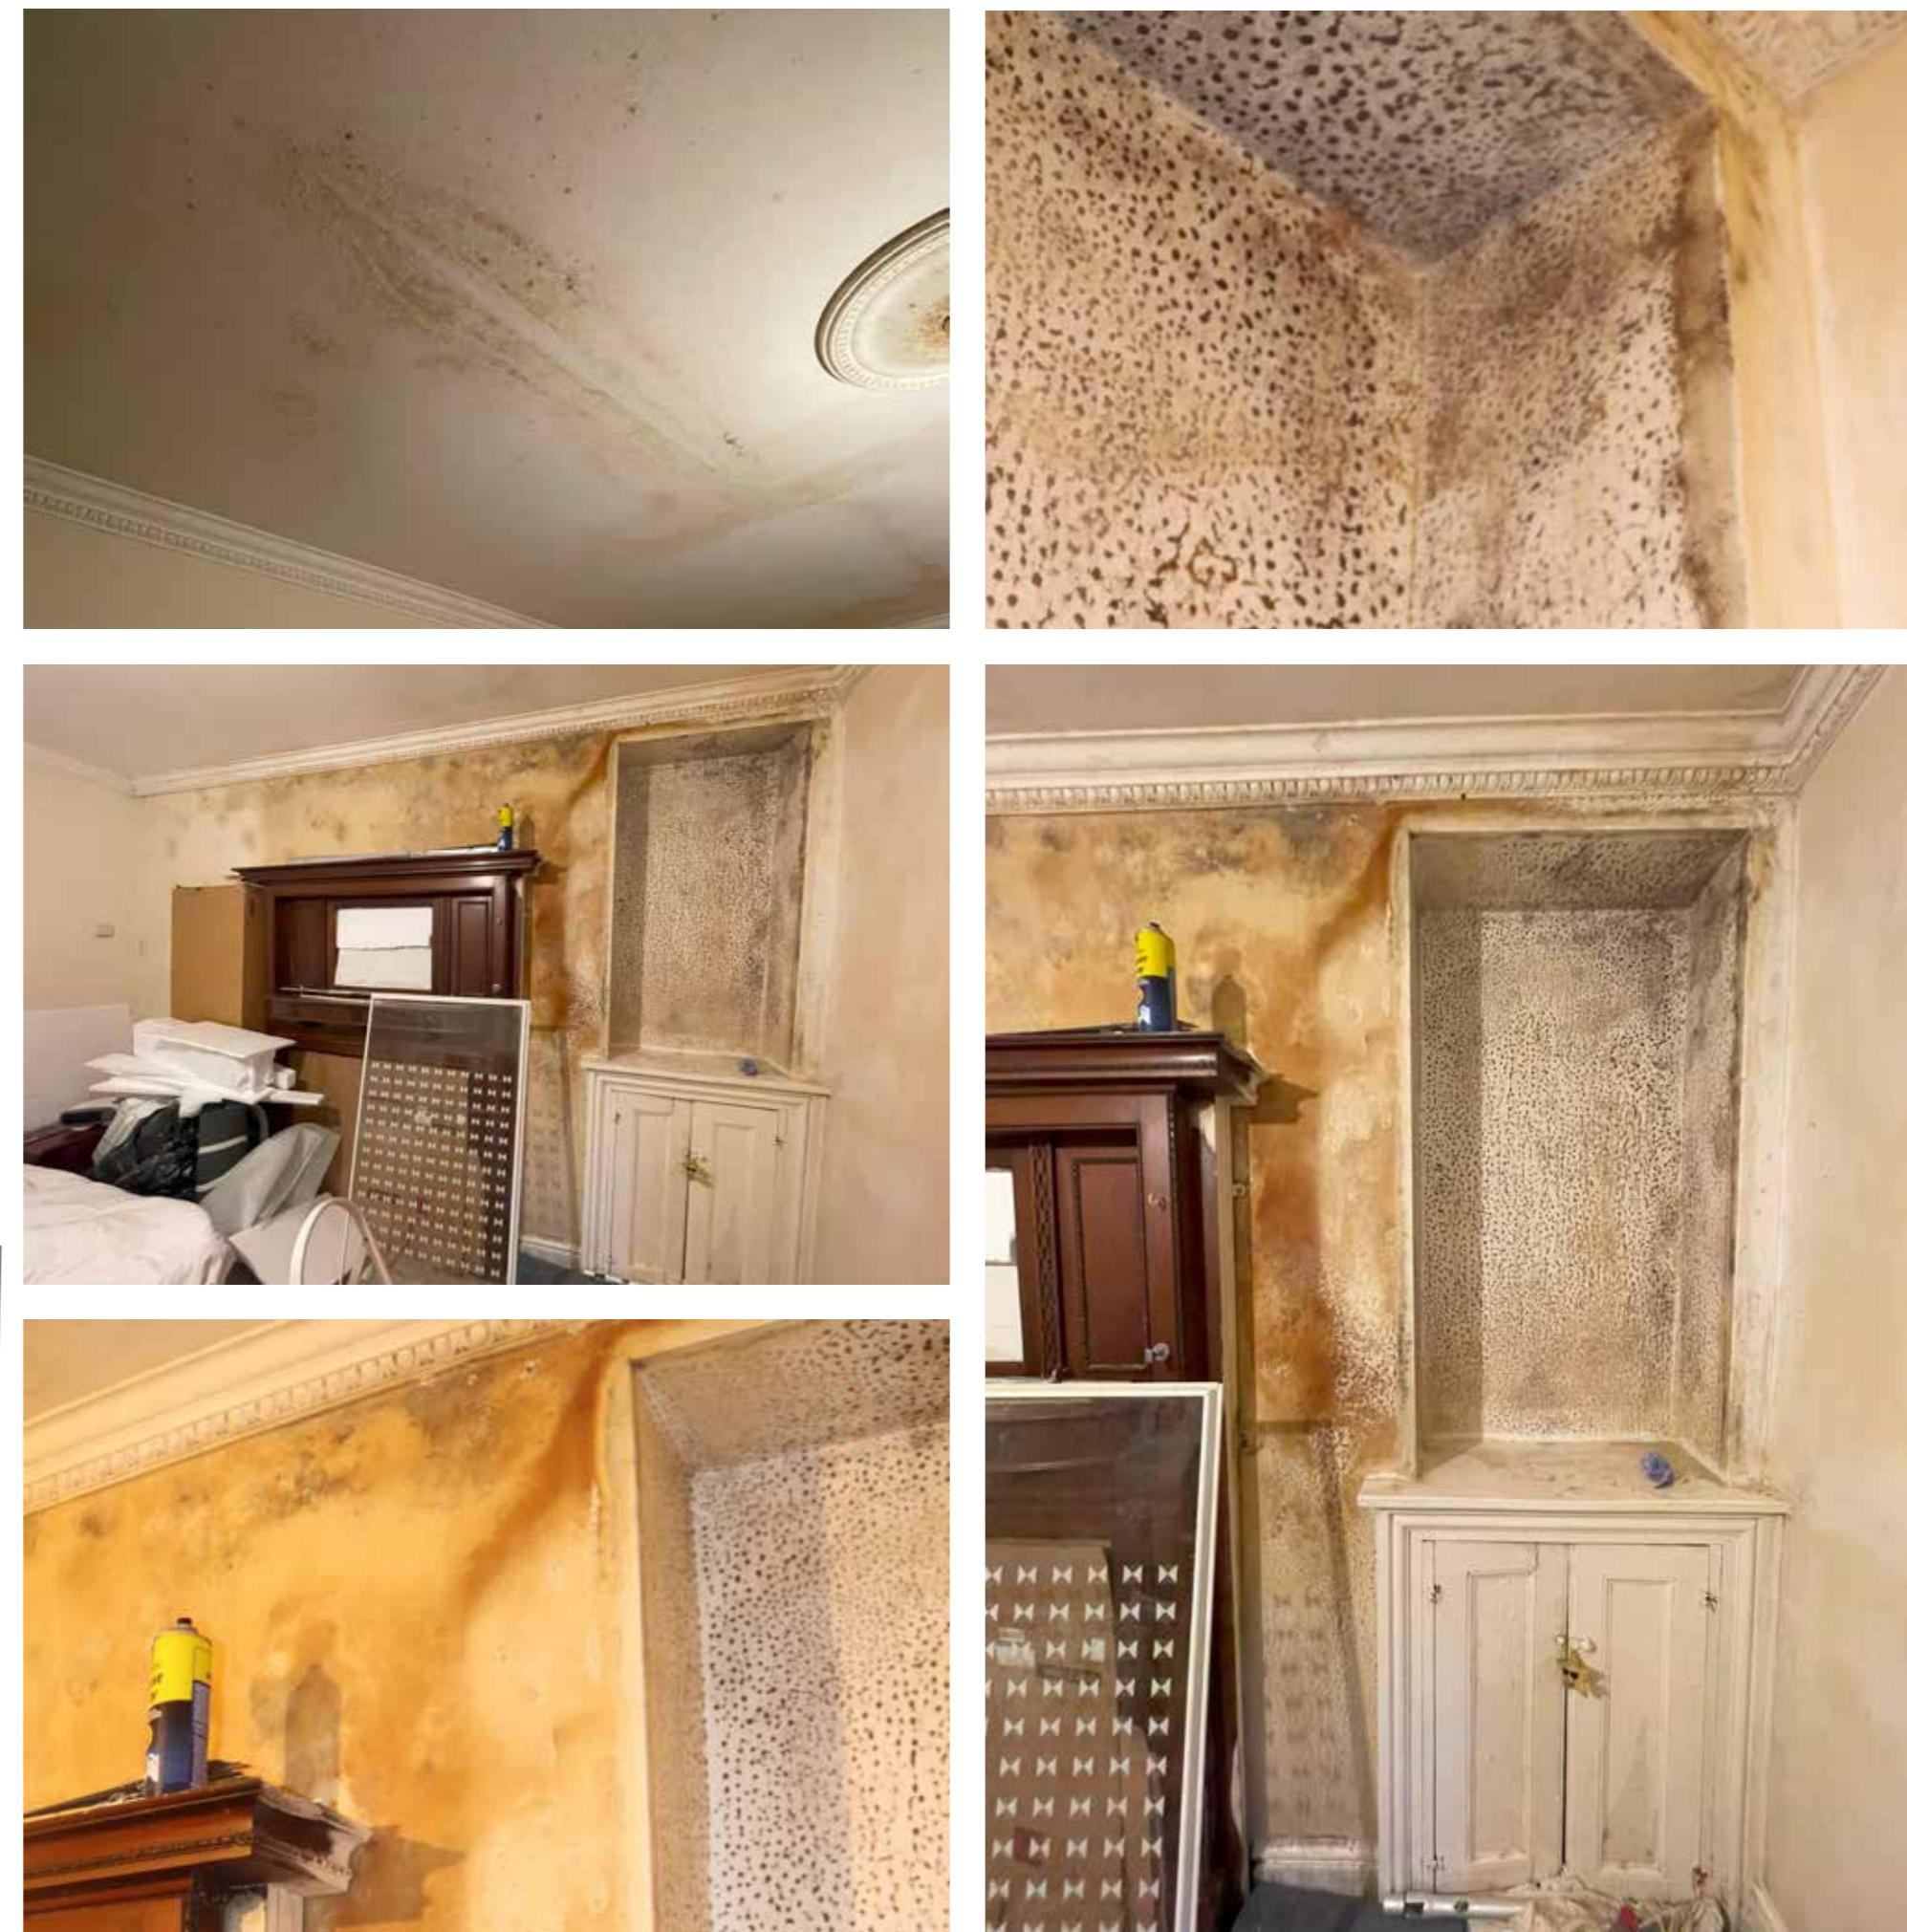
10.0 Interior - Ground Floor - East Flat Front Room

These photos are of the west wall to the room, facing the 'right of way' path, one the wall with roughcast cement render. The staining is awful around the fireplace particularly. It is orange in colour. It appears as though the fireplace is blocked up at this point, which is not ideal. However, to make this worse, at some time in the past, the chimneys appear to have been removed. This means that there may be no air movement / ventilation within the chimney breast and flue. As a result, the stale and stagnant air within the flue, holding old soot and 'nasties', is not ventilated out of the fabric, as intended; and so it sits there, reacts with moisture within the masonry, and is drawn, hygroscopically, through the masonry to the surface and stains the plaster an orange colour; and potentially leads to mould growth and noxious odours. The more moisture the wall holds, the worse the reaction. This soot can also badly damage the masonry itself.

Also, to the right of the fireplace is a recess. This is caked in black mould deposits. It is probable that this is so bad because the thickness of the wall in this area is much less than the rest of the wall; and so there is a greater cold-bridge to the outside and, hence, this is a colder part of the wall, which condensation would immediately move towards.

Once the plaster has been removed and the wall allowed to dry out, the proposals involve incorporating a vent in the face of the fireplace and a vent at the top of the roof, where the chimney used to be. Thus, some ventilation can be reintroduced into the flue.

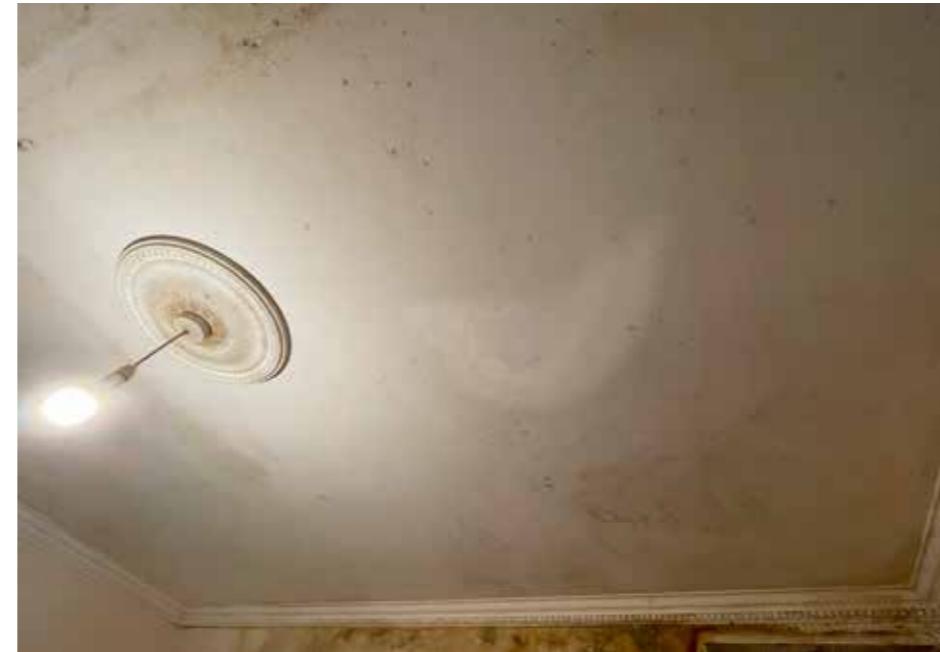
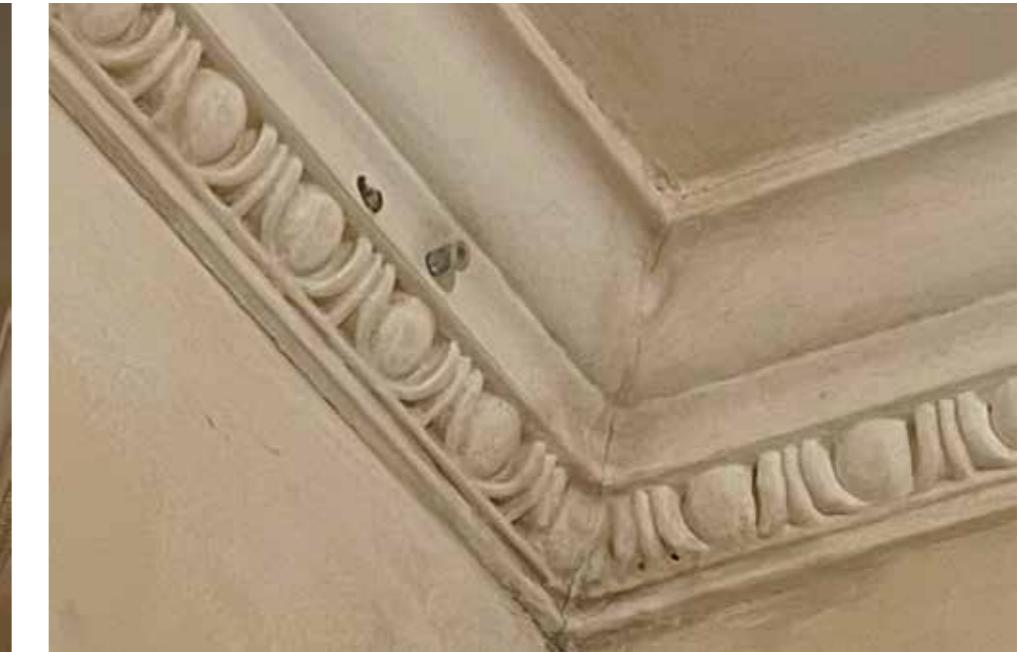
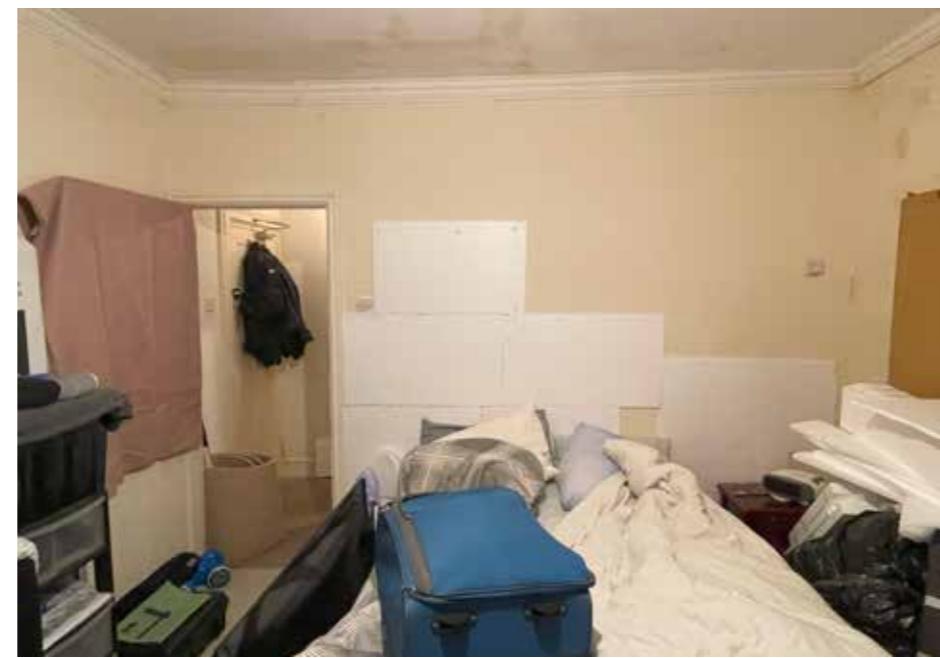
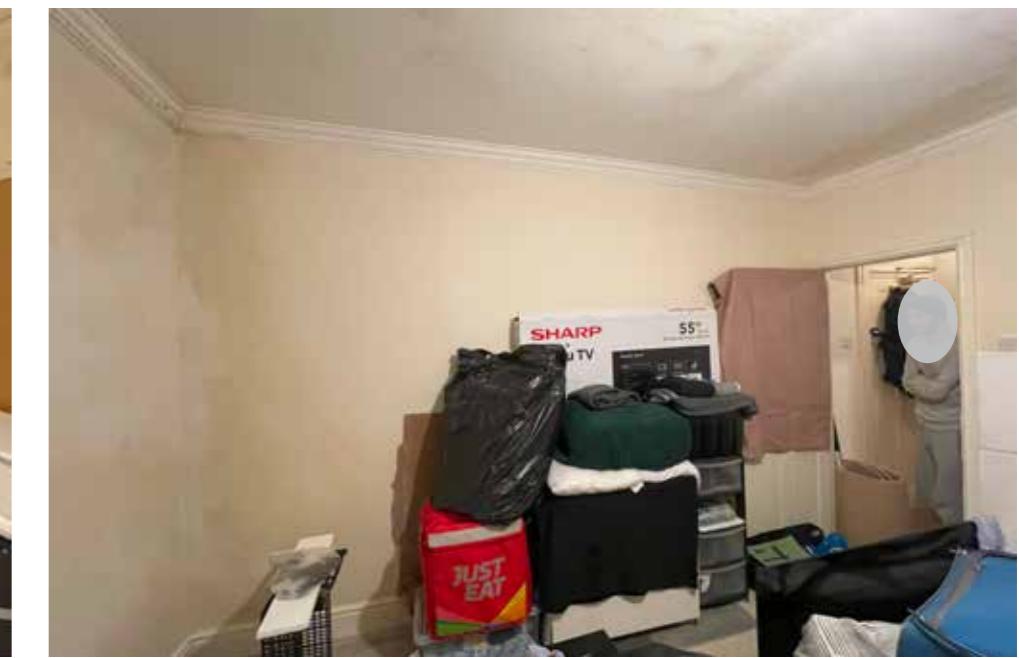
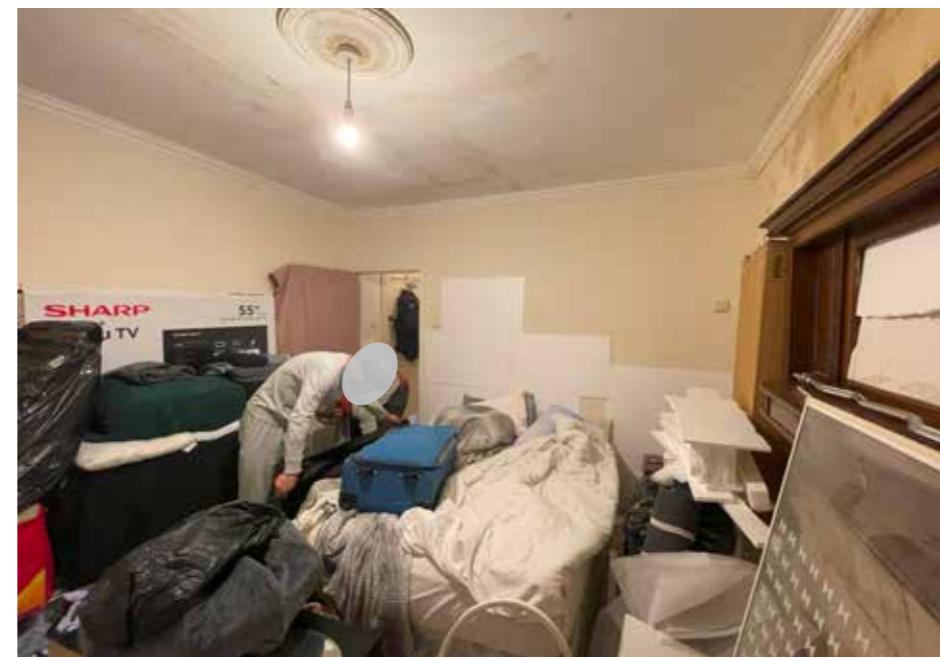
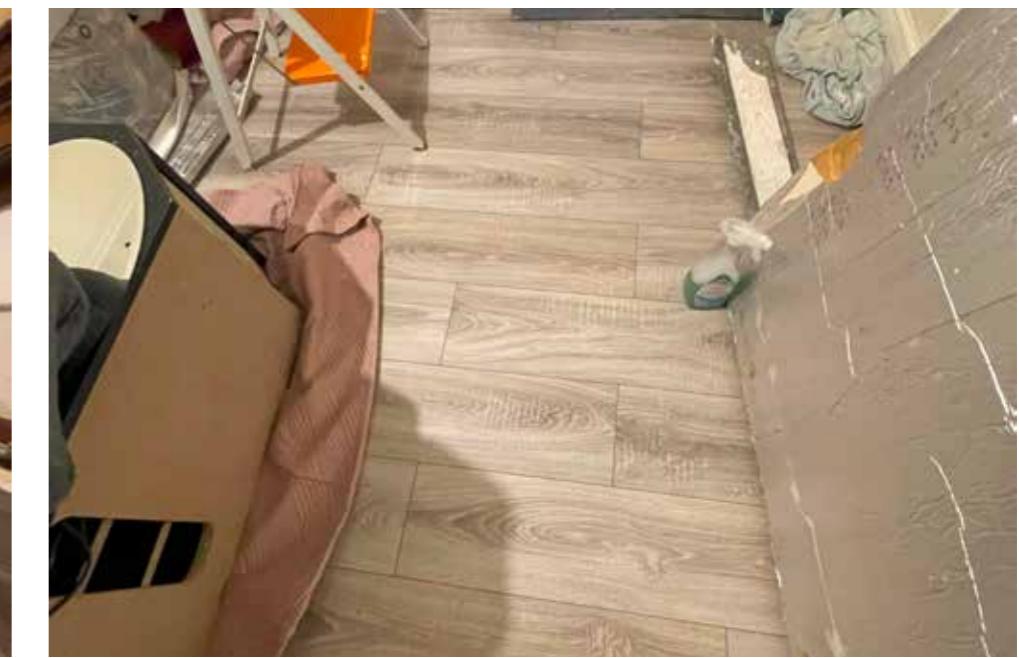
10.0 Interior - Ground Floor - East Flat Front Room

The floor to this room is a vinyl.

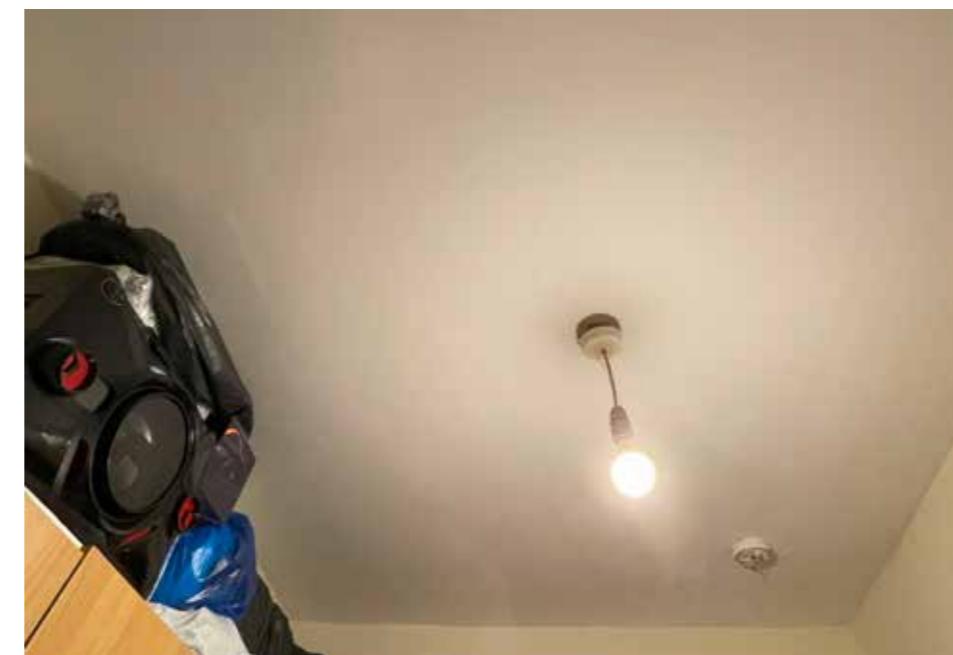
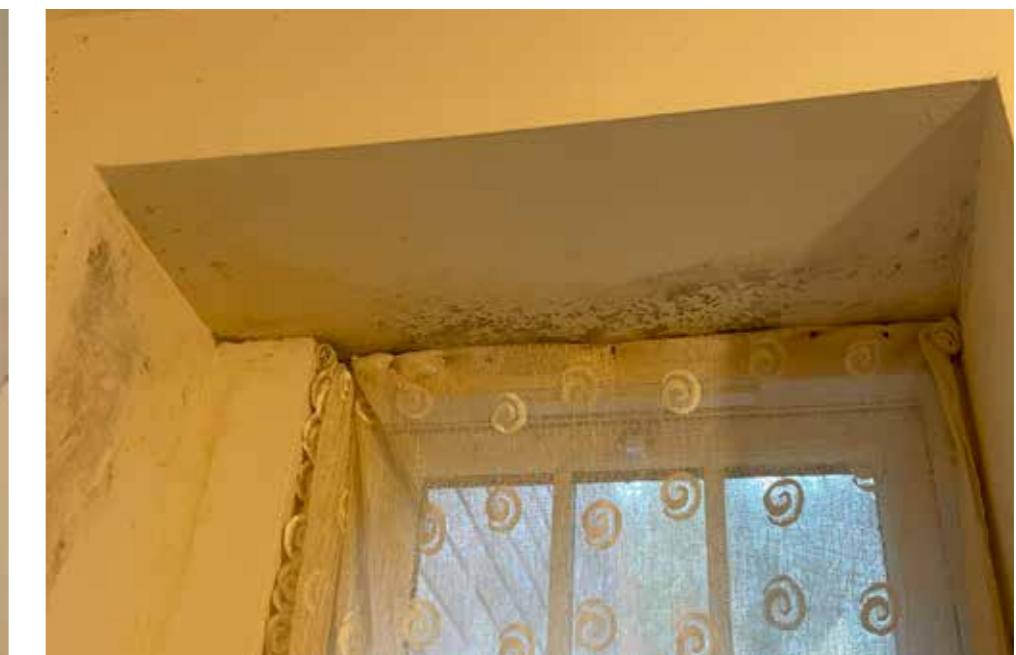
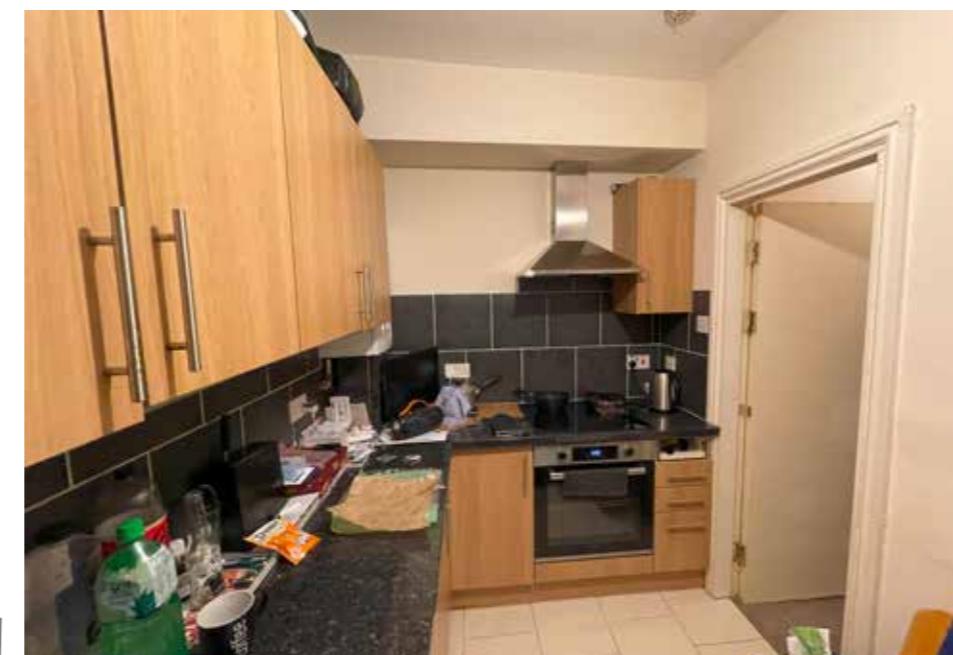
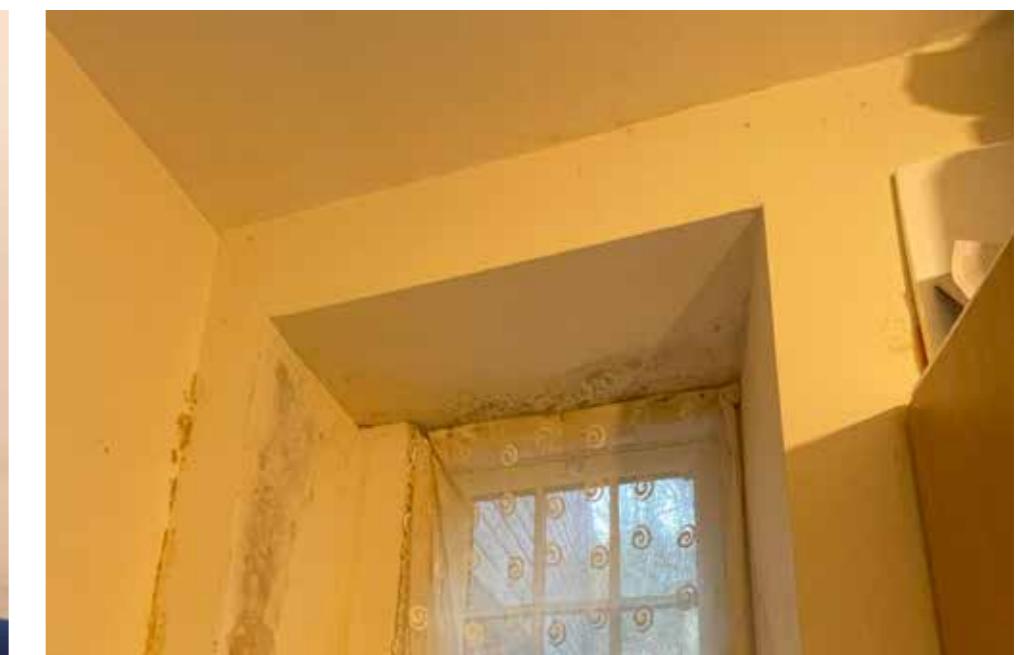
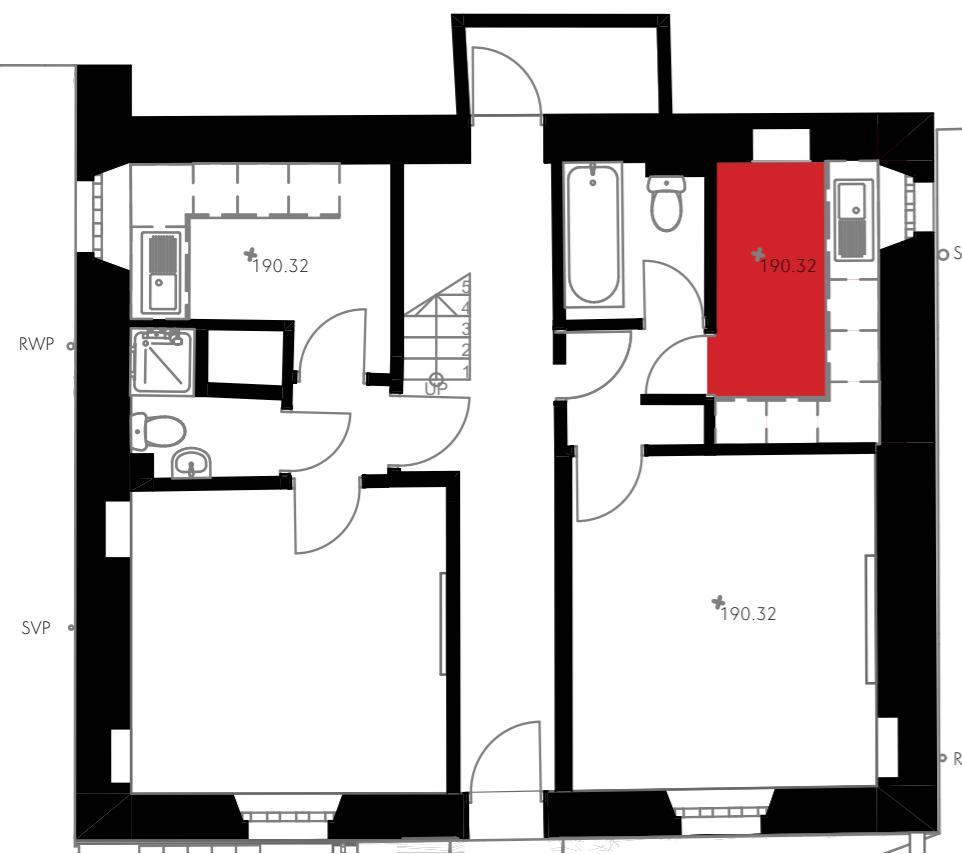
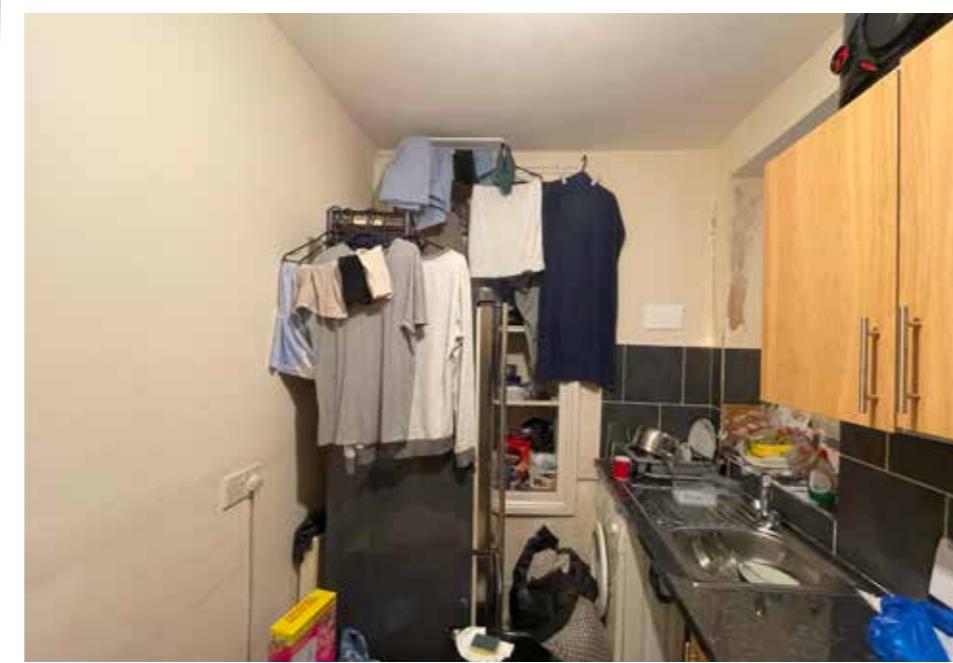
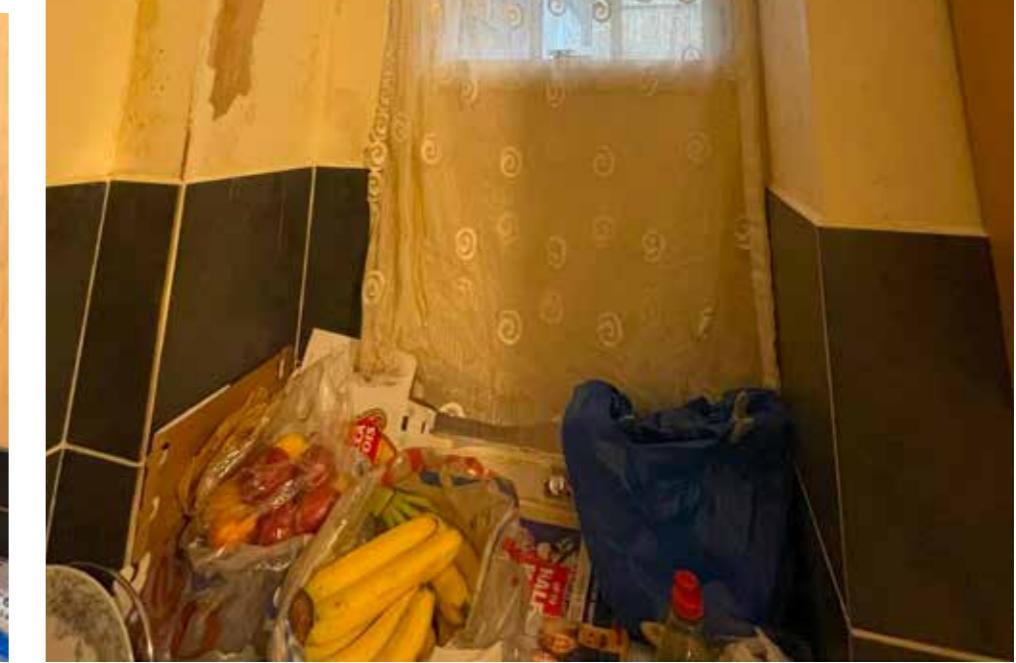
10.0 Interior - Ground Floor - East Flat Kitchen

The kitchen is of the same painted plastered walls and ceiling (with no cornice), a ceramic tile floor and a flush timber door. The kitchen walls are also covered with ceramic tiling and kitchen units, which means that it is not possible to see whether there is also bad mould and saturation behind the tiles and units. However, there is clearly mould around the window head (which used to be a door), which suggests a cold-bridge at the lintol.

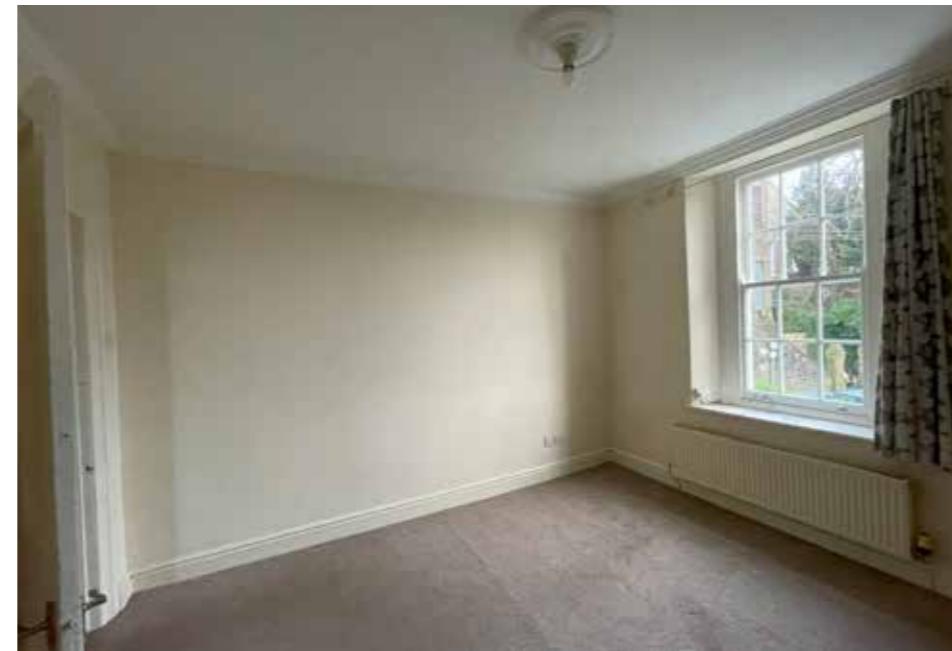
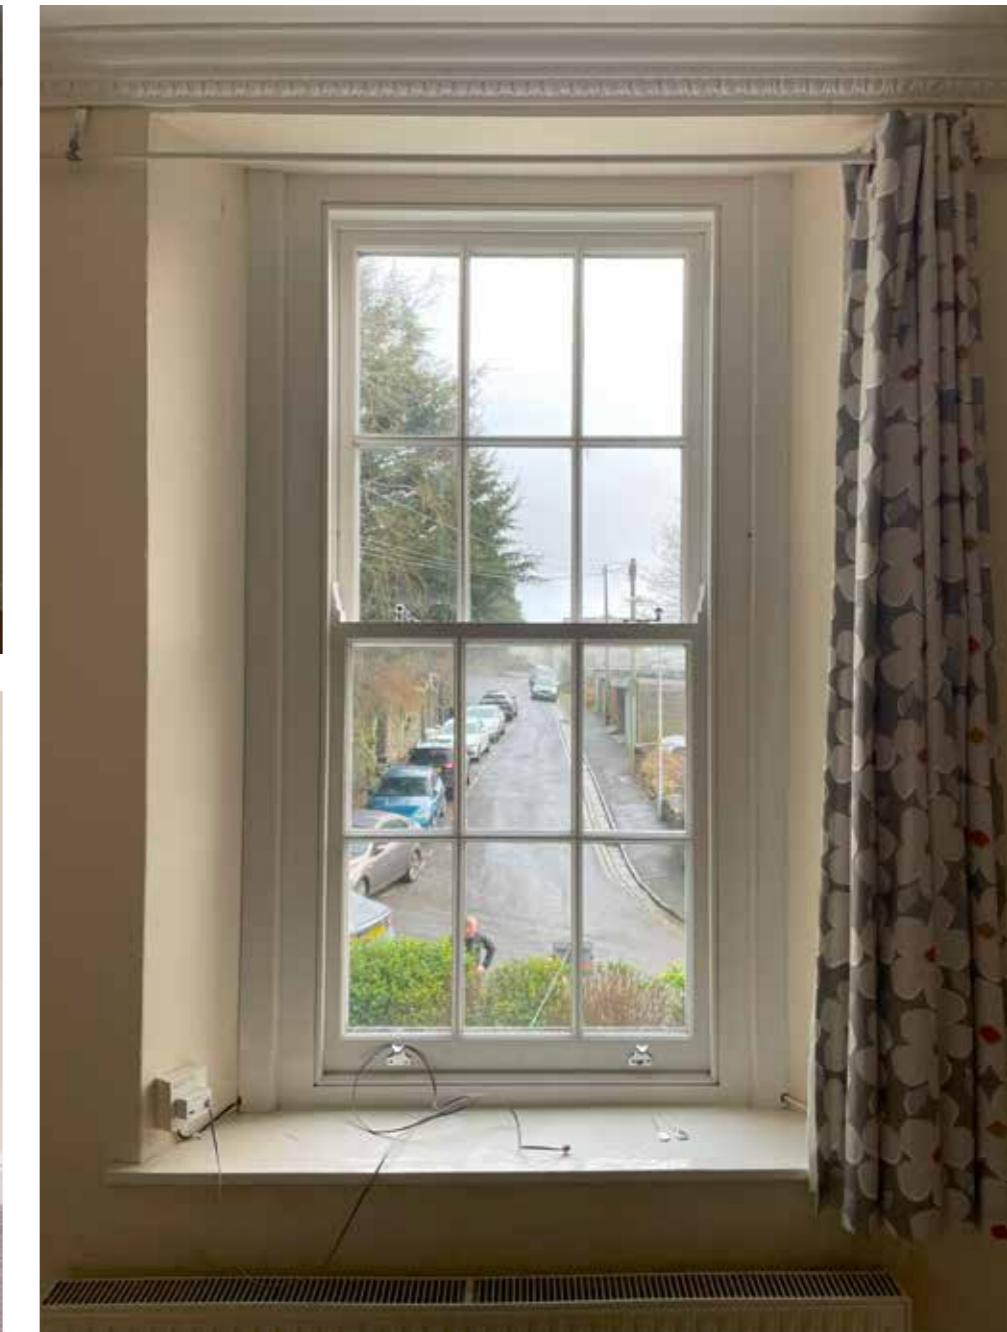
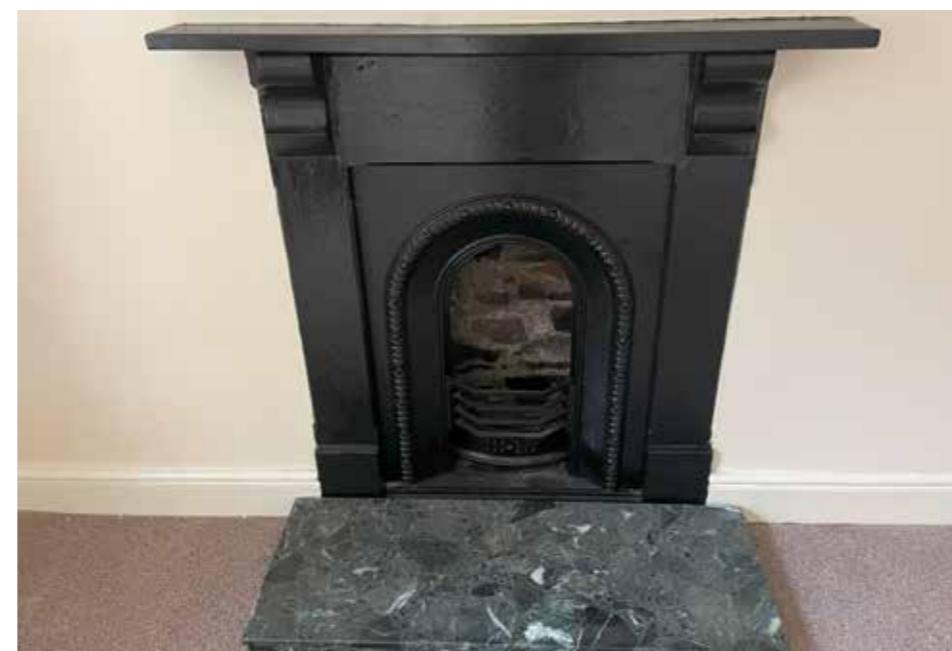
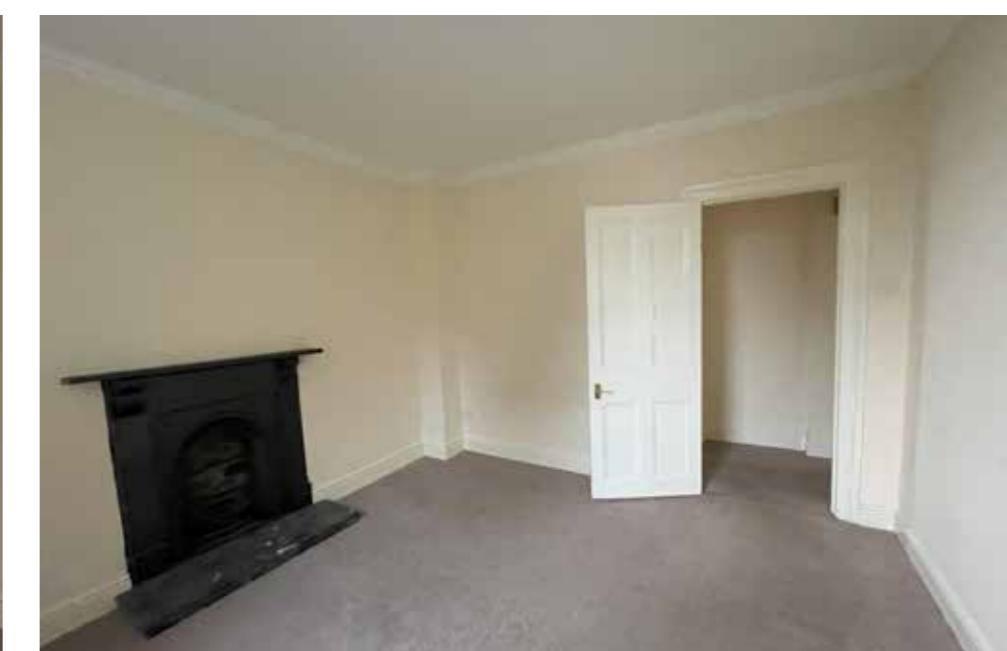
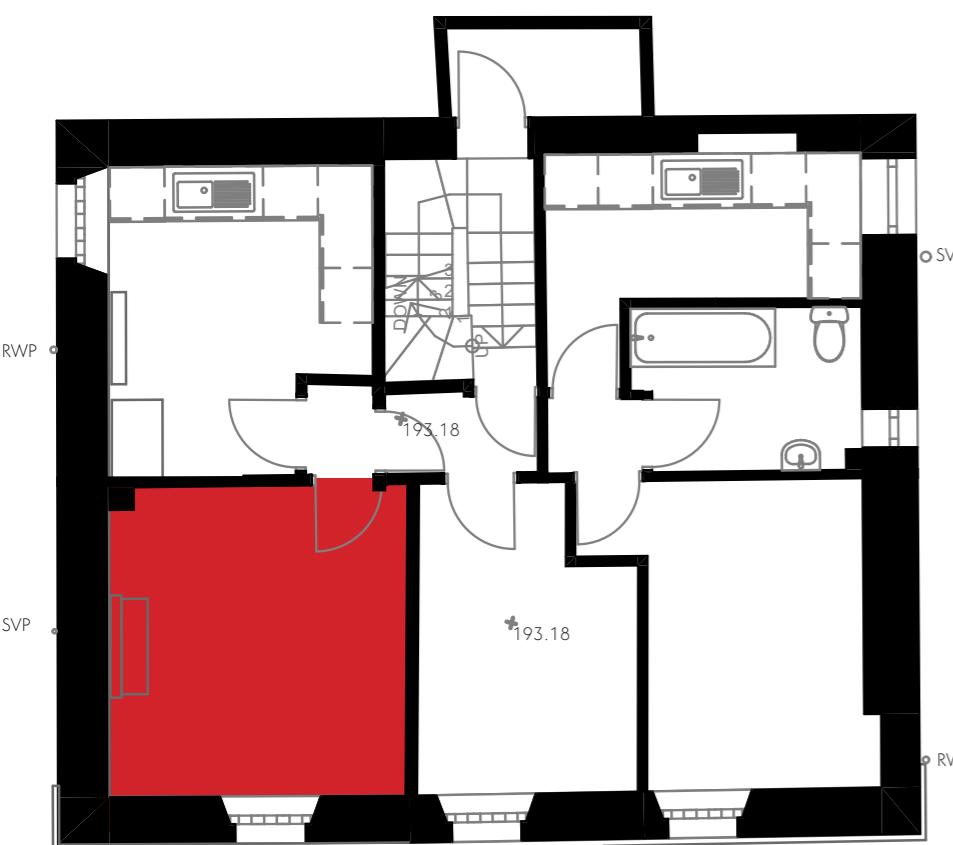
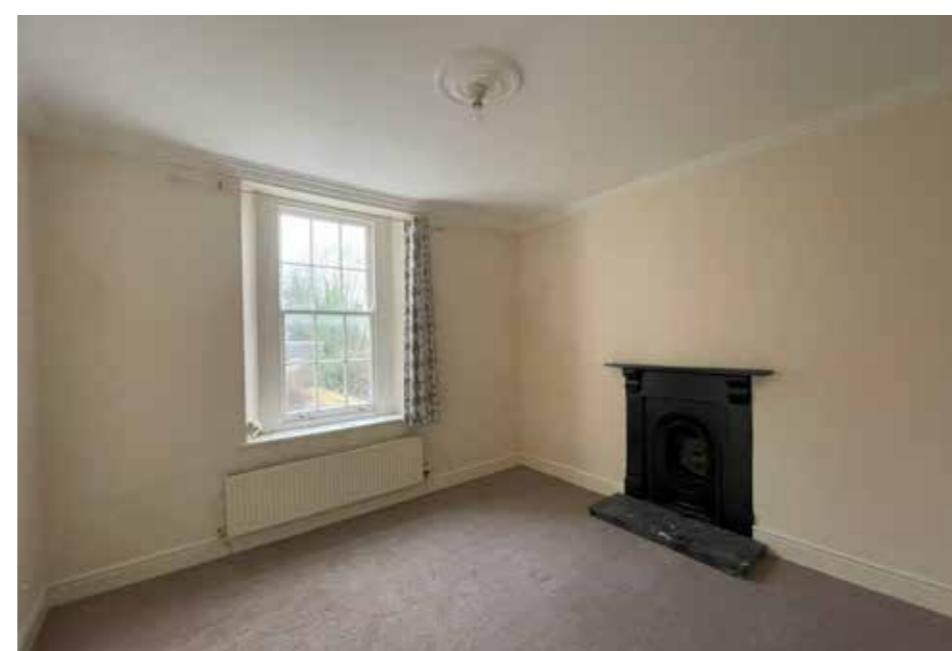
11.0 Interior - First Floor Flat - South West Room

This front room is of painted plastered walls and ceiling with a moulded cornice and a ceiling rose. The floor is carpeted; the door is a painted four-panelled timber door and the window a painted timber sash window with double glazing. The internal partitioning appears to be of plasterboarded timber studwork. There is a timber and metal fireplace surround and marble hearth. The brickwork of the wall is apparent within the fireplace.

All appear to be in a reasonable condition.

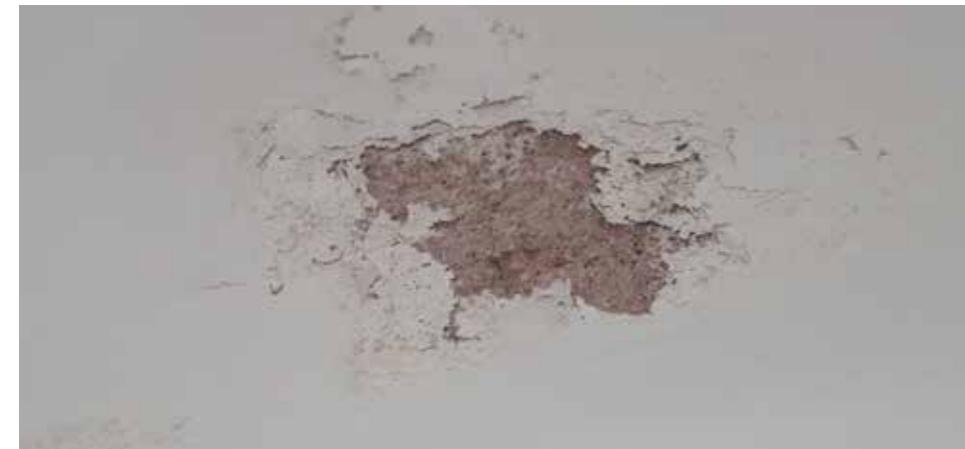
11.0 Interior - First Floor - Central Room

There is water-staining, dampness, spalled plaster and crystallised salts on the external front wall to the left of the window (see photo below). There is a significant amount of cracking render on the outside just above this point. This might explain how the inside face of the wall is damp - water has been getting behind the render, cannot evaporate externally and so is finding its way to the inside face of the wall, and drying, leaving salt crystals. The plaster needs removal and a new lime plaster applied.

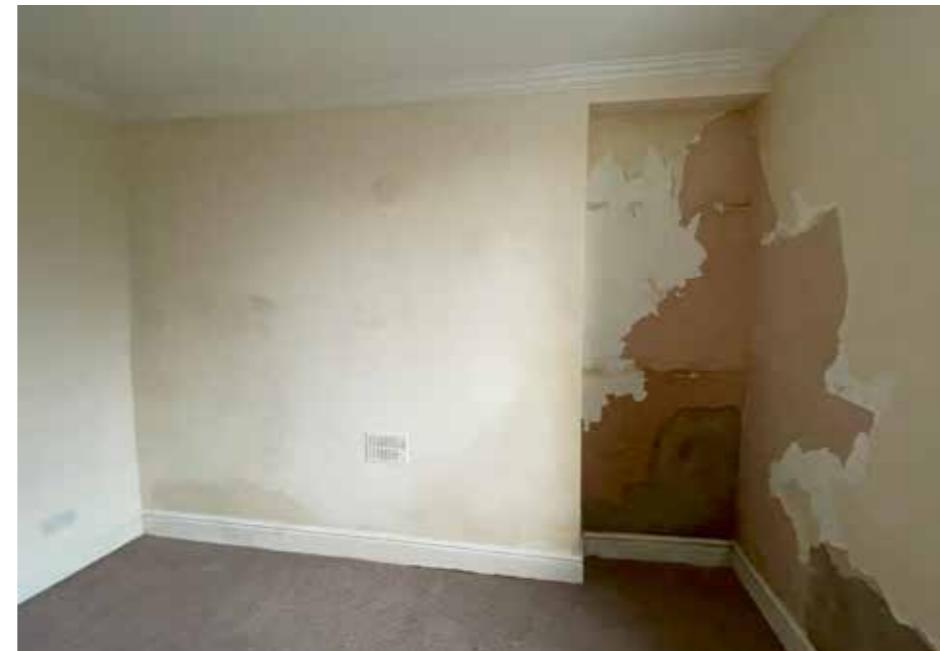
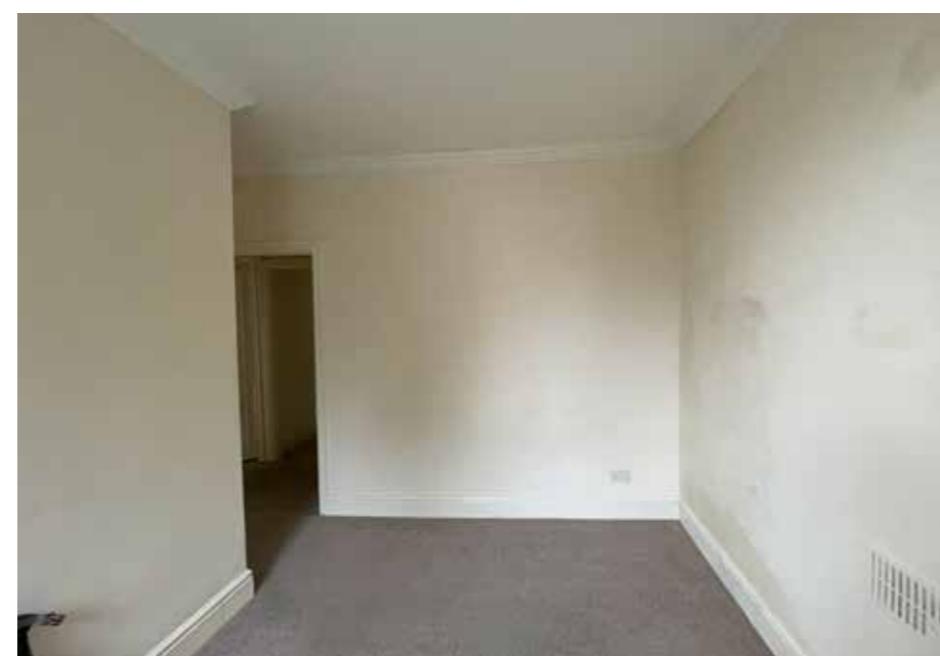
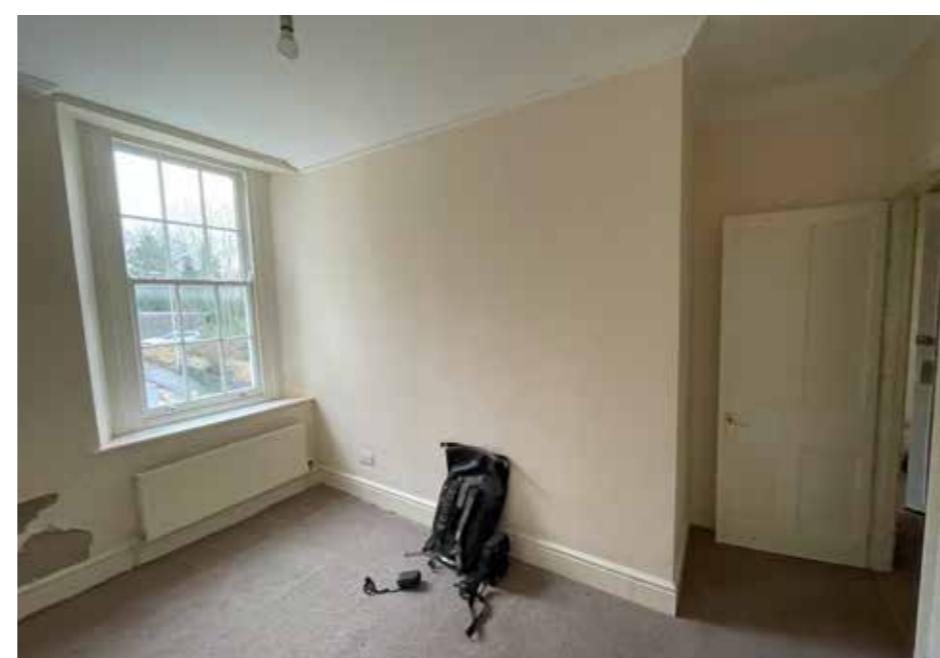
11.0 Interior - First Floor - South East Room

In the south east corner of the room - which is the external corner - there is a large area of peeling paint, cracking plaster and damp. There has recently been some cementitious plaster repairing of this area. This is where the wall thins out to form this recess, and hence forms a greater cold-bridge. The surface of the thicker wall (where the fireplace used to be) is also showing signs of dampness. This is the corner and side wall of the building where the wall is at its dampest in the ground floor below. This certainly suggests that there is a damp build-up to this part of the wall. It is an area of wall where the render externally is looking especially dark, stained and damp; and it is the area where there is a rain water downpipe, which might have been leaking; and an area where the old chimney breast may not be suitable vented.

The proposals involve the removal of the internal plaster and, probably, the removal of the external render. The chimney flue is to be vented at top and bottom, and in the middle; and the rainwater downpipe is to be replaced.

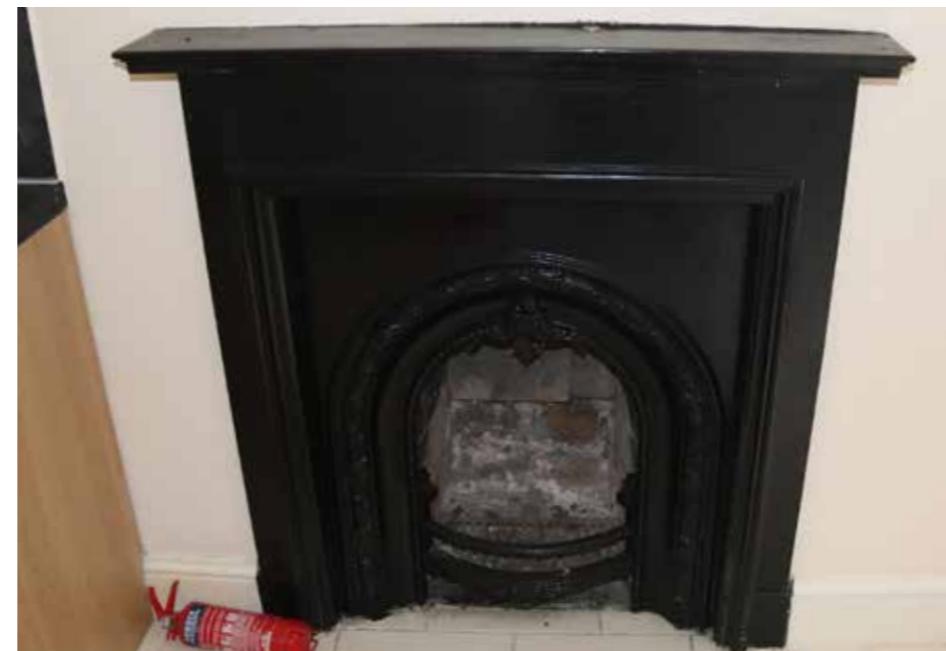
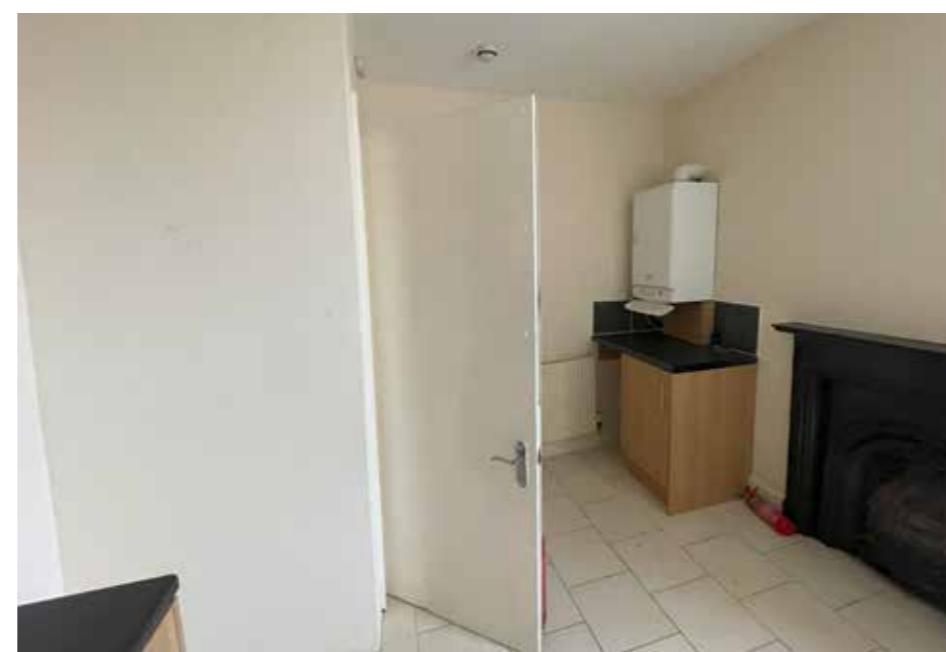
11.0 Interior - First Floor - Rear Kitchen

The condition of this room is reasonable; however, there is mould growth around the window, which suggests cold-bridging and condensation. This is not helped by the fact that the window is single-glazed. As such, the proposals replace this with Slimline double-glazing.
