## Primrose Hill, Merthyr Tydfil

### Structural Condition and Appraisal Report

# Primrose Hill, Merthyr Tydfill Mechanical Conditioning Report

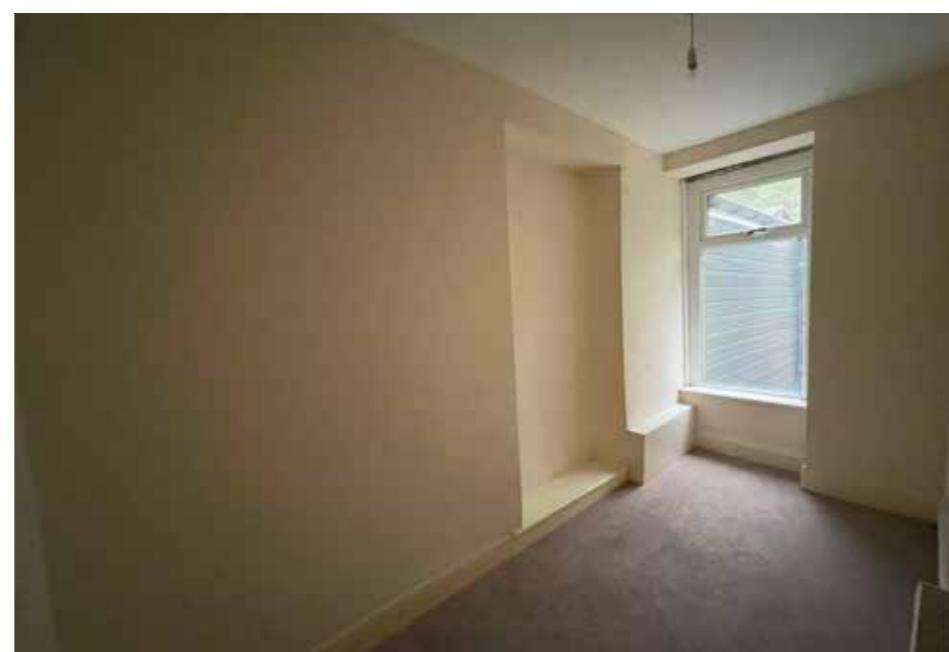
The condition of the room is reasonable; however, it was noted that there was a bit of a slope to the timber floor. A more detailed inspection of this, and all floors, is recommended in due course, when the carpet can be taken up.

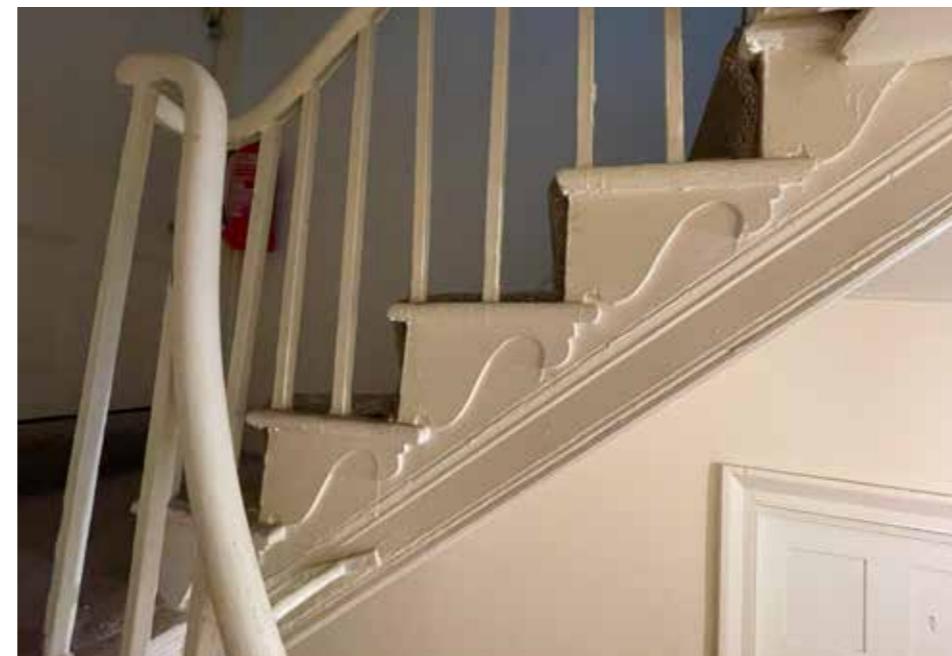
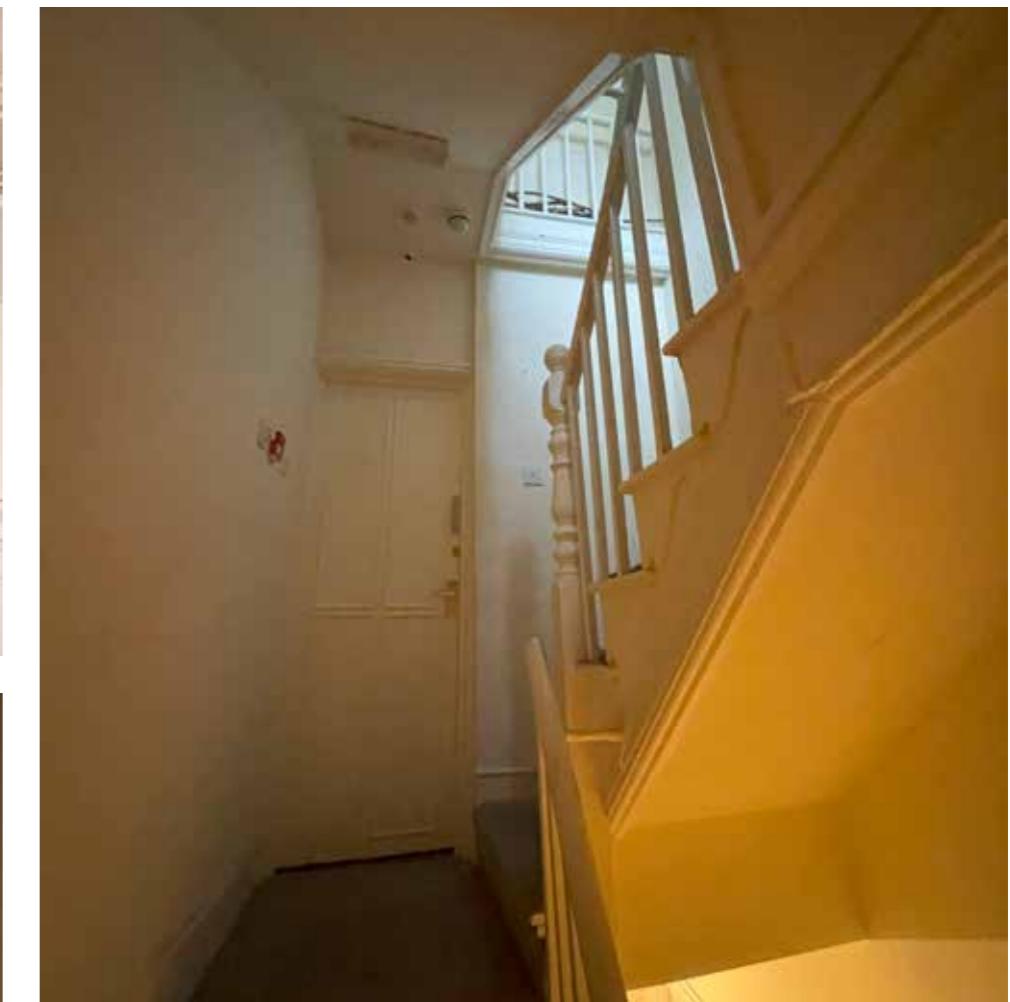
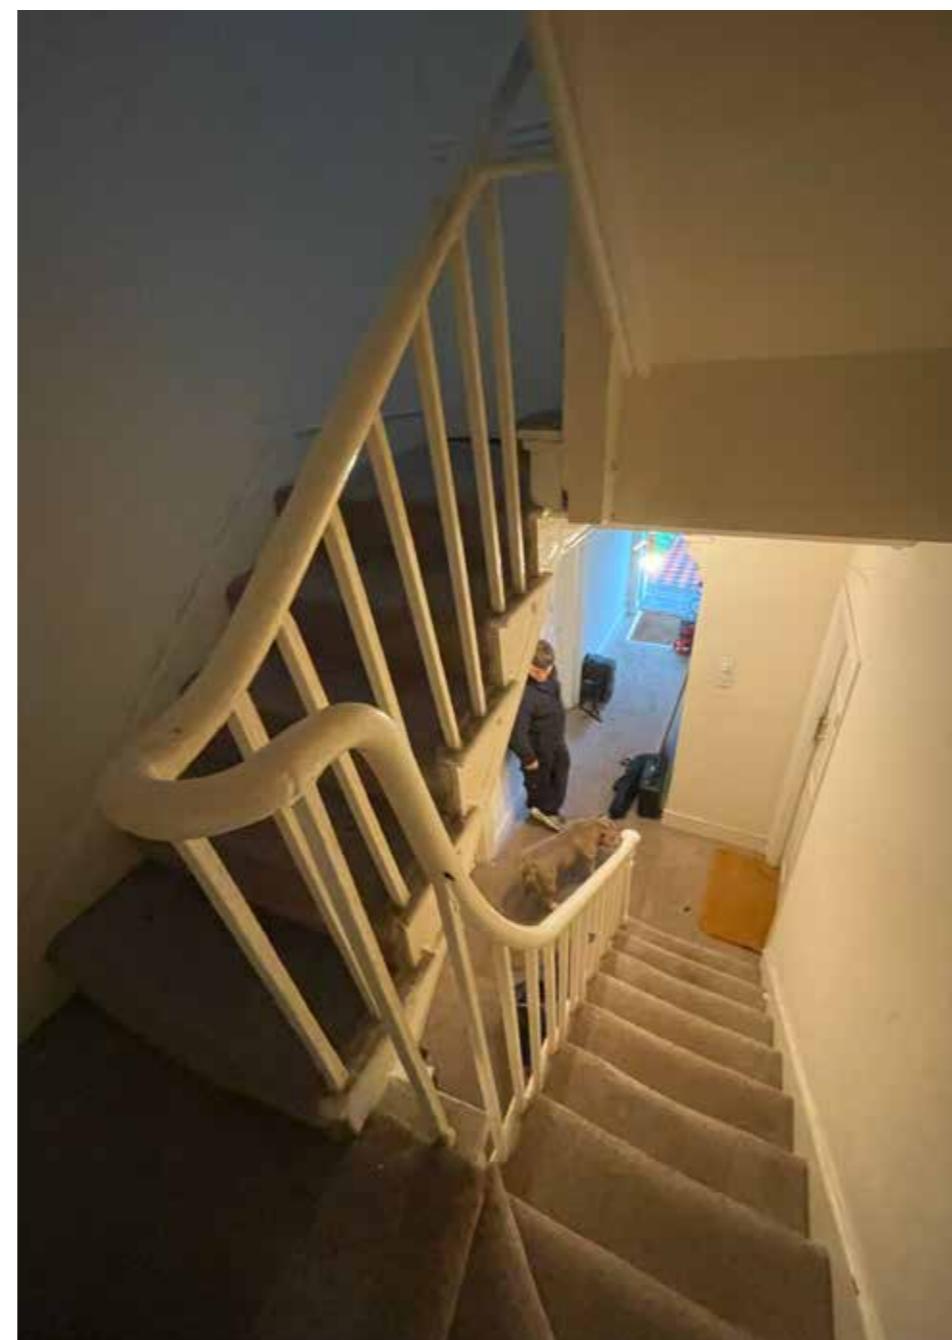
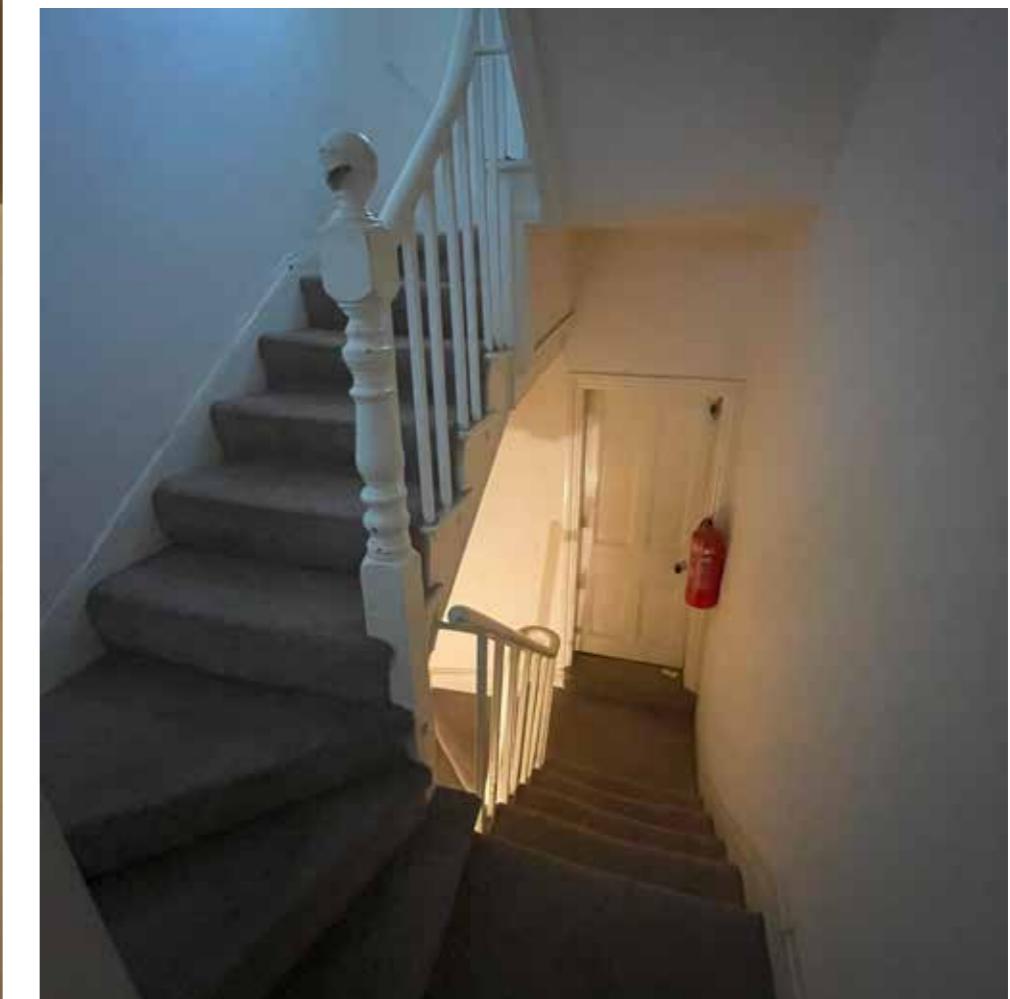
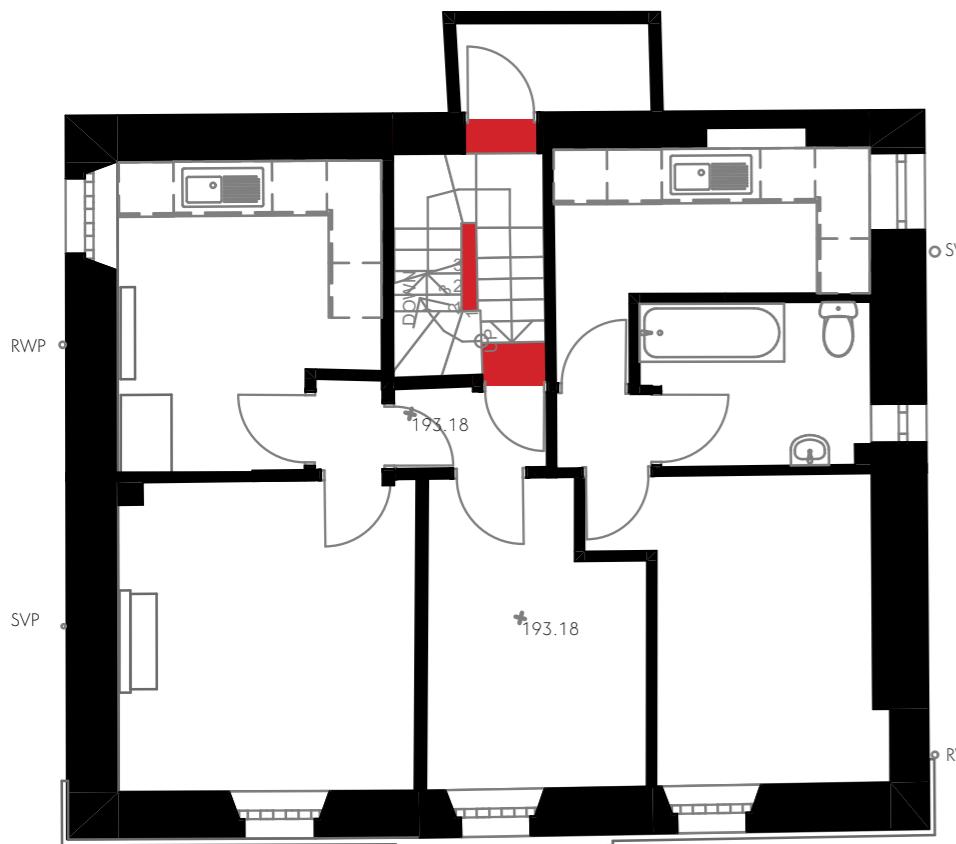
The single staircase is a timber staircase, carpeted; with an ovular handrail, square balusters and a turned round newel post; all painted white. Aside from the wear on the carpet, this appears all to be in reasonable condition

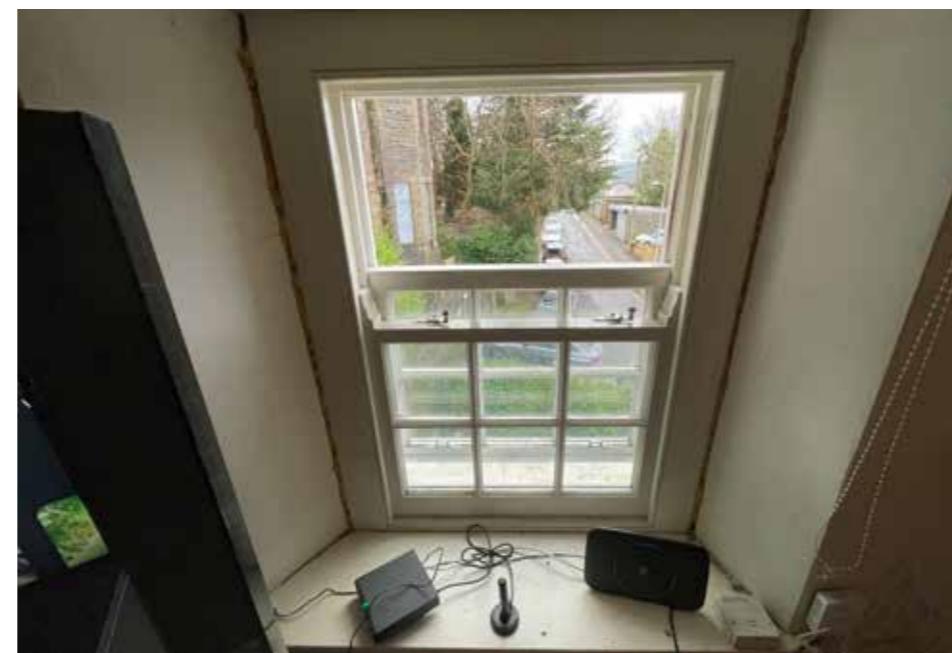
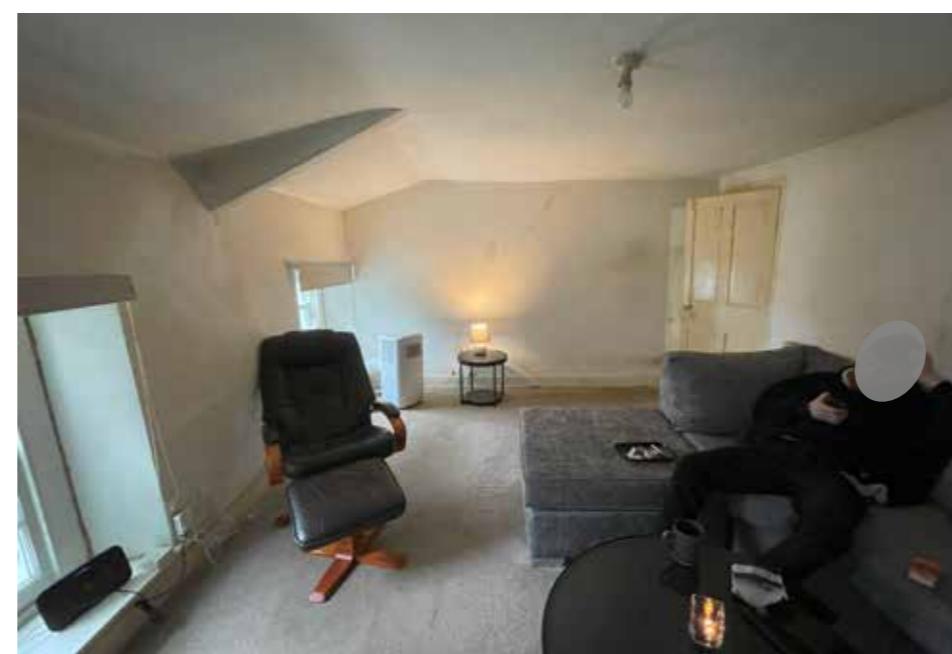
There is some staining on the walls and ceiling, albeit not significant or of too much concern; and there appears to have been some areas of crack repair, fairly recently, to some of the plasterwork on the walls.

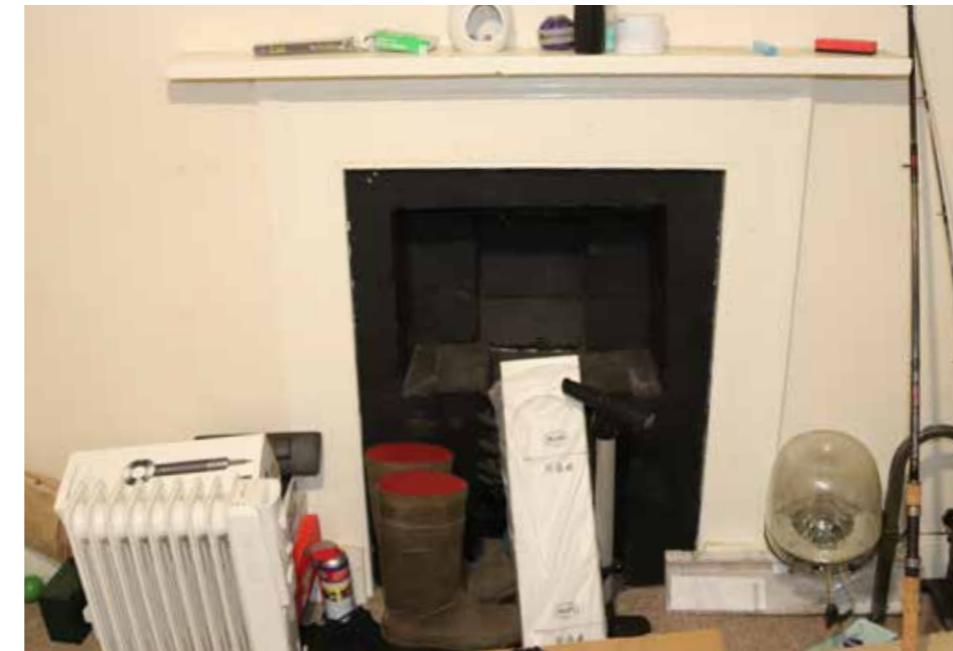
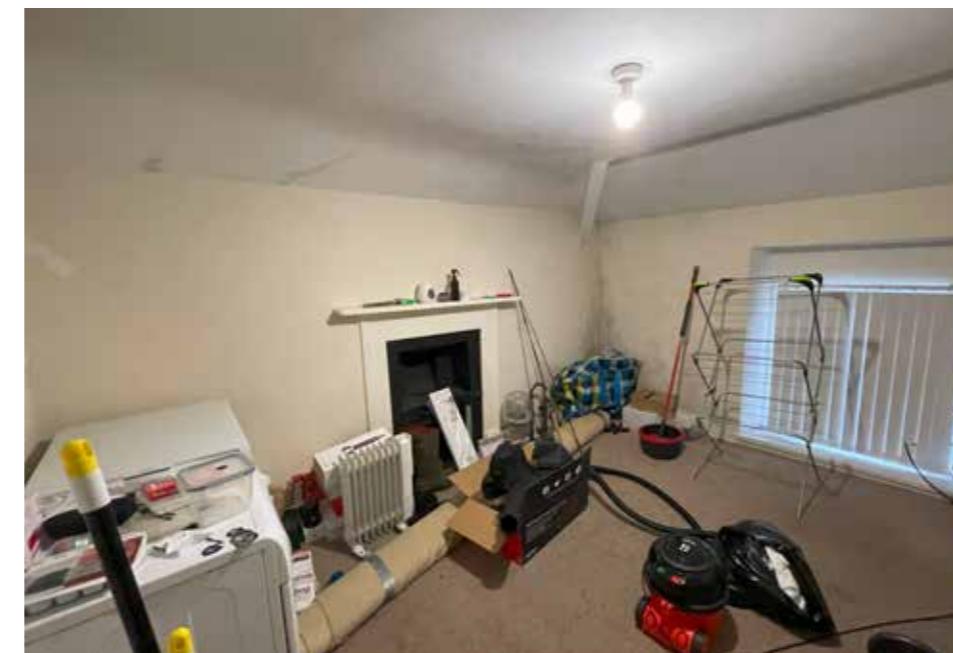
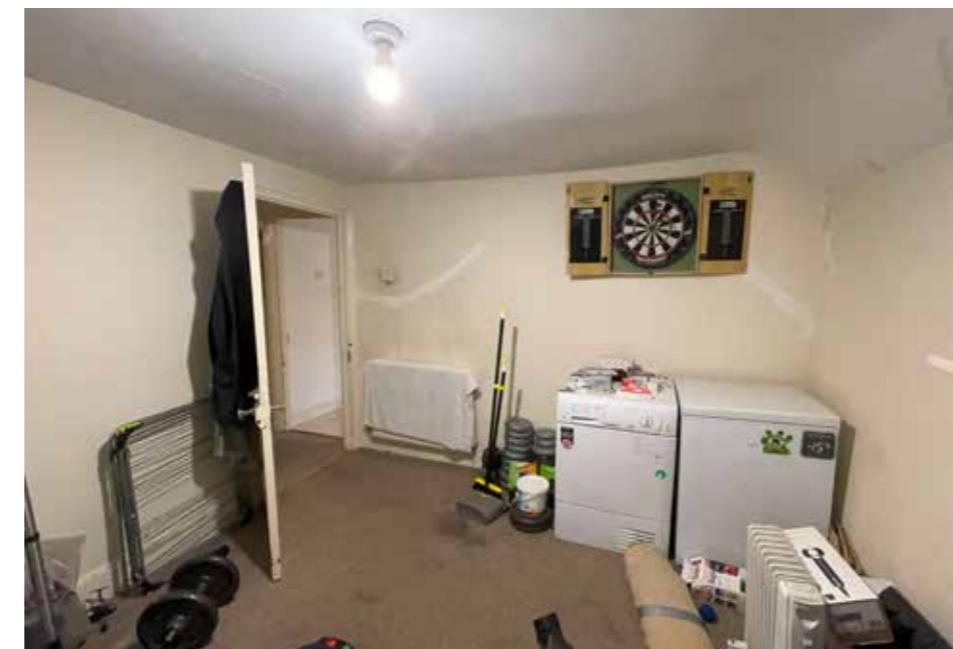
There is some staining on the walls and ceiling; and there appears to have been some areas of crack repair, fairly recently, to some of the plasterwork on the walls. The worst area of staining is to the external north west corner. This will require the plaster to be removed to see what is causing this.

- 3.2.2 Minor but extensive cracking was observed to the plaster through the wallpaper in the rear bedroom 2F and there are signs that the walls have been replastered. This is not of immediate structural concern but warrants further investigation to confirm the condition of the underlying masonry fabric.

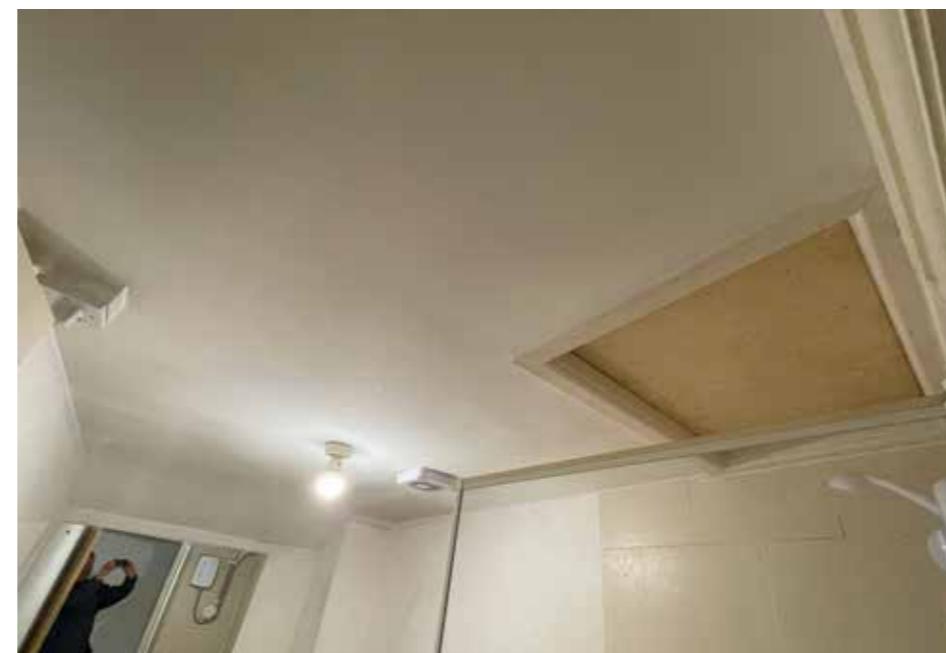
There is mould on one part of an internal wall; however, this is likely to be a case of moisture build-up and insufficient ventilation.

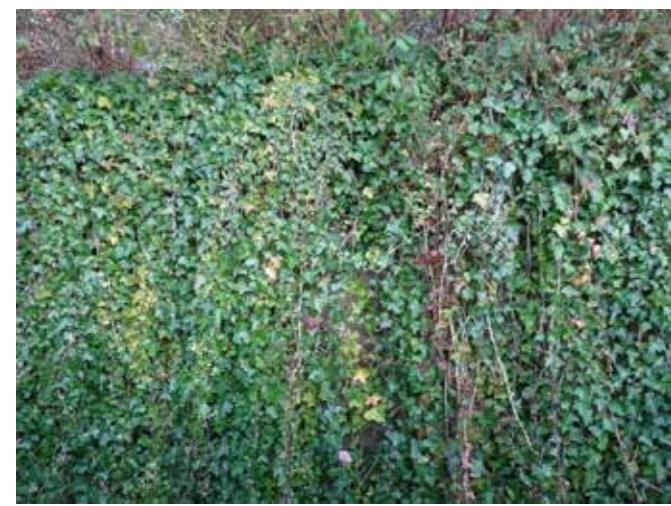
- 2.8.1 To the east of the building is an approx. 3m tall stone masonry retaining wall which is fully retaining an upper garden. The wall appears to comprise rubble stone masonry likely bound and originally pointed in lime mortar similar to the walls of the neighbouring Synagogue. The wall is currently covered with vegetation (ivy) and there is extensive vegetation / shrubs growing out of the head of the masonry therefore the wall was generally not inspectable.
- 2.8.2 The front elevation of the wall is heavily pointed in cement which is assumed to be a more recent repair.

- 3.5.1 The eastern retaining wall appears to be in reasonable condition and seems reasonably plumb where locally visible through the vegetation, however the elevation is generally covered with vegetation. The exact extent of distress / deterioration is unknown.

- 4.5 For the existing retaining wall, ongoing vegetation growth puts the masonry fabric at risk of further deterioration if left unaddressed with the potential to cause structurally significant harm to the existing fabric. The shrubs growing out of the head of the wall have the potential to accelerate degradation and risk localised loss of masonry which could fall from height unpredictably. The wall is also heavily pointed in cement which has the potential to trap water and accelerate degradation particularly considering the wall is fully retaining the upper garden which naturally drains towards the rear of the wall.

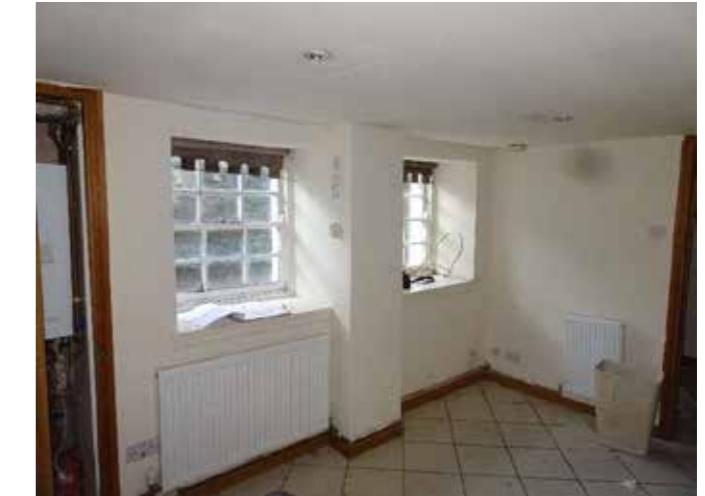
- 3.2.3 At basement level we anticipate that part of the masonry spine wall has been removed with an assumed steel lintel built into the ceiling / ground floor. The arrangement and condition of this beam are unknown.

- Inspection of the assumed steel beam in the basement where we suspect the historic spine wall was removed to inform details, specification and condition of the beam.

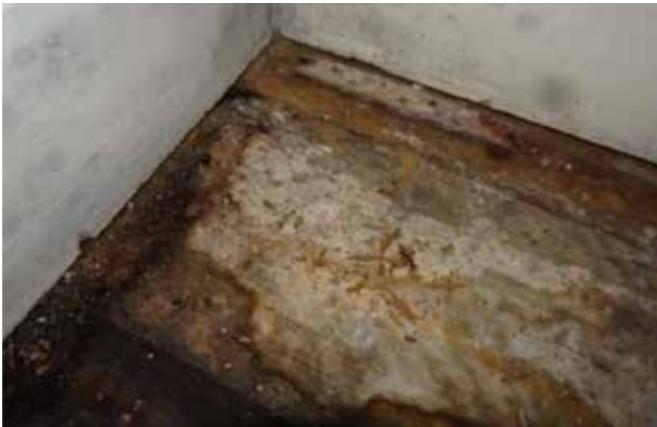
- 3.3.3 In room 1F where the floorboards were uncovered, there is localised evidence of minor decay to the floorboards in the southeast corner of the room. It is possible that this may also have affected the floor joists which are assumed to be built into the external wall in this location.

- Inspection of the existing timber floor buildups at all levels, in particular along the internal faces of the external walls where damp is most significant. This would require floorboards to be lifted in a couple of the rooms at each level by a contractor which would permit inspections by the structural engineer to confirm condition (degradation of the joists and bearings) and capacity of the existing joists to help inform future uses. Floorboards would then be reinstated following the works.

- 5.2 As part of the refurbishment, we recommend allowing for localised repair and replacement of timber joists if found to be in a decayed state.

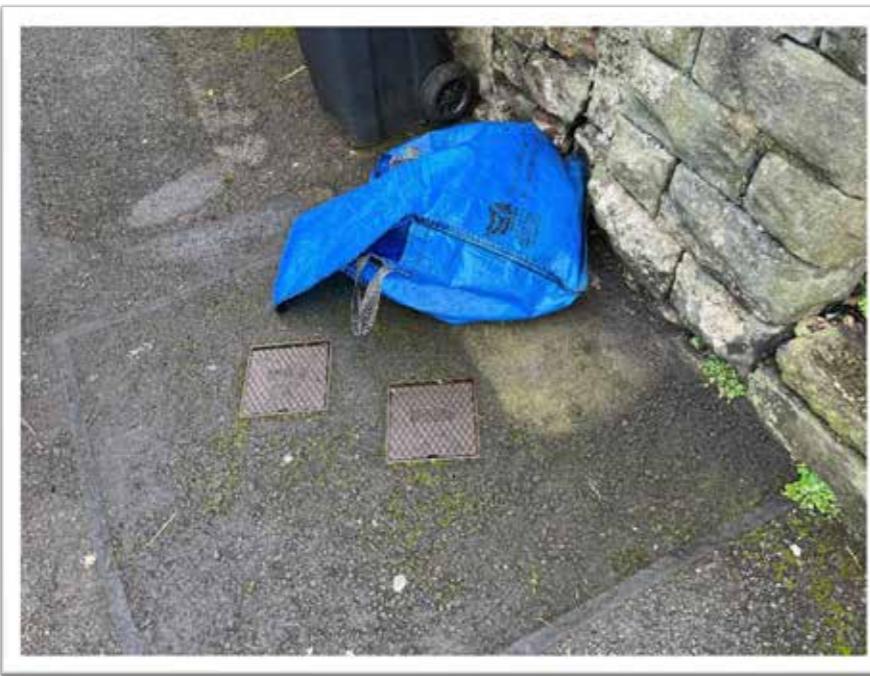
Overall, the condition of installation was found to be in a fair condition throughout.

Cold Water Mains Stop Cocks

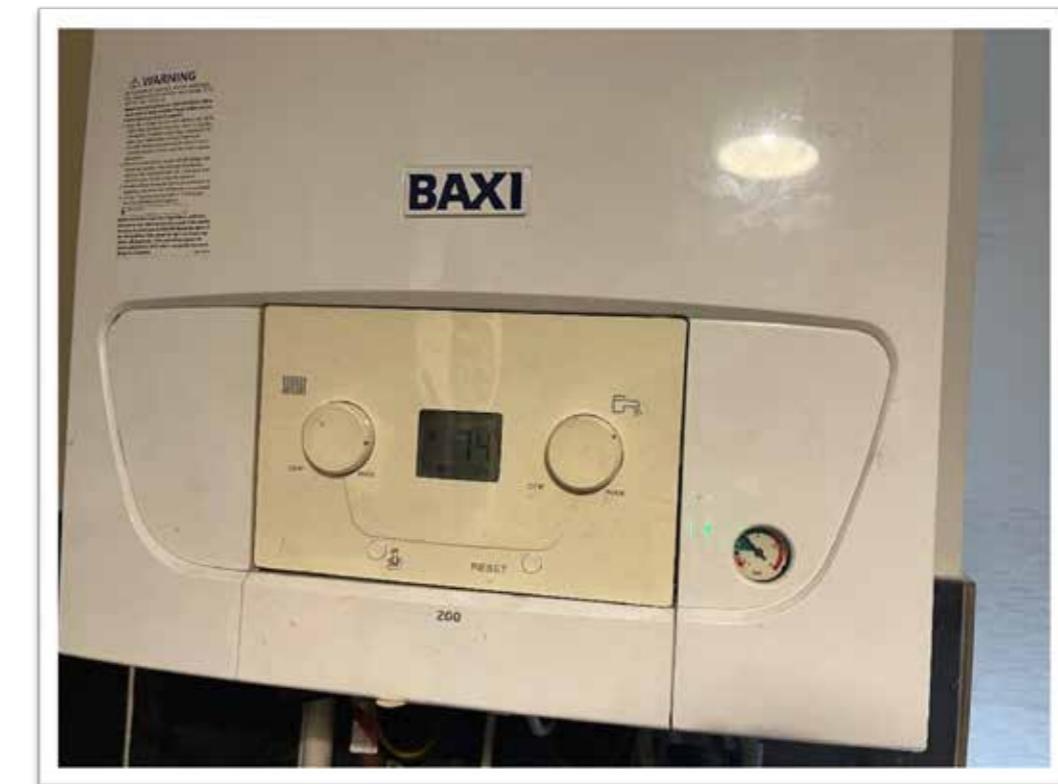
Baxi Combi Boiler

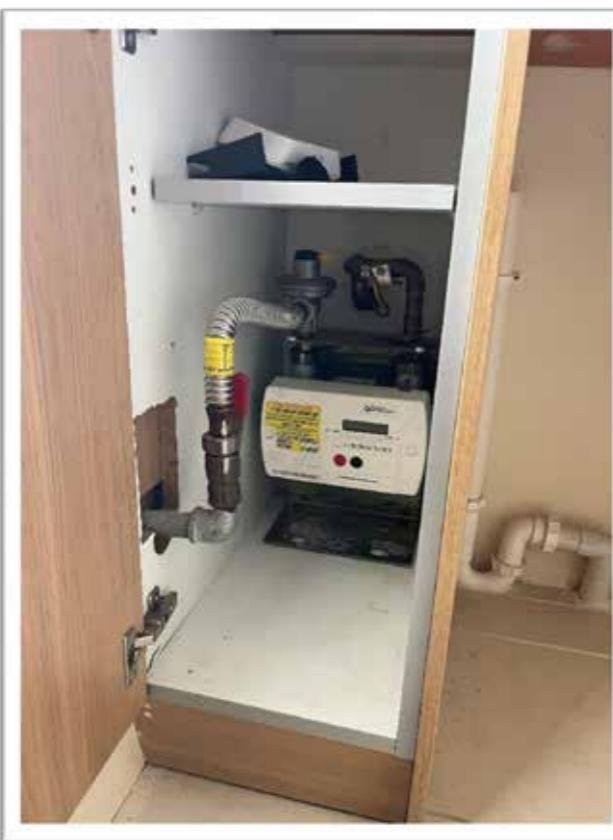
Overall, the condition of the installation was found to be fair.

Gas Meters

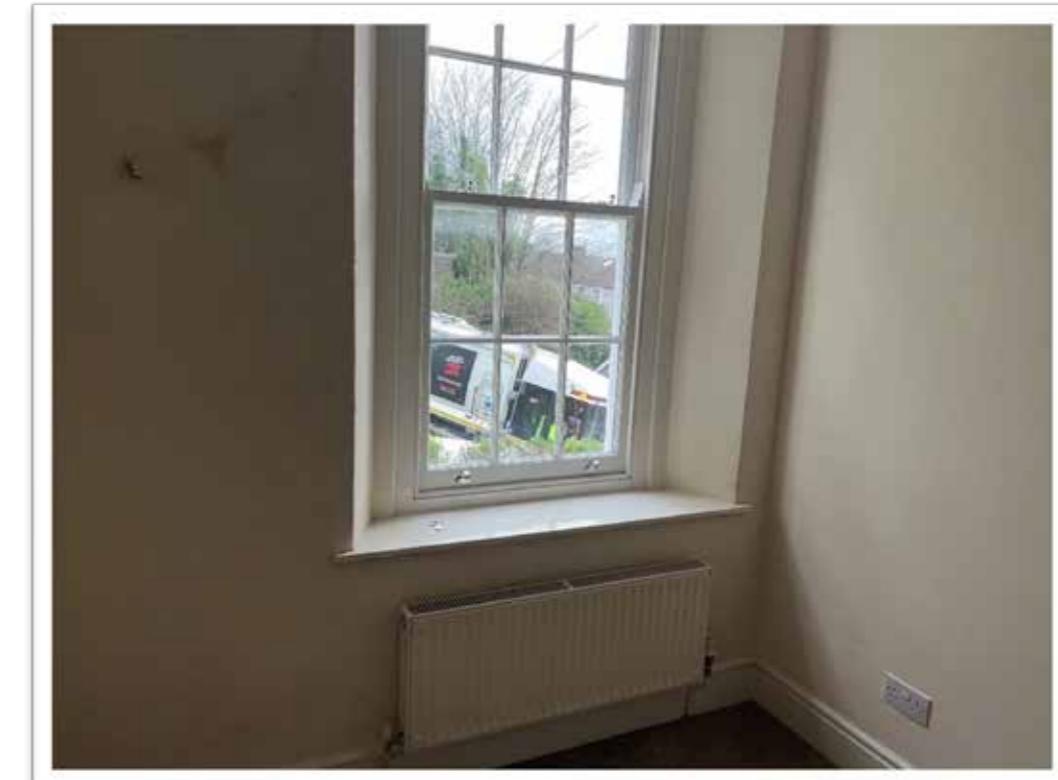
The steel panel radiators were generally in fair condition.

Steel Panel Radiators

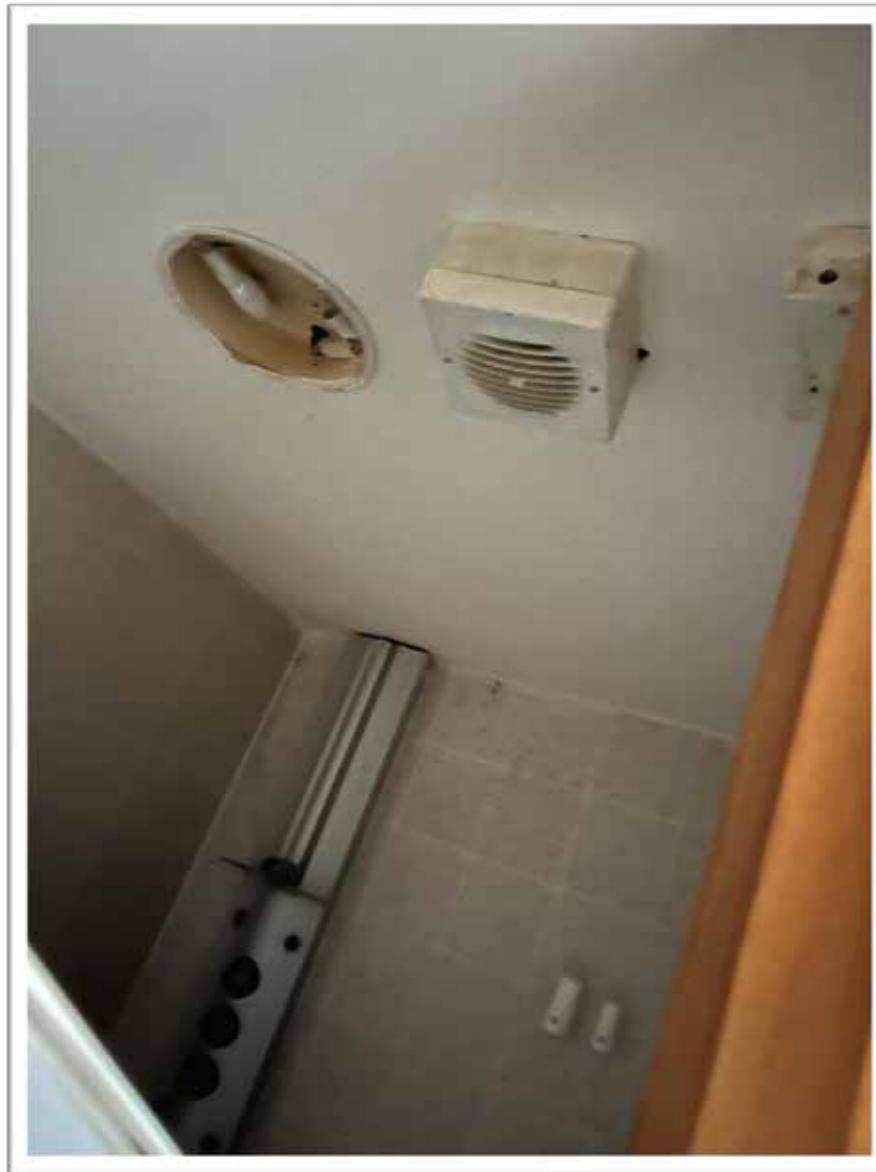
Mechanical ventilation generally is in very poor condition.

Bathroom Extractor Fan

Replace all mechanical ventilation.

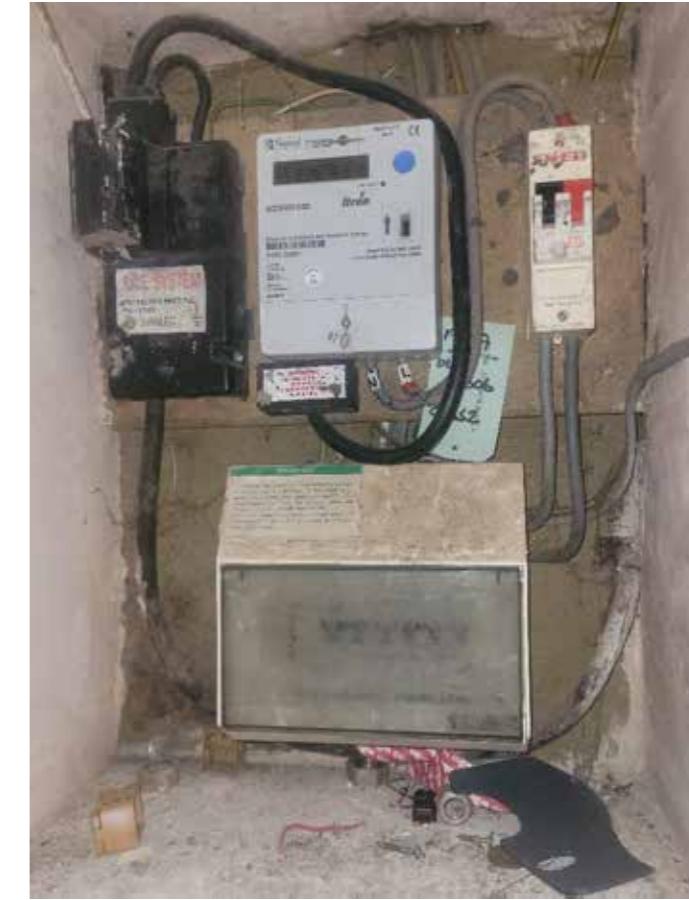
The basement flat is supplied by an underground National Grid service cable which terminates in a Single Phase and Neutral Cut Out unit as shown in the image below:

The electrical supply is a 60 Ampere single phase 2-wire TN-S 230-volt 50Hz. PME (TN-C-S) and there are no visual signs of any thermal damage or stress to the conductors.
