# BAT TREE SURVEY REPORT

HOOVER SITE,  
MERTHYR TYDFIL

<b>Project: Hoover Site, Merthyr Tydfil</b>		
<b>Project Number</b>	K001	
<b>Title</b>	Bat Tree Report	
<b>Document Number</b>	K001 – Bat Tree Report-V1.3	
<b>Client</b>	Walters	
<b>Issue Date</b>	30-Oct-25	
<b>Prepared by:</b>	David Price 30-Oct-25	
<p>This report has been prepared by Sylvan Ecology, with all reasonable skill, care, and diligence within the terms of the Contract with the client. We disclaim any responsibility to the client and others in respect of any matters outside the scope of the above. This report is confidential to the client, and we accept no responsibility of whatsoever nature to third parties to whom this report, or any part thereof, is made known. Any such party relies on the report at their own risk.</p>		
<b>Executive summary</b>		
Site	The survey was conducted on all trees within or on the boundary of the site, to assess their suitability for roosting bat.	
Protected Spp (Bats)	<b>Potential low Impact</b> – Some PRF-I trees were identified on site, that could be utilised by individual trees – Recommendations: impacts negated through mitigation

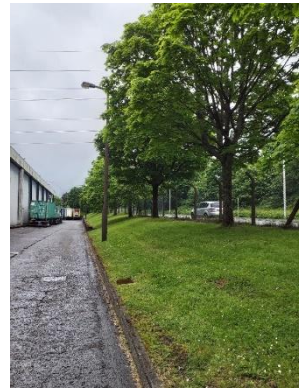
T22	Red Maple ( <i>Acer rubrum</i> )	14	Middle aged	Good	Tree of good form and vigour.	N/A	None	N/A
T23	Norway Maple ( <i>Acer platanoides</i> )	5	Young	Poor	Naturally regenerated boundary tree of poor form heavily suppressed to the north and west.	N/A	None	N/A
G24	Group of: Norway Maple ( <i>Acer platanoides</i> )	15	Middle aged	Good	Prominent trees of good form and vigour.	N/A	None	N/A
T25	Norway Maple ( <i>Acer platanoides</i> )	13	Middle aged	Fair to poor	Prominent boundary tree exhibiting significant dieback in centre of crown.	N/A	None

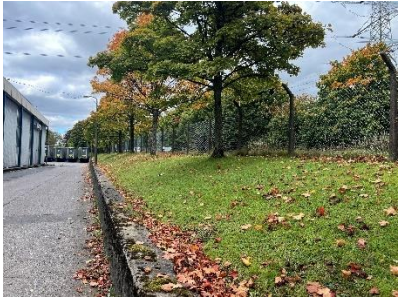
G29	Group of: Norway Maple ( <i>Acer platanoides</i> )	11	Middle aged	Good	Prominent boundary trees forming robust linear feature.	N/A	None

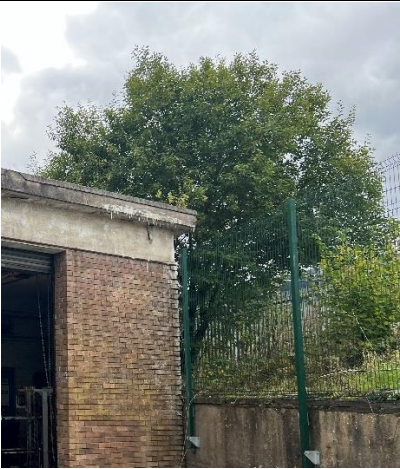
T30	Norway Maple ( <i>Acer platanoides</i> )	16	Middle aged	Good	Prominent boundary tree of good form and vigour.	N/A	None	N/A
T31	Goat Willow ( <i>Salix caprea</i> )	6	Middle aged	Fair	Scrubby naturally regenerated specimen of variable form whose crown extends over railway land.	N/A	None

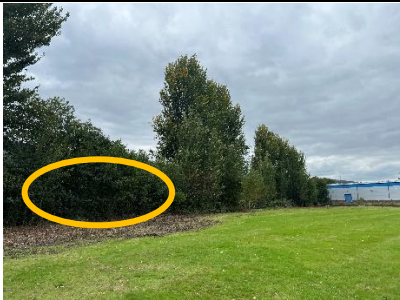
G46	Group of: Lombardy Poplar ( <i>Populus nigra</i> 'Italica'), Birch ( <i>Betula pendula</i> ), Hazel ( <i>Corylus avellana</i> ), Goat Willow ( <i>Salix caprea</i> )	Up to 10	Young / Middle aged	Fair	Scrubby naturally regenerated specimens forming linear screen adjacent to boundary.	N/A	None

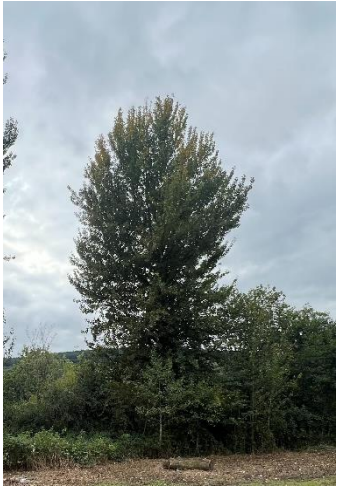
T47	Lombardy Poplar ( <i>Populus nigra</i> 'Italica')	21	Mature	Fair to poor	Isolated and prominent specimen that has suffered significant historical crown reduction leading to development of dysfunctional growth in mid and upper crown. This specimen is vulnerable to significant structural failure as it matures.	N/A	None

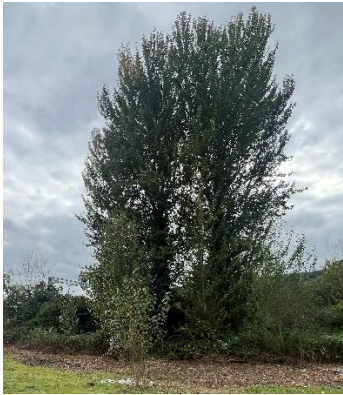
G48	Group of 2: Lombardy Poplar ( <i>Populus nigra</i> 'Italica')	24	Mature	Fair to poor	Prominent boundary specimens that have suffered significant historical crown reduction leading to development of dysfunctional growth in mid and upper crown. These specimens are vulnerable to significant structural failure as they mature.	N/A	None

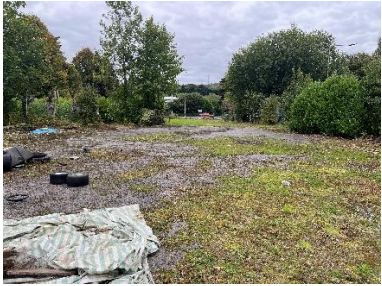
G57	Group of: Cherry Laurel ( <i>Prunus laurocerasus</i> ), Birch ( <i>Betula pendula</i> ), Goat Willow ( <i>Salix caprea</i> )	Up to 18	Middle aged	Fair	Evergreen hedgerow containing some scrubby specimens of naturally regenerated trees.	N/A	None

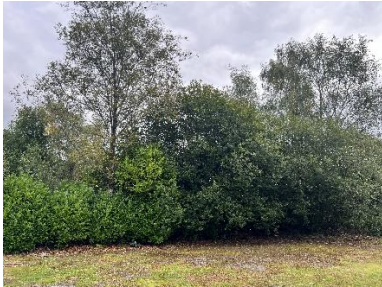
T58	Birch ( <i>Betula pendula</i> )	19	Mature	Good	Prominent specimen surrounded by dense vegetation thus preventing full inspection and accurate measurement. A tree of good form and vigour.	N/A	None

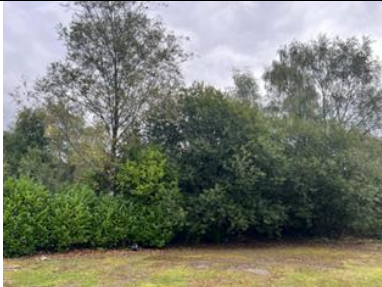
G59	Group of: Cherry Laurel ( <i>Prunus laurocerasus</i> )	2	Middle aged	Fair	Dense boundary hedgerow.	N/A	None

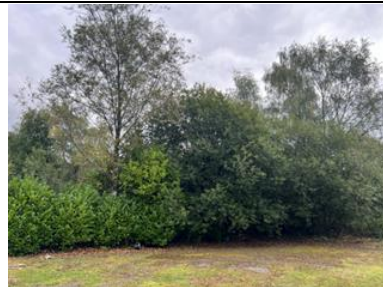
T60	Goat Willow ( <i>Salix caprea</i> )	11	Mature	Fair	Prominent and isolated naturally regenerated specimen located within roadside verge.	N/A	None

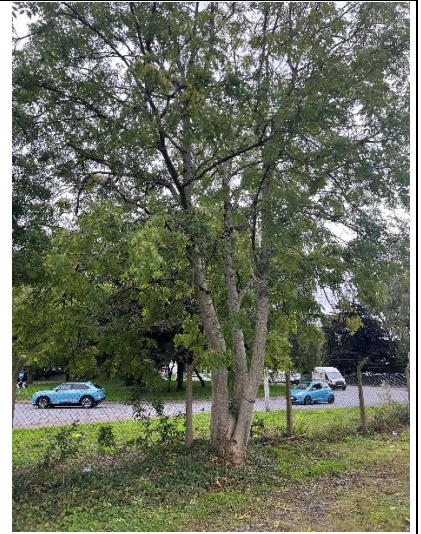
G64	Group of: Lime ( <i>Tilia × europaea</i> ), Norway Maple ( <i>Acer platanoides</i> ), Swedish Whitebeam ( <i>Sorbus intermedia</i> ), Hawthorn ( <i>Crataegus monogyna</i> )	Up to 19	Middle aged	Fair	Tree group dominated by a tall specimen of Lime. Some trees exhibit minor mechanical damage at base.	N/A	None	N/A
T65	Ash ( <i>Fraxinus excelsior</i> )	17	Middle aged	Poor	Multi-stemmed boundary tree exhibiting early-stage symptoms of Ash Dieback Disease.	N/A	None

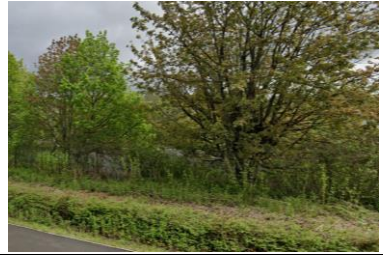
G75 Off site	Group of: Norway Maple ( <i>Acer platanoides</i> )	Up to 22	Mature	Good	Trees of reasonable form and vigour creating robust linear arboricultural feature.	N/A	None	N/A
T76 Off site	Dead					N/A	None	N/A
T77 Off site	Sycamore ( <i>Acer pseudoplatanus</i> )	18	Middle aged	Fair	Slightly suppressed specimen with crown more heavily developed on southwestern side.	N/A	None	N/A
G78	Group of: Birch ( <i>Betula pendula</i> ), Goat Willow ( <i>Salix caprea</i> ), Sycamore ( <i>Acer pseudoplatanus</i> ), Oak ( <i>Quercus robur</i> )	8	Young	Fair to poor	Naturally regenerated specimens of variable form and vigour.	N/A	None	N/A
G79	Group of 2: Norway Maple ( <i>Acer platanoides</i> )	9	Middle aged	Fair	Scrubby multi-stemmed specimens of variable form and vigour.	N/A	None

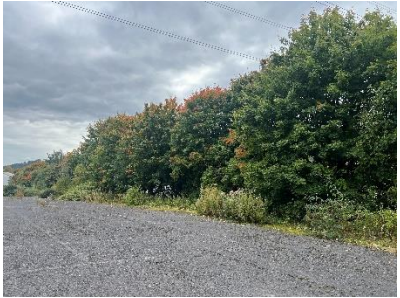
T98	Norway Maple ( <i>Acer platanoides</i> )	13	Middle aged	Good	Prominent boundary tree of good form and vigour.	N/A	None

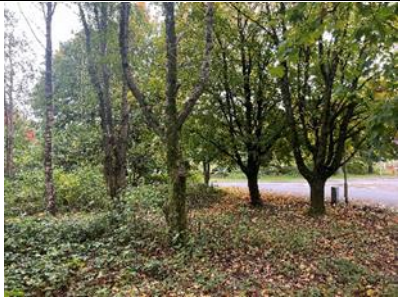
T99	Elder ( <i>Sambucus nigra</i> )	5	Mature	Poor	Multi-stemmed scrubby specimen exhibiting significant dieback on northern side of crown.	N/A	None	N/A
T100	Norway Maple ( <i>Acer platanoides</i> )	15	Middle aged	Fair	Tree of reasonable form and vigour.	N/A	None

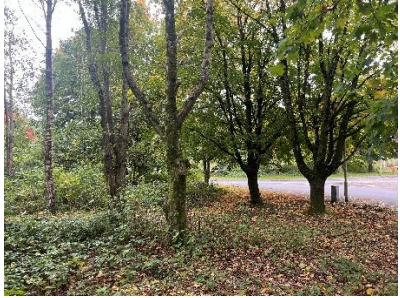
T101	Norway Maple ( <i>Acer platanoides</i> )	14	Middle aged	Fair	Tree of reasonable form and vigour.	N/A	None

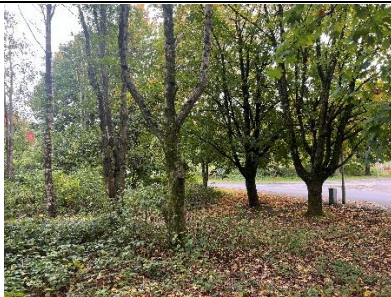
G102	Group of: Birch ( <i>Betula pendula</i> ), Alder ( <i>Alnus glutinosa</i> ), Norway Maple ( <i>Acer platanoides</i> )	Up to 18	Young / Middle aged	Fair	Spindly trees with low stem diameter to height ratio.	N/A	None

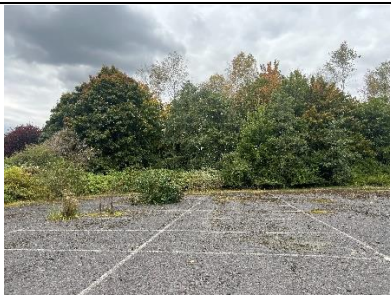
G103	Group of: Alder ( <i>Alnus glutinosa</i> ), Goat Willow ( <i>Salix caprea</i> )	11	Young	Poor	Scrubby. Naturally regenerated specimens established on tarmac surface that is likely to lead to instability in the foreseeable future.	N/A	None

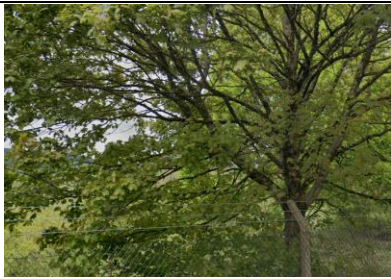
G104	Group of: Norway Maple ( <i>Acer platanoides</i> )	12	Middle aged	Fair	Woodland edge trees of reasonable form and vigour.	N/A	None	N/A
T105	Norway Maple ( <i>Acer platanoides</i> )	11	Middle aged	Good	Prominent roadside tree of good form and vigour.	N/A	None

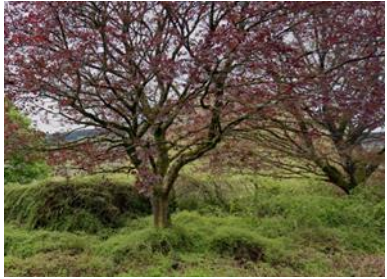
T107 Off site	Norway Maple ( <i>Acer platanoides</i> )	11	Middle aged	Fair	Prominent roadside tree that has suffered poor quality pruning on northern side of lower crown.	N/A	None

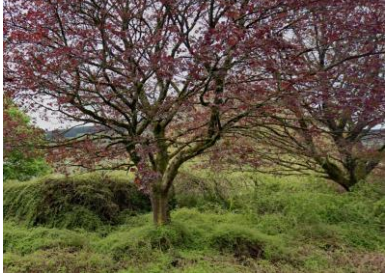
T109 Off site	Norway Maple ( <i>Acer platanoides</i> )	14	Middle aged	Good	Prominent roadside tree of good form and vigour.	N/A	None

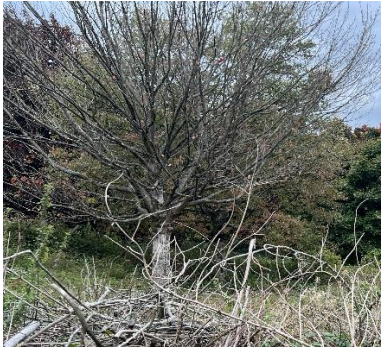
G110	Group of: Red Maple ( <i>Acer rubrum</i> )	10	Middle aged	Good	Boundary trees of good form and vigour.	N/A	None
