# BAT SURVEY REPORT

## HOOVER SITE, MERTHYR TYDFIL

<b>Project Number</b>	K001	
<b>Title</b>	Bat Survey Report	
<b>Document Number</b>	K001- Bat Report-V1.2	
<b>Client</b>	Walters	
<b>Issue Date</b>	29/09/2025	
<b>Prepared by:</b>	David Price - Consulting Ecologist 29/09/2025

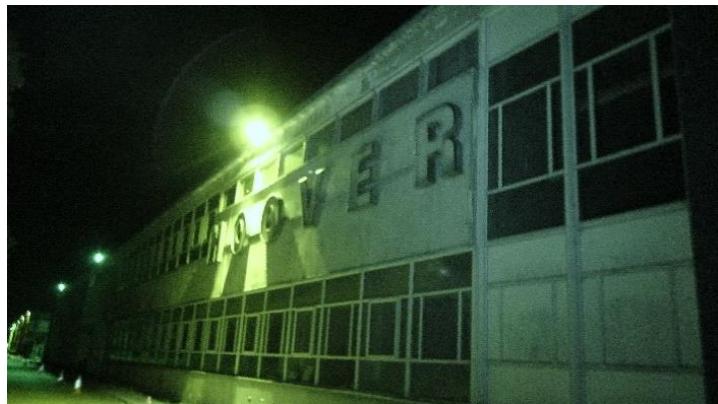
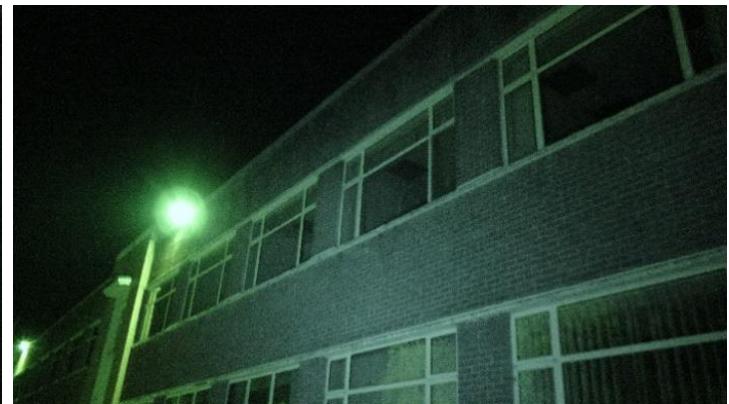
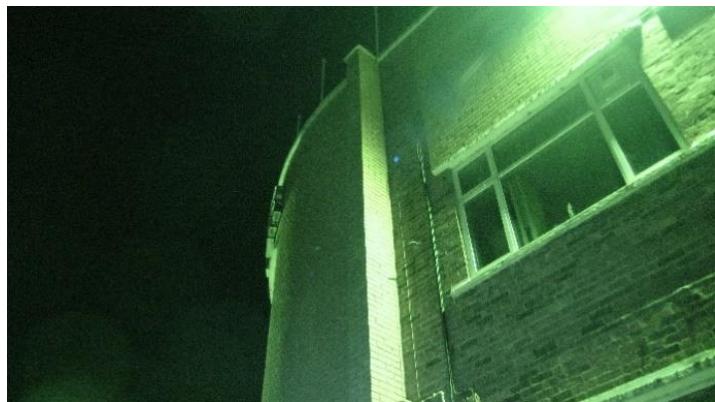
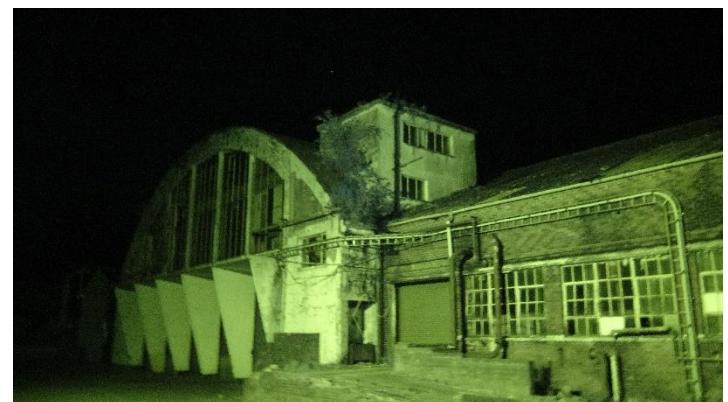
Building 1a.

The screenshots from the IR cameras are shown below; the high levels of light on site are clearly visible.
