BAT TREE SURVEY REPORT

HOOVER SITE, MERTHYR TYDFIL

Project Number	K001	
Title	Bat Tree Report	
Document Number	K001 – Bat Tree Report- V1.4	
Client	Walters	
Issue Date	11-Dec-25	
Prepared by:	David Price 11-Dec-25

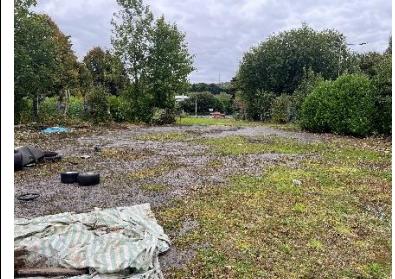
T58	Birch (<i>Betula pendula</i>)	19	Mature	Good	Prominent specimen surrounded by dense vegetation thus preventing full inspection and accurate measurement. A tree of good form and vigour.	N/A	None

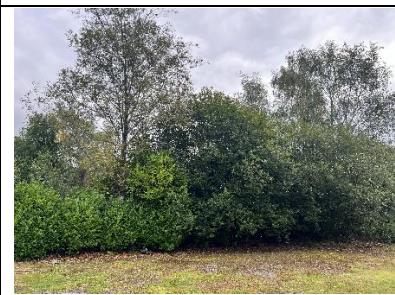
G59	Group of: Cherry Laurel (<i>Prunus laurocerasus</i>)	2	Middle aged	Fair	Dense boundary hedgerow.	N/A	None

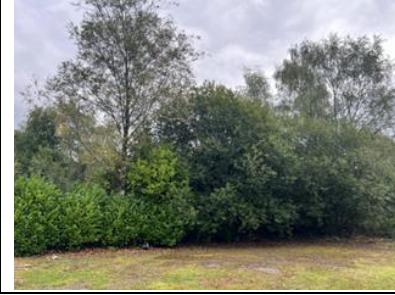
T60	Goat Willow (<i>Salix caprea</i>)	11	Mature	Fair	Prominent and isolated naturally regenerated specimen located within roadside verge.	N/A	None

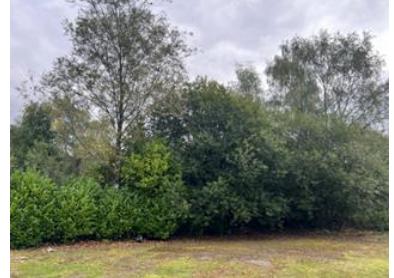
G61	Group of: Ash (<i>Fraxinus excelsior</i>), Whitebeam (<i>Sorbus aria</i>)	11	Middle aged	Poor	Boundary trees of variable form. Ash are infected with Ash Dieback Disease. Whitebeam has suffered significant basal pruning leading to development of internal decay.	No visible PRFs.	None

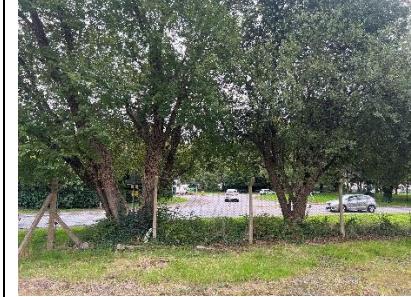
T67	Horse Chestnut (<i>Aesculus hippocastanum</i>)	17	Mature	Poor	Prominent boundary tree exhibiting significant internal decay within main stem and mid crown.	Some minor rot and damage to the tree, none of which offers viable roosting features. Some lifted bark offering limited roosting offer opportunities for crevice dwelling bats.	PRF-I

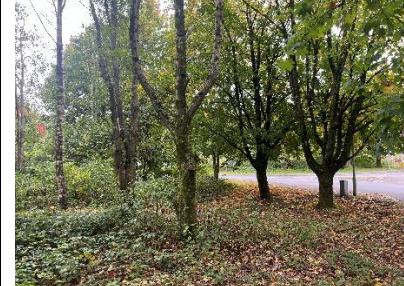
G103	Group of: Alder (<i>Alnus glutinosa</i>), Goat Willow (<i>Salix caprea</i>)	11	Young	Poor	Scrubby. Naturally regenerated specimens established on tarmac surface that is likely to lead to instability in the foreseeable future.	N/A	None

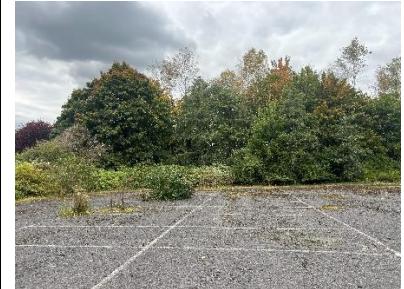
G104	Group of: Norway Maple (<i>Acer platanoides</i>)	12	Middle aged	Fair	Woodland edge trees of reasonable form and vigour.	N/A	None	N/A
T105	Norway Maple (<i>Acer platanoides</i>)	11	Middle aged	Good	Prominent roadside tree of good form and vigour.	N/A	None

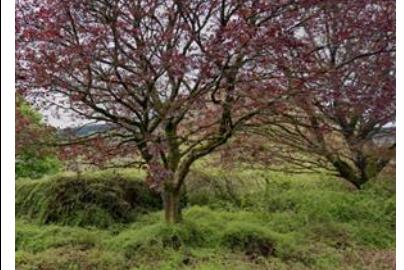
T108 Off site	Norway Maple (<i>Acer platanoides</i>)	13	Middle aged	Fair	Prominent roadside tree that has suffered significant poor quality pruning on northern and eastern side of lower crown. Possible weakness in lower fork at 2m.	N/A	None

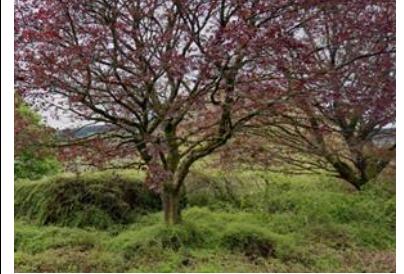
T109 Off site	Norway Maple (<i>Acer platanoides</i>)	14	Middle aged	Good	Prominent roadside tree of good form and vigour.	N/A	None
