BAT SURVEY REPORT

HOOVER SITE, MERTHYR TYDFIL

Project Number	K001	
Title	Bat Survey Report	
Document Number	K001- Bat Report-V1.3	
Client	Walters	
Issue Date	29/09/2025	
Prepared by:	David Price - Consulting Ecologist 29/09/2025

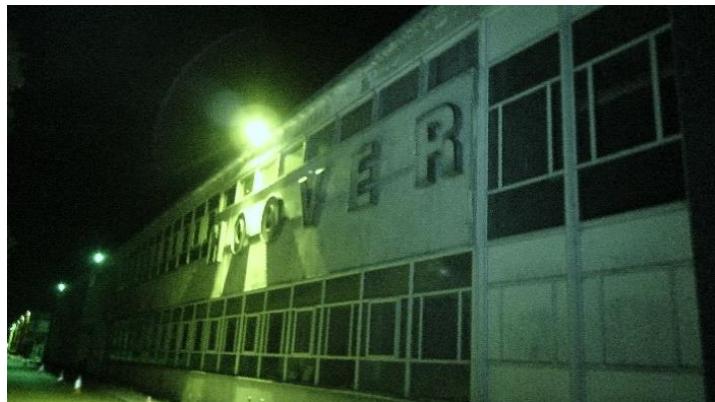
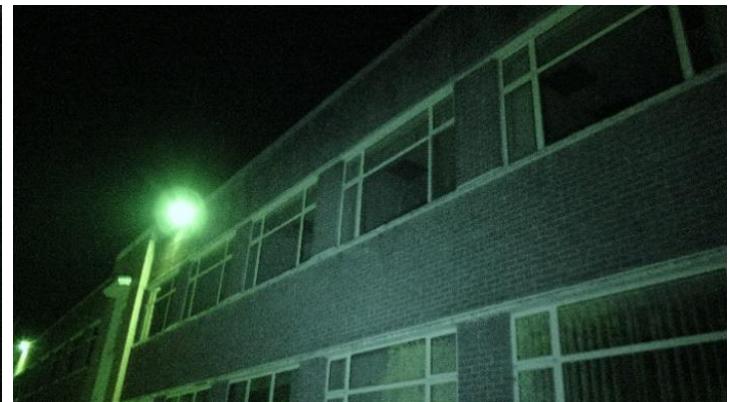
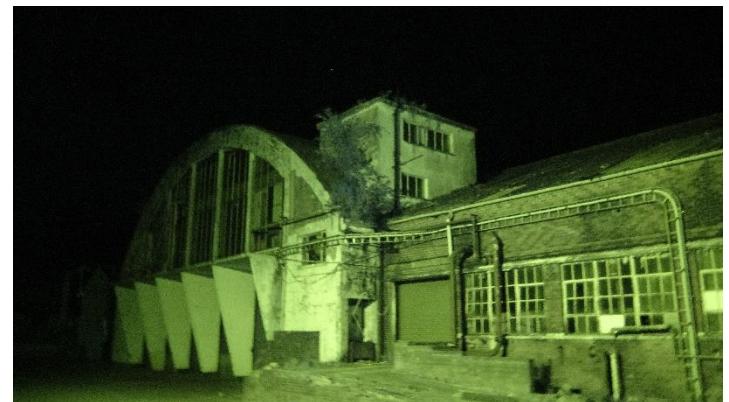
Building 1a.

The screenshots from the IR cameras are shown below; the high levels of light on site are clearly visible.
