*Report No. BC/MB/11.23.01.*

# **Coal Mining Risk Assessment: Land at Dowlais Rugby Club, Blaendowlais, Merthyr Tydfil.**

***Dowlais Rugby Club***

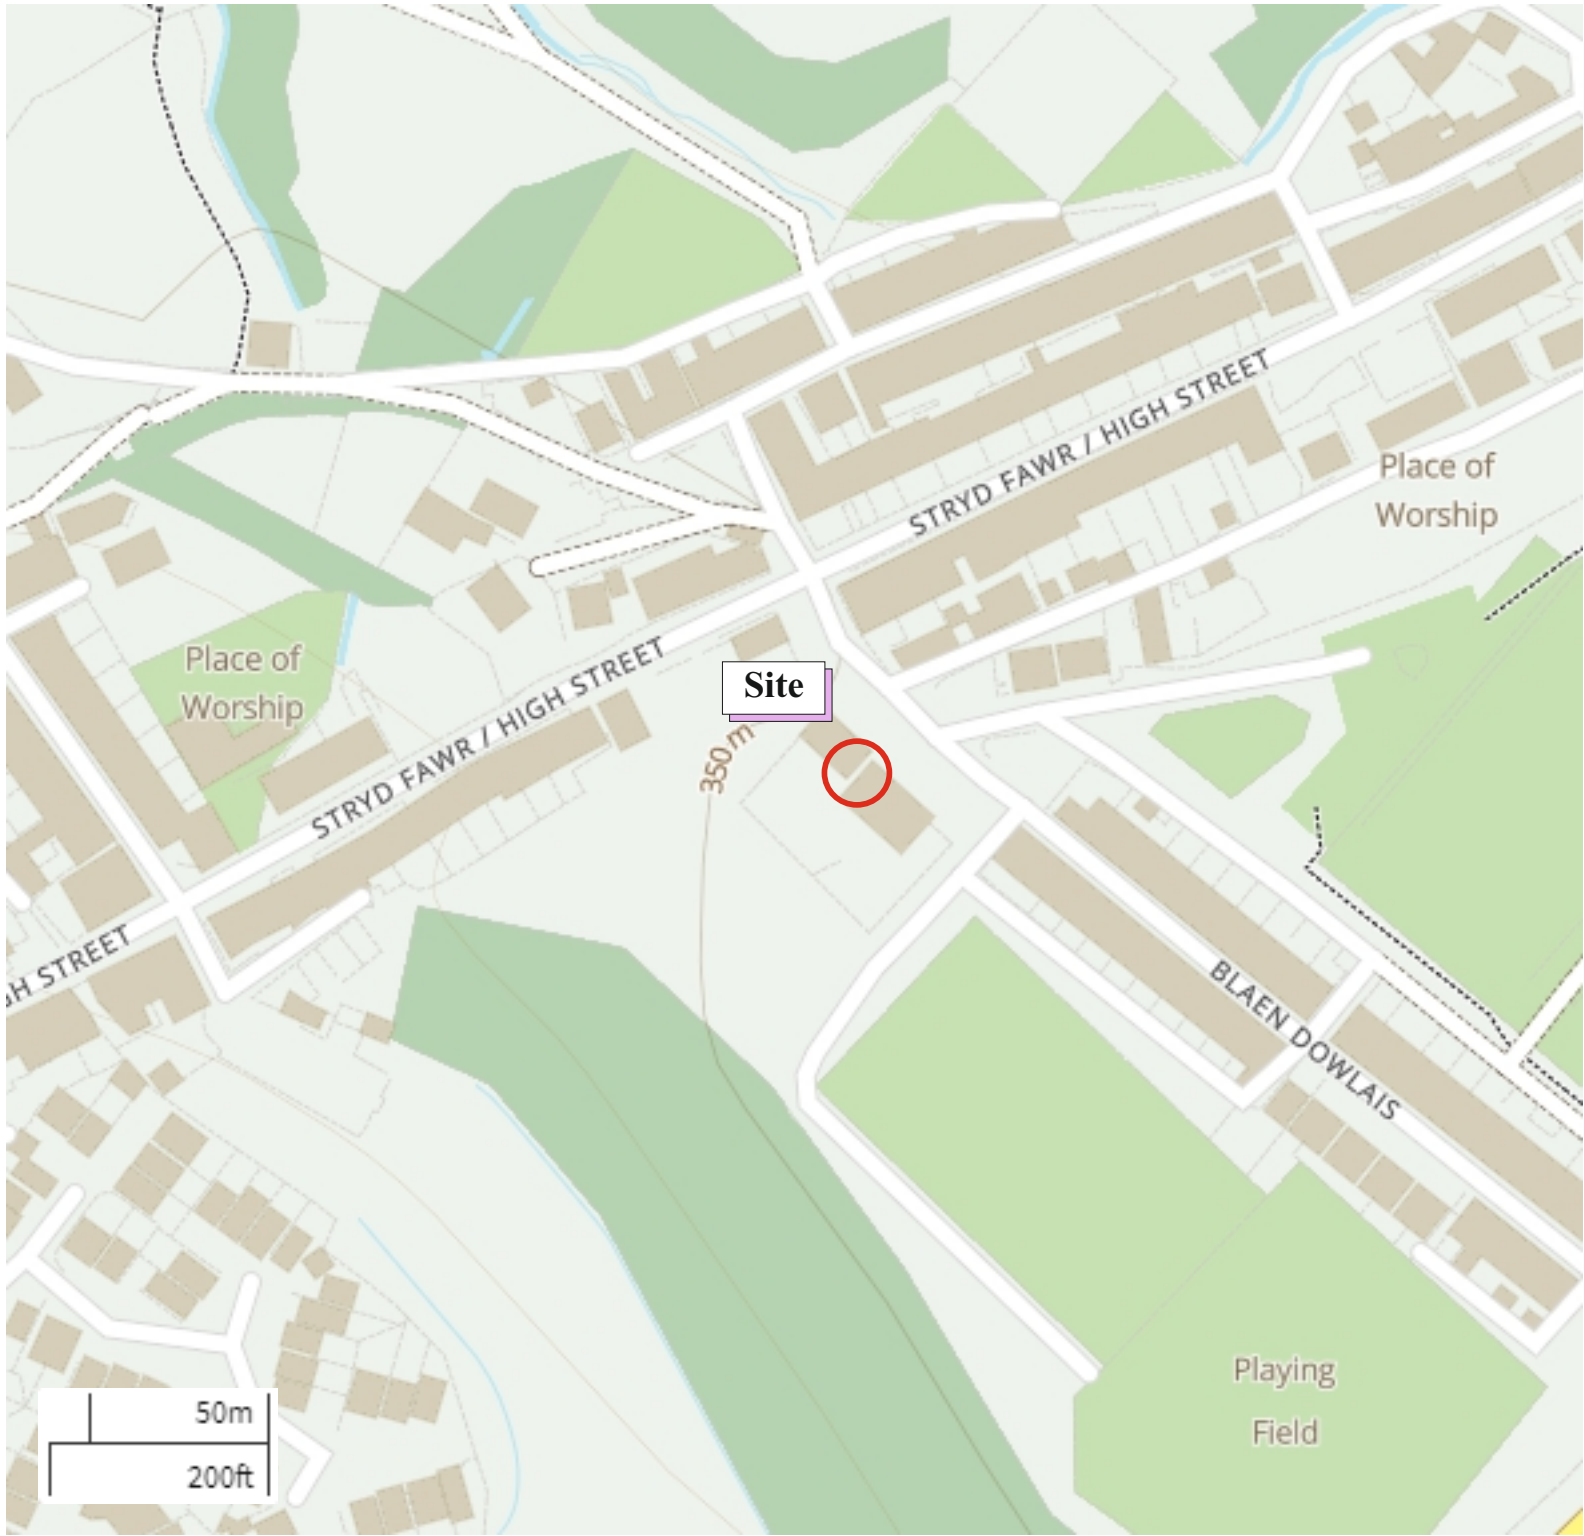
*Detailed Location Plan.*

Our searches found a record of only one disused shaft or adit within the confines of the Site, the disused mine entry is an adit shown to be present immediately to the south of the proposed extension, the adit was driven in a northerly direction and would pass beneath the complex that is the existing buildings and the proposed extension and poses a risk of subsidence to the proposed extension or a risk of there being weak ground present.

Excavations during the construction of the extension **must** be carefully monitored for any evidence of the adit being present and if anything unusual is observed then the excavation work should be stopped immediately and advice sought from a Chartered Geologist or from The Coal Authority.

The foundations for the proposed extension must mitigate against the risk of subsidence associated with the mine adit and/or the shallow ironstone workings, and against any weak ground that may be present as a result of the adit. It is recommended that a reinforced raft foundation is used and must be tied into the foundations of the two existing buildings.
