**Ffos-y-Fran, Merthyr Tydfil**

**Baseline and Preliminary Water Framework  
Directive Compliance Assessment**

**January 2025**

| Project Information | |
|---|---|
| File Ref: | 15840-WFD-03 |

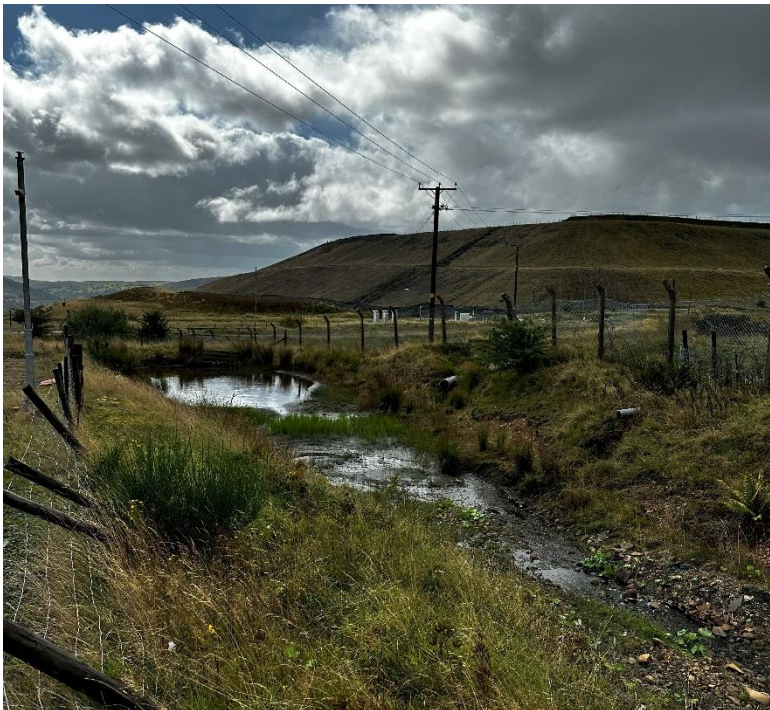
| Photo No.1 | 15840 – Ffos Y Fran |

| <b>Date: 11/09/2024</b><br><b>Description:</b><br><br>Watercourse flowing south at approximate NGR: 308840, 206216 | |

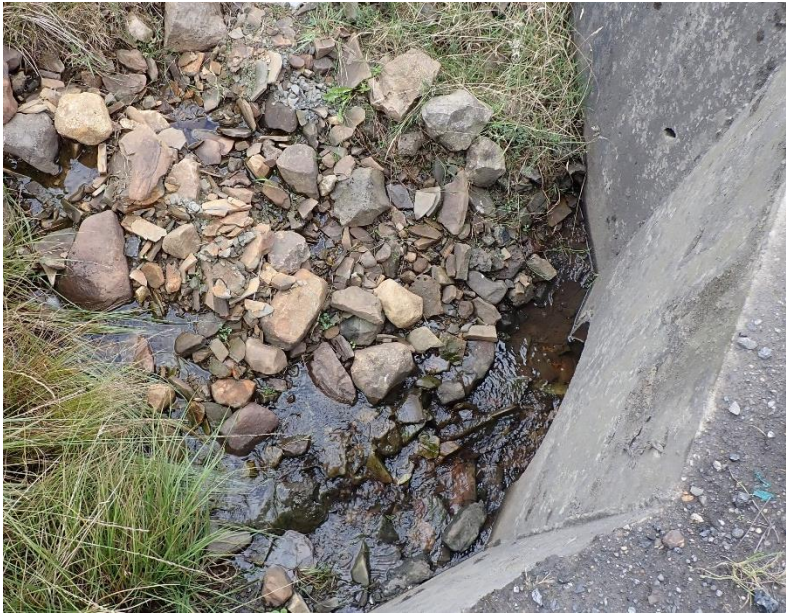
| Photo No.3 | 15840 – Ffos Y Fran |

| <b>Date: 11/09/2024</b><br><b>Description:</b><br>Culvert at approximate NGR: 308833, 206276 | |

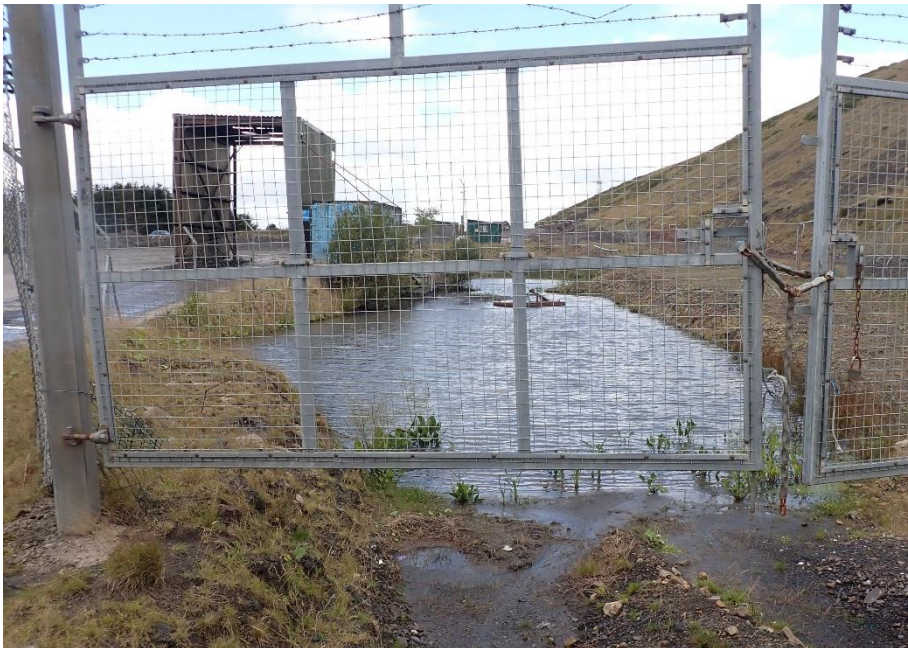
| Photo No. 4 | 15840 – Ffos Y Fran |

| <b>Date: 11/09/2024</b><br><b>Description:</b><br>Wheel wash lagoons. A closed system. Located at approximate NGR: 308791, 206290 (facing west) | |

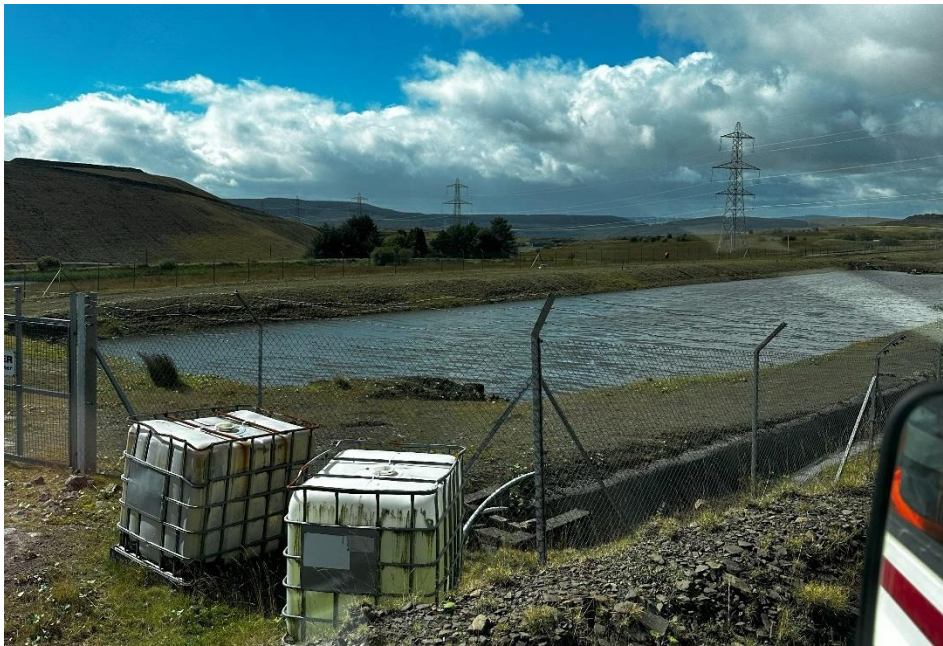
| Photo No.5 | 15840 – Ffos Y Fran |

| <b>Date: 11/09/2024</b><br><b>Description:</b><br><p>Water Treatment Area (WC1). Attenuation Lagoon</p> <p>Approximate NGR: 308372, 206416 (facing south-west)</p> | |

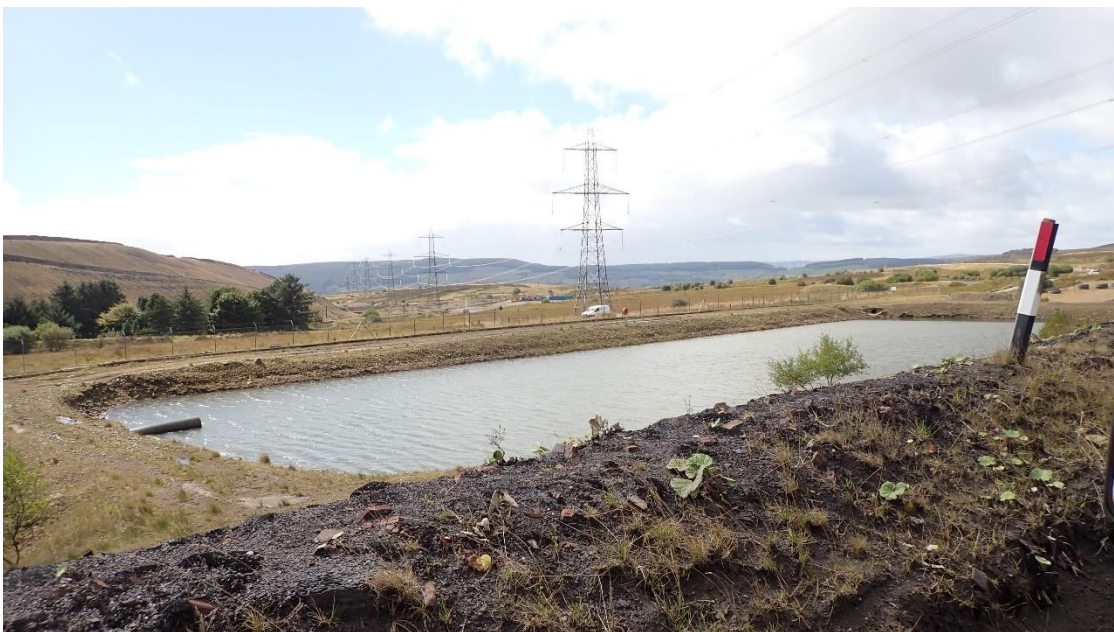
| Photo No.6 | 15840 – Ffos Y Fran |

| <b>Date: 11/09/2024</b><br><b>Description:</b><br><p>WC1. Second attenuation lagoon.</p> <p>Approximate NGR: 308209, 206452 (facing south-west)</p> | |

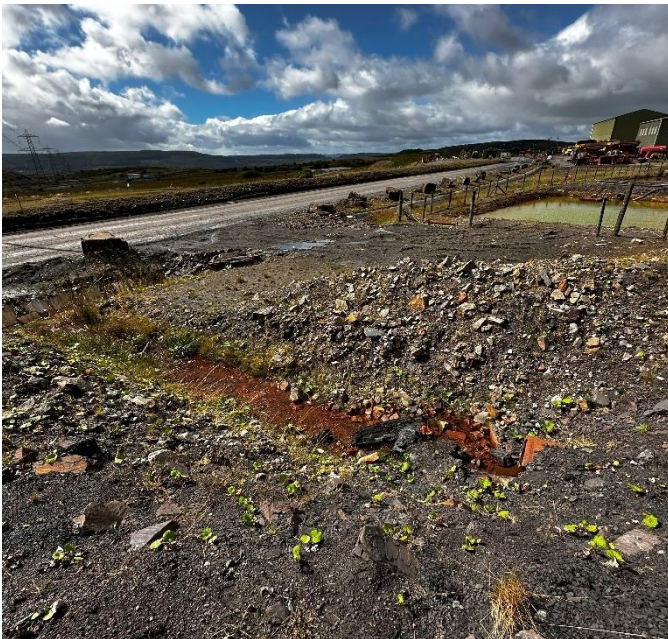
| <b>Date: 11/09/2024</b><br><b>Description:</b><br><p>Culvert outlet.<br/>Open watercourse channel before being culverted beneath the road to WC1.</p> <p>Approximate NGR:<br/>308132, 206490 (facing south-west)</p> | |

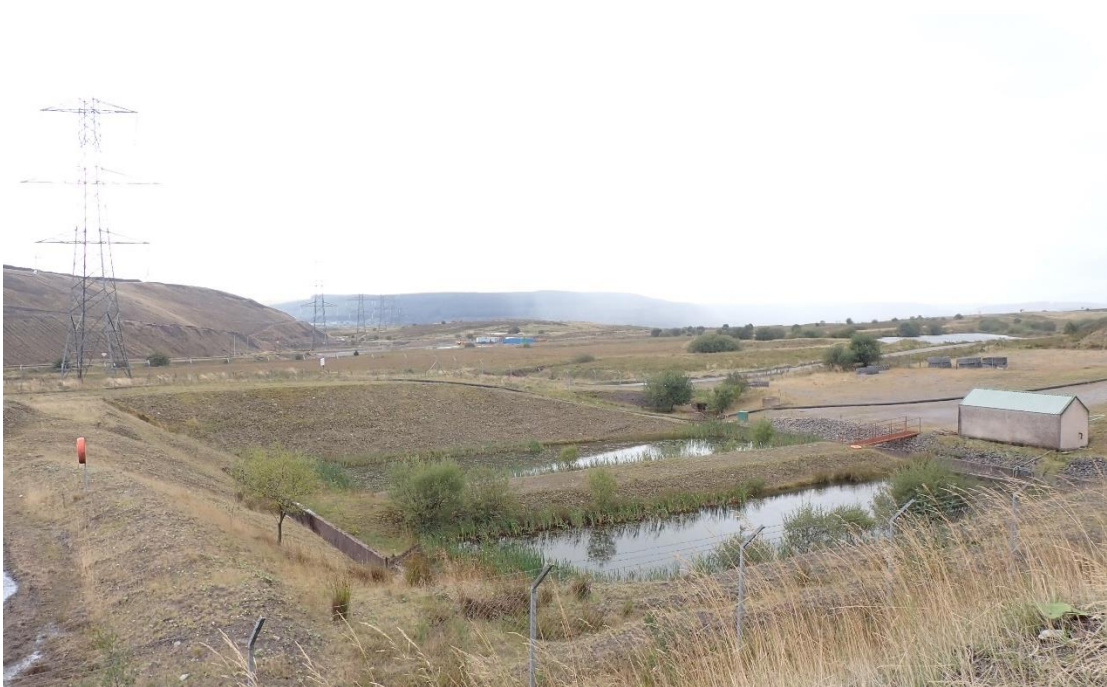
| <b>Photo No.9</b> | <b>15840 – Ffos Y Fran</b> |

| <b>Description:</b><br><br>Settlement lagoons as part of WC1.<br><br>Approximate NGR: 308097, 206481 (facing south-west) | |

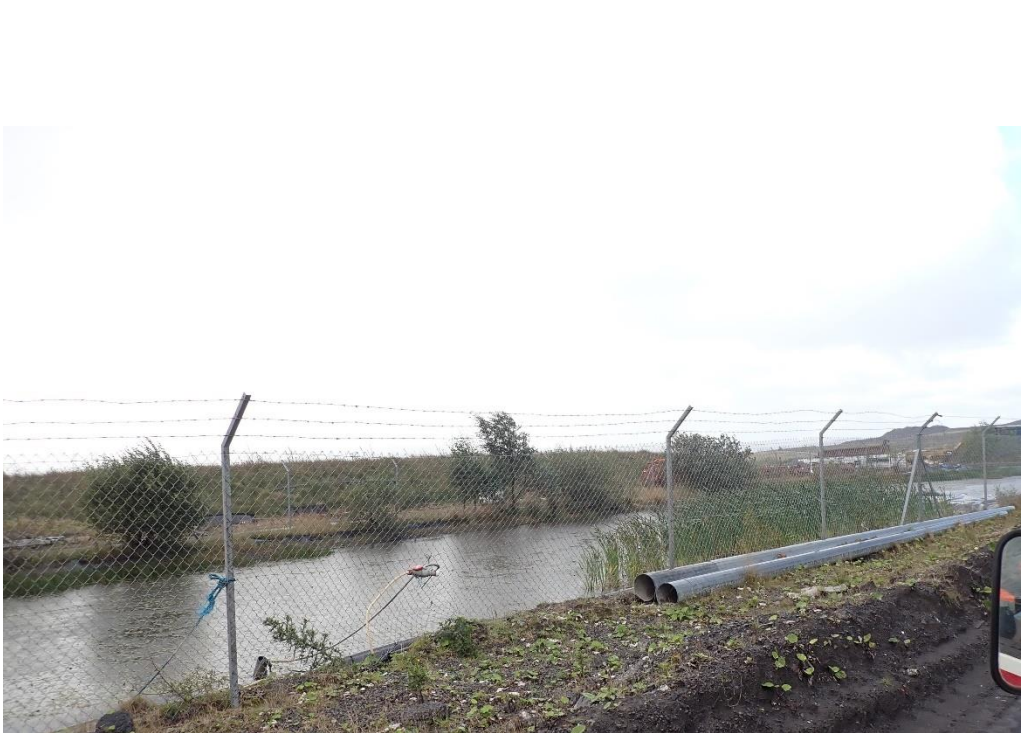
| <b>Photo No. 10</b> | <b>15840 – Ffos Y Fran</b> |

| <b>Description:</b><br><br>Barrel Wash Treatment Ponds. A close system at approximate NGR: 307947, 206501 | |

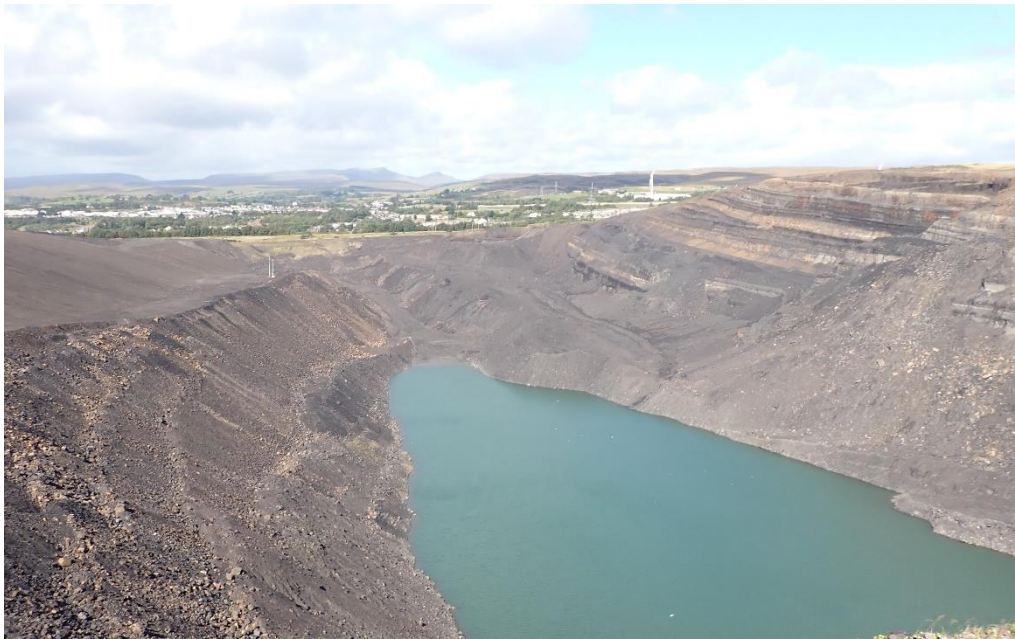
| <b>Photo No.11</b> | <b>15840 – Ffos Y Fran</b> |

| <b>Description:</b><br><br>Quarry void. Photo taken from viewing platform at approximate NGR: 307676, 206582 | |

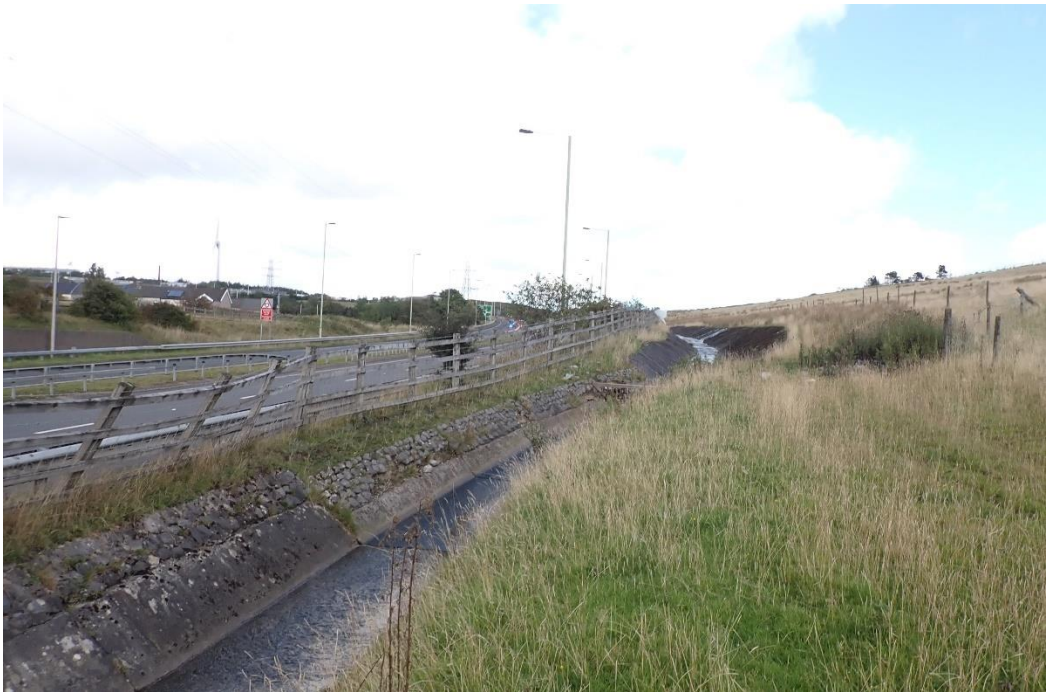
| <b>Photo No. 12</b> | <b>15840 – Ffos Y Fran</b> |

- A concrete channel was also observed in the northernmost extent of the site. This channel transitions into a culvert at approximate NGR: 307541, 207633 and is assumed to connect to the northernmost culvert along the north-western site boundary (known as Cae Harris culvert). No flow was observed during the site visit; it is assumed that the channel conveys surface water flows from OB1 during and following storm events.

| <b>Description:</b><br><br>Watercourse on northern site boundary, flowing in an easterly direction. Concrete channel.<br><br>Approximate NGR: 307559, 207676 | |

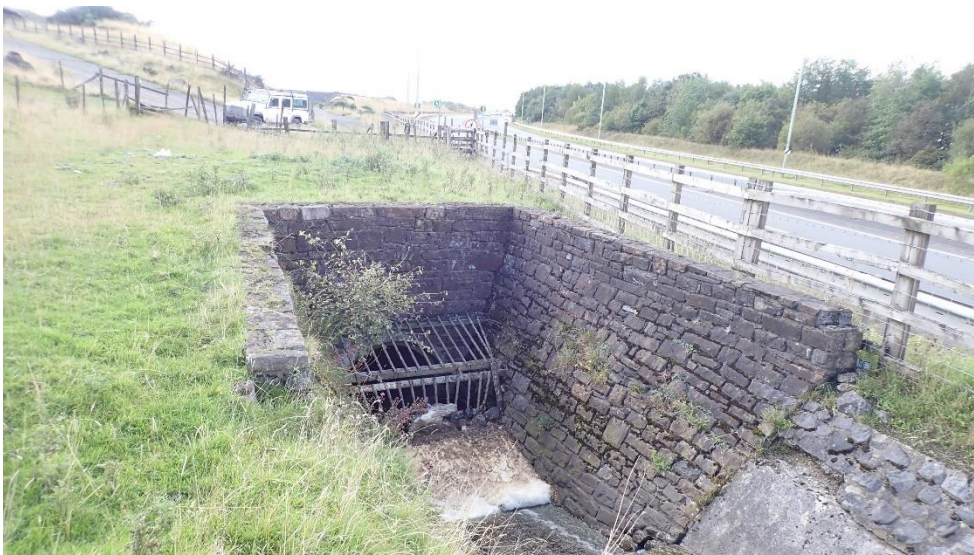
| Photo No.13 | 15840 – Ffos Y Fran |

| <b>Date: 11/09/2024</b><br><b>Description:</b><br><p>Culvert on northern site boundary at approximate NGR: 307549, 207667.</p> | |

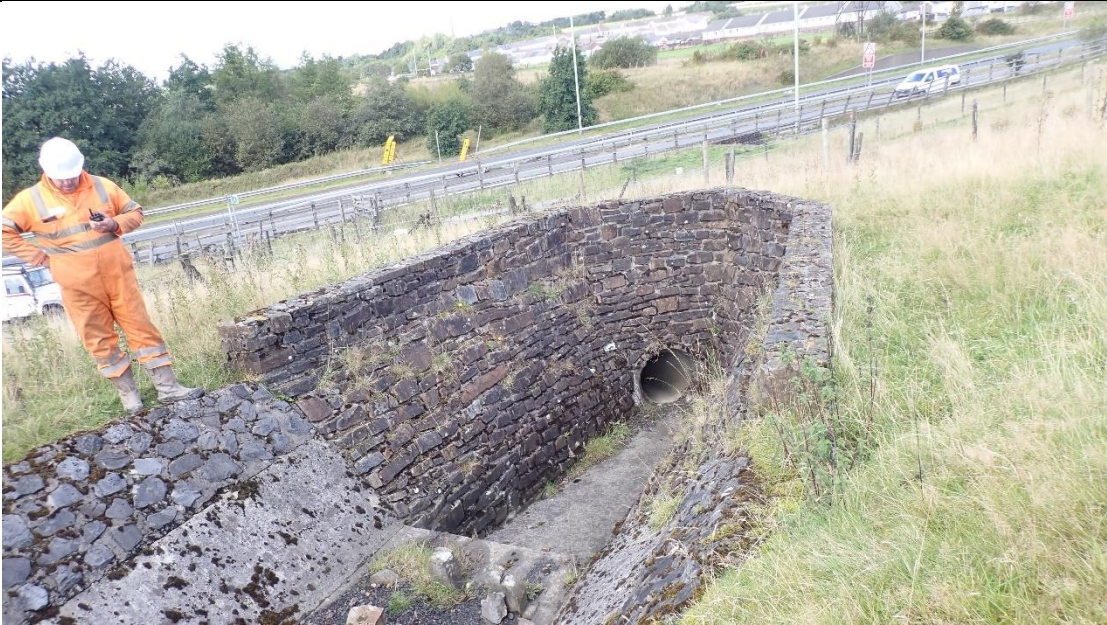
| <b>Photo No.15</b> | <b>15840 – Ffos Y Fran</b> |

| <b>Description:</b><br><br>Culvert inlet at approximate NGR: 307542, 207626 (facing north-east) | |

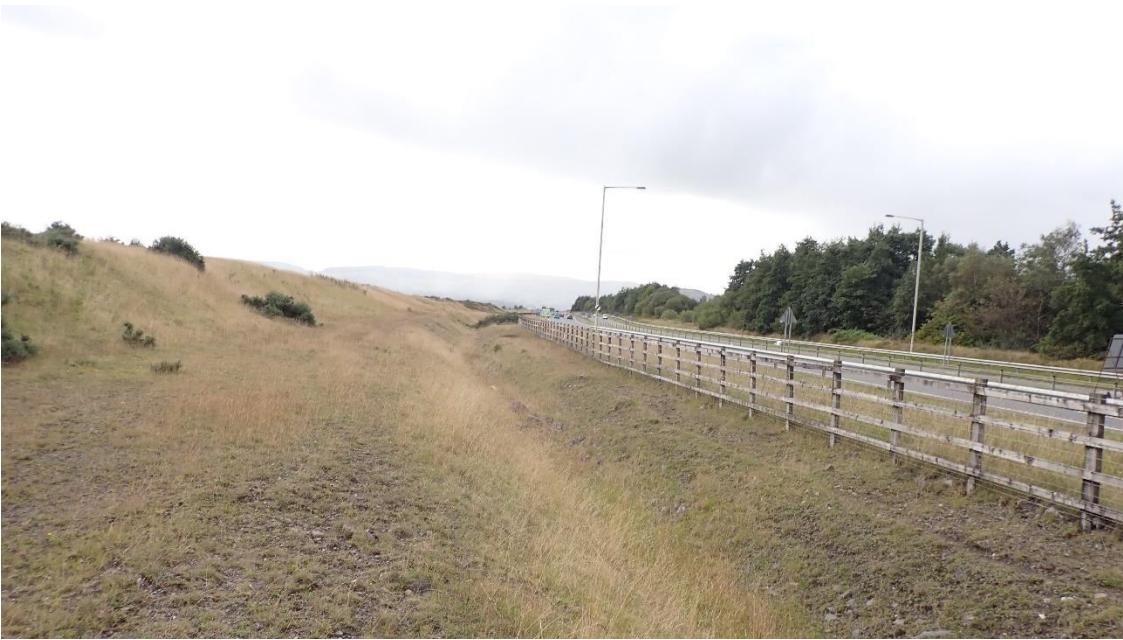
| <b>Photo No. 16</b> | <b>15840 – Ffos Y Fran</b> |

| <b>Description:</b><br><br>Swale/ depression along northern boundary.<br><br>Approximate NGR: 307365, 207550 (facing west) | |

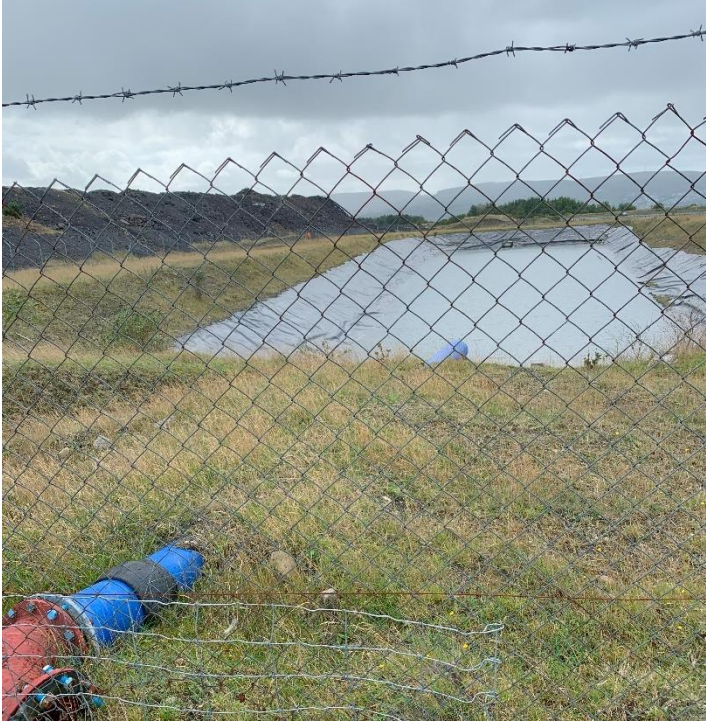
| <b>Photo No.17</b> | <b>15840 – Ffos Y Fran</b> |

| <b>Date: 11/09/2024</b><br><b>Description:</b><br><p>Attenuation lagoon as part of WB</p> <p>Approximate NGR: 306931, 207344 (facing west)</p> | |

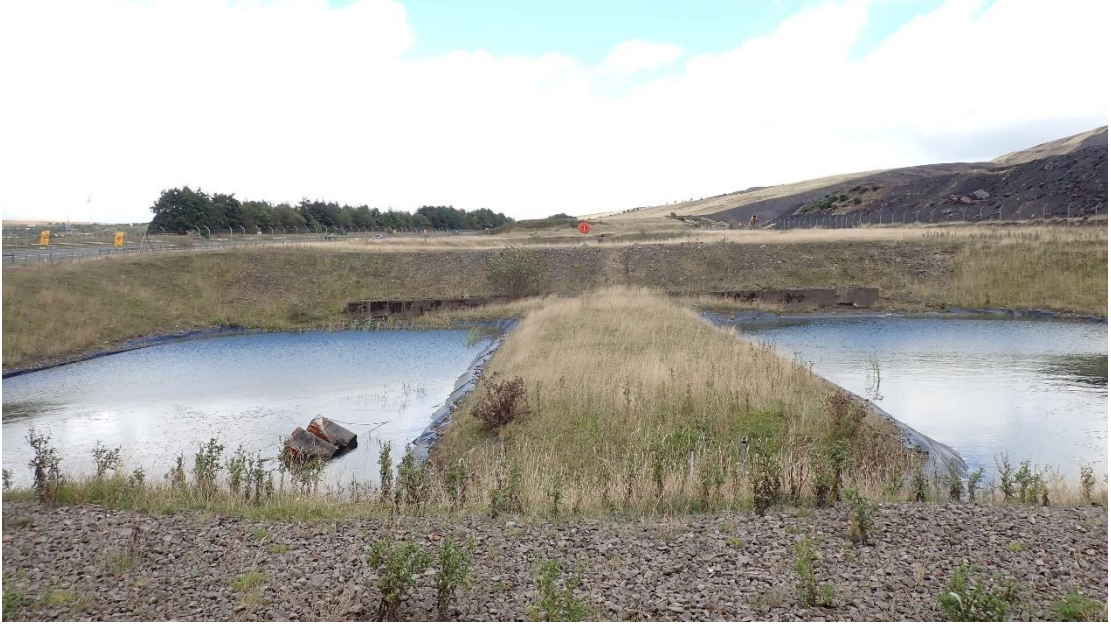
| <b>Photo No.19</b> | <b>15840 – Ffos Y Fran</b> |

| <b>Date: 11/09/2024</b><br><b>Description:</b><br><p>Settlement ponds as part of Water Treatment Area (WB)</p> <p>Approximate NGR: 306758, 207240</p> | |

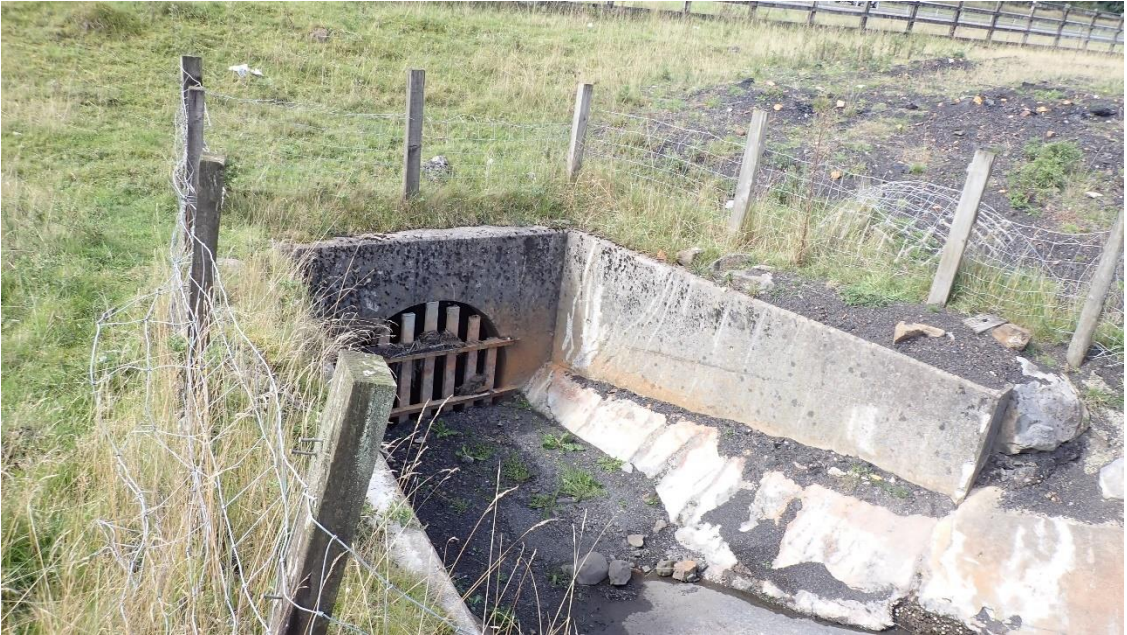
| <b>Photo No. 20</b> | <b>15840 – Ffos Y Fran</b> |

| <b>Date: 11/09/2024</b><br><b>Description:</b><br><p>Culvert conveying flows from the site under the A4060</p> <p>Approximate NGR: 306366, 206572</p> | |

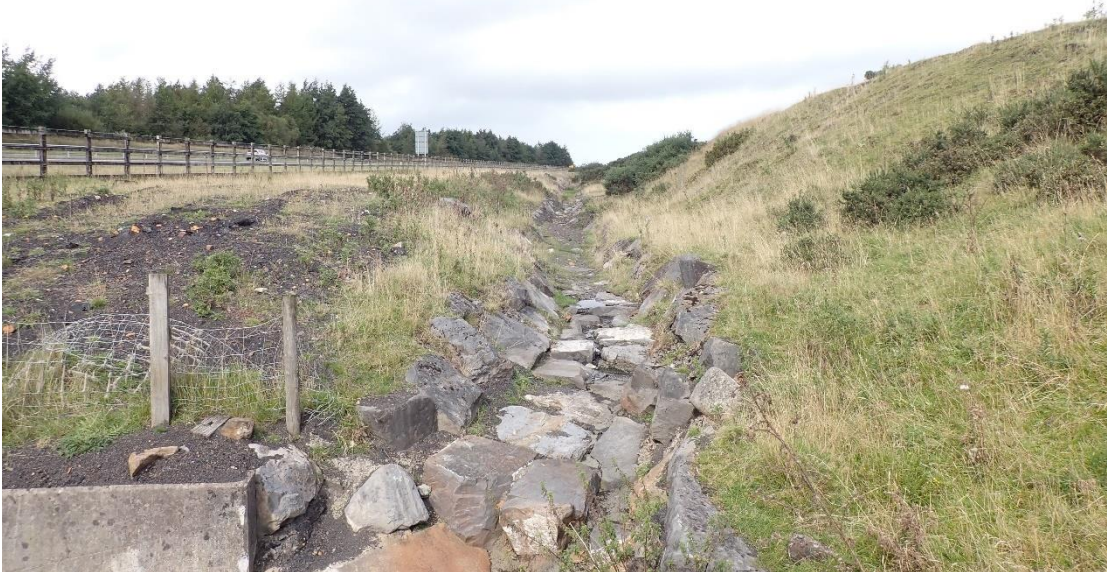
| <b>Photo No.21</b> | <b>15840 – Ffos Y Fran</b> |

| <b>Date: 11/09/2024</b><br><b>Description:</b><br><br>Open watercourse channel along the north-western site boundary conveying flows to the culvert<br><br>Approximate NGR: 306369, 206575 (facing north-east) | |

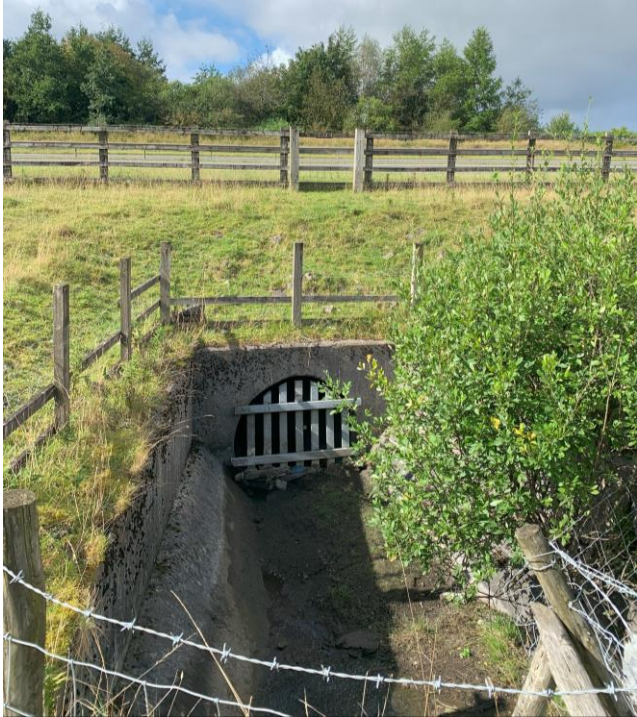
| <b>Photo No.23</b> | <b>15840 – Ffos Y Fran</b> |

| <b>Date: 11/09/2024</b><br><b>Description:</b><br><p>Culvert conveying flows from the site under the A4060</p> <p>Approximate NGR: 306591, 207113</p> | |

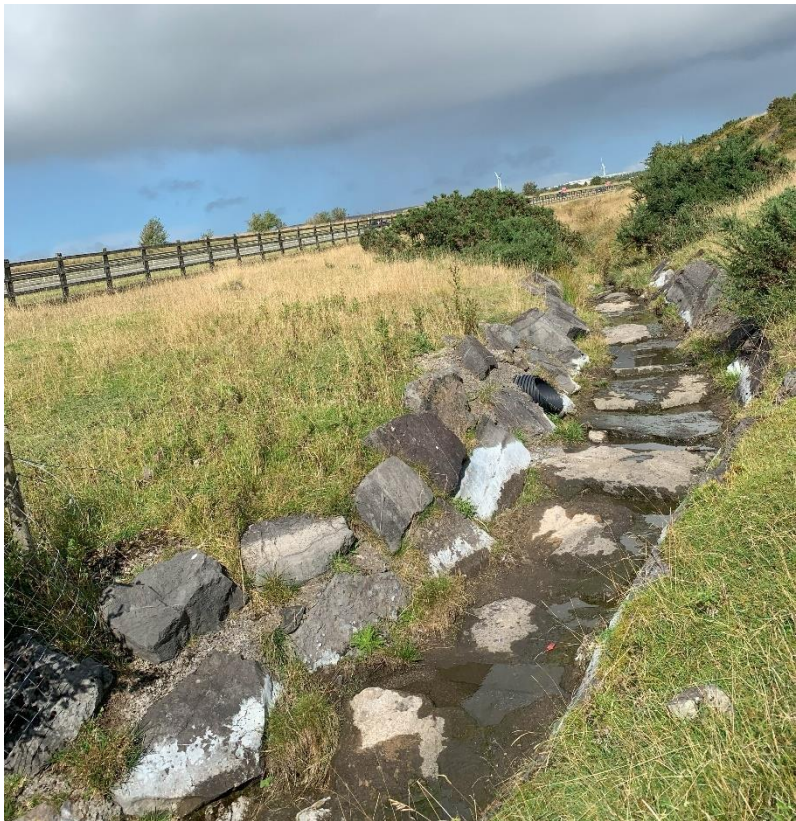
| <b>Photo No. 24</b> | <b>15840 – Ffos Y Fran</b> |

| <b>Date: 11/09/2024</b><br><b>Description:</b><br><p>Open watercourse channel along the north-western site boundary conveying flows to the culvert</p> <p>Approximate NGR: 306595, 207116 (facing north-east)</p> | |

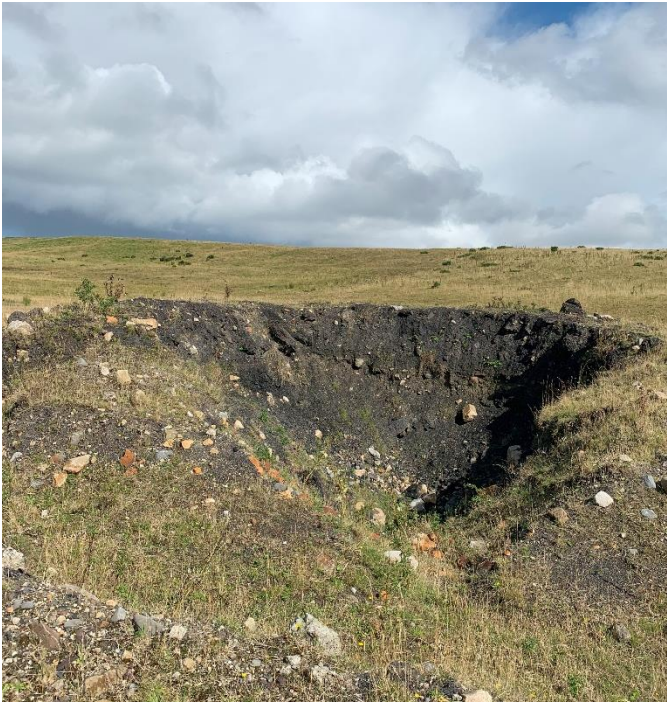
| <b>Photo No.25</b> | <b>15840 – Ffos Y Fran</b> |

| <b>Date: 11/09/2024</b><br><b>Description:</b><br><p>Sump hole in the north-western extent of the site.</p> <p>Approximate NGR: 306463, 206797</p> | |

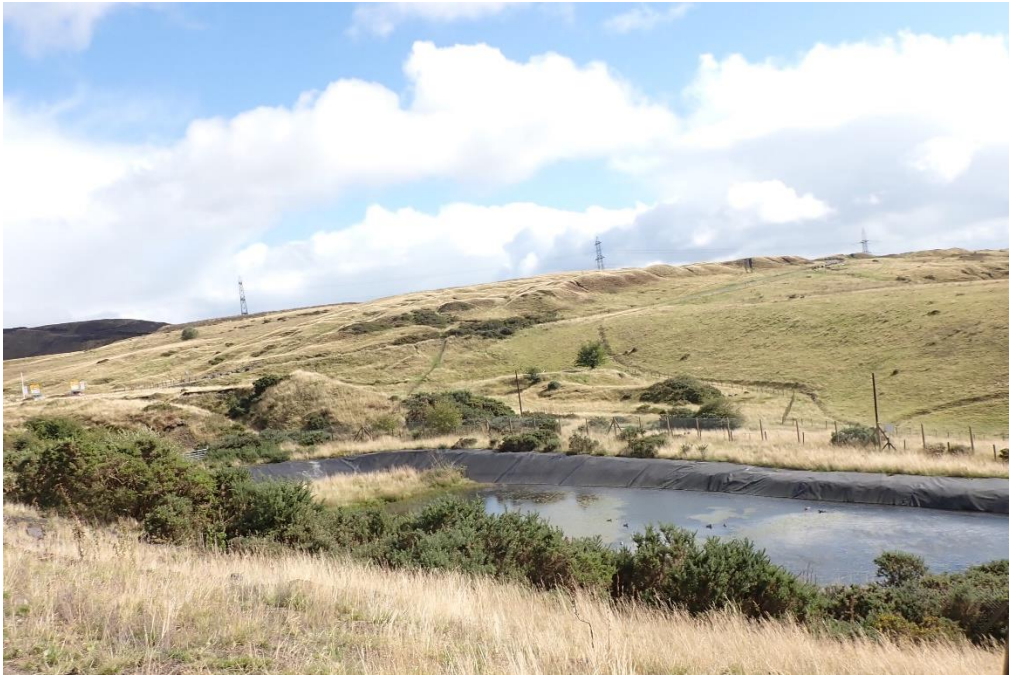
| Photo No.27 | 15840 – Ffos Y Fran |

| <b>Date: 11/09/2024</b><br><b>Description:</b><br><p>Lined lagoon in the south-western extent of the site at approximate NGR: 307097, 206062</p> | |

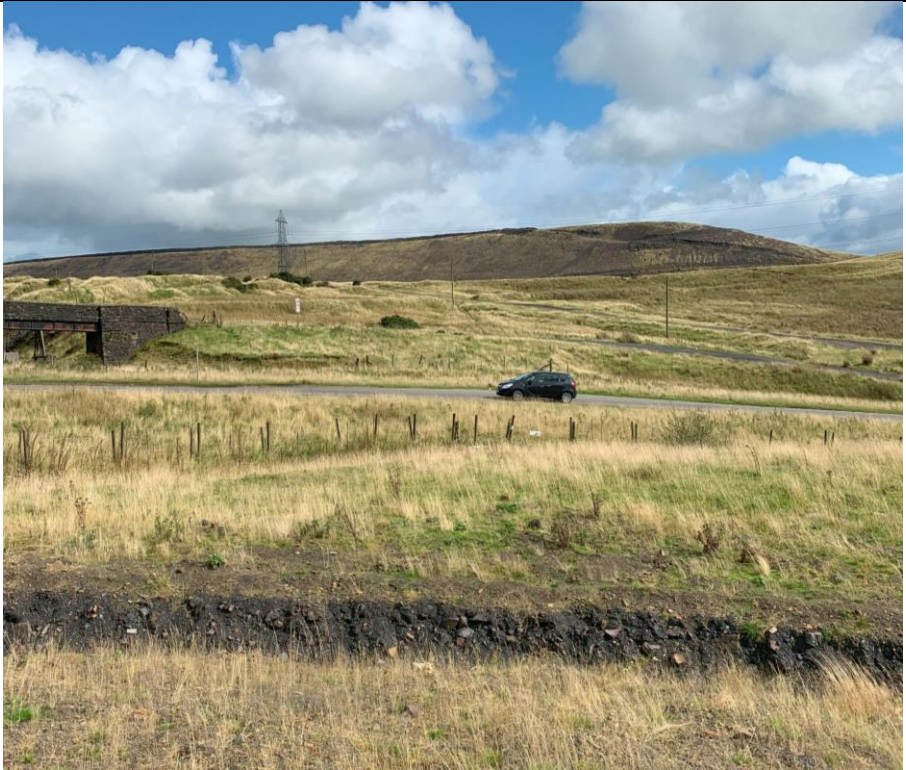
| Photo No. 28 | 15840 – Ffos Y Fran |

| <b>Date: 11/09/2024</b><br><b>Description:</b><br><p>Culvert under road</p> <p>Approximate NGR: 307356, 206045</p> | |

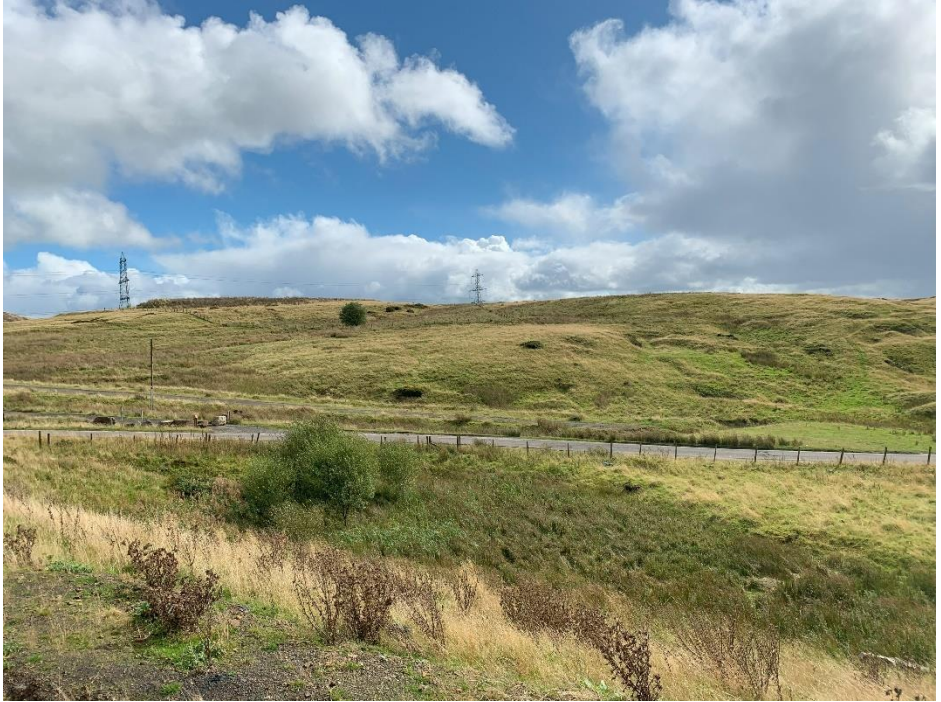
| <b>Photo No.29</b> | <b>15840 – Ffos Y Fran</b> |

| <b>Date: 11/09/2024</b><br><b>Description:</b><br><p>Wetland at approximate NGR: 307350, 206040</p> <p>Receives flows from the ditch which is culverted beneath Bogey Road</p> | |

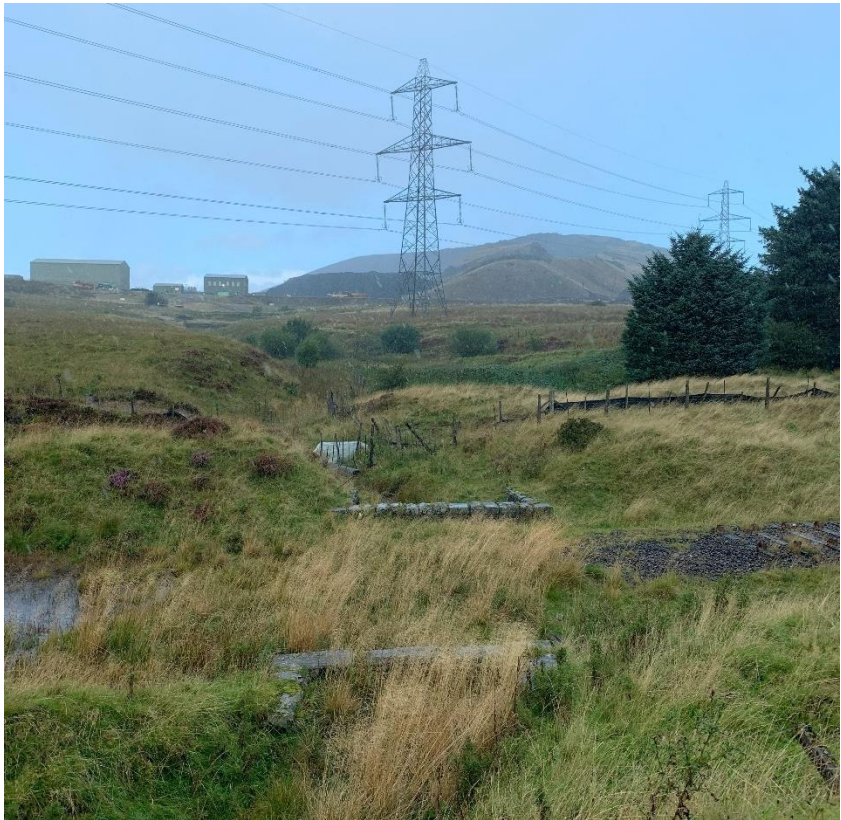
| <b>Photo No. 30</b> | <b>15840 – Ffos Y Fran</b> |

| <b>Date: 11/09/2024</b><br><b>Description:</b><br><p>Watercourse originating within the central ecological area and flowing south</p> <p>Approximate NGR: 308044, 206178 (facing north)</p> | |

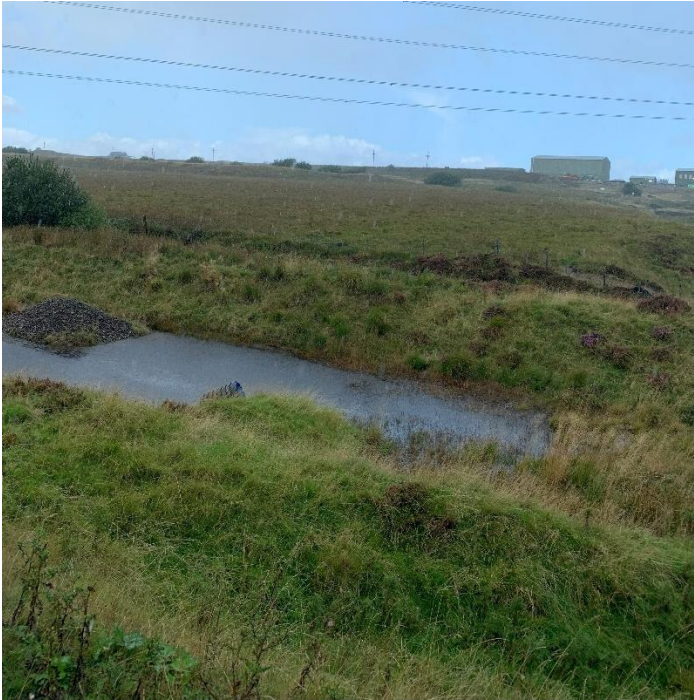
| <b>Photo No.31</b> | <b>15840 – Ffos Y Fran</b> |

| <b>Date: 11/09/2024</b><br><b>Description:</b><br><p>Pond located at approximate NGR: 308034, 206178</p> | |

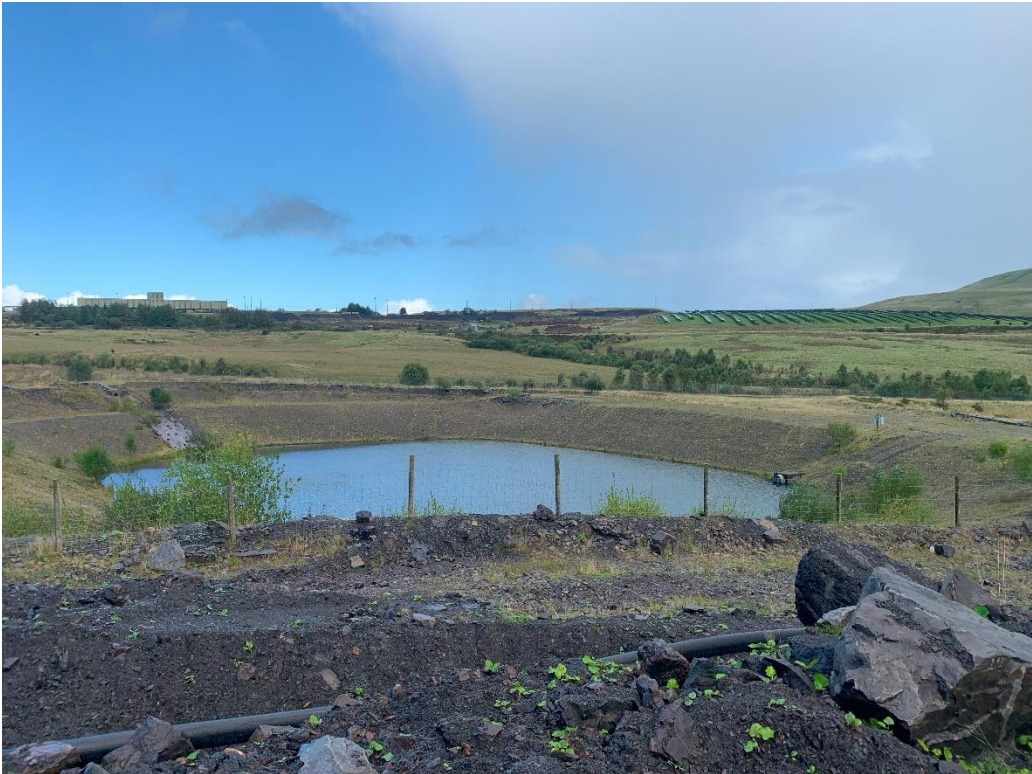
| <b>Photo No. 32</b> | <b>15840 – Ffos Y Fran</b> |

| <b>Date: 11/09/2024</b><br><b>Description:</b><br><p>Water Treatment Area<br/>WG Attenuation Pond</p> <p>Located south-east of OB3 at approximate NGR: 308733, 205634 (facing east)</p> | |

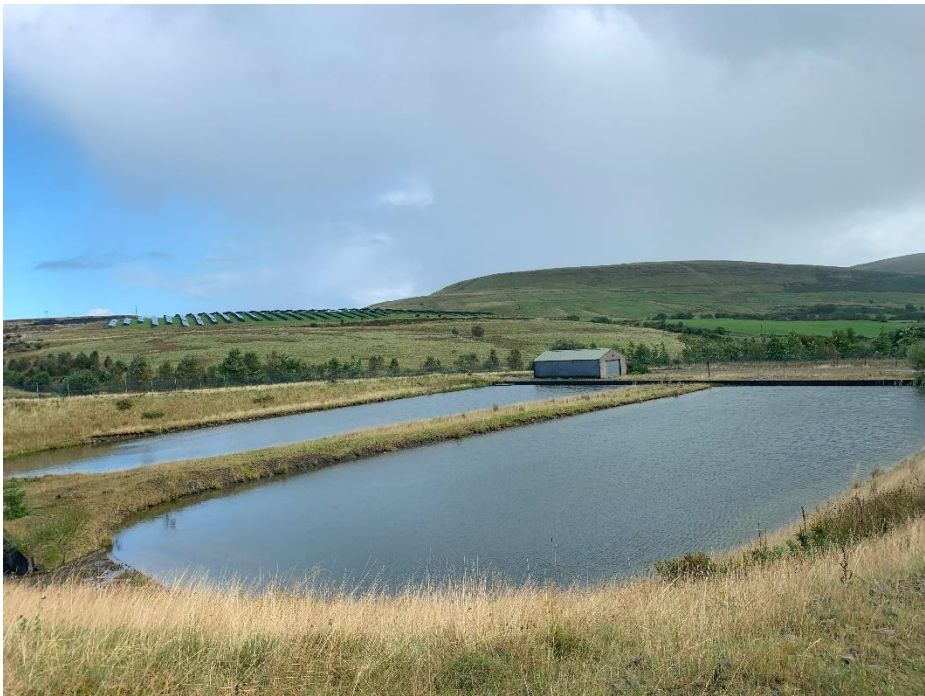
| <b>Photo No.33</b> | <b>15840 – Ffos Y Fran</b> |

| <b>Date: 11/09/2024</b><br><b>Description:</b><br><p>Water Treatment Area<br/>WG Settlement ponds</p> <p>Photo taken at<br/>approximate NGR:<br/>308781, 205553</p> | |

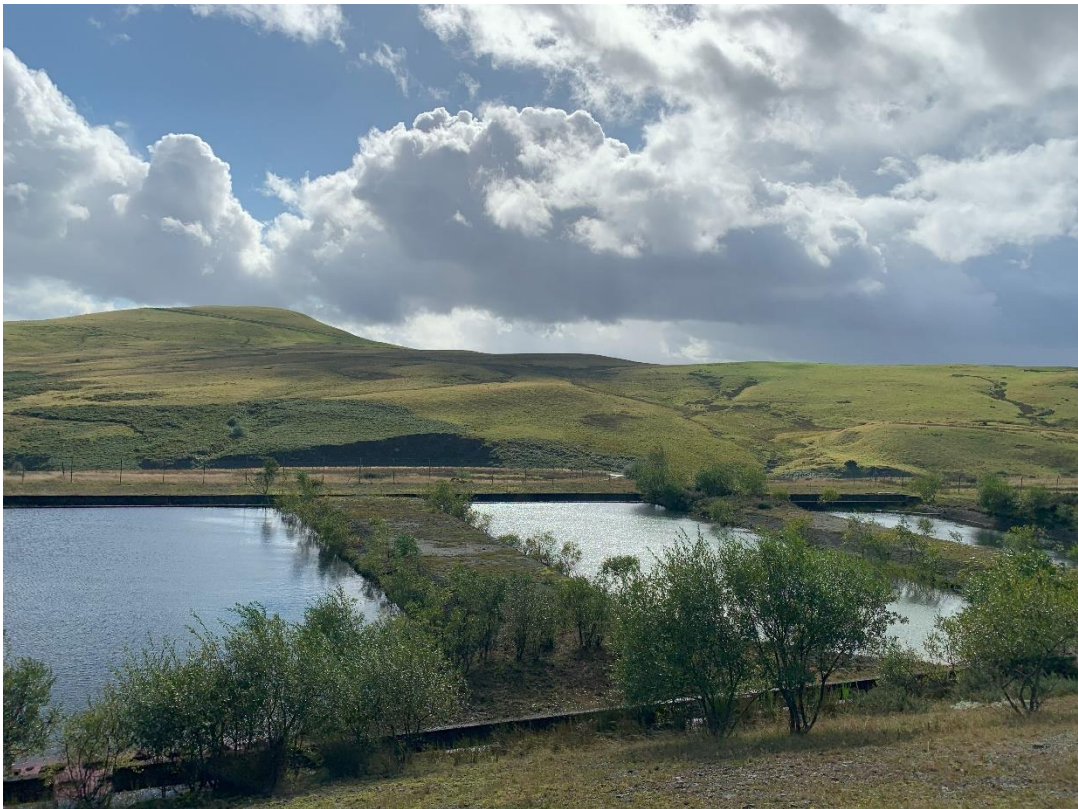
| <b>Photo No. 34</b> | <b>15840 – Ffos Y Fran</b> |

| <b>Date: 11/09/2024</b><br><b>Description:</b><br><p>Water Treatment Area<br/>WF. Comprises 4no.<br/>lagoons.</p> <p>Photo taken at<br/>approximate NGR:<br/>308499, 205200 (facing<br/>south-west)</p> | |

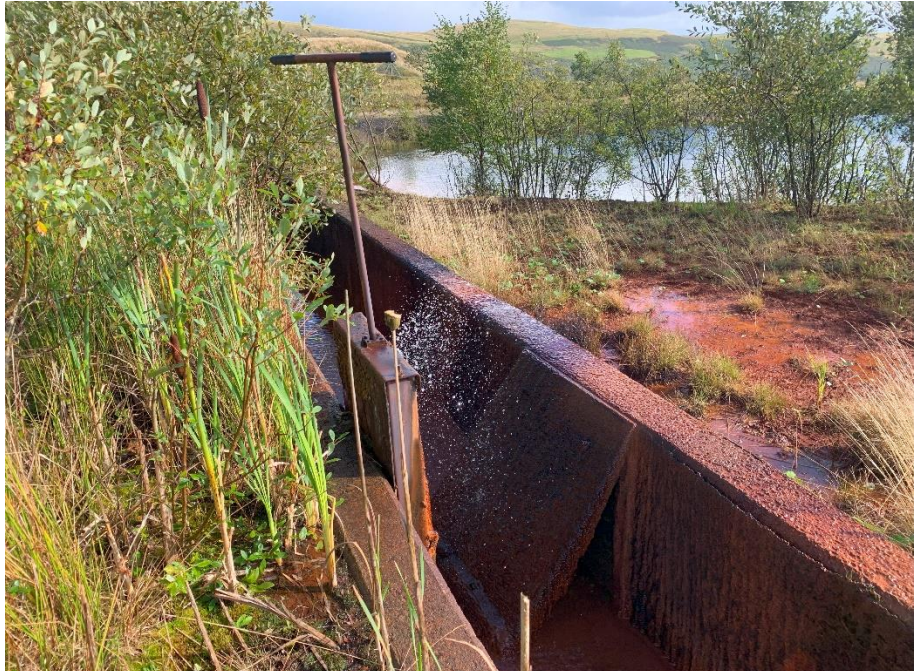
| Photo No.35 | 15840 – Ffos Y Fran |

| <b>Date: 11/09/2024</b><br><b>Description:</b><br><p>Penstock regulating the water flow into the water treatment area.<br/> Approximate NGR: 308474, 205188</p> | |

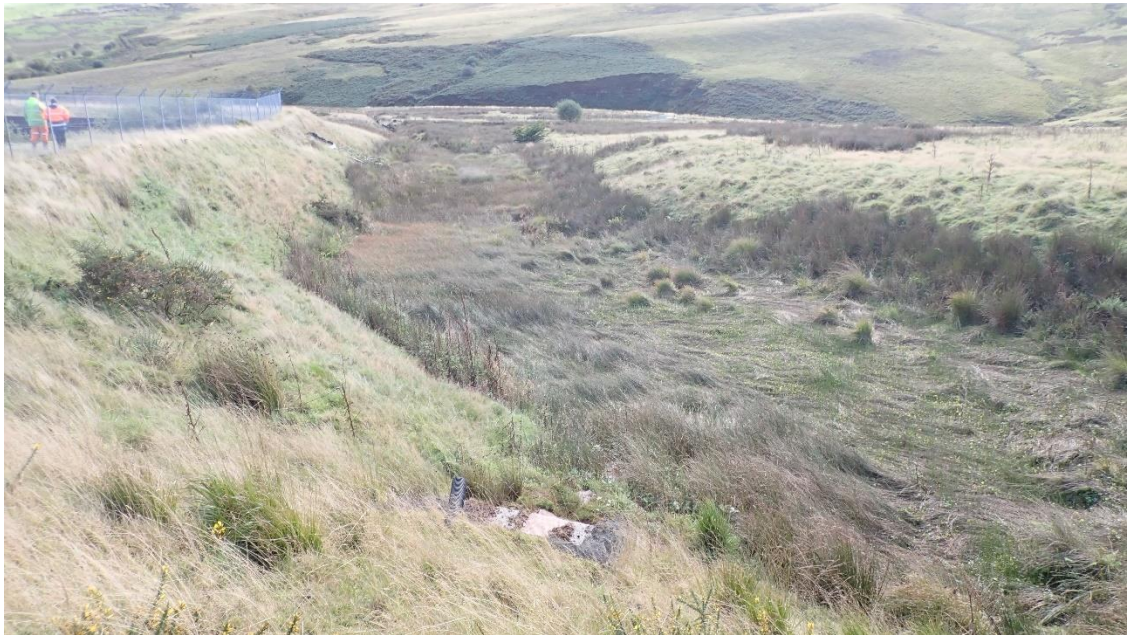
| Photo No. 36 | 15840 – Ffos Y Fran |

| <b>Date: 11/09/2024</b><br><b>Description:</b><br><p>Wide vegetated channel conveying flow to the Bargoed Taff 308404, 205234.</p> <p>2no. outlets discharge to this channel.</p> | |

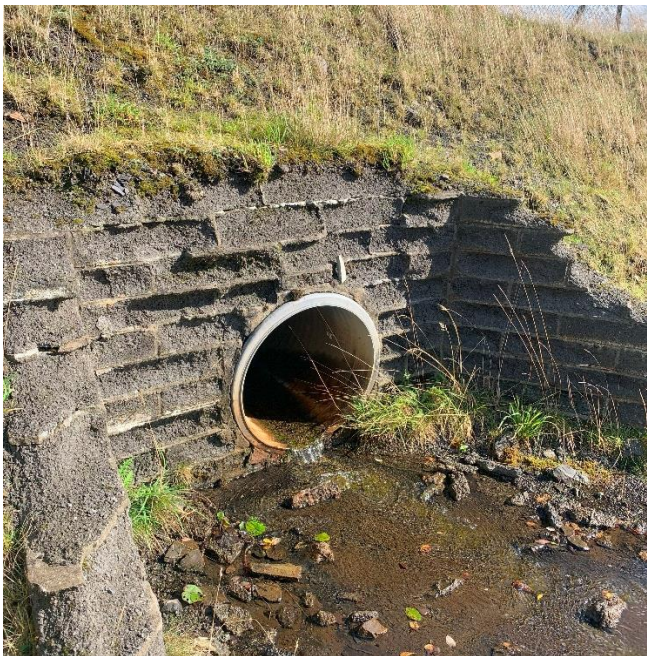
| <b>Photo No.37</b> | <b>15840 – Ffos Y Fran</b> |

| <b>Date: 11/09/2024</b><br><b>Description:</b><br><p>Discharge point for the 4no. lagoons at Water treatment area WF</p> <p>Approximate NGR: 308403, 205165</p> | |

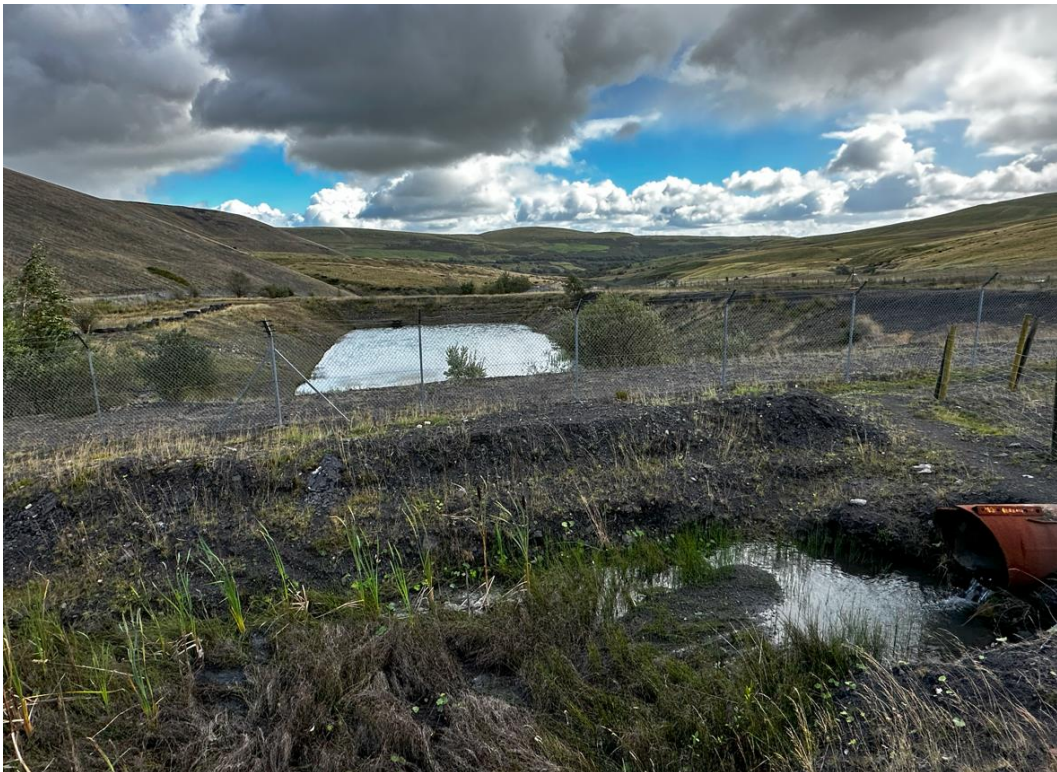
| <b>Photo No. 38</b> | <b>15840 – Ffos Y Fran</b> |

| <b>Date: 11/09/2024</b><br><b>Description:</b><br><p>Photograph showing settlement pond.</p> <p>Approximate NGR: 307731, 205565</p> | |

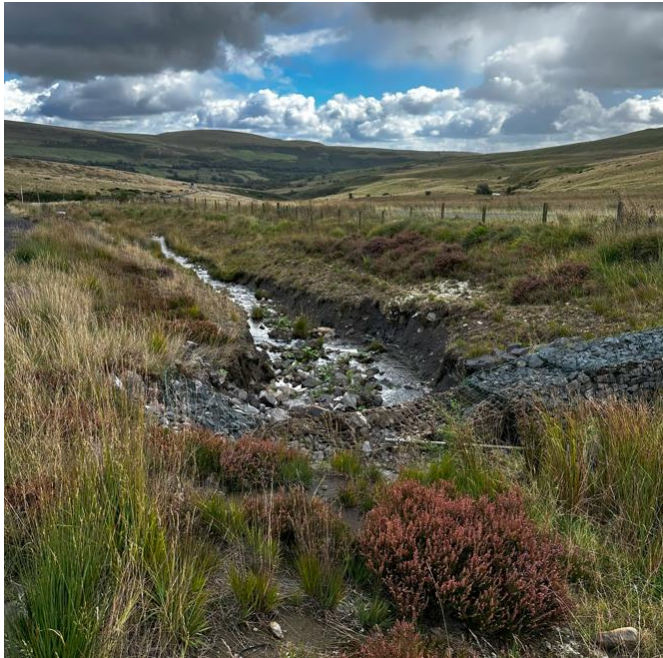
| Photo No.39 | 15840 – Ffos Y Fran |

| <b>Description:</b><br><br>Photograph showing discharge to the Bargoed Taff.<br><br>Approximate NGR: 307655, 205541 | |
