# Pandy Farm Barn

## **RIBA2 Report**

## **ACE Building Contractors**

11239.R.TH.02

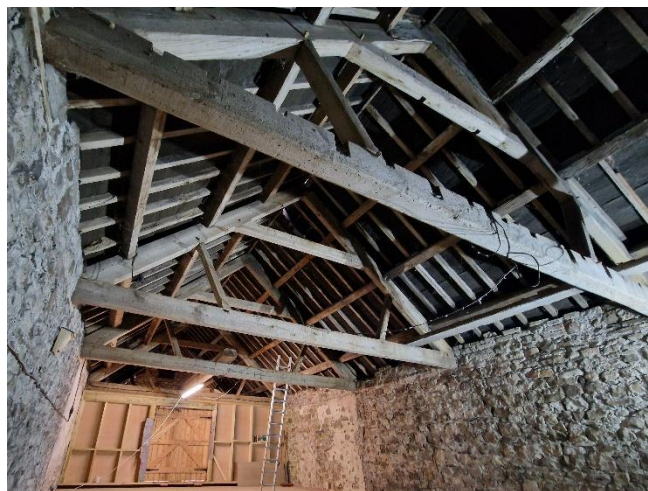
- 4.2.3 Roof finishes are non-original concrete tiles with a modern membrane beneath, generally in functional condition, with some indication of water ingress internally with limited, local, failures at the ridge, verges and eaves level adjacent to the east and west gables.

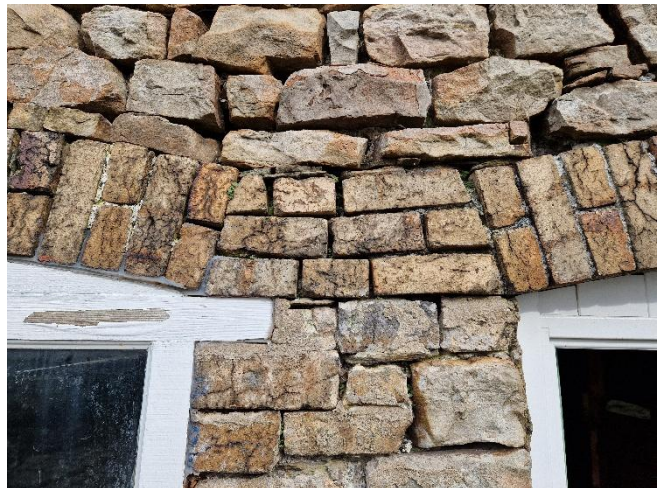
- 4.5 The most significant masonry defect which requires remediation, irrespective of potential conversion works, is located in the east gable elevation.

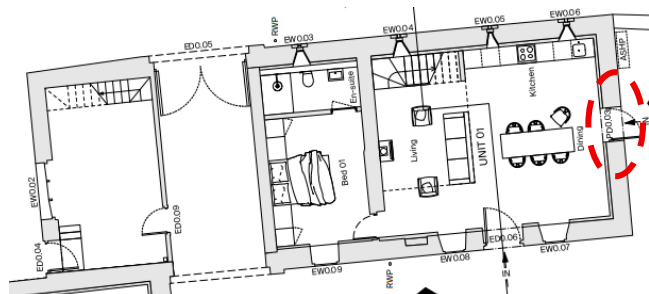
*Proposed ground floor doorway*

- 5.2 The most significant intervention is the proposed ground floor doorway opening in the east gable. However, while this provides further discontinuity to the elevation, this also affords an opportunity to reinforce the masonry laterally and centrally, (where it is required), via installation of the lintels required over the doorway, say pre-cast or in-situ concrete faced in timber if required.

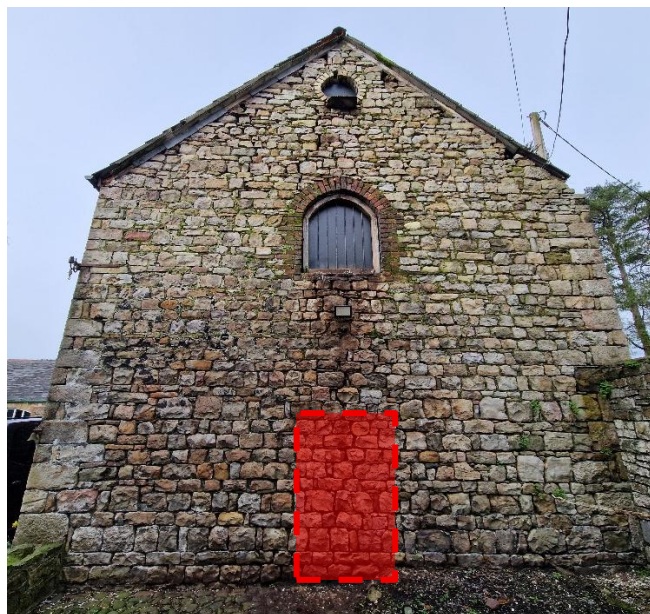
- 5.2.1 Vertical and lateral reinforcement of the masonry with lintels, in conjunction with the potential for improved lateral restraint provided by the first floor, will be structurally beneficial to the masonry.

*Proposed opening in east gable*

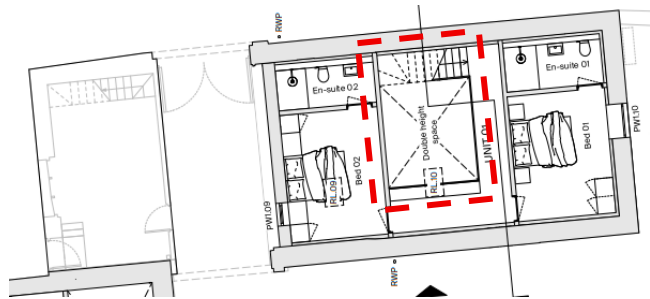
- 5.3 At first floor level a double-height space is proposed approximately in Bay D. The only original fabric this affects are the original timber floor beams, spanning the full width of the barn, (north to south). If possible, the void and associated stairs could be arranged to allow the retention of the original timber beams in-situ.

*First floor double-height space*
