## Bats & Trees Survey Report

Project: Bishop Hedley Catholic School

Instructed by: Wilmott Dixon Construction Ltd

Reported by: Ecological Services Ltd  
10 Mount Pleasant, Llanelly Hill, Abergavenny, Monmouth NP7 0NT  
Reported by

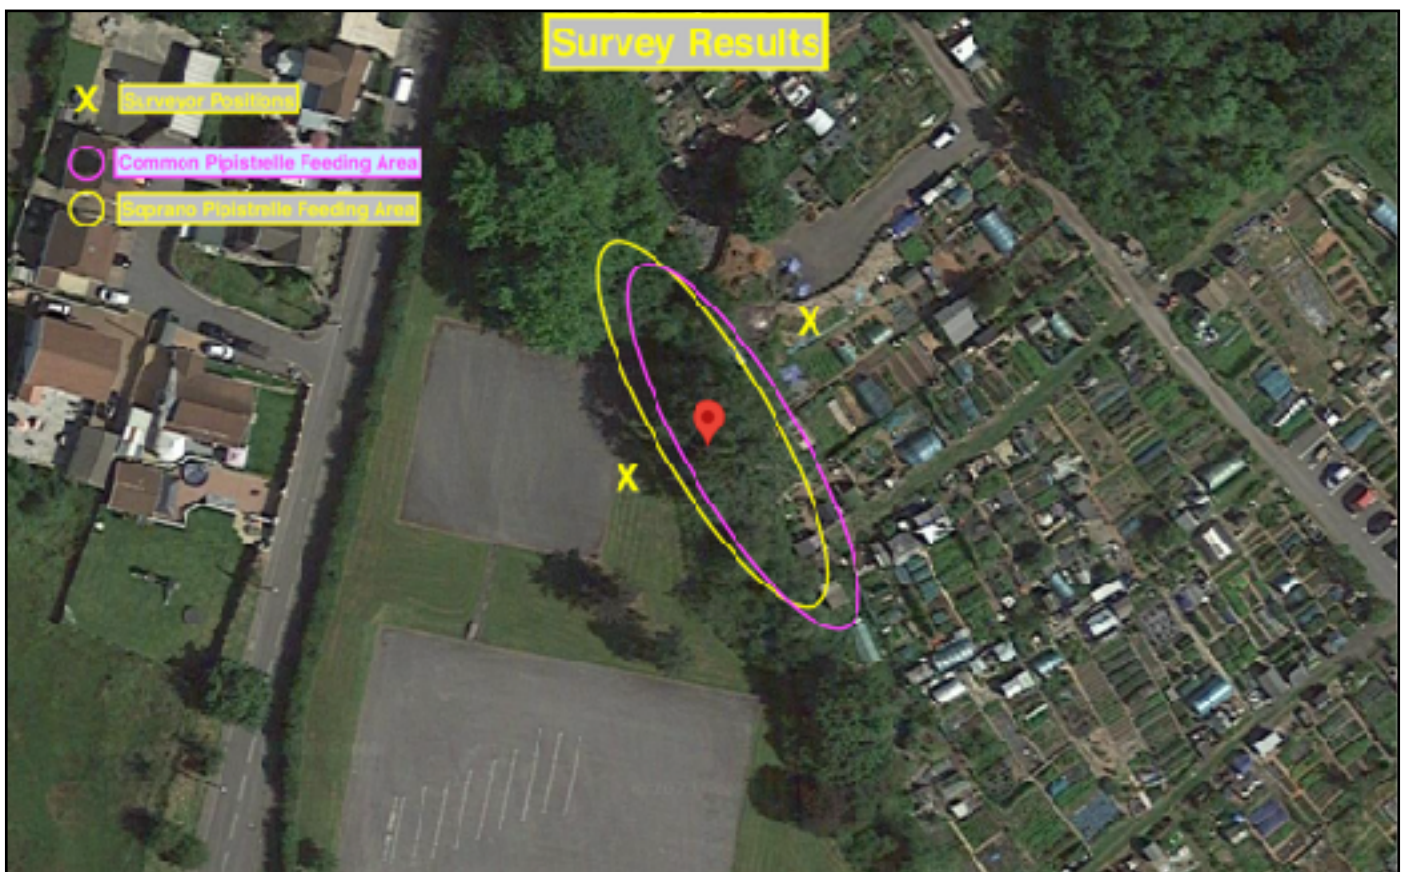
During both of the emergence surveys, a very low number of bat calls were recorded and no bats emerged from Tree 7. A small number of Common and Soprano Pipistrelles were observed foraging along the tree-line.
