# Tynycoedcae Farm, Merthyr Tydfil

## Historic building survey

**August 2019**

GGAT report no. 2019/039  
Project no. P2022  
National Grid Reference:  
SO 01457 07480

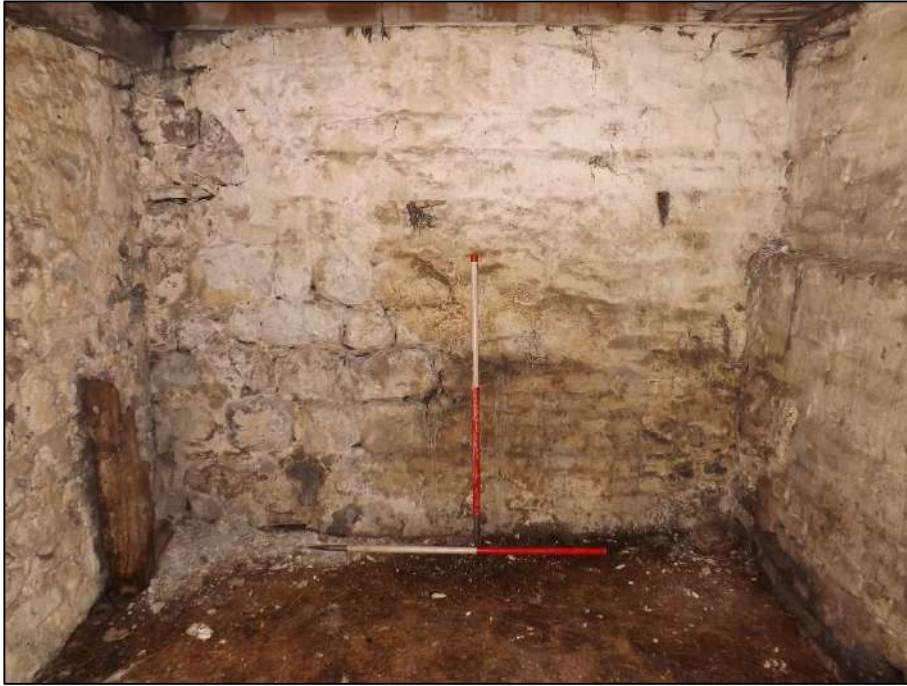
This was the smallest of the three annexes, measuring 2m by 4m and had been built by utilising the north wall of Annexe 2, the west elevation of the barn and building an 'L' shaped wall to enclose the room. The annexe featured a combination of brick and stone in the construction but stone predominated. The interior was whitewashed and featured a brick and cobble floor. The doorway had originally been wider, perhaps being 1.6m wide but had been partially blocked with brick and stone to narrow the entrance and create a window. The roof was intact, consisting of slates supported by timber joists.

Annexe 3 appeared to have been used as a store room or similar but may have initially been built as a small animal pen. The floor sloped to the west possibly to aid drainage, and the wide door as was initially constructed would aid the passage of animals or larger equipment.

Plate 24. West elevation of barn as seen from inside Annexe 3. Scale 1m.

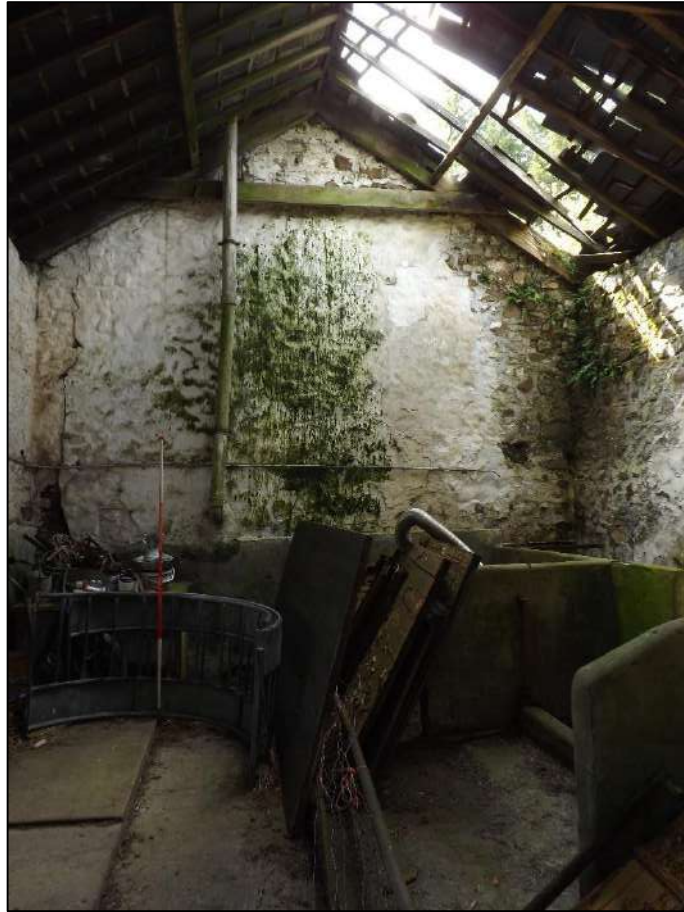
**Plate 27. Interior of the south wall showing stored farm items and part of the byre. Scale 2m.**

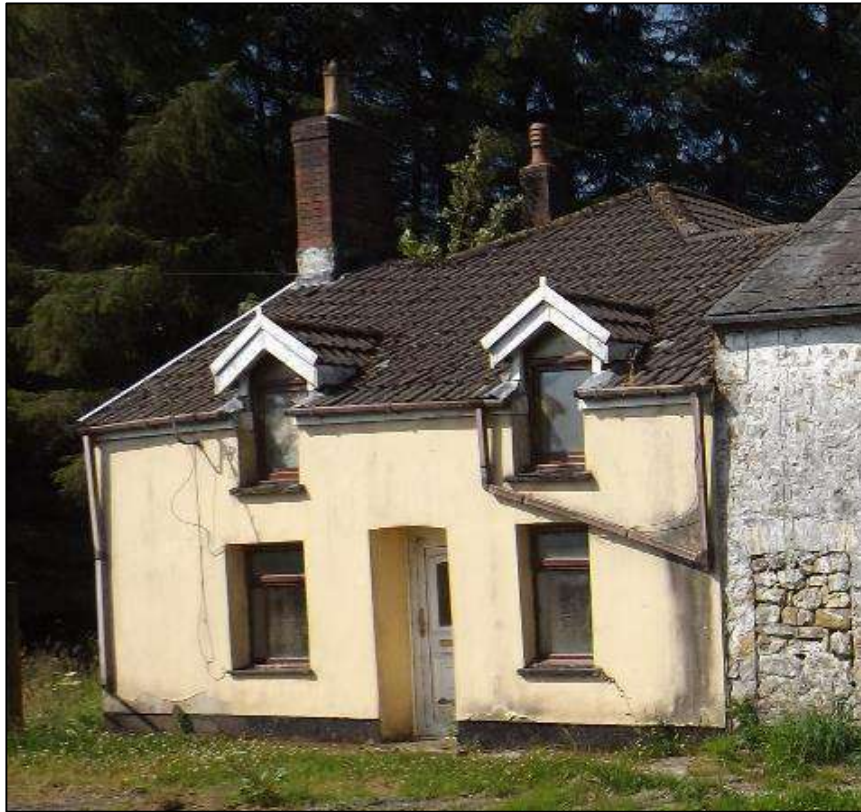
The east elevation formed the main entrance into the cottage and was furnished with two windows on the ground floor, each located either side of the front door and two dormer type windows to the first floor. The roof line was situated at the same height as the original roof line for the barn and there is a possibility that the cottage was built to incorporate the south end of the barn. This is supported by the similarity of the arch over the cottage front door to those over the barn doors. The entire elevation was rendered with concrete and the cottage possessed a roof made of ceramic tiles. The roof was furnished with lead flashing, wooden soffits and a modern gutter system.

**Plate 31. Oblique view of the east elevation of the cottage. No scale but the doorway measured 2m in height by 1m in width.**

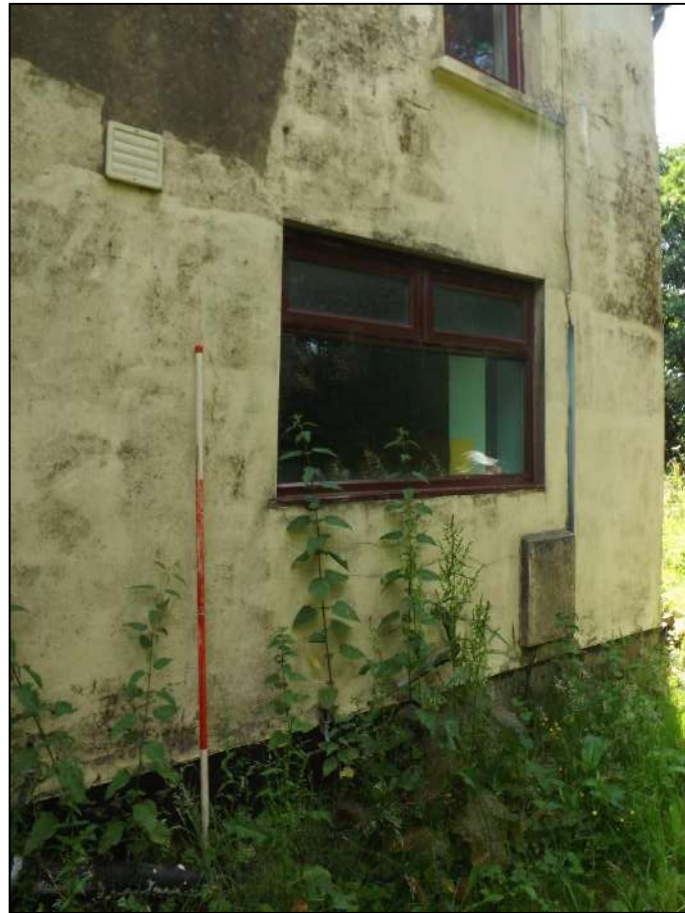
It was not possible to obtain a satisfactory photograph of the cottage west elevation due to the presence of trees. However, the elevation was pierced by four modern windows, two on the ground floor and two on the first floor. The northernmost ground floor window was somewhat recessed and may once have been a doorway that had been converted to a window for the ground floor bathroom.

**Plate 33. Ground floor kitchen window in the west elevation of the cottage. Scale 2m.**

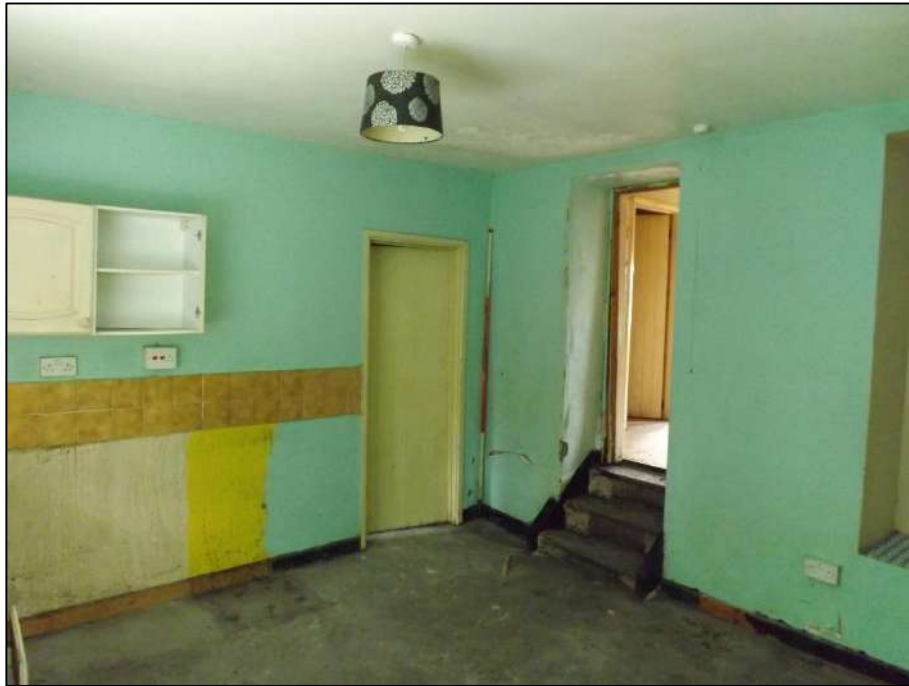
The kitchen area floor was a concrete screed and that of the living room was overlain by a wood effect material. The ceiling in the kitchen area was rendered and that of the living area had exposed but heavily painted beams. The appearance and therefore relative age of these beams was obscured by the paint.

**Plate 34. North east corner of the kitchen showing the steps into the living room and doorway (closed) into the bathroom. Scale 2m.**

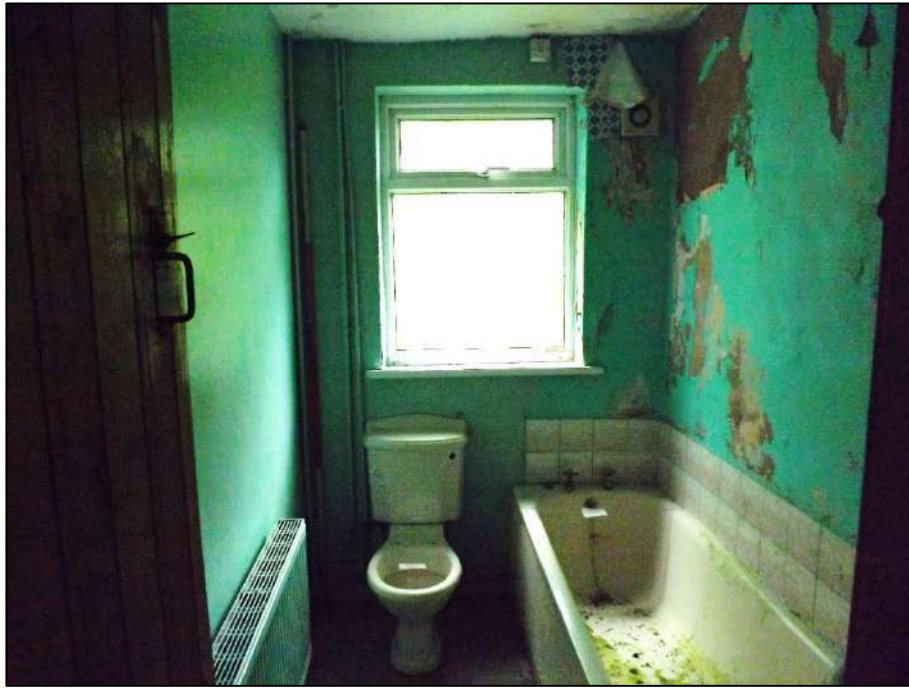
Fittings in the kitchen included a modern sink unit, with the bathroom being an unremarkable modern example.

Plate 36. Modern bathroom on the ground floor. Scale to the left of the toilet 2m.

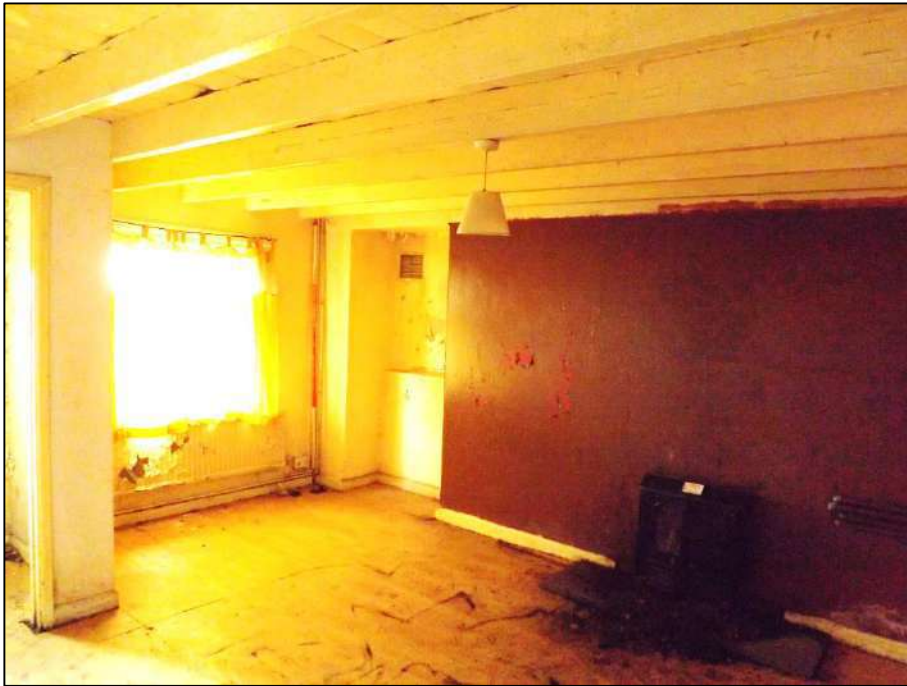
An unusual semi-circular recess, measuring 1m in width by 0.5m in depth was noted in the south east corner which had no apparent function. It was initially thought that this recess was another blocked doorway but as the feature extended to the first floor bedroom above (see below). It is possible that the feature was simply a niche but some thought must be given to the idea of the feature being part of a circular stairway.

**Plate 37. South east corner of the living room. Scale 2m.**

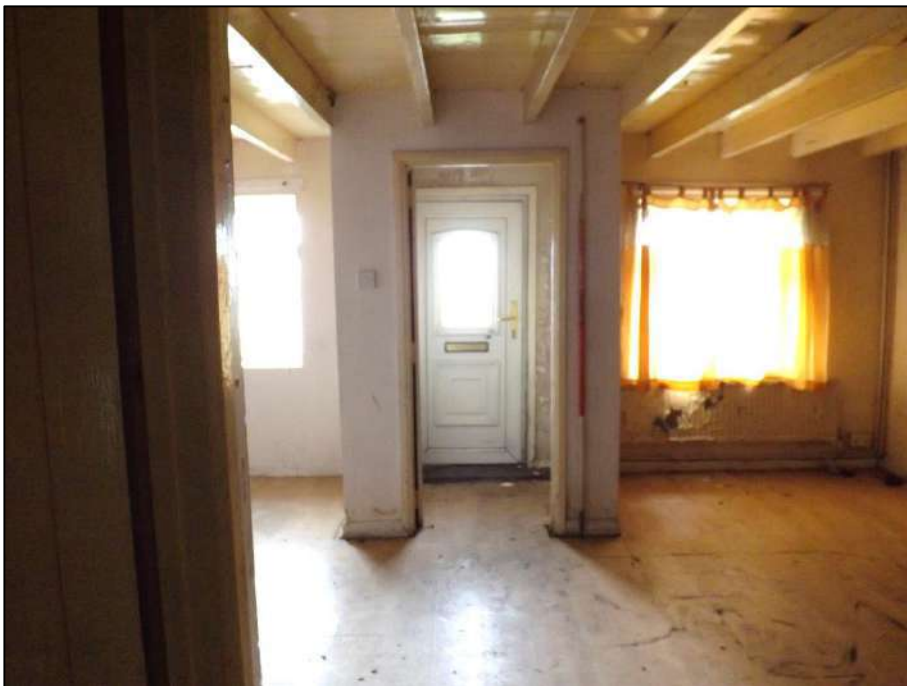
The living room was essentially square in plan and was largely devoid of features. A modern full length internal porch had been built using partition walling and a relatively modern looking fireplace occupied the centre of the southern wall of the living room. A distinctive line in the render of the surround of the fireplace suggested that this feature had been re-modelled; one of the chimneys was located above the fireplace on the roof. More partitioning had been used to create a storage area beneath the stairs, which were located in the north west corner of the room.

**Plate 38. Internal porch and exposed ceiling beams in the living room. Scale 2m.**

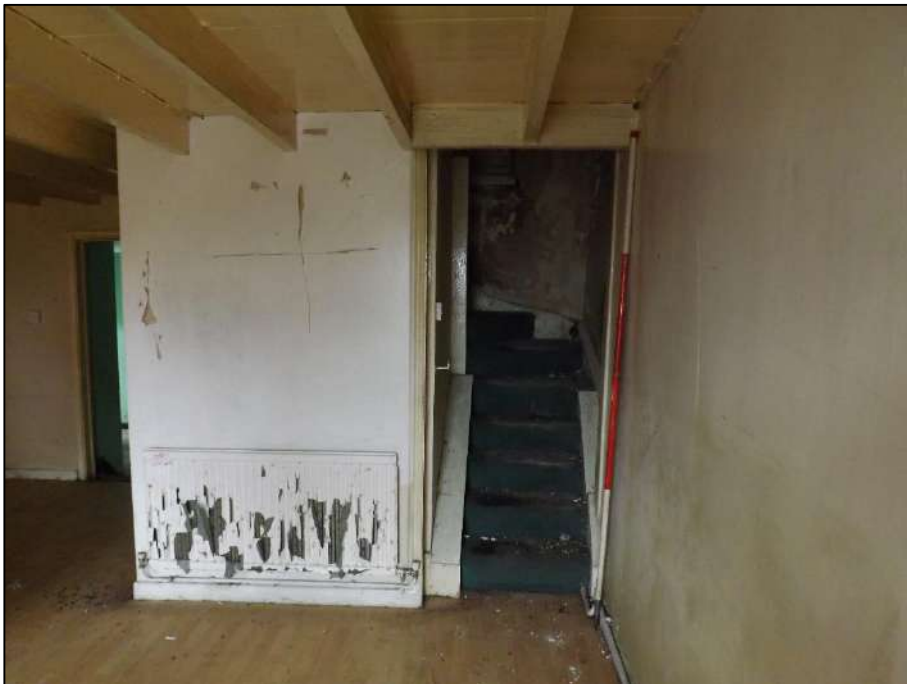
**Plate 40.** View of the stairwell leading to the first floor. Scale 2m.

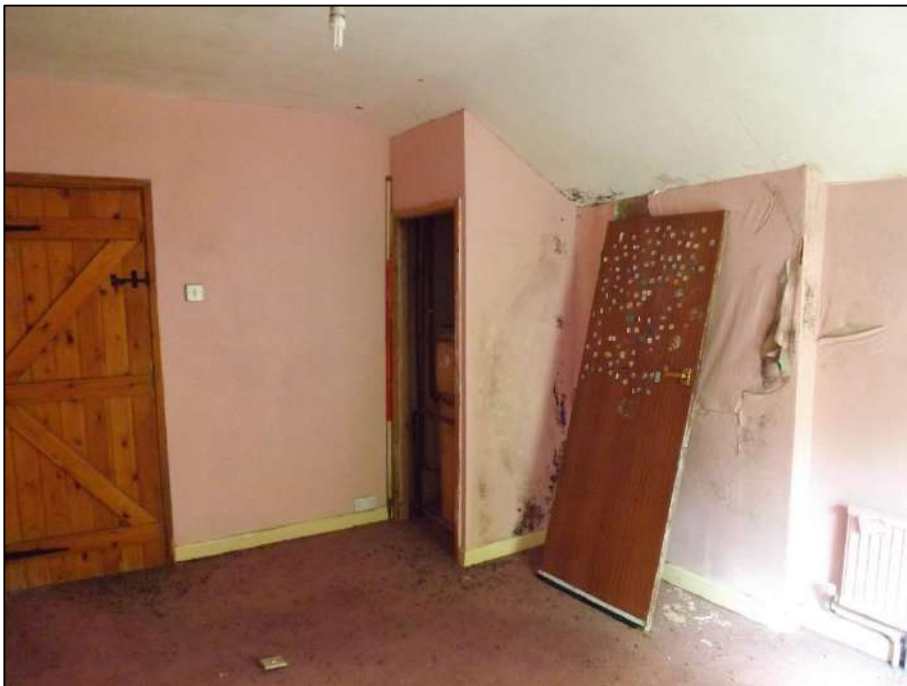
**Plate 43.** Plasterboard boiler cupboard within the south west bedroom. Note the childrens' stickers on the door, the only sign of personalisation within the entire cottage. Scale 2m.

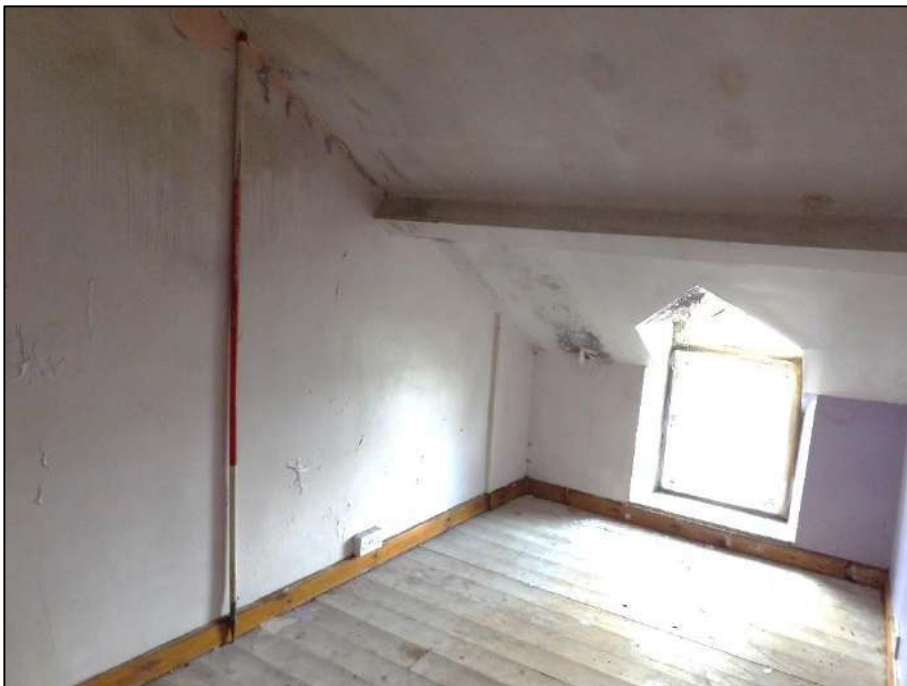
**Plate 45. View into the north east bedroom showing dormer window arrangement and plasterboard ceilings.**

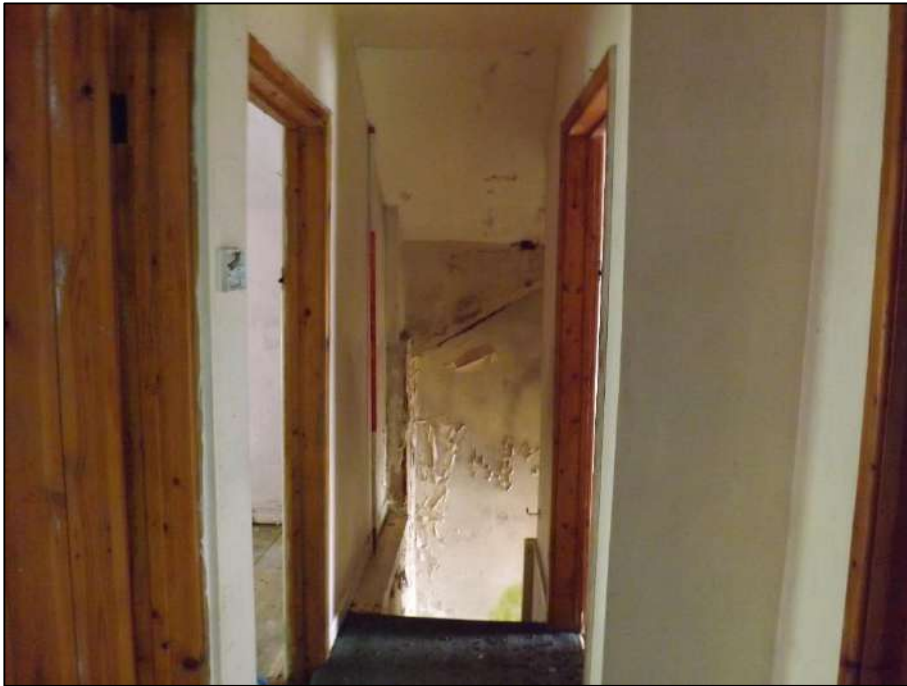
Plate 46. View along the landing towards the stairwell. Scale 2m.

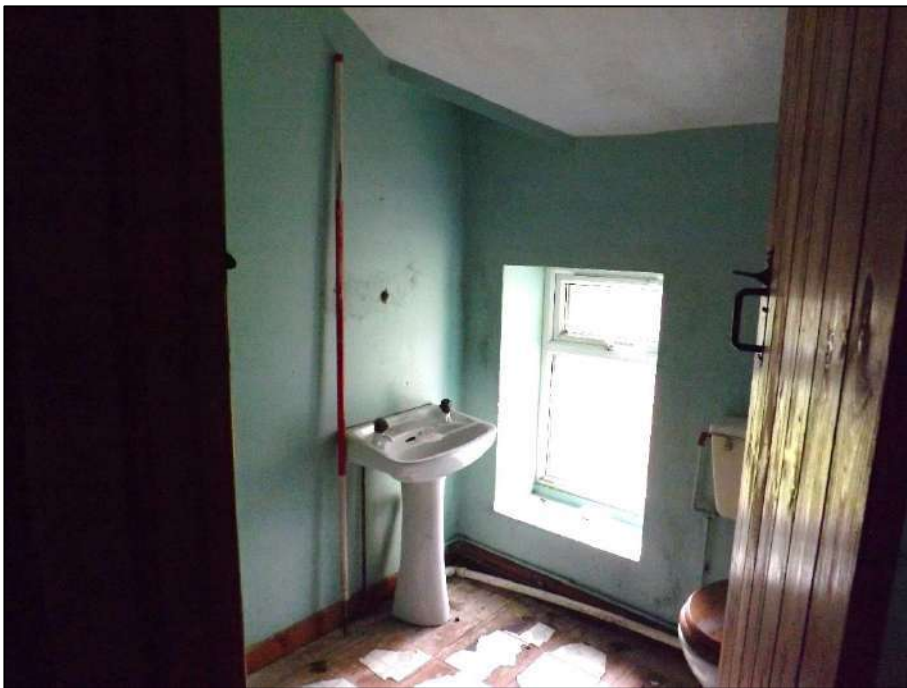
Plate 47. General view of the upstairs toilet and sink. Scale 2m.

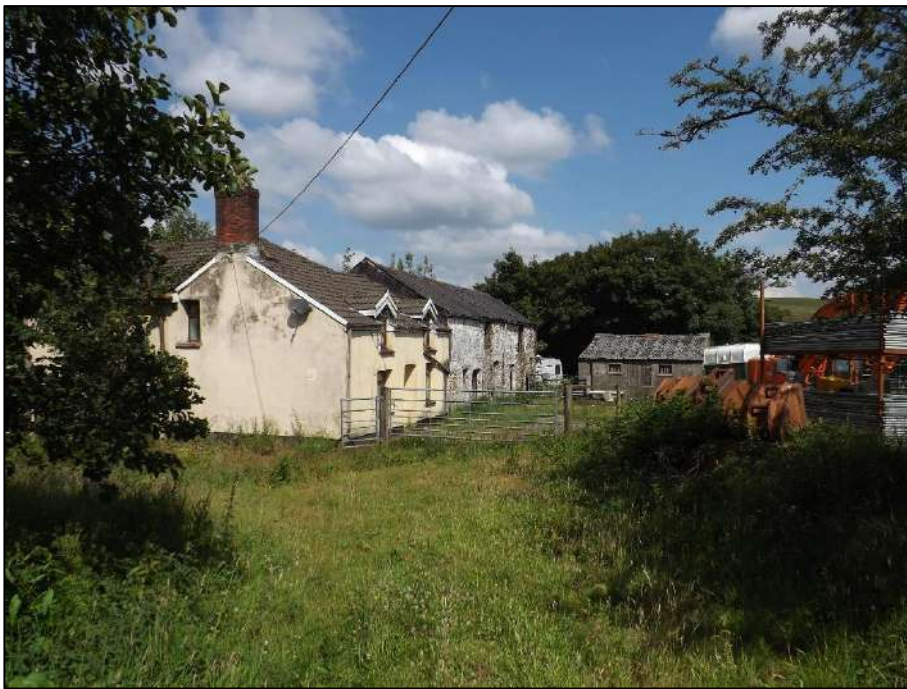
**Plate 49. General view of Tynycoedcae Farm from the original access track.**
