## **Project**

**Project Name:** Greenfield School, Merthyr Tydfil

**Project Date:** 09/04/2021

**Inspection Standard:** MSCC5 Sewers & Drainage GB (SRM5 Scoring)

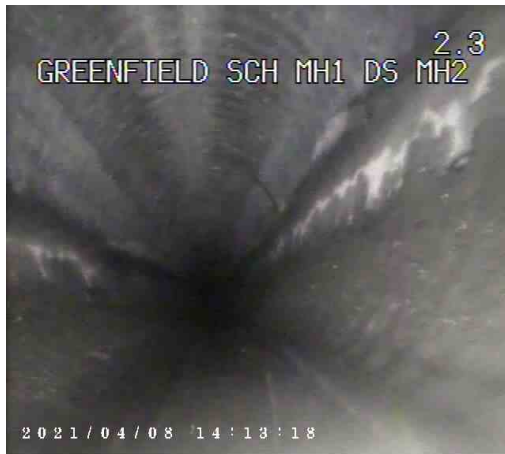
MH1X\_f96da183-a2df-487f-bae7-30318694c6ec\_20210409\_1  
05429\_003.jpg, 00:00:13, 1.90 m  
Water level, 5% of the vertical dimension

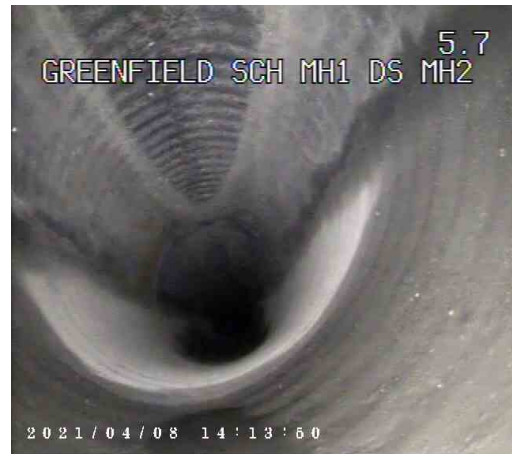
MH1X\_dfd13ff8-0cdb-43a4-b758-b8a06526be58\_20210409\_1  
05537\_208.jpg, 00:00:47, 5.80 m  
Water level, 0% of the vertical dimension

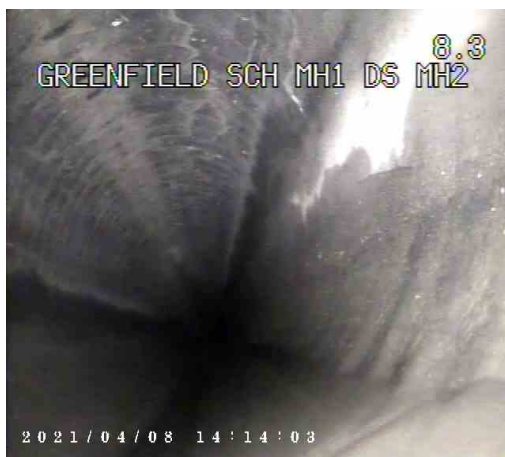
MH1X\_ae0f5811-2854-468b-a1bd-668774410336\_20210409\_1  
105703\_096.jpg, 00:00:58, 7.90 m  
Water level, 5% of the vertical dimension

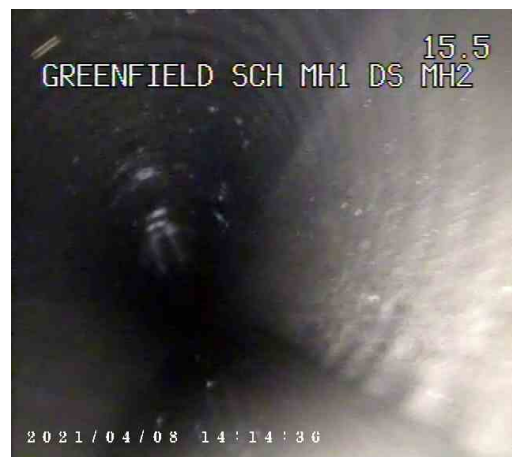
MH1X\_251f051c-3ba5-4938-850a-062b869e1f1f\_20210409\_1  
05824\_237.jpg, 00:01:32, 15.50 m  
Water level, 5% of the vertical dimension

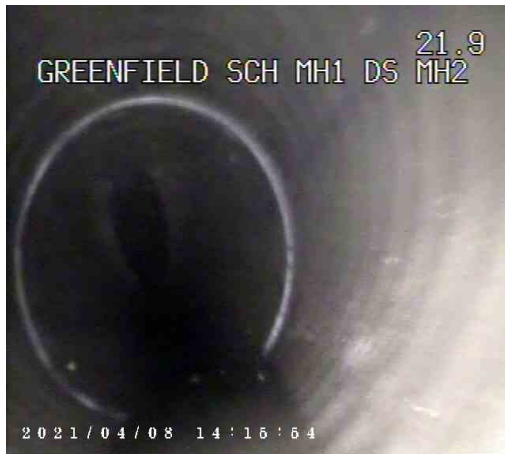
MH1X\_e56bb6df-649e-4fa0-898d-a6186d770c44\_20210409\_110024\_969.jpg, 00:02:50, 21.90 m  
Water level, 5% of the vertical dimension

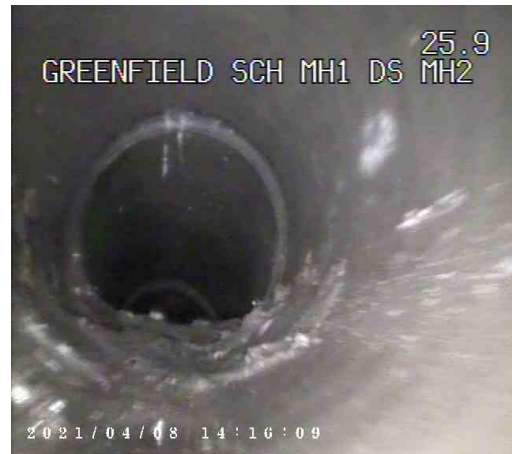
MH1X\_0b20c898-eaf4-4eb6-b407-67ab085efb9c\_20210409\_110102\_815.jpg, 00:03:05, 25.90 m  
Water level, 0% of the vertical dimension

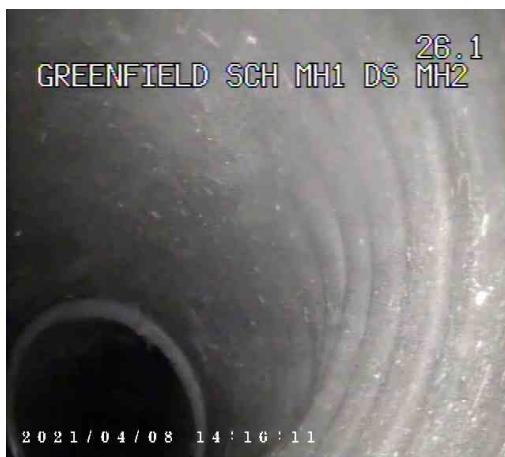
MH1X\_80bbb0b6-74e0-48e5-8f15-96d0218fb9a5\_20210409\_110136\_624.jpg, 00:03:08, 26.10 m  
Line deviates down

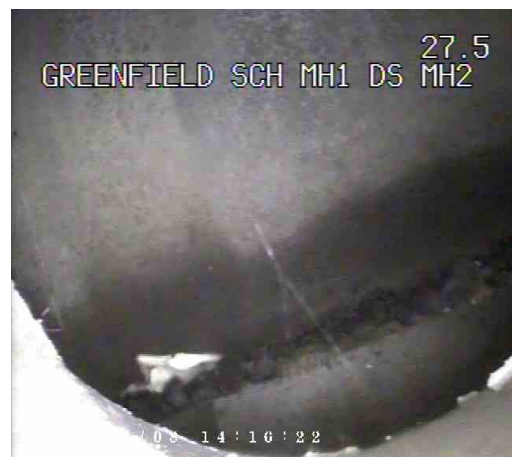
MH1X\_b285c35b-7ed8-4069-ab9d-096be5e741c9\_20210409\_110215\_049.jpg, 00:03:18, 27.70 m  
Finish node type, manhole, reference number: MH2

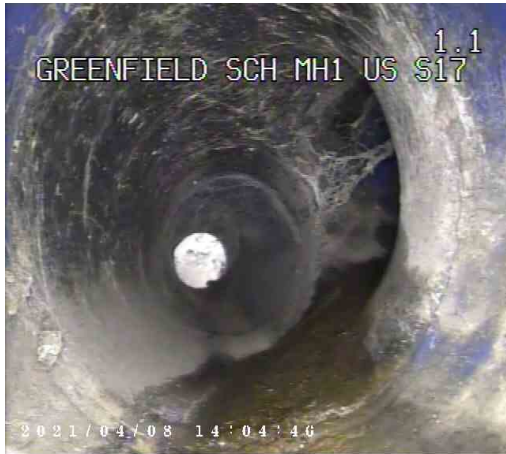
S17X\_089b7654-ac54-43b0-a985-7d4709dd27fd\_20210409\_111310\_415.jpg, 00:00:27, 1.20 m  
Junction at 3 o'clock, diameter: 150mm

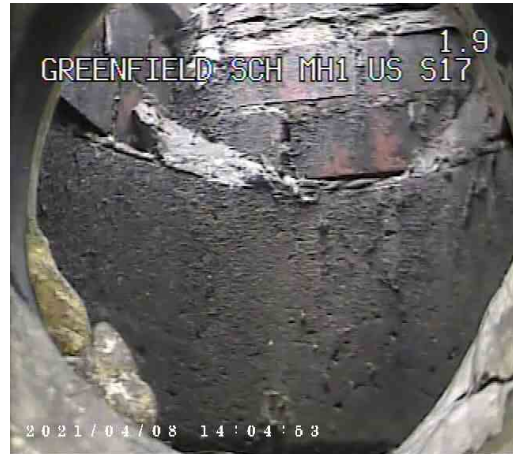
S17X\_769ef3f8-d217-4f46-986e-247e8d287586\_20210409\_111403\_878.jpg, 00:00:34, 2.00 m  
Finish node type, gully, reference number: S17

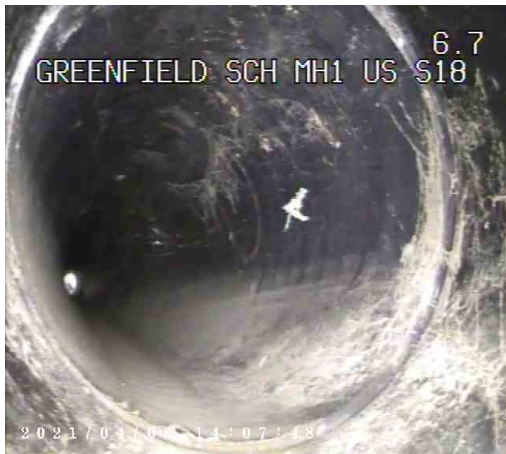
S18X\_91ca7592-87f6-4824-8366-25d00cf2e490\_20210409\_11546\_054.jpg, 00:00:37, 6.70 m  
Line deviates left

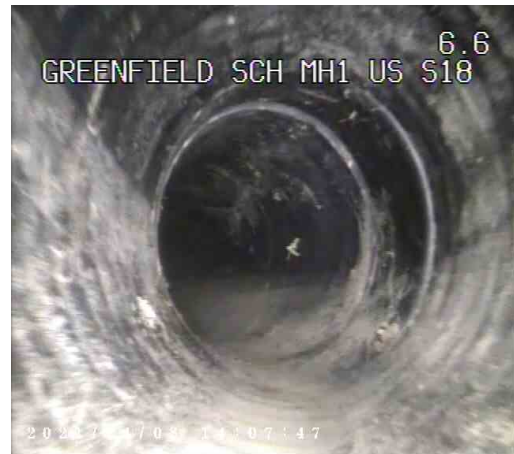
S18X\_3237d3fb-c1ef-4f8b-88a7-18ec8fdef0ef\_20210409\_111551\_334.jpg, 00:00:37, 6.70 m  
Line deviates left

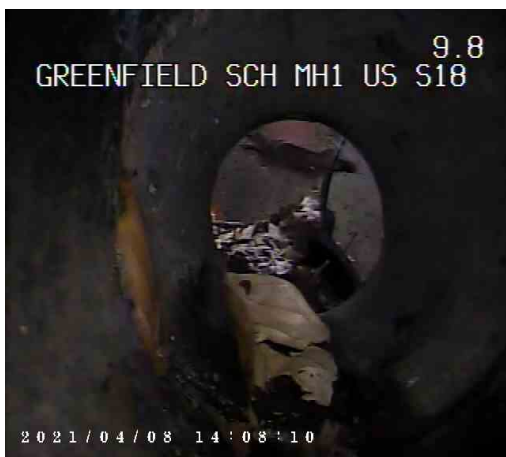
S18X\_558a6820-ffa2-49d5-b89e-17a486da2022\_20210409\_111721\_464.jpg, 00:01:02, 10.70 m  
Finish node type, gully, reference number: S18

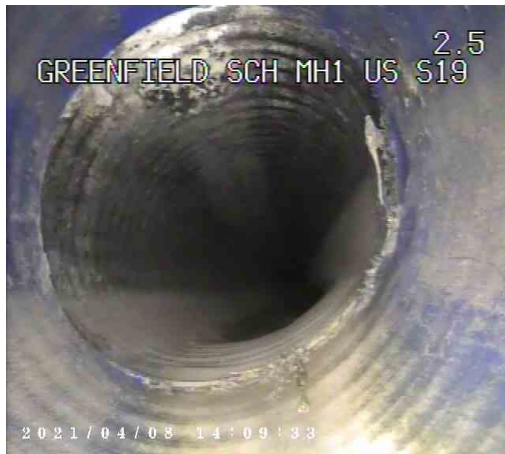
S19X\_2070d7b8-d2cf-4c01-9172-b5b239d22960\_20210409\_112421\_670.jpg, 00:00:12, 2.70 m  
Shape changes to oval, new size(s), 130mm high, 180mm wide, Pipe been squashed at bottom on the joint

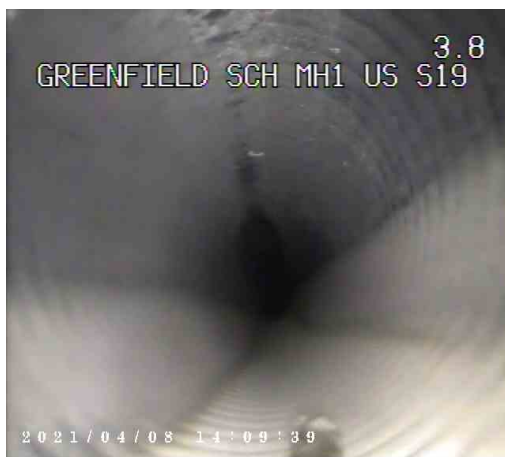
S19X\_7ea72eda-0da7-4549-95e6-02b0c66ac28d\_20210409\_112715\_862.jpg, 00:00:18, 3.80 m  
Water level, 0% of the vertical dimension

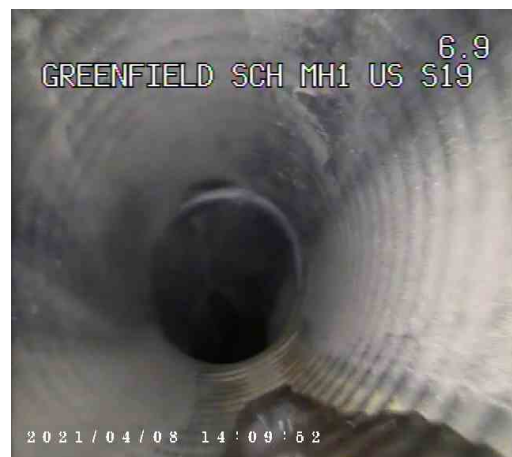
S19X\_711f6029-df59-49b7-b19c-adf65fa9dac7\_20210409\_112757\_552.jpg, 00:00:31, 6.90 m  
Line deviates up

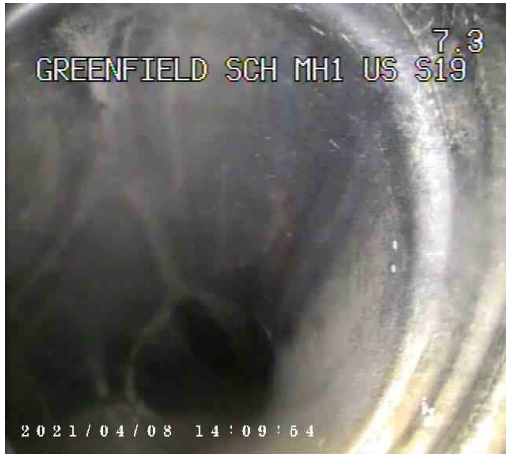
S19X\_dd9d0d94-ce81-4efb-9e94-30d3a27859e2\_20210409\_112824\_126.jpg, 00:00:34, 7.50 m  
Line deviates down

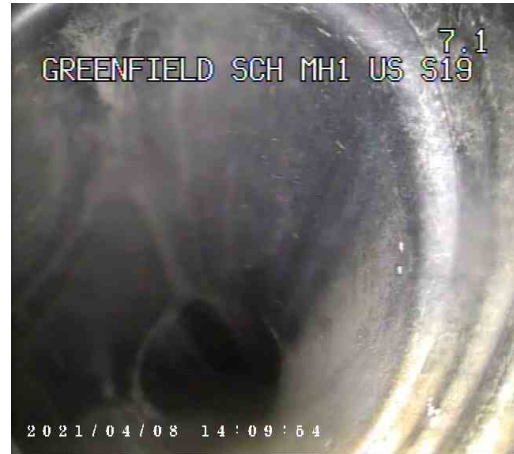
S19X\_2e24307a-6ed1-441f-9c50-af9d07d74163\_20210409\_112930\_845.jpg, 00:00:34, 7.50 m  
Line deviates down

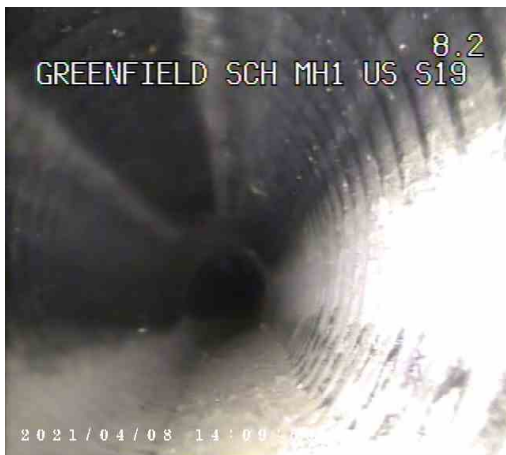
S19X\_19c7ea18-c9f5-4cb1-8efc-64b29e25f29c\_20210409\_113031\_413.jpg, 00:00:37, 8.00 m  
Settled deposits, coarse, 10% cross-sectional area loss, start

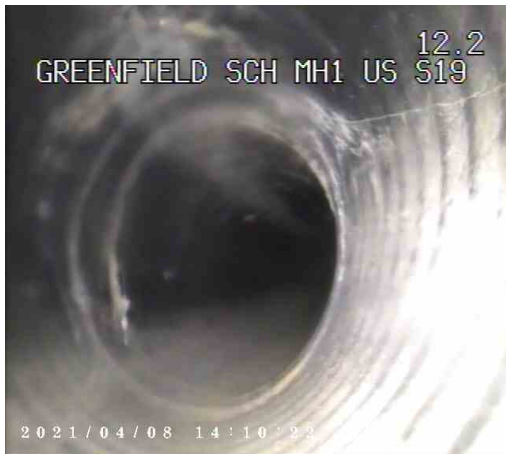
S19X\_21fa4948-da78-44f8-b296-5c18644e2fec\_20210409\_1  
13231\_501.jpg, 00:01:01, 12.50 m  
Line deviates right

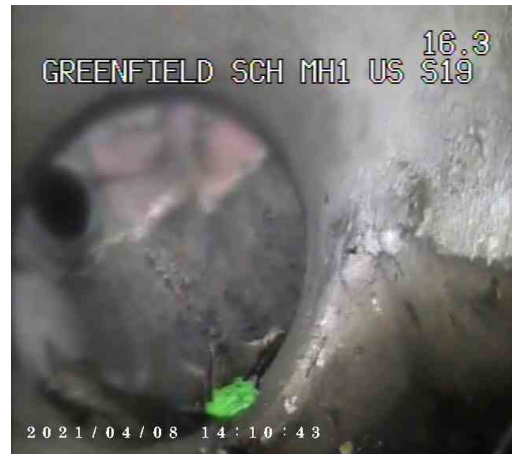
S19X\_f1c9d01c-bf8b-4ac8-9bcf-4b6760874b71\_20210409\_11  
3309\_684.jpg, 00:01:22, 16.50 m  
Finish node type, gully, reference number: S19

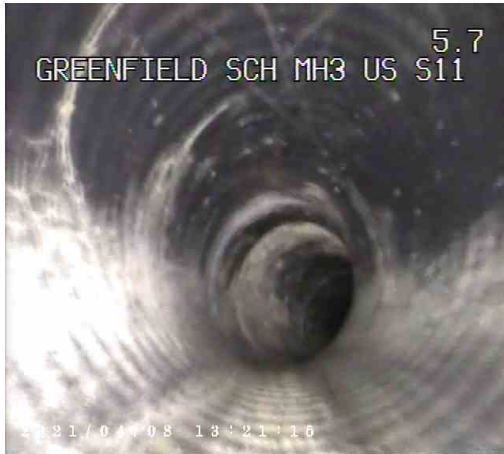
S11X\_aa7399ee-ac2e-4dee-b6f6-cfd1c82ae481\_20210409\_1  
15057\_980.jpg, 00:00:31, 5.70 m  
Line deviates right

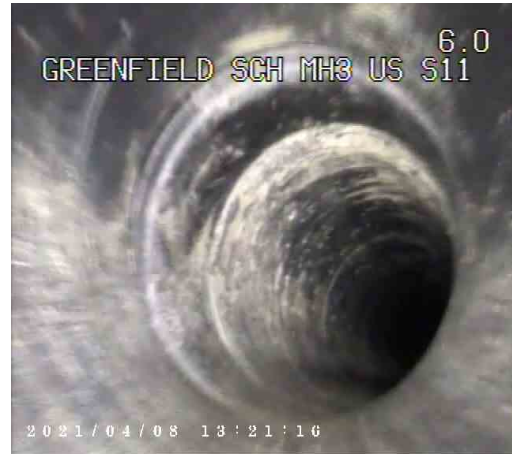
S11X\_f74460b6-796b-4a6d-b9f2-52fe2d621ad6\_20210409\_1  
15124\_147.jpg, 00:00:32, 6.20 m  
Line deviates down

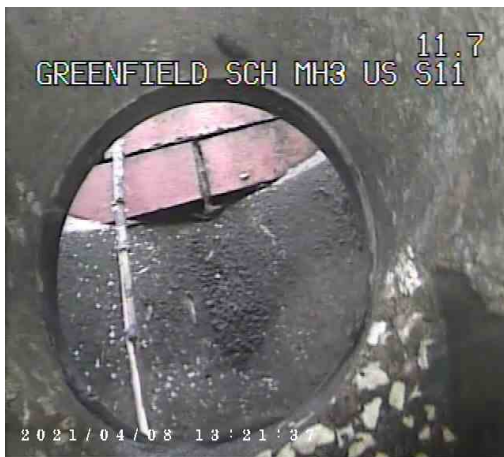
S11X\_c5085f99-47e5-4918-93e6-d9c7a5a02d1b\_20210409\_1  
115218\_531.jpg, 00:00:54, 11.90 m  
Finish node type, gully, reference number: S11

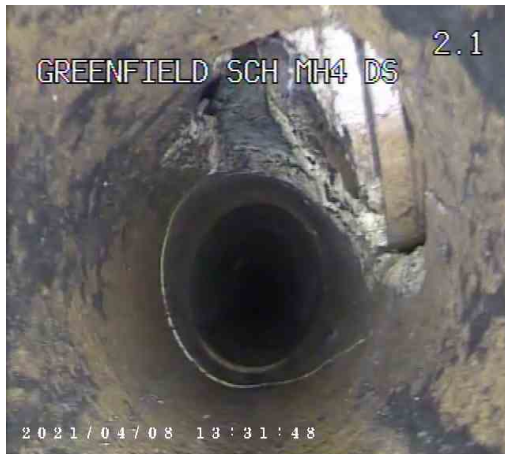
MH4X\_7cdd99c8-6439-4cff-9660-40e9250bf3df\_20210409\_15415\_579.jpg, 00:00:26, 2.20 m  
Connection other than junction at 2 o'clock, diameter: 100mm

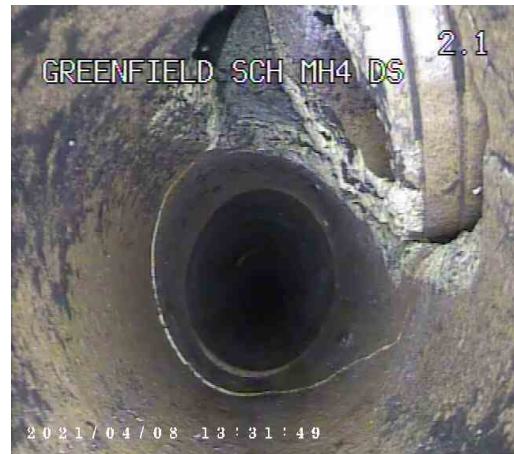
MH4X\_c281e691-c5dd-4067-893f-dc45341f6845\_20210409\_115448\_307.jpg, 00:00:26, 2.20 m  
Connection other than junction at 2 o'clock, diameter: 100mm

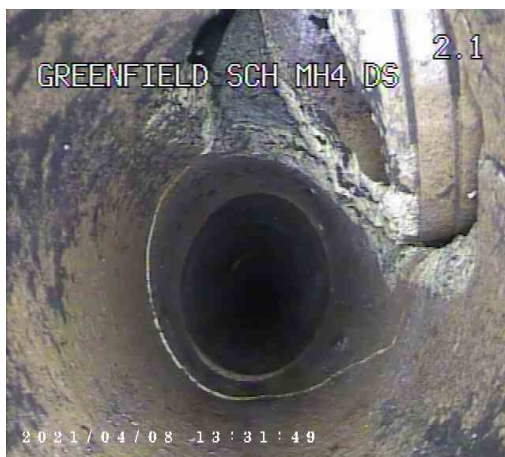
| Section | PLR | Grade | Description |
|---|---|---|---|
| 7 | MH4X | 4 | Hole in drain or sewer at joint at 12 o'clock |

MH4X\_888a0a1b-f5d6-4178-8084-9966d7f5f239\_20210409\_15543\_842.jpg, 00:00:27, 2.20 m  
Hole in drain or sewer at joint at 12 o'clock, Hole above connecting pipe.

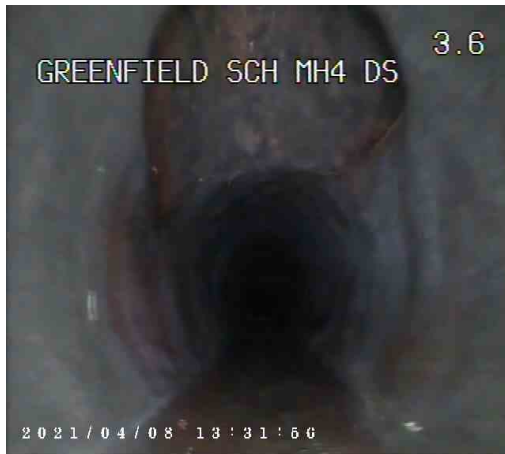
MH4X\_02b55f38-d5c0-4024-9a94-641a095bf93a\_20210409\_115656\_235.jpg, 00:00:33, 3.80 m  
Junction at 12 o'clock, diameter: 100mm

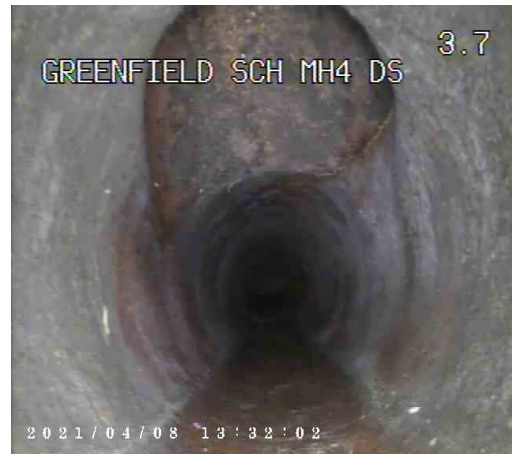
MH4X\_2c47259a-7974-4135-a027-93da851b07c5\_20210409\_115705\_772.jpg, 00:00:33, 3.80 m  
Junction at 12 o'clock, diameter: 100mm

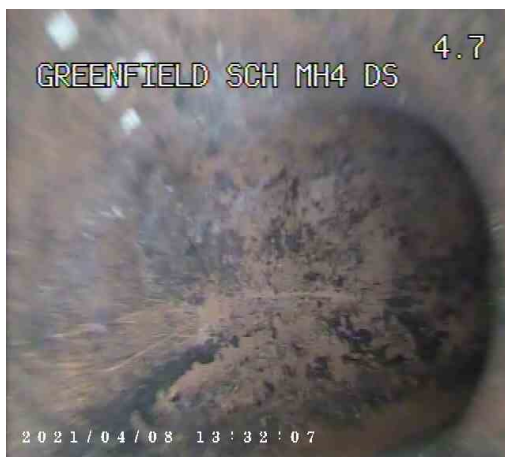
MH4X\_898e3ae4-a4e6-42f0-a37a-9054f851f5dc\_20210409\_115725\_890.jpg, 00:00:44, 4.80 m  
Line deviates right

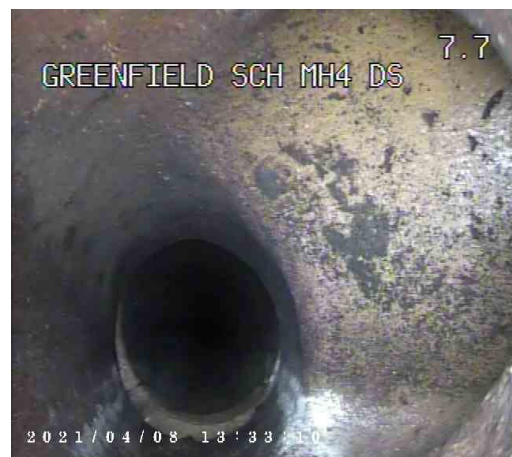
MH4X\_1121c319-d81f-439c-b0c2-1f6b5c487b0b\_20210409\_115848\_979.jpg, 00:01:47, 7.80 m  
Junction at 3 o'clock, diameter: 100mm

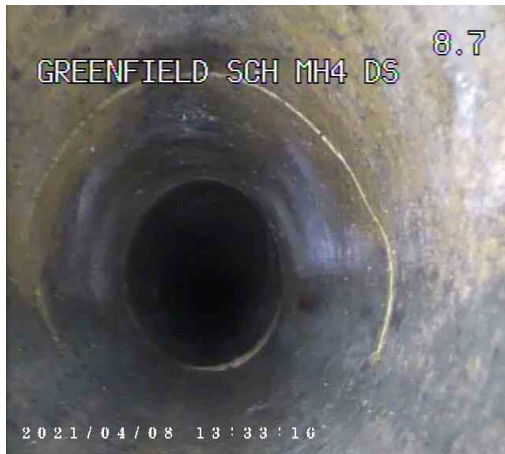
| No. | m+ | Code | Observation |
|---|---|---|---|
| 9 | 8.90 | CC | Crack, circumferential from 12 o'clock to 12 o'clock |

| Scale: 1:99 | Position [m] | Code | Observation | MPEG | Photo | Grade |
|---|---|---|---|---|---|---|
| | 8.90 | CC | Crack, circumferential from 12 o'clock to 12 o'clock | 00:01:54 | MH4X_739ae0a7-c8ac-4b7b-9 | 2 / 2 |

MH4X\_739ae0a7-c8ac-4b7b-9a3c-6cac798f8d48\_20210409\_115924\_634.jpg, 00:01:54, 8.90 m  
Crack, circumferential from 12 o'clock to 12 o'clock

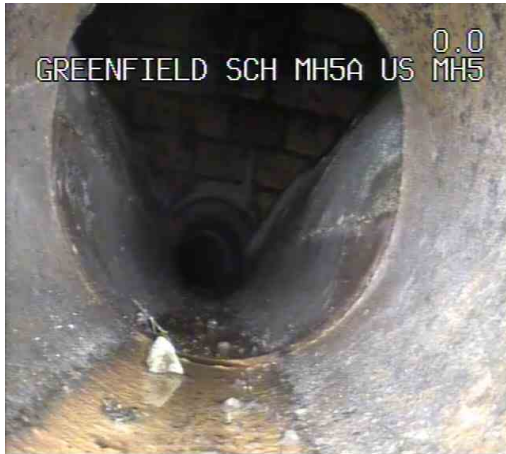
MH5X\_857c9a79-cda8-431f-8440-64e2c46772c0\_20210409\_120159\_034.jpg, 00:00:00, 0.00 m  
Start node type, manhole, reference number: MH5A

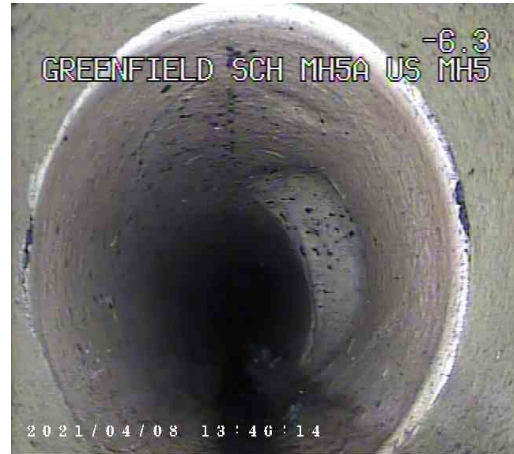
MH5X\_f93115d9-cea1-4036-8b8e-14dbf8a3a84a\_20210409\_120334\_338.jpg, 00:00:44, 6.30 m  
Connection other than junction at 3 o'clock, diameter: 100mm

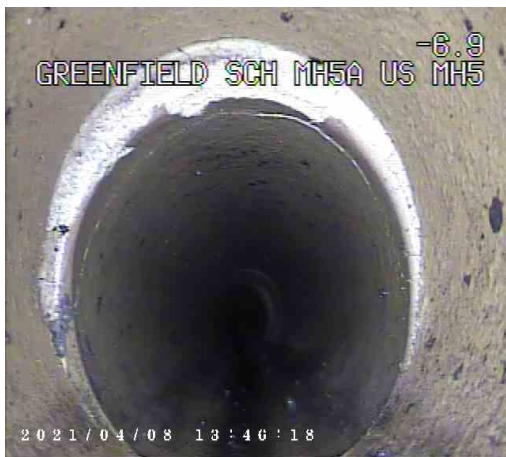
MH5X\_66ca5f3c-a5ba-4cae-84ed-91cc88a78fdc\_20210409\_120404\_401.jpg, 00:00:49, 7.00 m  
Joint displaced, medium

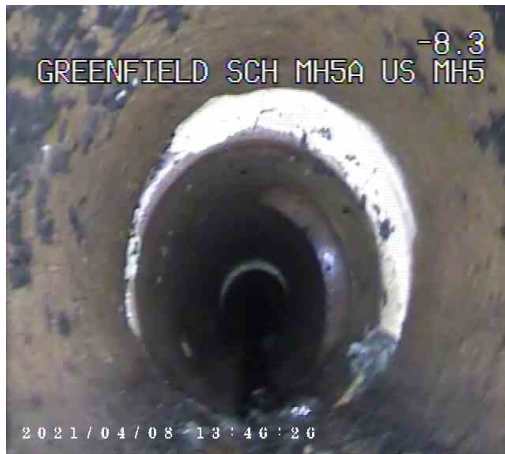
MH5X\_ed2a13a7-1ff5-4519-9d26-d6a8b7d03c89\_20210409\_121031\_657.jpg, 00:00:56, 8.00 m  
Joint displaced, medium

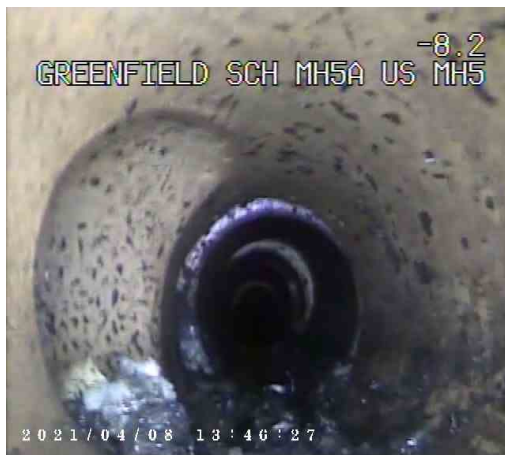
MH5X\_d11b7c41-9c04-4916-954e-1ee8bb77c292\_20210409\_121229\_612.jpg, 00:00:58, 8.50 m  
Junction at 9 o'clock, diameter: 100mm

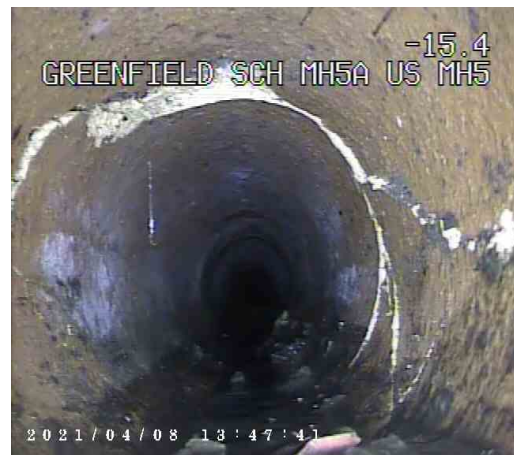
| No. | m+ | Code | Observation |
|---|---|---|---|
| 10 | 15.10 | CC | Crack, circumferential from 12 o'clock to 12 o'clock |

| Scale: 1:237 | Position [m] | Code | Observation | MPEG | Photo | Grade |
|---|---|---|---|---|---|---|
| | 15.10 | CC | Crack, circumferential from 12 o'clock to 12 o'clock | 00:02:06 | MH5X_32<br>5b1eac-ae<br>86-49ed-8 | 2 / 2 |

MH5X\_325b1eac-ae86-49ed-895e-ded158ba6d0b\_20210409\_121752\_672.jpg, 00:02:06, 15.10 m  
Crack, circumferential from 12 o'clock to 12 o'clock

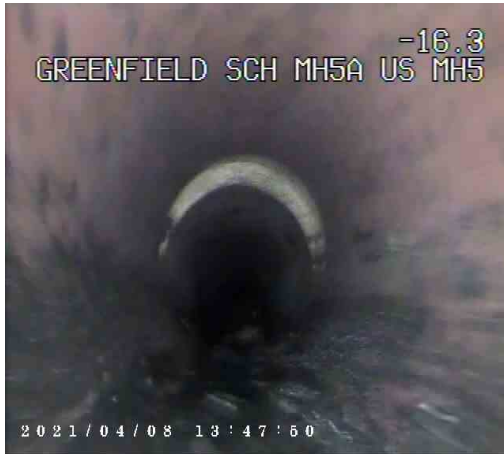
MH5X\_7f03486a-89f9-4ab3-bba0-de8f049f1135\_20210409\_1  
21840\_128.jpg, 00:02:21, 16.10 m  
Joint displaced, medium

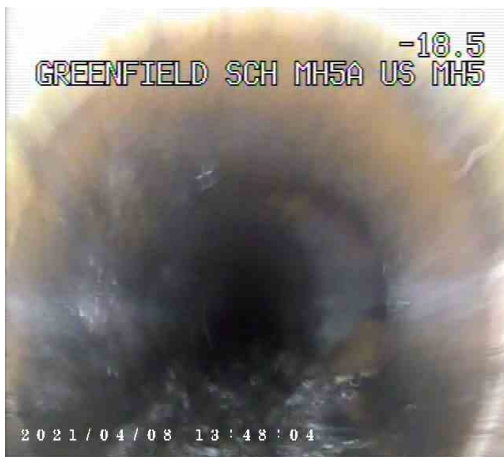
MH5X\_acbd7248-6231-4b46-a672-8c097db1e455\_20210409\_1  
121936\_998.jpg, 00:02:34, 18.50 m  
Junction at 3 o'clock, diameter: 100mm

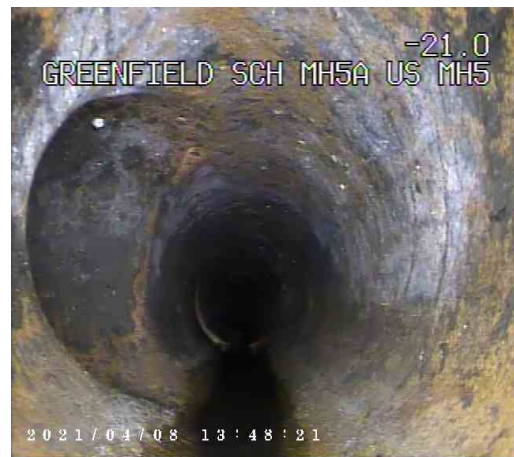
MH5X\_bf7cc711-0405-4473-80bf-90adac1f197a\_20210409\_1  
22030\_112.jpg, 00:02:52, 20.70 m  
Junction at 9 o'clock, diameter: 100mm

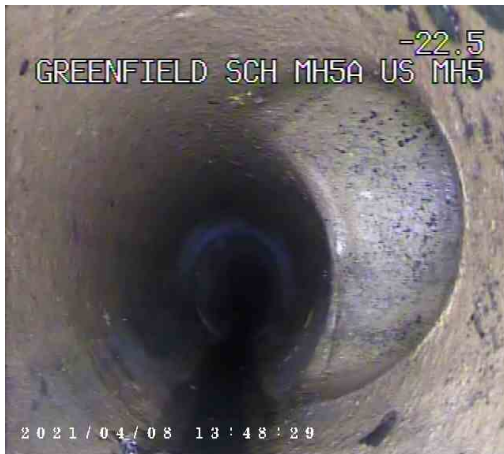
MH5X\_70d000f5-7d43-4408-8de3-99c12868eb38\_20210409\_122110\_704.jpg, 00:02:57, 21.00 m  
Junction at 3 o'clock, diameter: 100mm

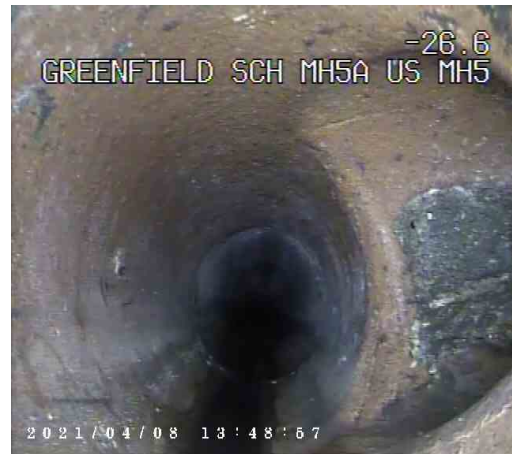
MH5X\_3de3c608-3ca9-4df5-82a4-0cbb77bf69d4\_20210409\_124610\_717.jpg, 00:03:28, 26.50 m  
Junction at 3 o'clock, diameter: 100mm

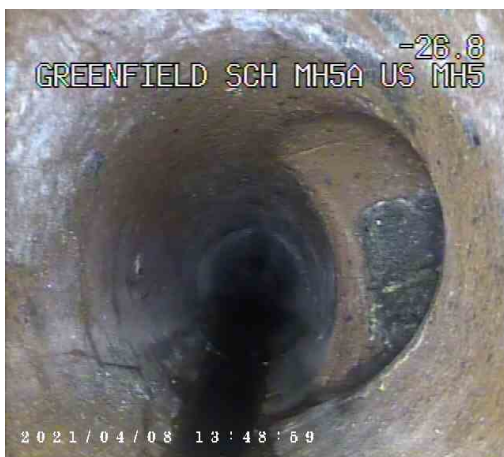
MH5X\_e8c25c13-a069-4575-8b33-8322c95d3991\_20210409\_124621\_301.jpg, 00:03:28, 26.50 m  
Junction at 3 o'clock, diameter: 100mm

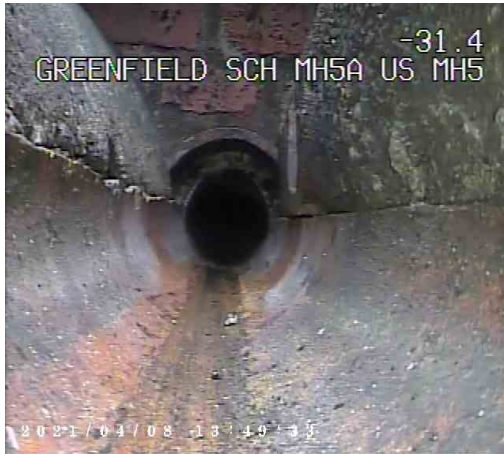
MH5X\_c277b9ef-9935-4106-a967-1f7466084c7a\_20210409\_125028\_910.jpg, 00:04:03, 31.50 m  
Finish node type, manhole, reference number: MH5

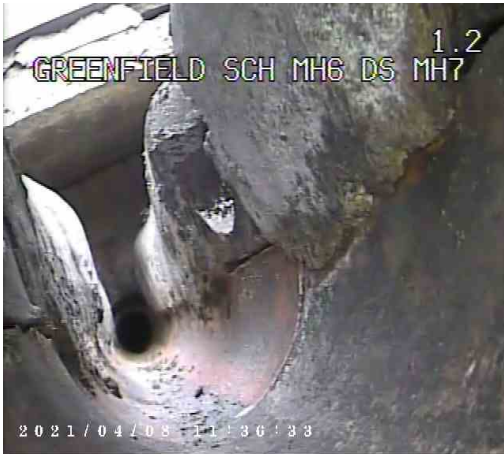
MH6X\_44777bc9-d1f8-48ec-8480-dbaf49b4bfd2\_20210409\_1  
25318\_324.jpg, 00:00:16, 1.20 m  
Finish node type, manhole, reference number: MH7

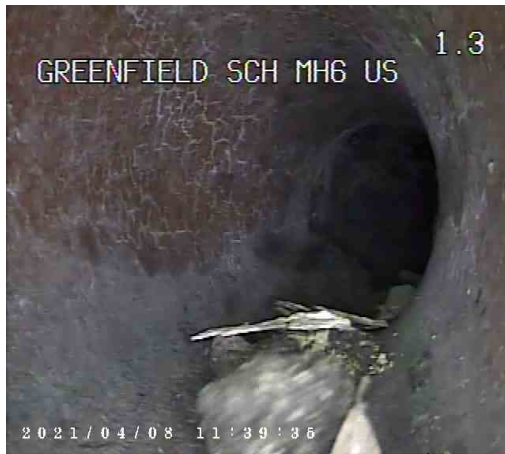
USX\_7a828640-c1d6-4a7a-9674-9aaeb3a251d0\_20210409\_1  
25454\_260.jpg, 00:00:21, 1.50 m  
Line deviates right

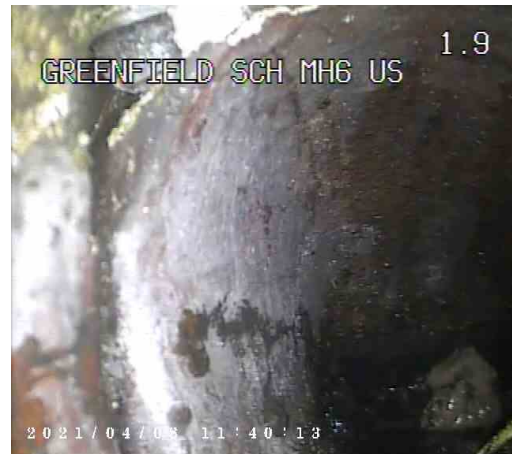
USX\_efae770e-45bc-4fa3-9975-e84f165ecac2\_20210409\_12  
5616\_381.jpg, 00:00:25, 1.80 m  
Finish node type, gully, reference number: US

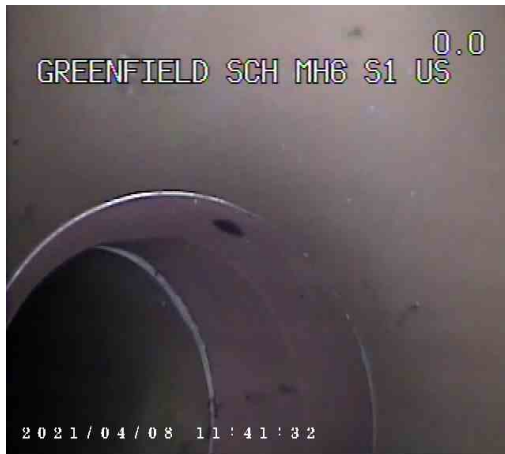
S1X\_0ecd798d-34c4-490e-b51f-78300f2b0124\_20210409\_12  
5820\_861.jpg, 00:00:02, 0.30 m  
Line deviates left

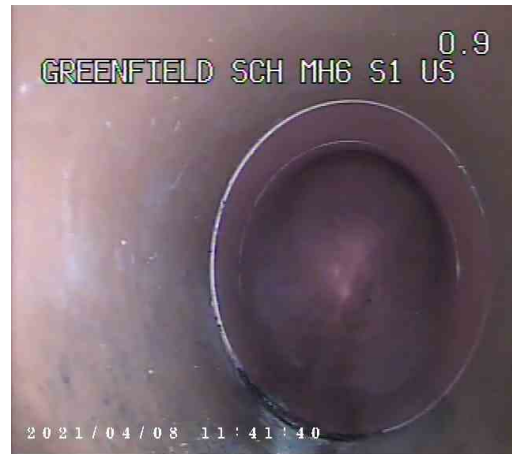
S1X\_19ca1c7e-920f-4f7f-a9b8-e17fe0d7bf5c\_20210409\_1303  
25\_598.jpg, 00:00:10, 1.00 m  
Line deviates up

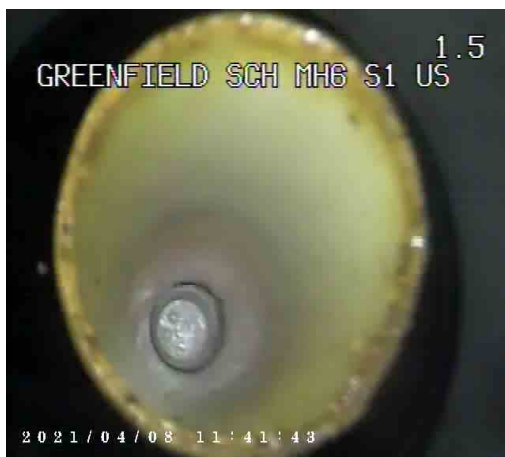
S1X\_d1463d36-f64a-4ed6-8c1a-95be66f60feb\_20210409\_13  
0303\_076.jpg, 00:00:13, 1.50 m  
Survey abandoned, End of line in building.

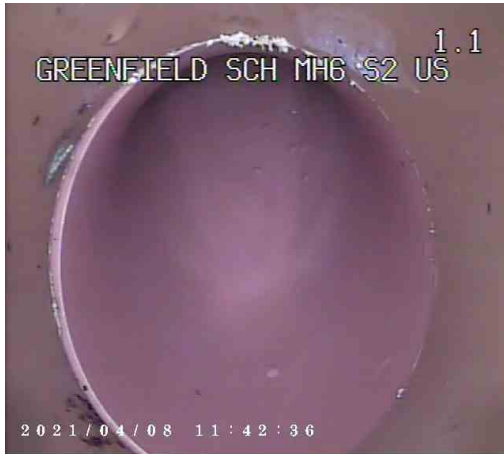
S2X\_7fb62b8d-49c5-448e-b280-f56655060e90\_20210409\_13  
0642\_195.jpg, 00:00:13, 1.20 m  
Line deviates up

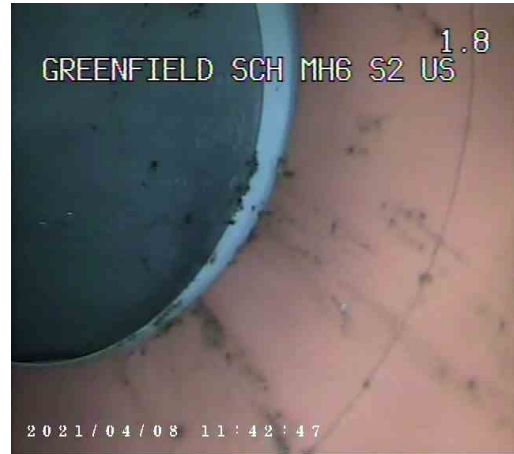
S2X\_9e983243-242c-42f5-81ee-73fb63cb095e\_20210409\_13  
0737\_883.jpg, 00:00:24, 1.80 m  
Survey abandoned, End of line in building.

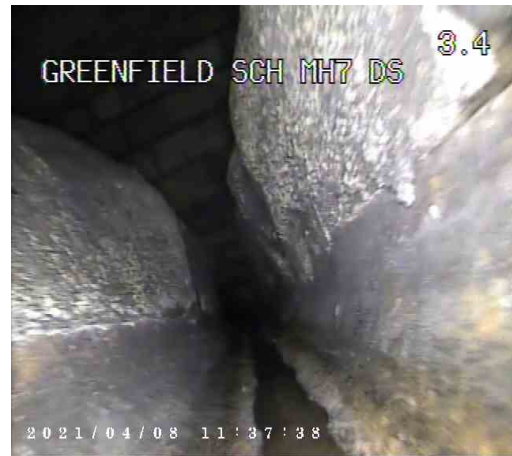
MH7X\_e3b41572-4d52-4222-92fc-d4791c236a15\_20210409\_131021\_411.jpg, 00:00:20, 3.40 m  
Finish node type, manhole, reference number: MH7A

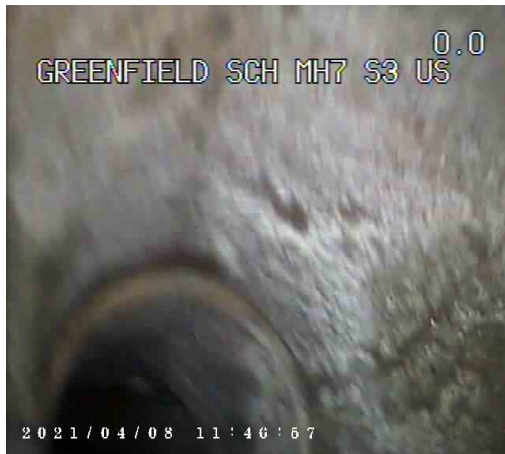
S3X\_4ed7c991-3afb-4c49-a974-1f5c96bc161b\_20210409\_13  
1207\_659.jpg, 00:00:02, 0.20 m  
Line deviates left

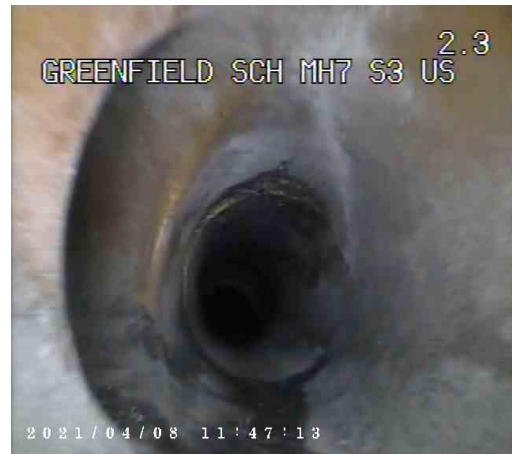
S3X\_e2d87558-950d-4720-a65b-363b13c3e288\_20210409\_1  
31250\_314.jpg, 00:00:18, 2.40 m  
Junction at 9 o'clock, diameter: 100mm

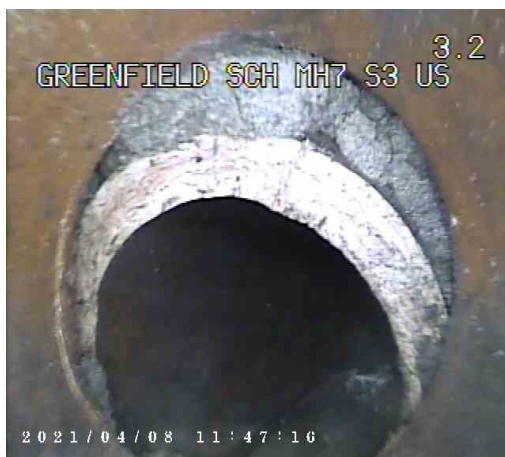
S3X\_08081d13-713e-4616-8395-f5720fc488ca\_20210409\_13  
1314\_018.jpg, 00:00:21, 3.40 m  
Joint displaced, large

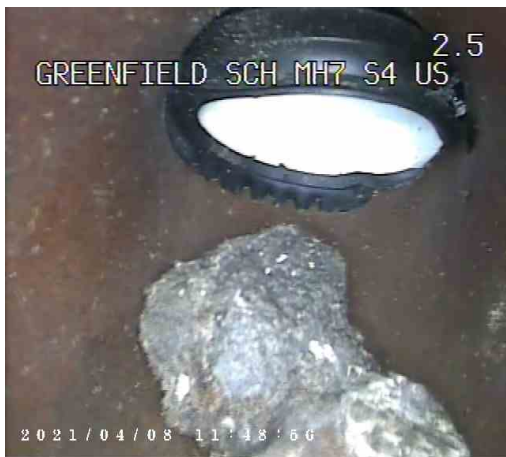
S4X\_f9f919cd-5e90-4493-bac2-2d880f9852d1\_20210409\_13  
2126\_617.jpg, 00:00:41, 2.50 m  
Survey abandoned, End of line in building.

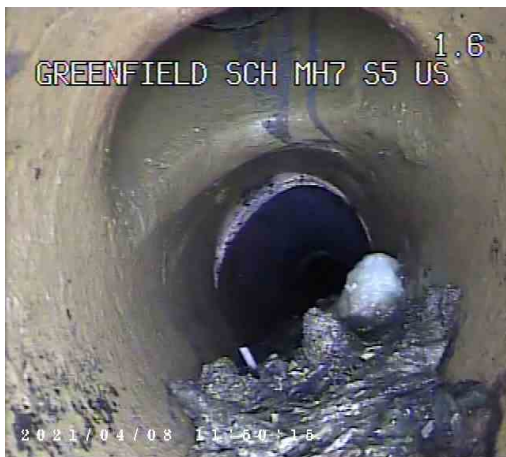
S5X\_2742bc33-e987-4a5b-a546-aa8244d85aa1\_20210409\_1  
32356\_896.jpg, 00:00:11, 1.80 m  
Junction at 11 o'clock, diameter: 100mm

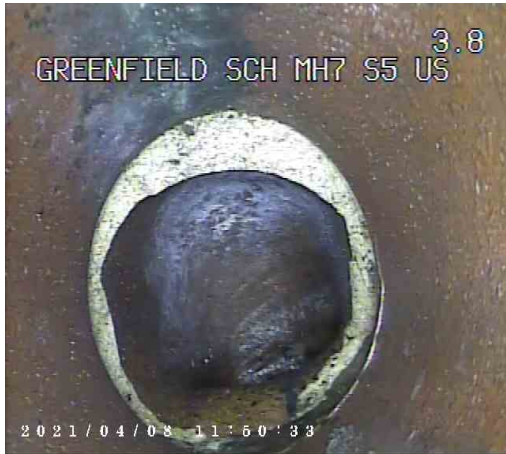
S5X\_7b3c2c66-a94f-4294-b0bc-2bdb9c732503\_20210409\_13  
2526\_209.jpg, 00:00:28, 4.00 m  
Joint displaced, medium

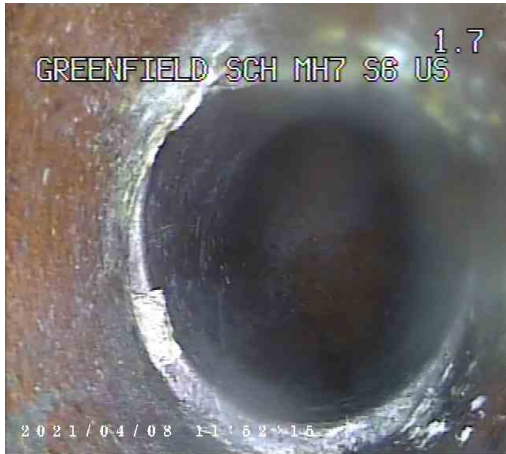
S6X\_84fb33d9-67fd-4f7f-b726-649c8c28c2d8\_20210409\_133  
009\_859.jpg, 00:00:18, 1.80 m  
Line deviates up

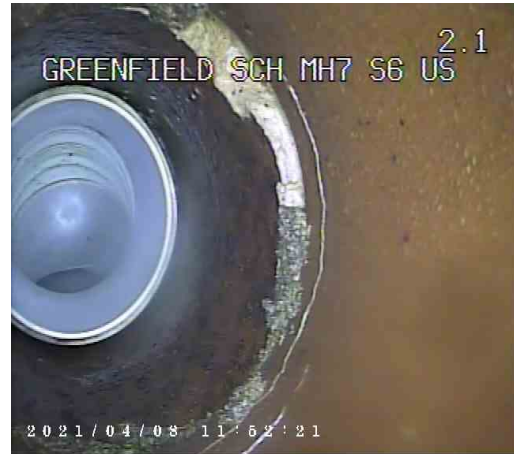
S6X\_8a054d3d-90ad-4ea2-a2d0-509a61adccf9\_20210409\_1  
32936\_313.jpg, 00:00:19, 2.10 m  
Survey abandoned, End of line in building.

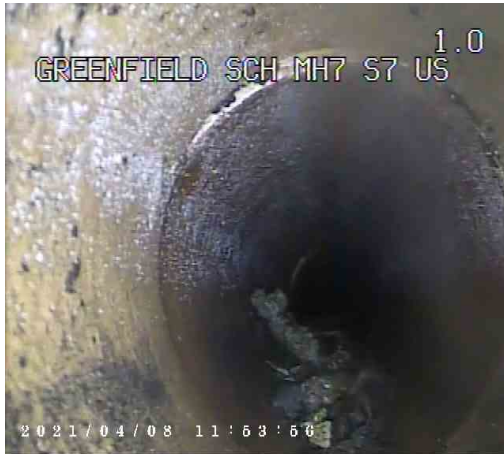
S7X\_59a4078a-df71-4787-89bc-8338e67859ba\_20210409\_133206\_000.jpg, 00:00:07, 0.80 m  
Settled deposits, coarse, 5% cross-sectional area loss, start

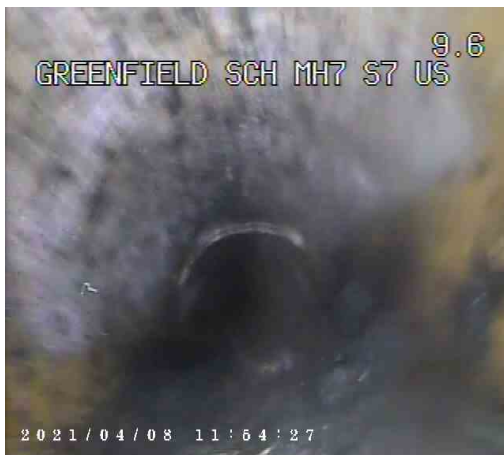
S7X\_af4ce3c3-fa8c-4191-8308-354cad624a1d\_20210409\_133458\_768.jpg, 00:00:39, 9.60 m  
Settled deposits, coarse, 5% cross-sectional area loss, start

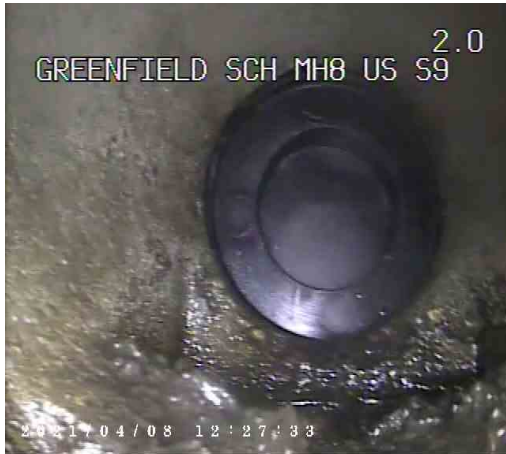
S9X\_c1669317-3808-477a-afb2-7840c786f451\_20210409\_13  
4051\_258.jpg, 00:00:19, 2.40 m  
Finish node type, gully, reference number: S9

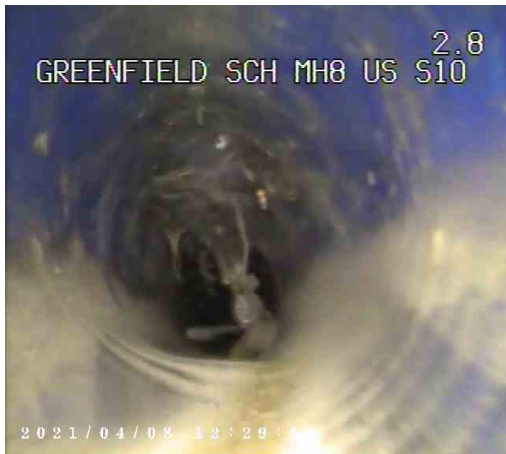
S10X\_a237a71e-862e-4f3e-aa15-d3d8db956608\_20210409\_134349\_695.jpg, 00:00:15, 3.00 m  
Deformed sewer or drain, 5%, Floor of pipe pushed in.

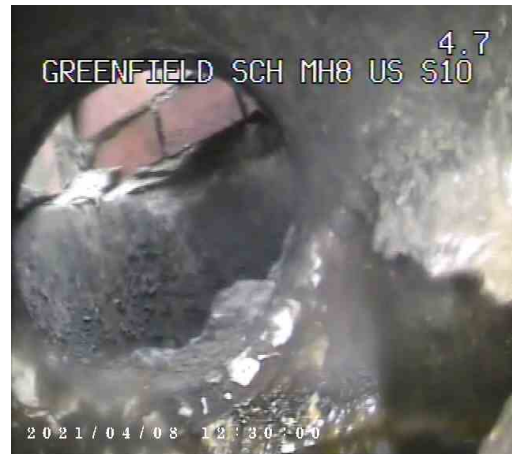
S10X\_1ec06c95-b3fd-4fa9-9632-d8d7eecfb5a1\_20210409\_134423\_767.jpg, 00:00:24, 5.00 m  
Finish node type, gully, reference number: S10

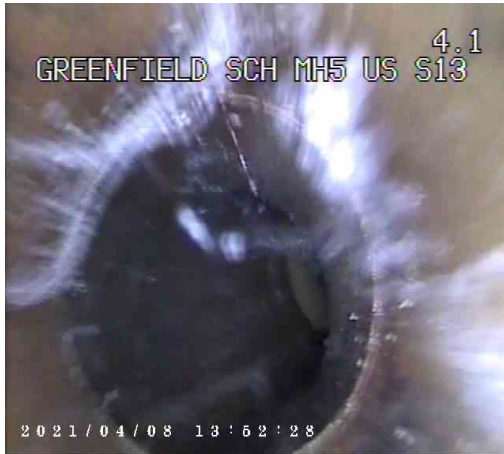
S13X\_dd2a357b-bafa-4e85-81db-428d8884858f\_20210409\_1  
50949\_043.jpg, 00:00:21, 4.50 m  
Line deviates right

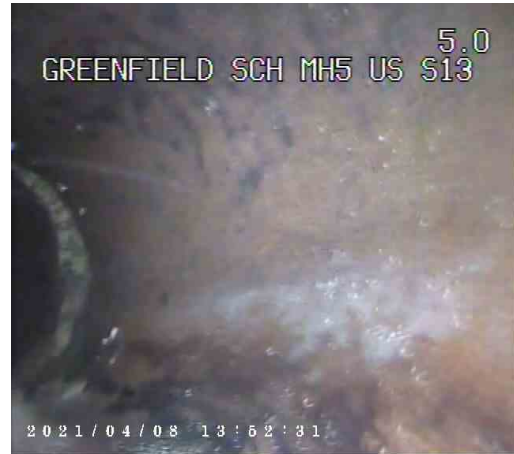
S13X\_27bdda10-4cc5-43d7-8140-5413cf6729aa\_20210409\_1  
51022\_815.jpg, 00:00:23, 5.00 m  
Line deviates left

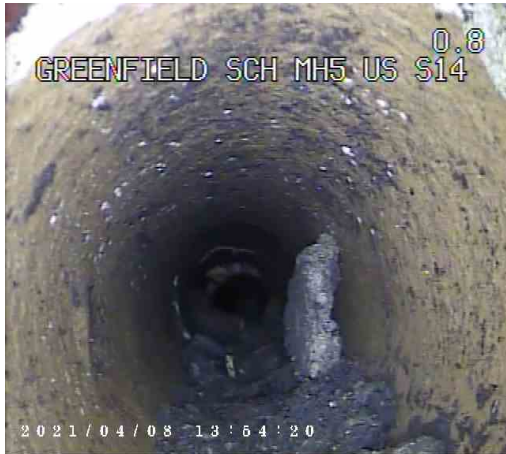
S14X\_64b2182a-1397-4ba6-b866-a1851ed92341\_20210409\_151635\_286.jpg, 00:00:06, 0.80 m  
Settled deposits, coarse, 5% cross-sectional area loss, start

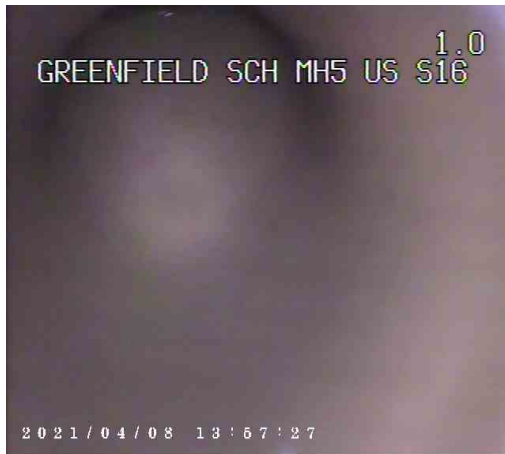
S16X\_0013b286-9fe8-4e66-b95c-abf64ac29ad9\_20210409\_1  
52159\_933.jpg, 00:00:06, 1.00 m  
Line deviates up

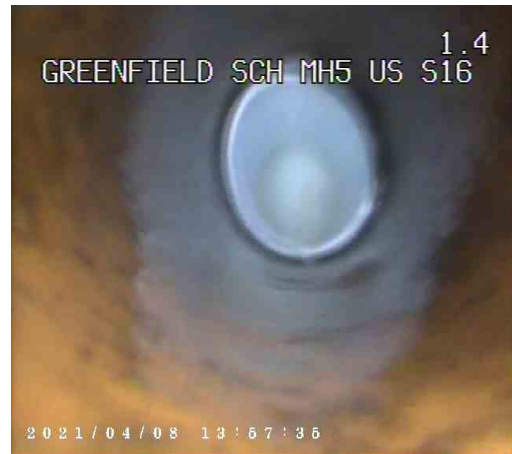
S16X\_1de308cd-0bd9-40b1-af55-92919569234e\_20210409\_  
152236\_813.jpg, 00:00:14, 1.40 m  
Survey abandoned, End of line in building

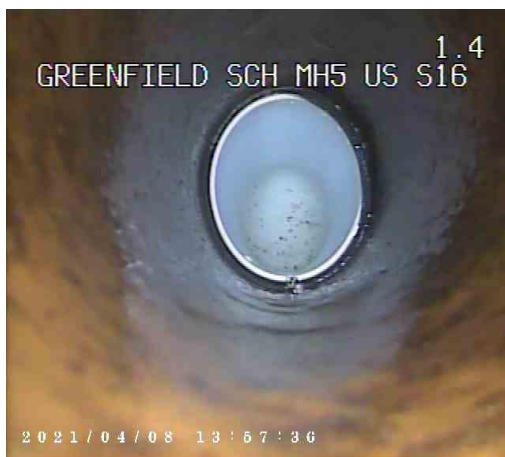
S16X\_a93acb7b-ae4f-4e0e-a6d8-b49a16f0670c\_20210409\_1  
52242\_349.jpg, 00:00:14, 1.40 m  
Survey abandoned, End of line in building
