Primrose Hill, Merthyr Tydfil

RECORD OF BUILDING AND CONDITION ASSESSMENT REPORT, WITH REPAIR PROPOSALS

.....(449)2503-GVWP-A-HIS-P01

Date: 05.03.25

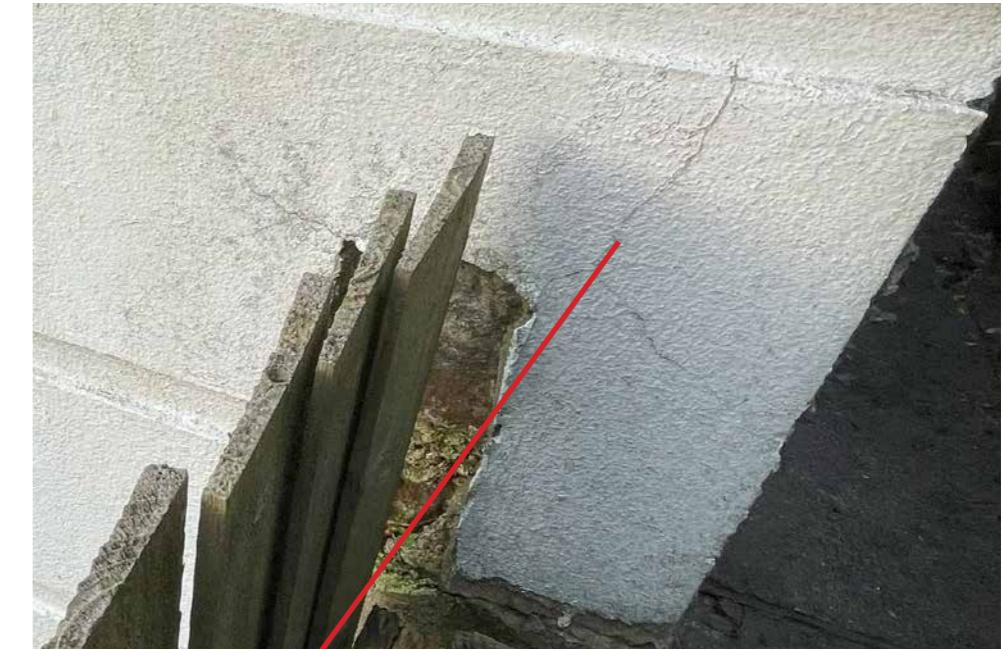
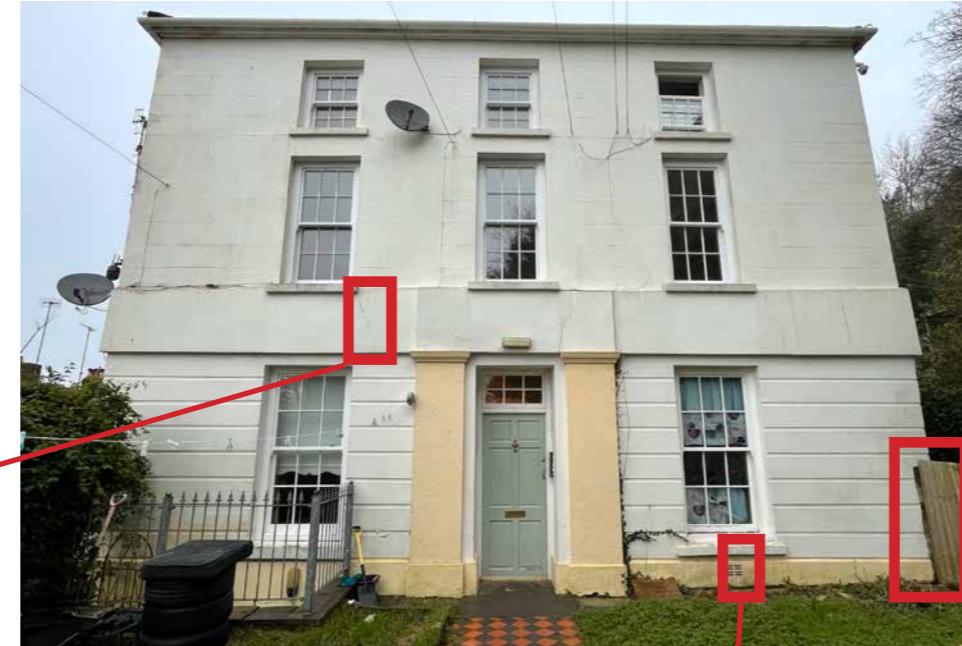
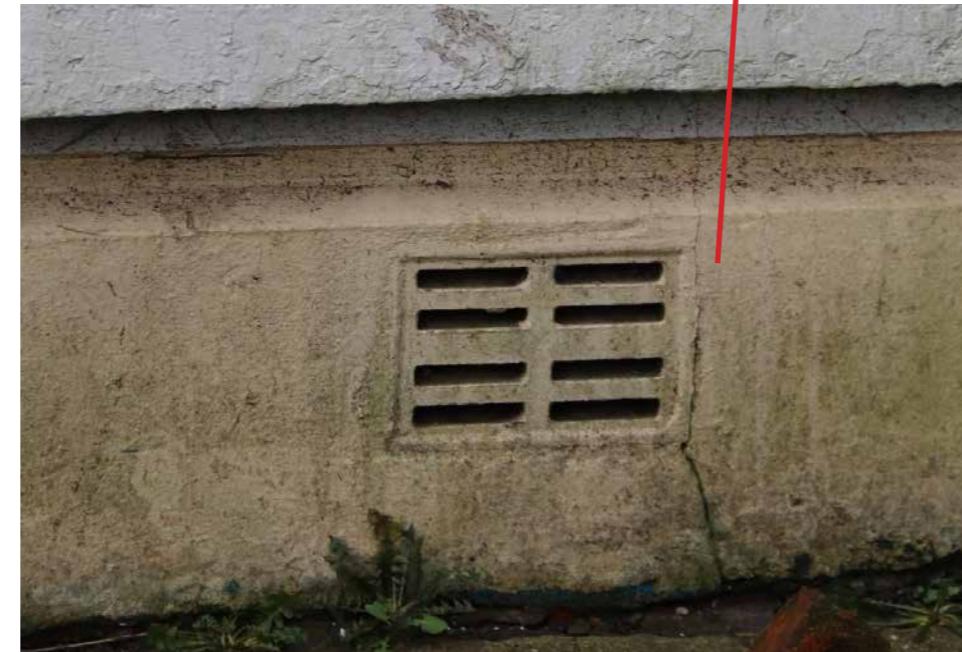
The front elevation has been applied with a cementitious render, sometimes known as 'stucco'. To the upper two floors, the render has been incised to emulate coursed finished stone. Below the flat deep band underneath the first floor window cills, the render has been rusticated. The substrate behind the render (i.e. the masonry with which the walls were built) appears to be red brick (as suggested by the one view in the bottom right photo on the next page); however, there could also be stone. Given the age of the building, this render would initially have been a lime and sand render, not cementitious.

Clearly apparent across the elevation are cracks in the render - see photos on this page and the next page. This is a problematic issue. Traditional buildings made of solid masonry walls are designed to be slightly flexible. Lime mortar and render provides that flexibility, which allows the walls to expand and contract nominally without cracking. Cement render is not flexible, and so any expansion or contraction in the walls cannot be absorbed by the coating. The result is often the appearance of cracks within the cement render. Once cracks occur, water enters the wall through the cracks, and is held between the render and the masonry. Lime render is vapour-permeable, whilst cement render is impermeable. So, if the render was lime, not only would there be many fewer, if any, cracks; but also the moisture absorbed into the wall fabric would be drawn out of the wall (hygroscopically) through the joints and render, would sit on the surface of the wall, and be evaporated by the sun and wind. With cement render, it is not possible for the moisture to escape through the coating, and hence to evaporate on the surface. As such, a cement rendered wall, once cracks occur, holds onto the moisture. This can result in various defects – the breaking down of the masonry itself; the widening of cracks (as moisture held, freezes and expands); saturation of the masonry, which could cause damp or mould internally (especially if the internal plaster is gypsum, not lime, as it is here); saturation of timber in contact with the masonry, which could cause mould, rot or infestation; and a generally unhealthy building.

To that end, we recommend very carefully hacking off the cementitious render to the external face (as well as the cementitious / gypsum plaster to the internal face), allowing as long a time as possible for the external walls to dry out, by exposing both external and internal faces of the masonry to evaporation), and then re-applying a 3-coat lime render to the outside face of the walls (and a 3-coat lime plaster to the inside faces). The external render will need to be smooth-finished with the top coat, rusticated at ground floor and incised at upper floors, to emulate coursed finished stone, to match the design of the existing stucco.

Trying to remove cementitious render, which usually bonds extremely well to masonry, can cause damage to the stone. However, sometimes it can be removed fairly easily with little damage; with the work in the right hands. This is a risk; however, given the damp condition internally, this may be a risk which needs to be taken.

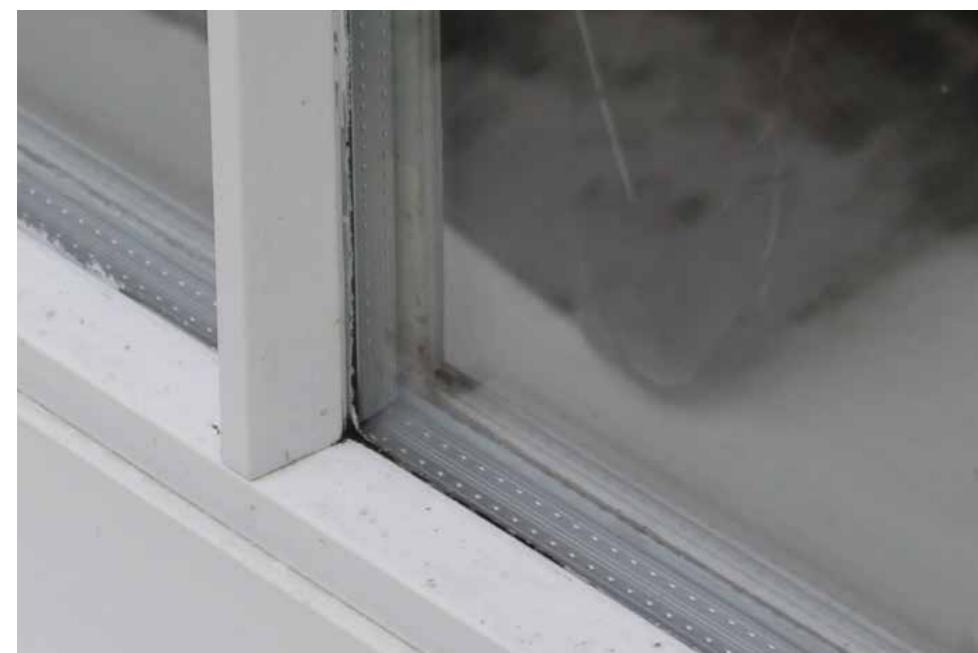
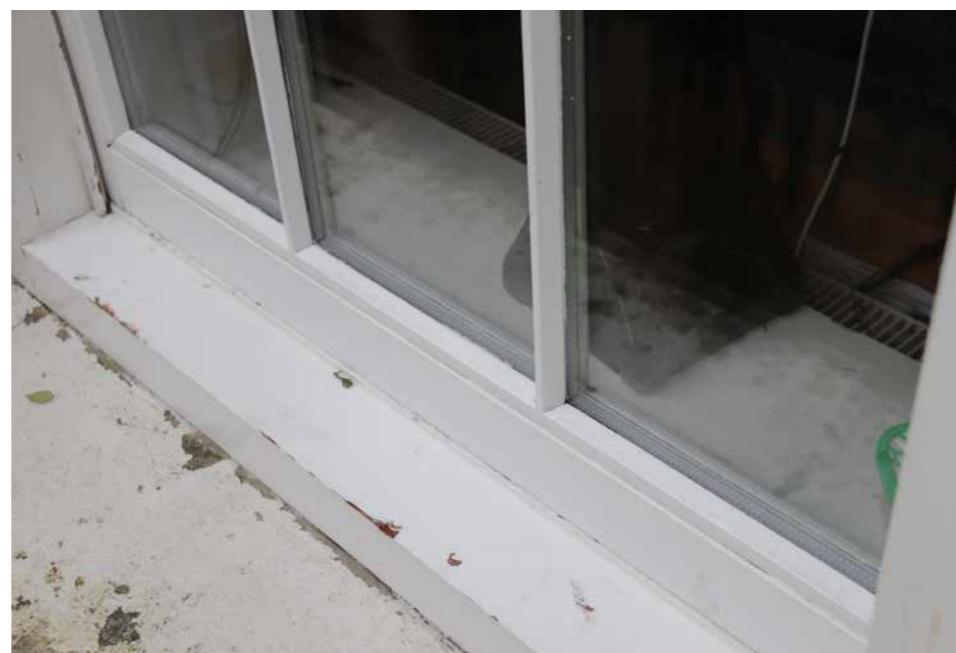
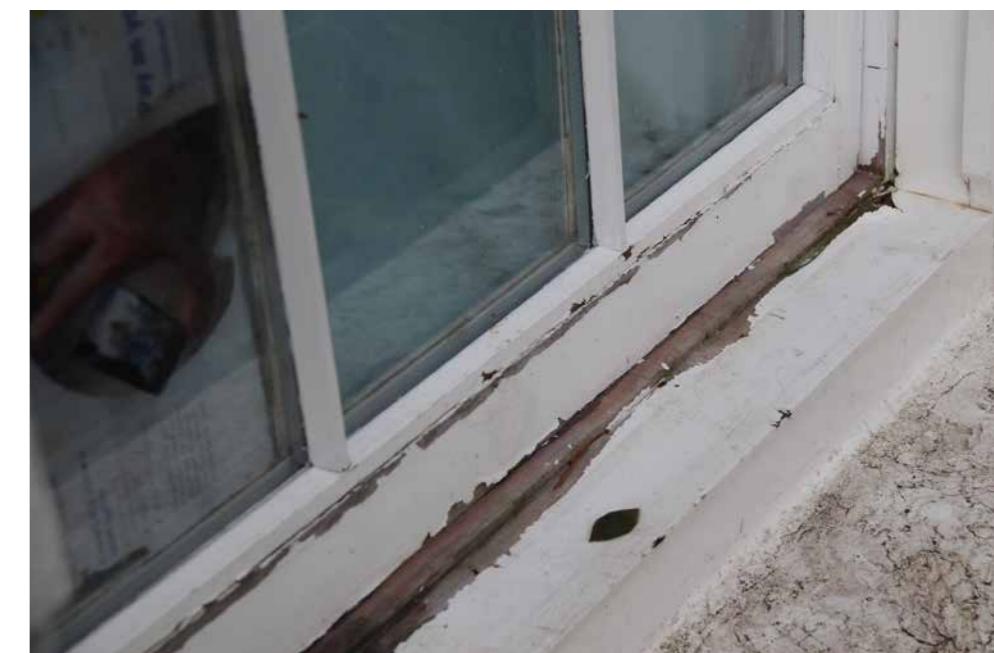
2.2 Front Elevation Ground Floor Windows

All of the windows to the front elevation are of 6-over-6 timber sashes, painted off-white. The glazing panes are sealed double-glazed units. However, it appears as though, rather than each glass pane being individual, each sash is a full glass pane, and the timber glazing bars are planted on, externally and internally. All 8no. windows appear to be modern and are likely to have been fairly recently installed.

With this in mind, they are generally in a good condition. One window - that being the ground floor bottom right (the room with particularly bad condensation and internal mould growth) is in need of some re-painting - see bottom right hand photo. Also, the left hand side of the cill to this window is showing signs of saturation, and potential loss of timber strength, due to being unprotected by paint in this area.

With the proposals, we recommend lightly rubbing down all windows and providing them with a couple of coats on new paint, matching the existing off-white colour. The timber cill to the ground floor right hand window may require some localised removal of timber with a new spliced repair inserted, before re-coating.

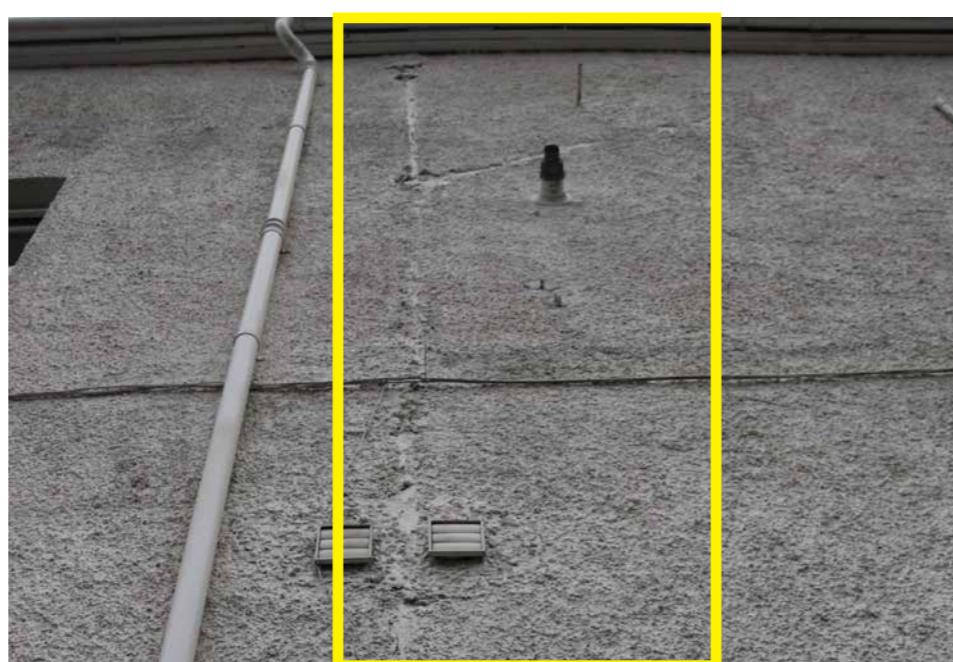
3.0 Side (West) Elevation

To this side elevation, the render is roughcast, also painted off-white. It is not known whether this is a cementitious; however, it is assumed to be. There are 'scars' in the render where previous pipework has been removed (see yellow box below), and there is the occasional crack in the render; however, apparently where recent smooth repairs have been applied (see red box below). In the main, the render is showing very few cracks and very little damage. Whilst we would prefer all renders to be lime, where the render is little damaged and appears to be keeping the rain out, then we would suggest that it remain in place - at least for now. Any cracks (such as that in the red box) should be made good, and the whole walls should be re-painted; but we might suggest this render is not hacked off at this stage. There is a crack in the window cills - see red box - which also requires a local repair. There is a drainage channel at the base of the wall - see photo below - which appears to be in a reasonable condition; however, it contains some surface cracks which should be repaired; and the drain cleaned out.

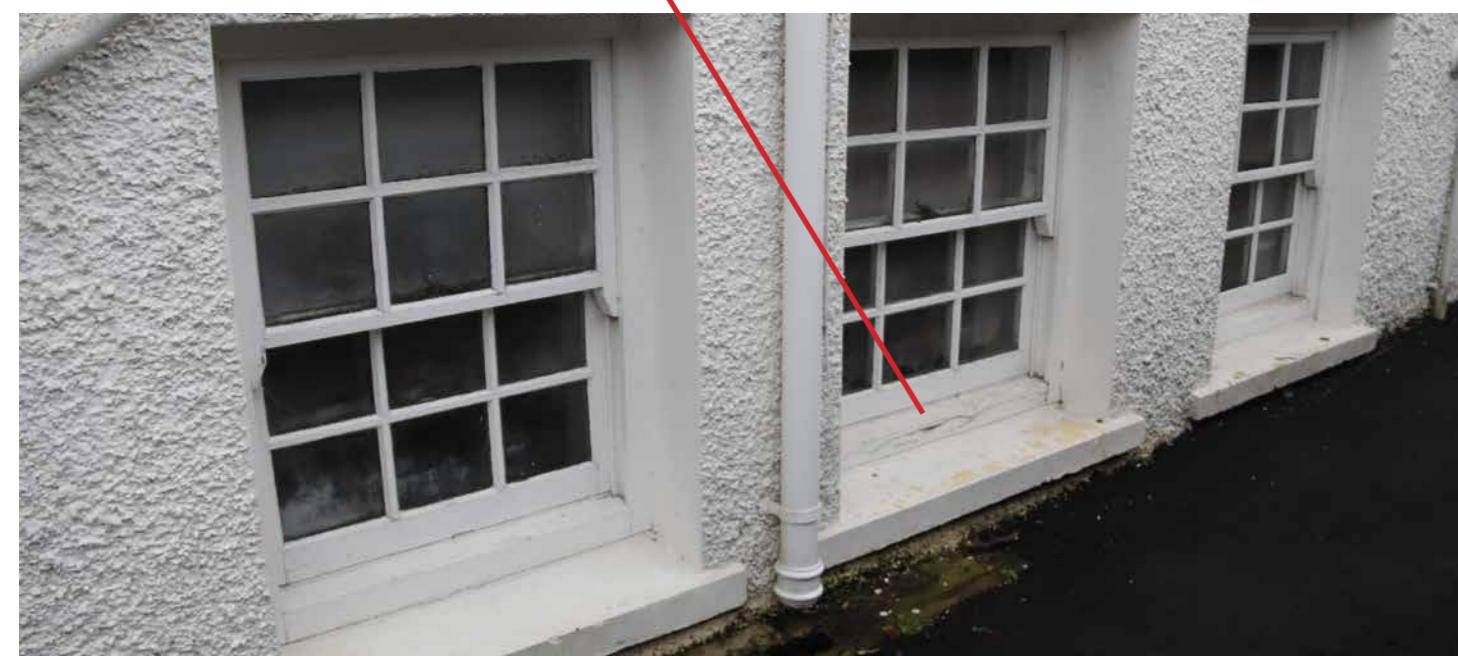
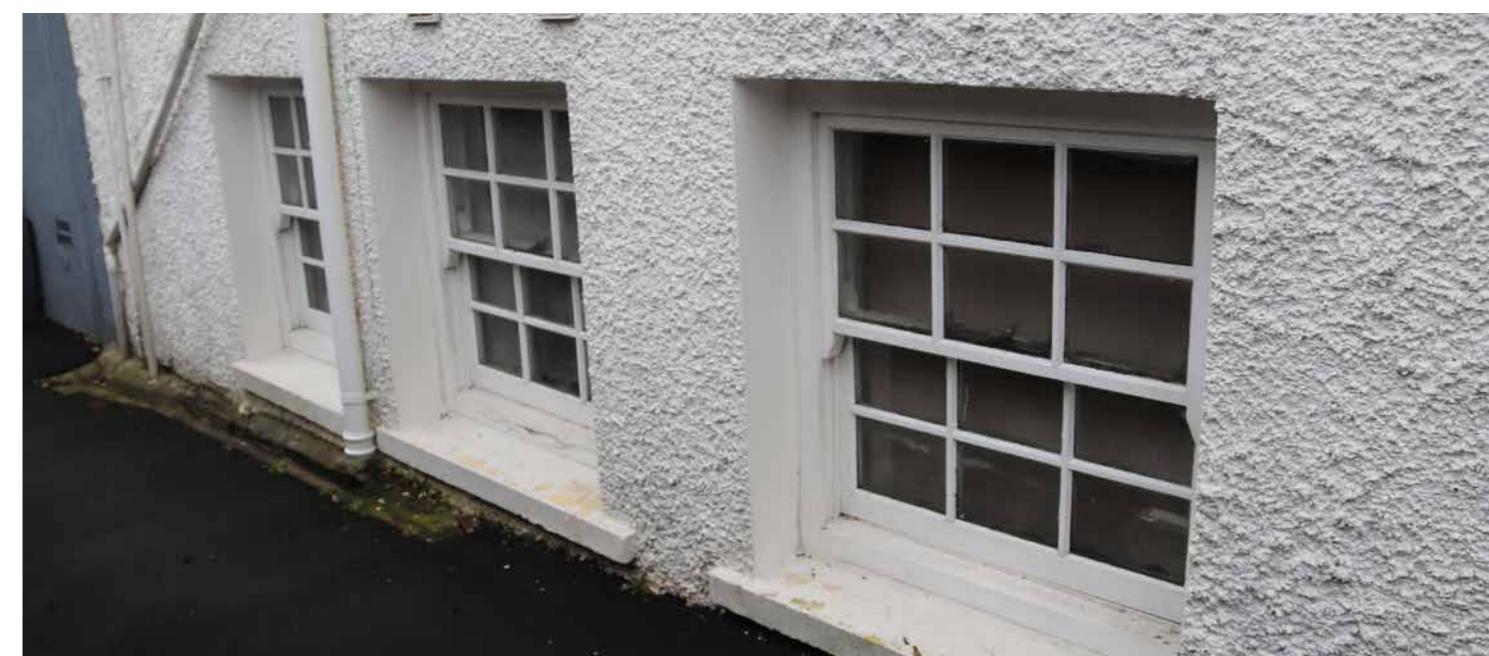
3.0 Side (West) Elevation

The 3no. 6-over-6 timber sash windows at the base of this elevation, and the 2no. central-pivoted windows down the side, at ground and first floor, are all timber windows, painted off-white. The panes to all 5no. windows are single-glazed. In the main, they appear to be in a reasonable condition, some having recently been re-painted; however, the timber cill to the middle low window has suffered from water ingress and is showing signs of loss of body. This should be rubbed back and, if any of the wood is soft, or 'gives' to the penetration of a sharp object, then the soft central should be cut out and a new section of timber spliced in, and the cill painted.

Indeed, it is proposed that all windows and cills are lightly rubbed back and re-painted a matching off-white.

It is also proposed that the glazing to all 5no. of these windows are replaced with 'Slimline' double-glazed units with white spacers.

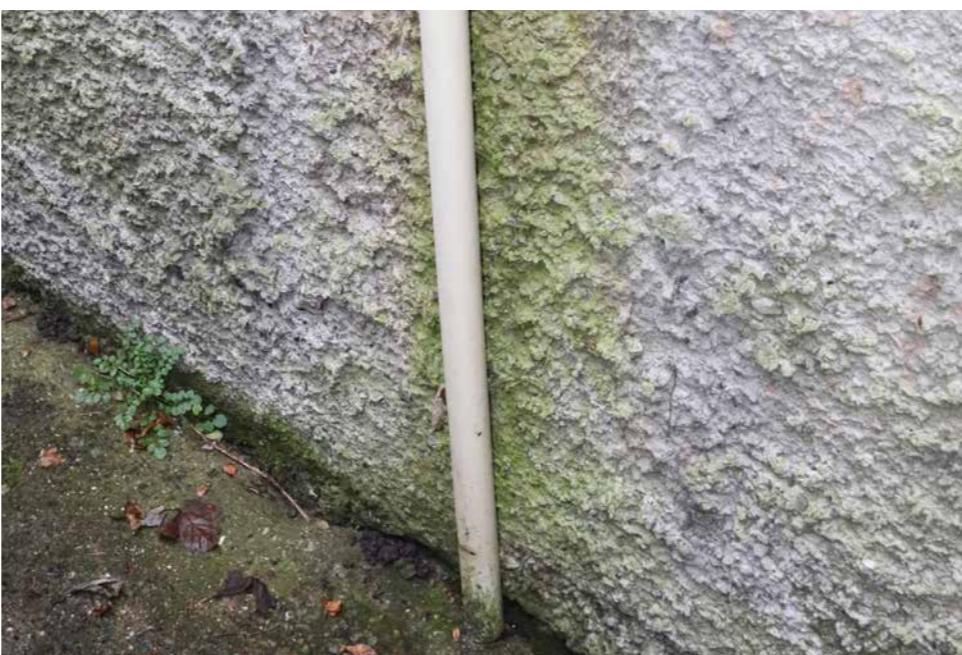
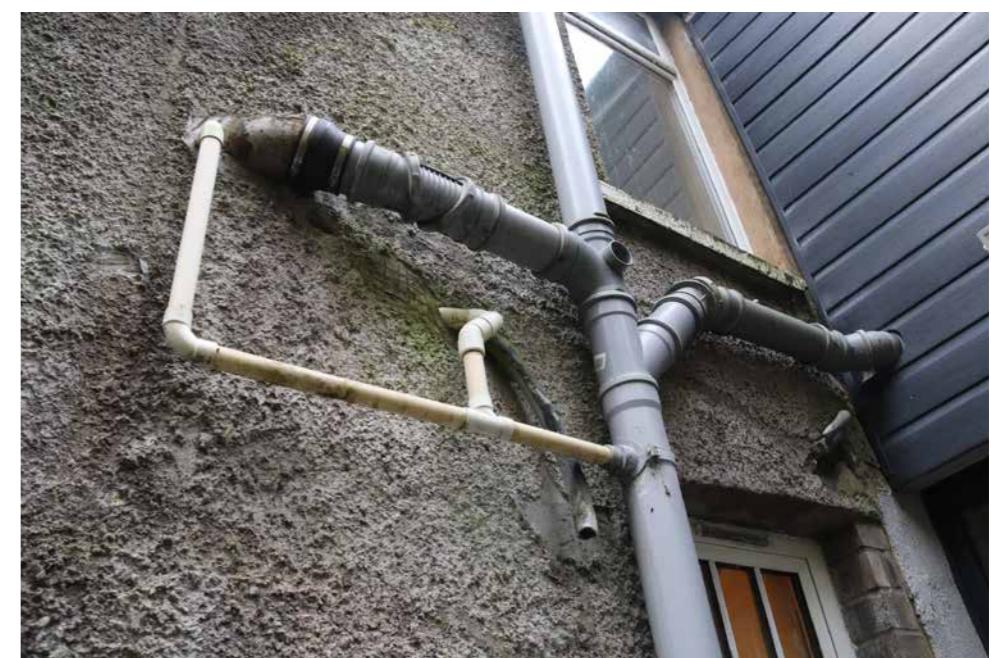
4.0 Side (East) Elevation

To this side elevation, the render is also roughcast; however, here it is a mixture of off-white and light grey with dark grey and green environmental and organic staining. It is not known whether this is a cementitious; however, it is assumed to be. This elevation comprises a number of soil drainage pipes, surface water drainage pipes and condensate pipes. It is assumed that, over time, leaks from one of more of these pipes has stained the render. It is also of concern that the rainwater pipe spills out onto concrete, which then runs into a gully. This means that the water splashes off the concrete and probably splashed back onto the wall.

The worst of the mould growth inside is on this elevation, at ground floor. It is not possible to determine if there are any defects in the masonry of the wall which would have caused this issue; or whether there are problematic cold bridges; or that it is simply a case of internal condensation; however, the worst issues are within a recess in this wall.

We recommend that the internal plaster is removed and the masonry investigated from inside. This may remove the need to expose the masonry from the outside; however, it may not. So, for now, we also recommend that the render is also removed from the outside face and, once the wall has dried out, and any defects in the masonry addressed, then the walls should be re-rendered with a roughcast lime render. We also propose that the drain is provided with a shoe which dresses into the gully cover to stop the chance of splashback.

It is recommended that all joints in all pipework is checked and any issues with either pipes or joints addressed.

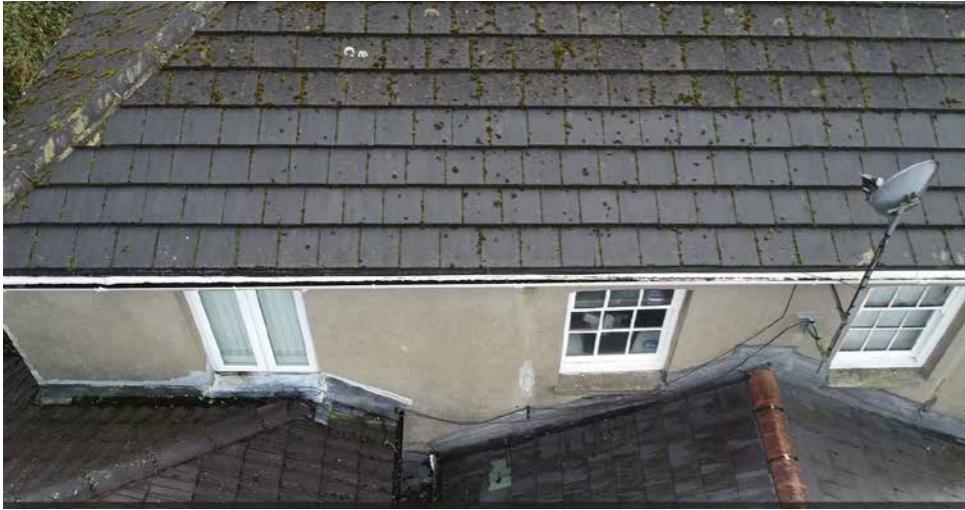
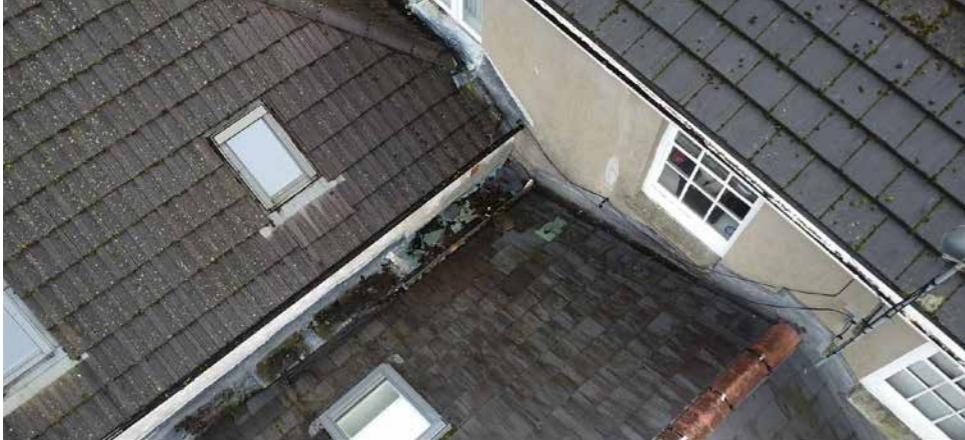
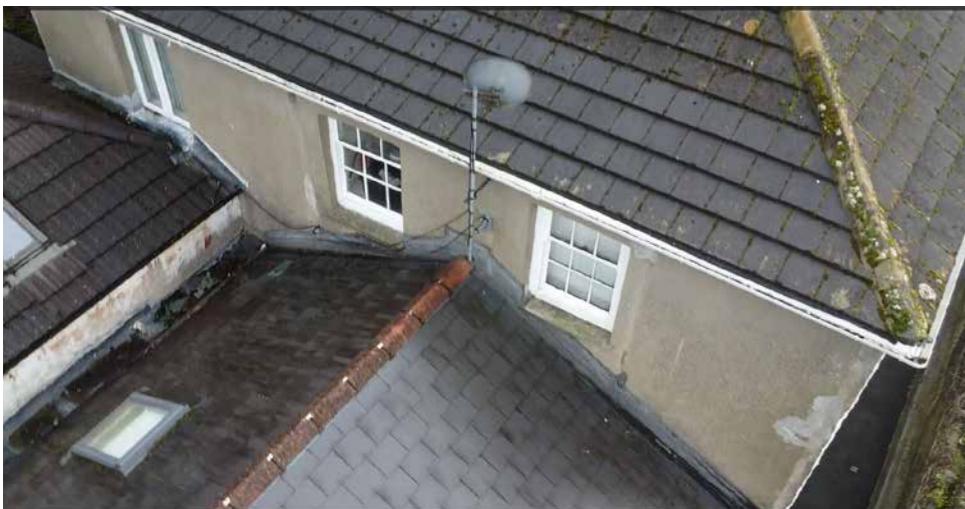
5.0 Rear (North) Elevation

The majority of the north external wall is not internal, apart from the top section. The view of the top section of this rear elevation is so limited that no assessment can be made on it. The one thing that is apparent is that there has been some patch repair work undertaken to the render.

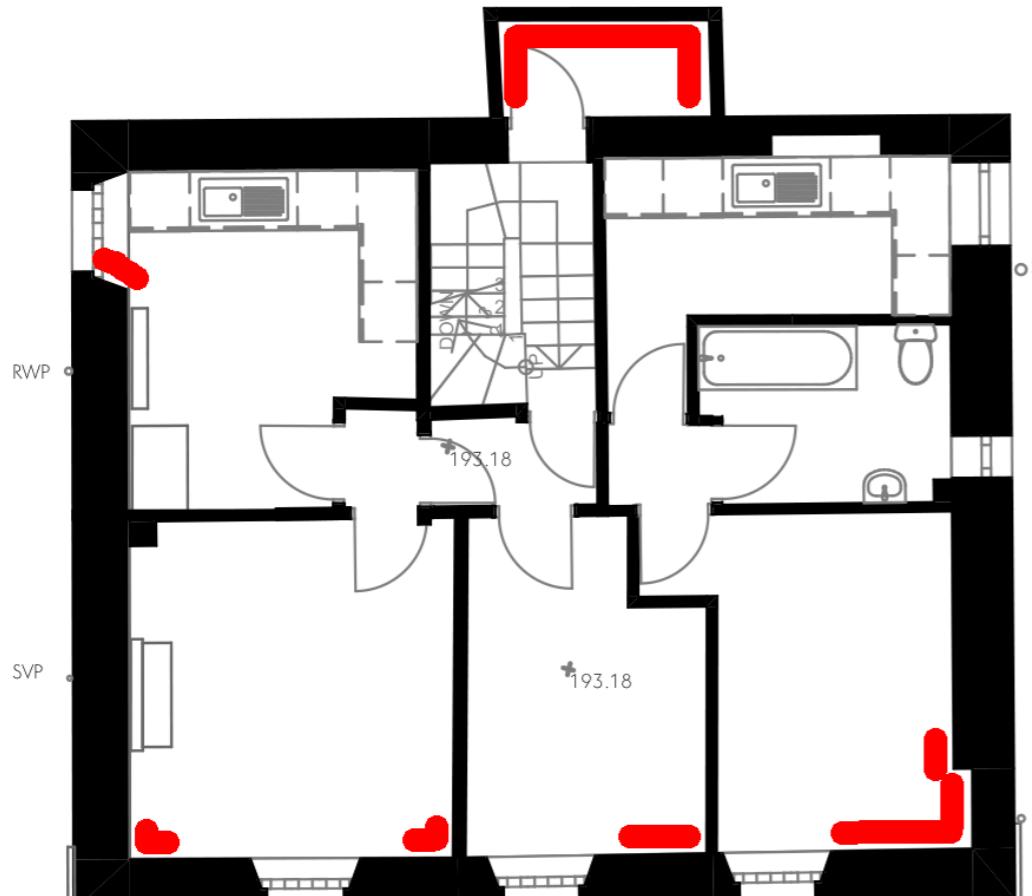
First Floor

Insofar as it might help determine where likely damp ingress issues are, on this page, in red on the plan below, we identify where damp is clearly apparent on the internal face of the external walls.

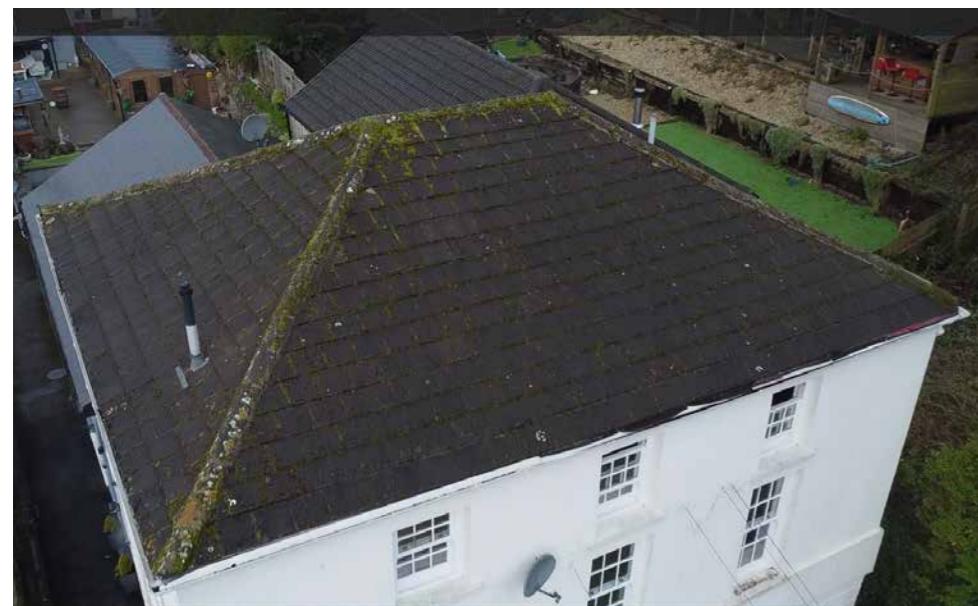
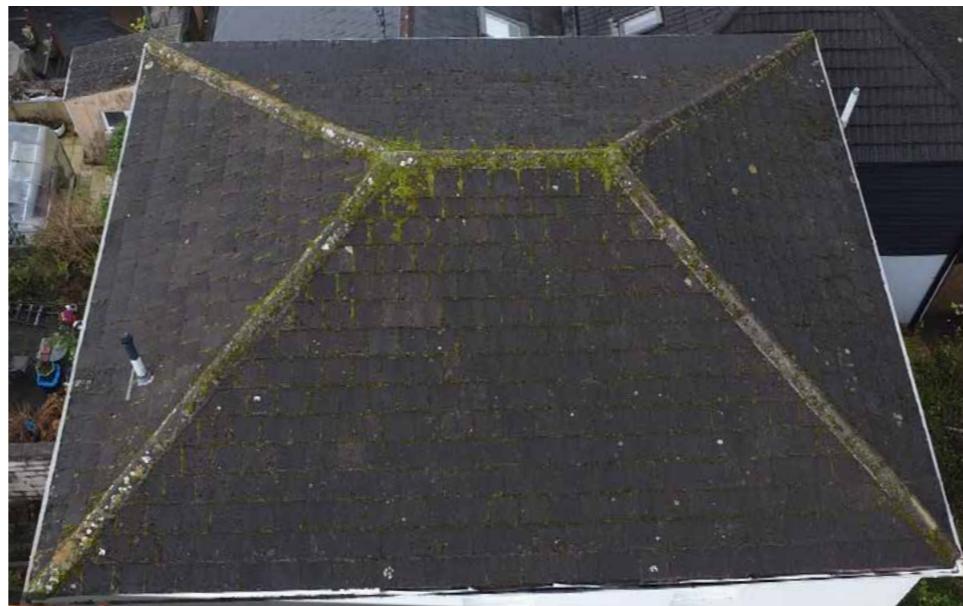
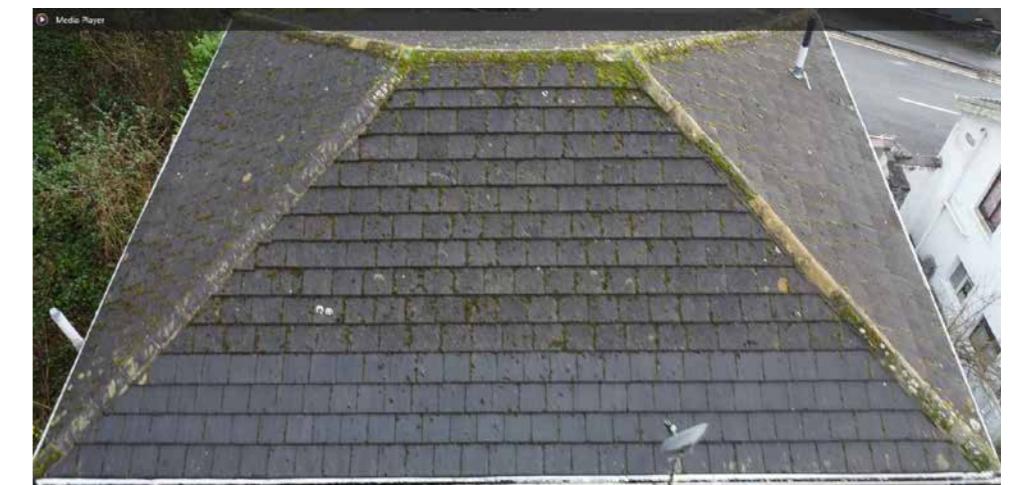
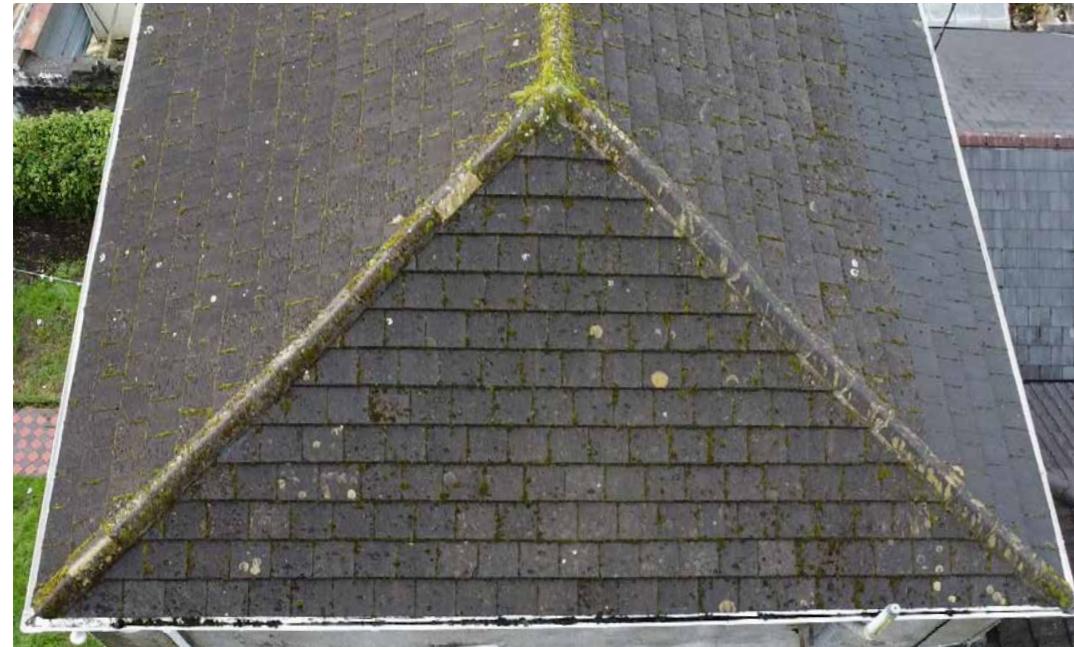
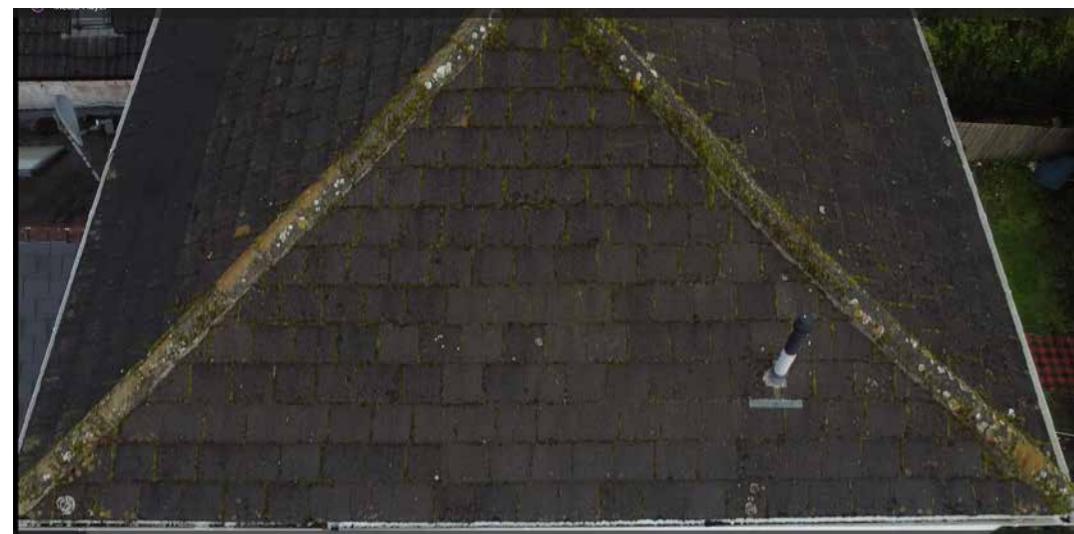
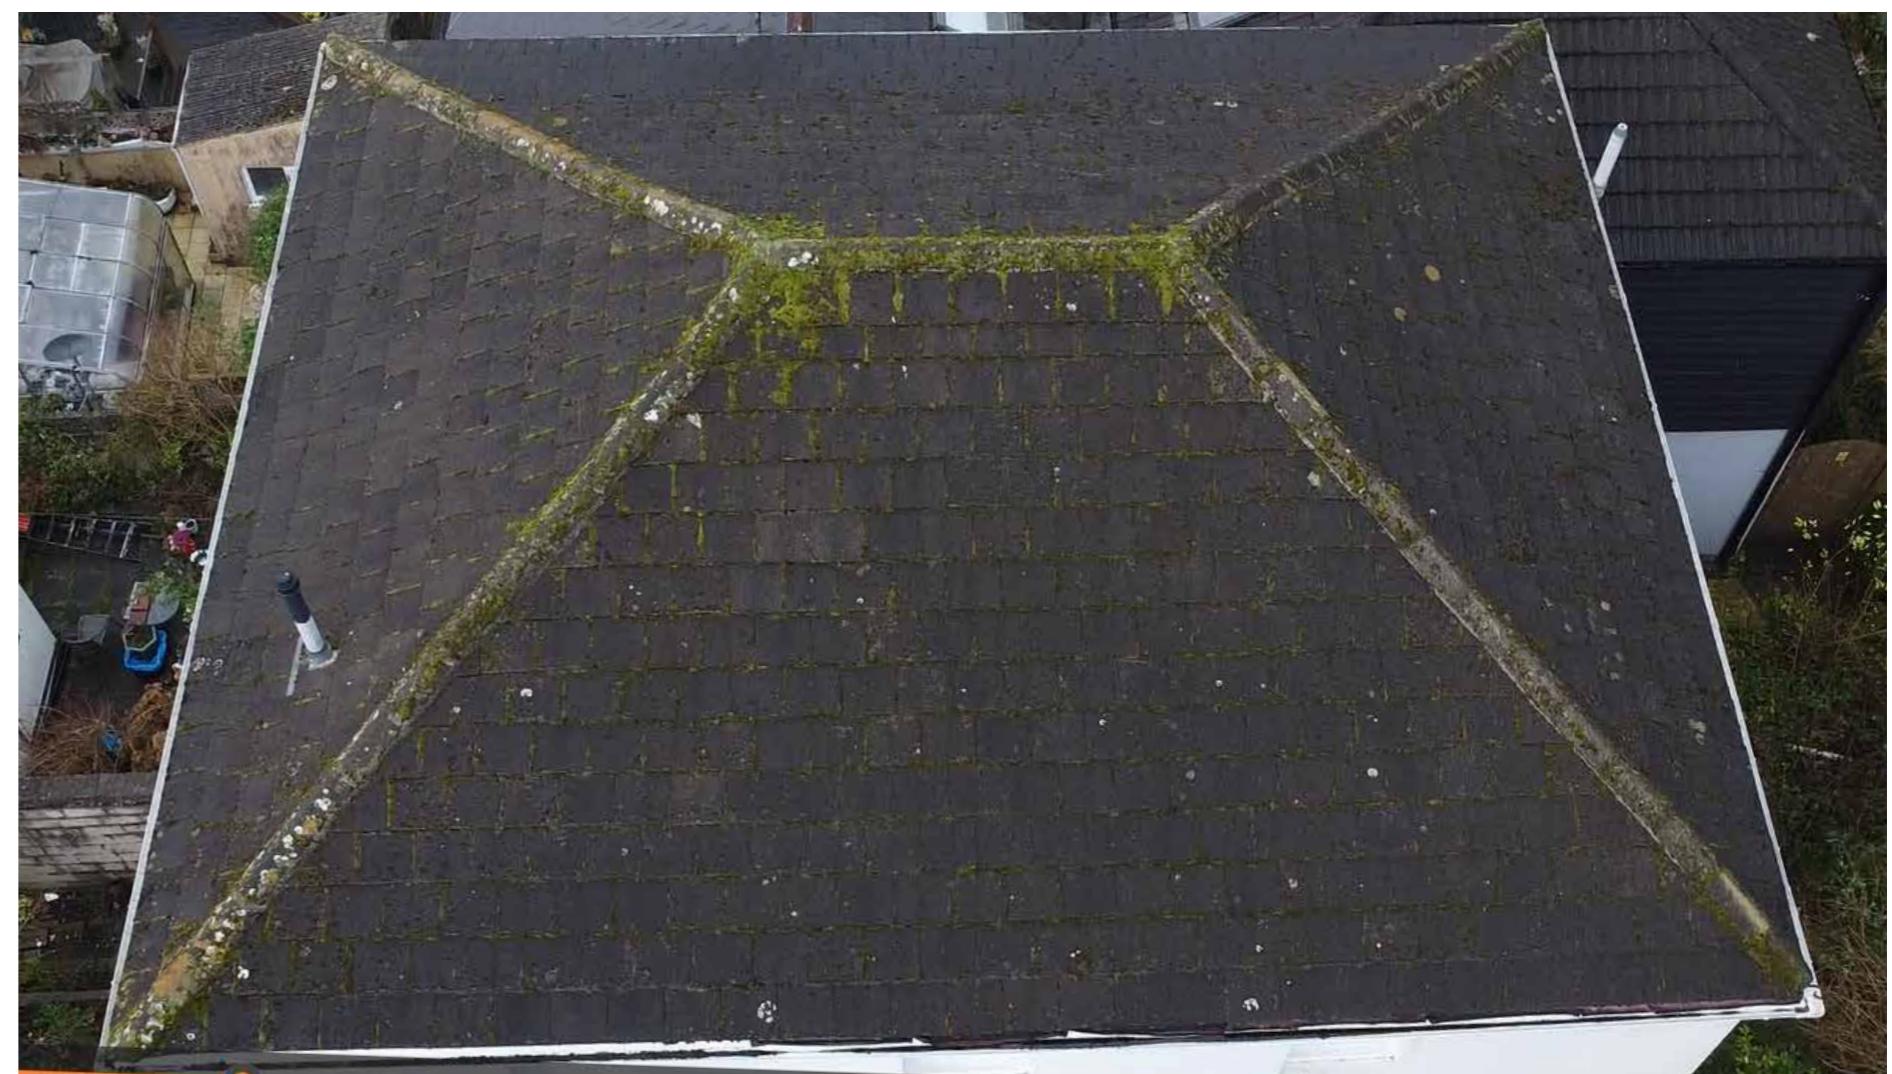
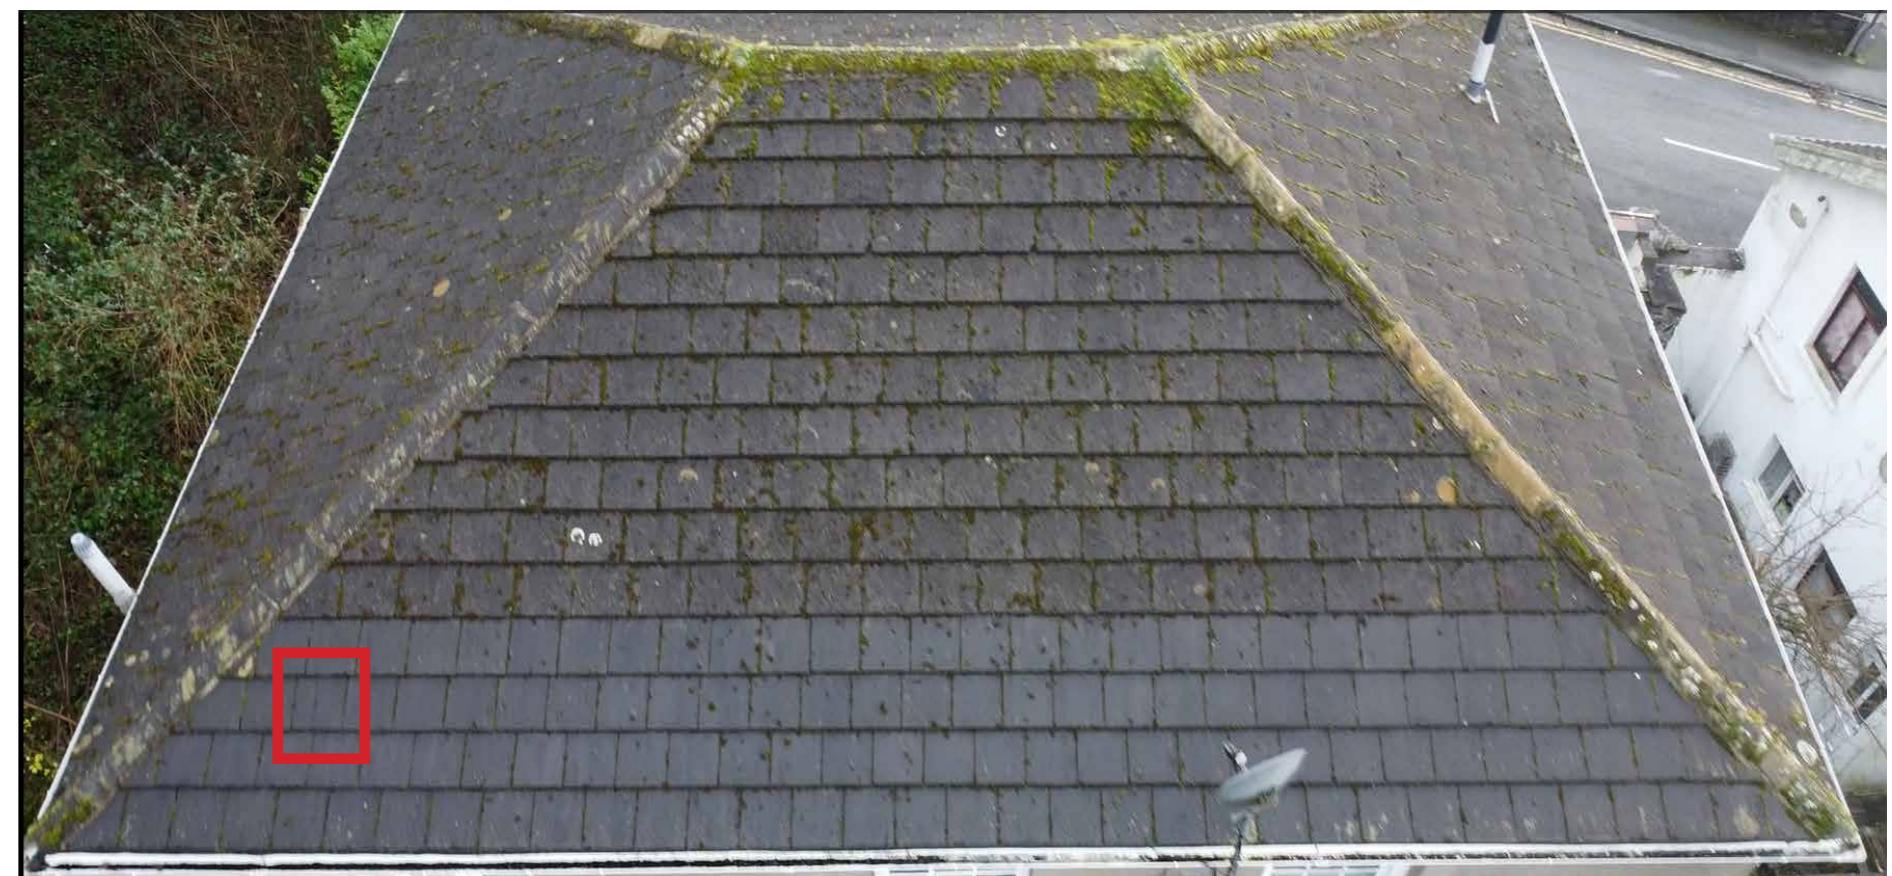
The roof is a simple rectangular hipped roof, covered in concrete tiles and rounded concrete ridge and hip tiles. The surface of the tiles is heavily mossed on the ridge and some hips. However, there do not appear to be any lost tiles, nor slipped tiles, and only a small number of broken tiles. In this regard, the roof covering appears to be in a reasonable condition. To the north pitch, it appears as though the bottom four courses have been replaced in the more recent past. One of those 'new' tiles is broken down the middle - see red box on next page.
