Primrose Hill, Merthyr Tydfil

RECORD OF BUILDING AND CONDITION ASSESSMENT REPORT, WITH REPAIR PROPOSALS

.....(449)2503-GVWP-A-HIS-P01

Date: 05.03.25

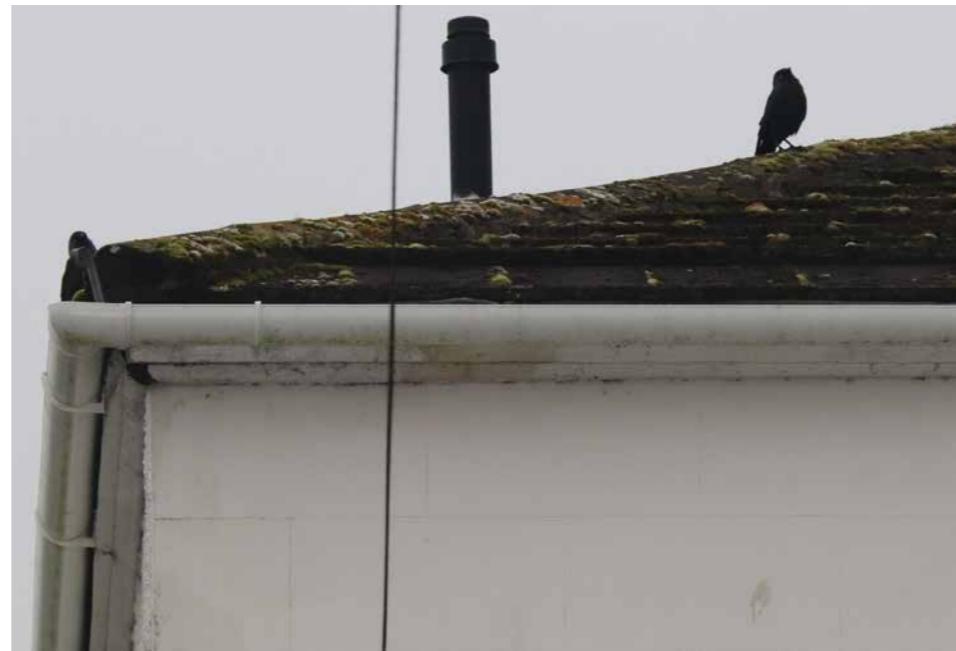
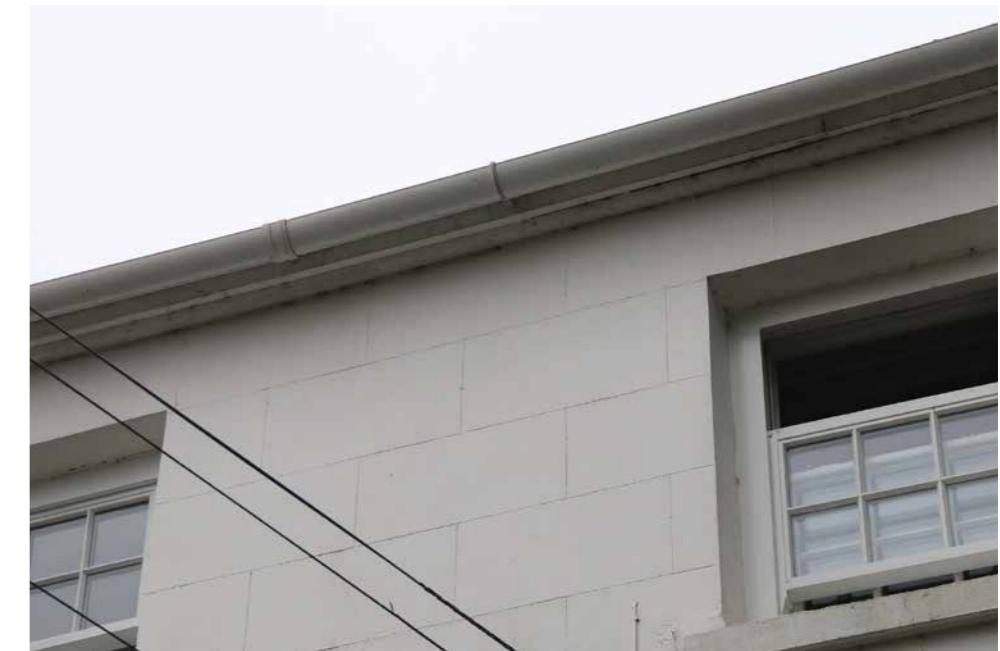
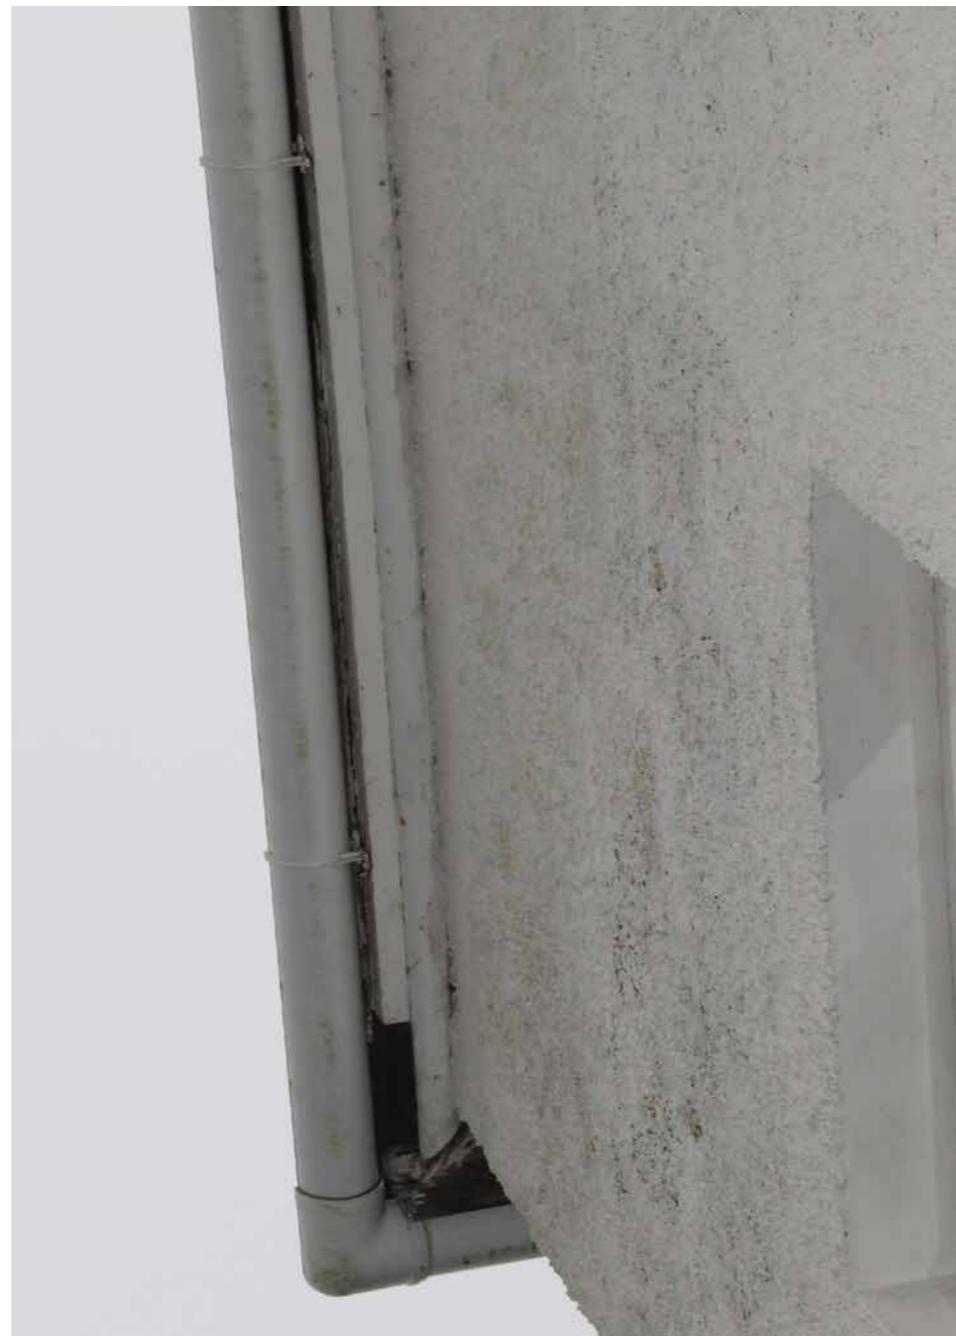
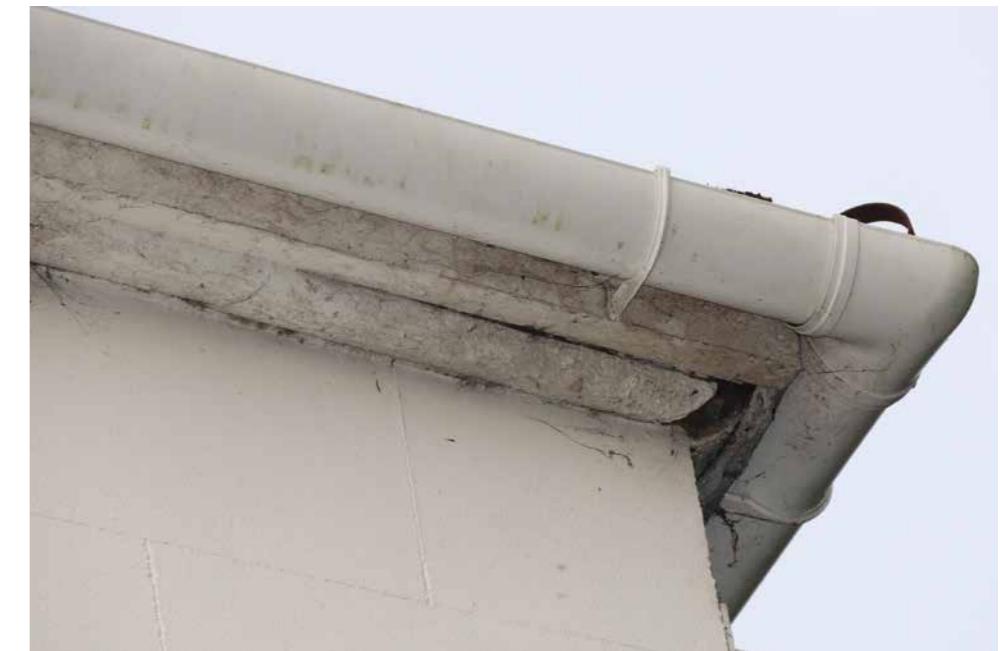
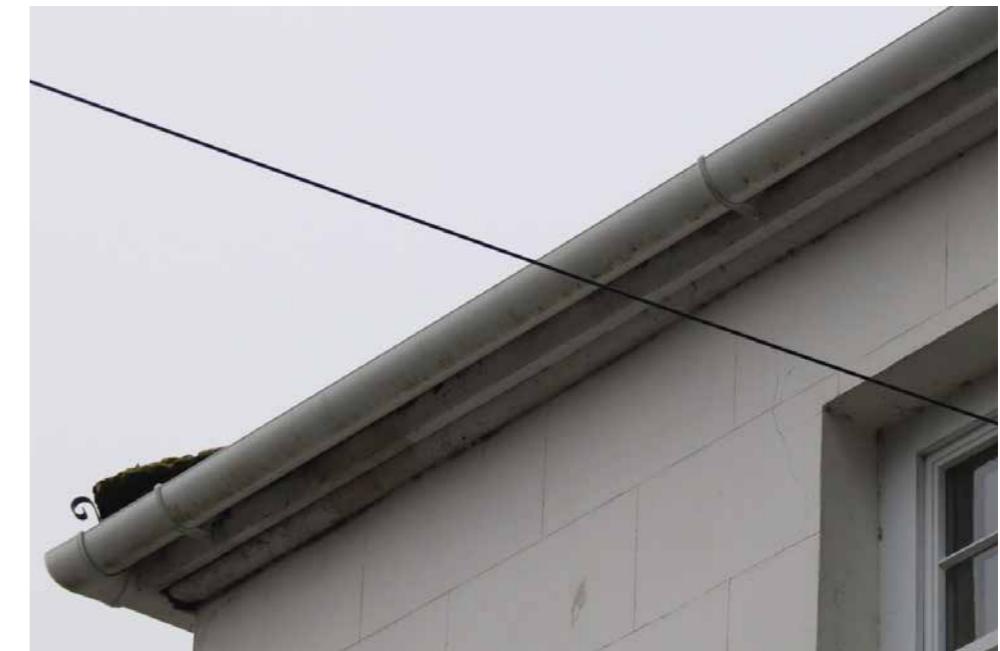
7.1 Eaves

It is not possible to determine the condition of the fascia and soffit from this distance; and so it will be necessary to review them in more detail once scaffolding is up.

This being said, they appear to be in a reasonable condition, and may only be in need of a rub down and re-paint.

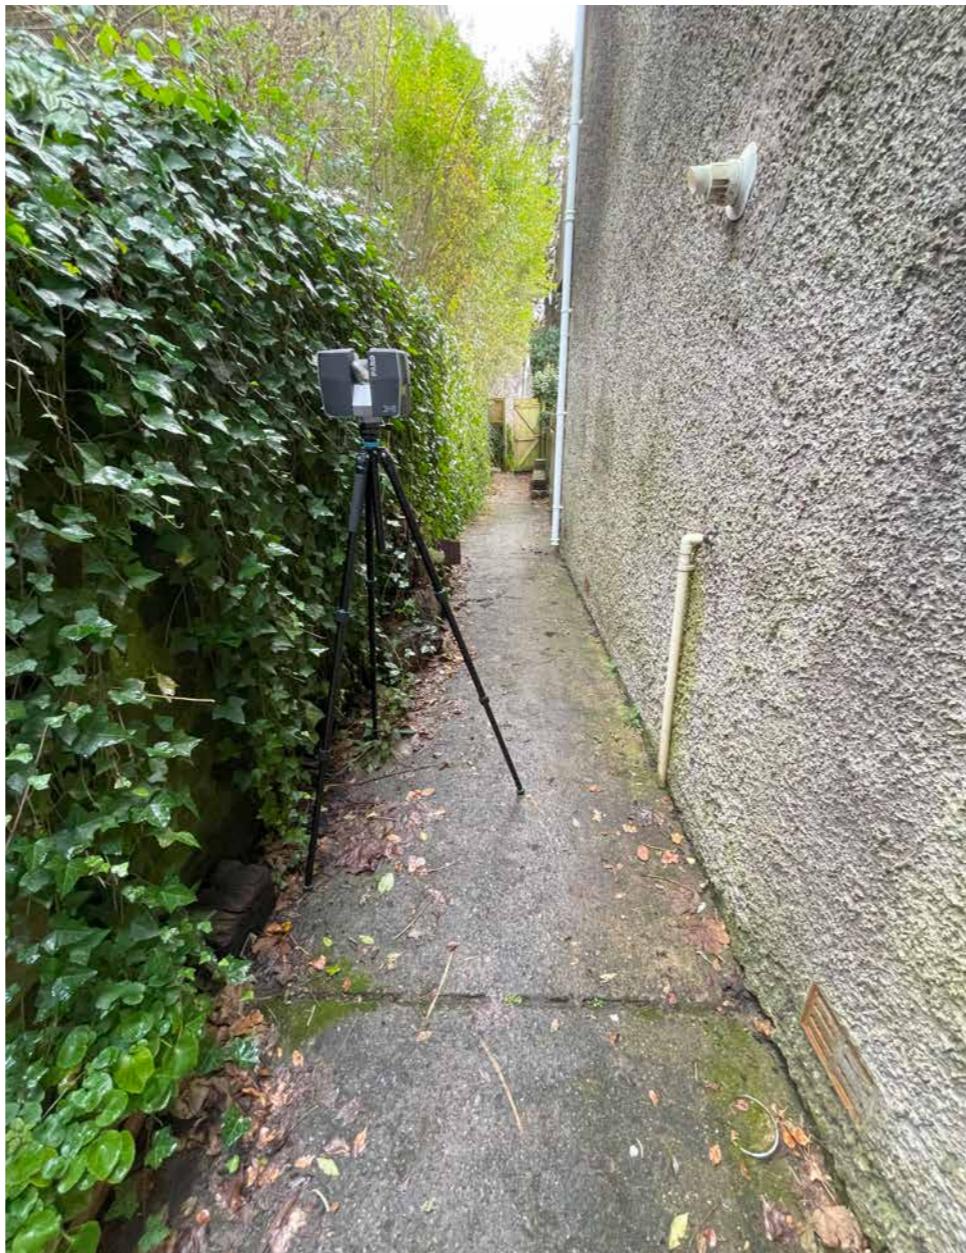
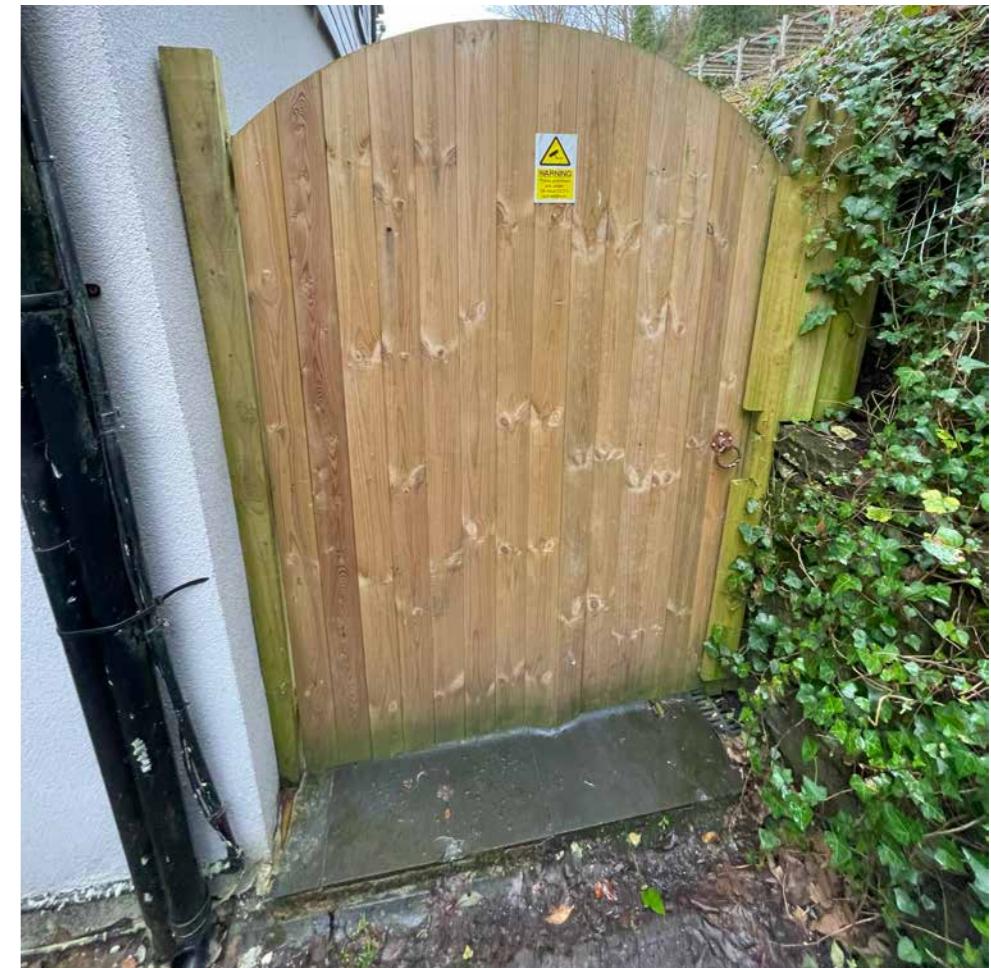
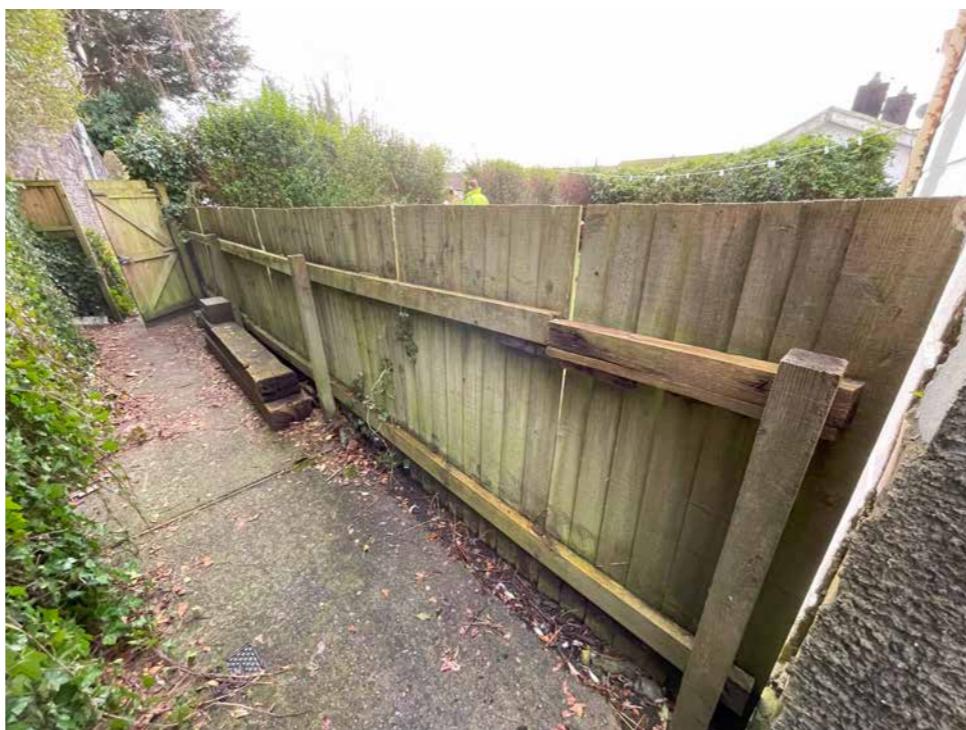
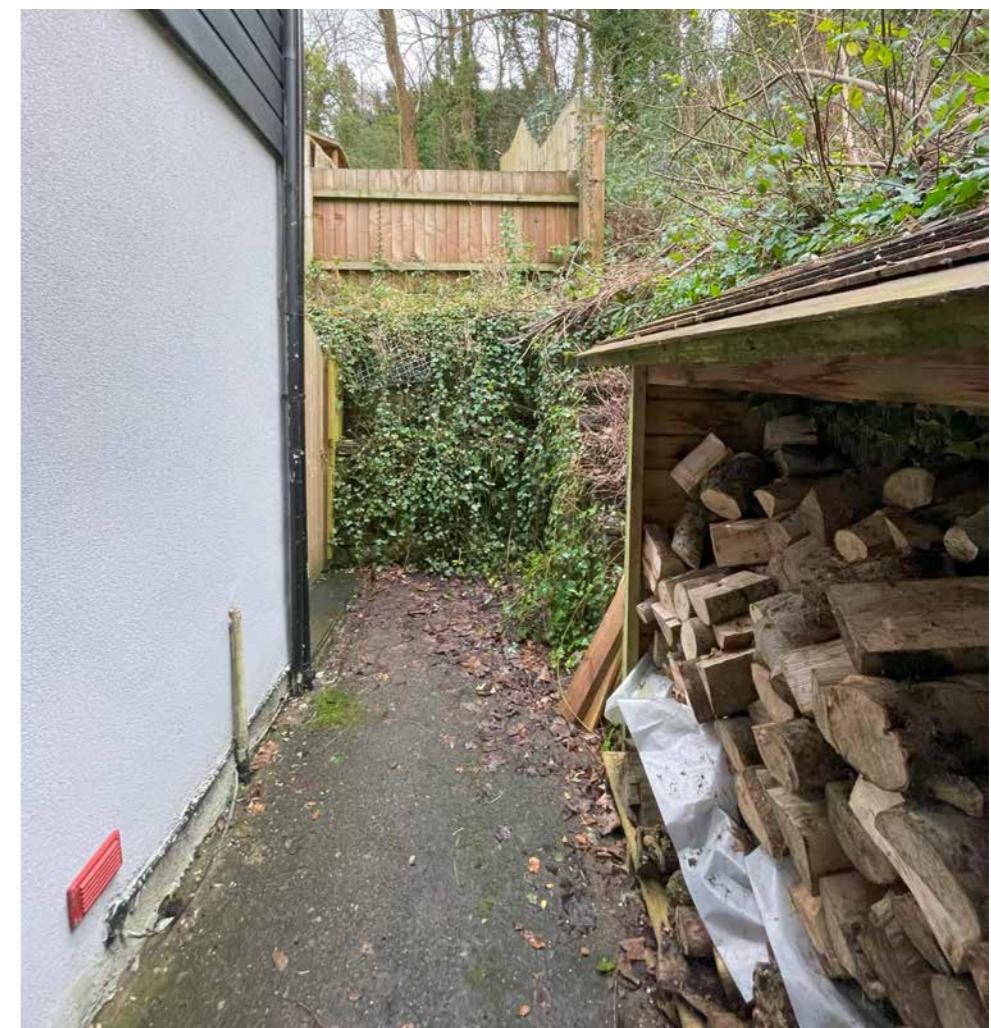
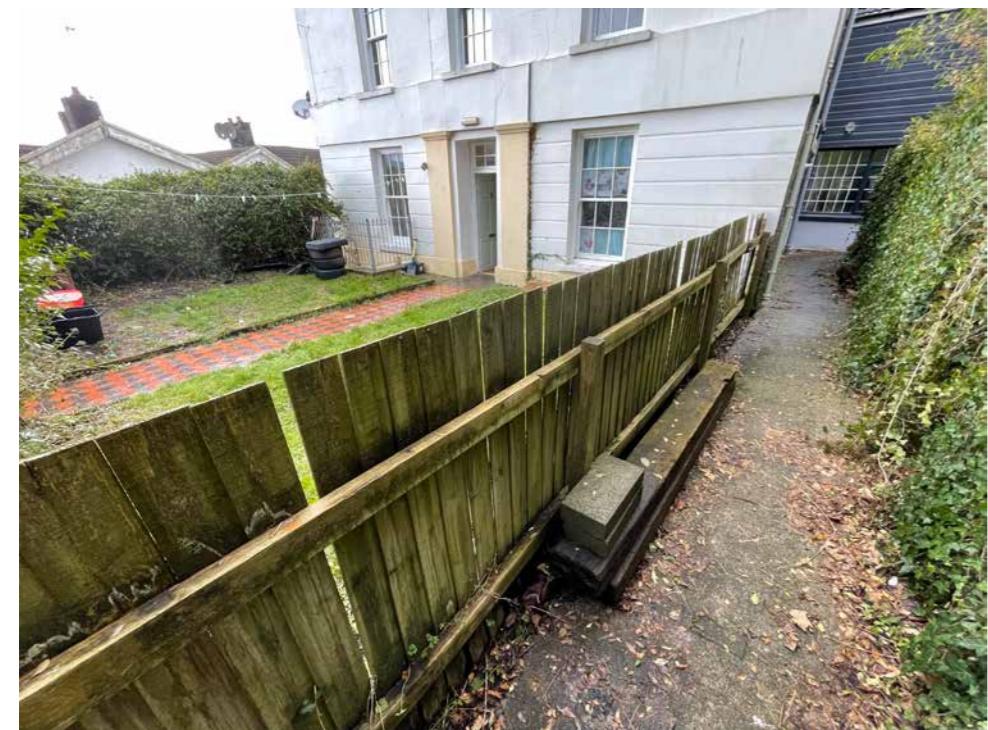
8.1 Side Path

The side path has a concrete surface which appears to be in a reasonable condition.

There is a timber boarded fence between the path and the front garden to Primrose Hill.

This path constitutes a 'Right of Way' to the property behind and to the north of Primrose Hill, which is accessed via a timber boarded gate - see top right photo.

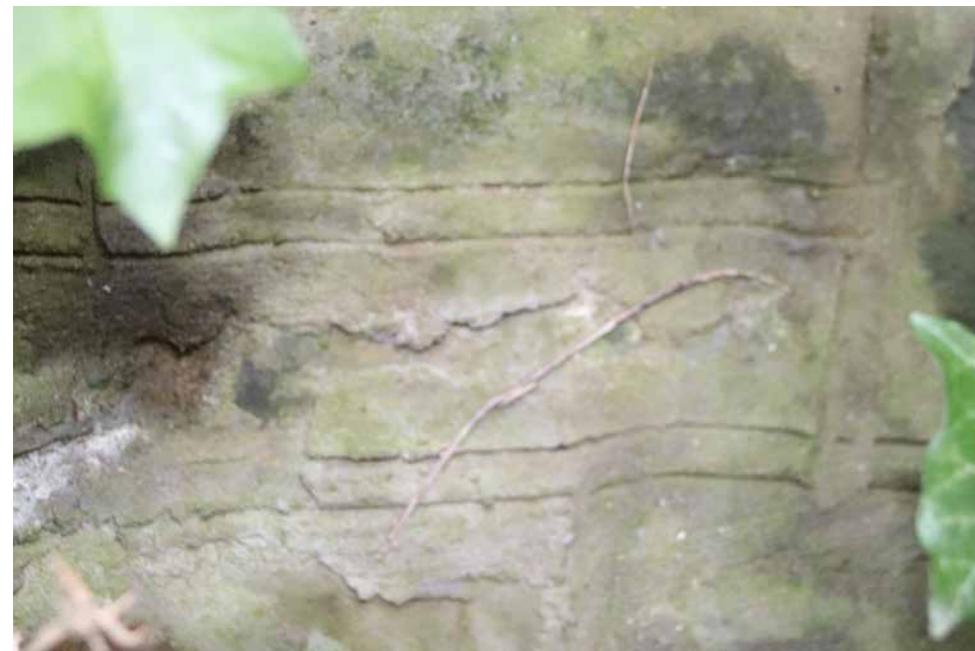
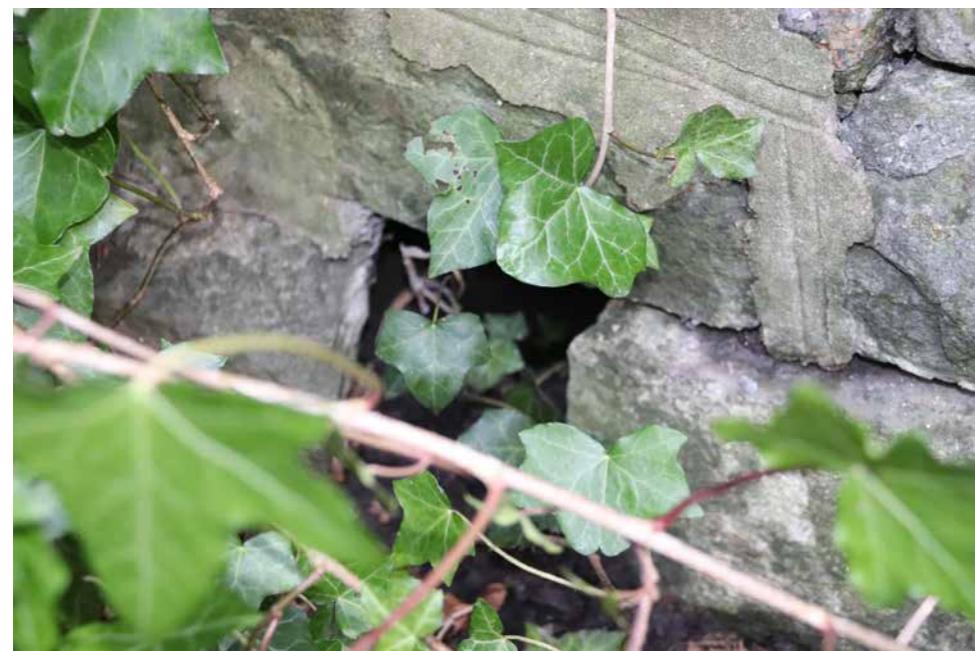
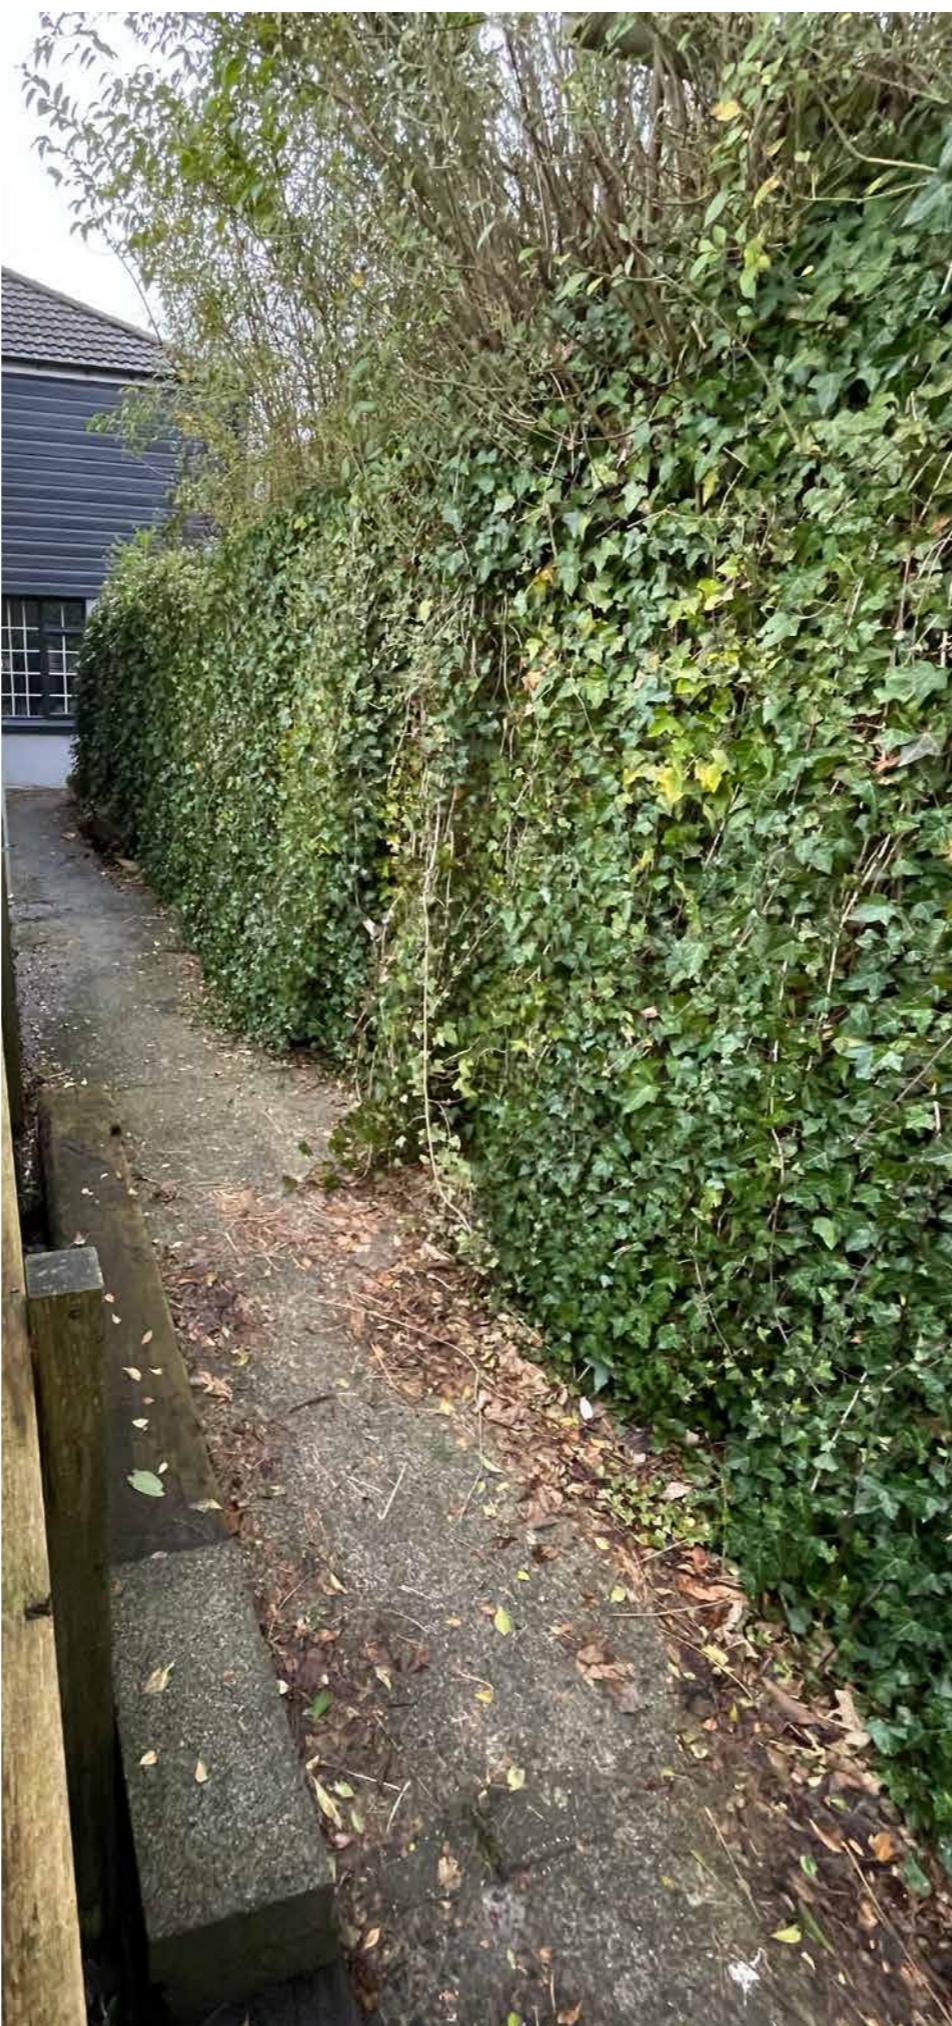
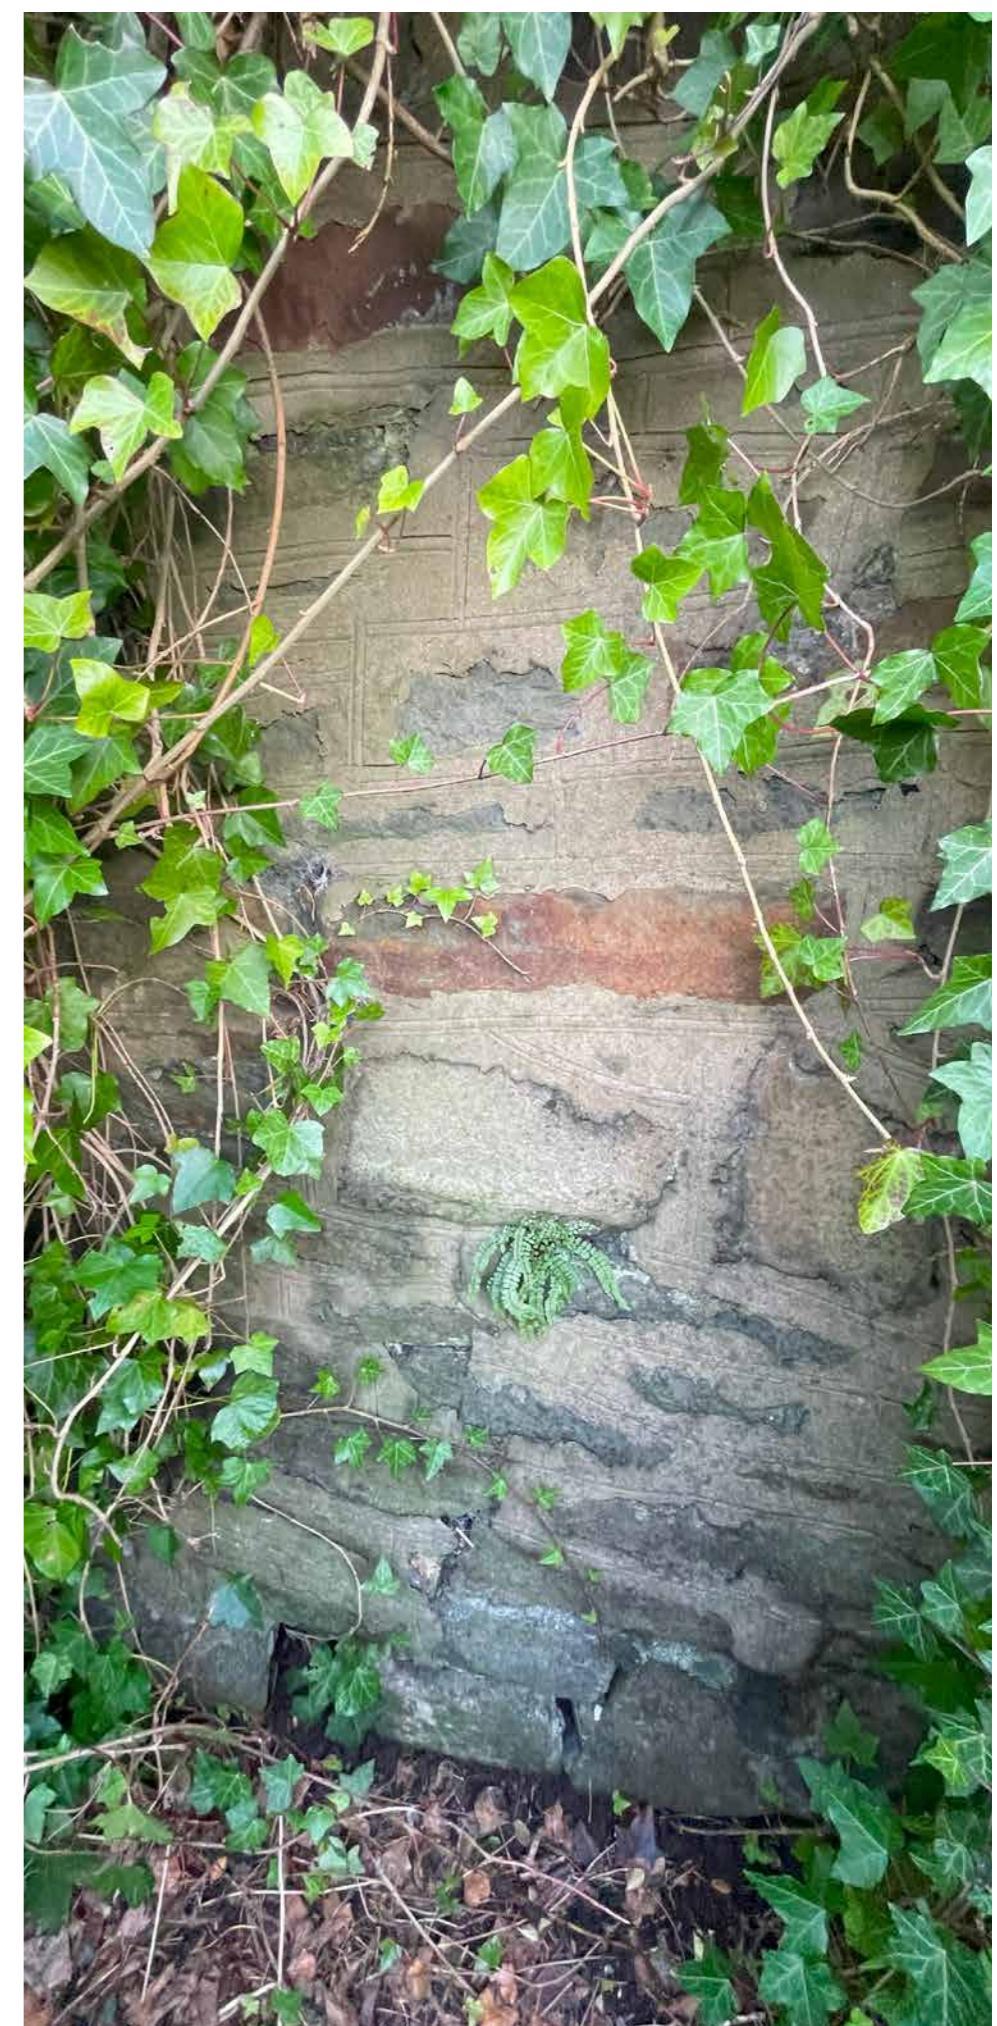
8.2 Retaining Wall

Covered by ivy and other vegetation, to the side of the path, east of Primrose Hill, is a retaining wall, approximately 3m high, made of rubble stonework. It is assumed that the stones are bedded on a lime mortar (albeit not confirmed) and that it used to be pointed in a lime mortar; however, it is apparent that the wall has more recently been pointed in a cementitious mortar, using a buttering / part rendering which has covered much of the stonework. The wall is covered in vegetation, to face and top, and so the wall could barely be inspected; however, there is concern about the use of cement for the pointing and for the restriction this will have put to the passage of moisture through the wall.

A 'makeshift' drainage hole was apparent at the base in one location; however, it is not clear whether there is a full drainage provision to this wall. That being said, percolation tests undertaken to the ground above suggests a good level of natural drainage in the ground above this wall.

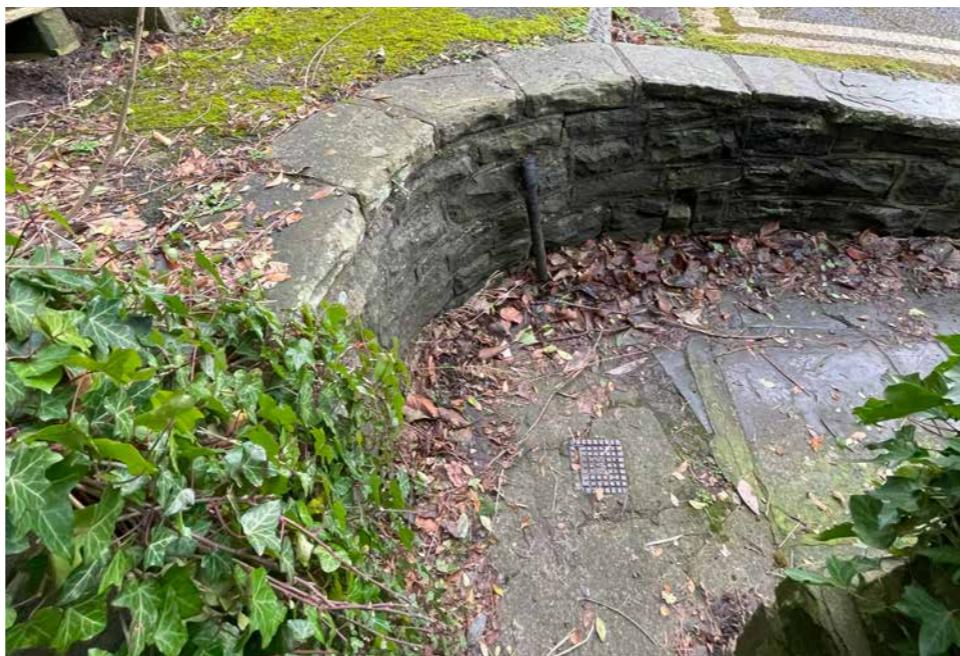
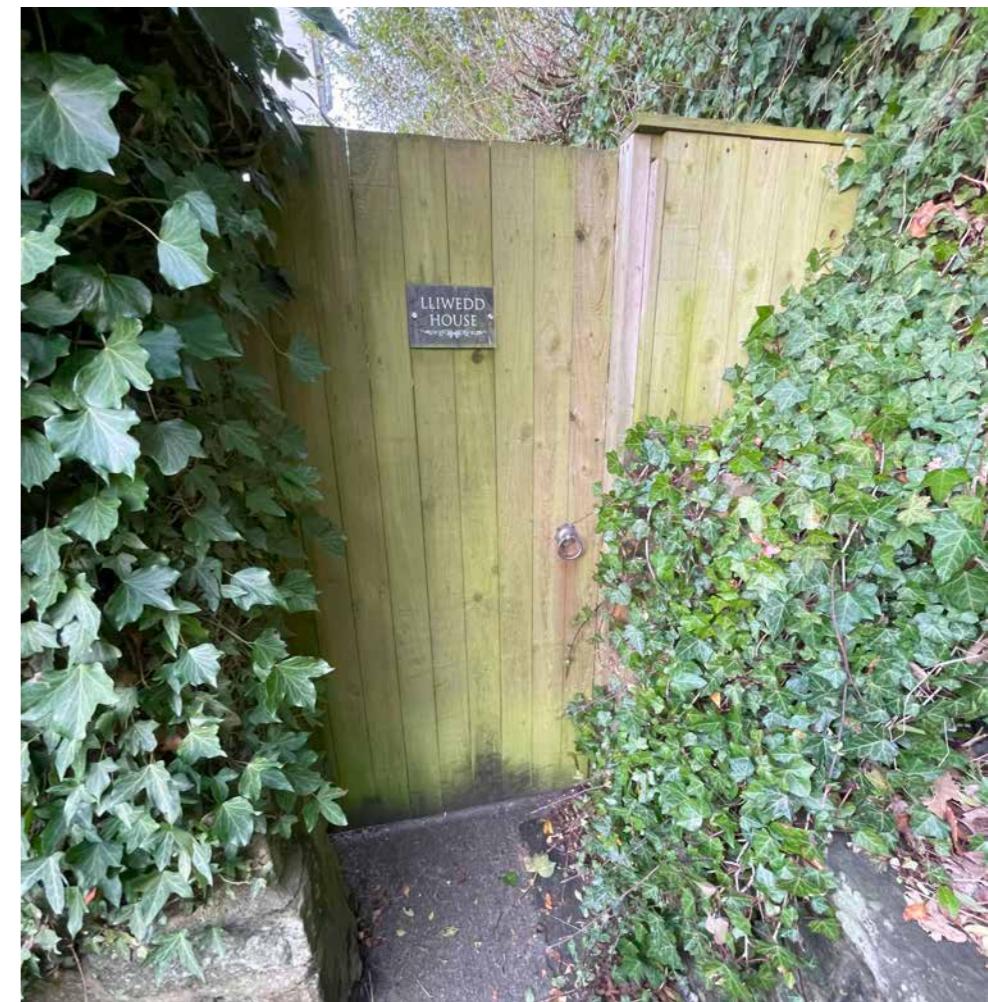
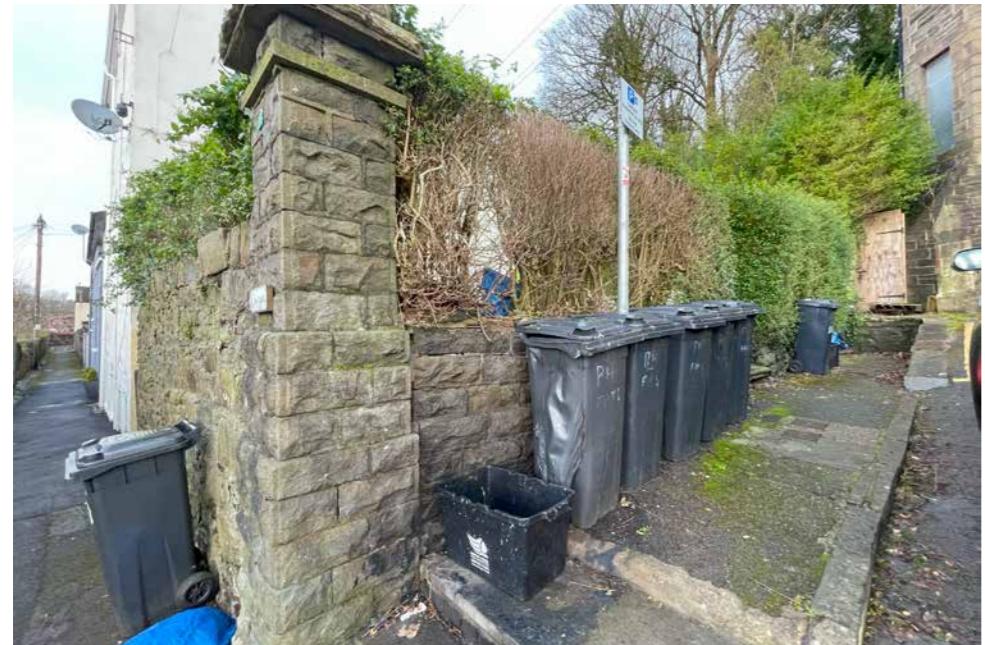
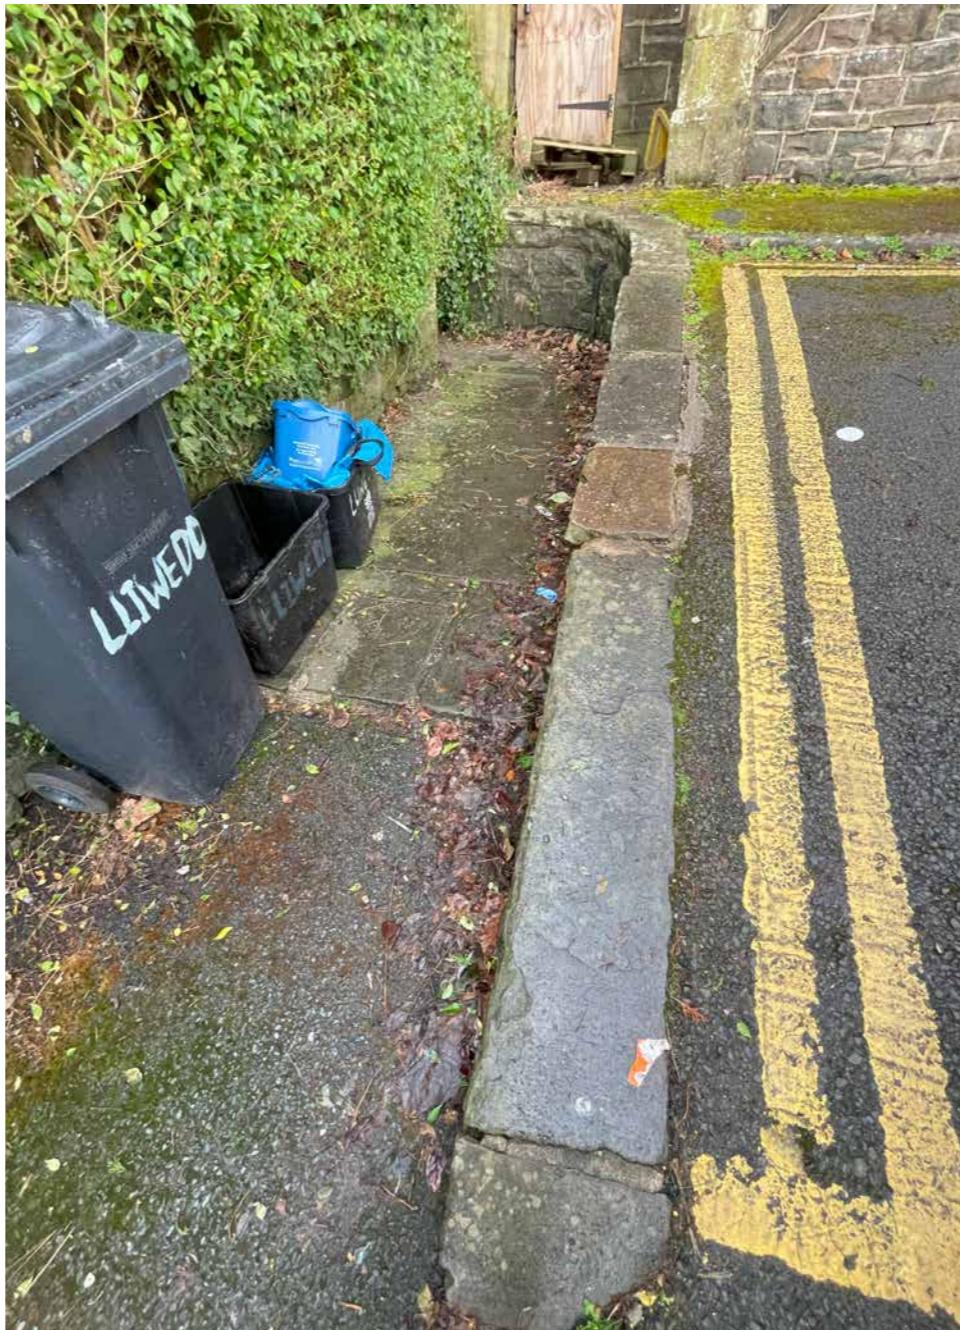
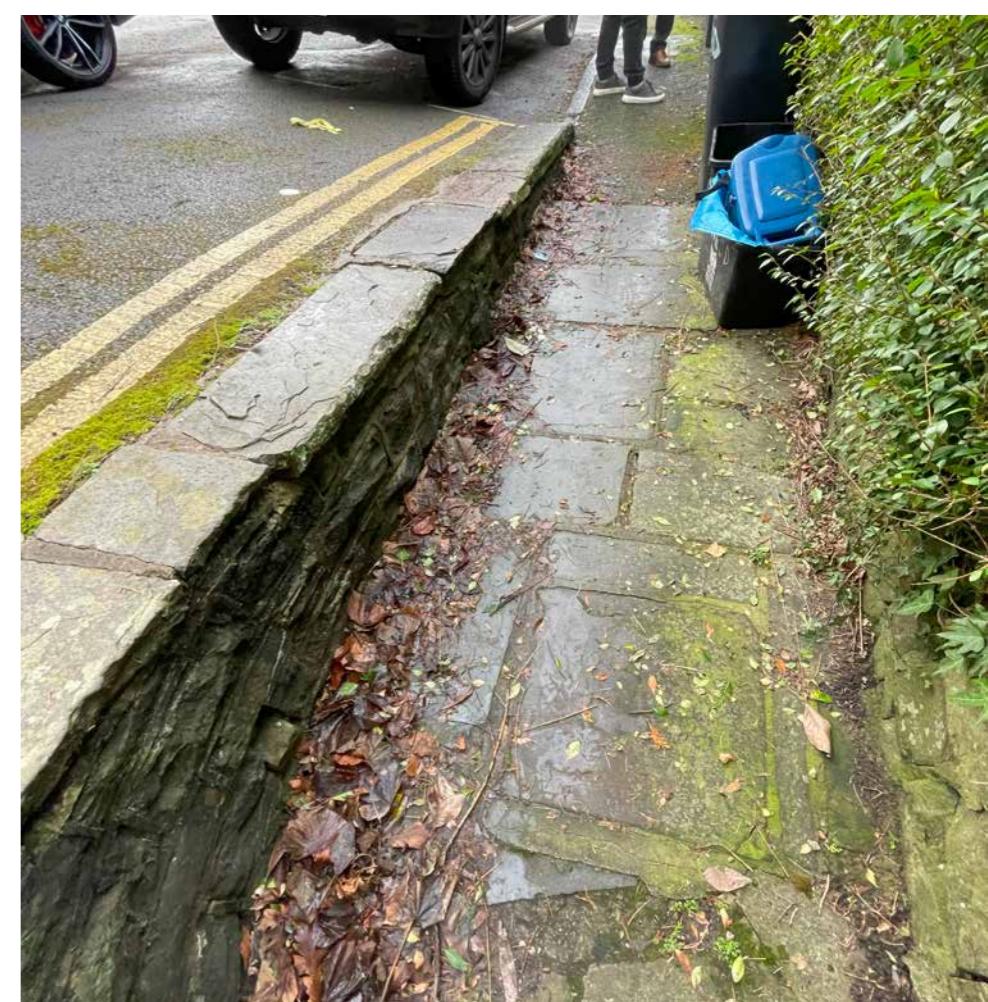
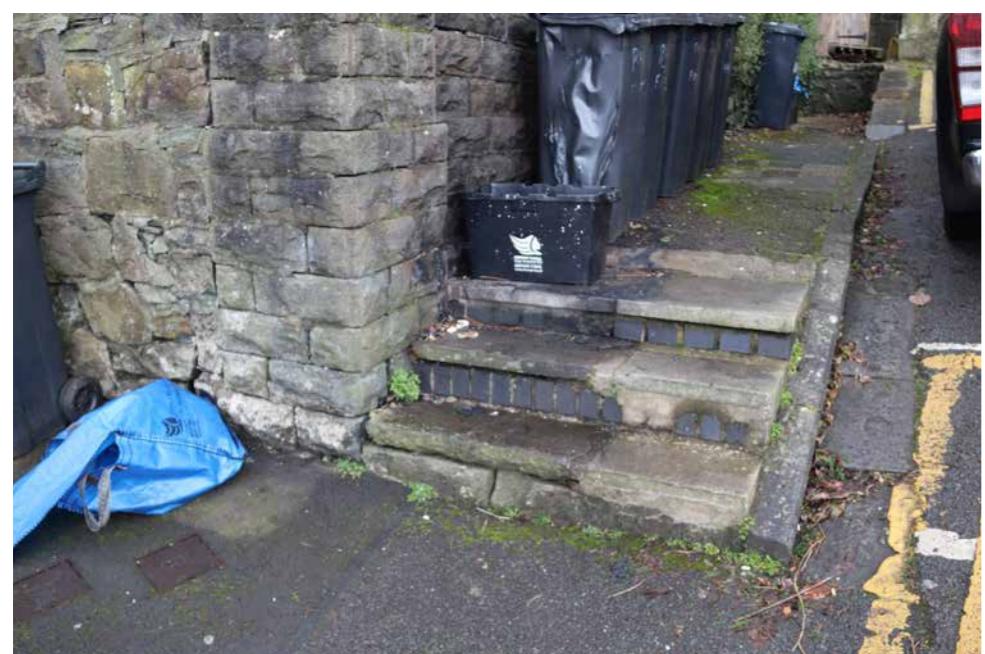
9.1 Front Pavement

Between the tarmac road and the front wall to Primrose Hill's front garden there is a row of coping stones and then a drop to an area of stone flag paving. The tarmac is sloped, whilst the flagging is level, with the stone-capped wall acting as a retaining wall for the sloped road. The retaining wall then curves around at the top, leading towards the Right of Way path. At the bottom of the path is a set of three stone steps faced on the risers in blue-black engineering brick.
