Primrose Hill, Merthyr Tydfil

RECORD OF BUILDING AND CONDITION ASSESSMENT REPORT, WITH REPAIR PROPOSALS

.....(449)2503-GVWP-A-HIS-P01

Date: 05.03.25

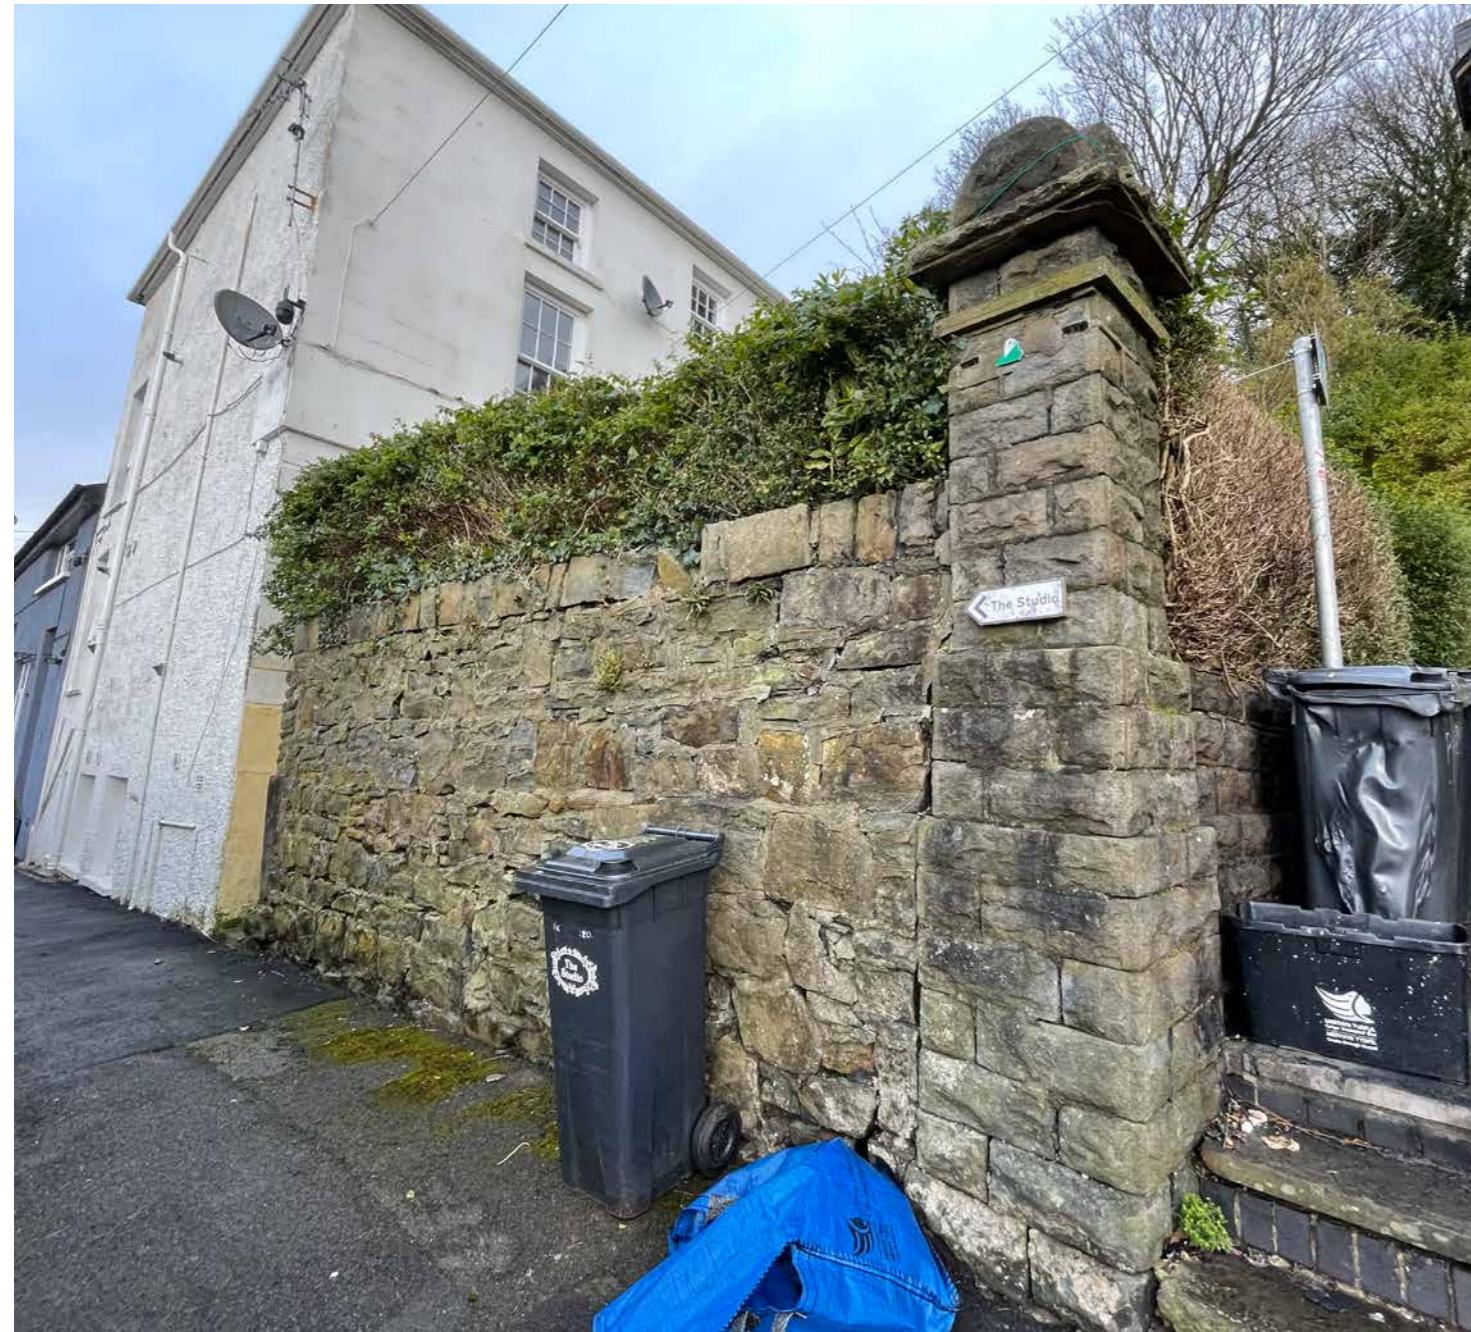
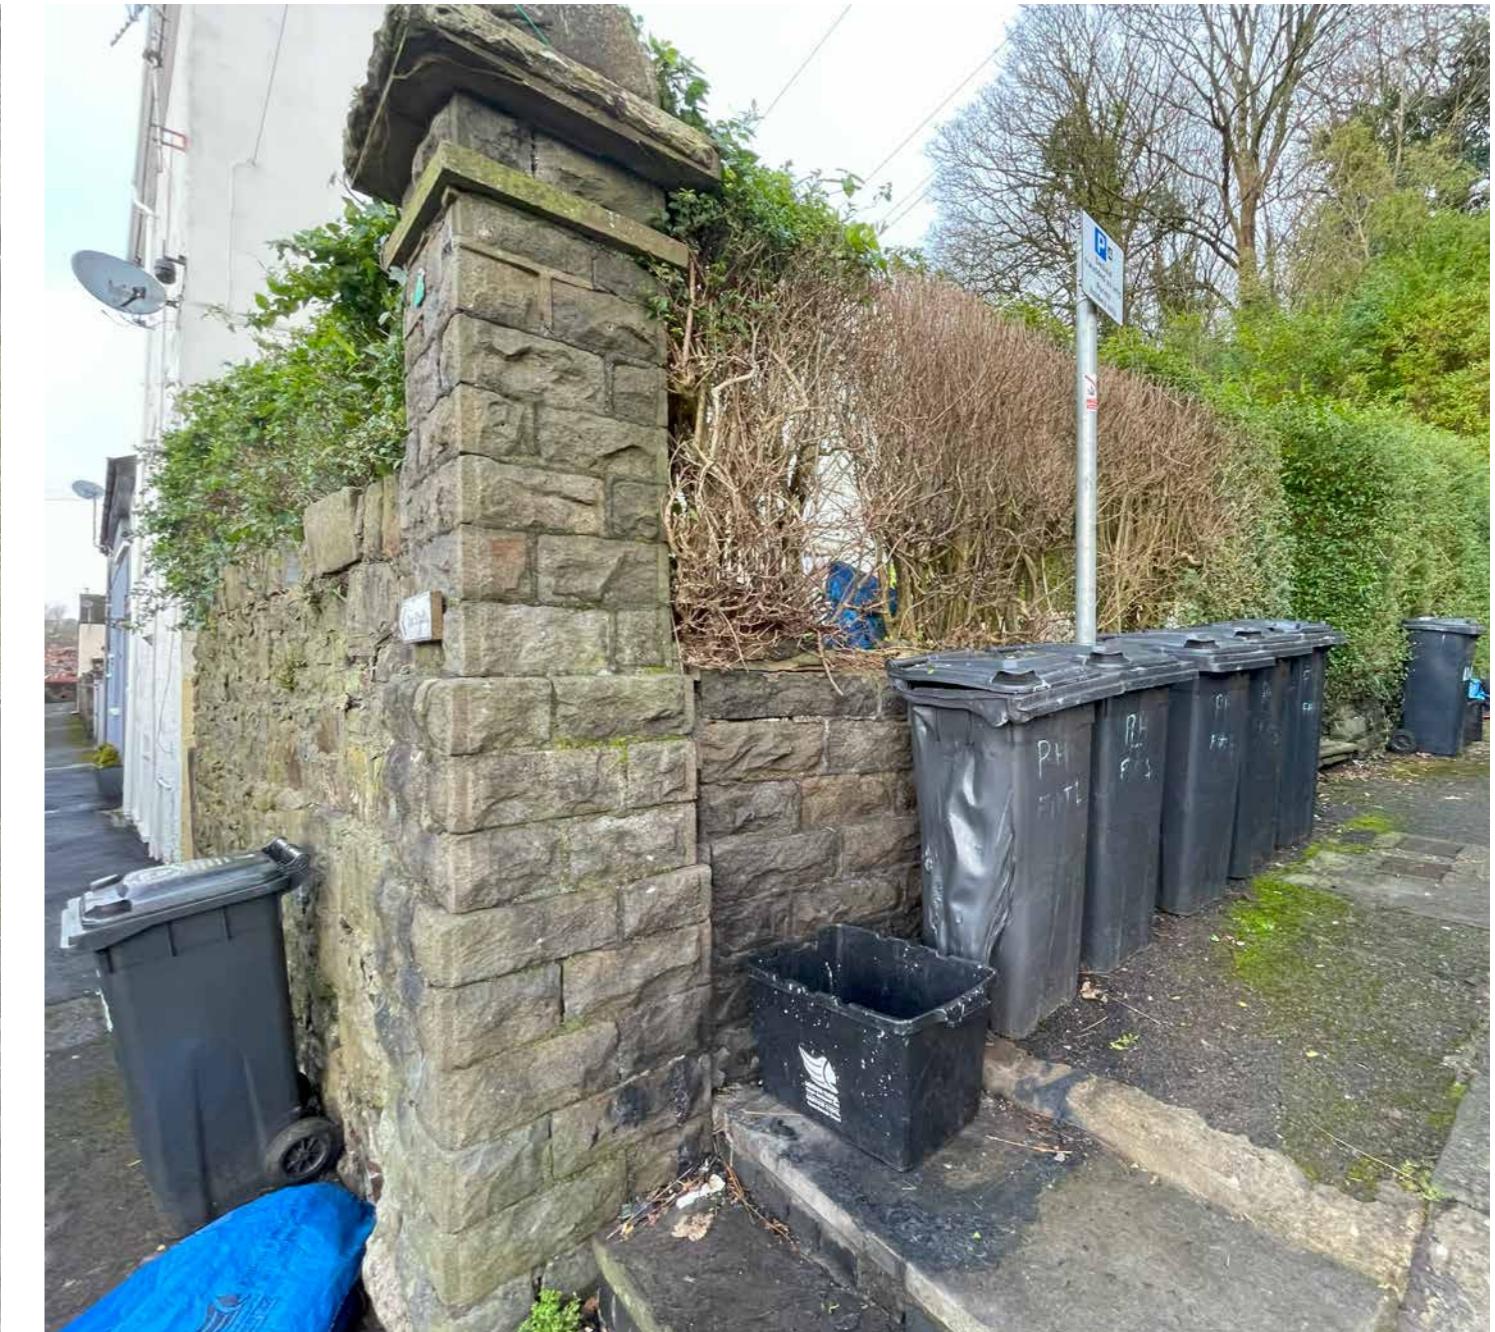
9.2 Front and Side Walls

To the west and south of the front garden is a pennant rubble stone enclosure wall, part retaining on the west. On the corner is a square, tall gate-post.

The stonework is bedded in lime mortar. In the past, it has been repointed in cement mortar; however, a fair bit of that has broken up and fallen away. Many of the joints are recessed and in need of pointing.

The proposals involve raking out the joints and removing what remains of the cement pointing, and re-pointing the whole wall in a lime mortar.

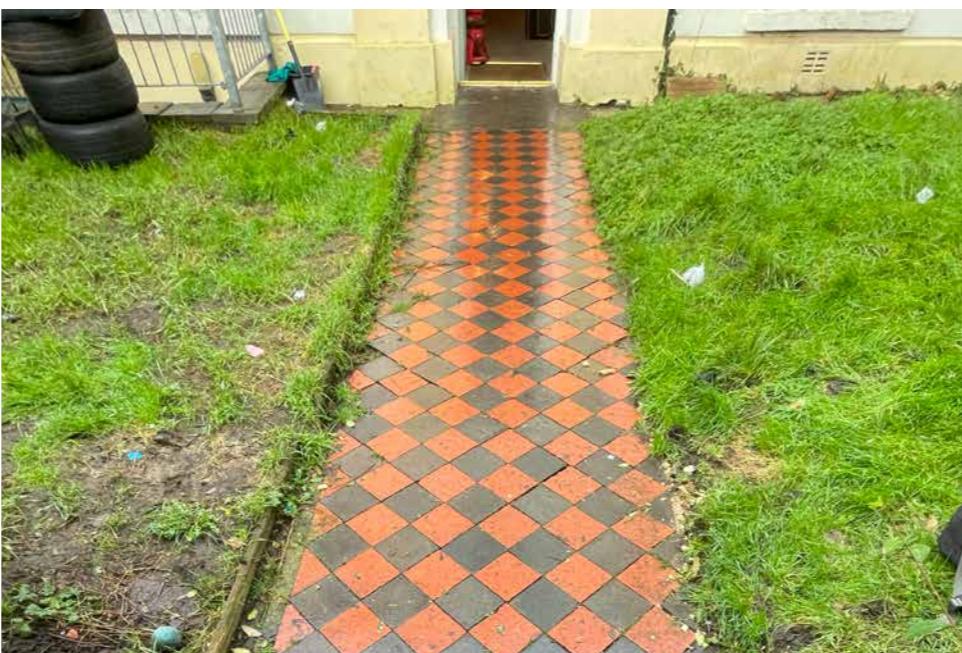
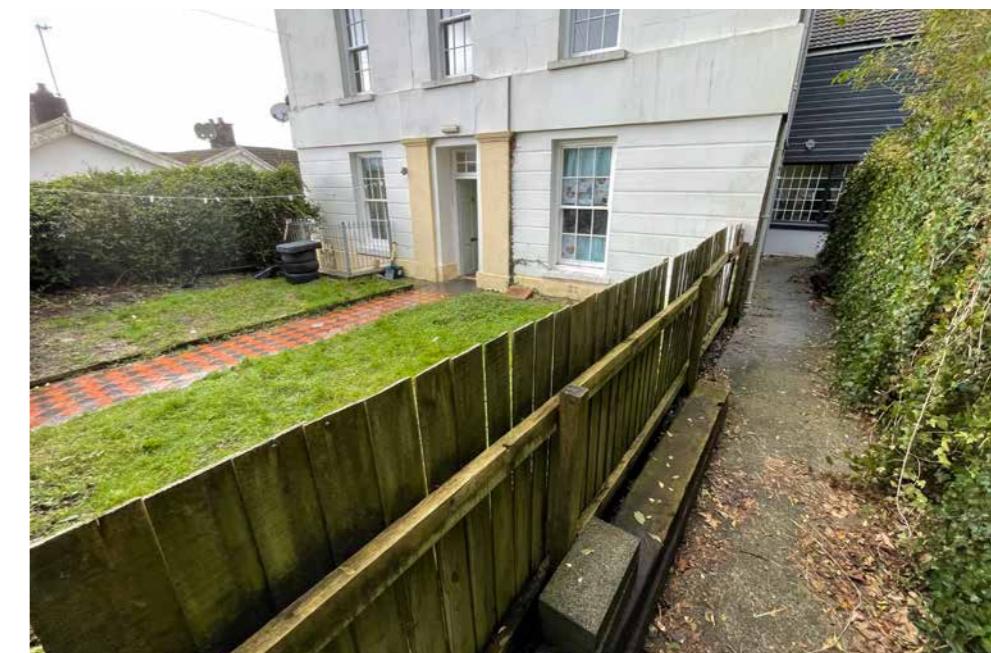
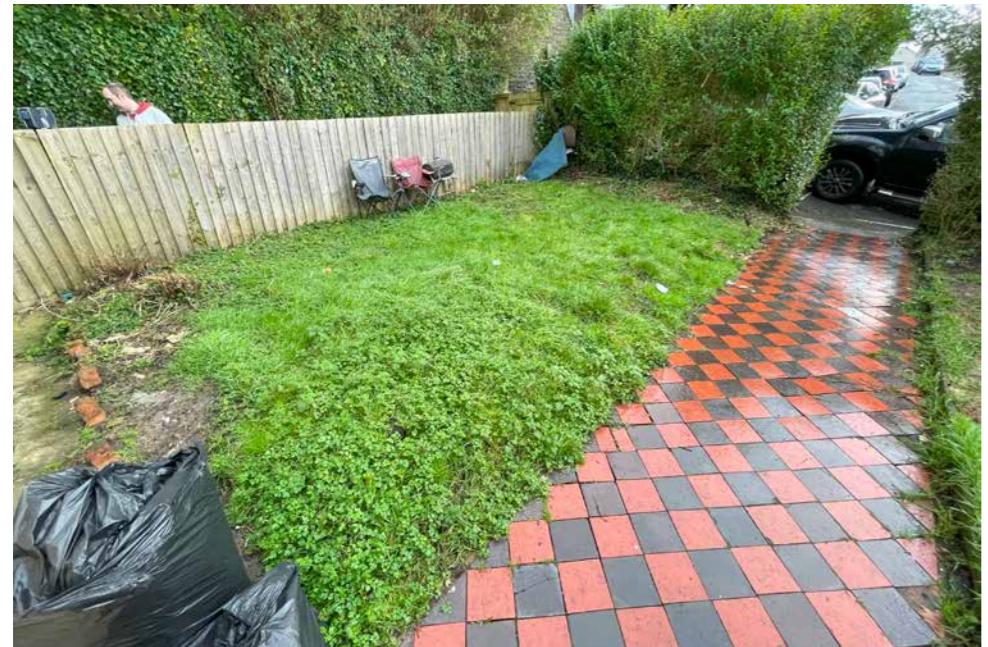
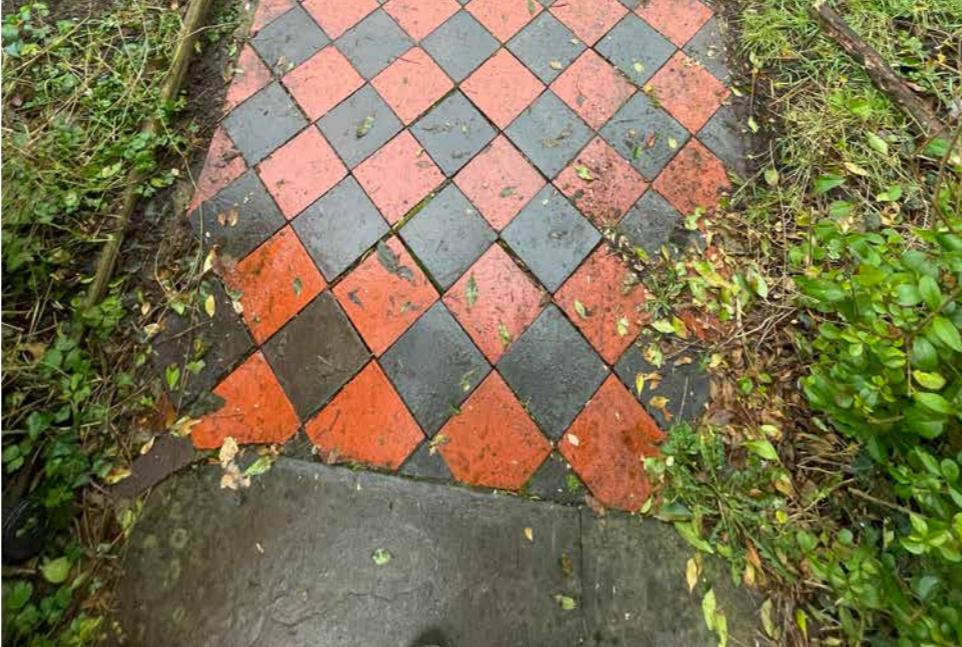
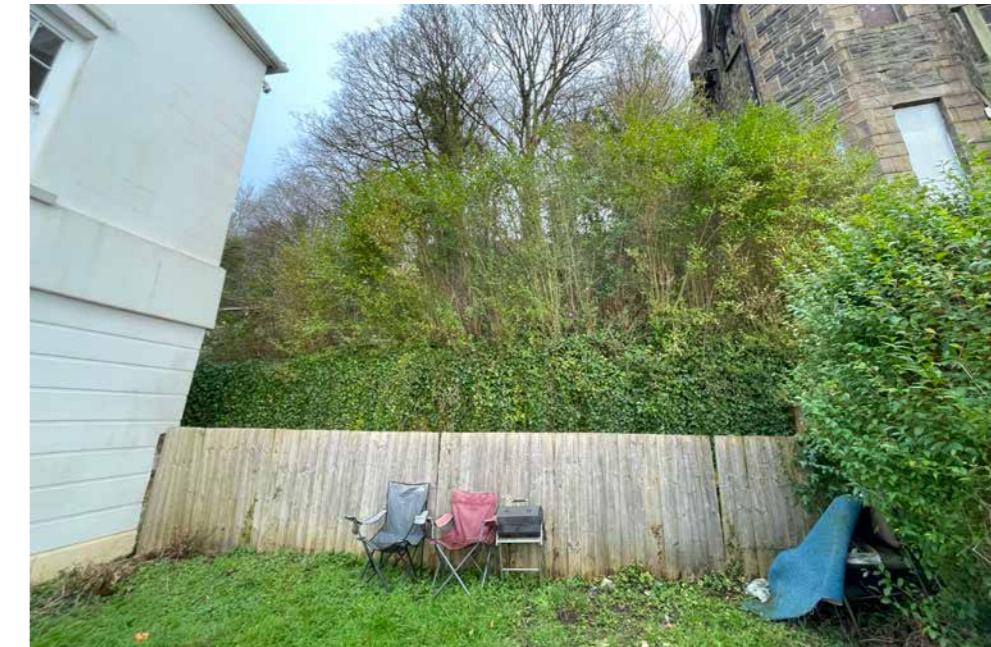
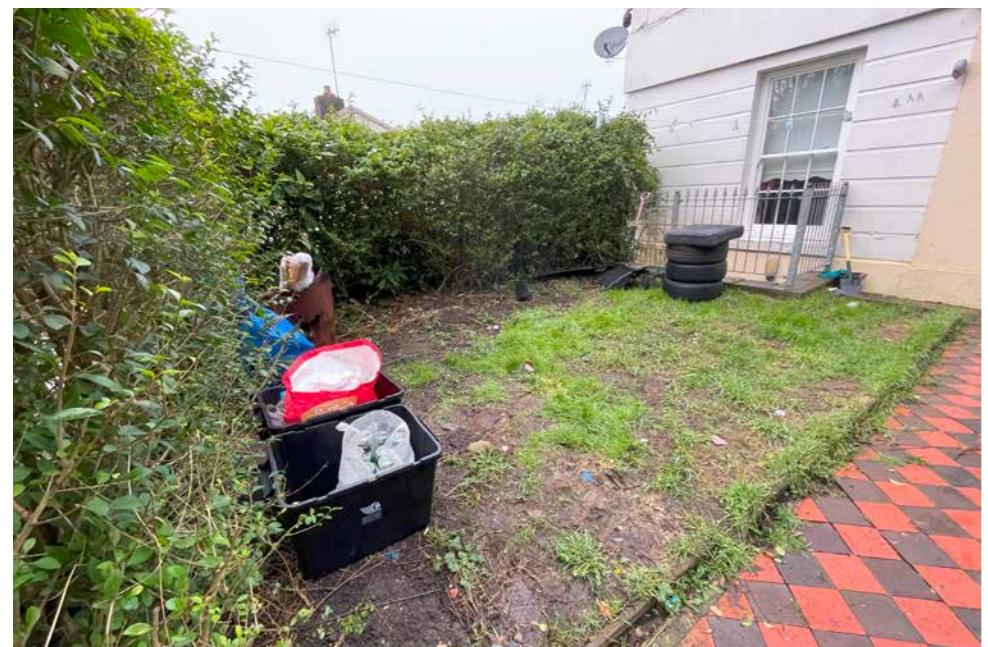
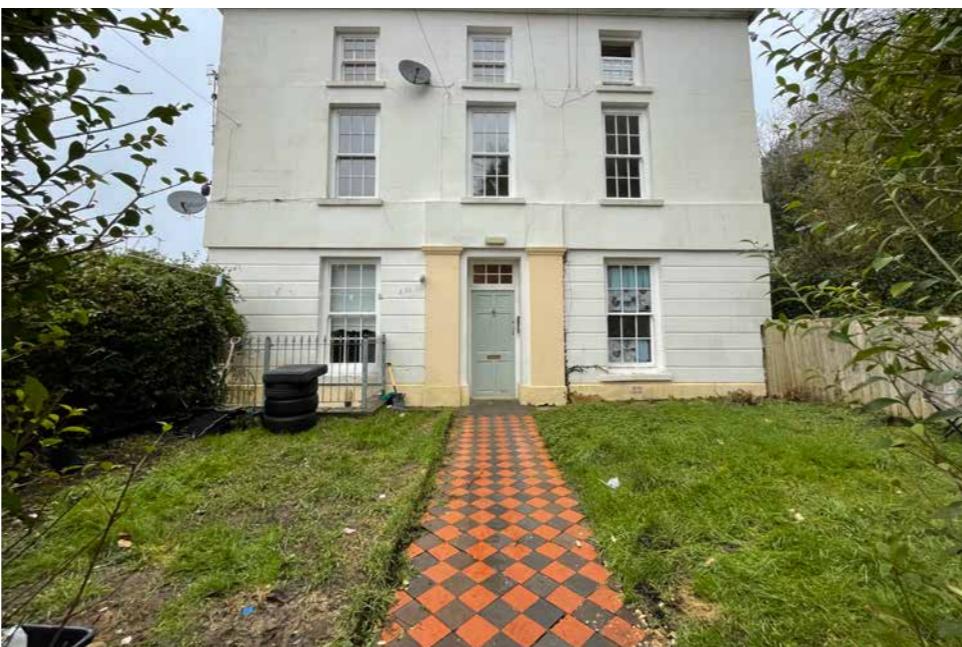
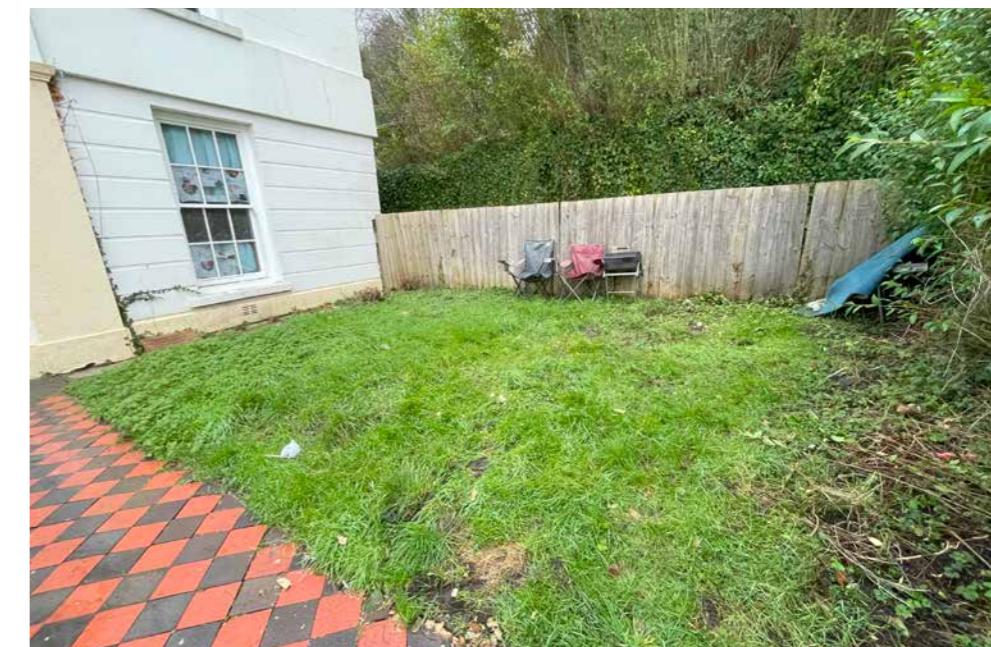
9.3 Front Garden

The front garden is turfed on both sides of a terracotta and black diamond-pattern quarry tiled path, running from the opening in the front wall to the entrance door.

The tiling is in a reasonable condition; however, there are a small number of damaged tiles and most of the grouting has been lost.

It is proposed that those damaged tiles are replace like-for-like and the whole area is re-grouted.

During any construction works, it is very important that this path is protected from further damaged.

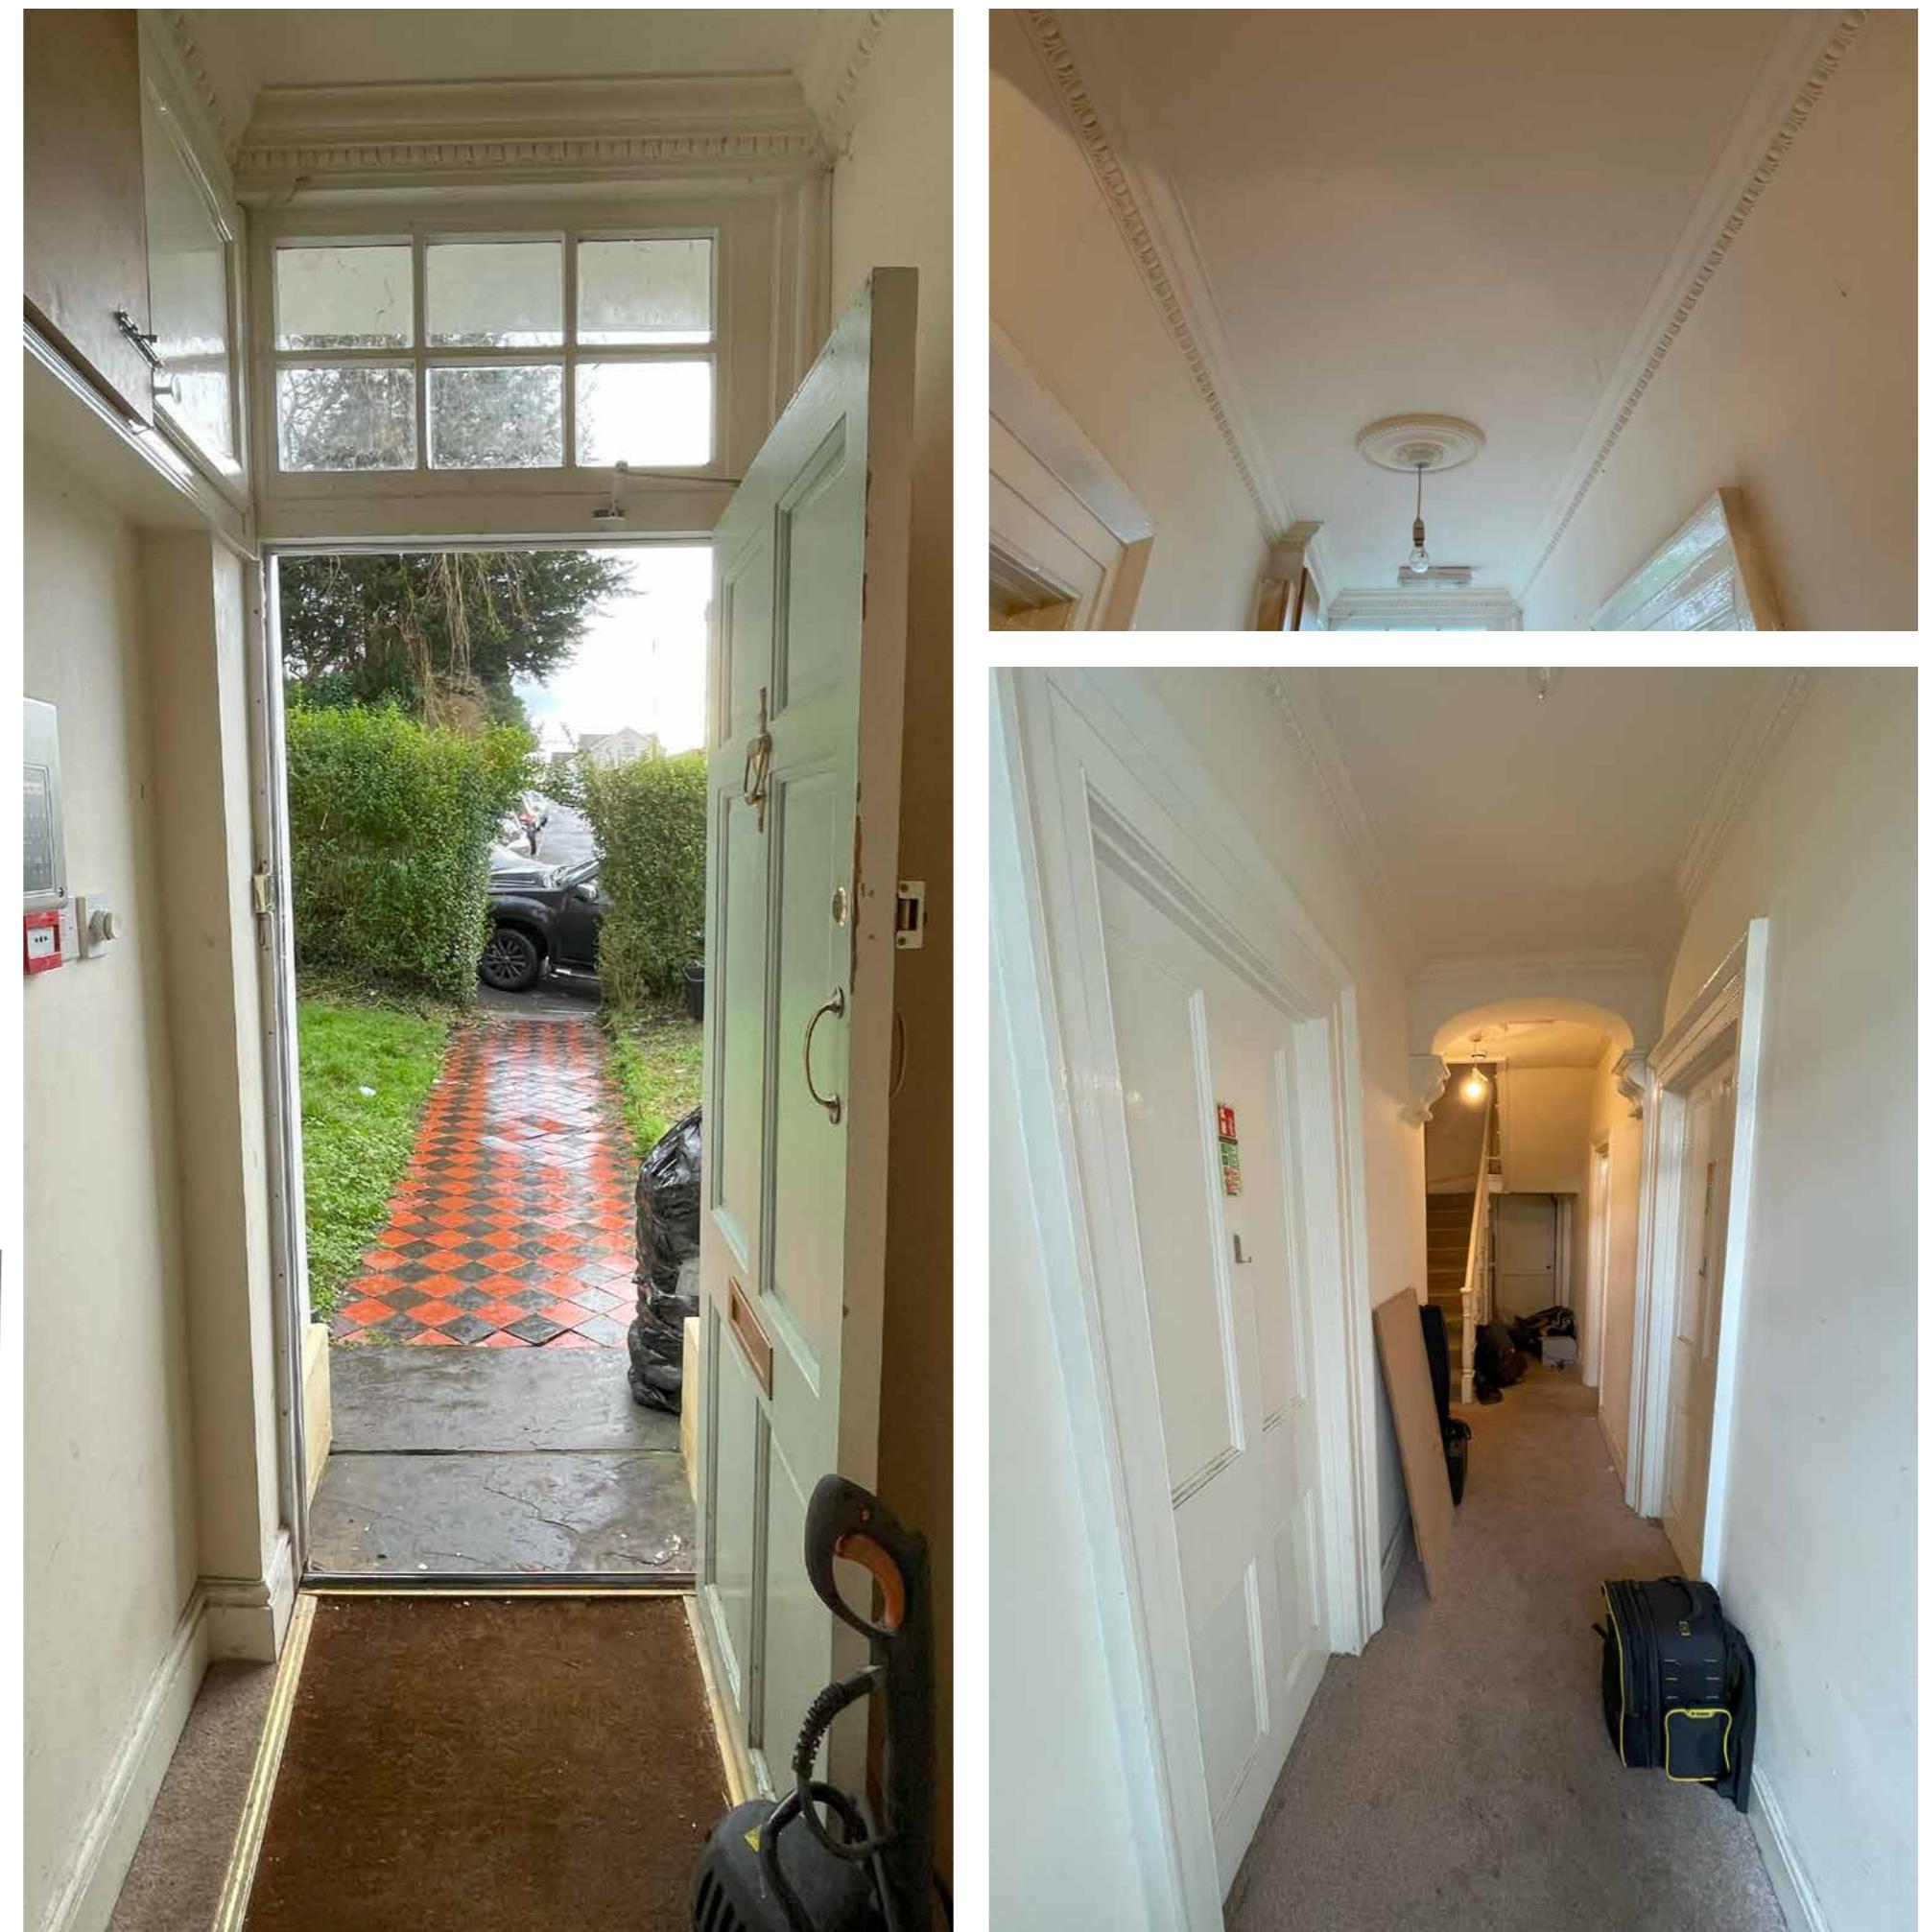
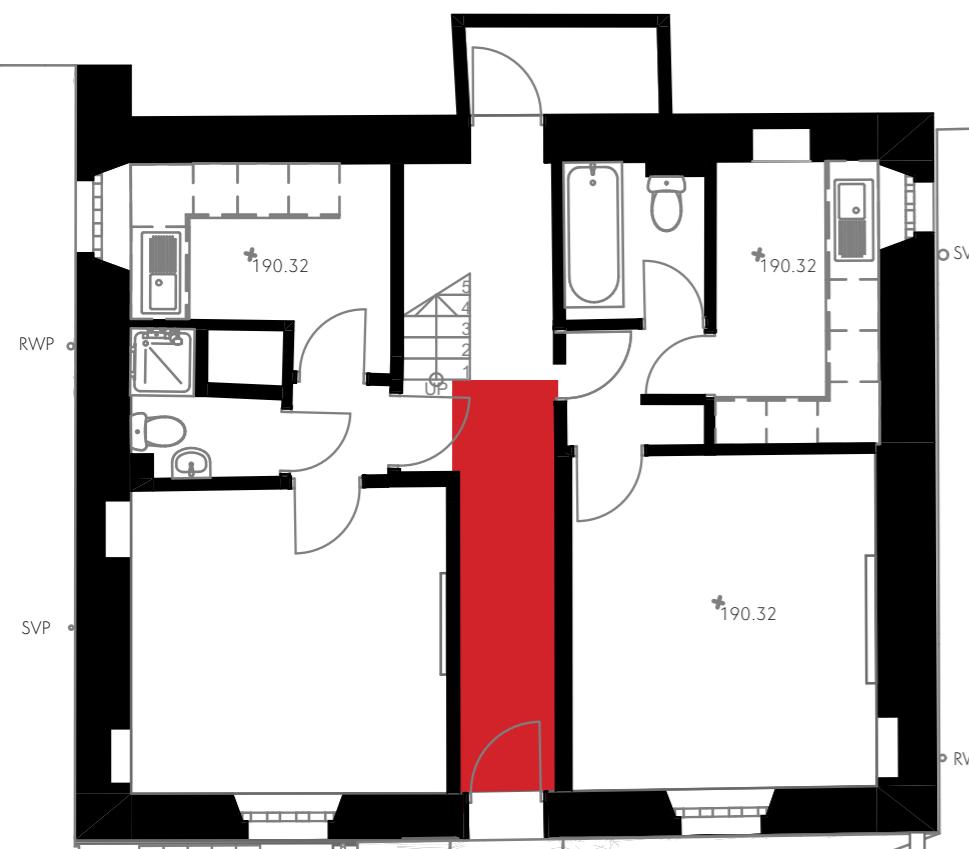
There are a number of scars on the paintwork; however, generally, the fabric and finishes are in a reasonable condition.

The floor is carpeted, which is a little worn, and there is a matwell at the front.

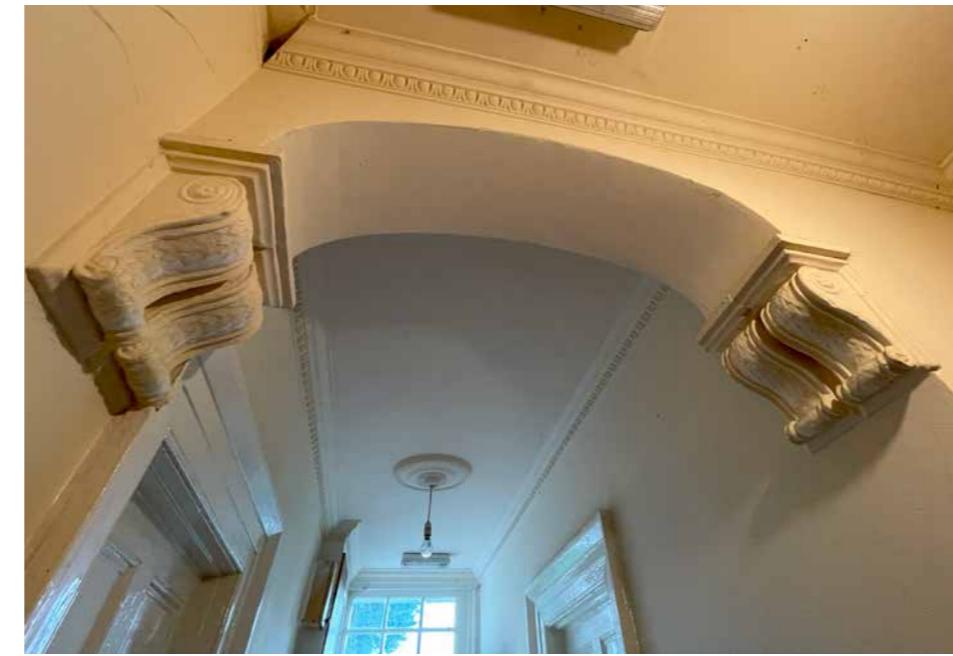
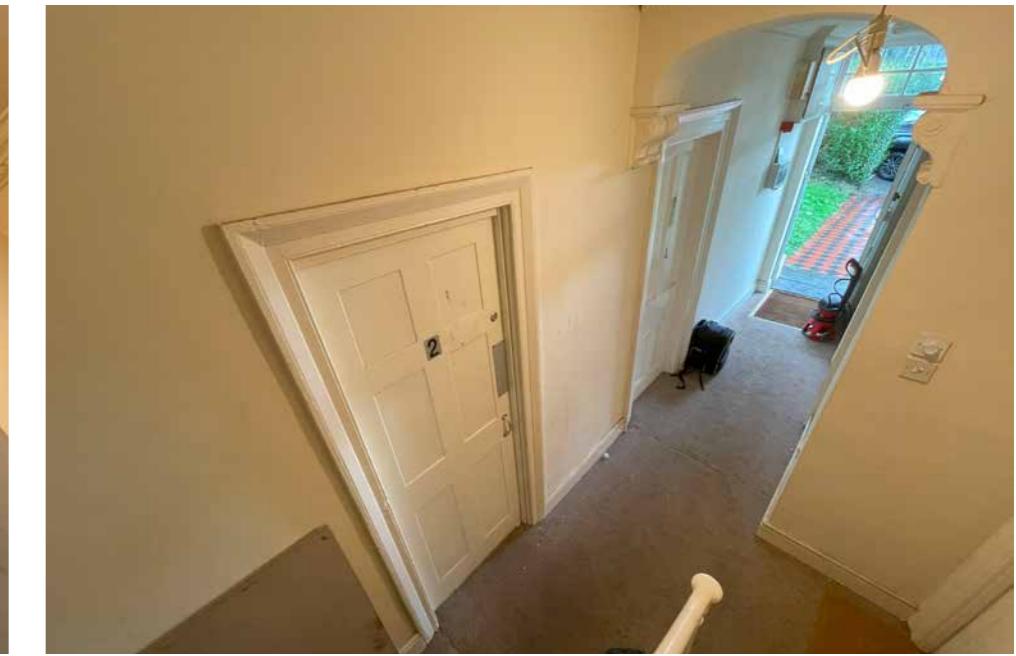
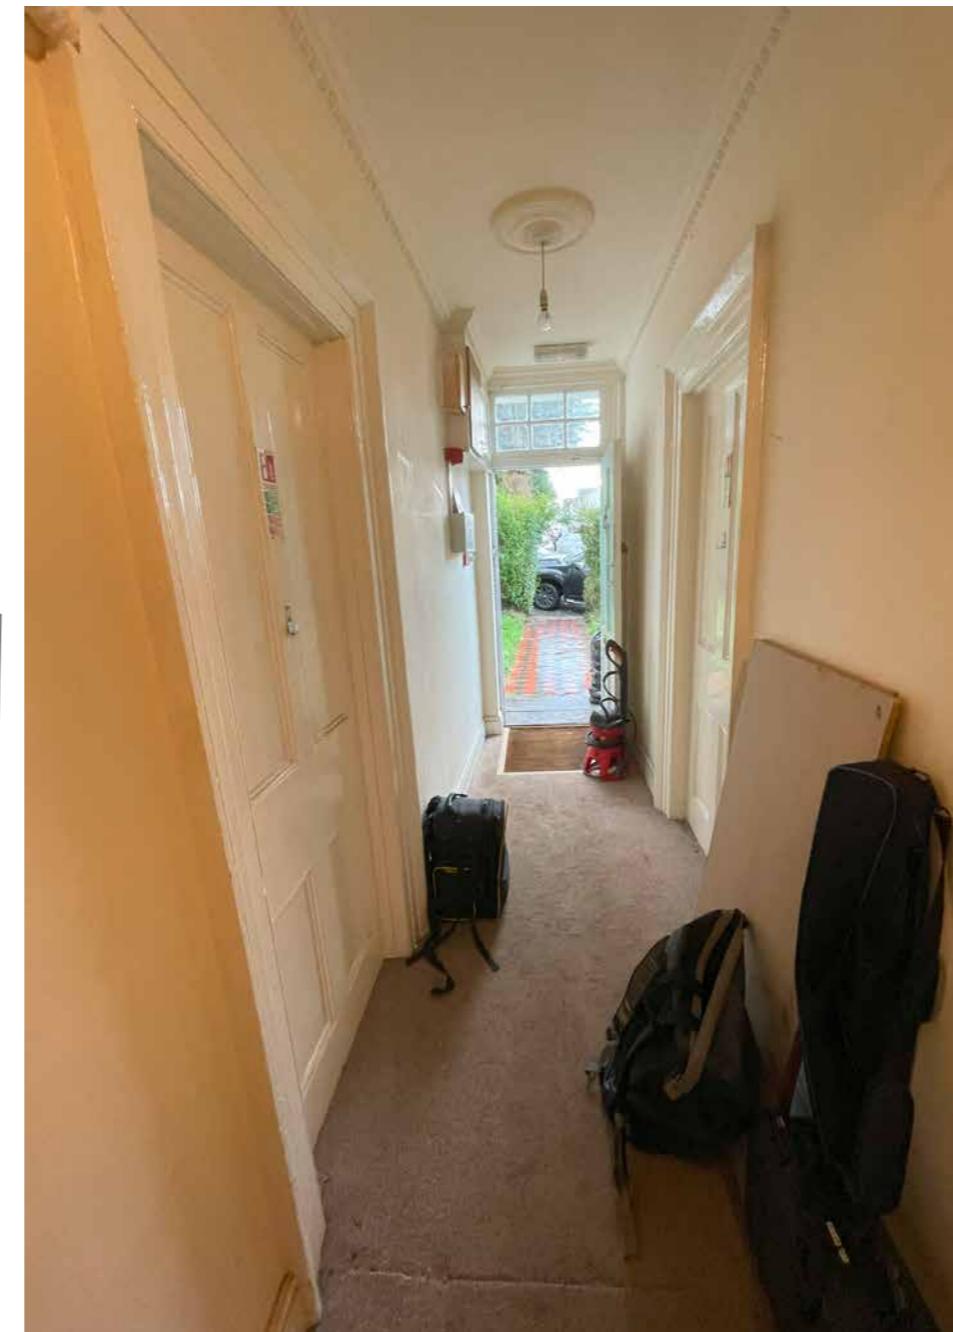
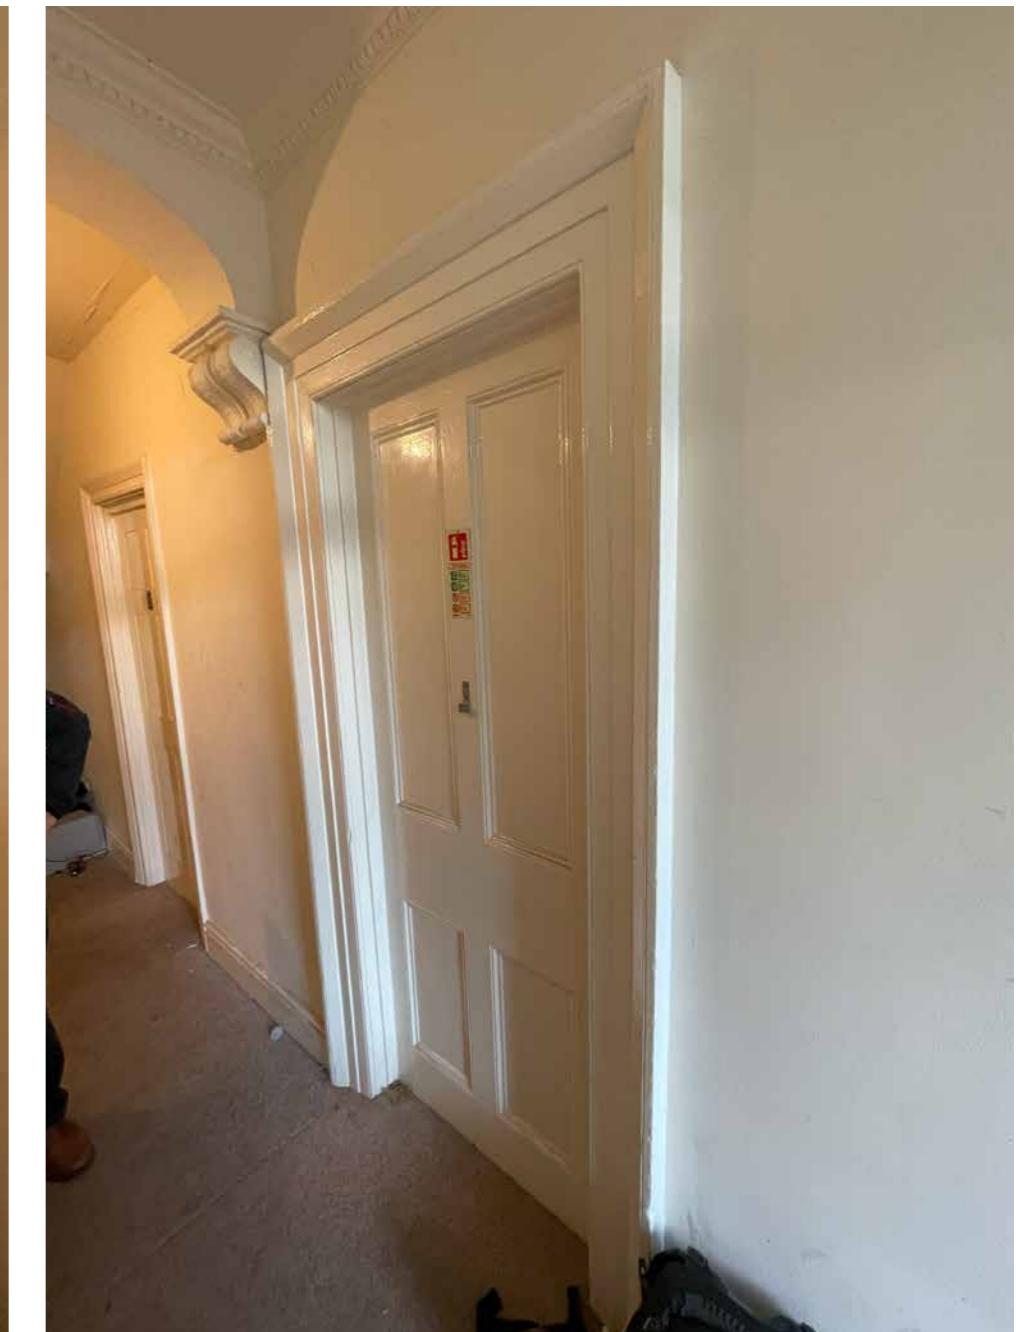
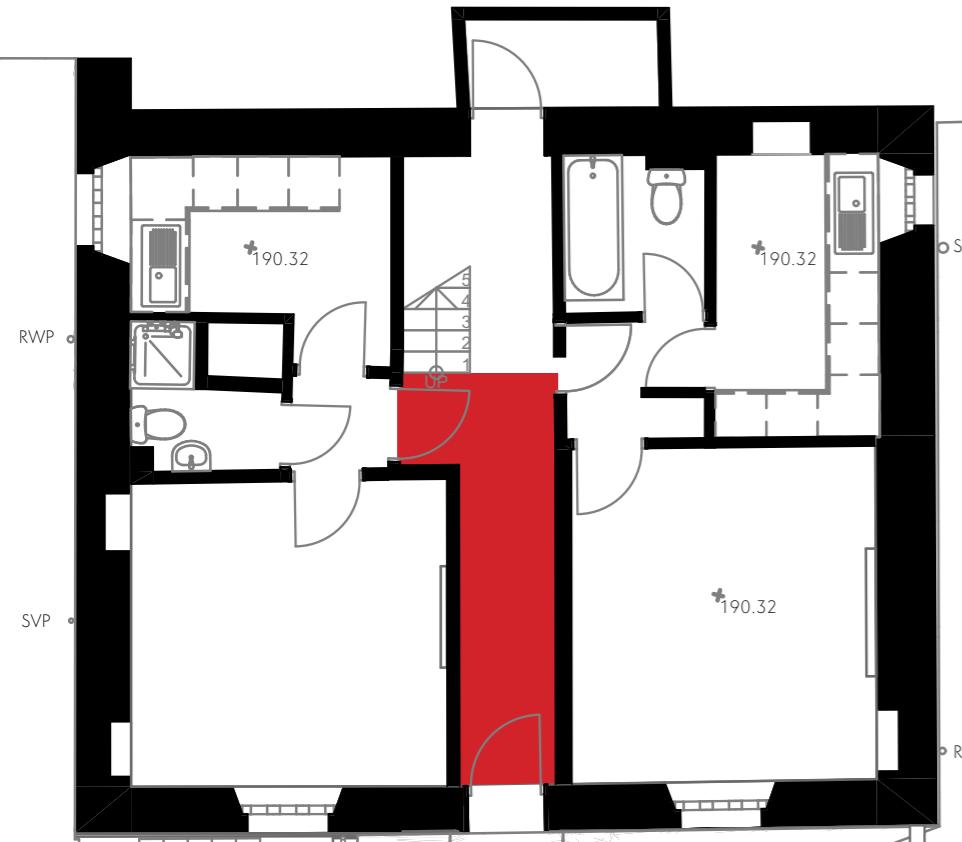
10.0 Interior - Ground Floor - Entrance Lobby

Where the entrance corridor becomes the stair lobby, an interesting arch flies over the junction, springing from twinned swirled corbels. The egg-and-dart cornice continues over the top.
