Primrose Hill, Merthyr Tydfil

RECORD OF BUILDING AND CONDITION ASSESSMENT REPORT, WITH REPAIR PROPOSALS

.....(449)2503-GVWP-A-HIS-P01

Date: 05.03.25

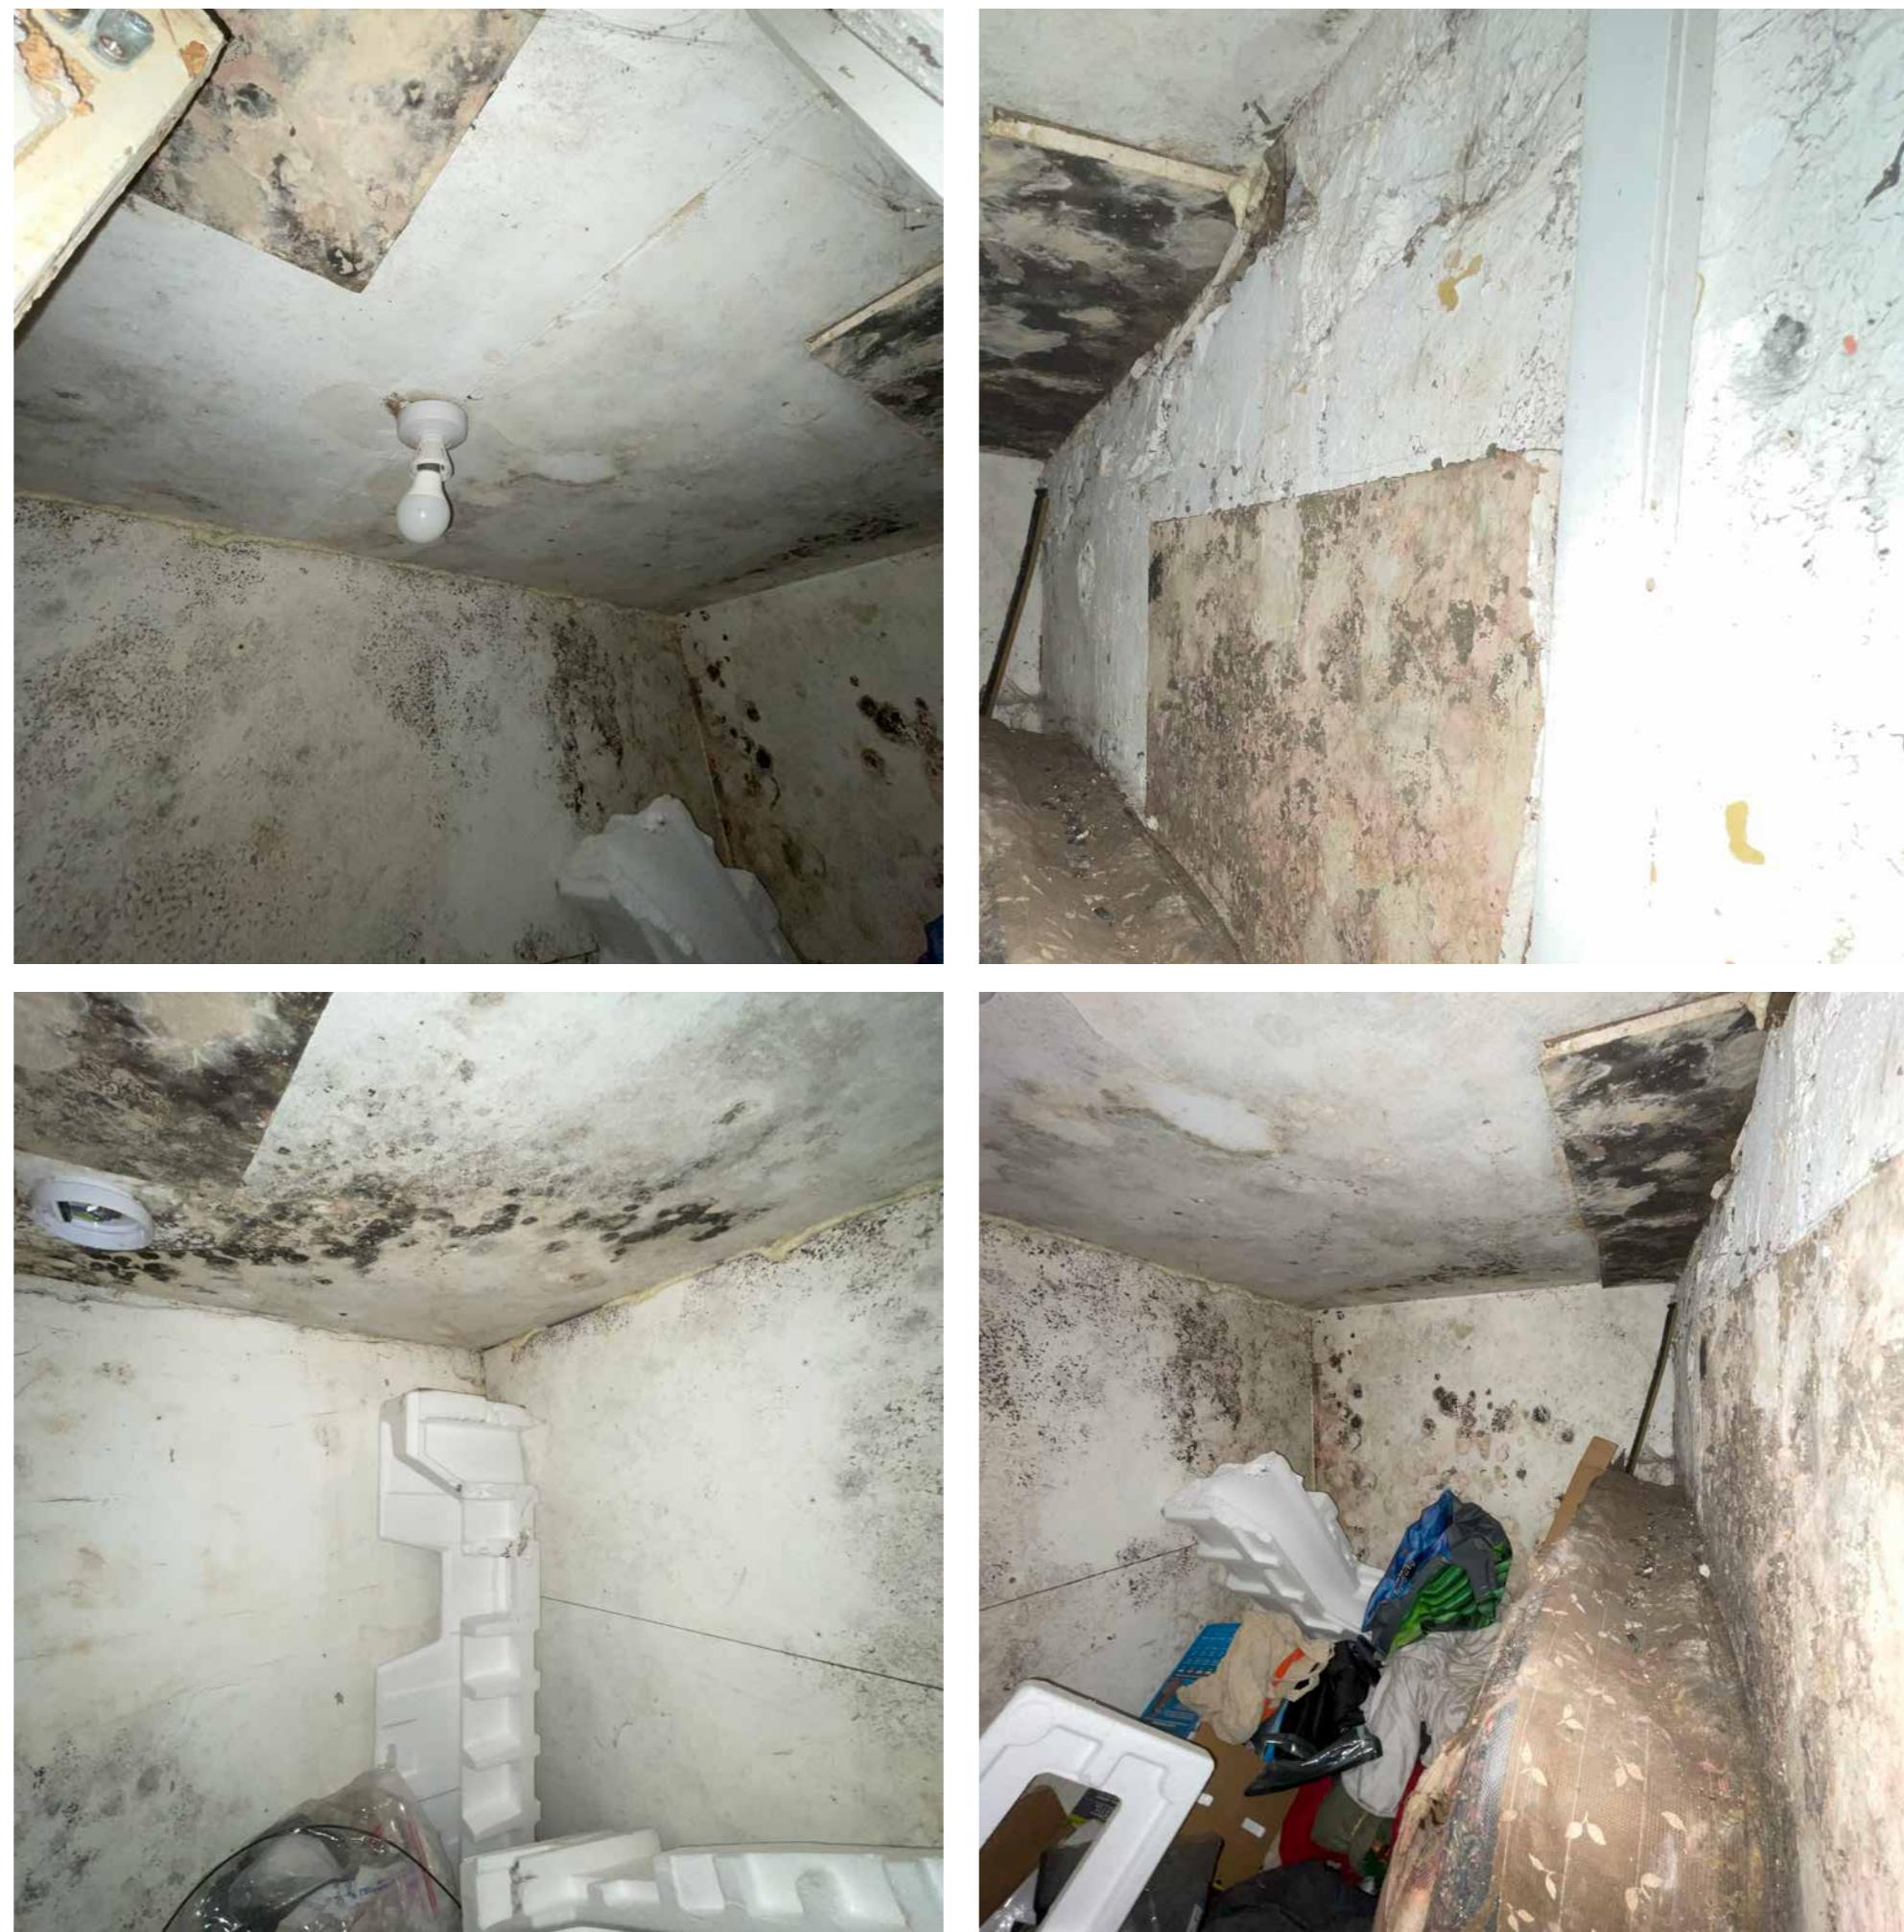
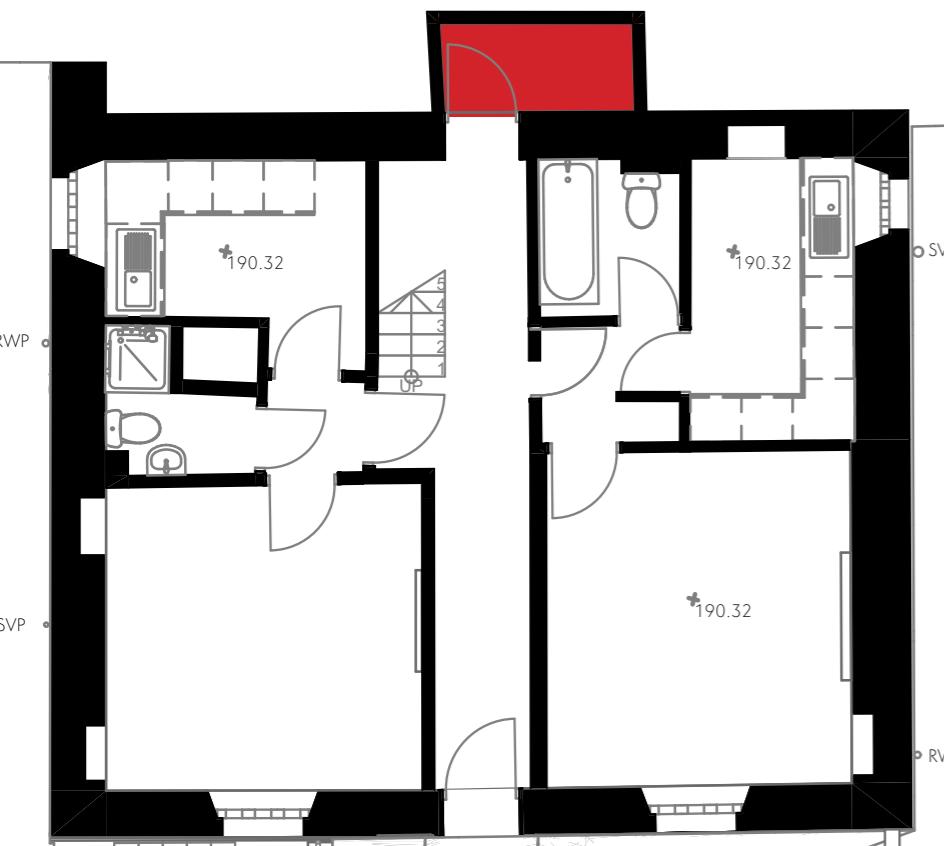
10.0 Interior - Ground Floor - Rear Store Room

The masonry enclosure store at the back of the corridor is 'landlocked' with the building behind and the matching store above. It is suffering from damp and mould growth on all four walls and the soffit. Containing various elements, an completely dark inside, it is difficult to get a good appreciation for its detailed condition.

There appears to be no ventilation at all to the space, and no heating. To that end, condensation and mould growth, with cold bridging to the envelope, is inevitable.

The proposals involve adding a heating source to the space and providing ventilation. This is likely to be in the form of a door transfer grille at the bottom and top of the door, in order to encourage some cross ventilation. However, given that this will be used as a store, and it is within a fire escape route, the grilles will need to be intumescent fire-rated grilles. This intervention will need to be discussed with the Building Control Officer.

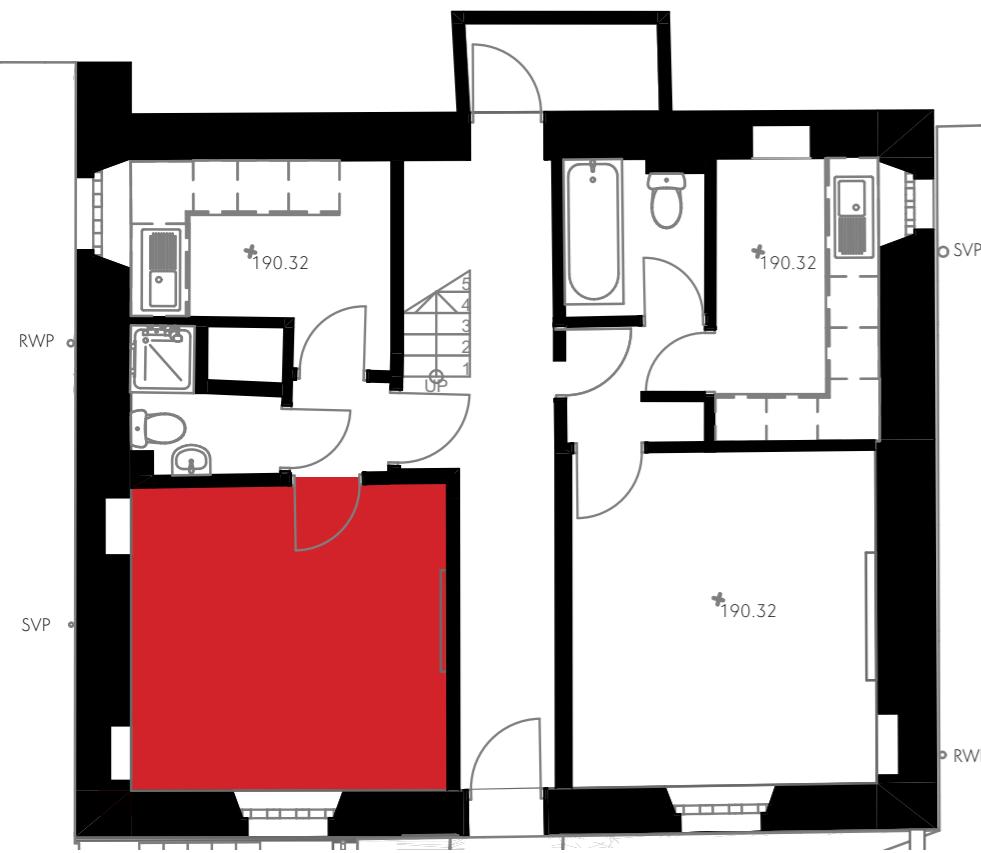
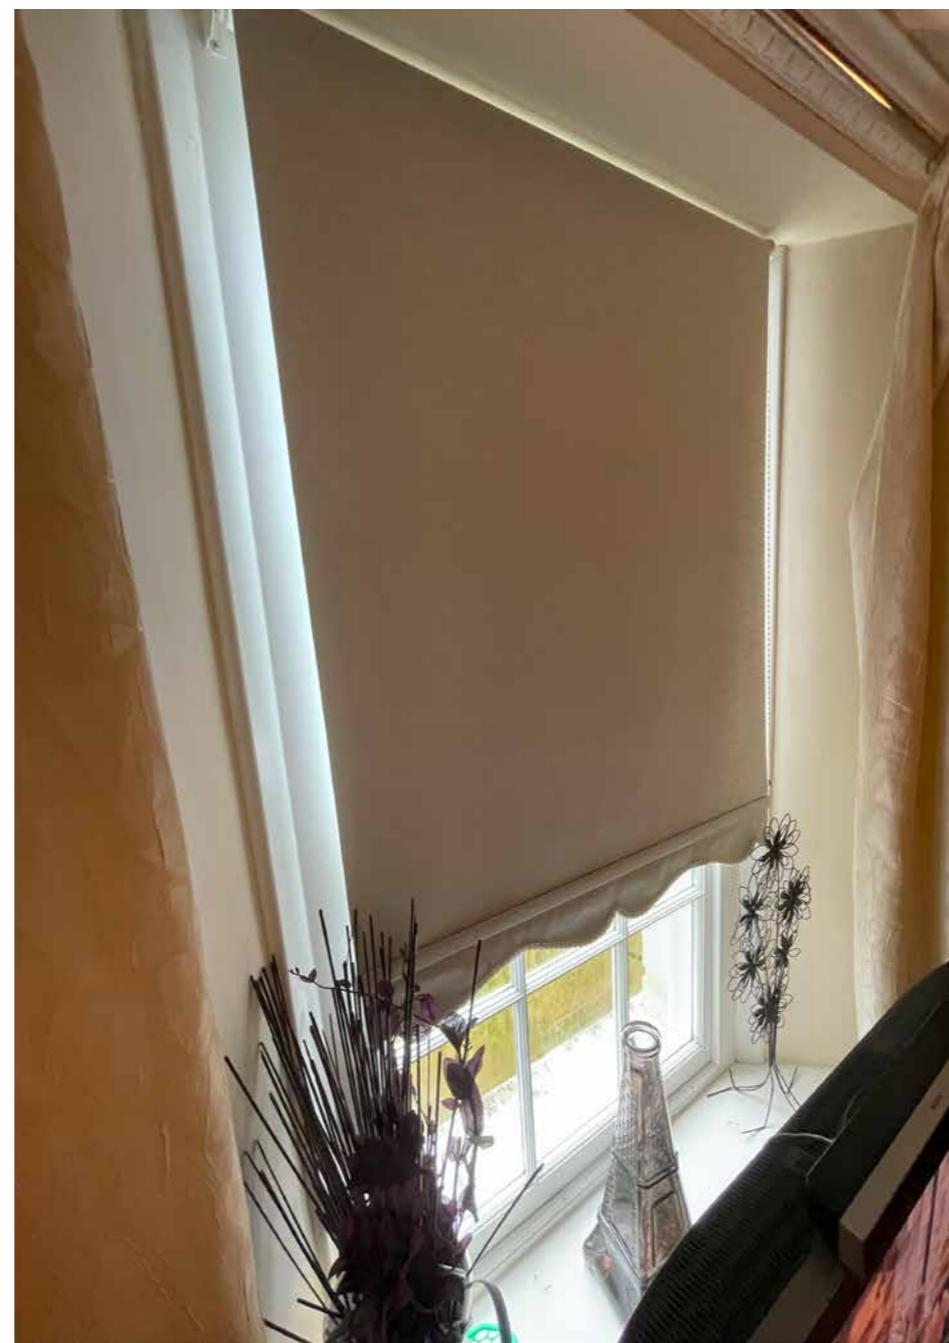
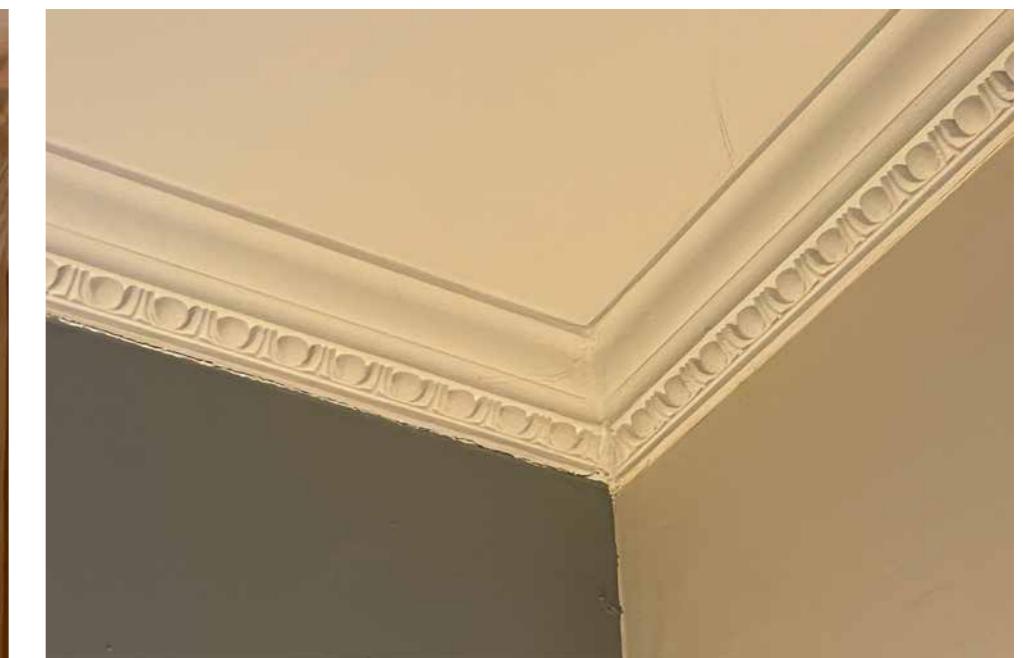
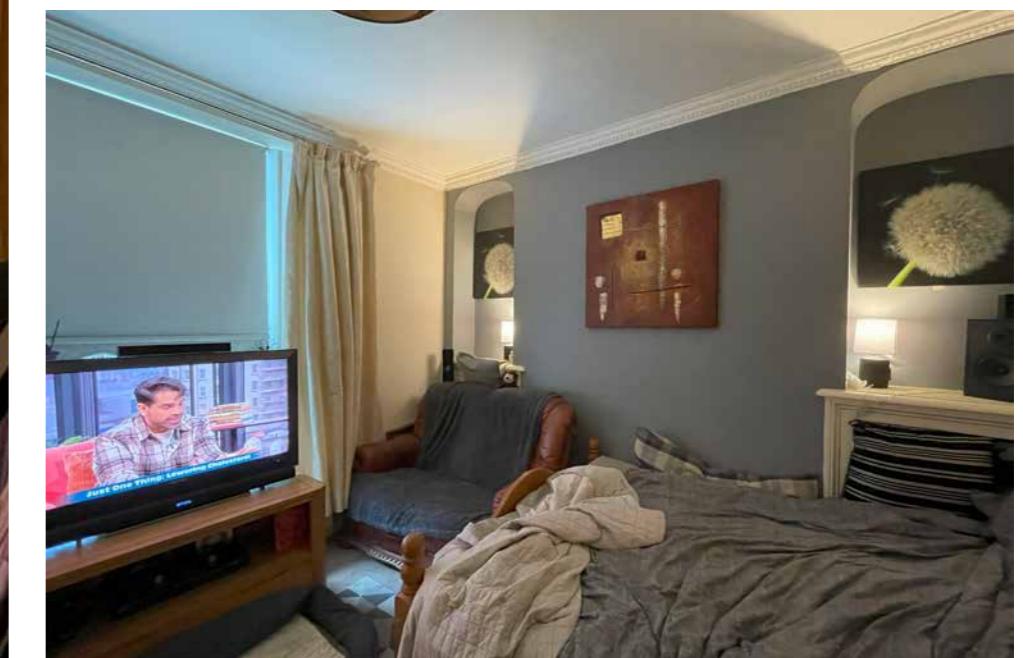
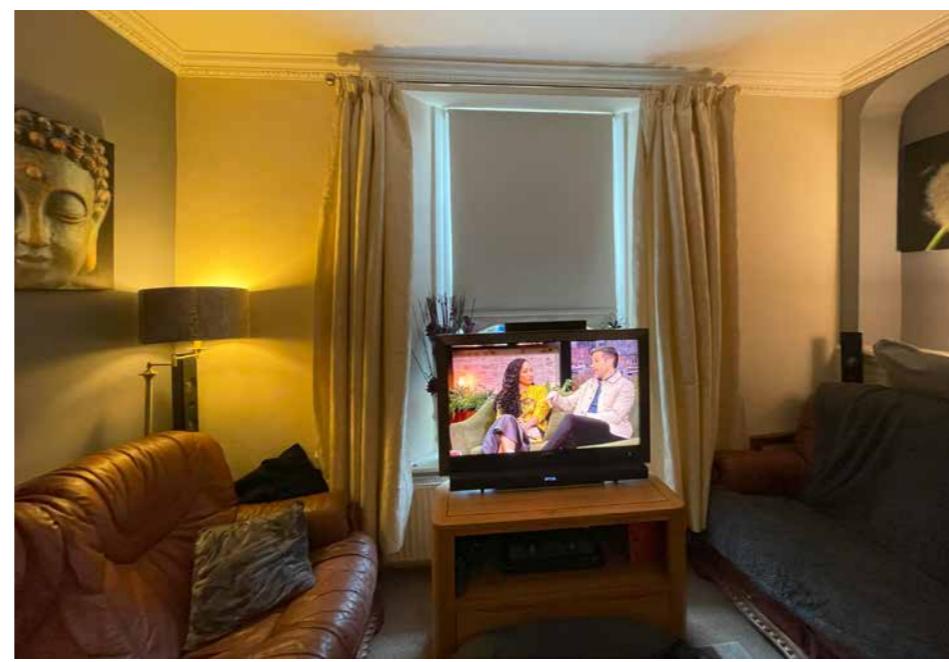
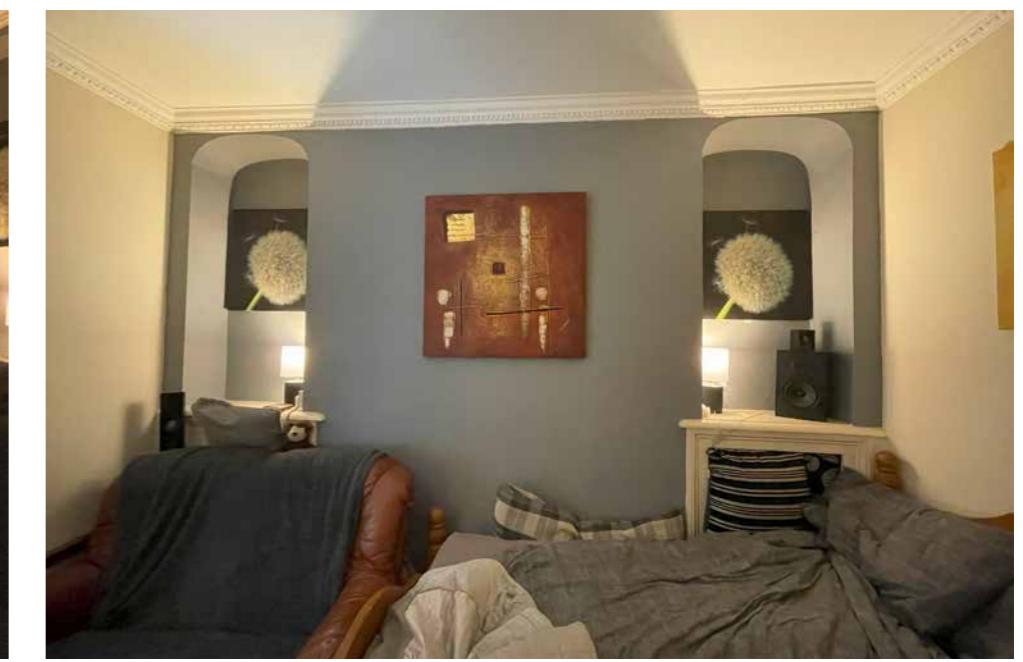
10.0 Interior - Ground Floor - West Flat Front Room

Much as the central entrance lobby, the front room to the West Flat is of painted plastered walls and ceilings with an egg-and-dart cornice and a ceiling rose. The floor is carpeted; the door is a painted four-panelled timber door and the window a painted timber window with double glazing. All appear to be in a good condition.

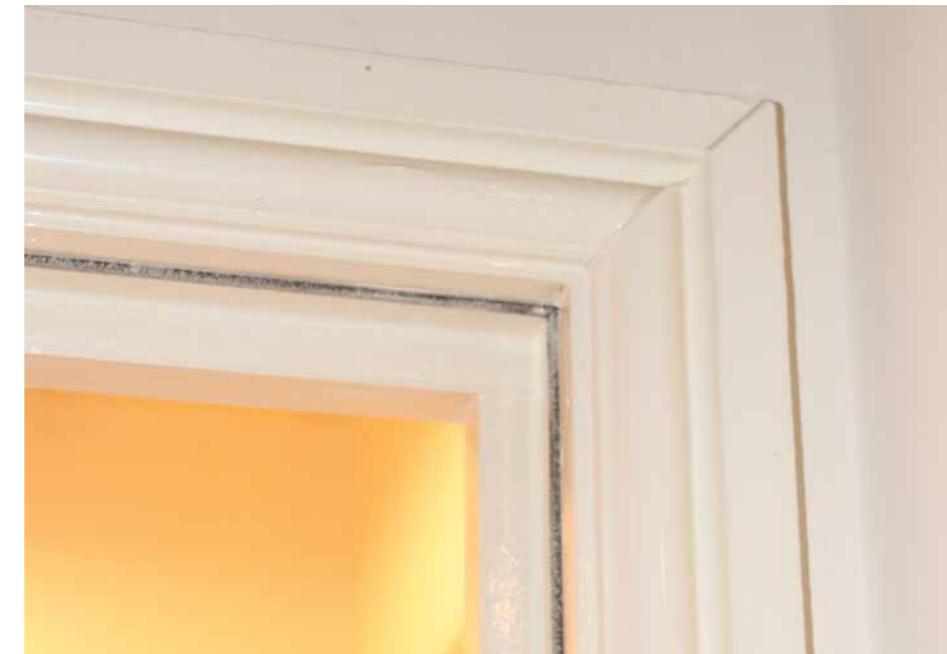
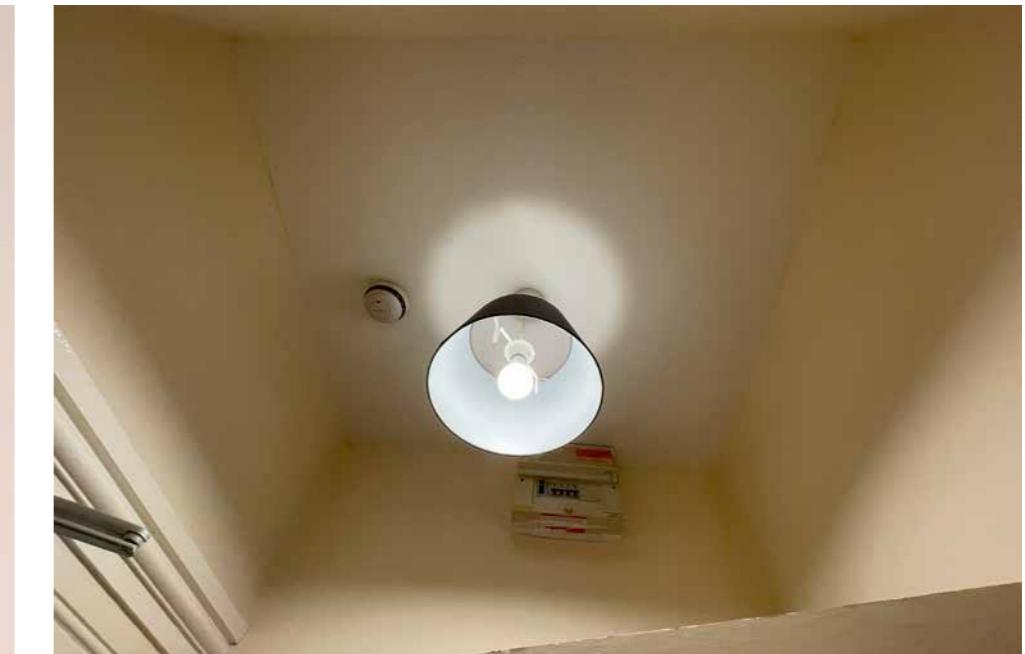
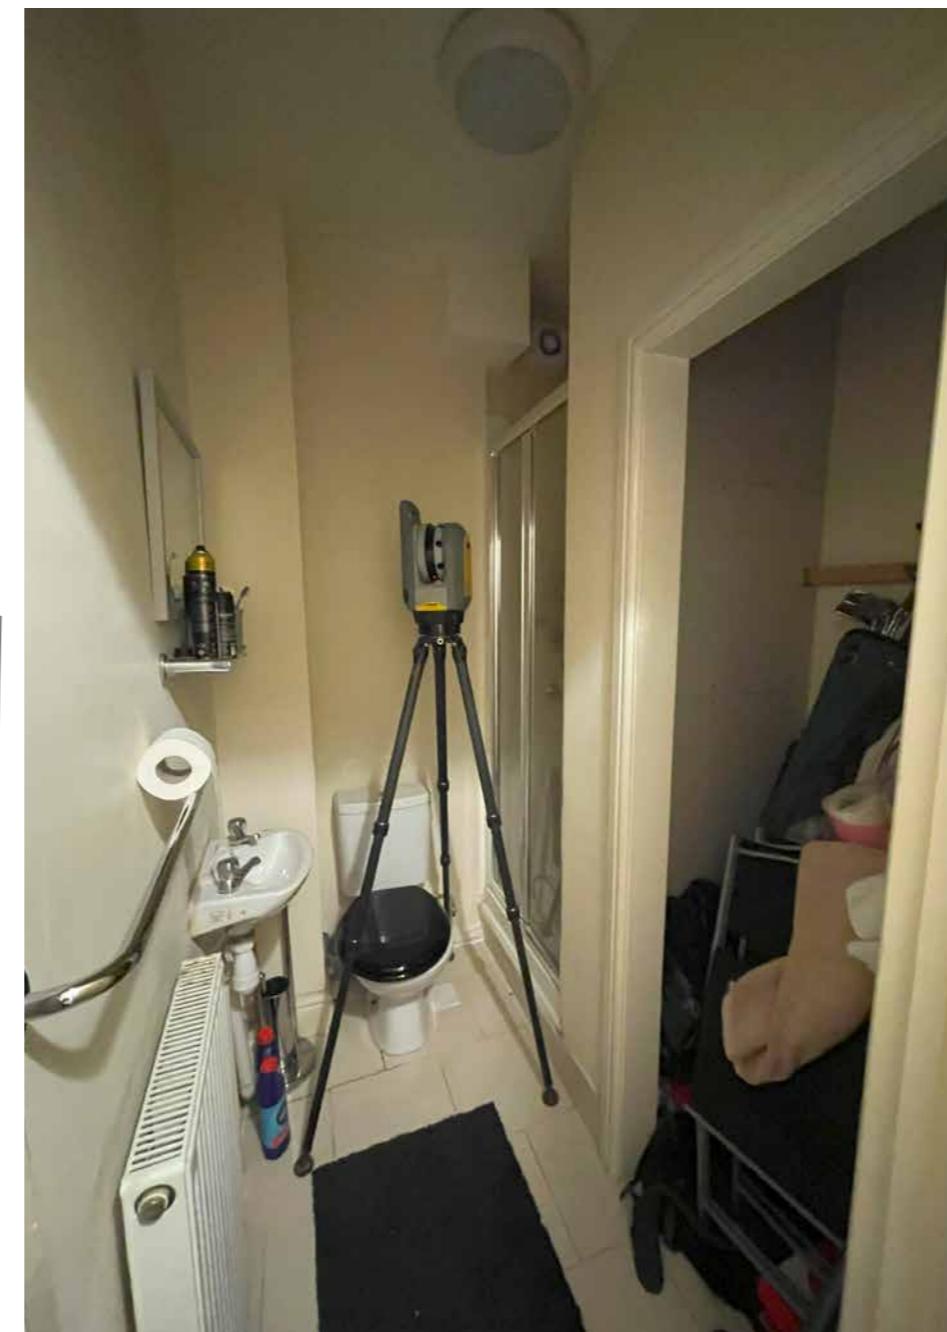
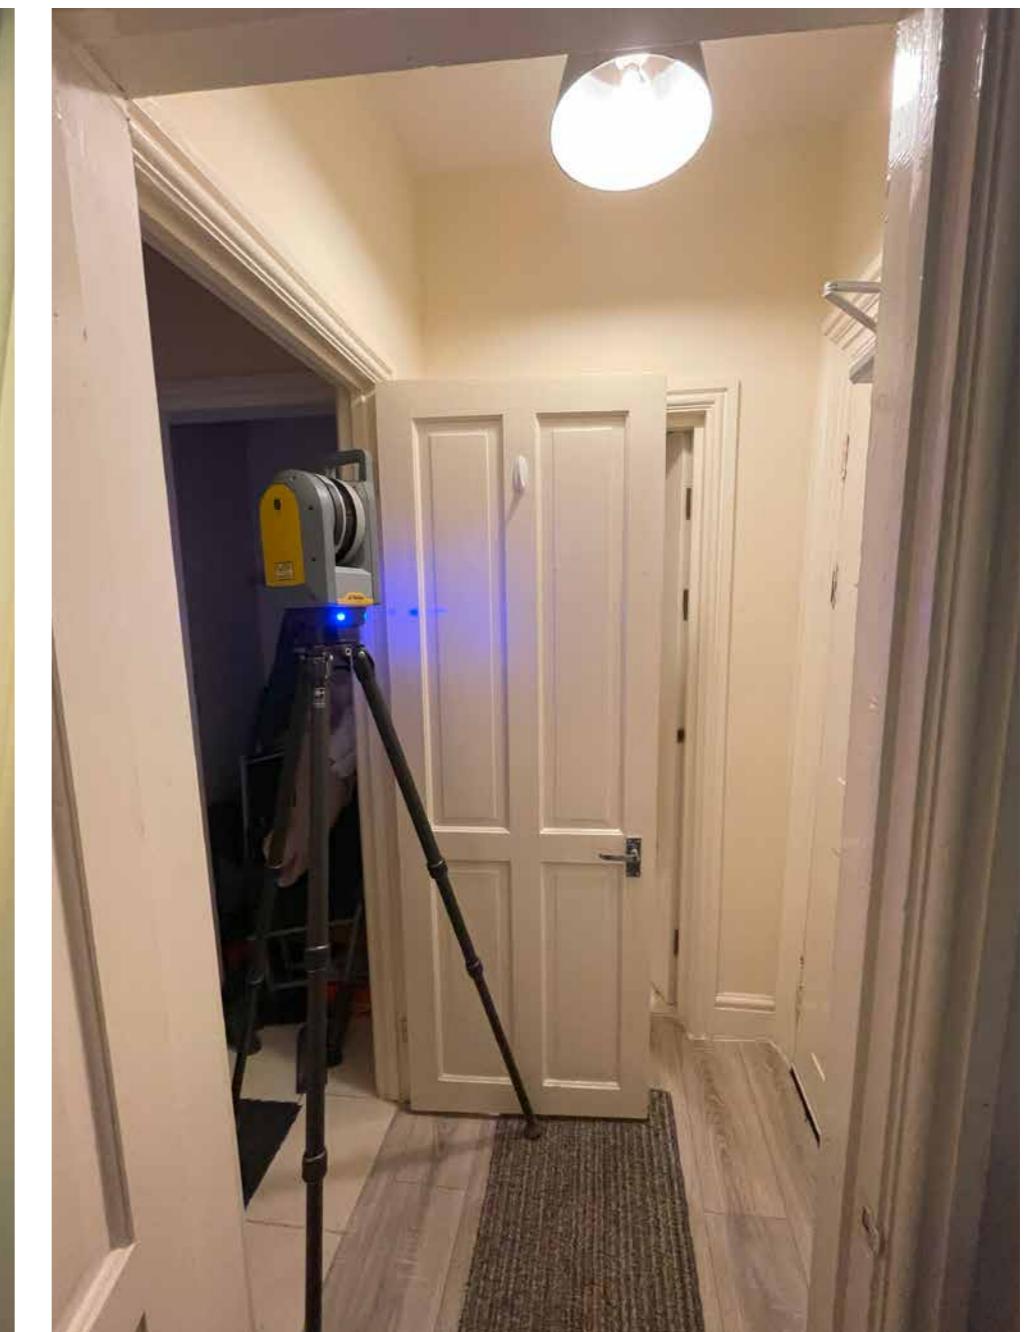
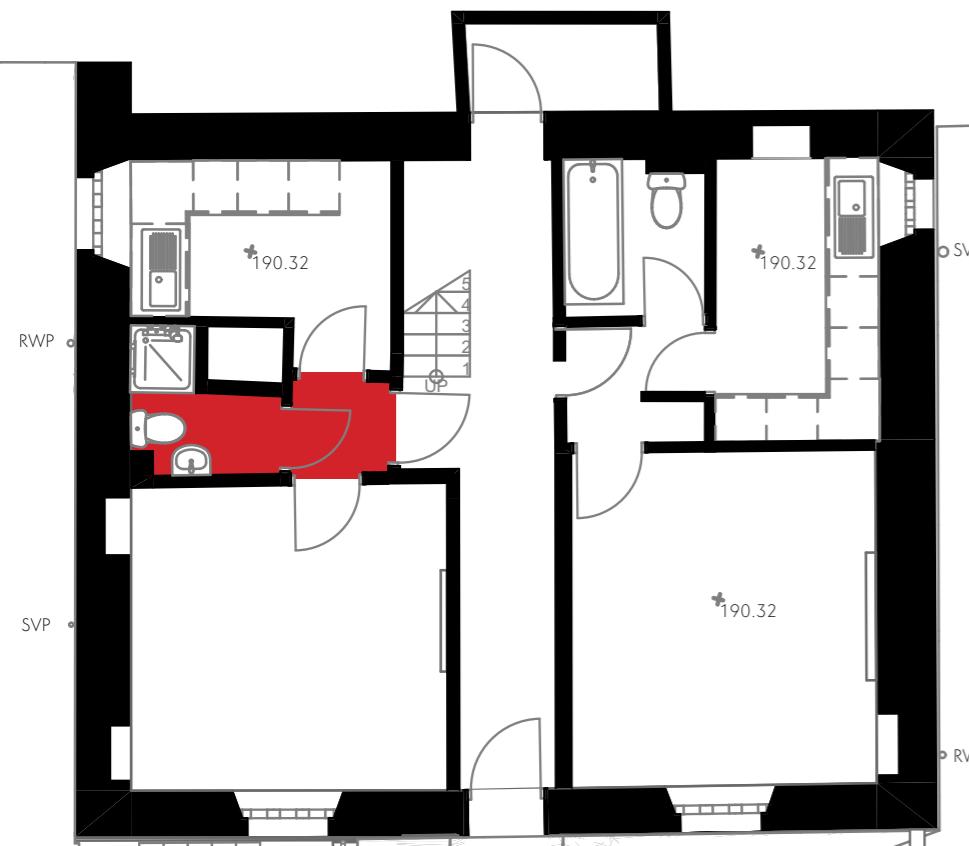
10.0 Interior - Ground Floor - West Flat Bathroom and Lobby

Also with painted plastered walls and ceilings (this time with no cornice), and timber four-panelled painted doors, the floor to the bathroom is of ceramic tiling and, to the lobby, of vinyl. All appears to be in a reasonable condition.

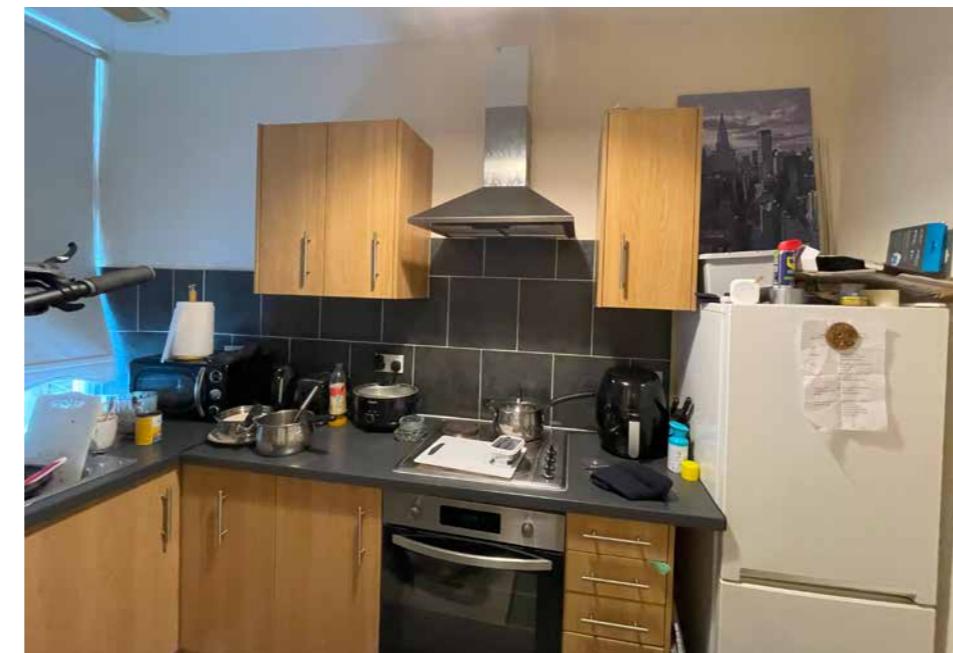
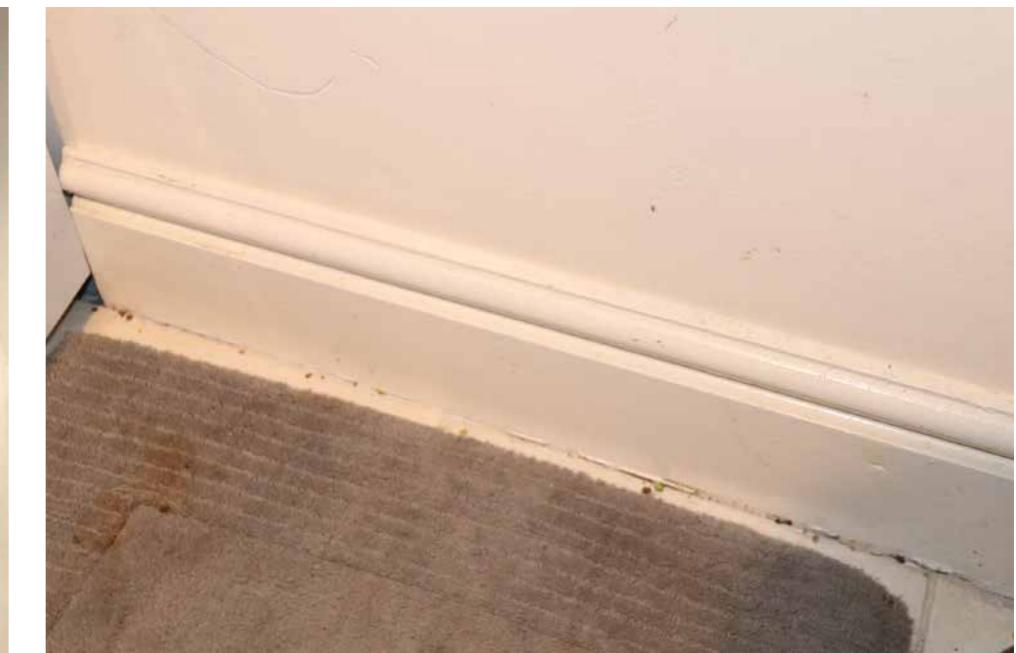
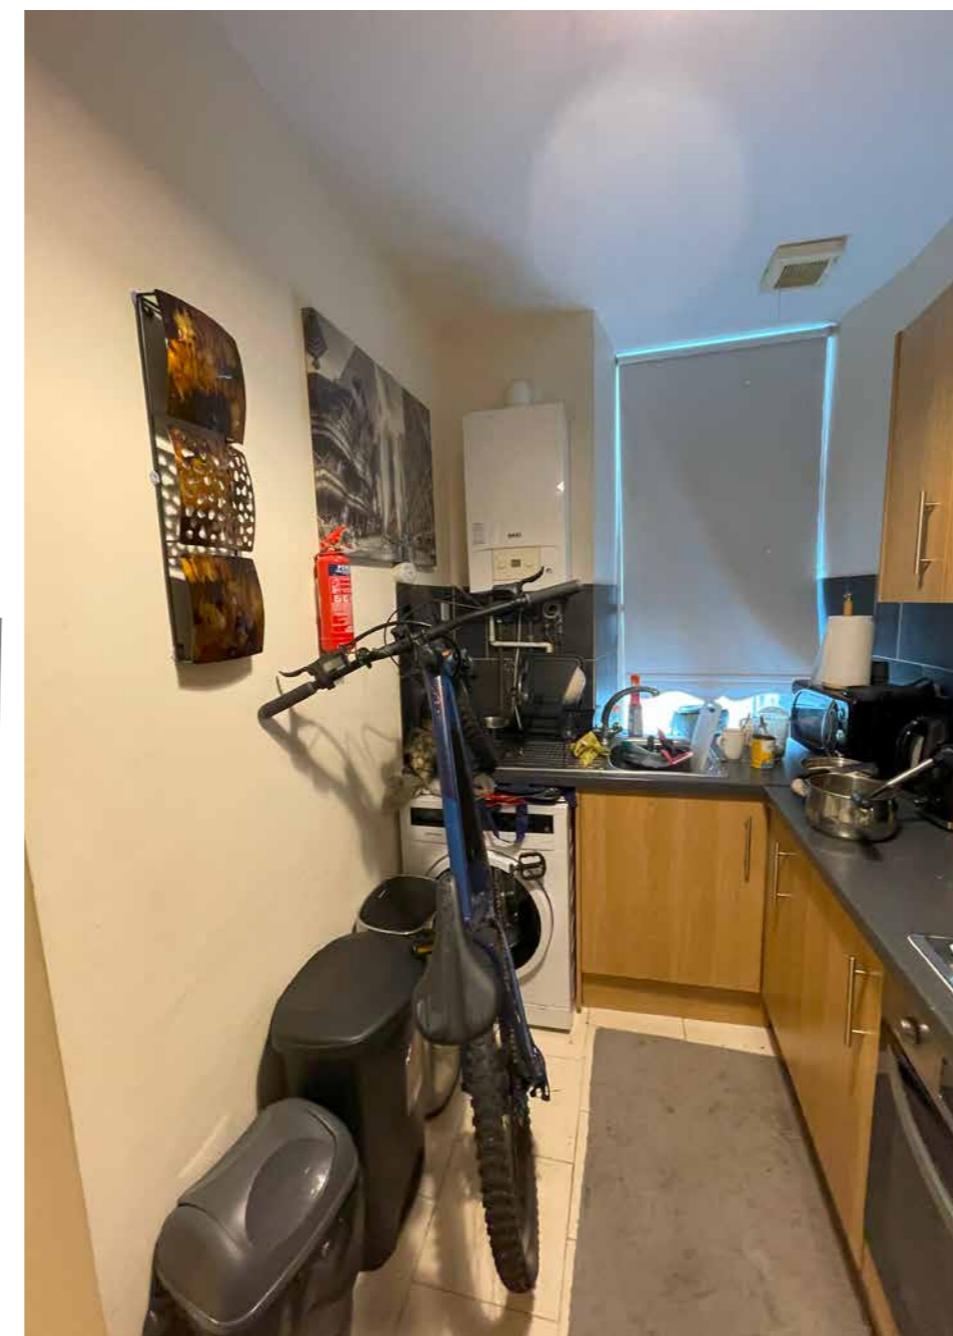
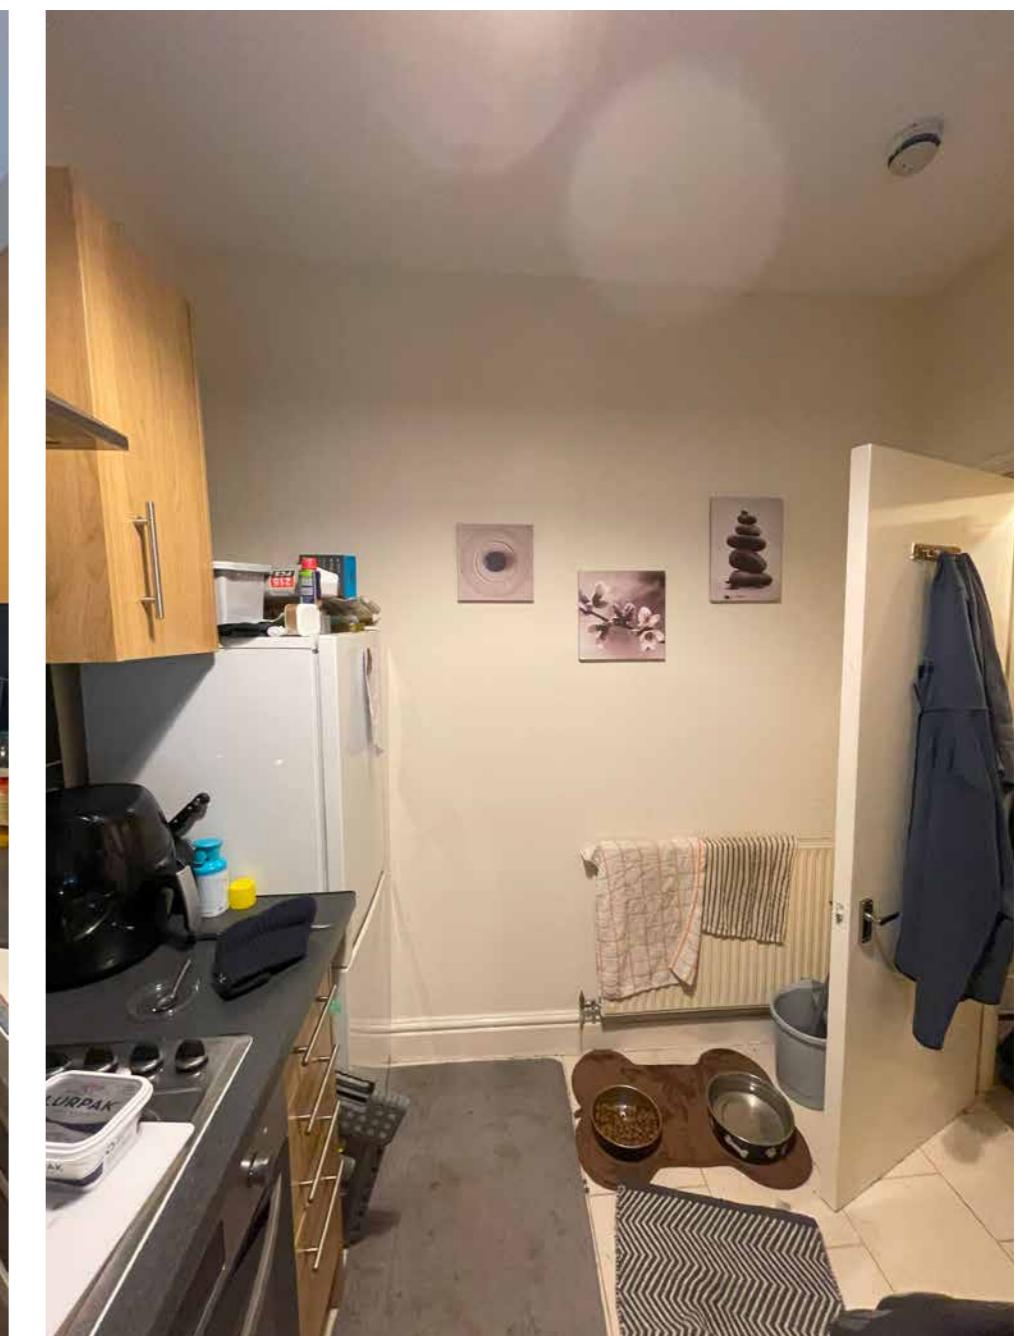
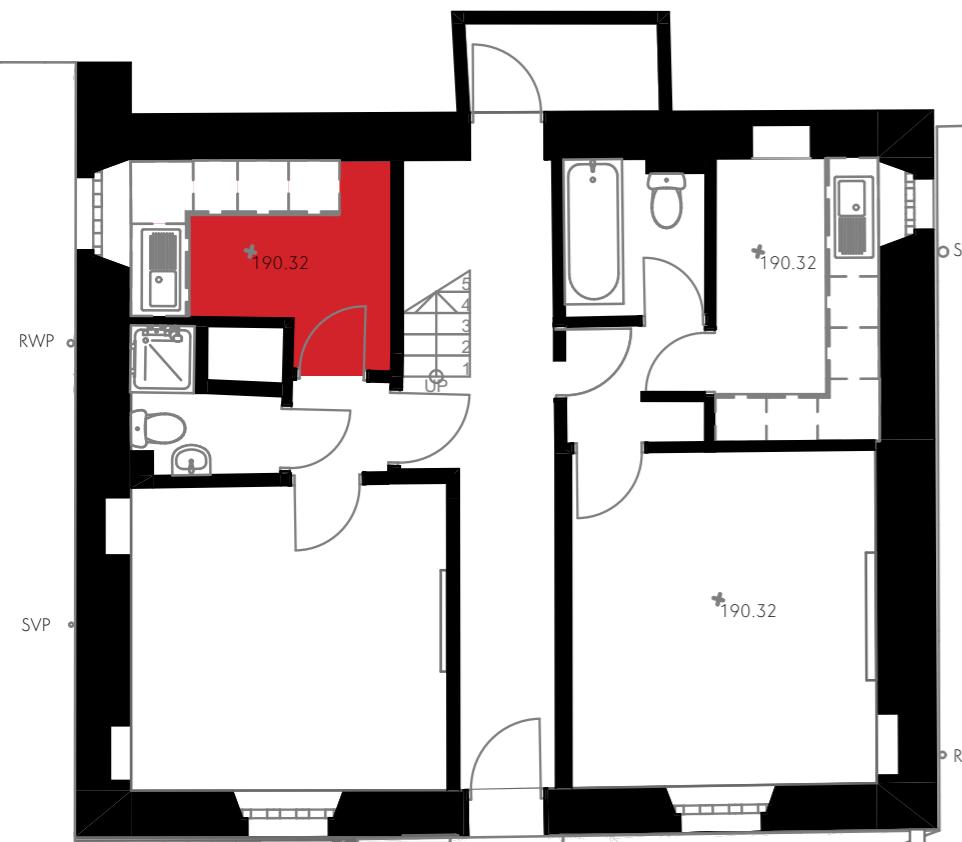
10.0 Interior - Ground Floor - Kitchen

With painted plastered walls and ceilings (again with no cornice), with some splashback tiling above the kitchen units, and a timber flush painted door, the floor to the kitchen is of ceramic tiling; and the window is timber-frame, single glazing. All appears to be in a reasonable condition.

The proposals replace the glass in the window with Slimline double glazing.
