Primrose Hill, Merthyr Tydfil

RECORD OF BUILDING AND CONDITION ASSESSMENT REPORT, WITH REPAIR PROPOSALS

.....(449)2503-GVWP-A-HIS-P01

Date: 05.03.25

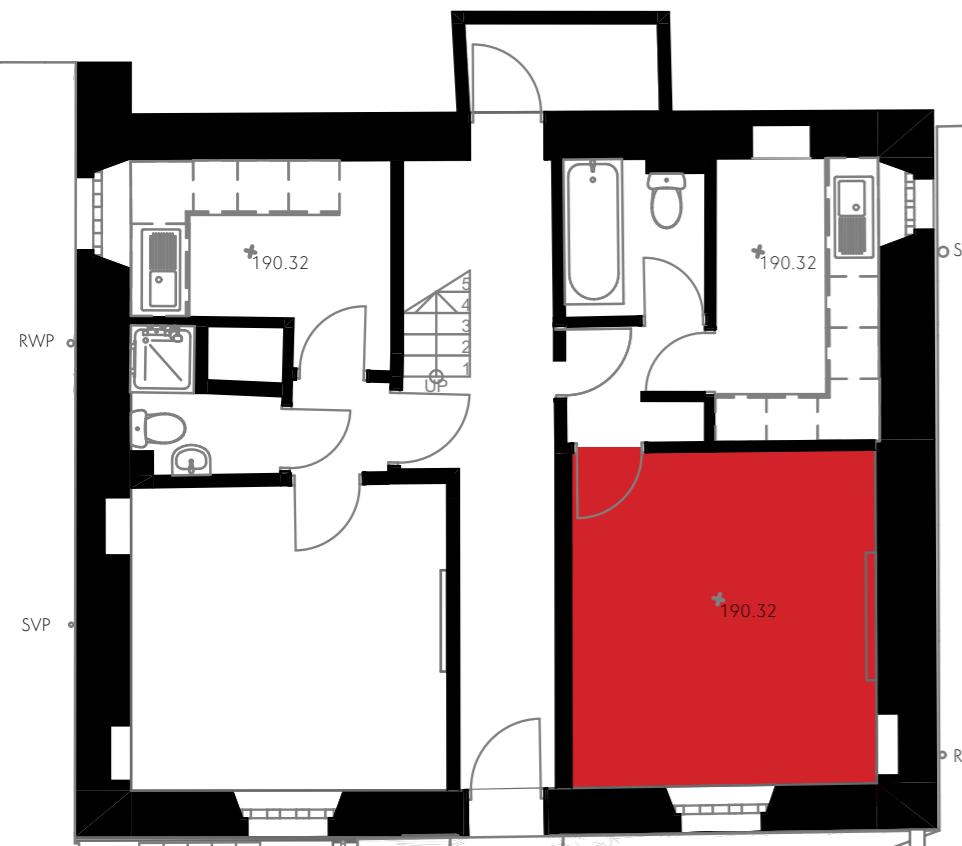
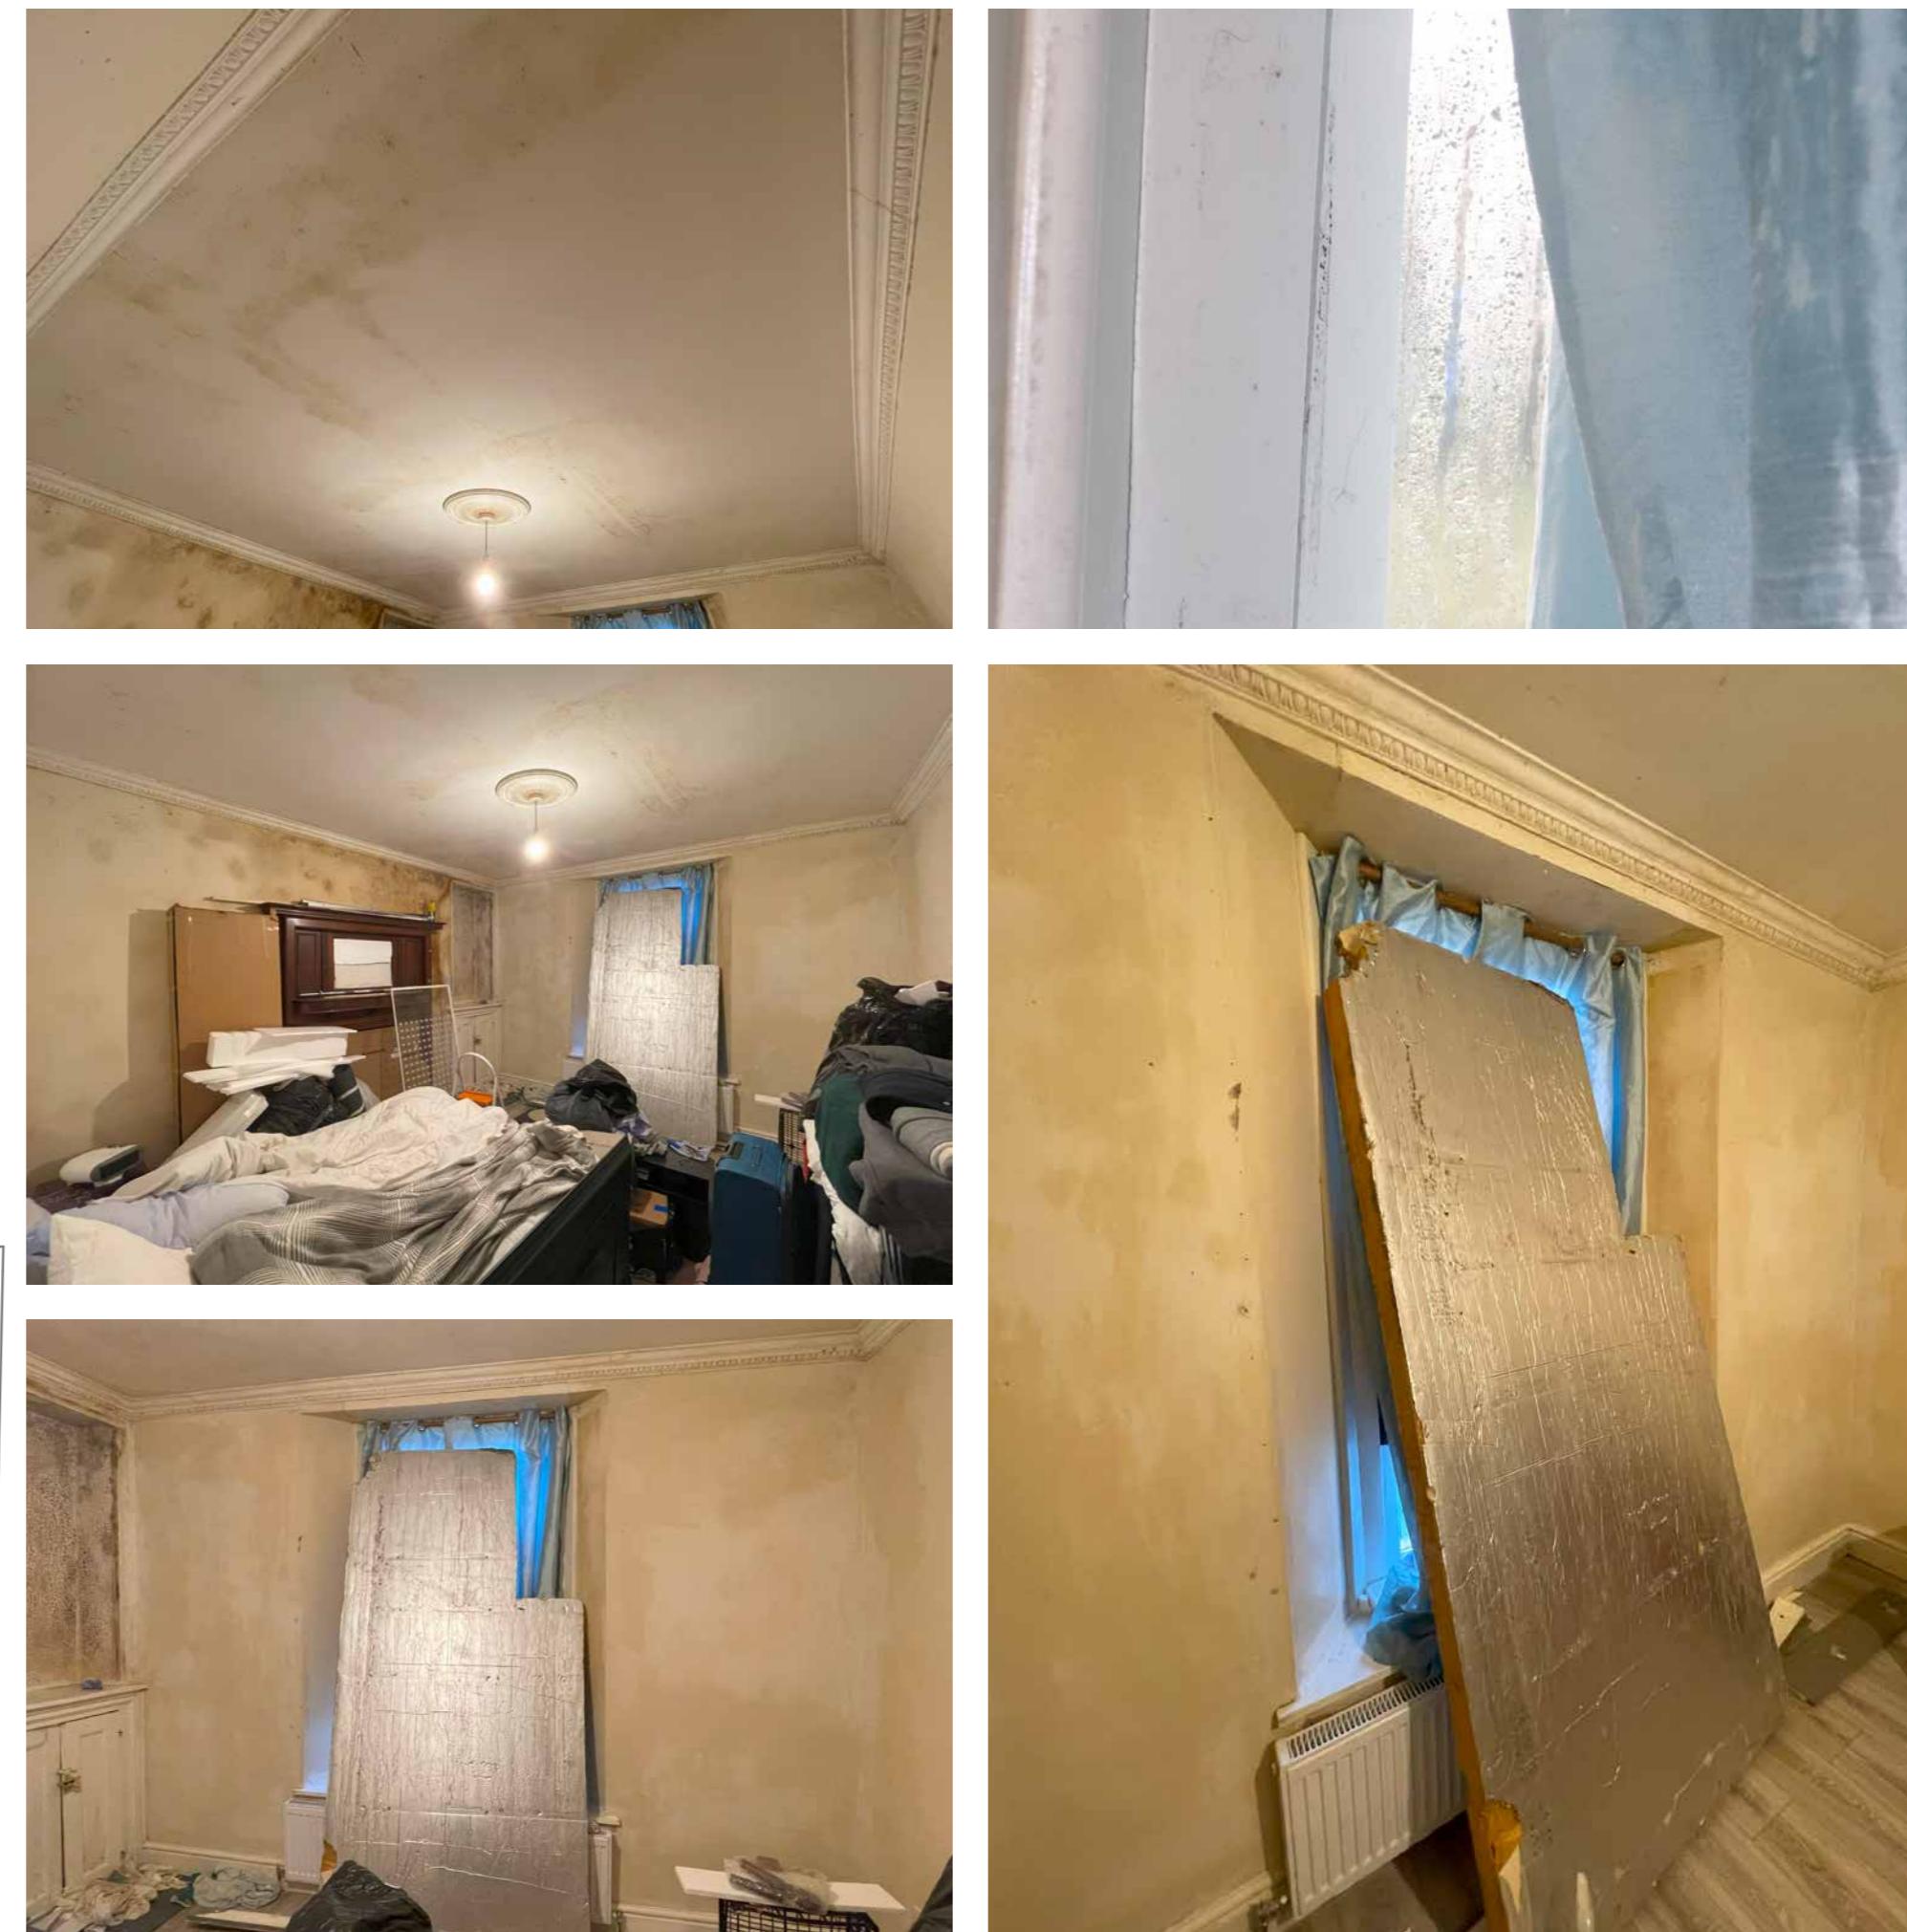
10.0 Interior - Ground Floor - East Flat Front Room

Whilst, also of painted plastered walls and ceiling, with egg-and-dart cornice and ceiling rose; this room and flat is coated with staining and wet - to walls and ceiling - and large areas of mould growth. One questions why this flat is so bad, whilst the matching flat on the other side is not. Indeed, the window is double glazed, and new. The proposals will involve removing all of the plaster and investigating the masonry behind. There could be defects in the walls; there could be cold-bridges; there could be damp coming in from outside and, unable to escape, it has saturated the walls, causing damp conditions internally. However, the level of condensation in this flat is extremely high - note the water streaming down the window, which is new and double-glazed. One feels that part of the problem may be with the tenant's living habits. There appears to be no background heating on (we were advised that the boiler did not always work); it does not look like the windows were often opened to ventilate the space; insulation had been applied to the inside face of walls (thereby stopping any warmth getting into the walls and drying them out); and it looked like washing was regularly dried in the space and cooking a regular thing, with questionable hood ventilation.

There may well be an issue with the walls; they may well be holding moisture unable to escape due to the cementitious render and gypsum plaster; there may well be gaps in the construction and/or cold-bridges. This will all need to be investigated once the render and plaster is off. However, there is also poor heating (maybe none), poor ventilation (arguably none) and a lot of moisture-producing activity inside. We are also aware that the tenants regularly clean down the walls. This may also be adding moisture into the plaster.

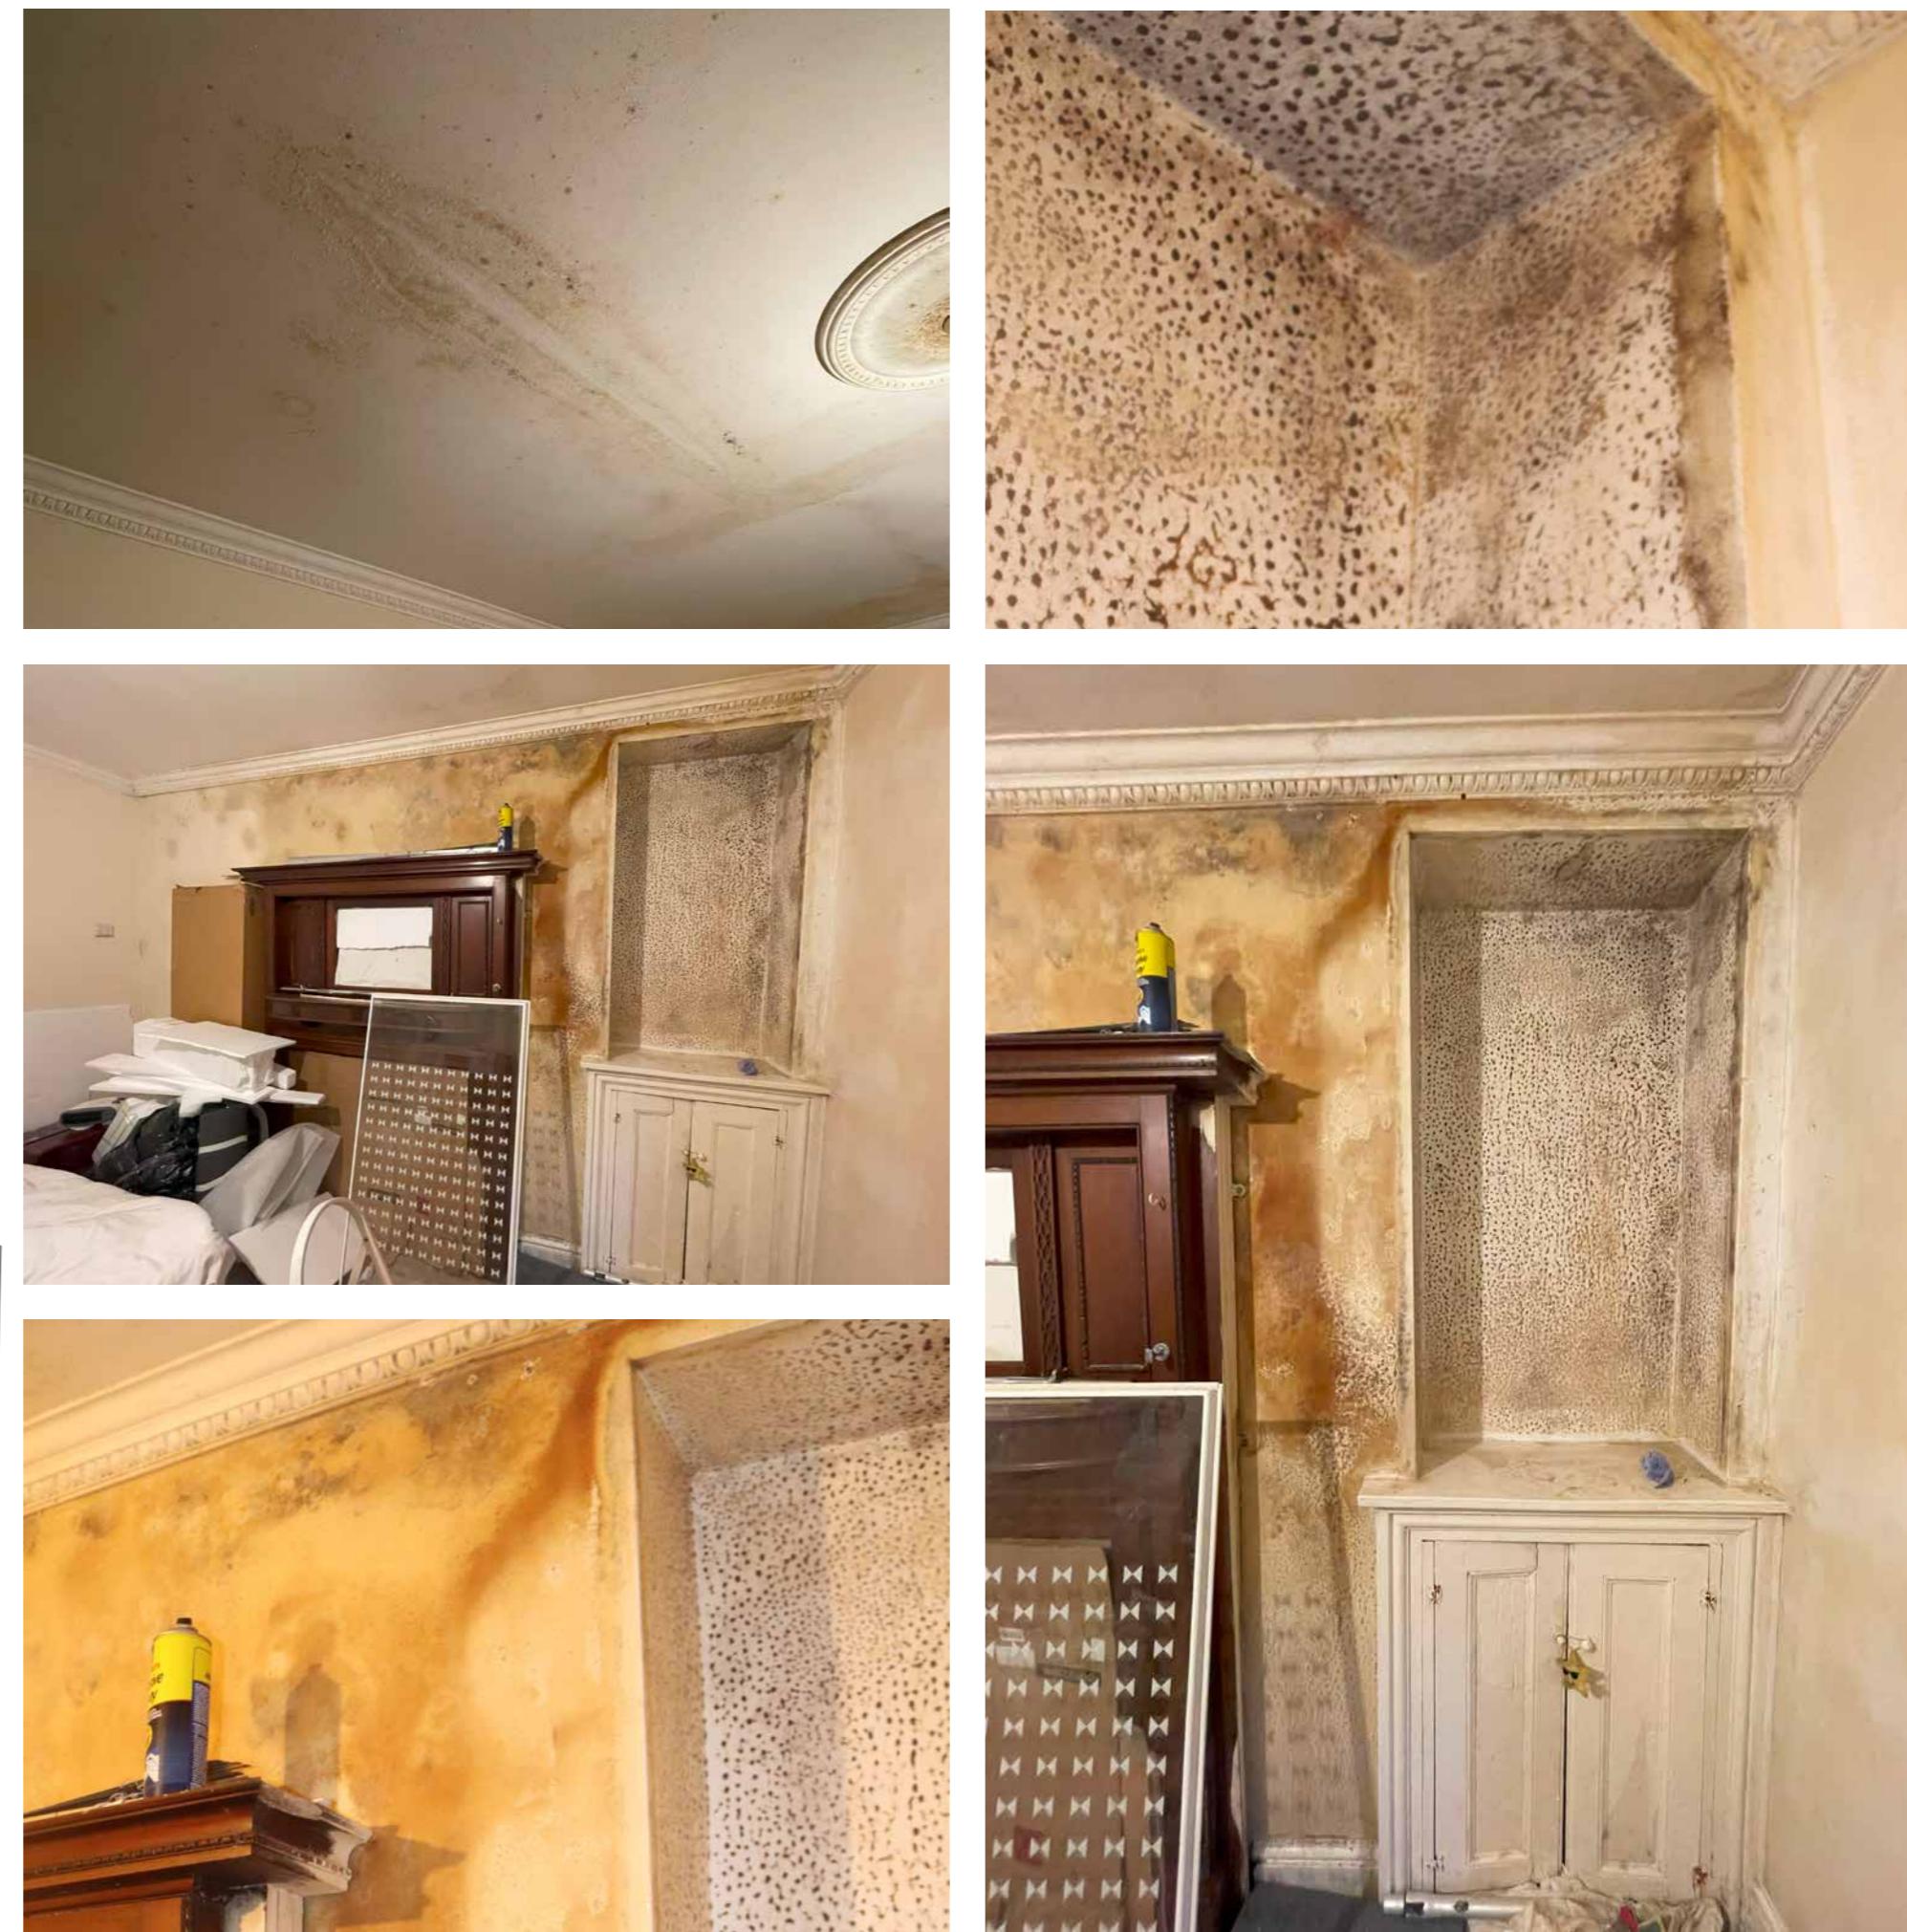
10.0 Interior - Ground Floor - East Flat Front Room

These photos are of the west wall to the room, facing the 'right of way' path, one the wall with roughcast cement render. The staining is awful around the fireplace particularly. It is orange in colour. It appears as though the fireplace is blocked up at this point, which is not ideal. However, to make this worse, at some time in the past, the chimneys appear to have been removed. This means that there may be no air movement / ventilation within the chimney breast and flue. As a result, the stale and stagnant air within the flue, holding old soot and 'nasties', is not ventilated out of the fabric, as intended; and so it sits there, reacts with moisture within the masonry, and is drawn, hygroscopically, through the masonry to the surface and stains the plaster an orange colour, and potentially leads to mould growth and noxious odours. The more moisture the wall holds, the worse the reaction. This soot can also badly damage the masonry itself.

Also, to the right of the fireplace is a recess. This is caked in black mould deposits. It is probable that this is so bad because the thickness of the wall in this area is much less than the rest of the wall; and so there is a greater cold-bridge to the outside and, hence, this is a colder part of the wall, which condensation would immediately move towards.

Once the plaster has been removed and the wall allowed to dry out, the proposals involve incorporating a vent in the face of the fireplace and a vent at the top of the roof, where the chimney used to be. Thus, some ventilation can be reintroduced into the flue.

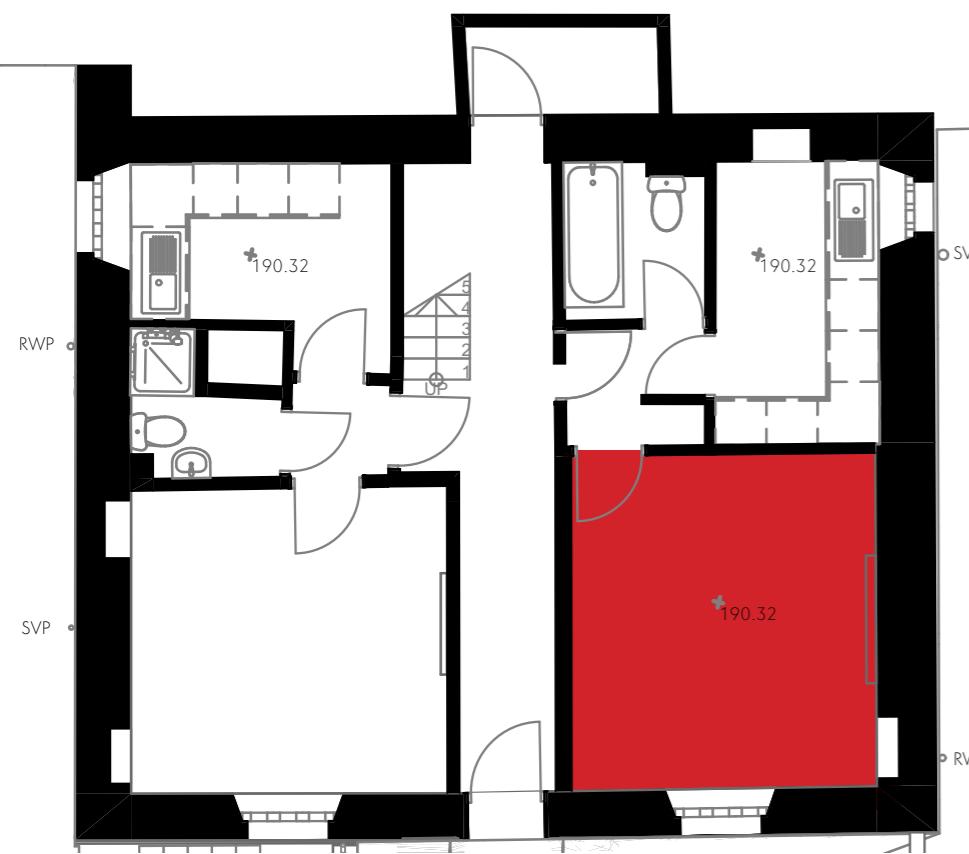
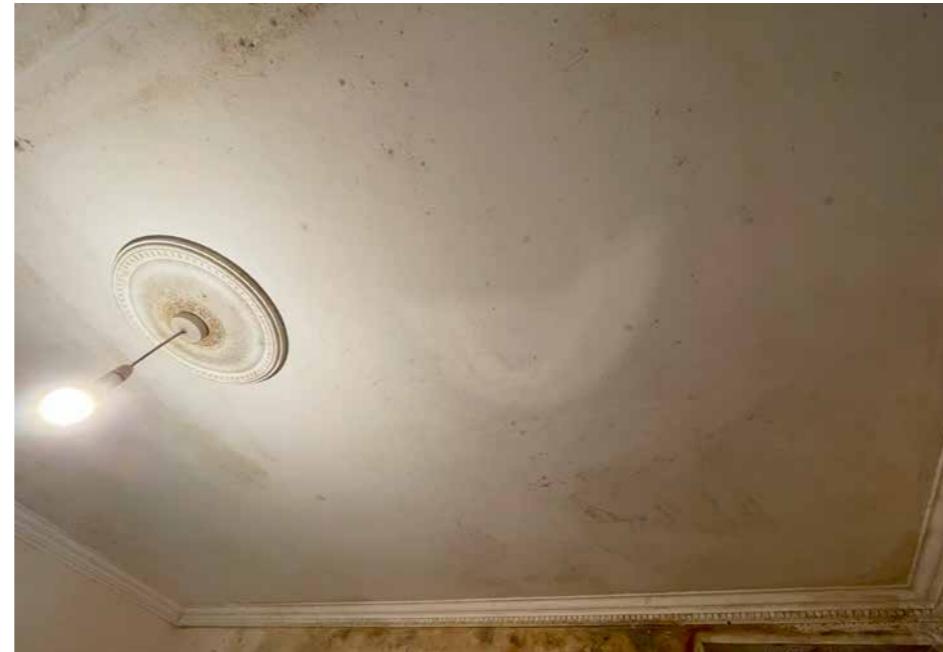
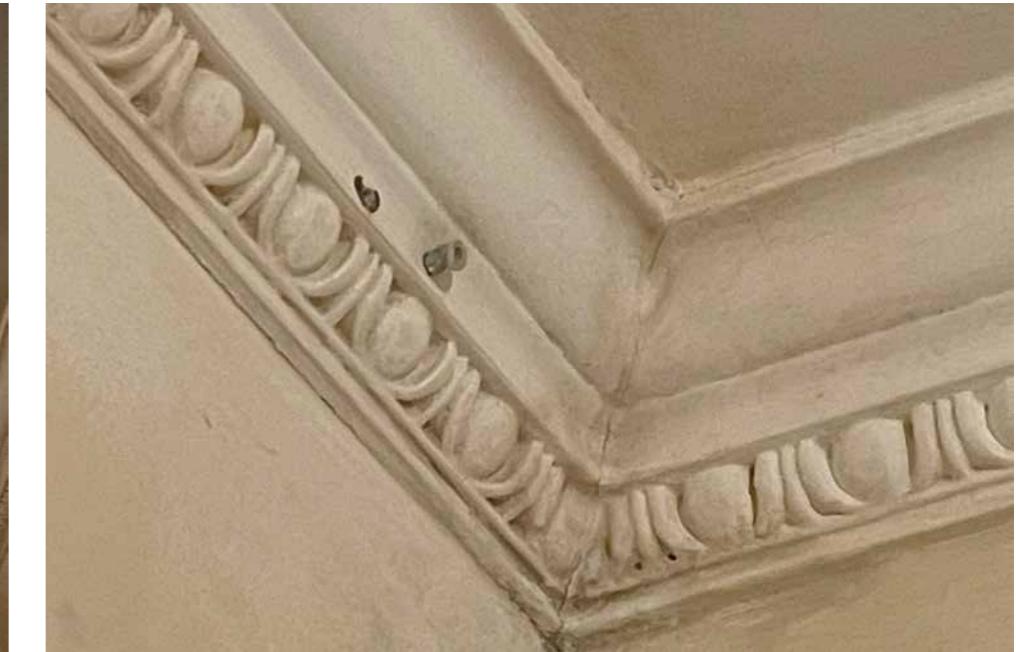
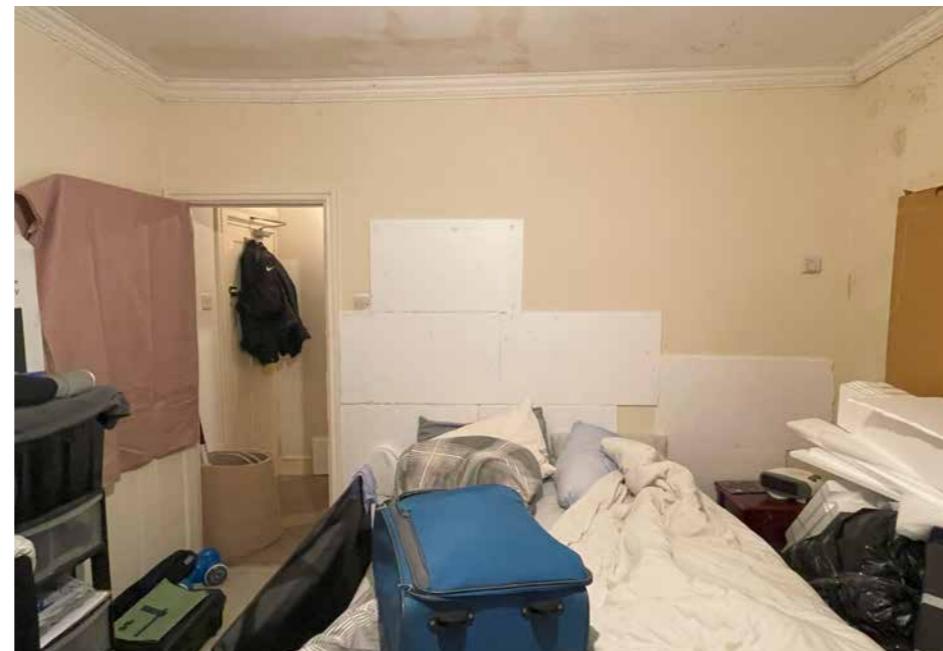
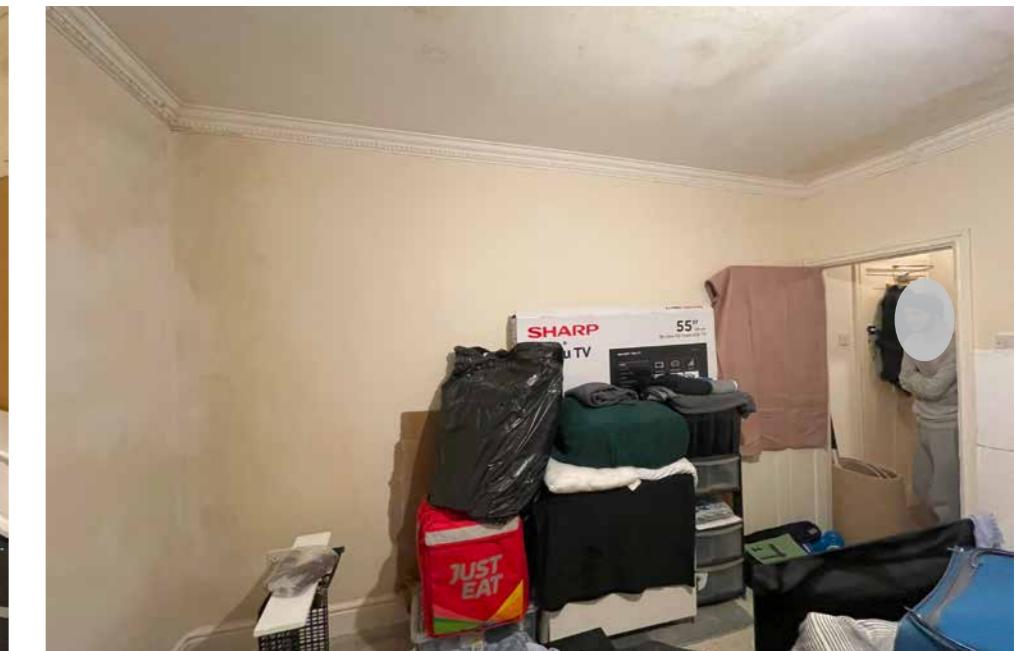
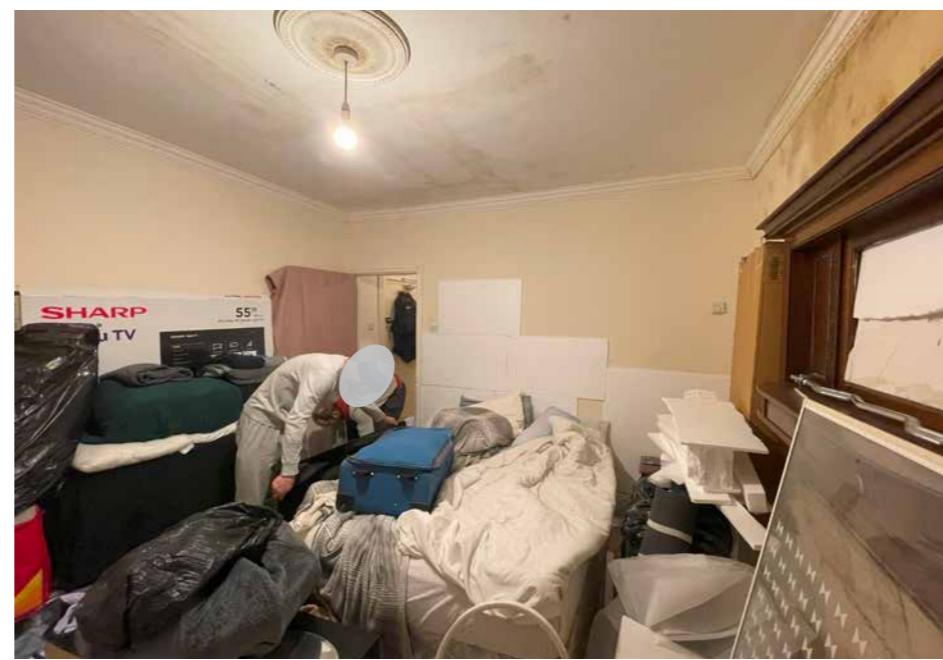
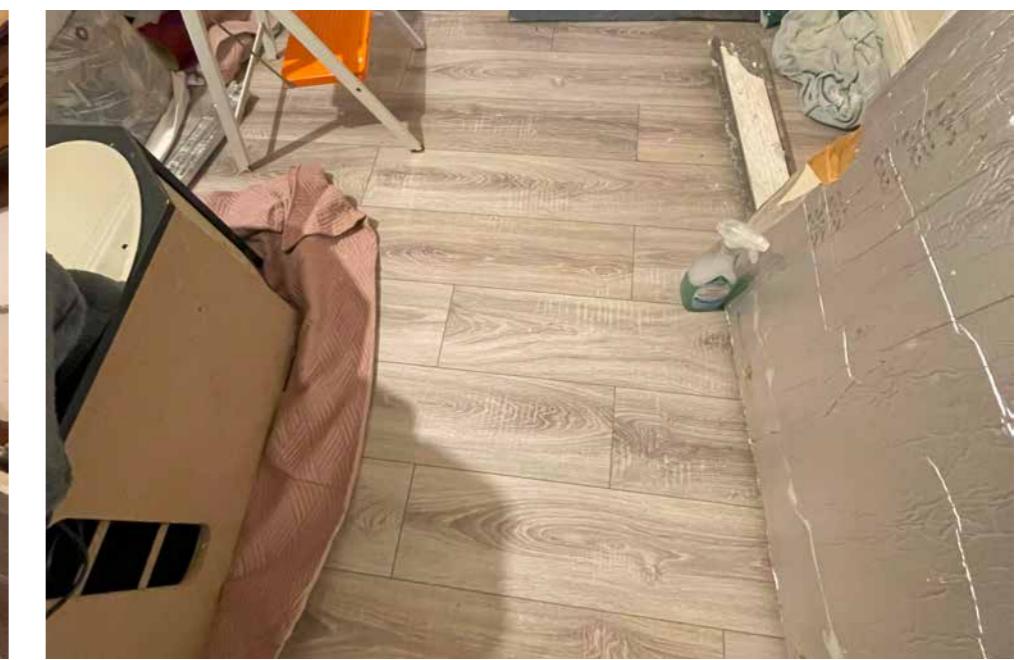
10.0 Interior - Ground Floor - East Flat Front Room

The floor to this room is a vinyl.

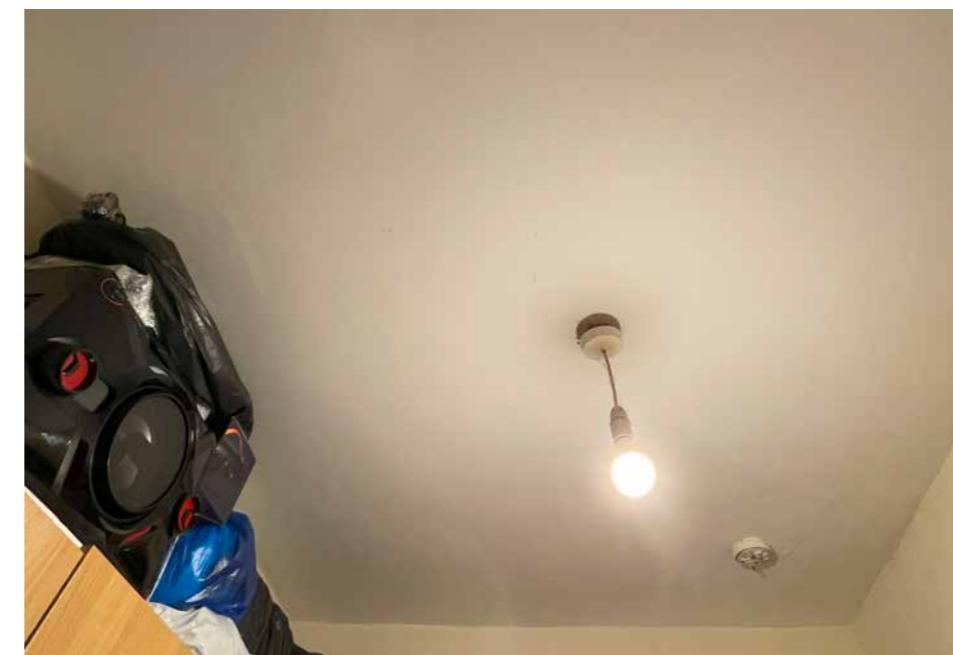
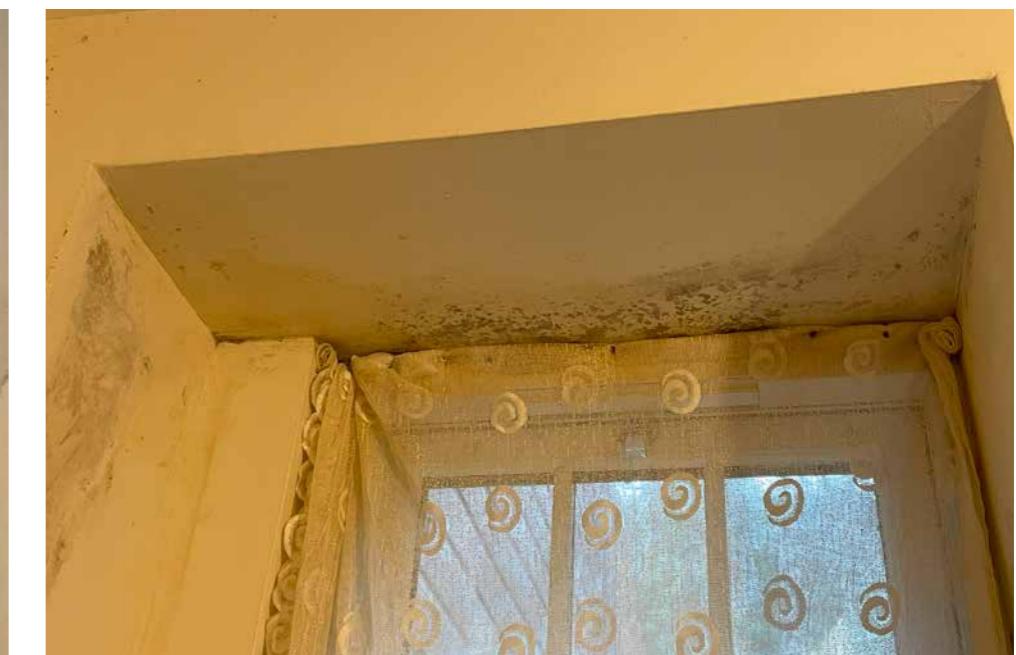
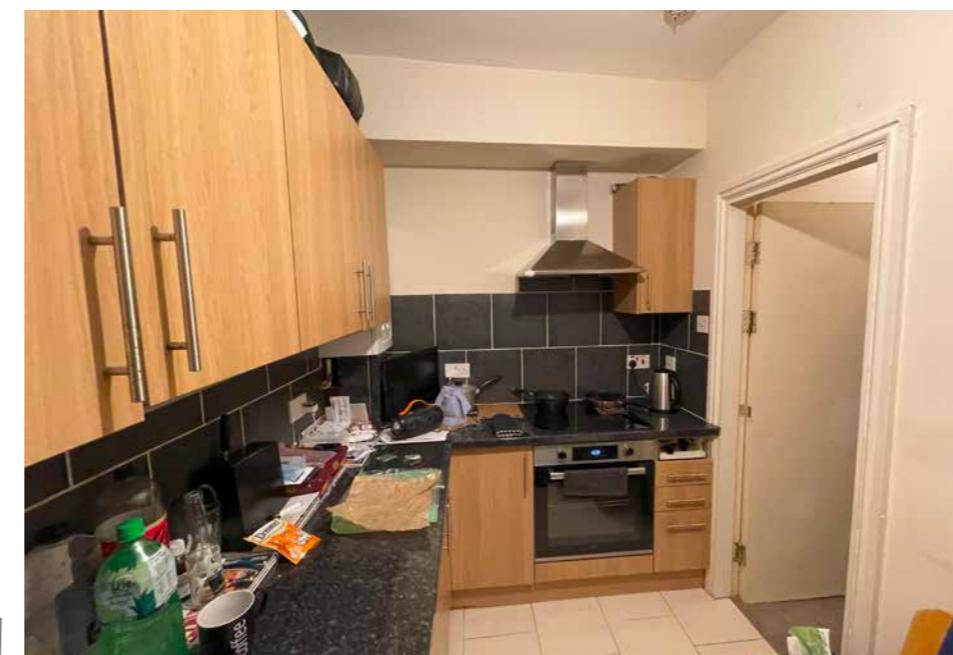
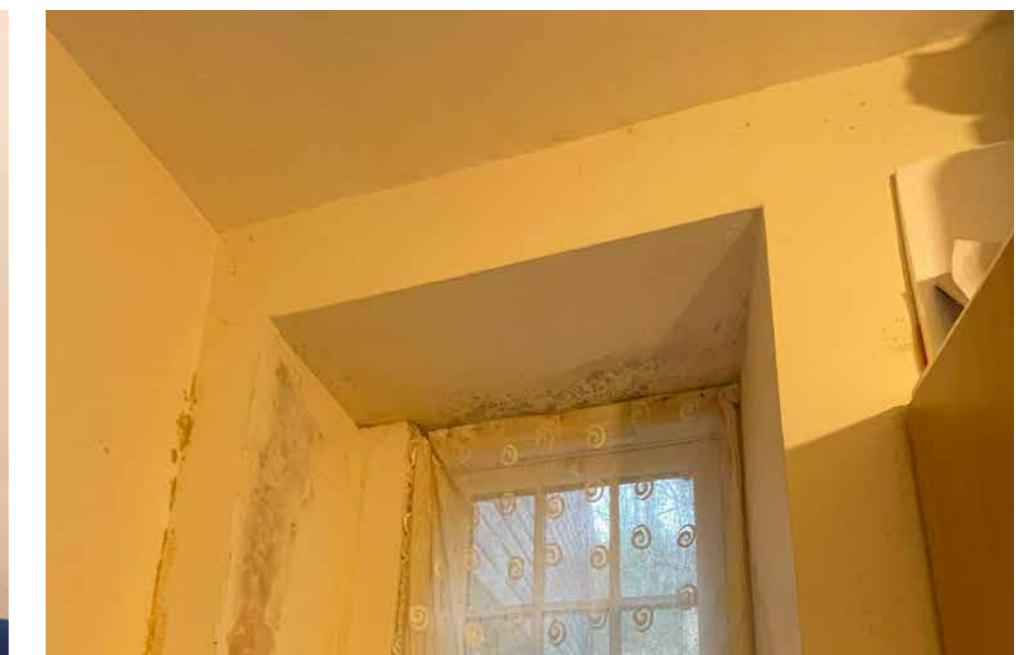
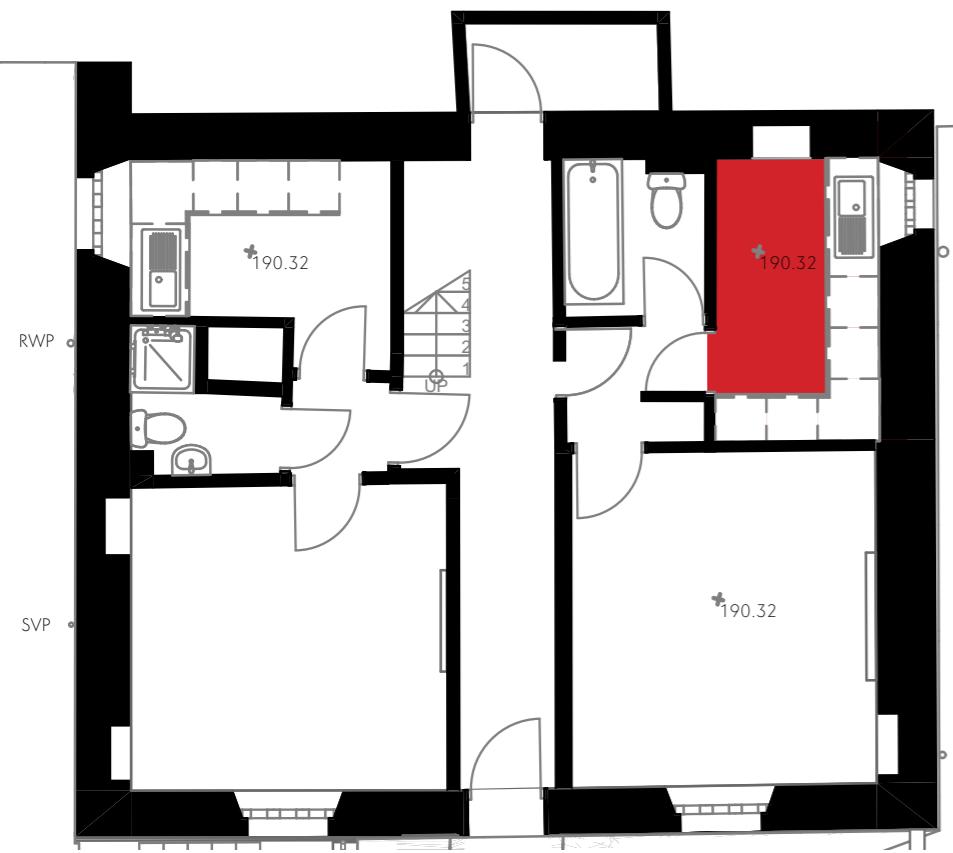
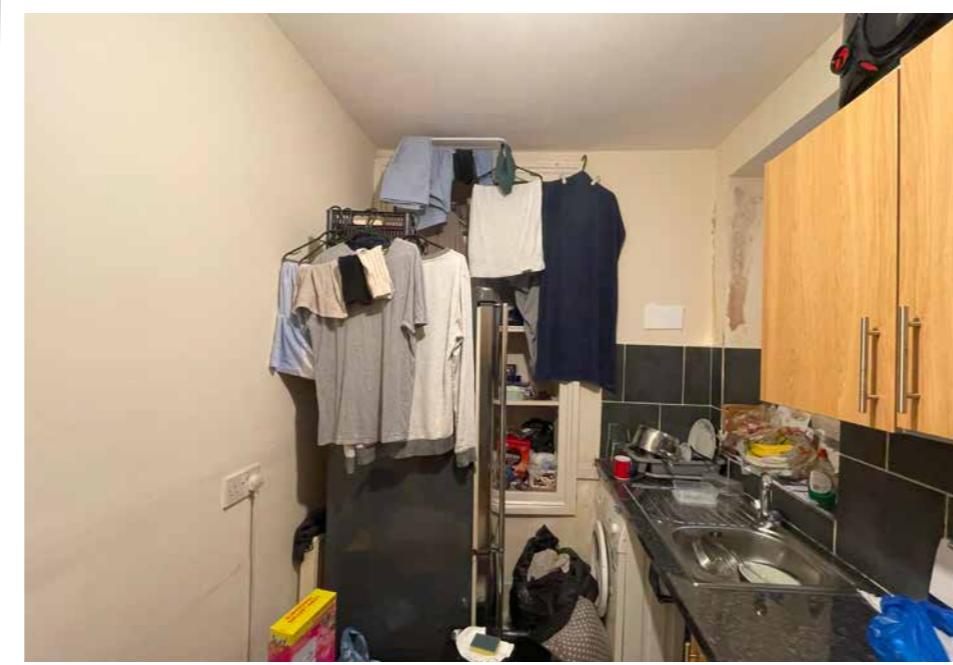
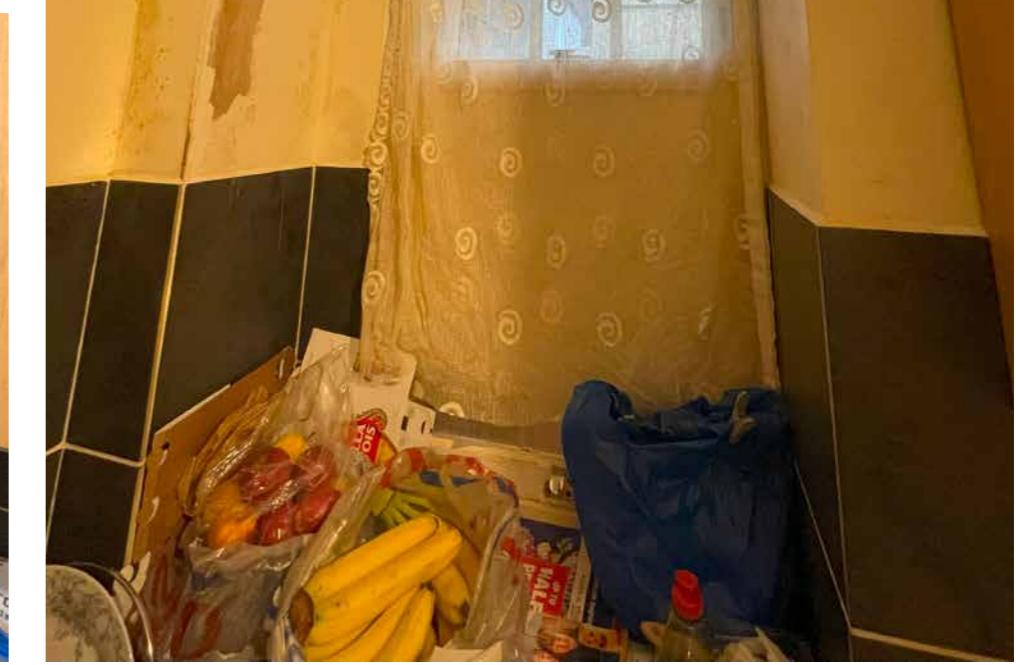
10.0 Interior - Ground Floor - East Flat Kitchen

The kitchen is of the same painted plastered walls and ceiling (with no cornice), a ceramic tile floor and a flush timber door. The kitchen walls are also covered with ceramic tiling and kitchen units, which means that it is not possible to see whether there is also bad mould and saturation behind the tiles and units. However, there is clearly mould around the window head (which used to be a door), which suggests a cold-bridge at the lintol.

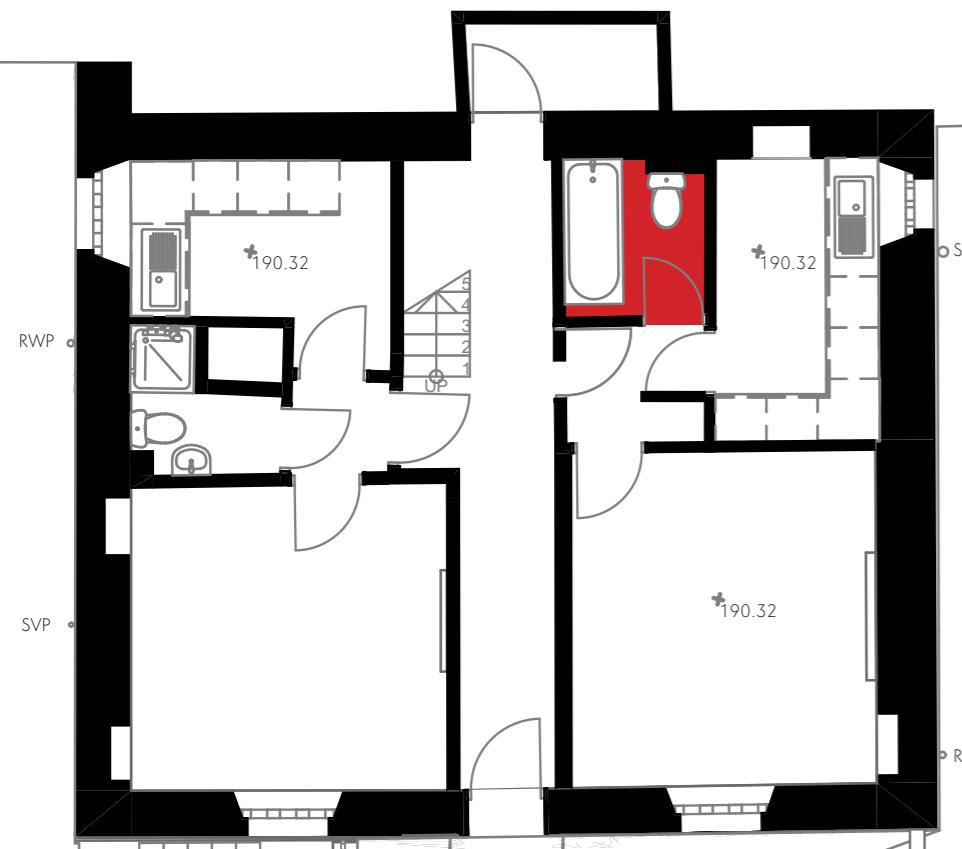
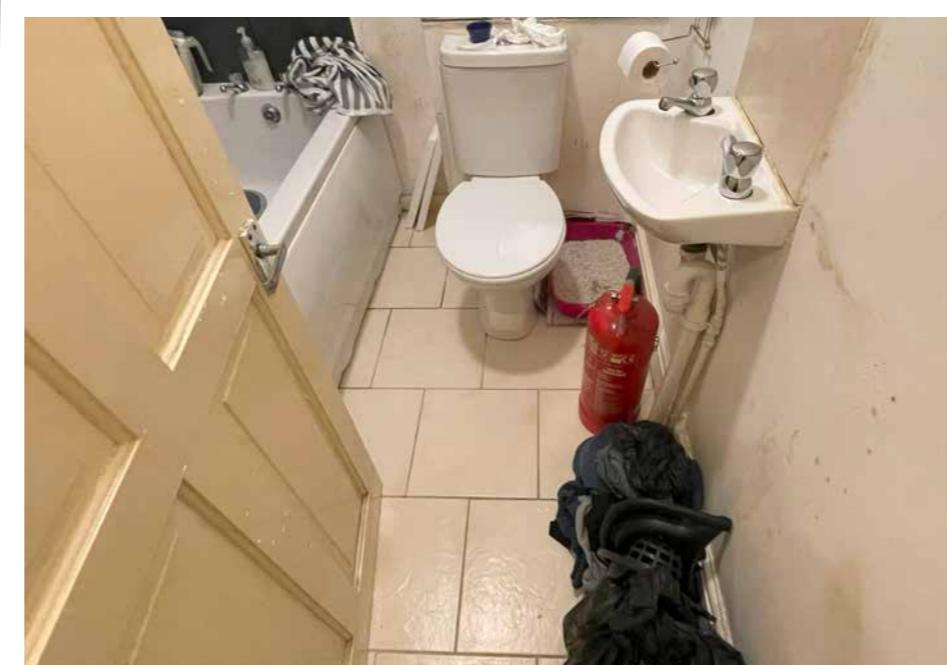
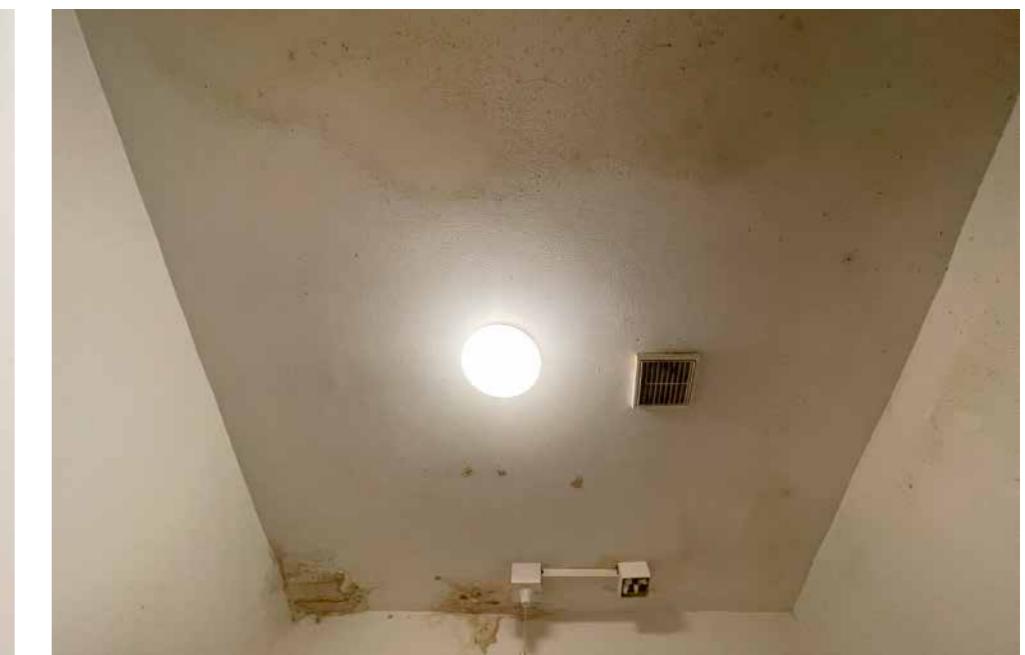
10.0 Interior - Ground Floor - East Flat Bathroom

The bathroom is of the same painted plastered walls and ceiling (with no cornice), a ceramic tile floor and a timber four-panelled door. The walls are also covered, in part, with ceramic tiling, which means that it is not possible to see whether there is also bad mould and saturation behind the tiles. However, there is clearly mould to all of the walls and the ceiling.

There is a vent in this room; however, that is inefficient and insufficient for removing the moisture produced in this room. As a result, the moisture is condensing on the walls and causing mould and staining.
