Primrose Hill, Merthyr Tydfil

RECORD OF BUILDING AND CONDITION ASSESSMENT REPORT, WITH REPAIR PROPOSALS

.....(449)2503-GVWP-A-HIS-P01

Date: 05.03.25

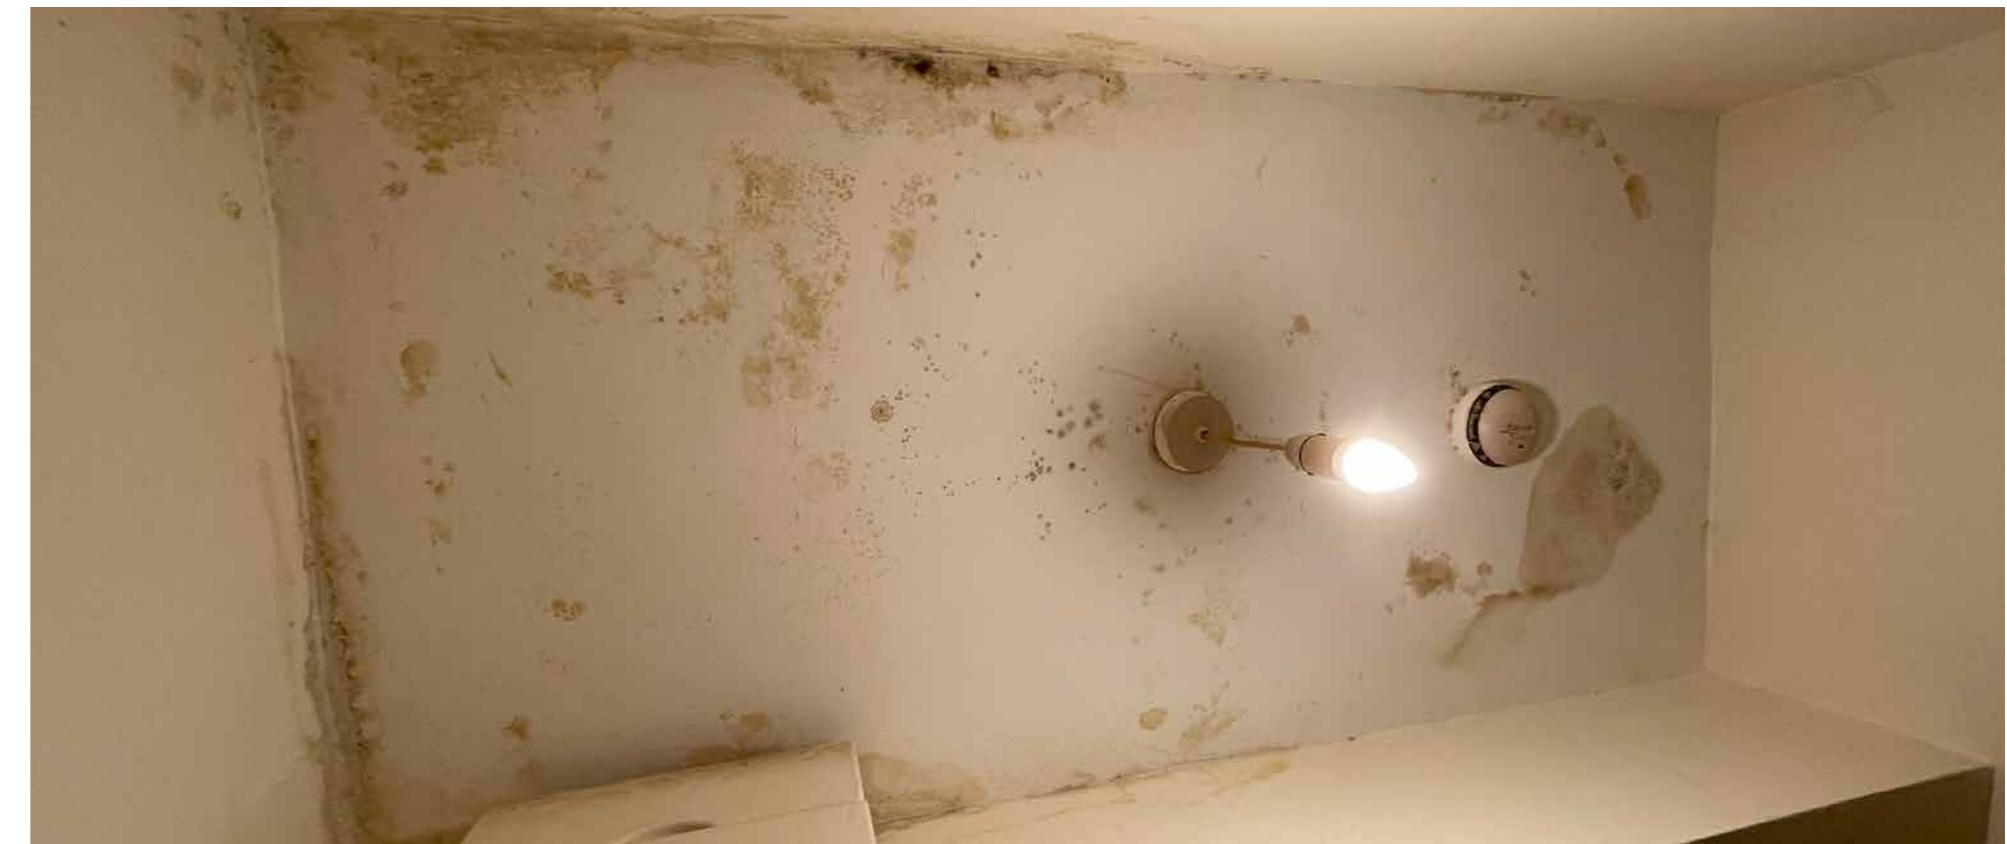
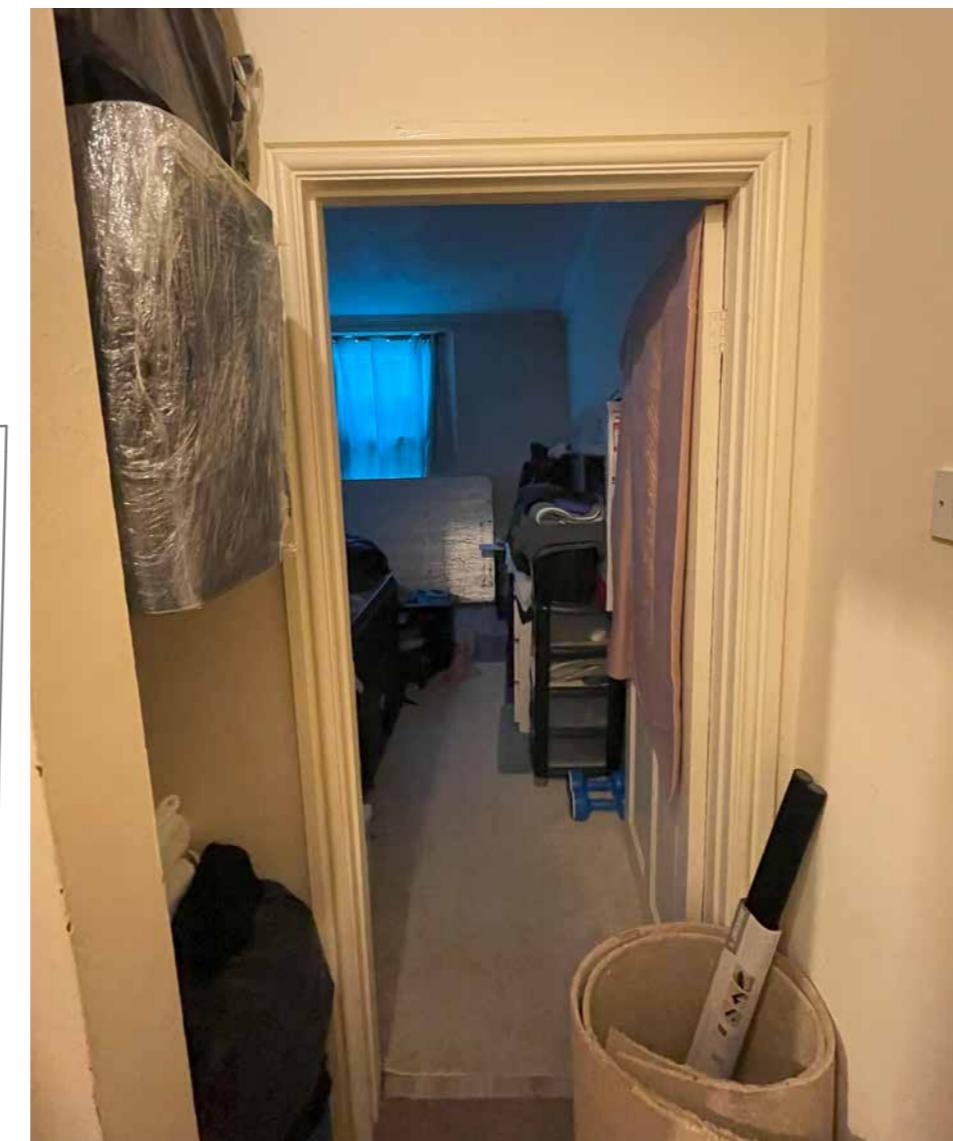
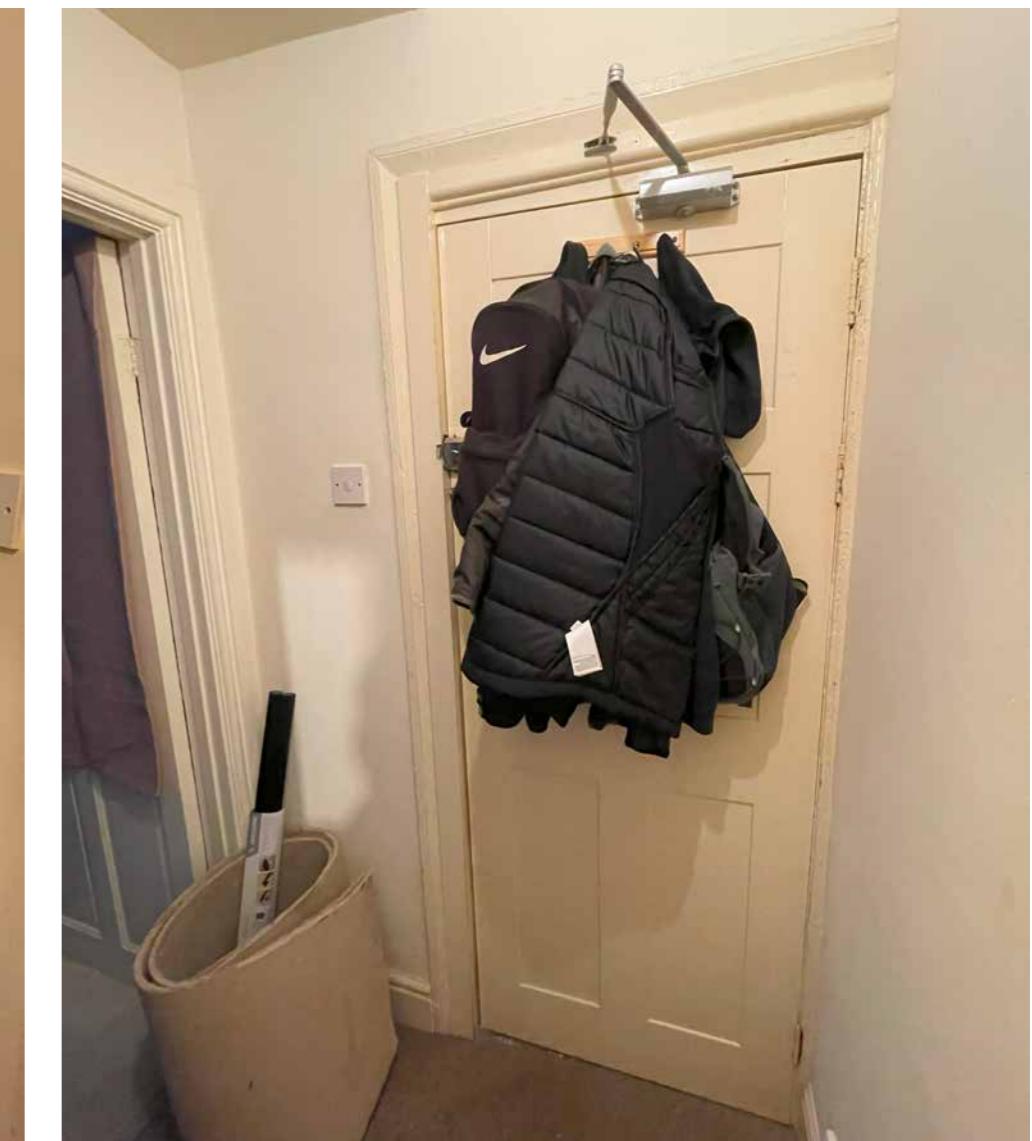
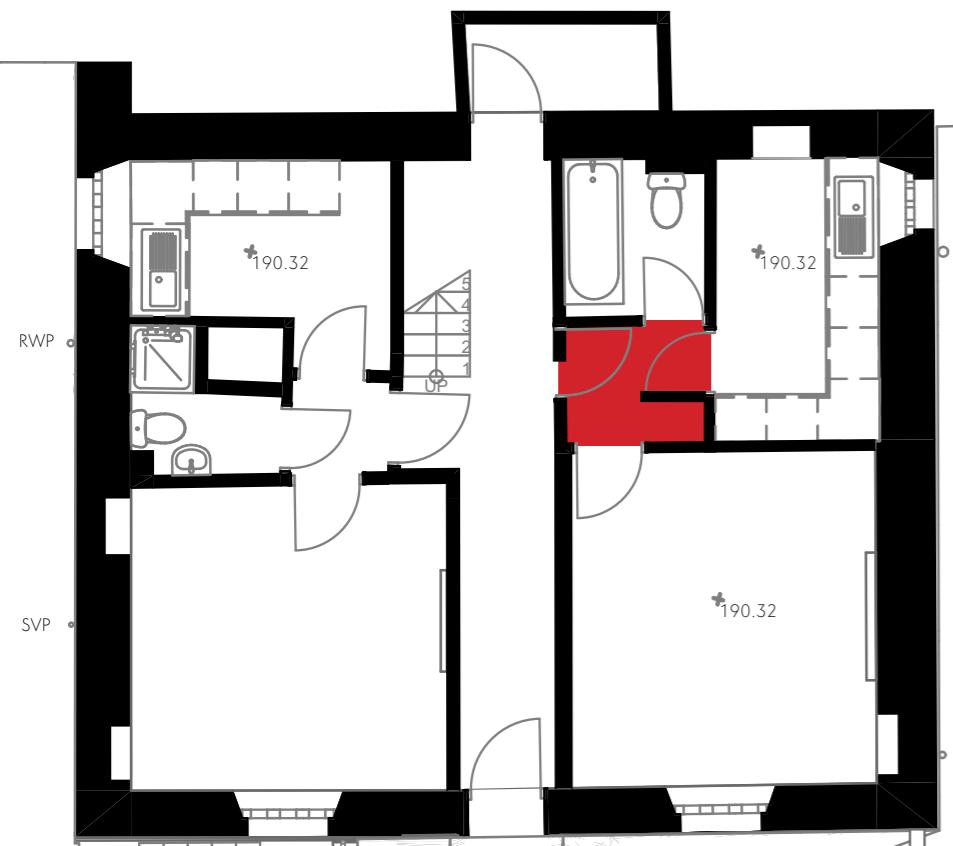
10.0 Interior - Ground Floor - East Flat Lobby

There is no obvious sign of significant staining and mould on the plastered walls to the lobby; however, it is very bad at the plastered ceiling. There is no means of ventilation in this space (which collects moisture from the bathroom, kitchen and bedroom) and no apparent means of heating. As a result condensation is not controlled.

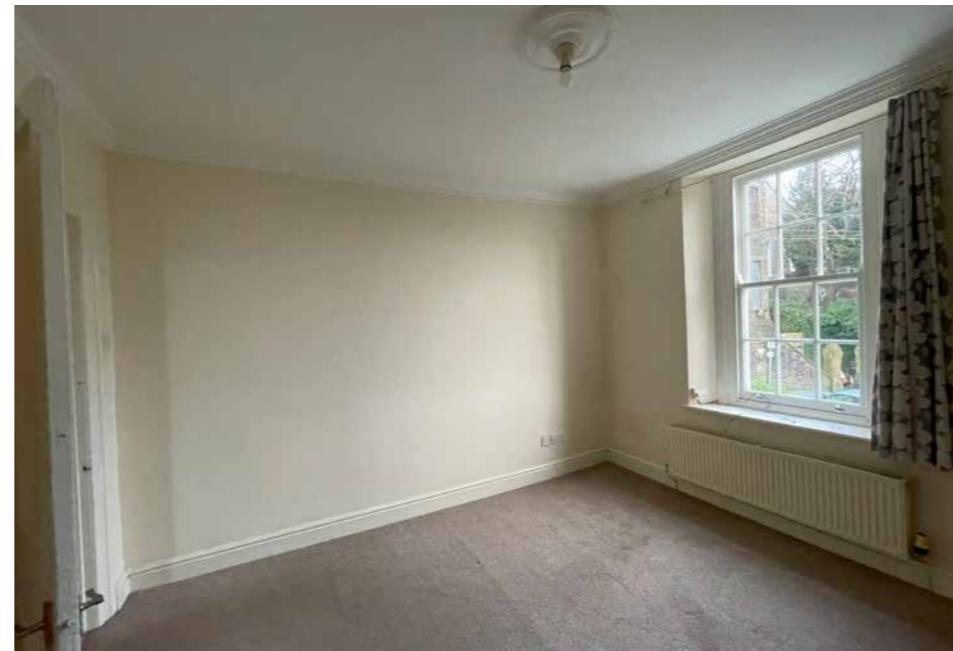
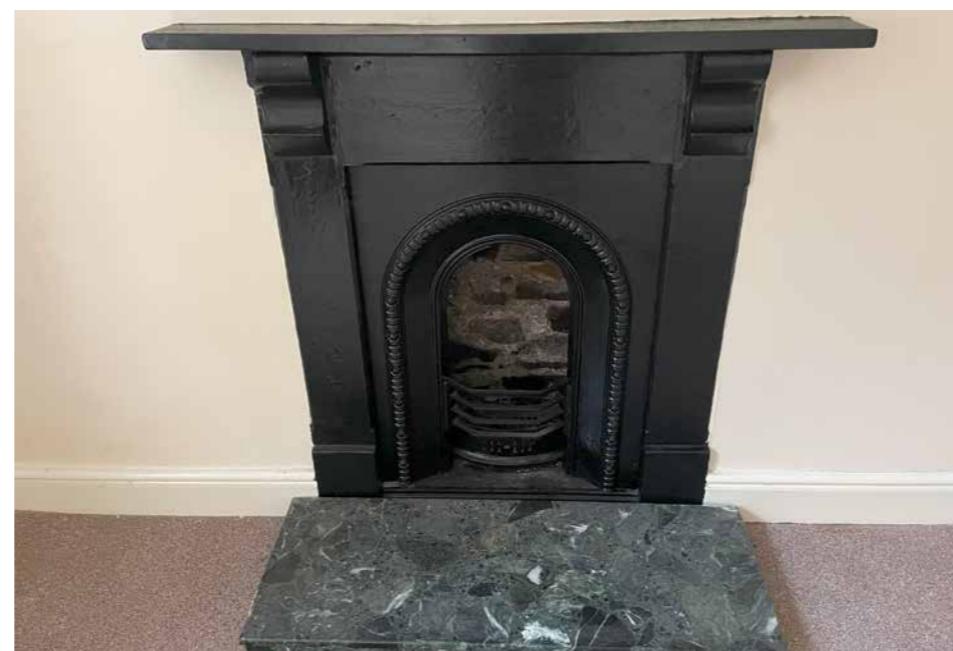
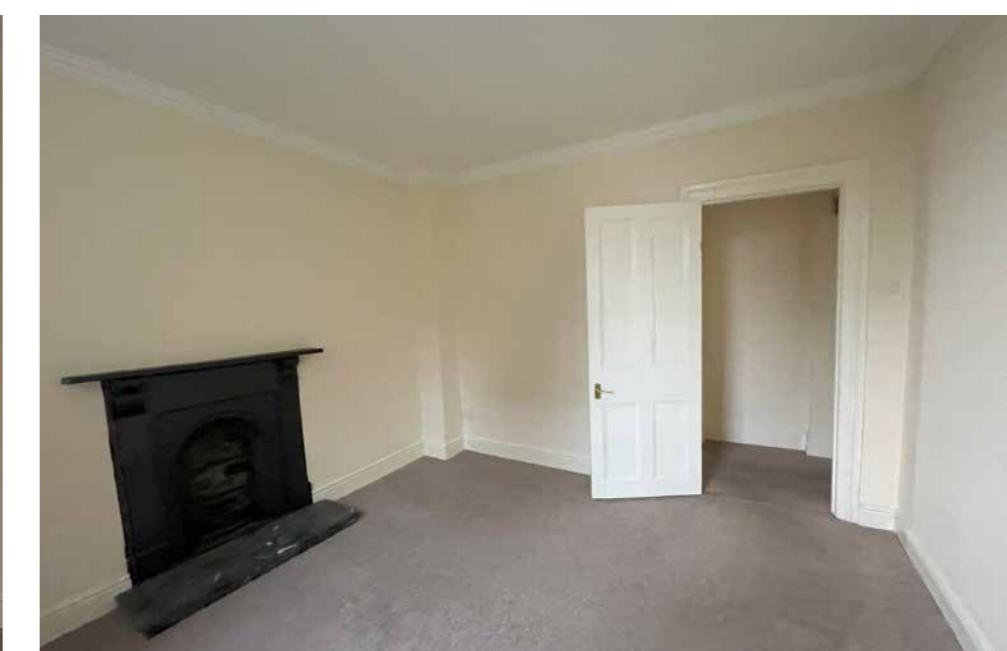
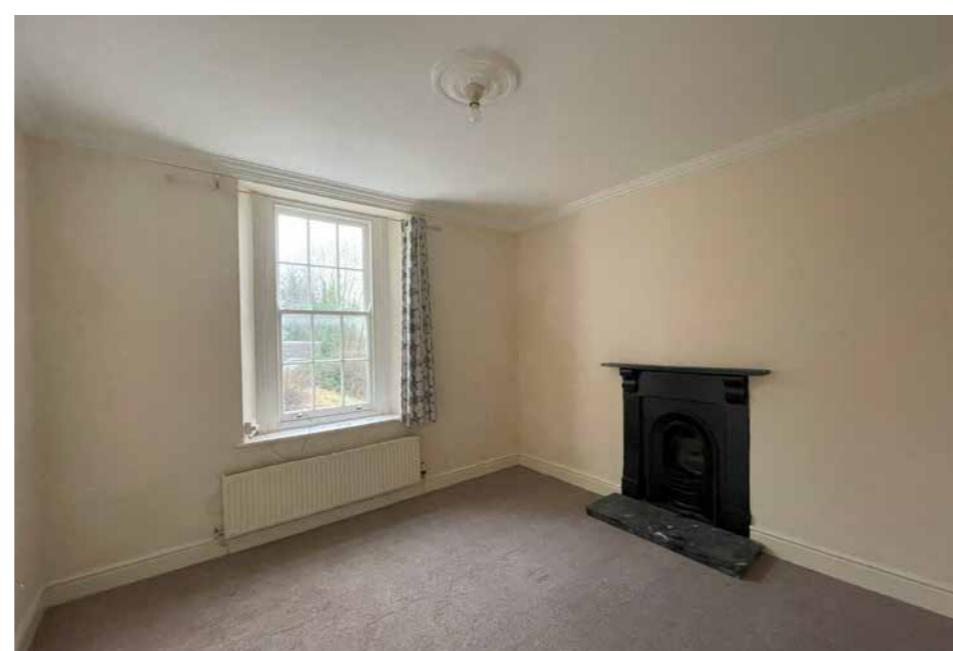
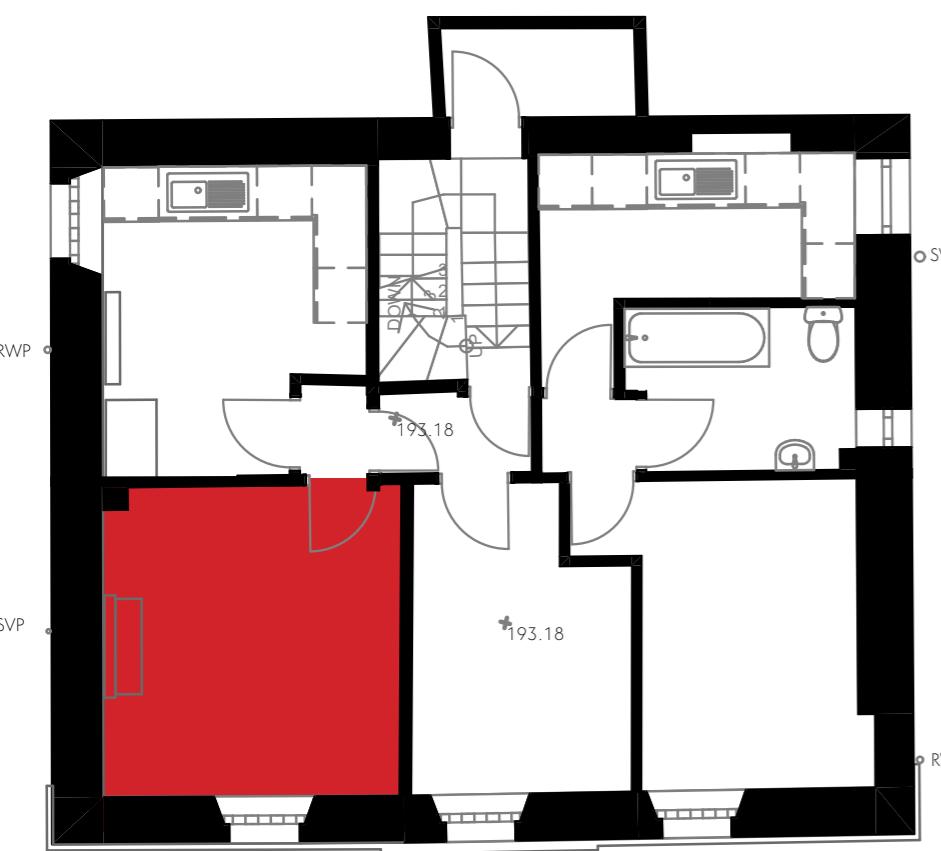
11.0 Interior - First Floor Flat - South West Room

This front room is of painted plastered walls and ceiling with a moulded cornice and a ceiling rose. The floor is carpeted; the door is a painted four-panelled timber door and the window a painted timber sash window with double glazing. The internal partitioning appears to be of plasterboarded timber studwork. There is a timber and metal fireplace surround and marble hearth. The brickwork of the wall is apparent within the fireplace.

All appear to be in a reasonable condition.

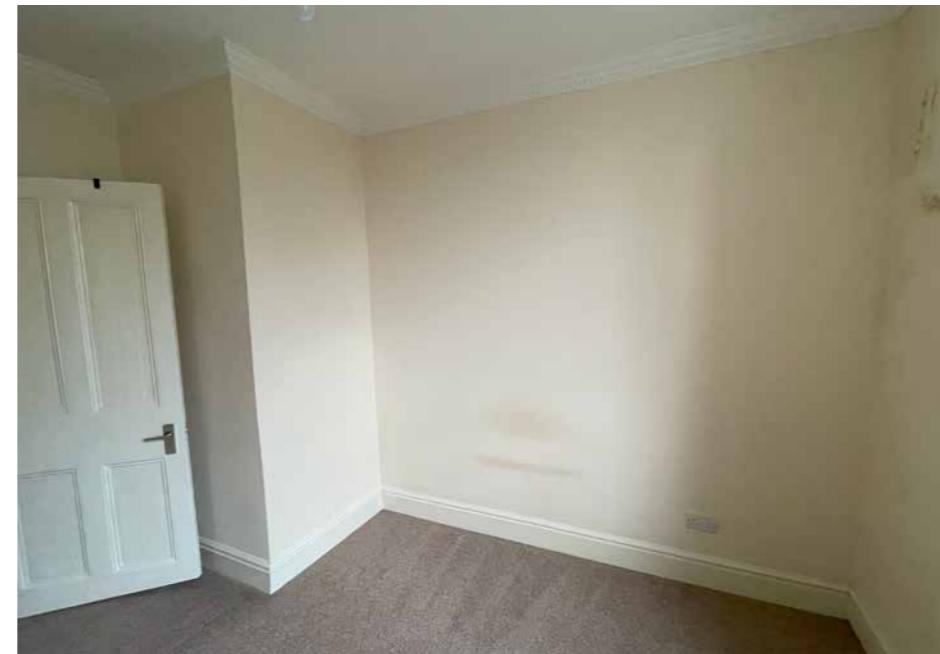
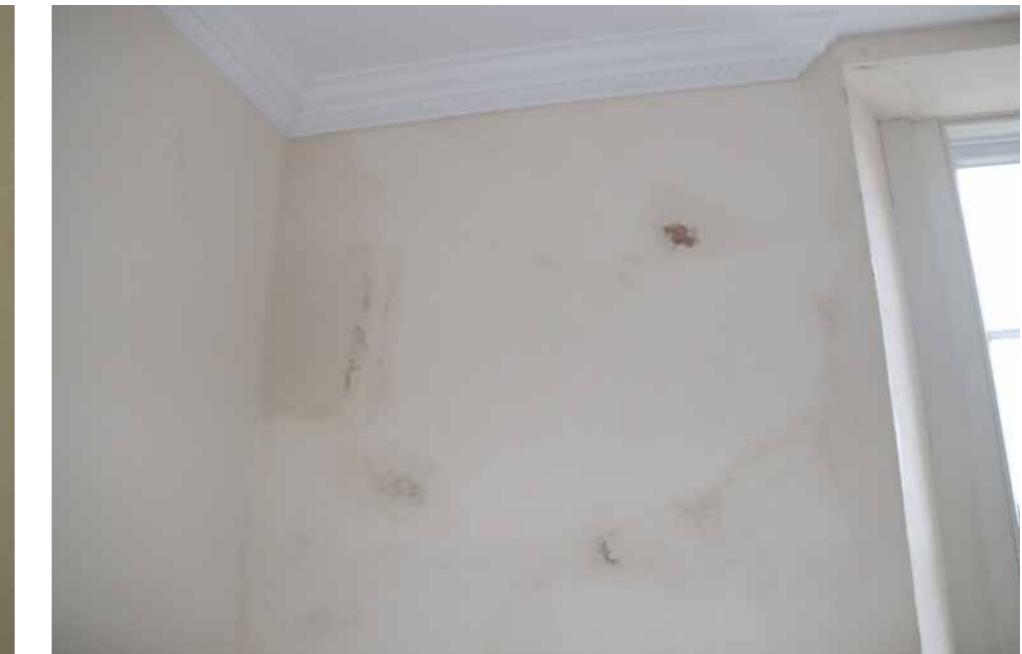
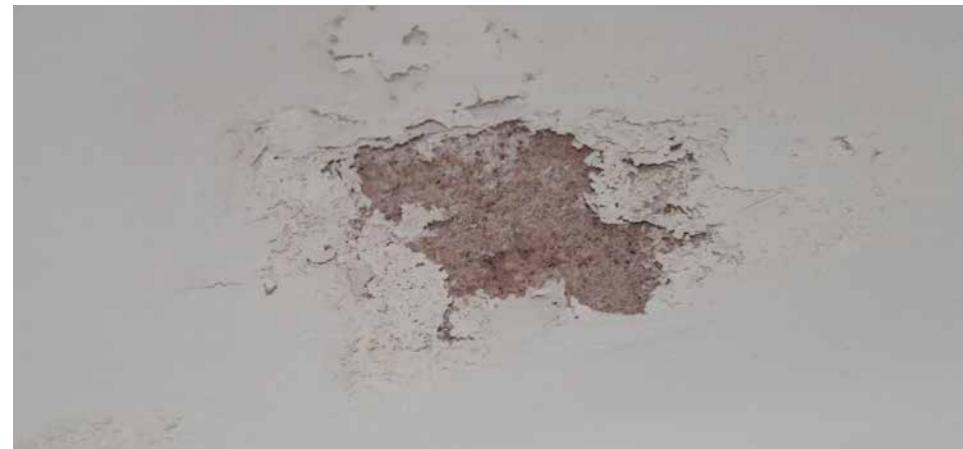
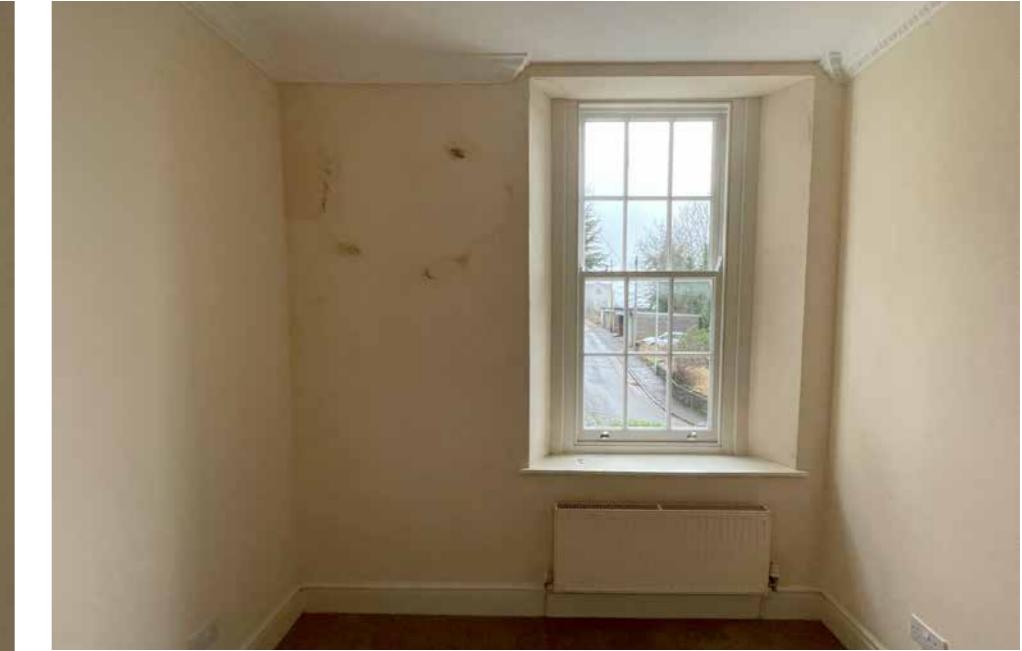
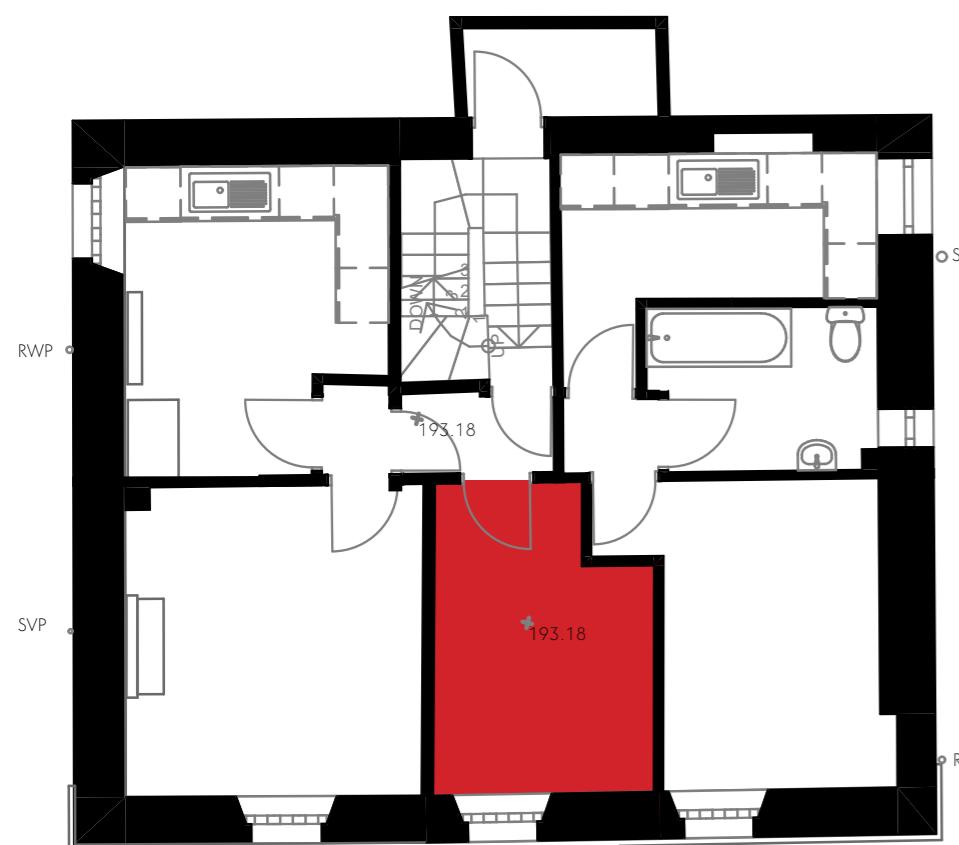
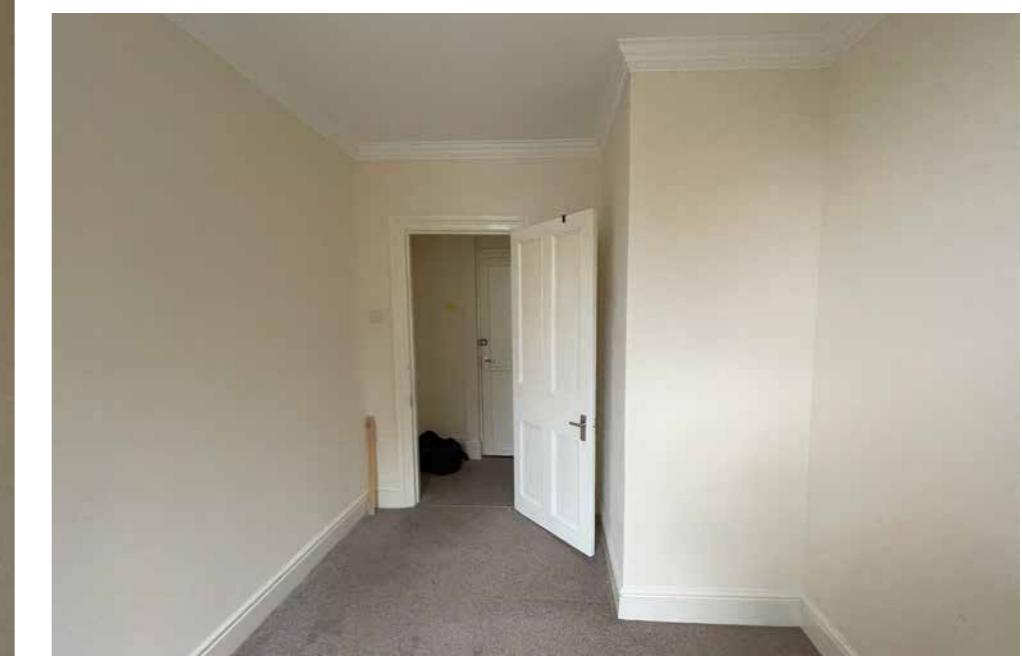
11.0 Interior - First Floor - Central Room

This front room is also of painted plastered walls and ceiling with a moulded cornice and a ceiling rose. The floor is carpeted; the door is a painted four-panelled timber door and the window a painted timber sash window with double glazing. The internal partitioning appears to be of plasterboarded timber studwork.

There is water-staining, dampness, spalled plaster and crystallised salts on the external front wall to the left of the window (see photo below). There is a significant amount of cracking render on the outside just above this point. This might explain how the inside face of the wall is damp - water has been getting behind the render, cannot evaporate externally and so is finding its way to the inside face of the wall, and drying, leaving salt crystals. The plaster needs removal and a new lime plaster applied.

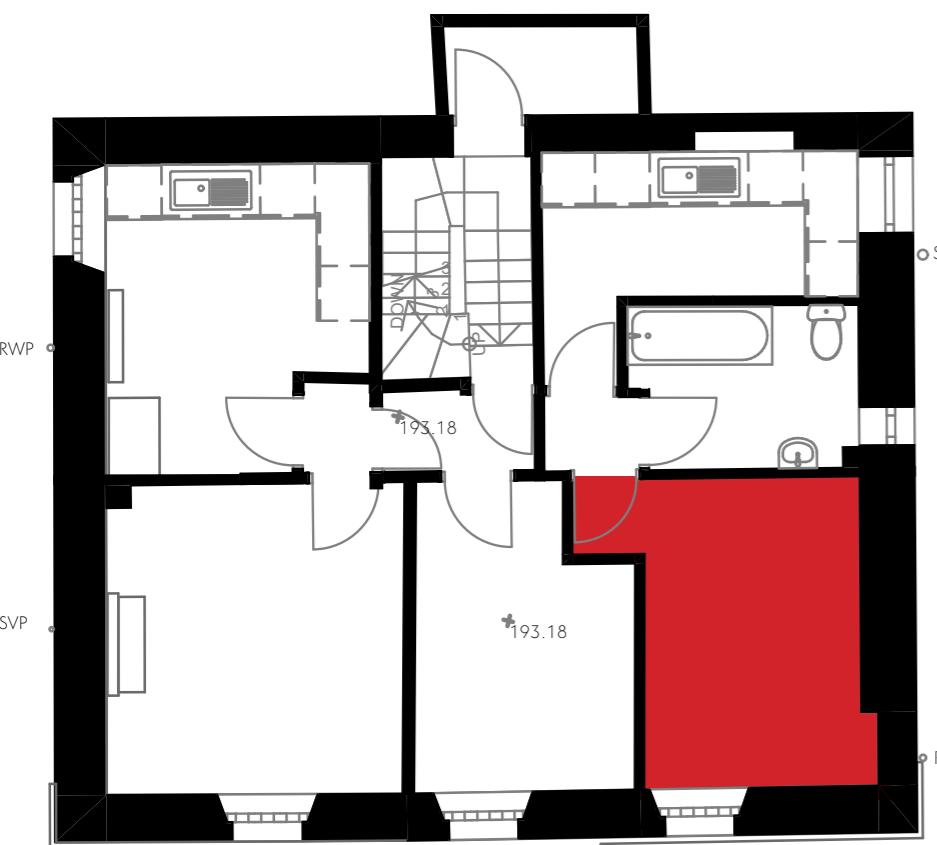
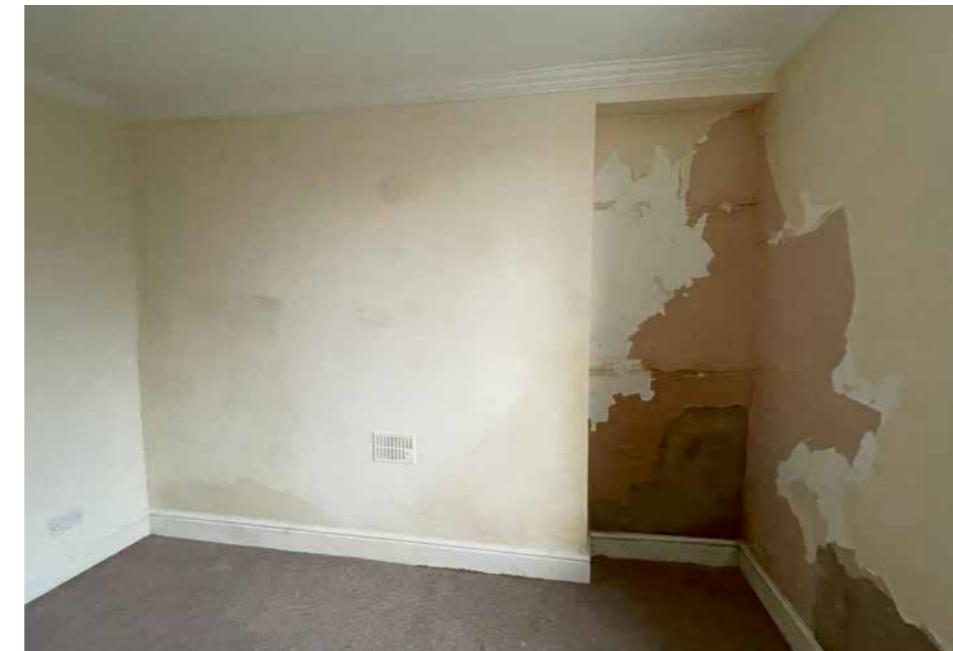
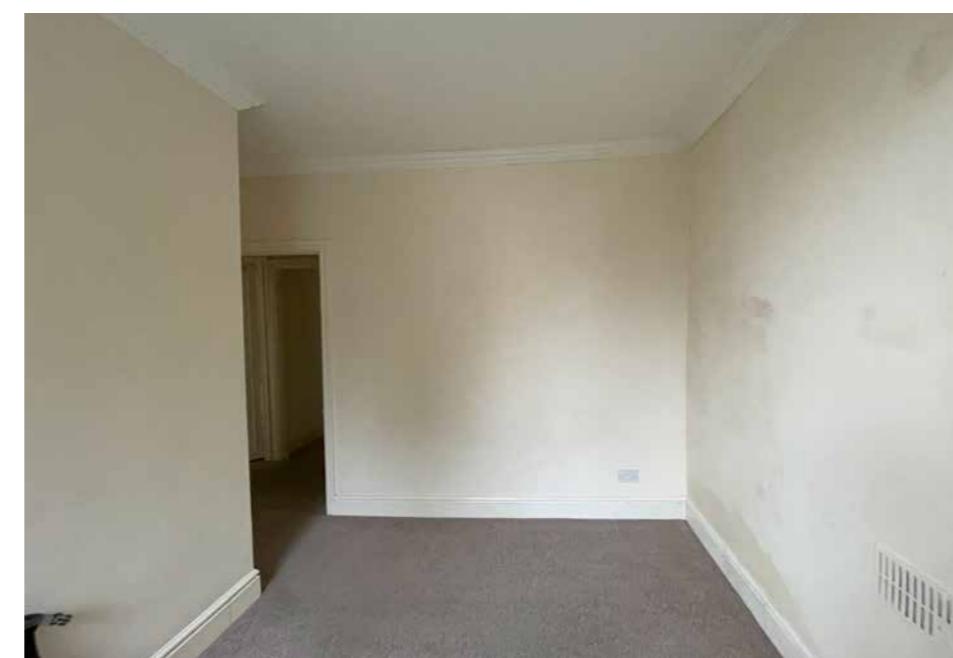
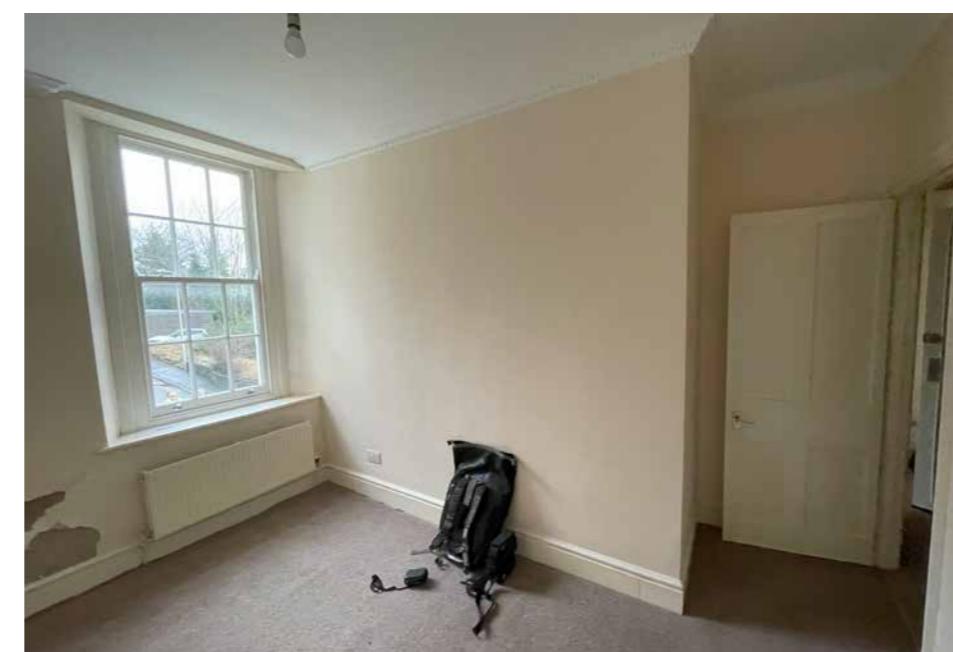
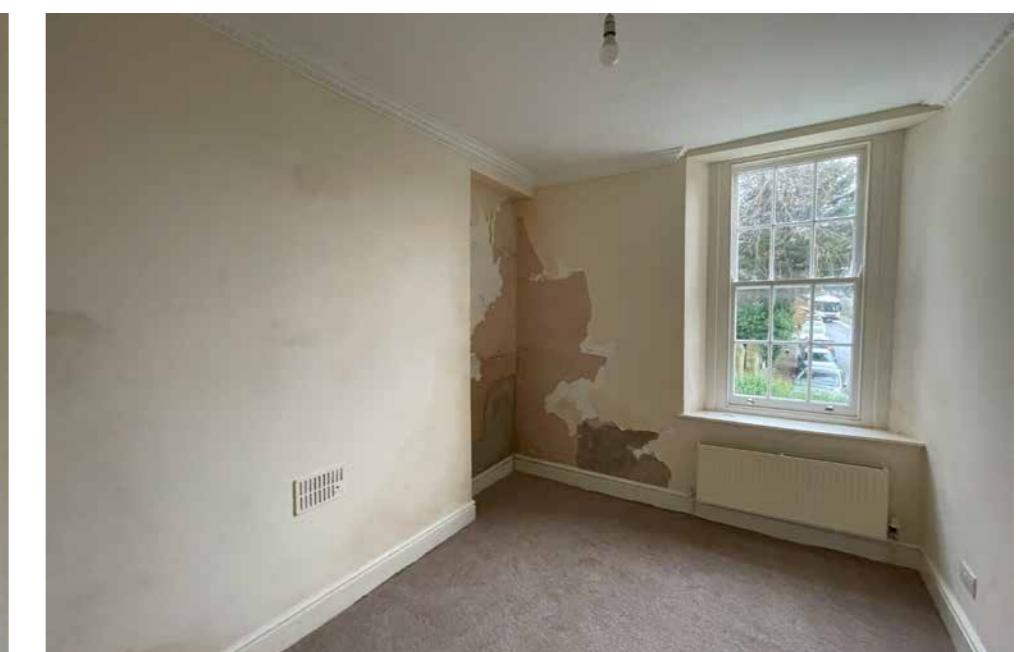
11.0 Interior - First Floor - South East Room

This front room is also of painted plastered walls and ceiling with a moulded cornice and a ceiling rose. The floor is carpeted; the door is a painted four-panelled timber door and the window a painted timber sash window with double glazing. The internal partitioning appears to be of plasterboarded timber studwork. There is a vent in the wall where it is presumed a fireplace used to be. This must be venting the flue within the wall.

In the south east corner of the room - which is the external corner - there is a large area of peeling paint, cracking plaster and damp. There has recently been some cementitious plaster repairing of this area. This is where the wall thins out to form this recess, and hence forms a greater cold-bridge. The surface of the thicker wall (where the fireplace used to be) is also showing signs of dampness. This is the corner and side wall of the building where the wall is at its dampest in the ground floor below. This certainly suggests that there is a damp build-up to this part of the wall. It is an area of wall where the render externally is looking especially dark, stained and damp; and it is the area where there is a rain water downpipe, which might have been leaking; and an area where the old chimney breast may not be suitable vented.

The proposals involve the removal of the internal plaster and, probably, the removal of the external render. The chimney flue is to be vented at top and bottom, and in the middle; and the rainwater downpipe is to be replaced.

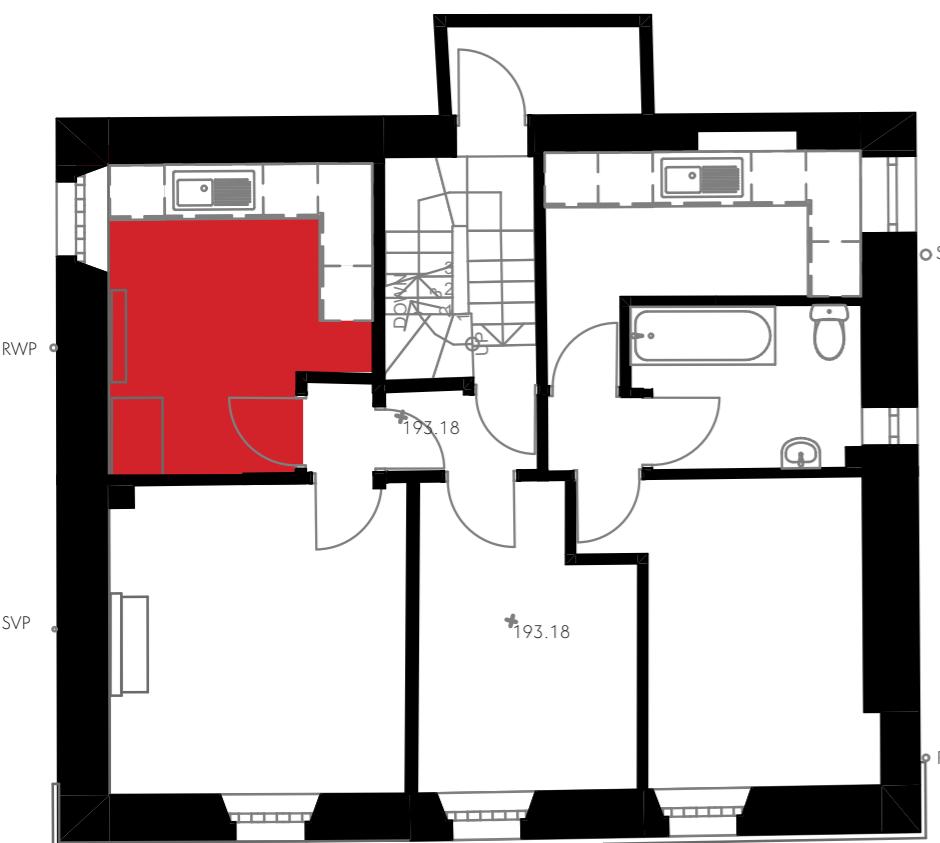
11.0 Interior - First Floor - Rear Kitchen

This rear kitchen is also of painted plastered walls and ceiling with no cornice. There is a run of kitchen units on two walls. The floor is of ceramic tiling. The door is a flush painted timber. The window is painted timber, with a top-hung casement. The glazing is single-glazed. The internal partitioning appears to be of plasterboarded timber studwork. There is a timber and metal fireplace surround, with both brickwork and stonework of the wall apparent within the fireplace.

The condition of this room is reasonable; however, there is mould growth around the window, which suggests cold-bridging and condensation. This is not helped by the fact that the window is single-glazed. As such, the proposals replace this with Slimline double-glazing.

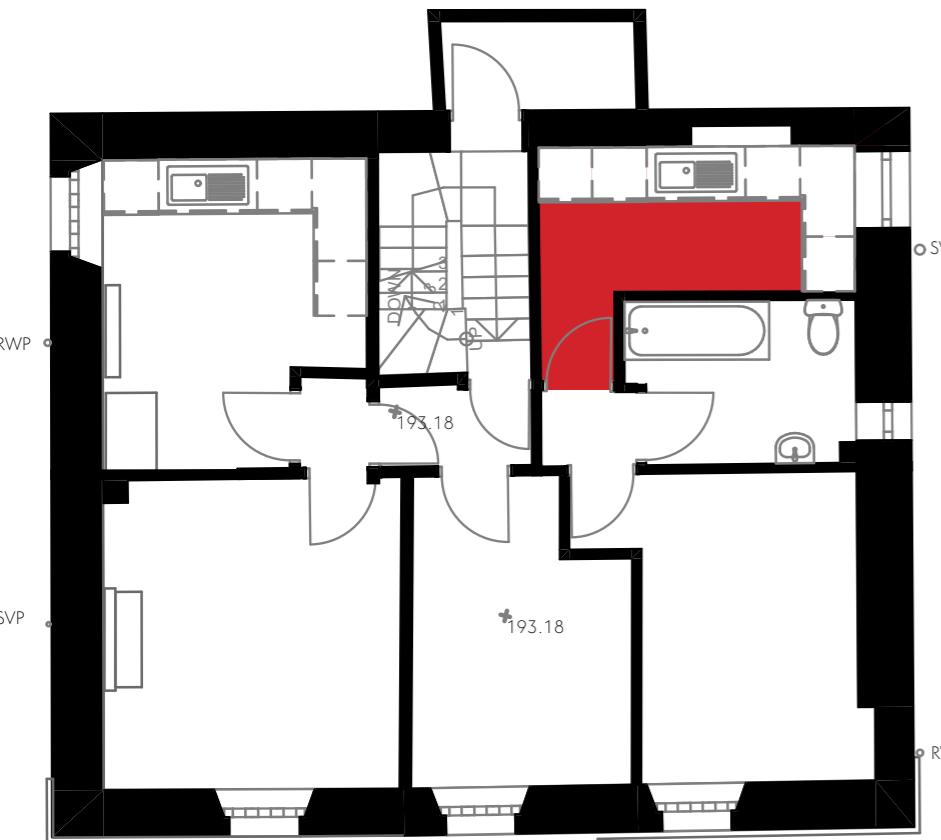
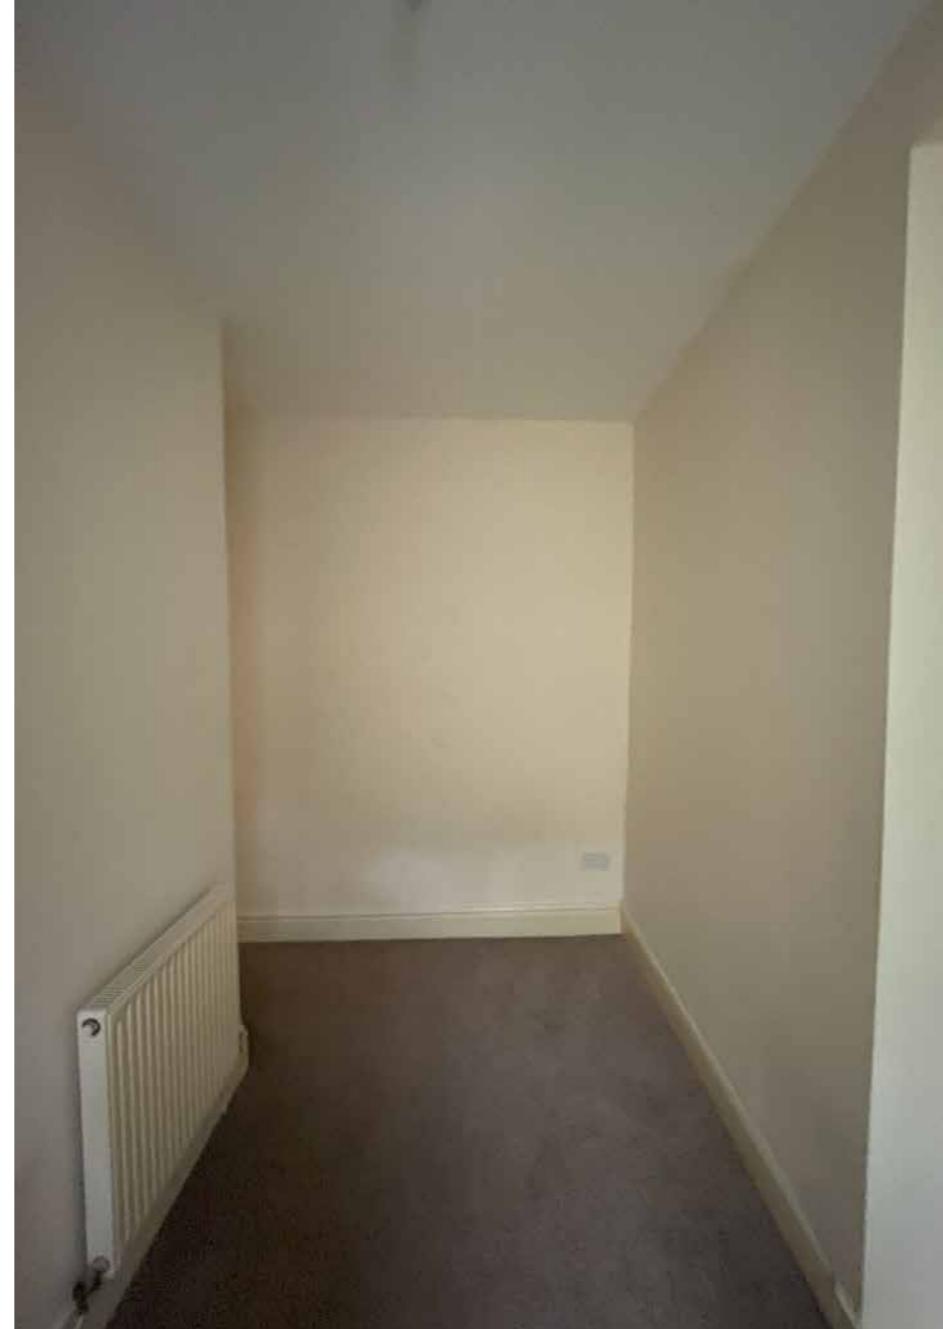
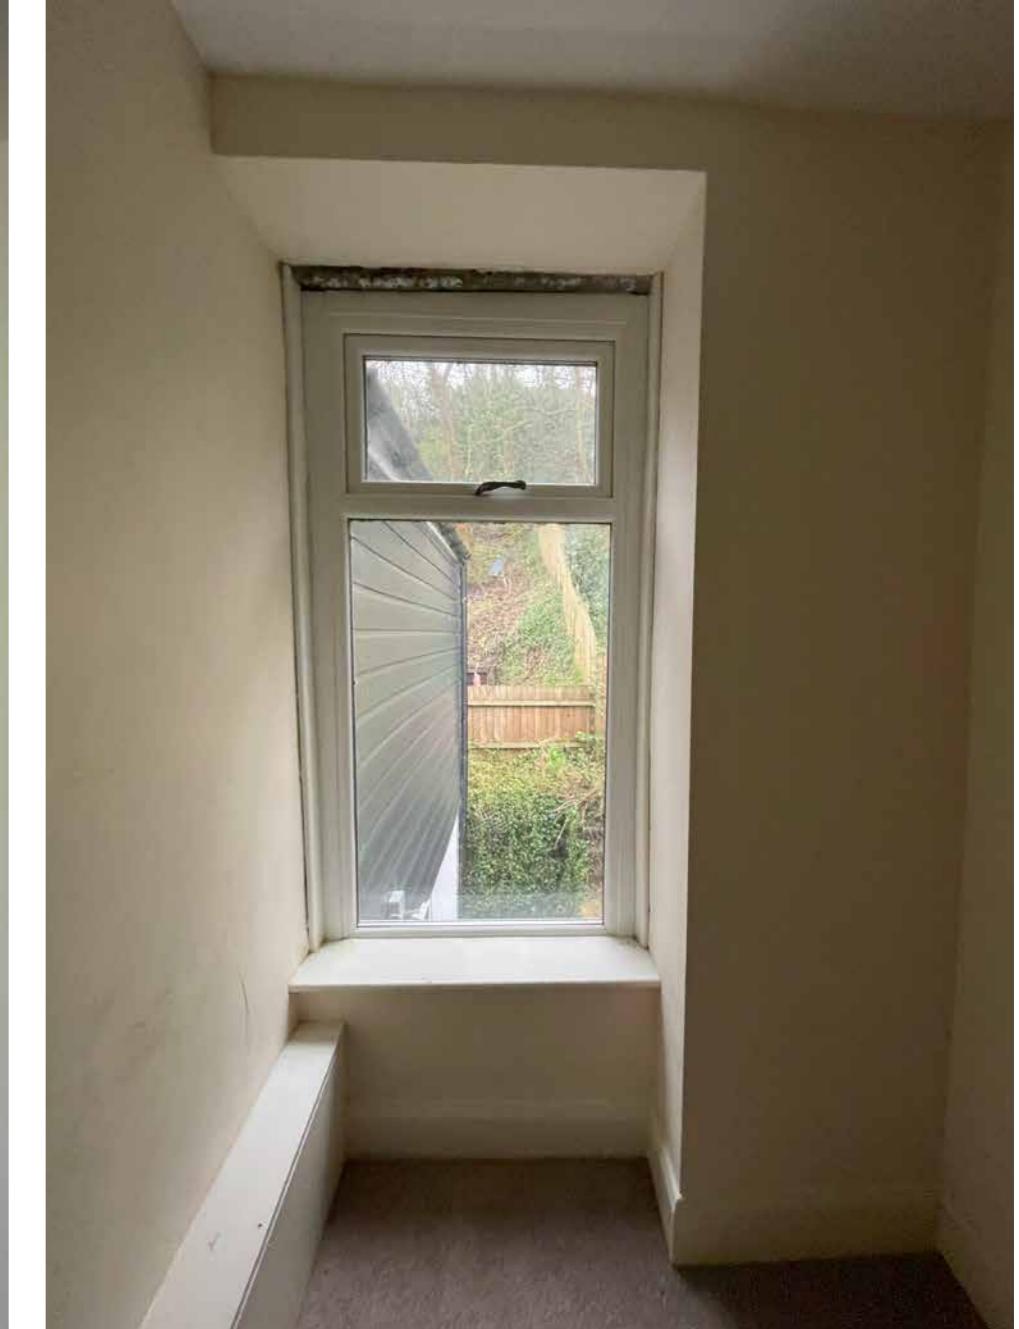
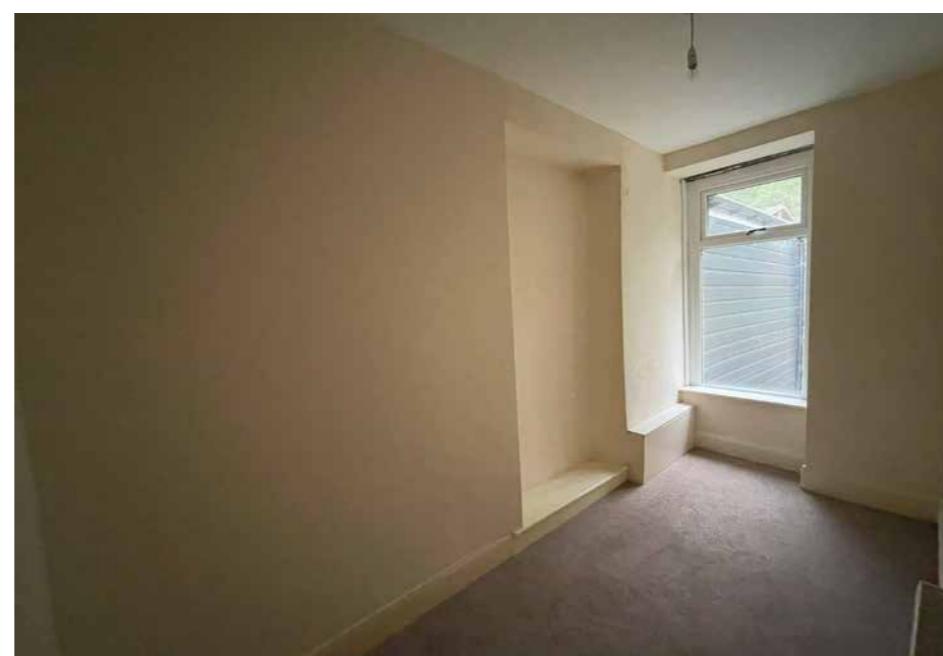
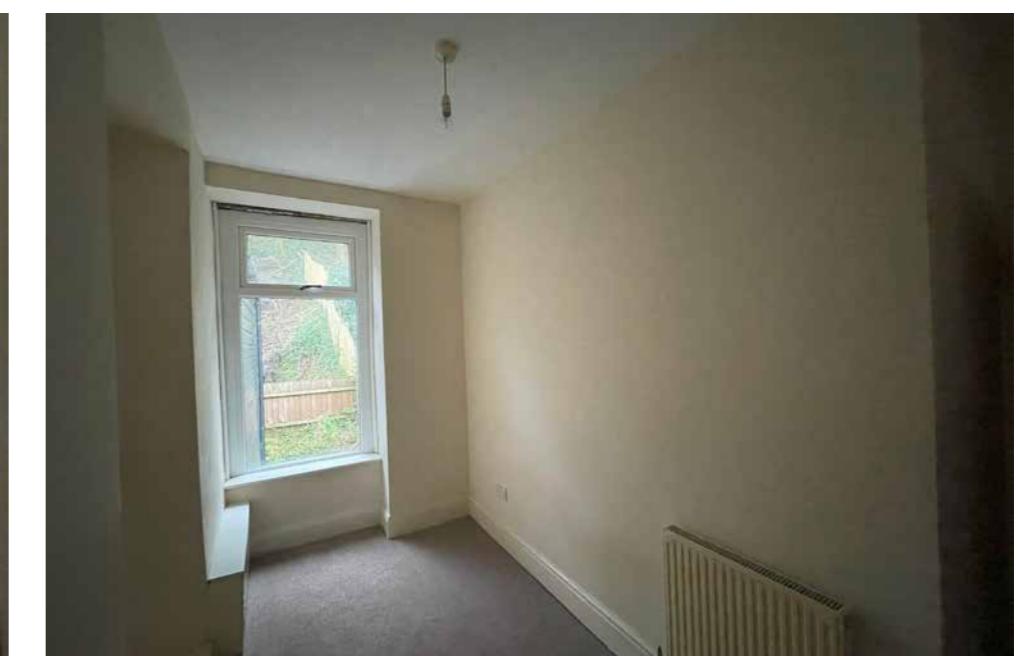
This rear room is also of painted plastered walls and ceiling with a no cornice. The floor is carpeted; the door is a painted four-panelled timber door and the window a painted timber top-hung casement window with double glazing. The internal partitioning appears to be of plasterboarded timber studwork.

The condition of the room is reasonable; however, it was noted that there was a bit of a slope to the timber floor. A more detailed inspection of this, and all floors, is recommended in due course, when the carpet can be taken up.
