Primrose Hill, Merthyr Tydfil

RECORD OF BUILDING AND CONDITION ASSESSMENT REPORT, WITH REPAIR PROPOSALS

.....(449)2503-GVWP-A-HIS-P01

Date: 05.03.25

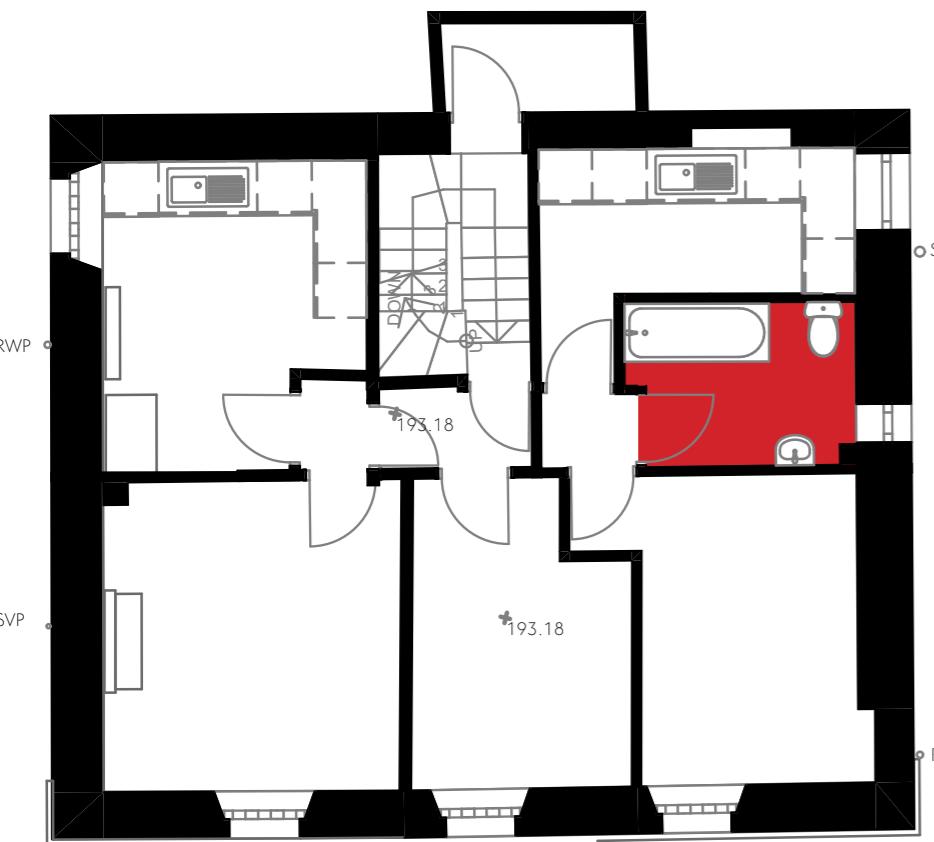
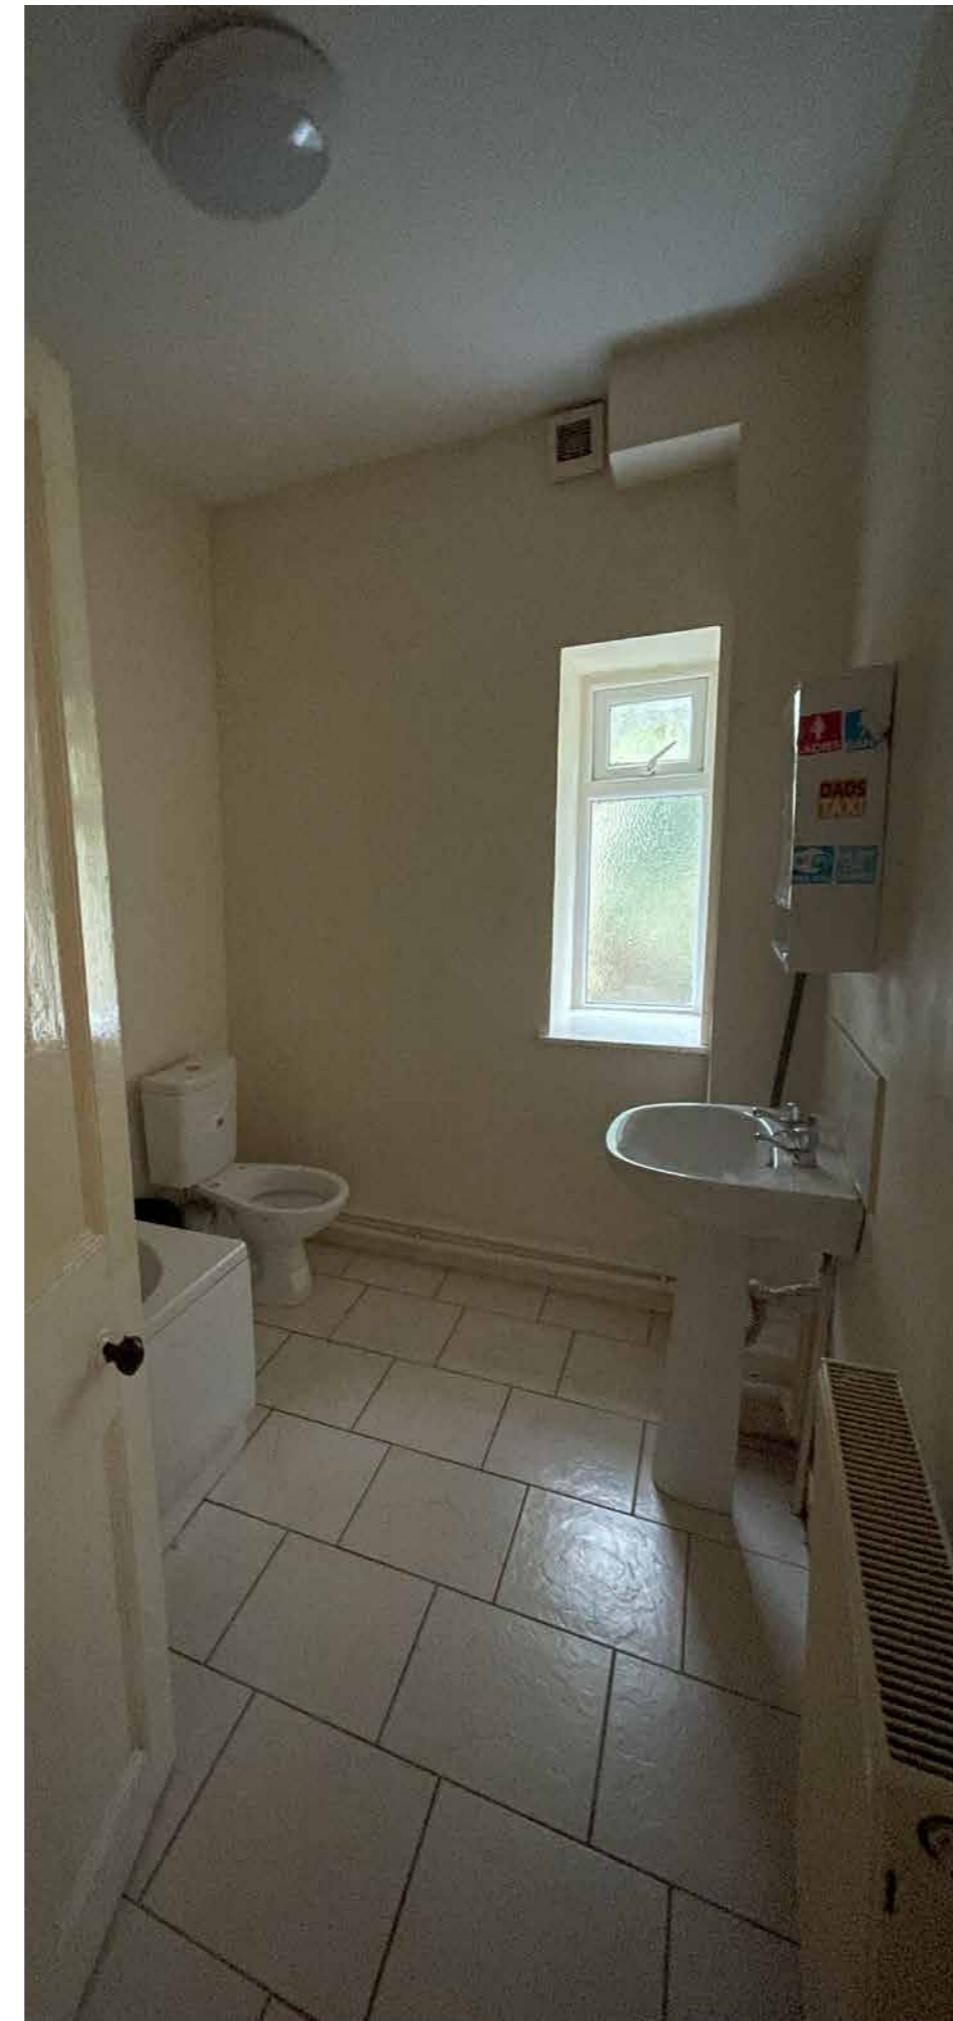
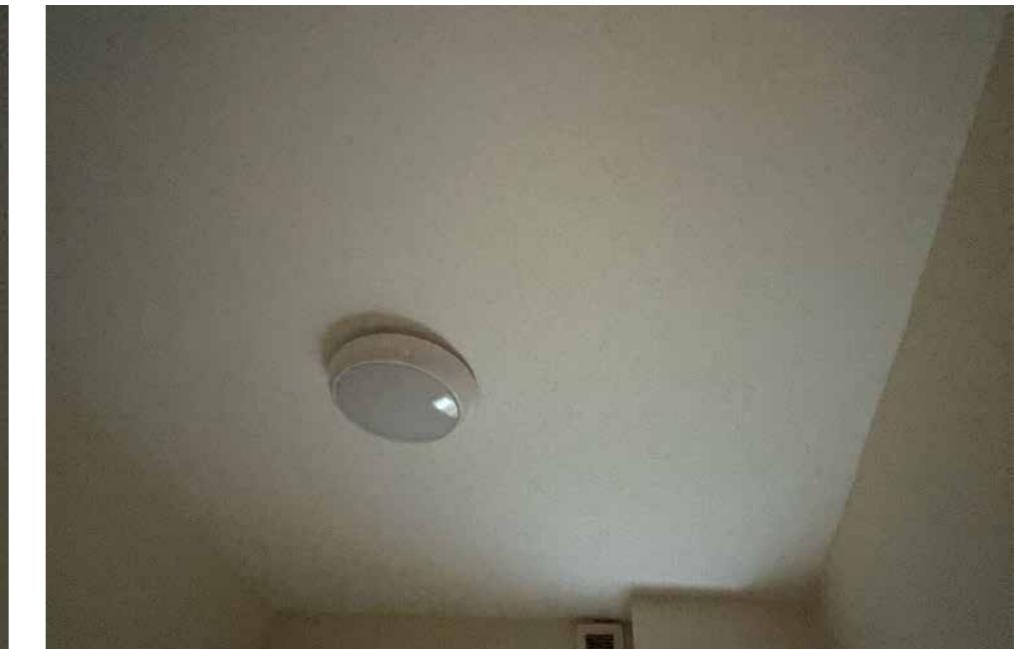
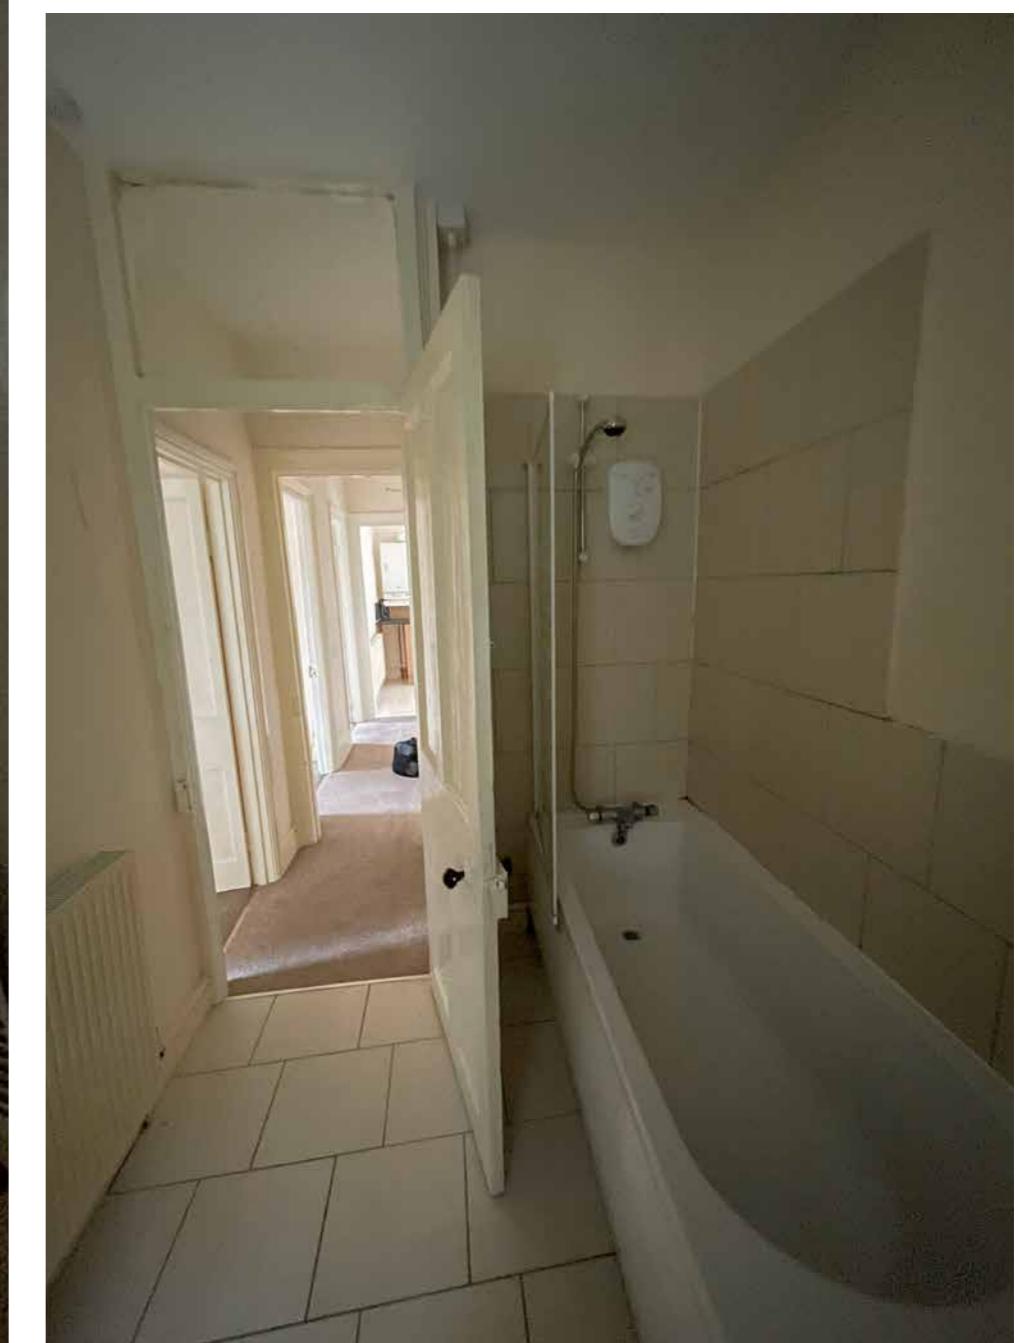
11.0 Interior - First Floor - Bathroom

The bathroom is also of painted plastered walls and ceiling with a no cornice. The floor is ceramic tiled; the door is a painted four-panelled timber door and the window a painted timber top-hung casement window with double glazing. The internal partitioning appears to be of plasterboarded timber studwork.

The condition of the room is reasonable.

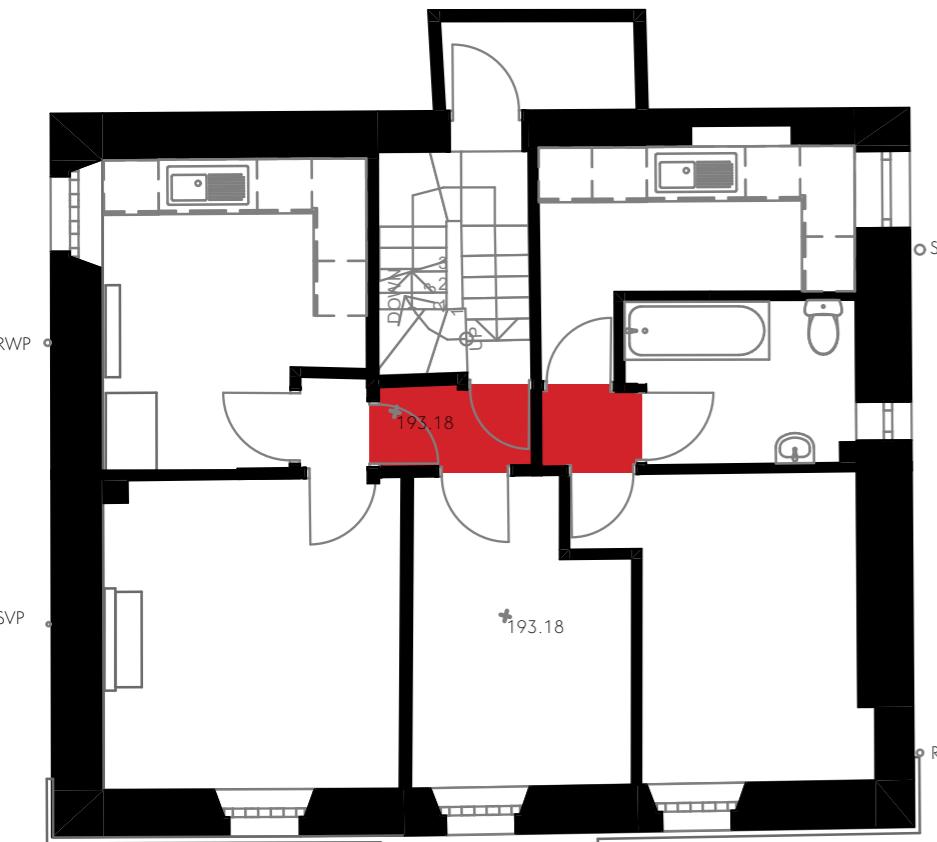
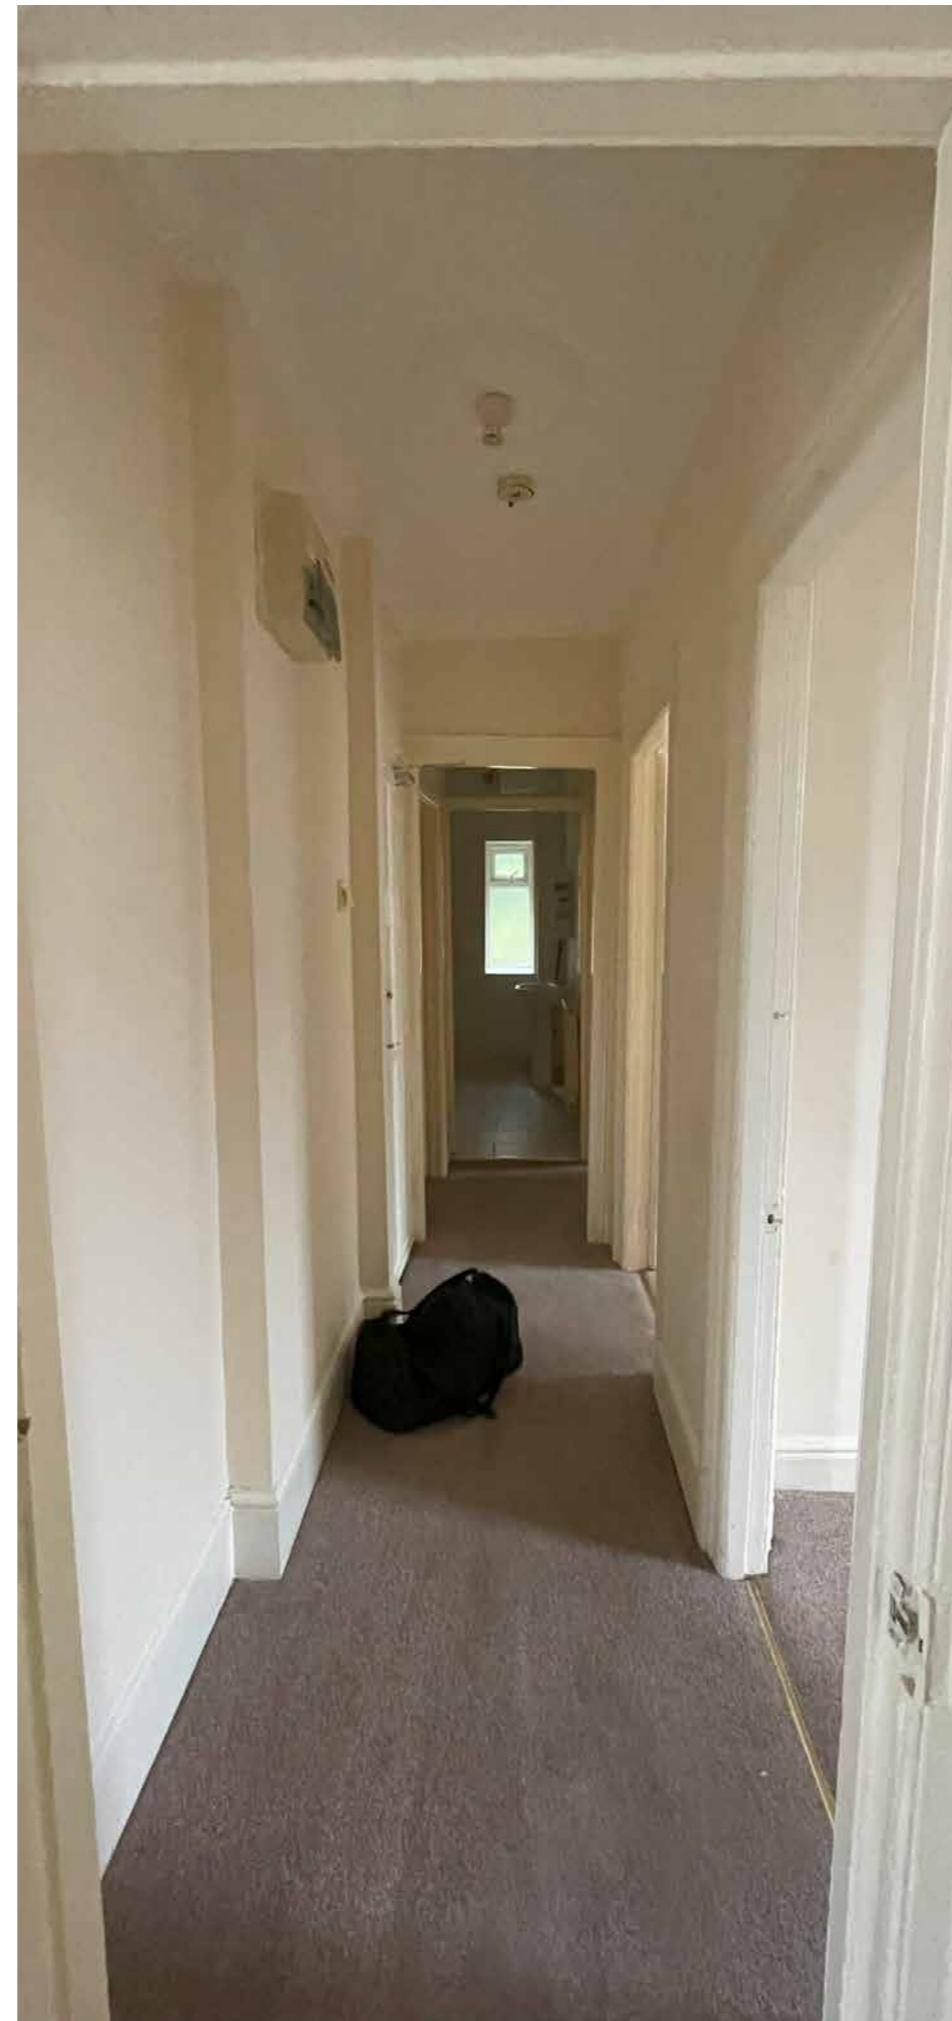
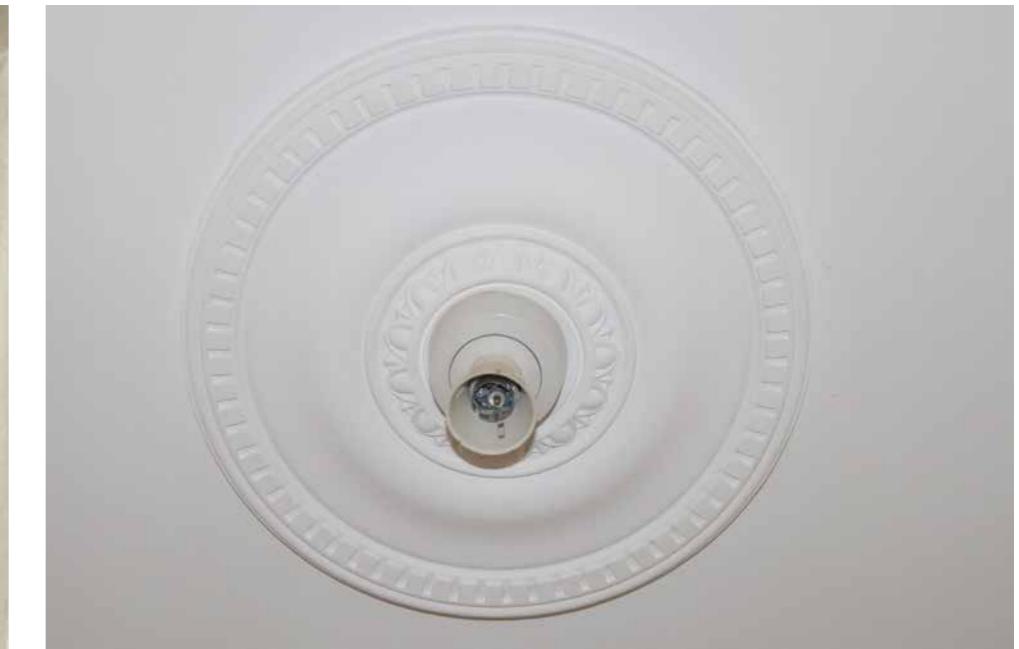
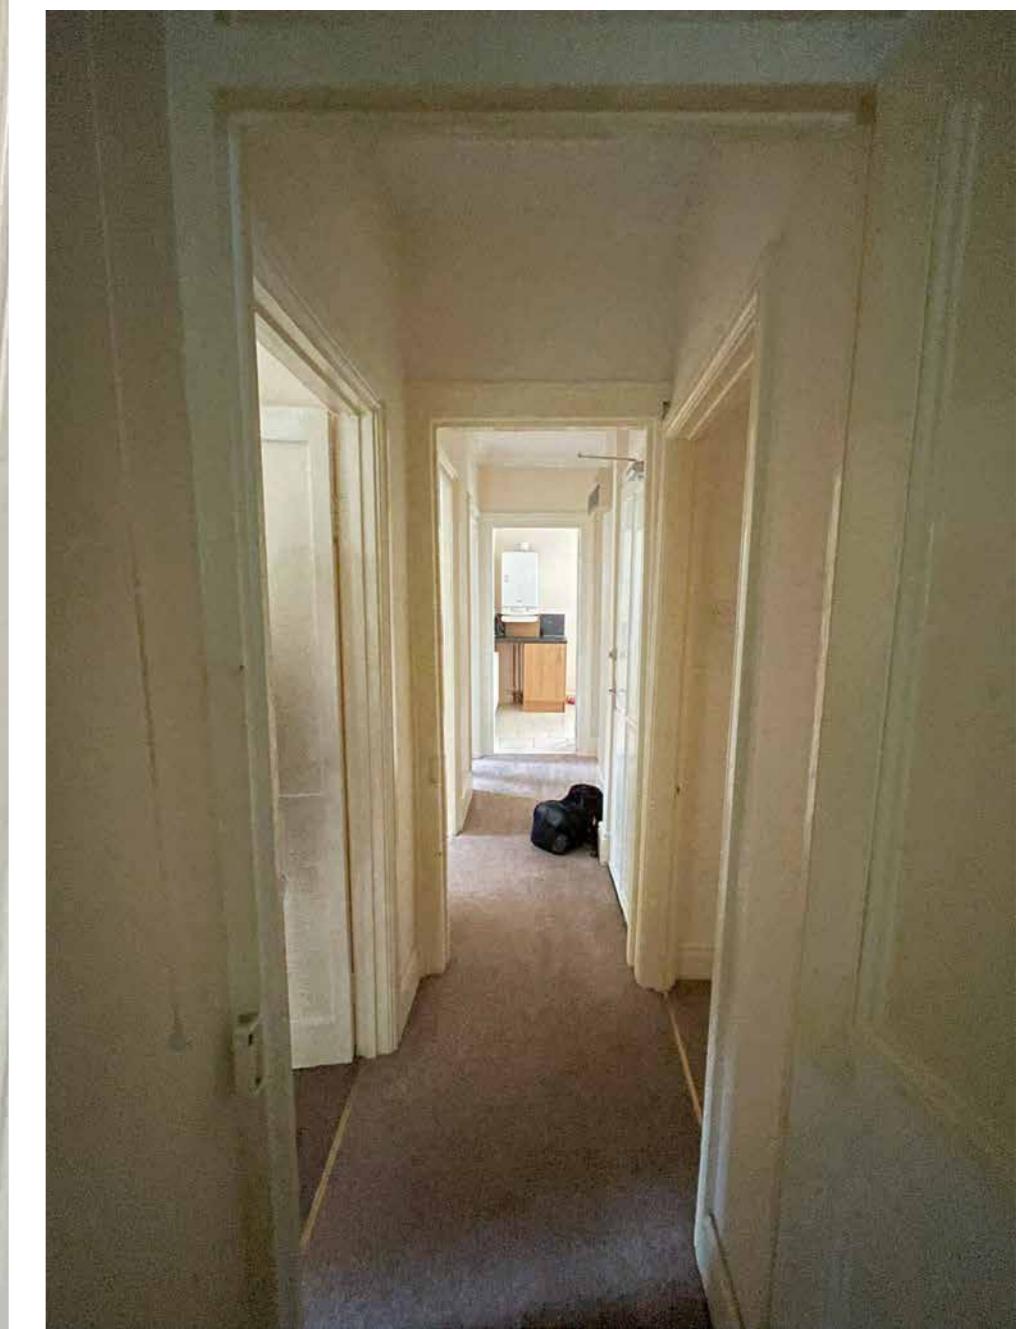
11.0 Interior - First Floor - Hall

This hall space is also of painted plastered walls and ceiling with a moulded cornice and a ceiling rose. The floor is carpeted; the doors are painted four-panelled timber door. The internal partitioning appears to be of plasterboarded timber studwork.

The condition of the space is reasonable.

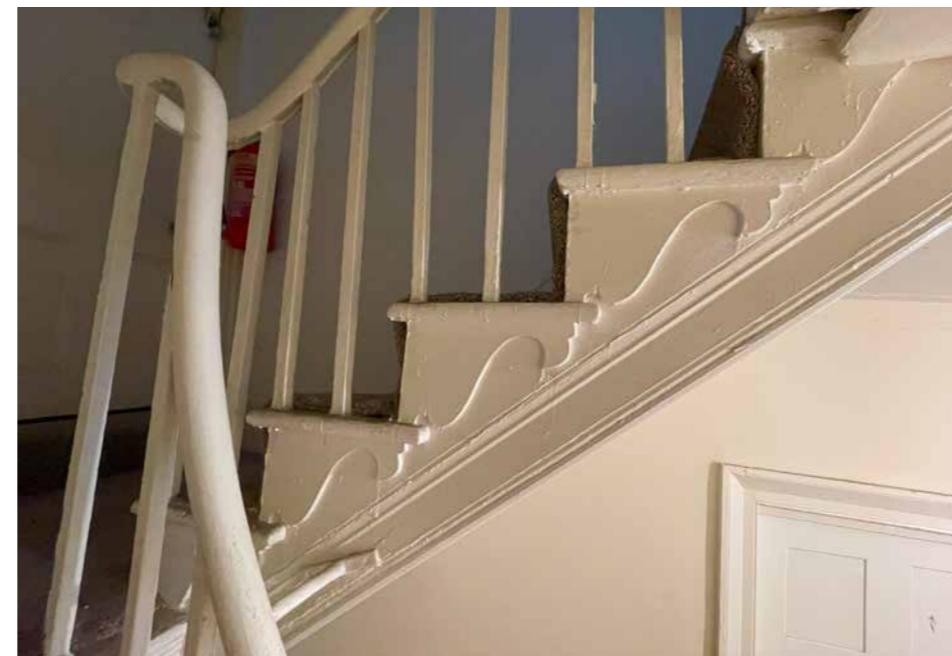
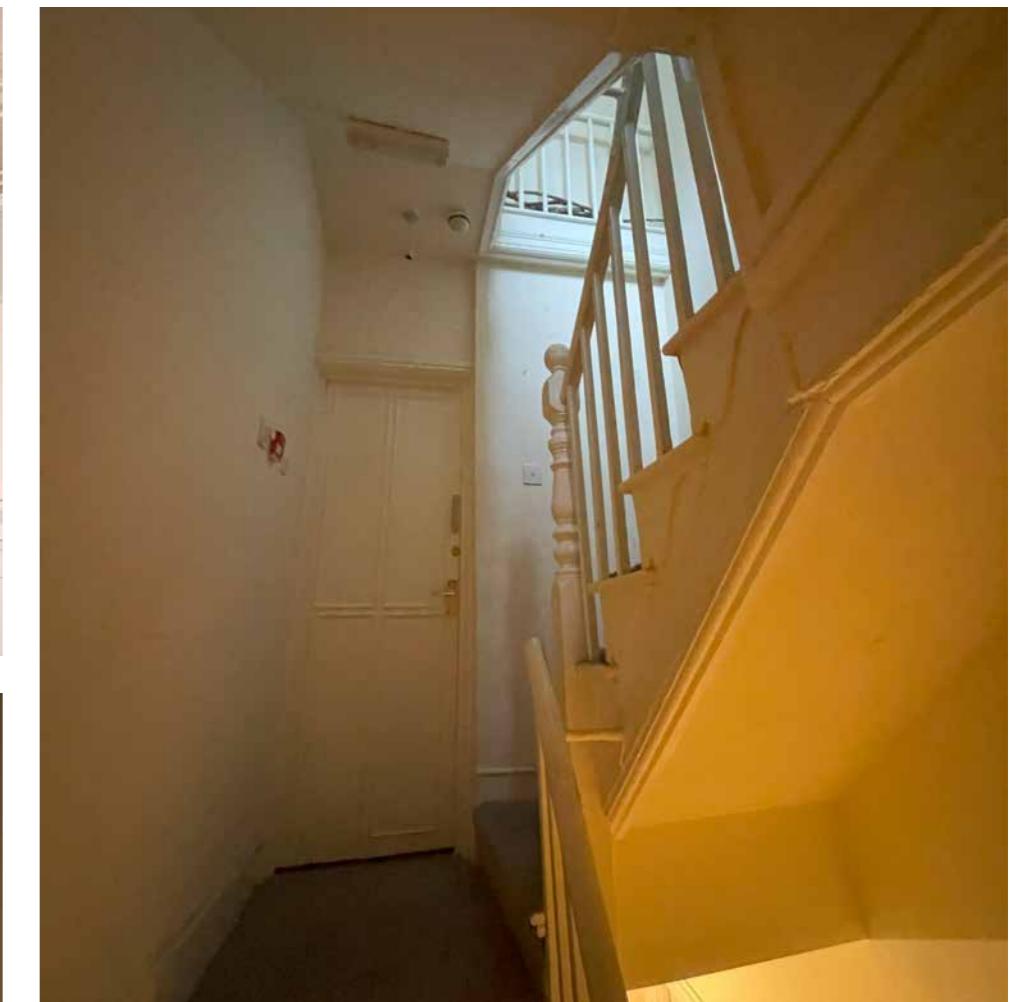
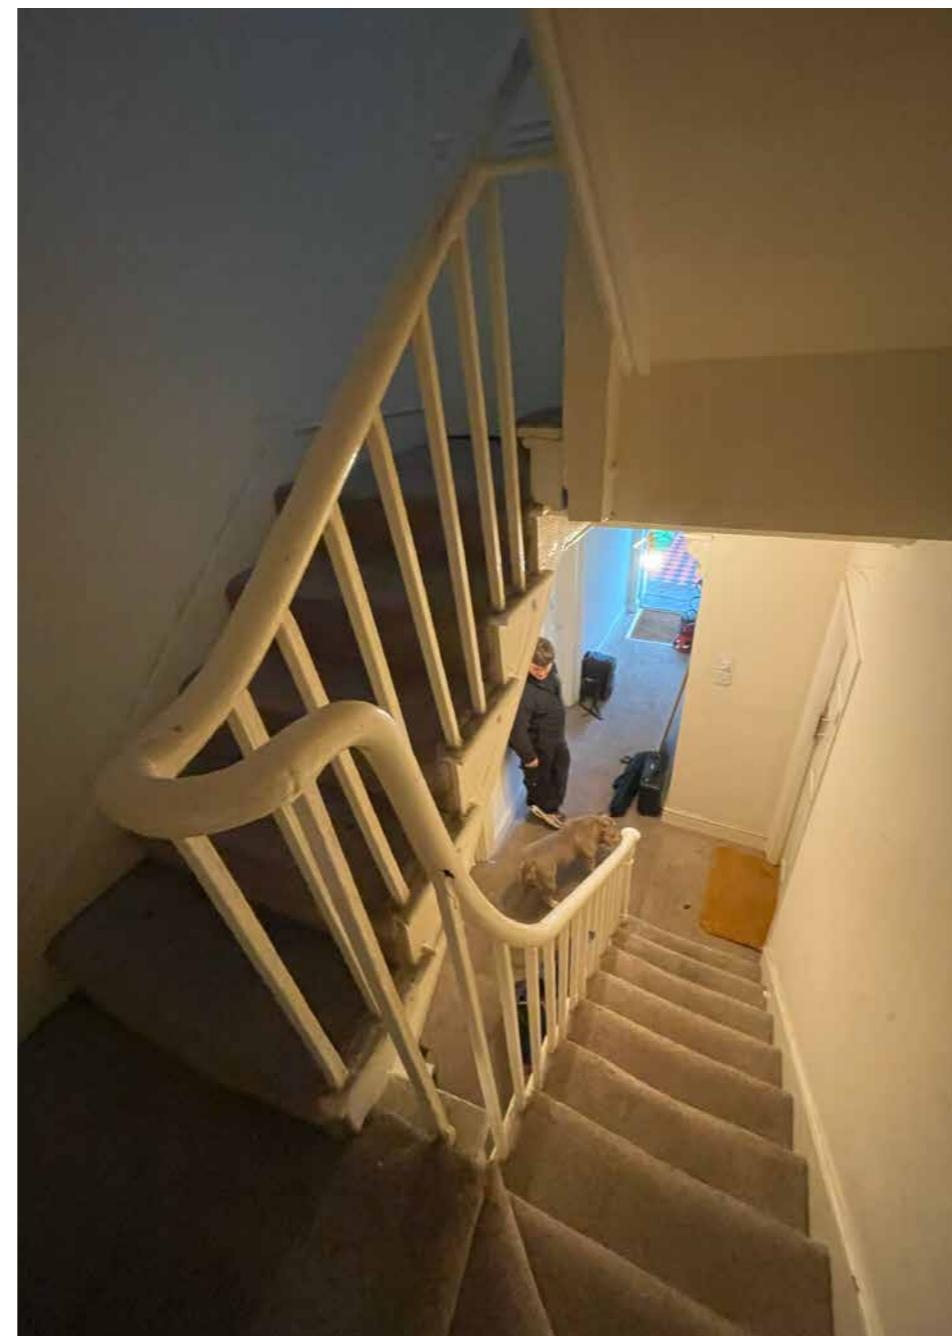
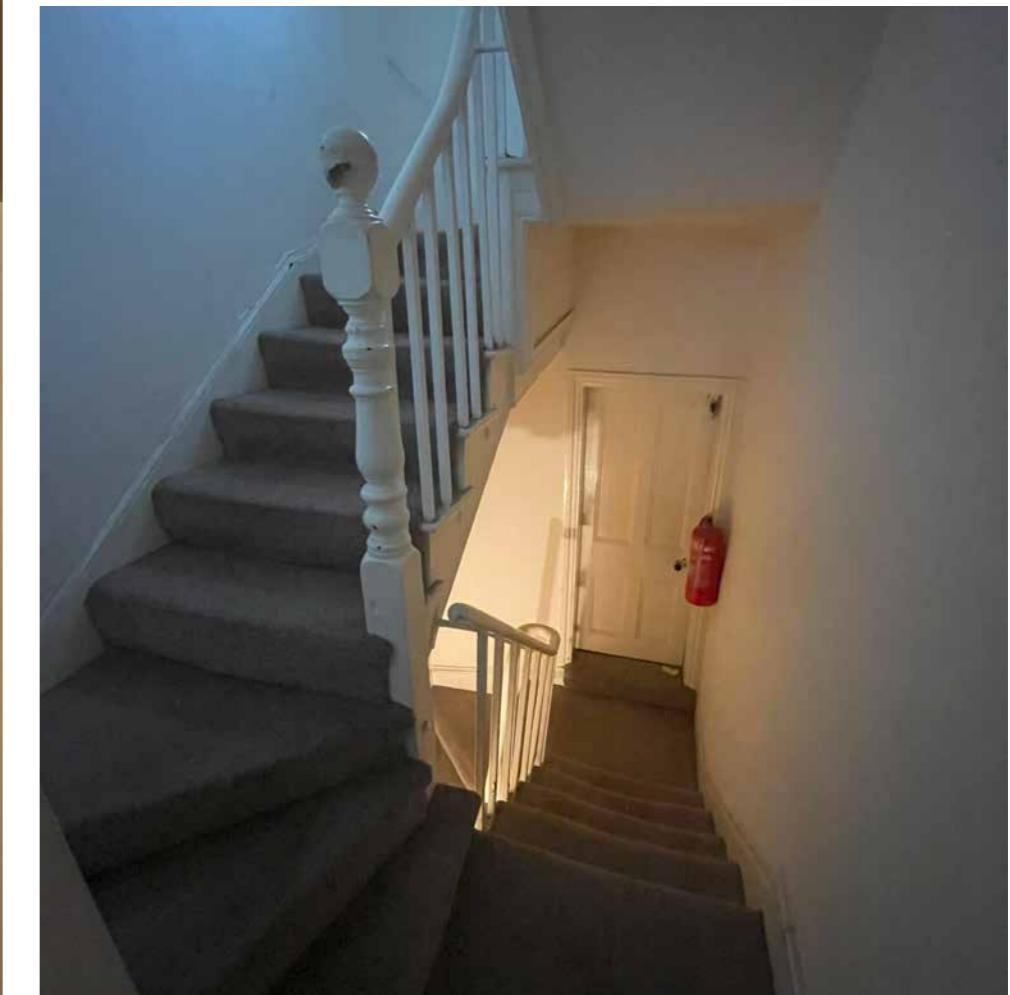
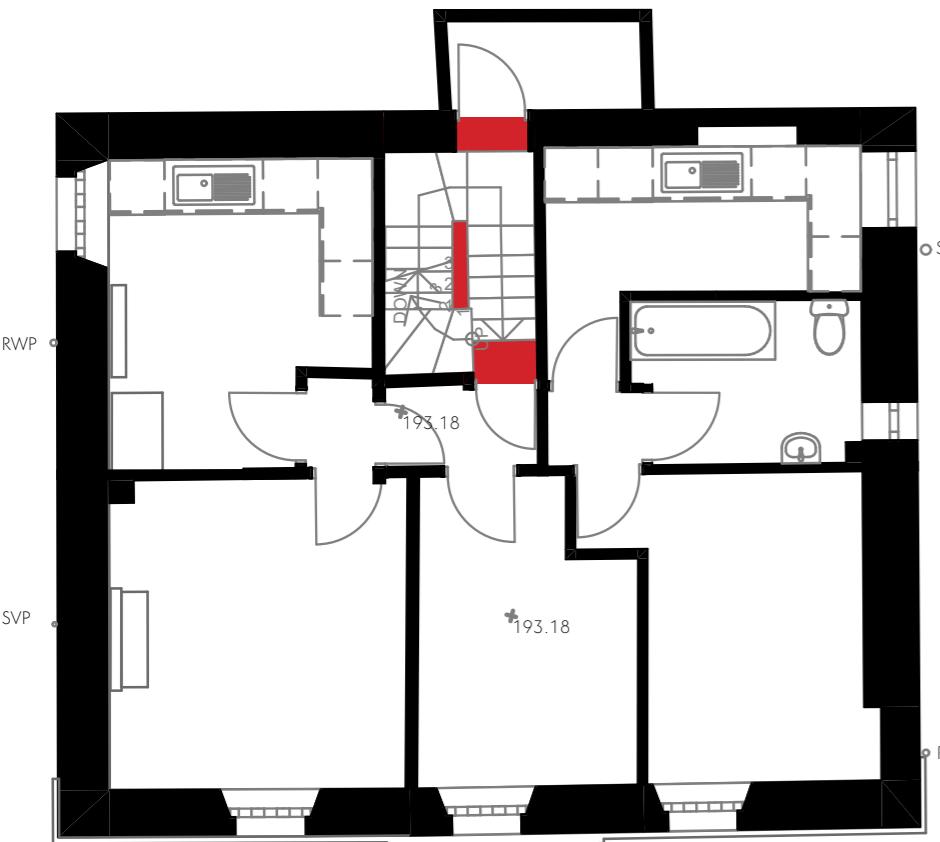
11.0 Interior - First Floor - Staircase

This staircase space is also of painted plastered walls and ceiling. The steps and landing are carpeted; the doors are painted four-panelled timber door. The internal walls around the staircase appear to be of masonry.

The single staircase is a timber staircase, carpeted; with an ovular handrail, square balusters and a turned round newel post; all painted white. Aside from the wear on the carpet, this appears all to be in reasonable condition

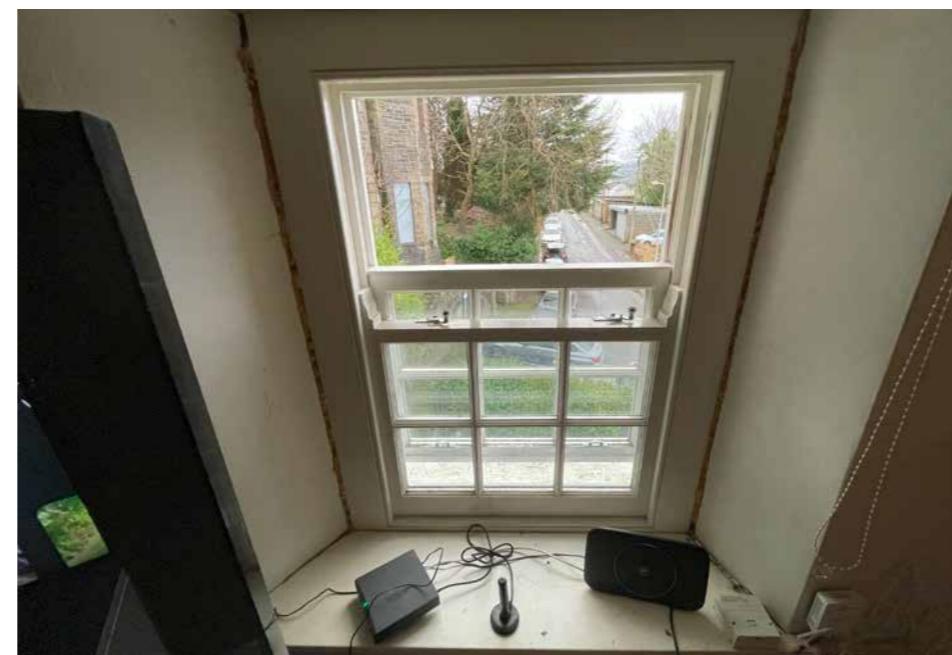
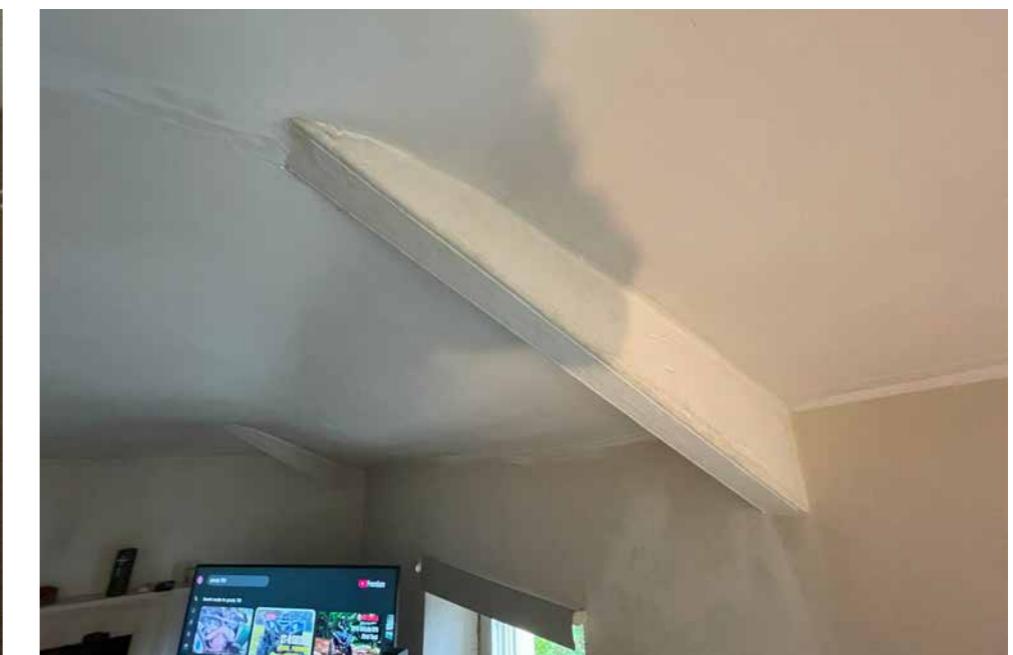
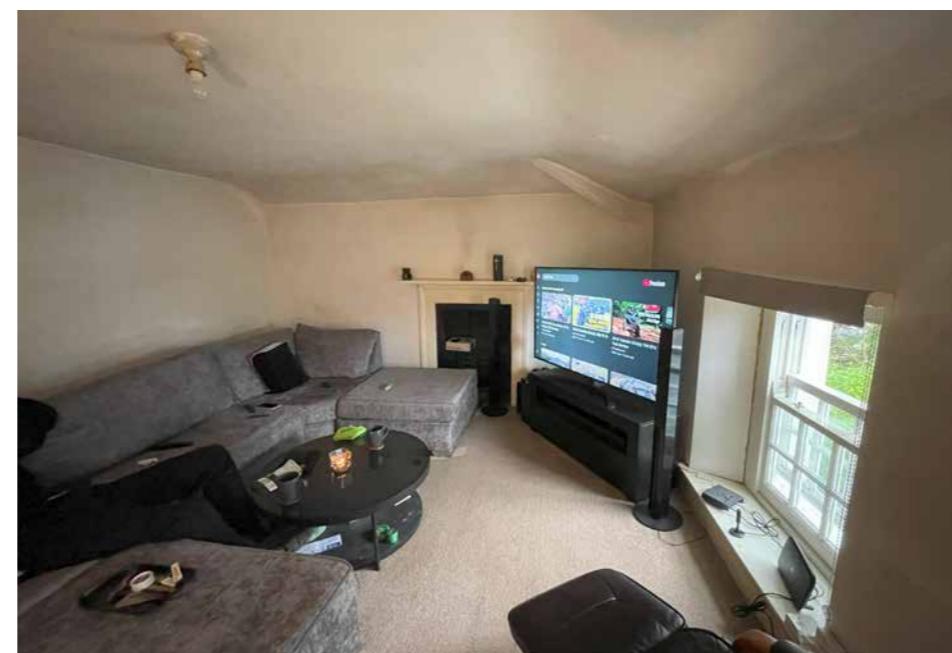
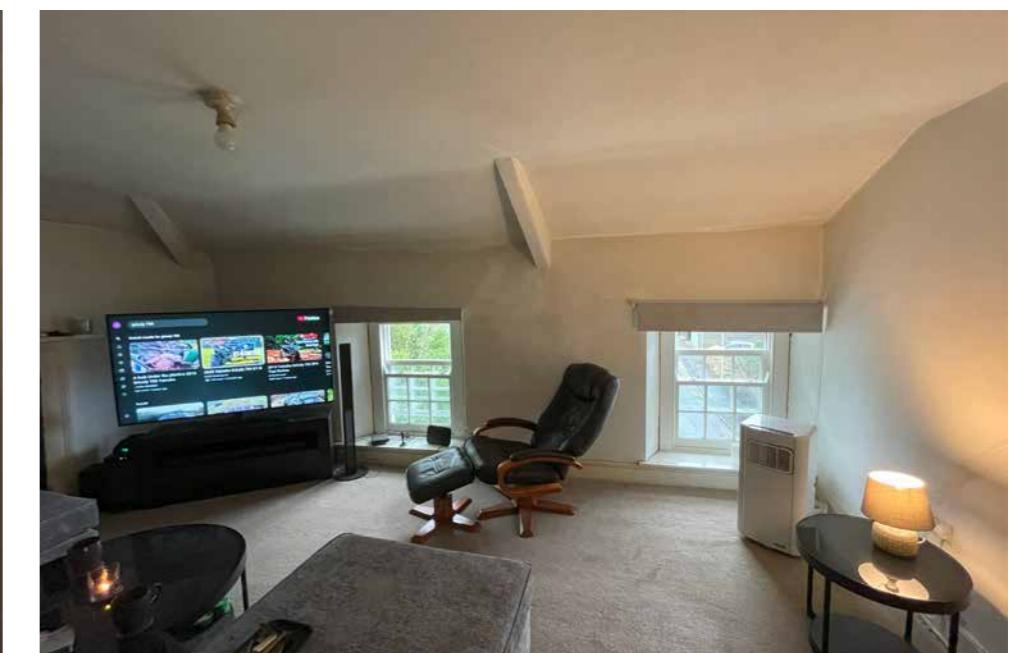
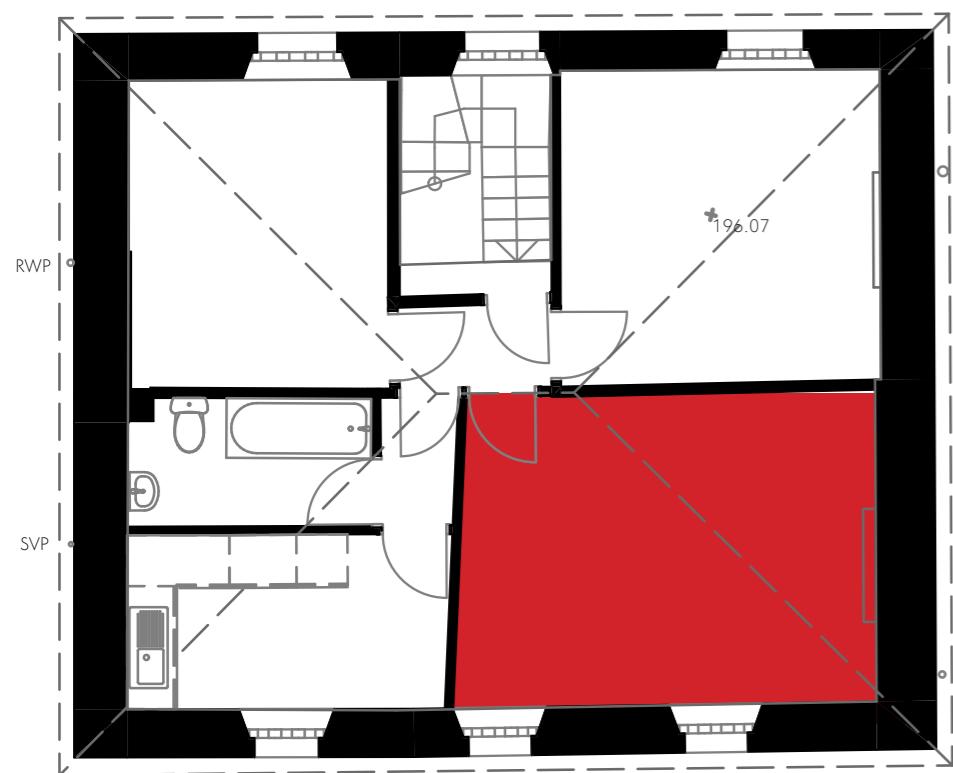
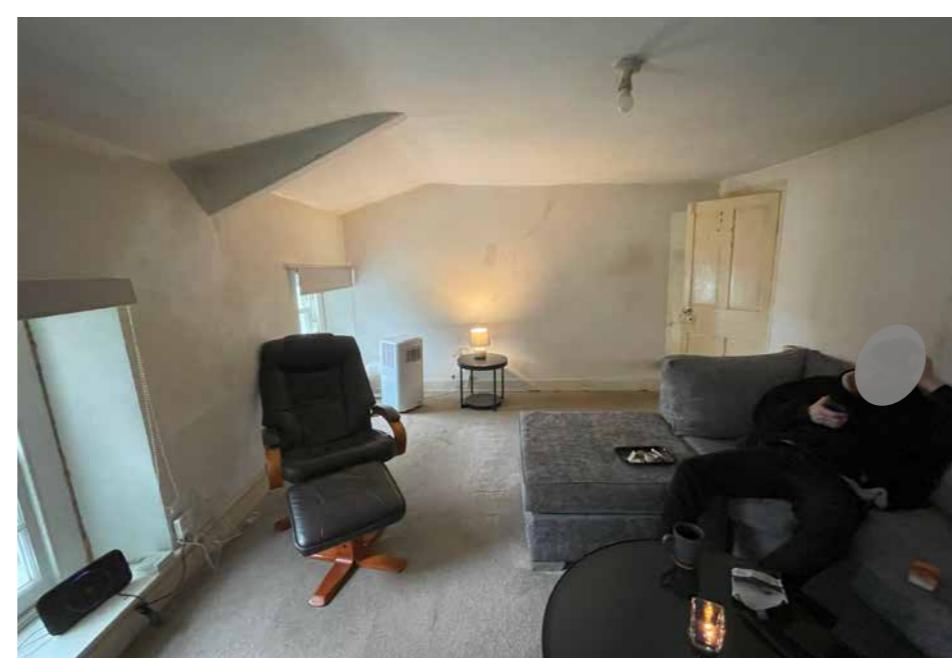
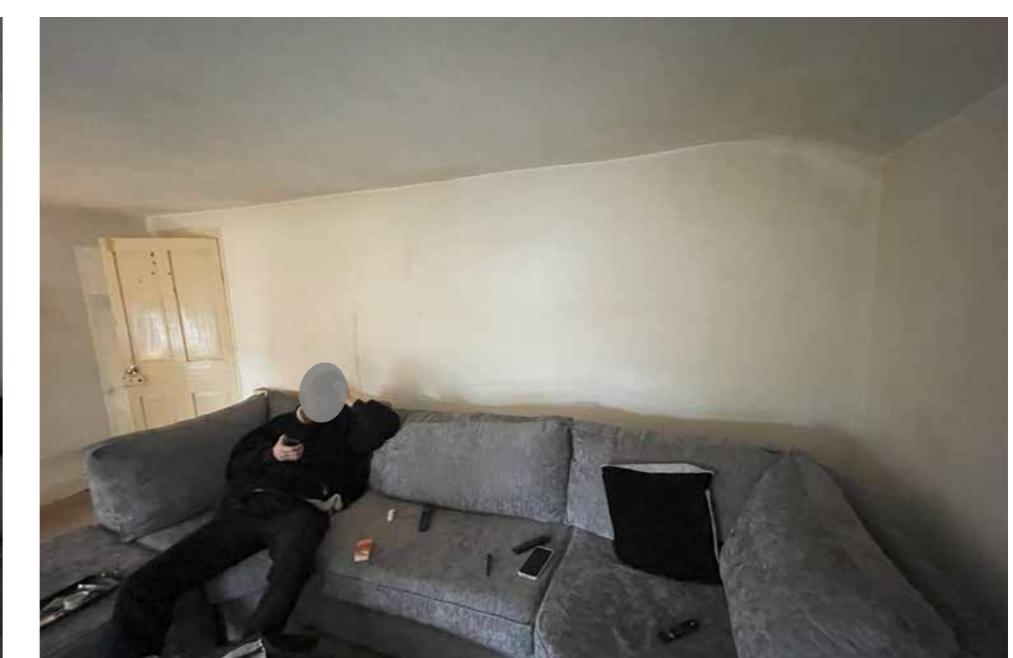
12.0 Interior - Second Floor - Front South East Room

The floor is carpeted; the door is a painted four-panelled timber door and the windows are painted timber sash windows with double glazing. It is notable that the windows have been recently inserted and/or sealed around the edges with piped insulation, as this insulation is still on view and has not been covered. The internal partitioning appears to be of plasterboarded timber studwork. There is a timber and metal fireplace surround and marble hearth to the east external wall.

There is some staining on the walls and ceiling, albeit not significant or of too much concern; and there appears to have been some areas of crack repair, fairly recently, to some of the plasterwork on the walls.

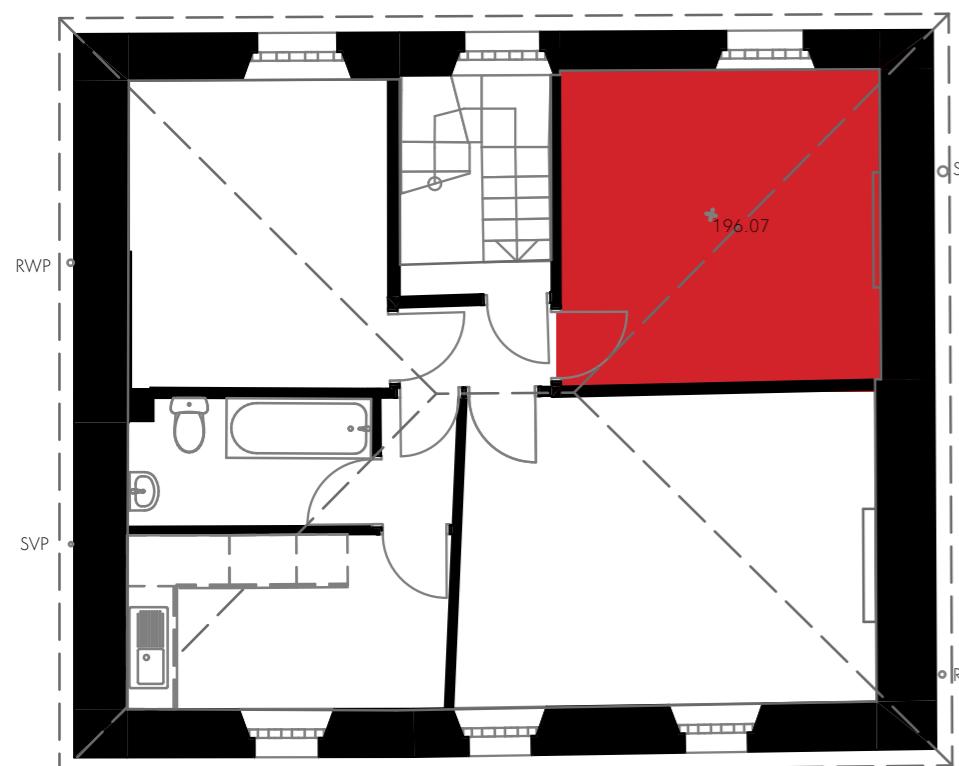
12.0 Interior - Second Floor - Rear North East Room

There is some cracking and staining on the walls and ceiling, particularly on the external east wall; albeit not significant or of too much concern.
