Primrose Hill, Merthyr Tydfil

RECORD OF BUILDING AND CONDITION ASSESSMENT REPORT, WITH REPAIR PROPOSALS

.....(449)2503-GVWP-A-HIS-P01

Date: 05.03.25

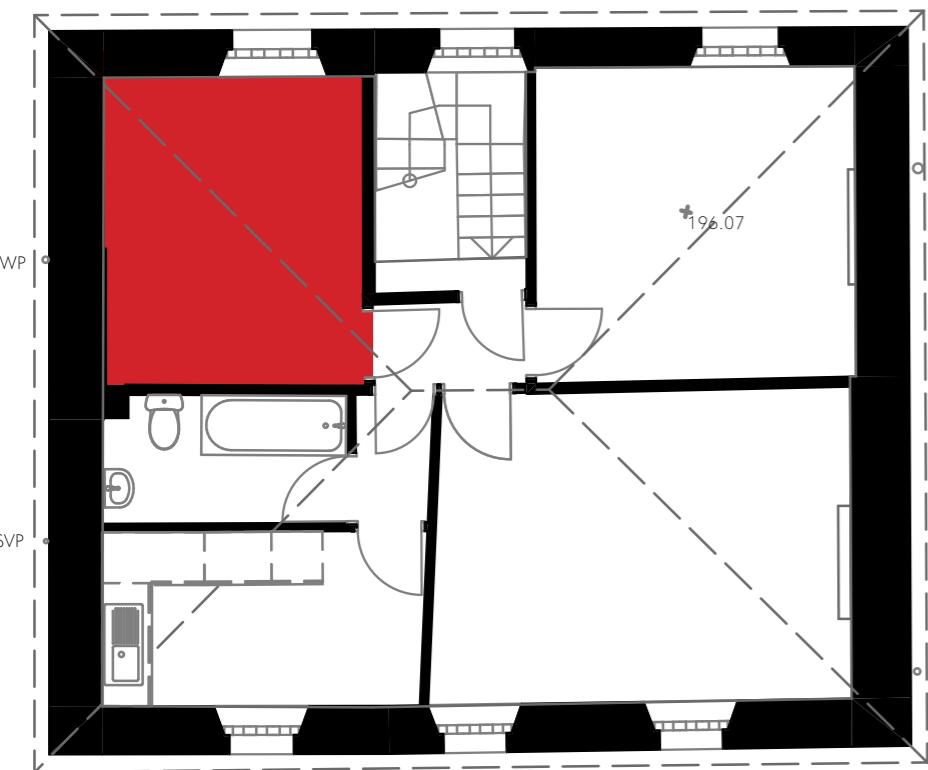
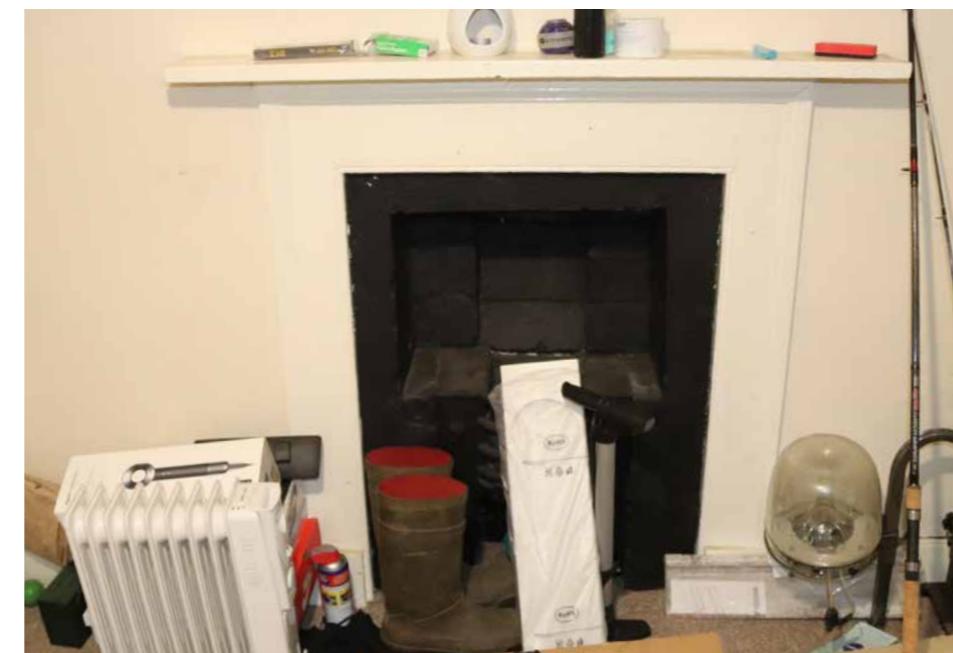
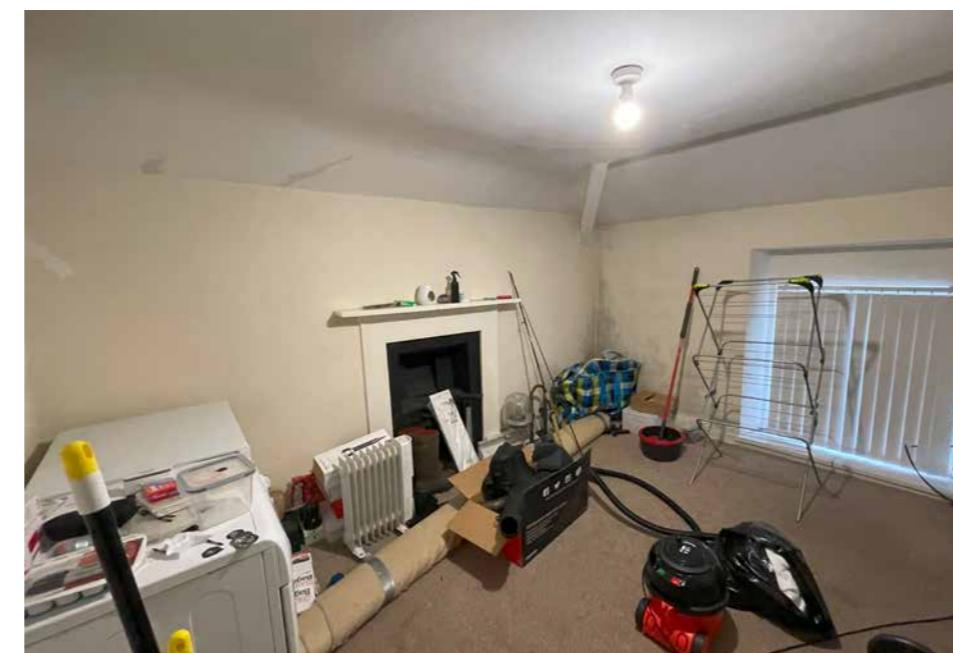
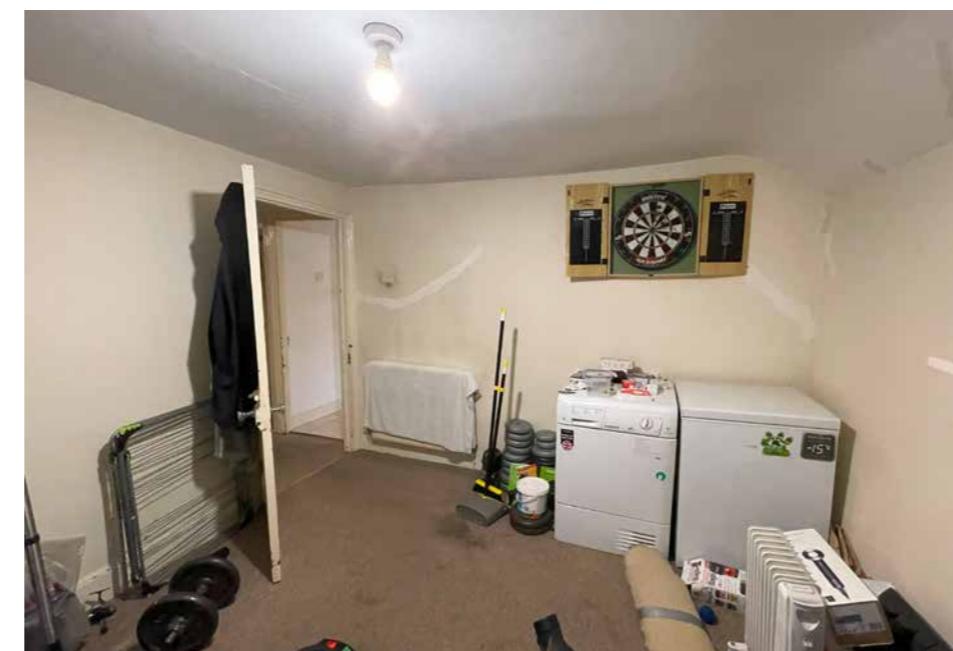
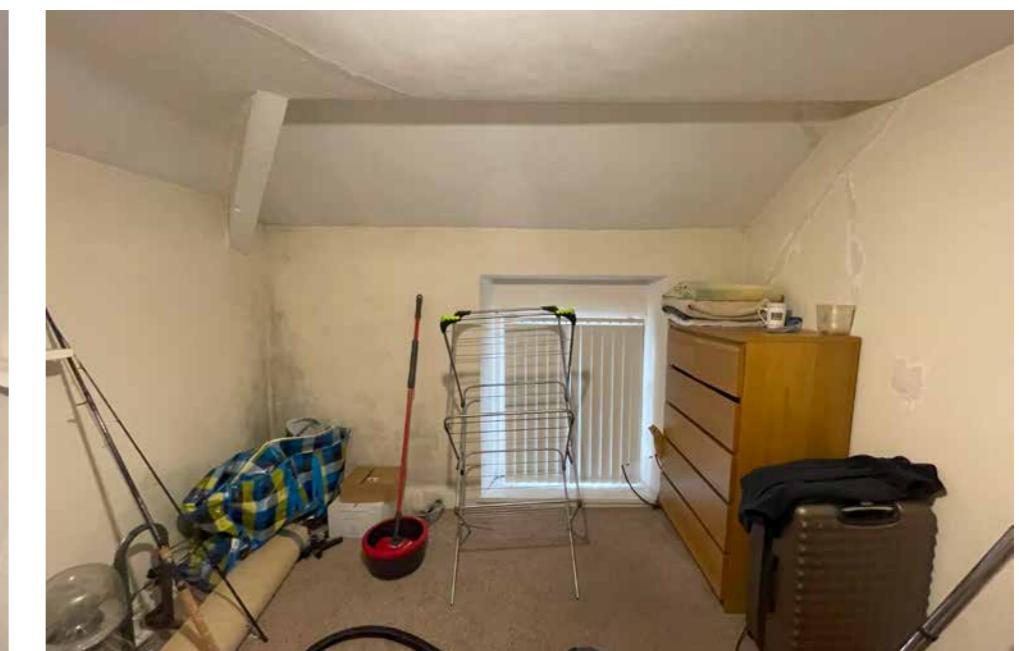
12.0 Interior - Second Floor - Rear North West Room

There is some staining on the walls and ceiling; and there appears to have been some areas of crack repair, fairly recently, to some of the plasterwork on the walls. The worst area of staining is to the external north west corner. This will require the plaster to be removed to see what is causing this.

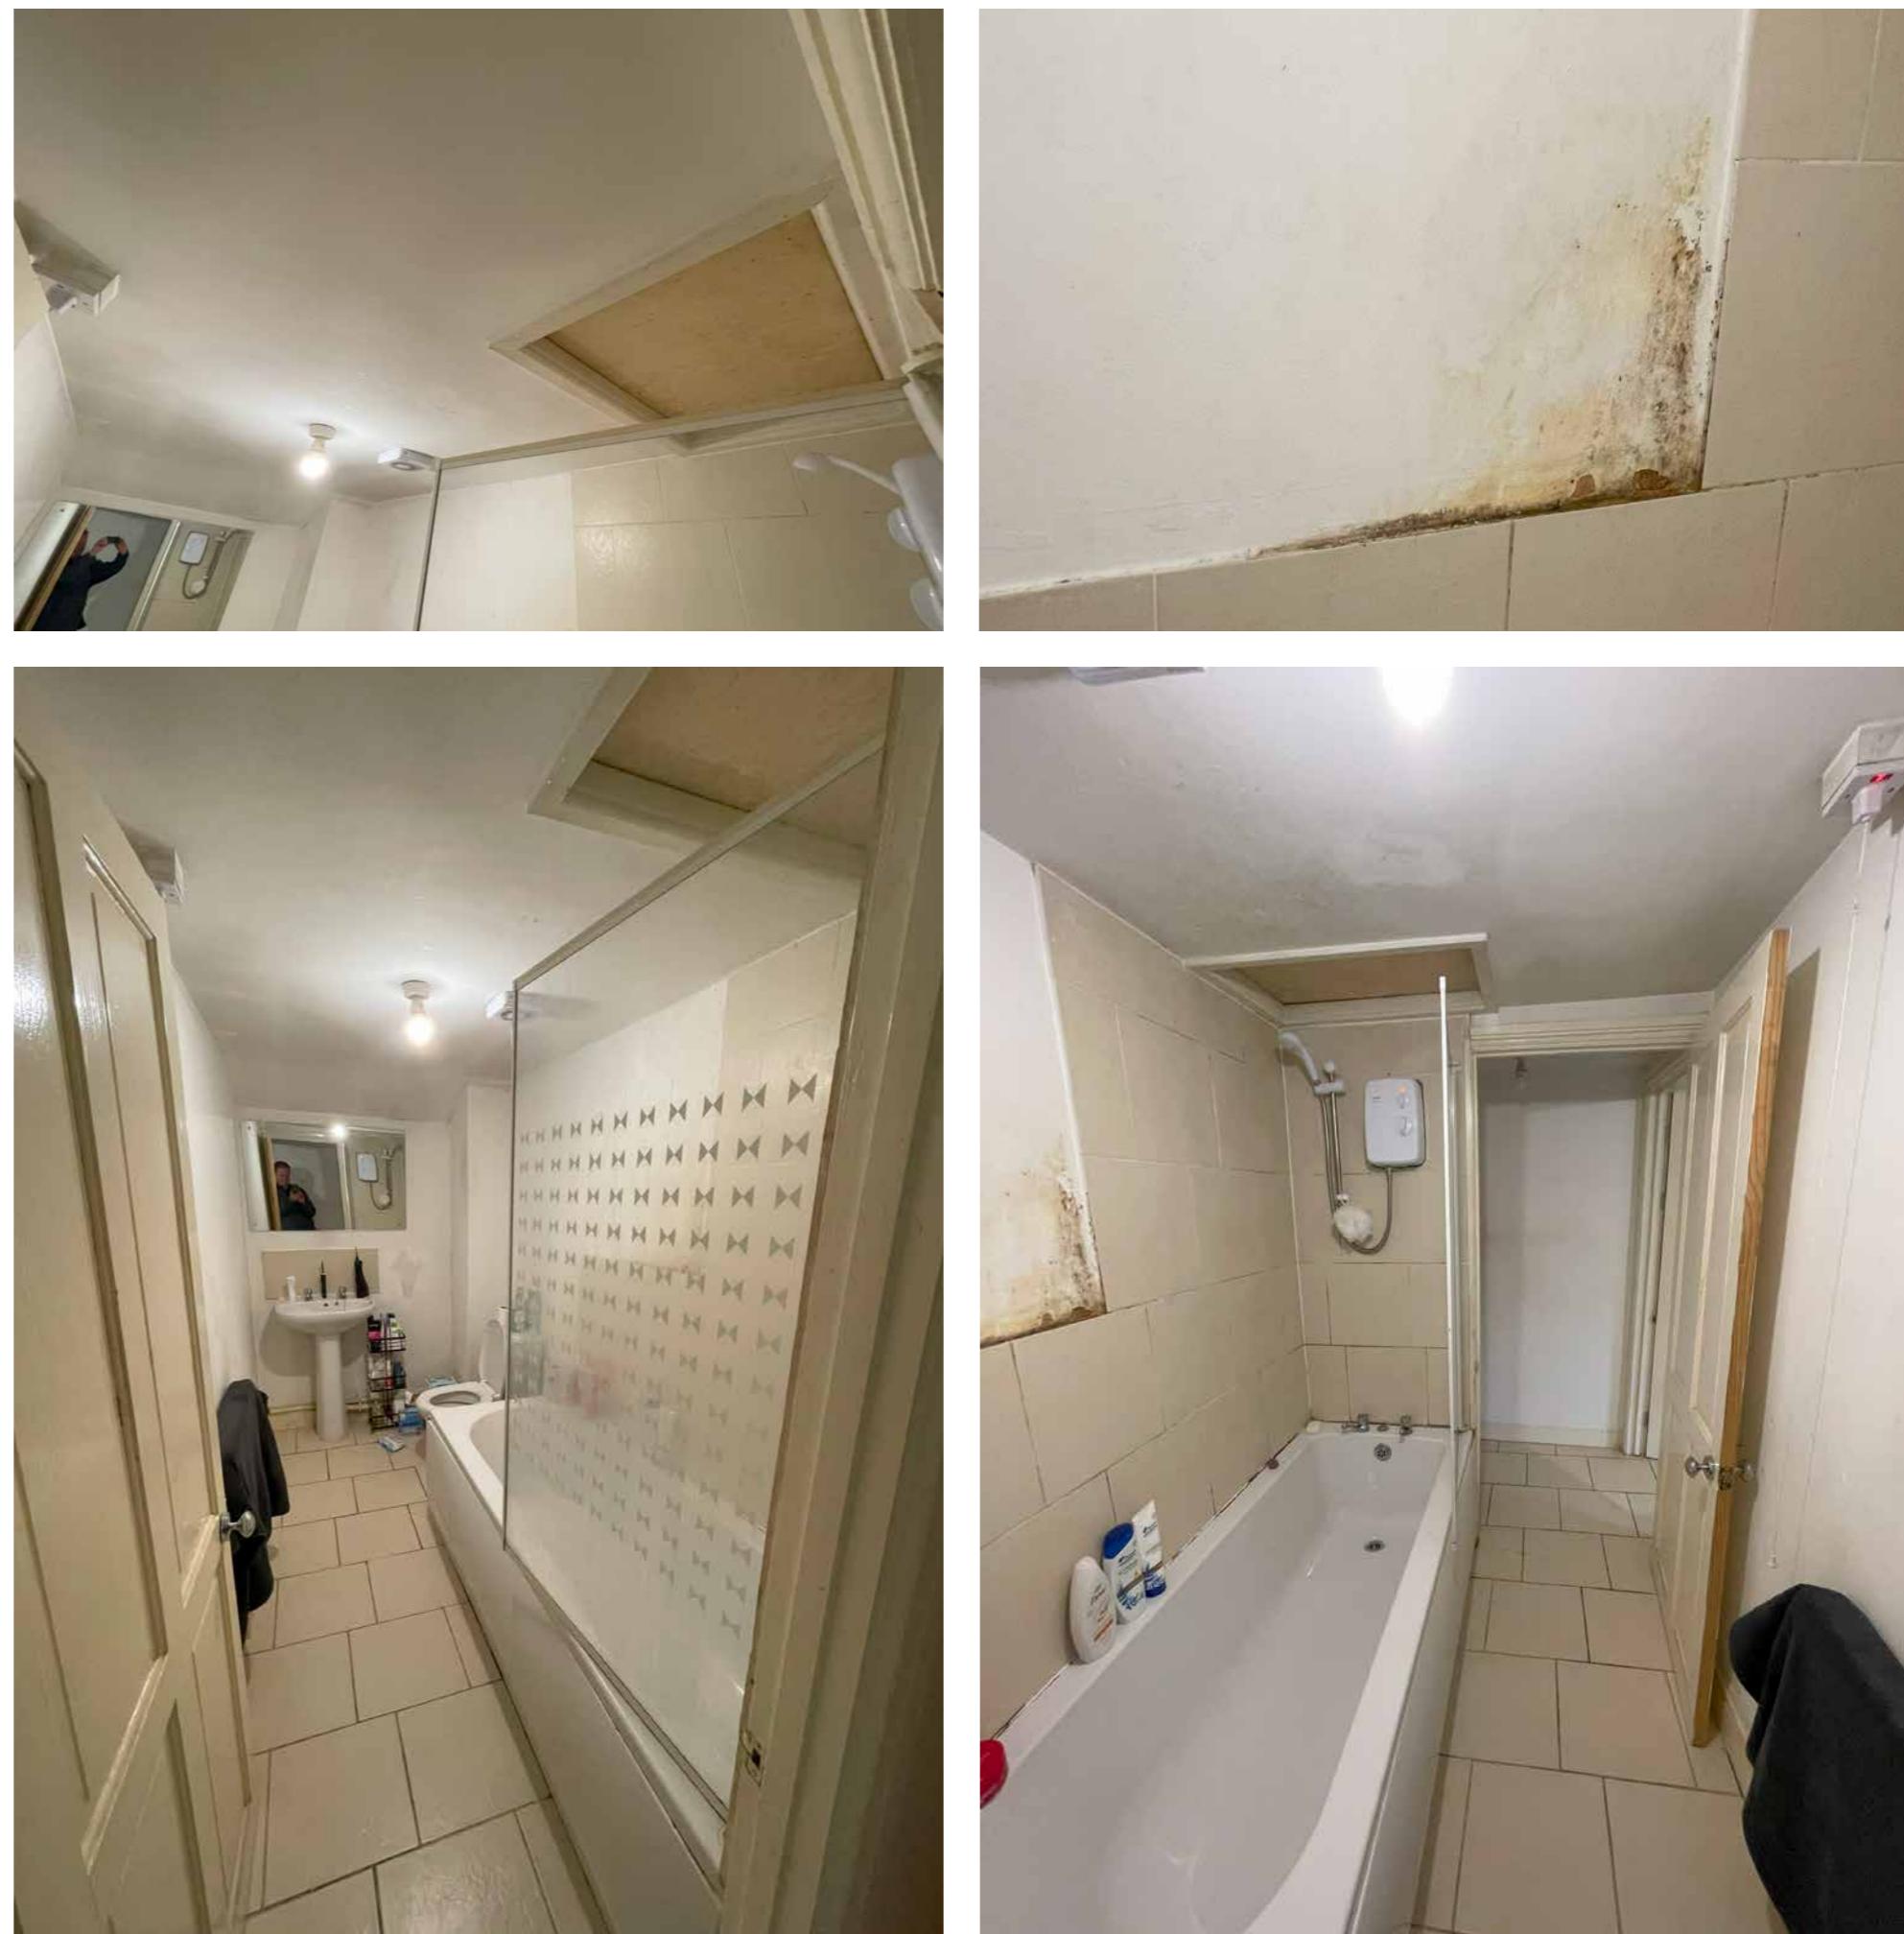
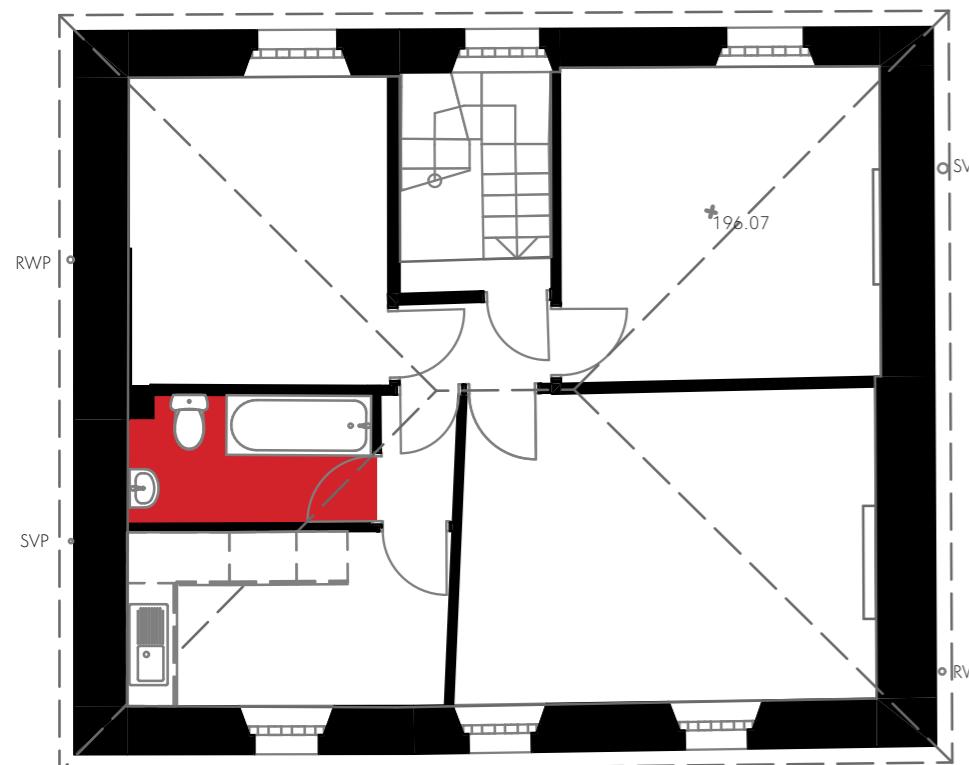
12.0 Interior - Second Floor - Bathroom

There is mould on one part of an internal wall; however, this is likely to be a case of moisture build-up and insufficient ventilation.

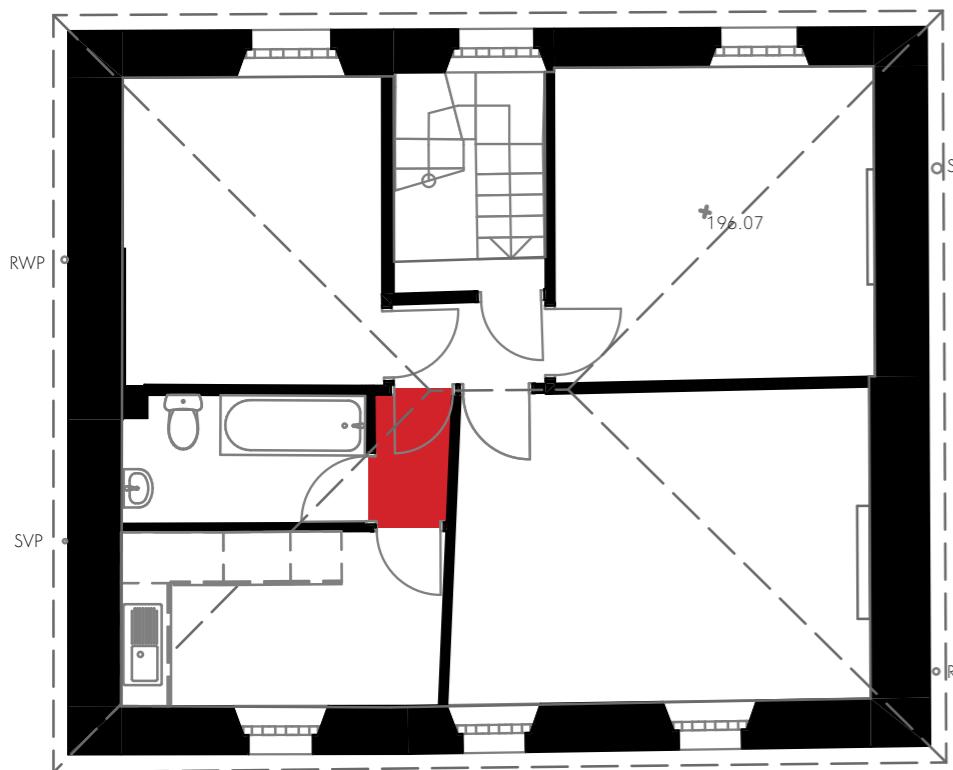
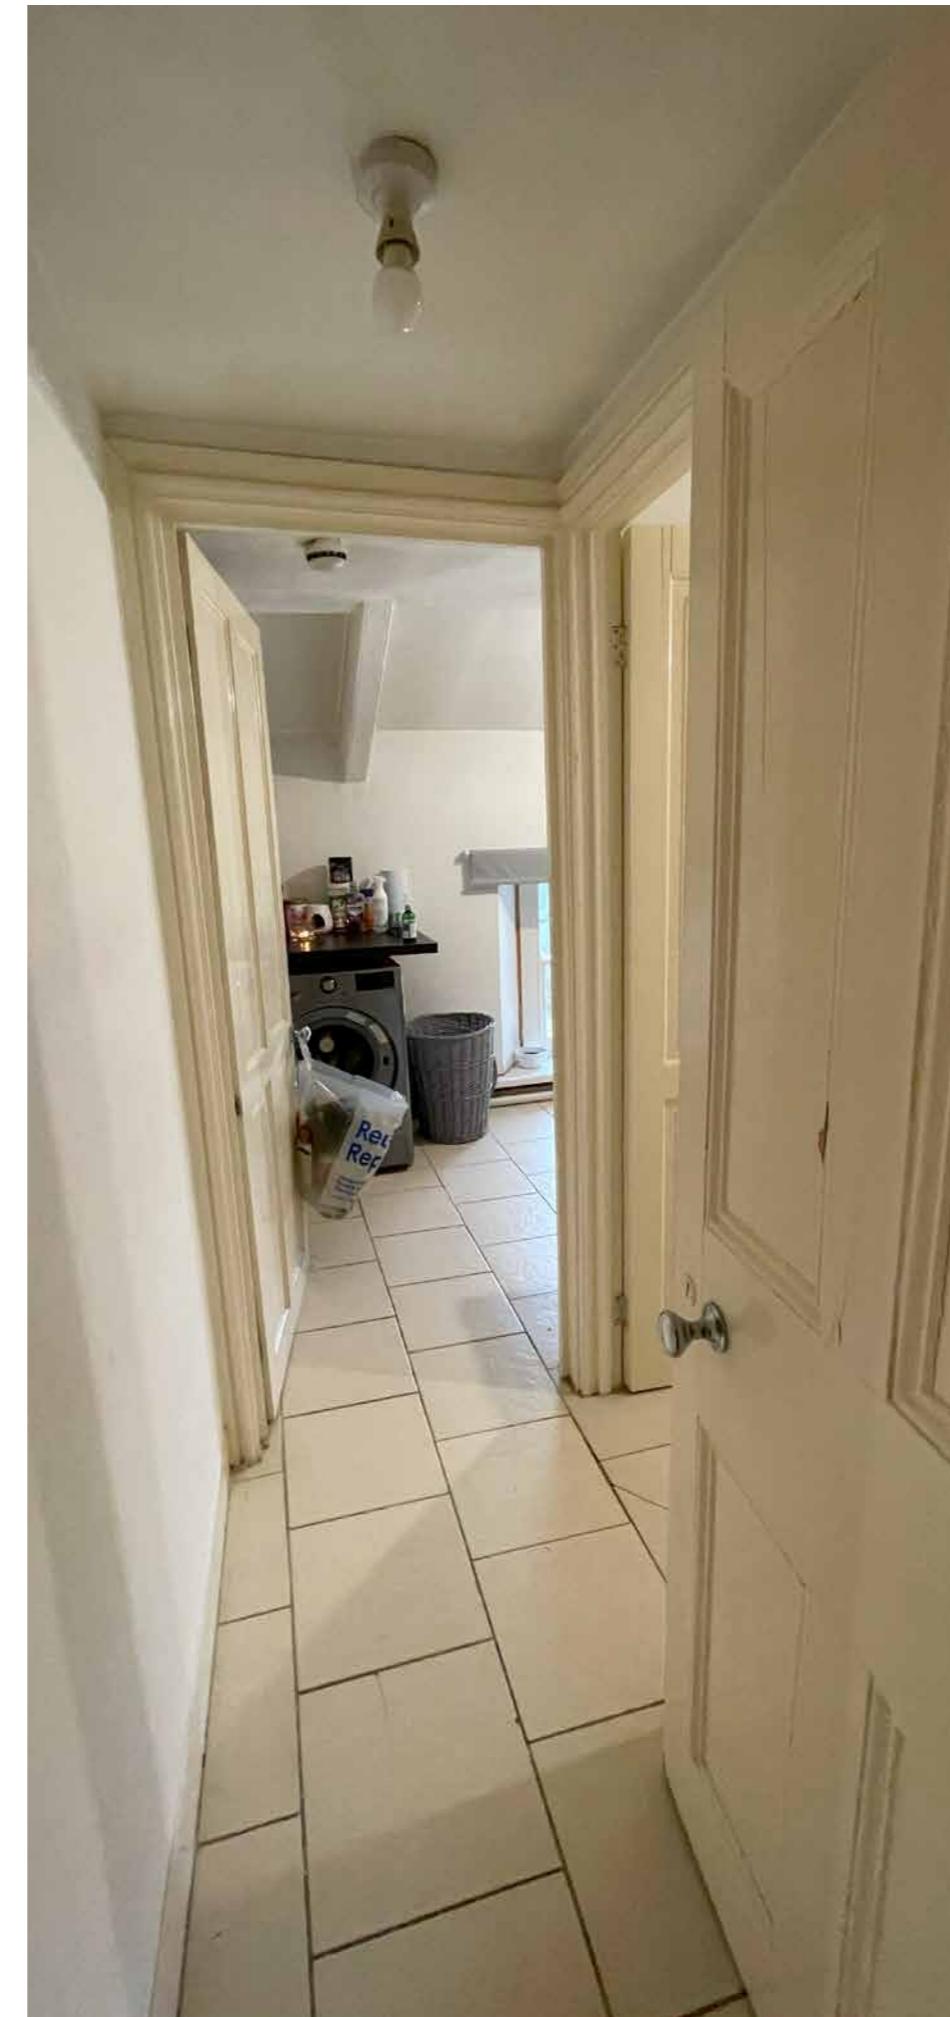
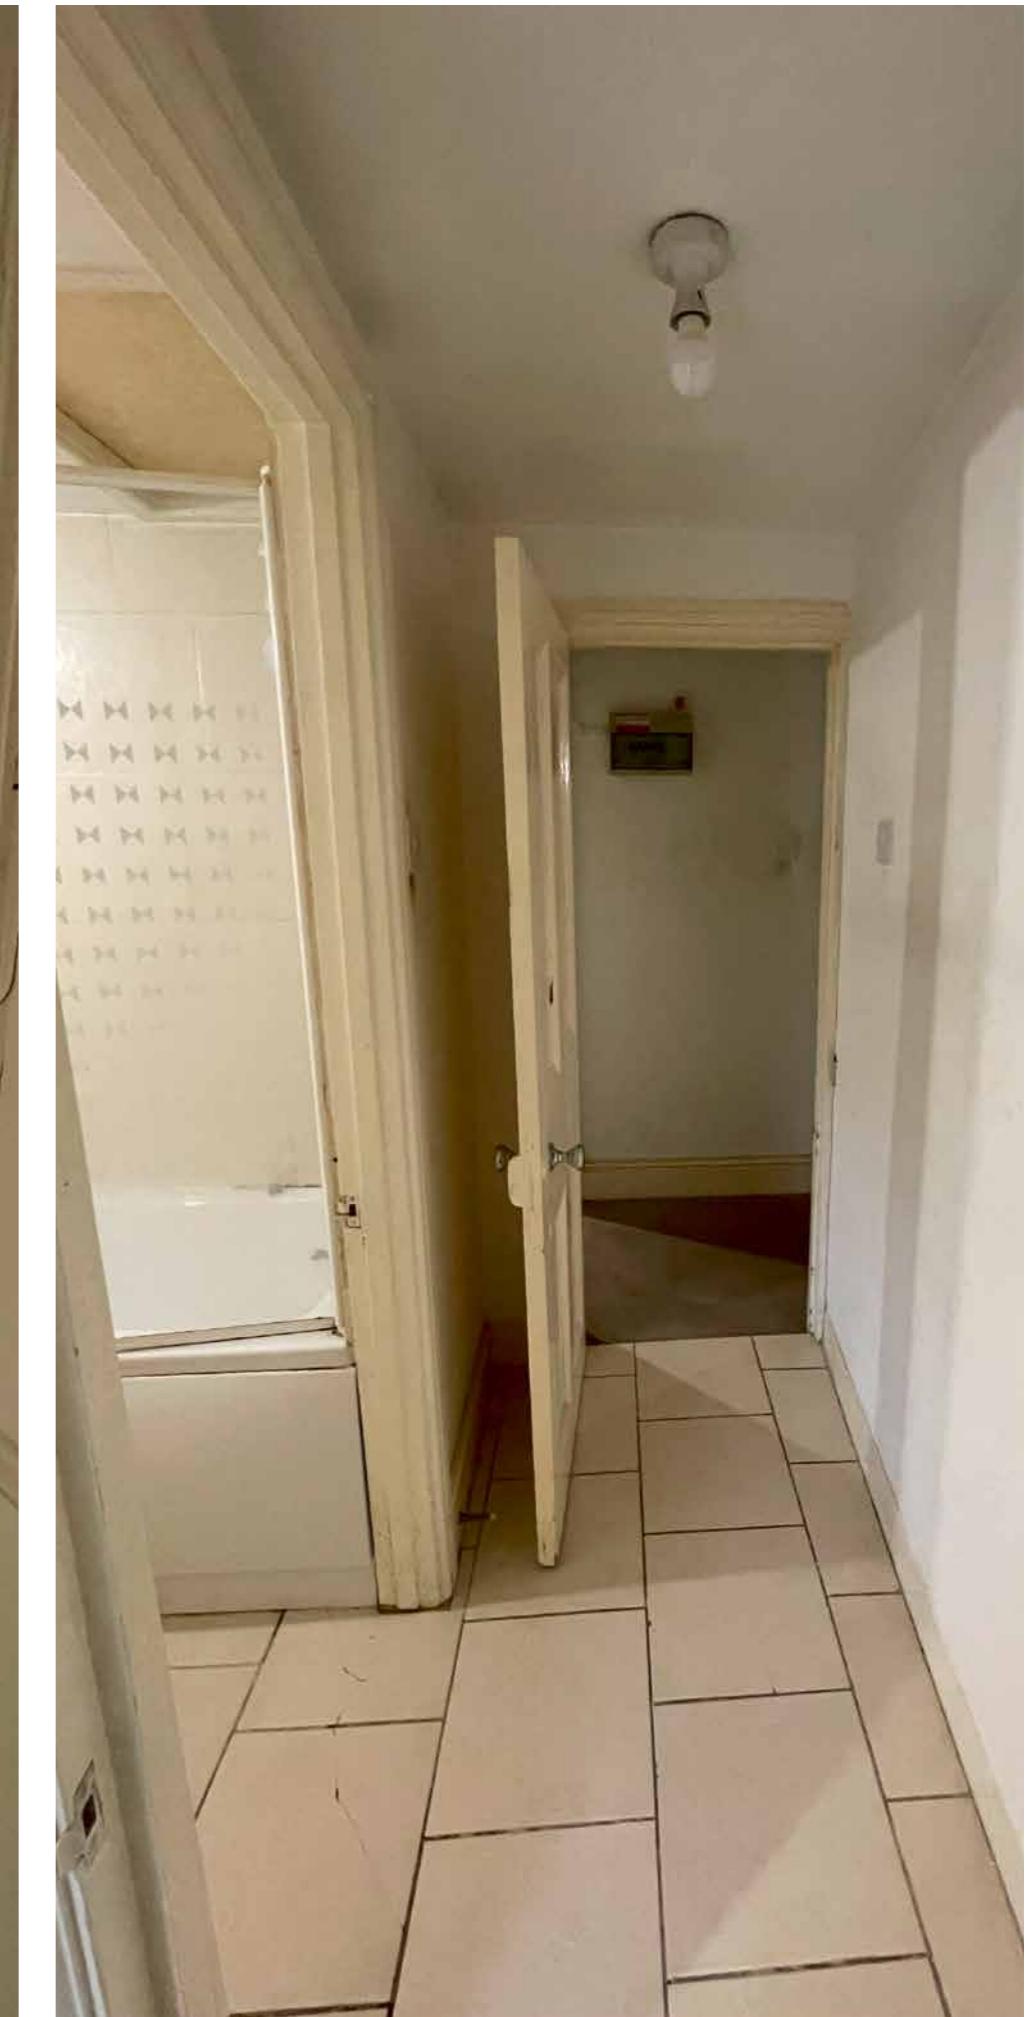
12.0 Interior - Second Floor - Lobby

The condition of this space appears to be reasonable.

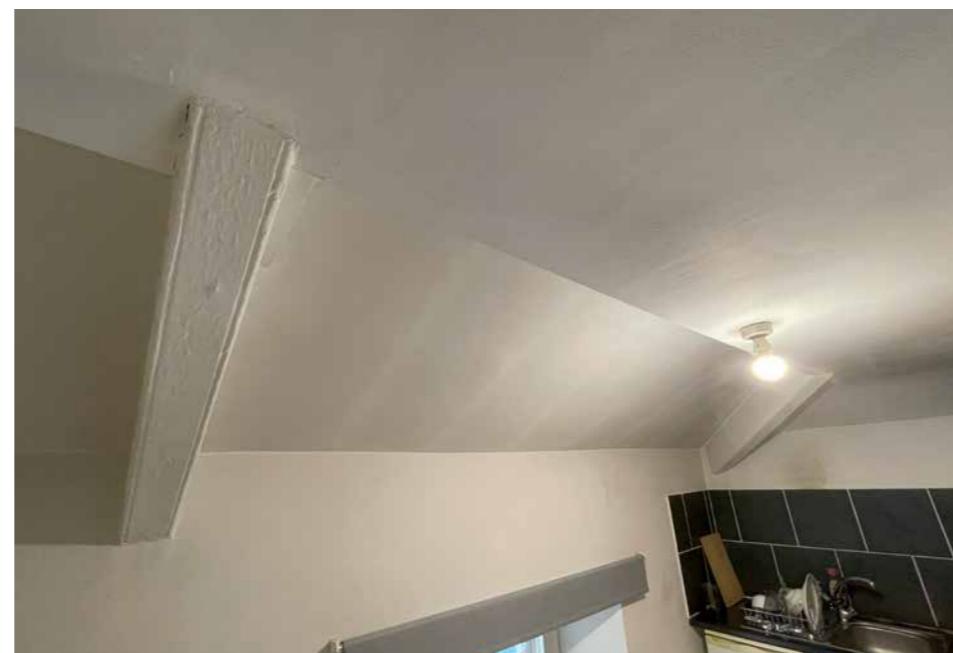
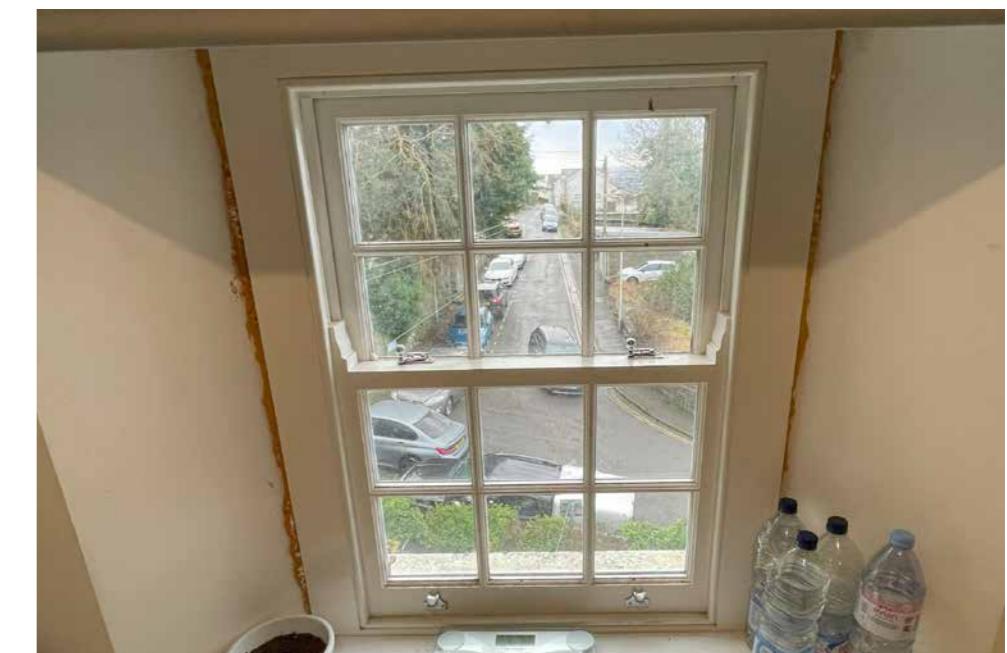
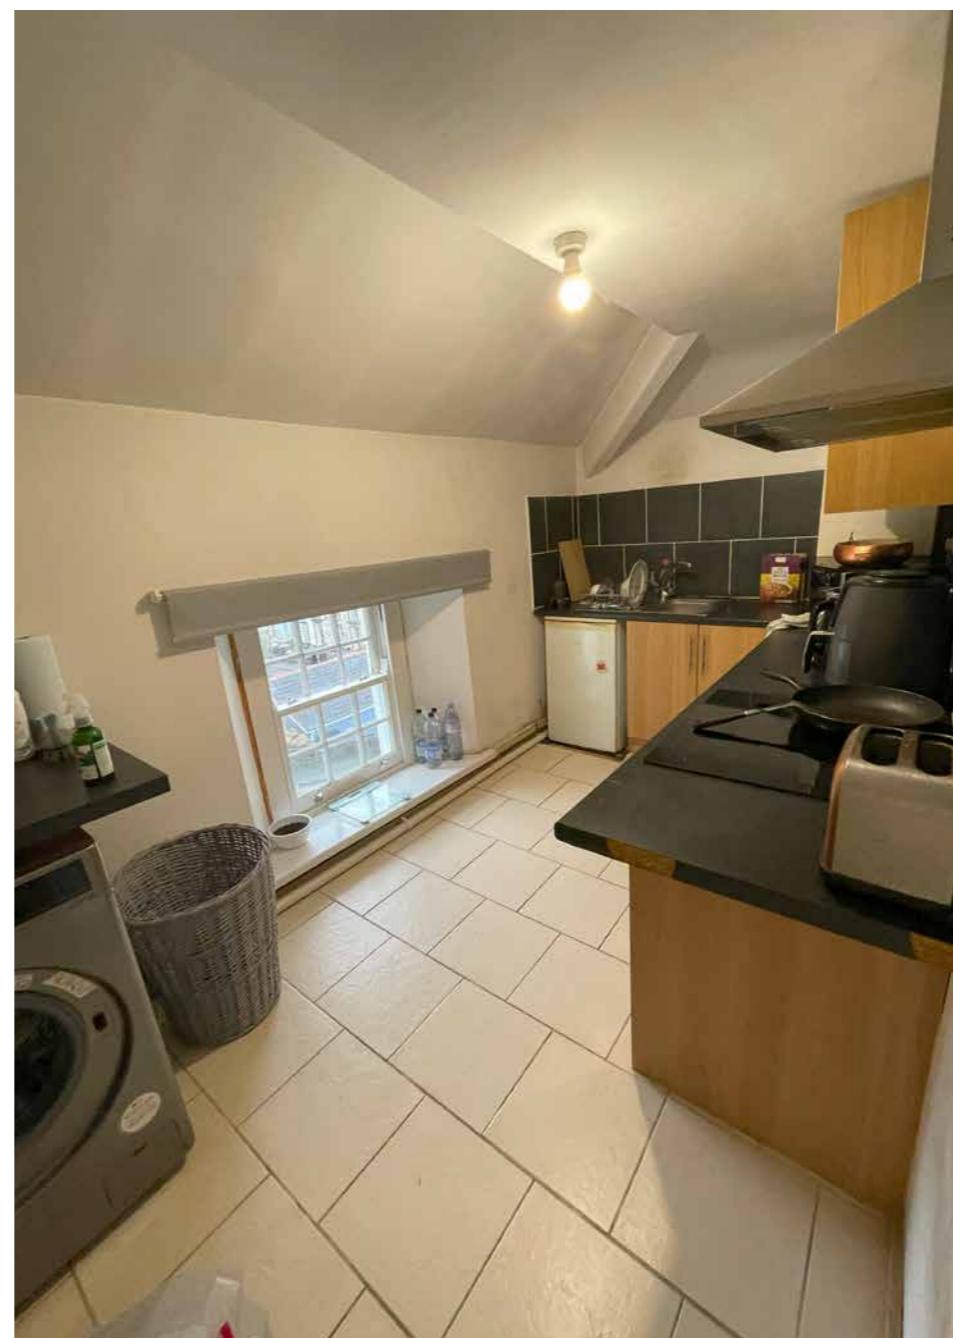
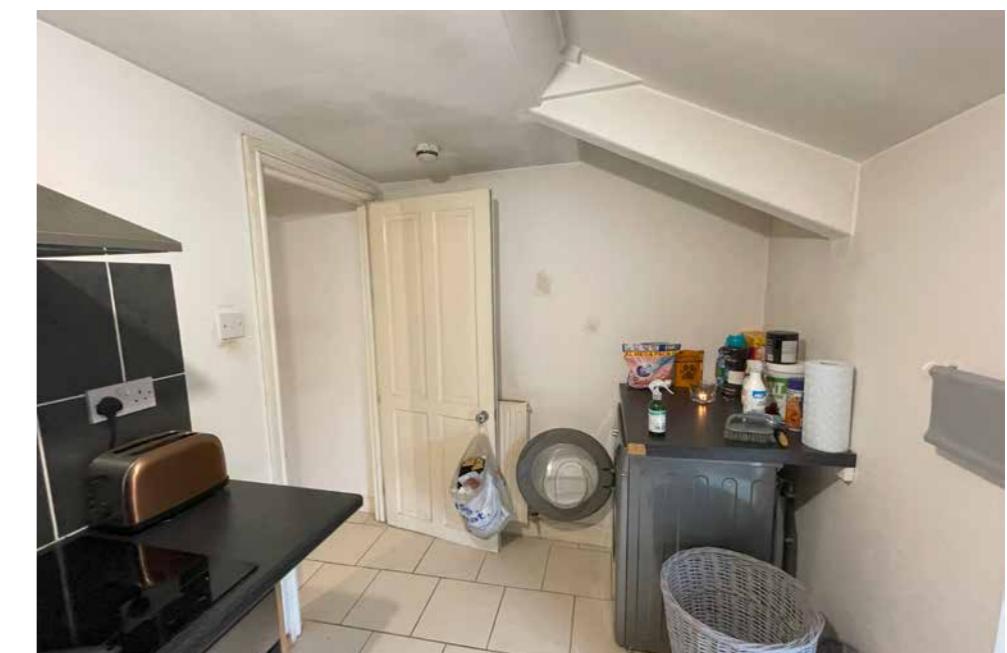
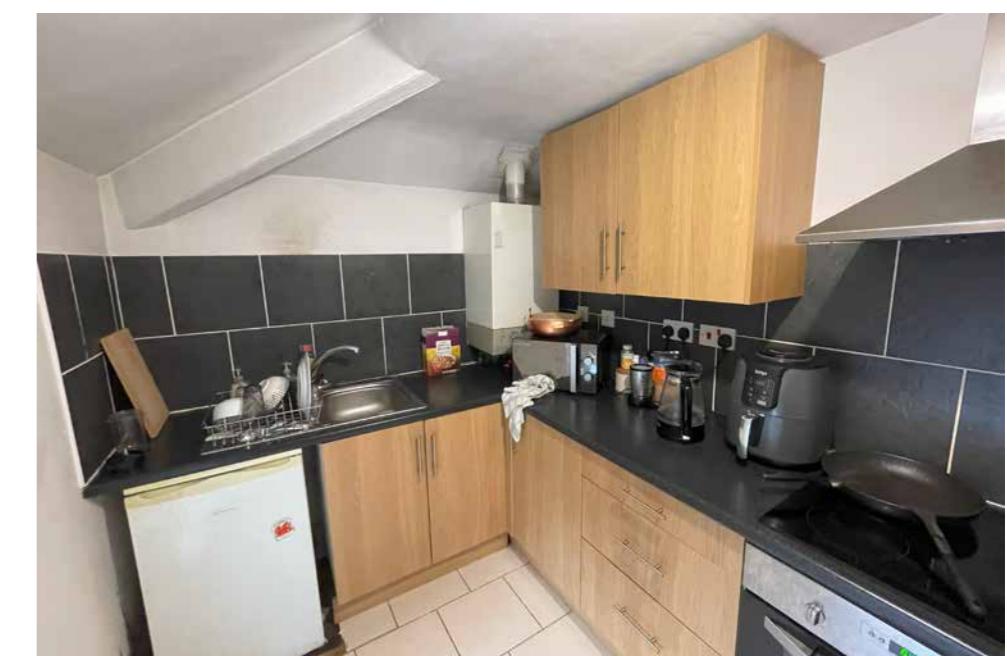
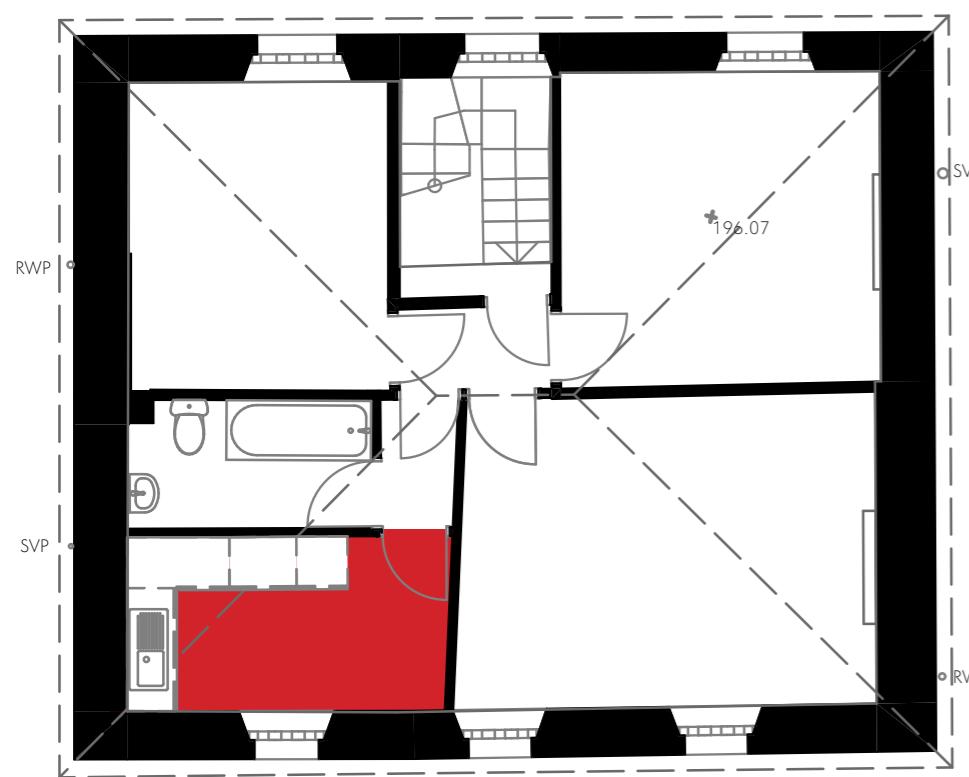
The floor is ceramic tiled; the door is a painted four-panelled timber door and the windows are painted timber sash windows with double glazing. It is notable that the windows have been recently inserted and/or sealed around the edges with piped insulation, as this insulation is still on view and has not been covered. The internal partitioning appears to be of plasterboarded timber studwork.

The condition of this room appears to be reasonable.

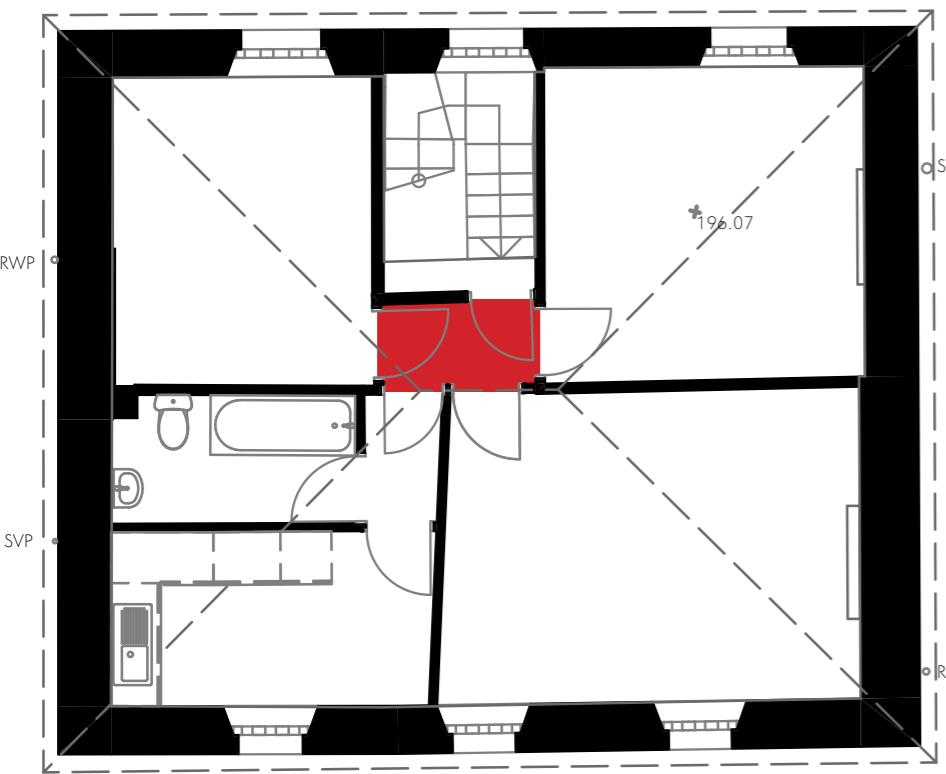
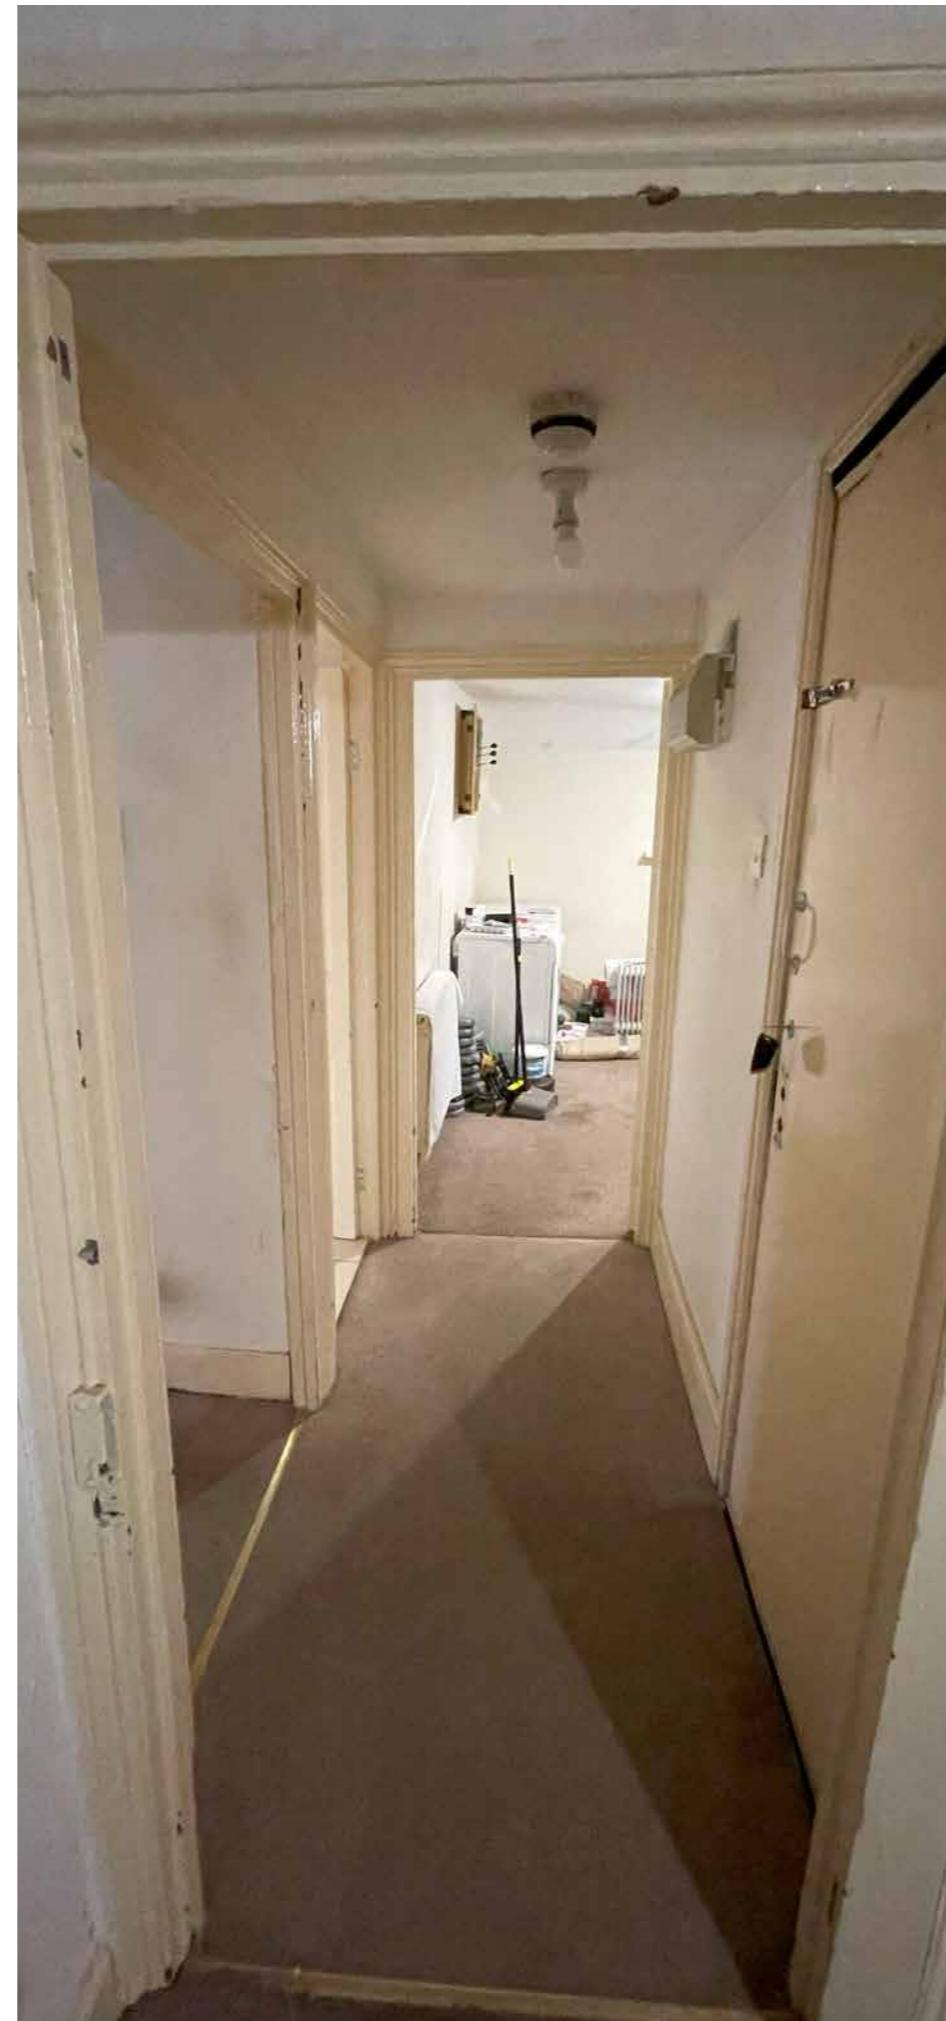
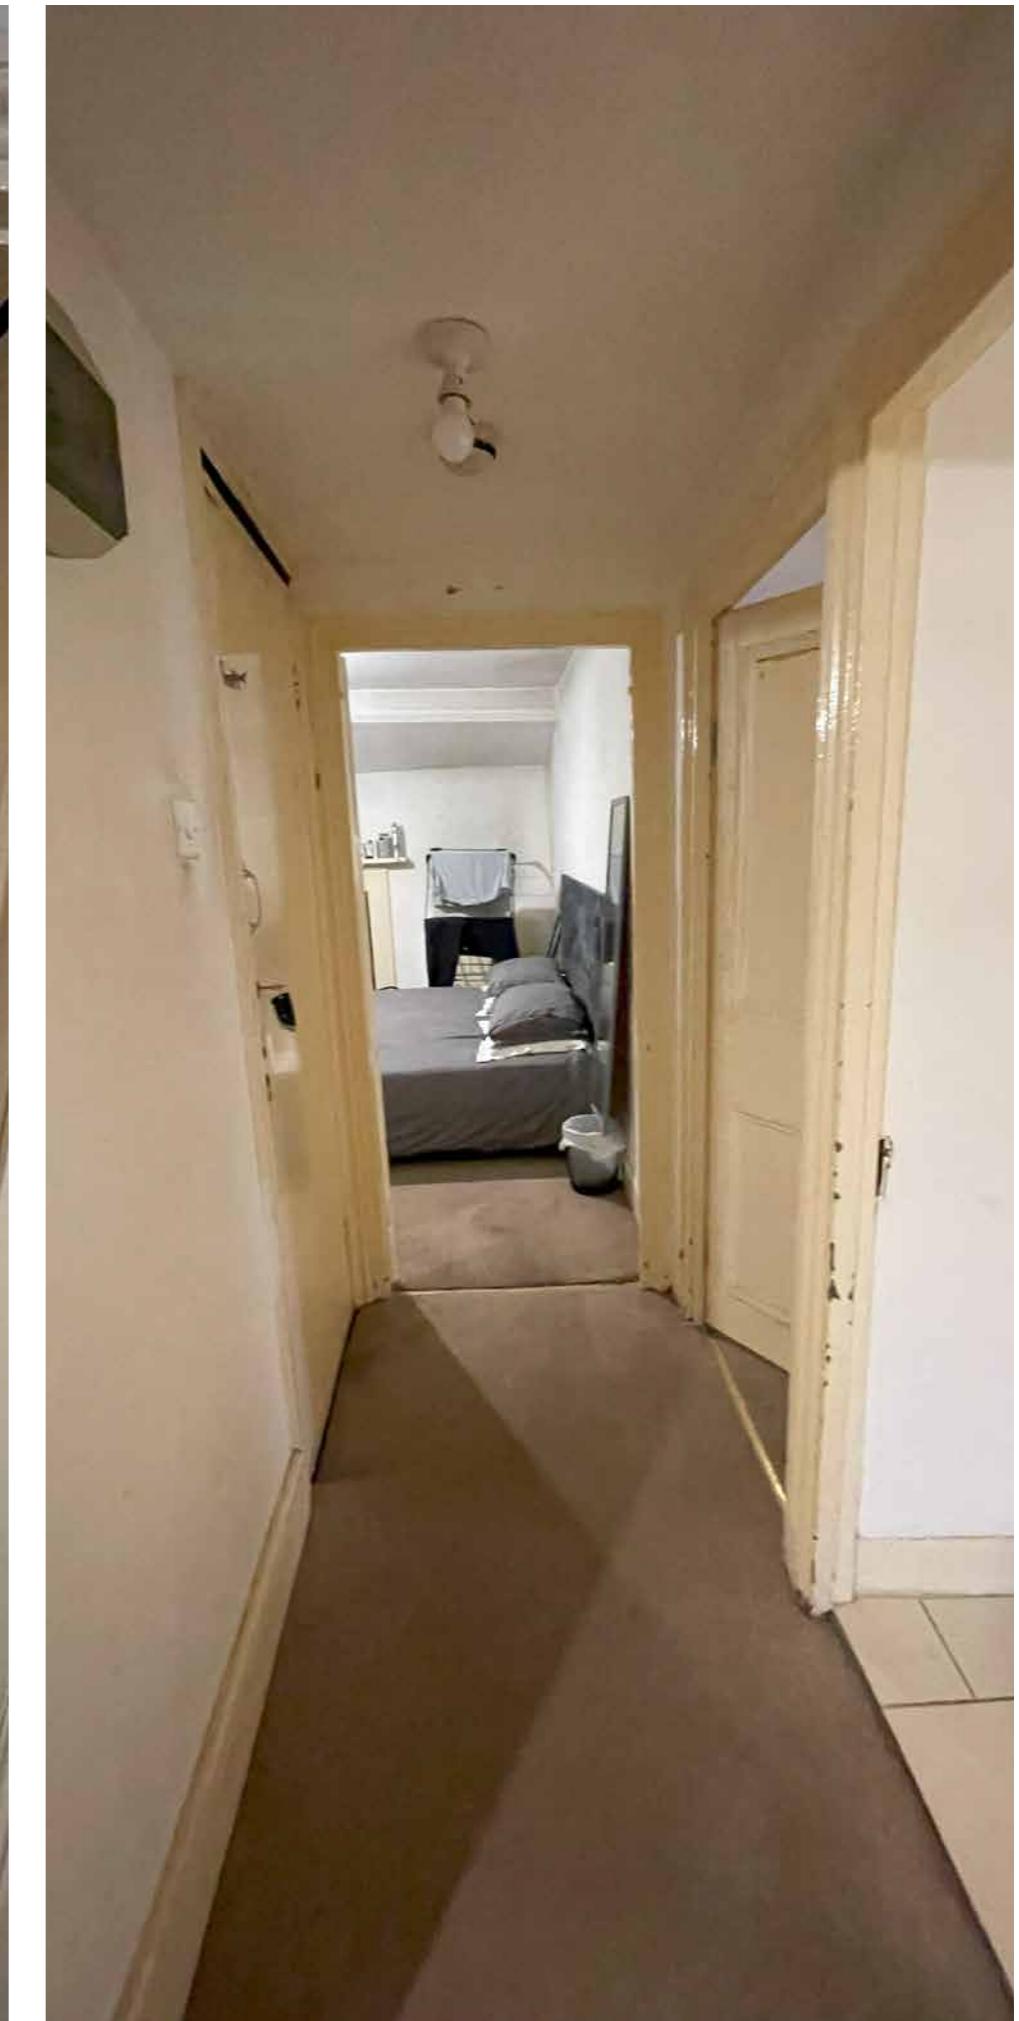
12.0 Interior - Second Floor - Corridor

This corridor is also of painted plastered walls and ceiling with no cornice. The floor is carpeted. The doors are painted four-panelled timber doors.

The condition of this area appears to be reasonable.
