Primrose Hill, Merthyr Tydfil

RECORD OF BUILDING AND CONDITION ASSESSMENT REPORT, WITH REPAIR PROPOSALS

.....(449)2503-GVWP-A-HIS-P01

Date: 05.03.25

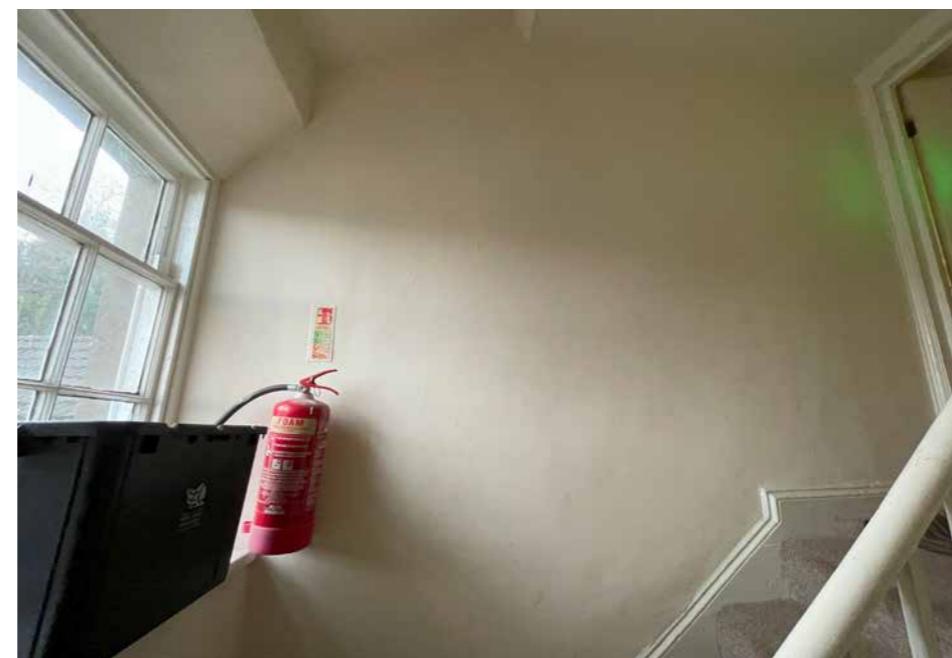
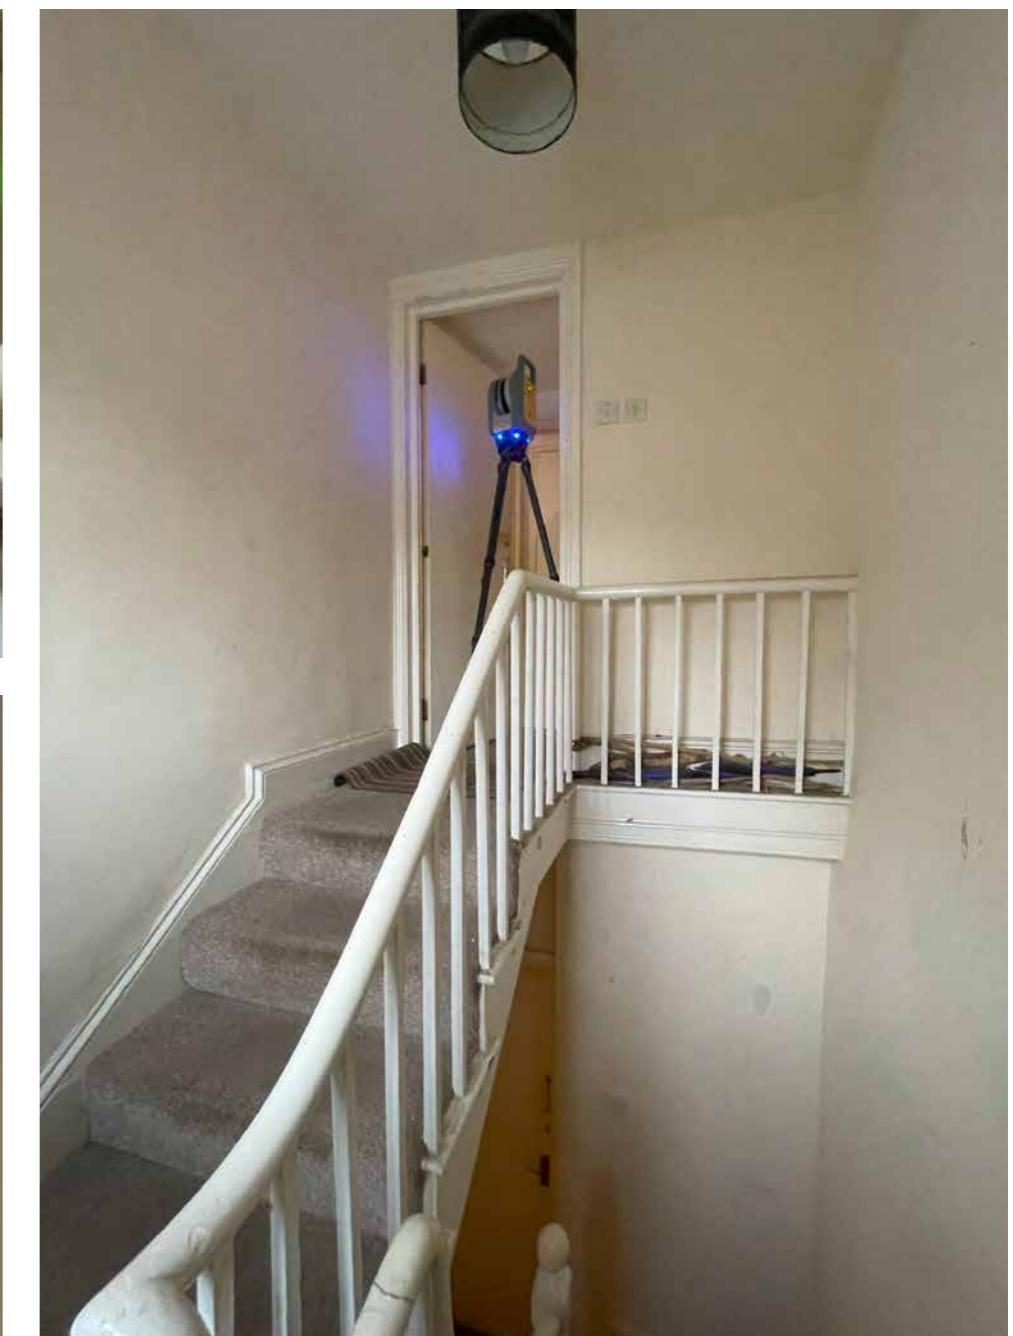
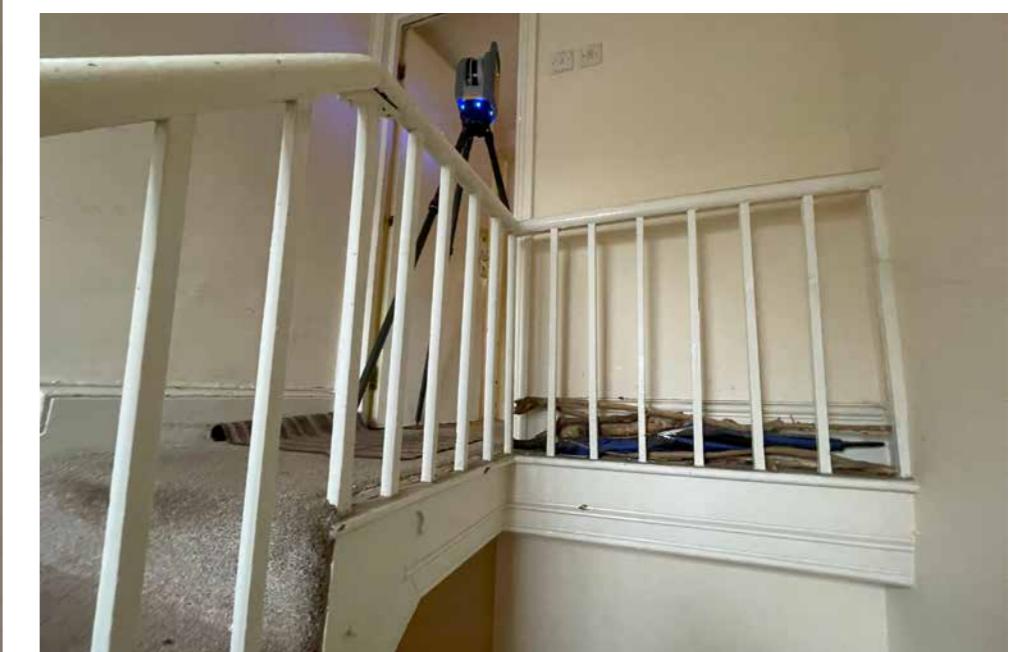
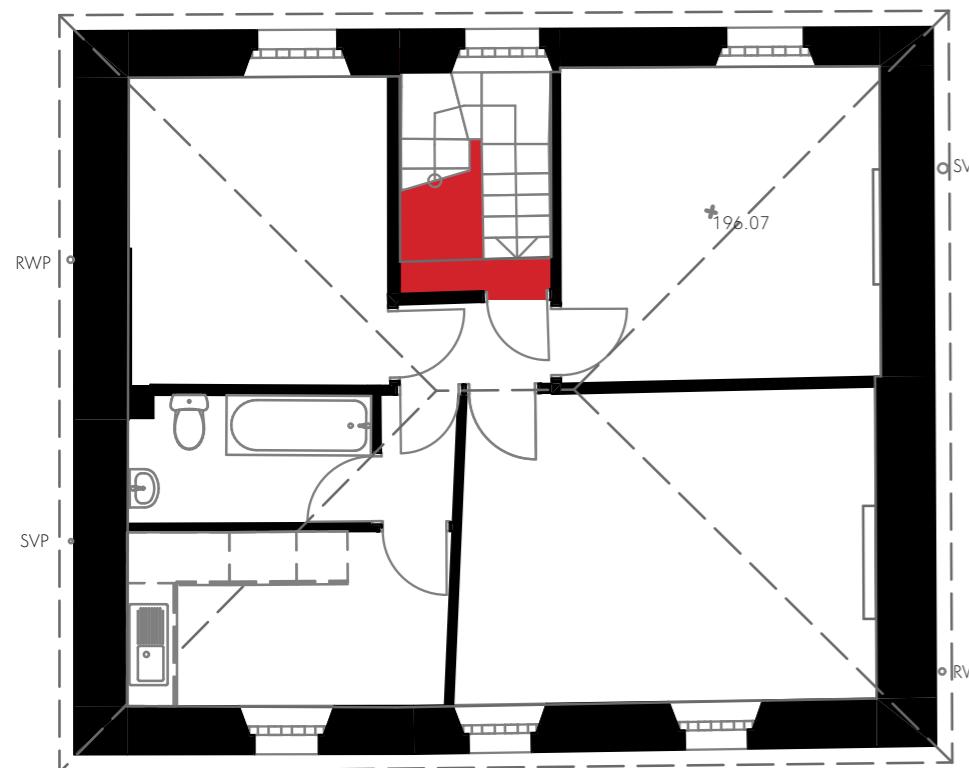
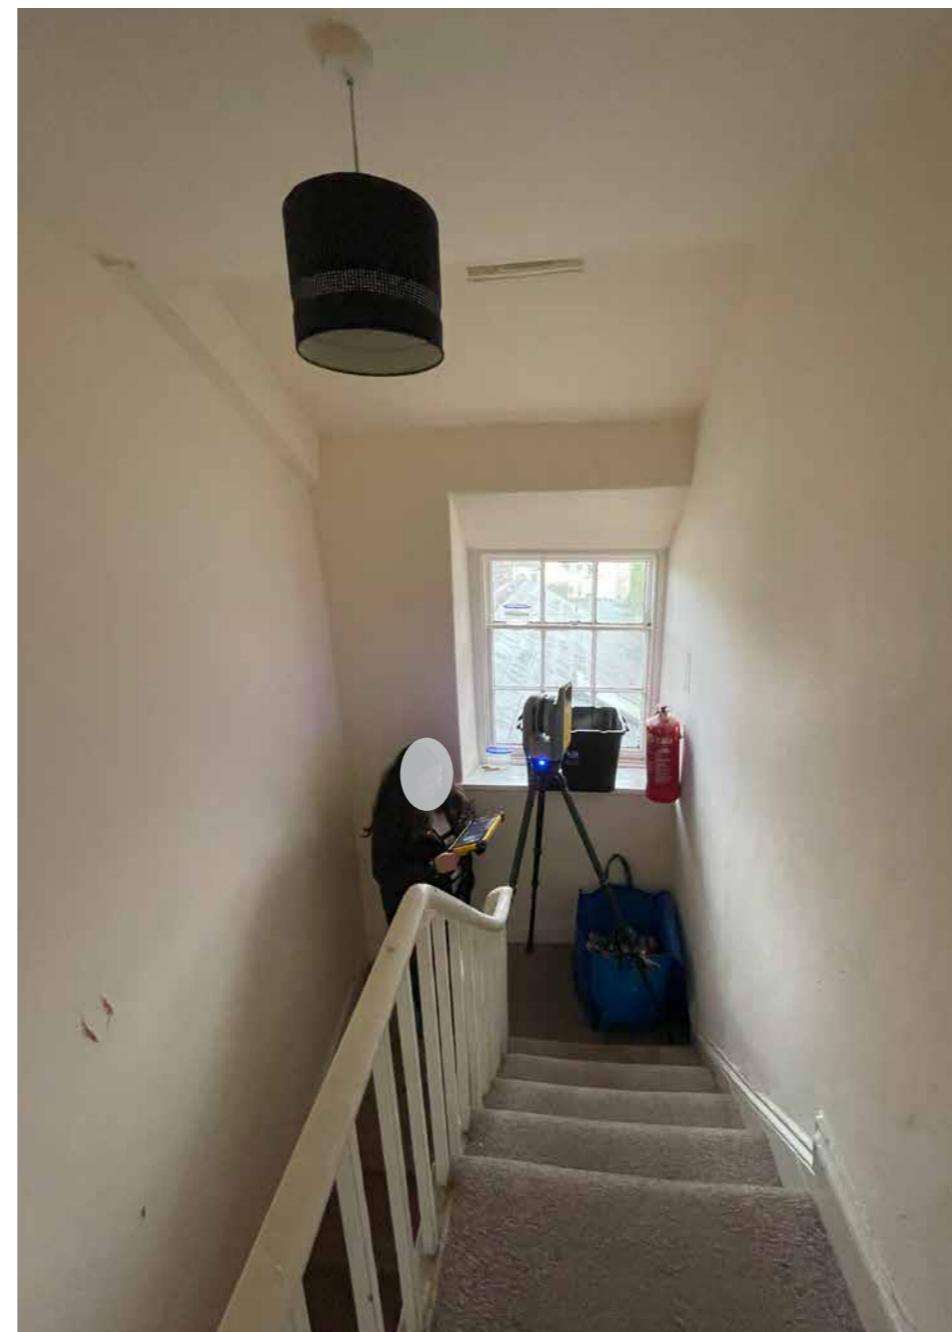
12.0 Interior - Second Floor - Staircase

The single staircase is a timber staircase, carpeted; with an ovoidal handrail, square balusters and a turned round newel posts; all painted white. Aside from the wear on the carpet, this appears all to be in reasonable condition.

The condition of this area appears to be reasonable.

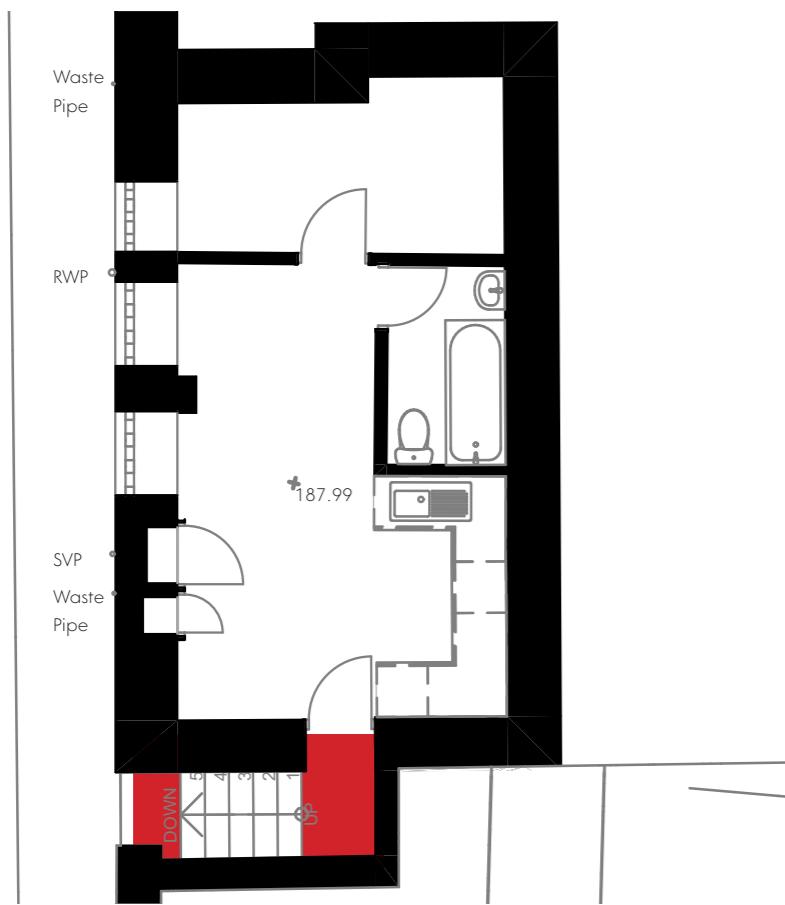
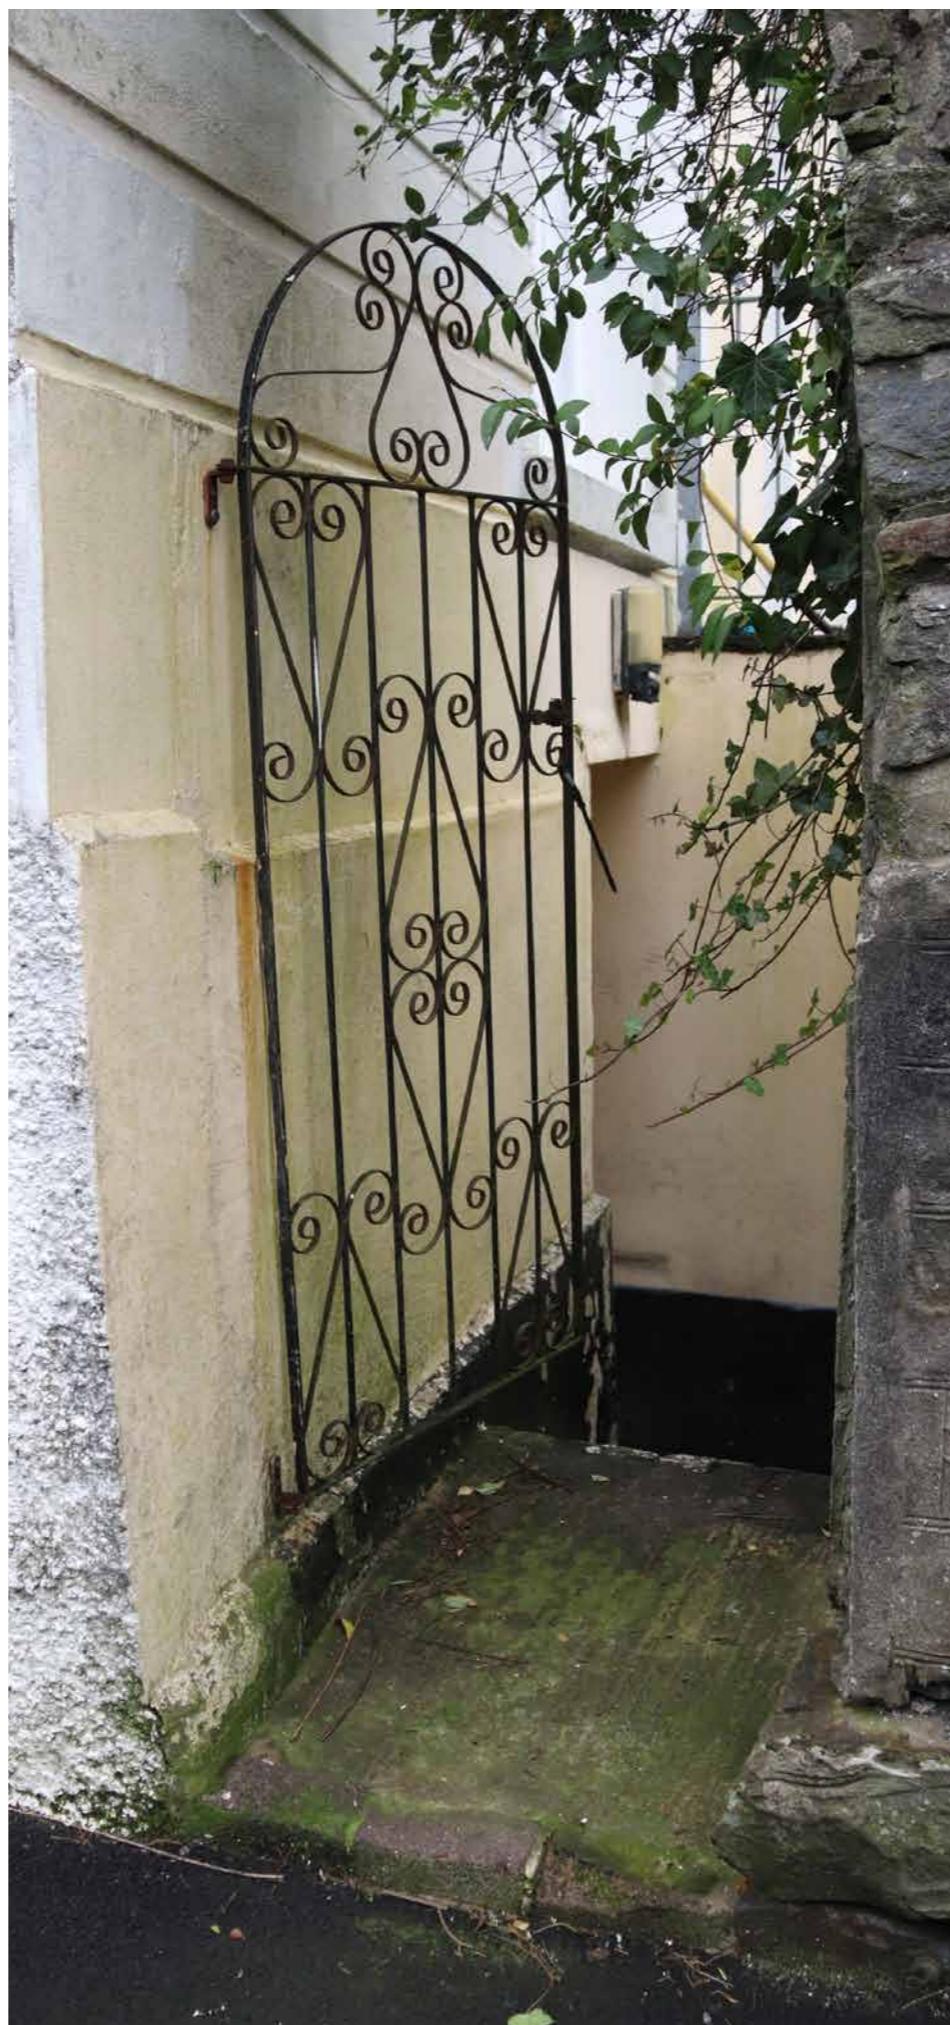
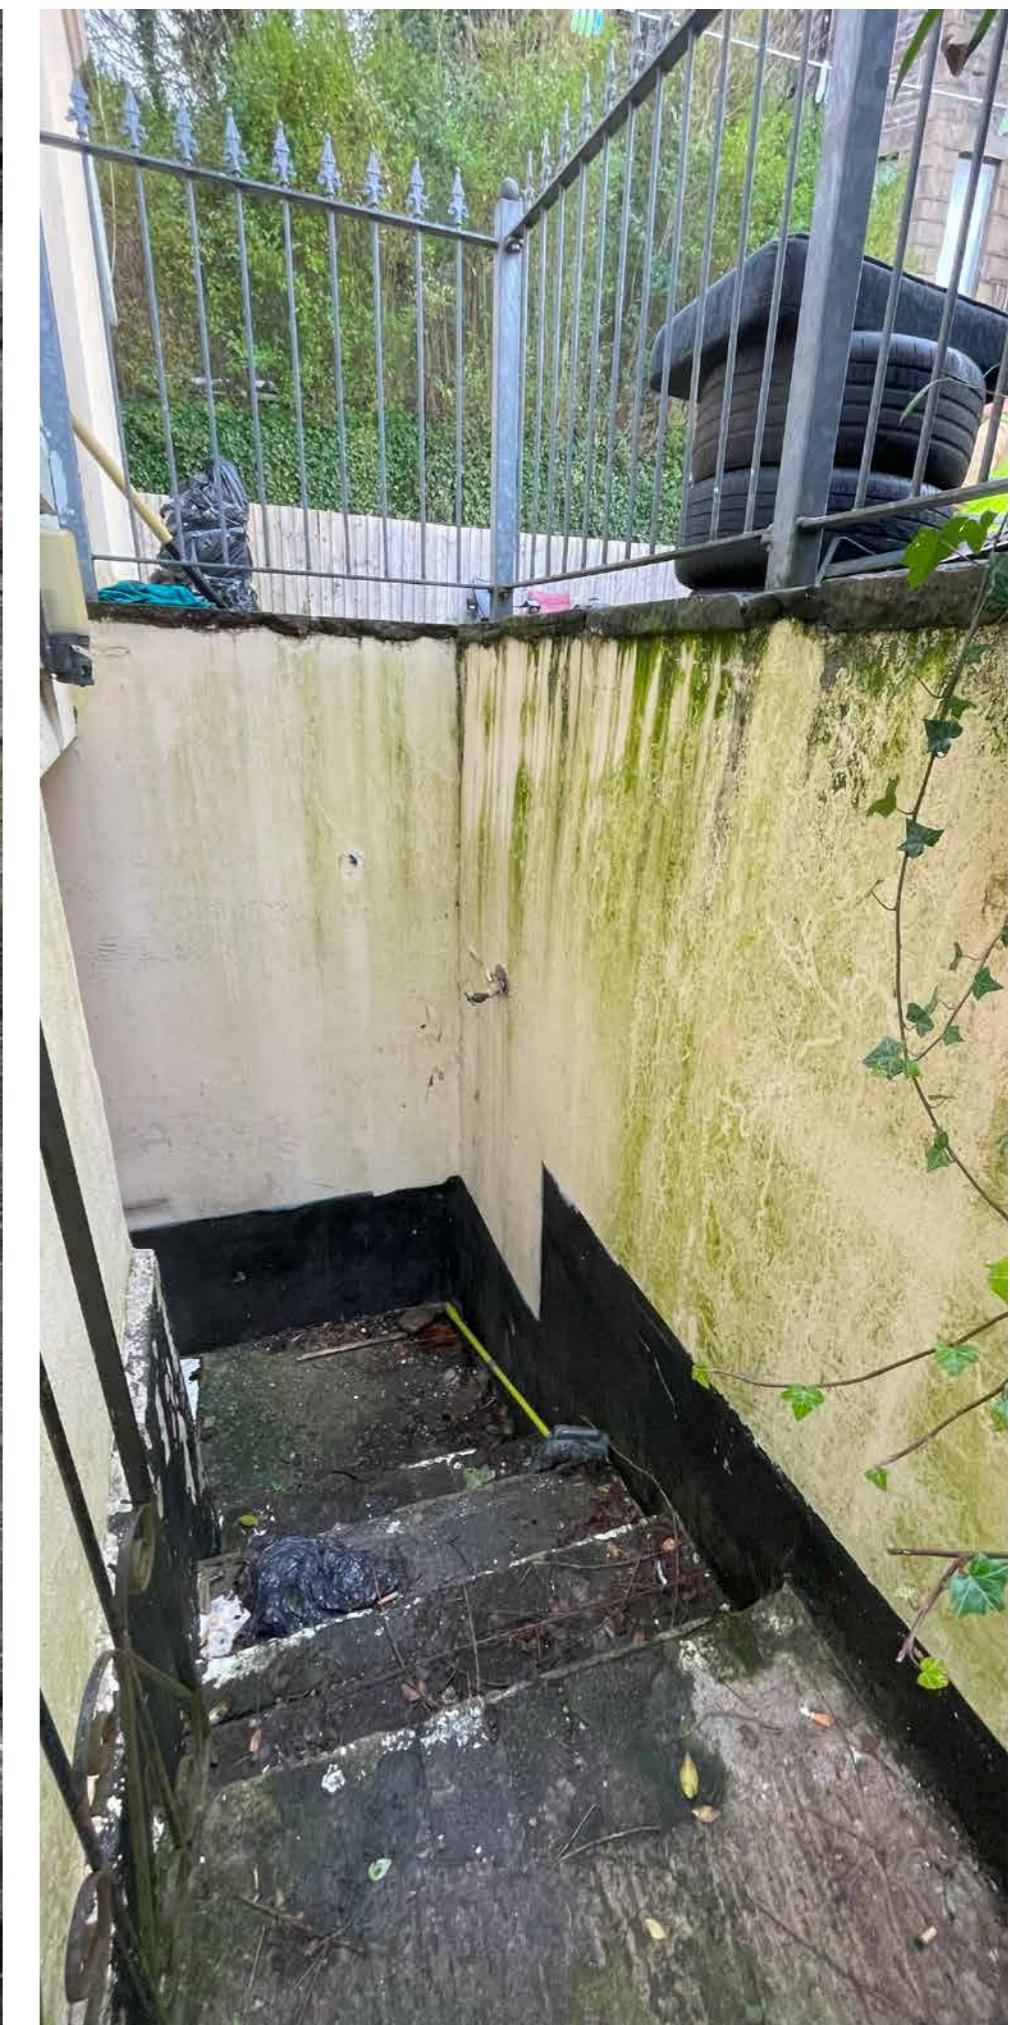
13.0 Interior - Lower Ground Floor Flat Entrance

The lower ground floor flat is entered from the side lane, down a series of four concrete steps, with cement rendered walls either side. An attractive metal gate is at the top of the steps.

The proposals involve a good clean of the steps and the application of safety nosings to each step, as they are currently potentially slippery.

The outer wall is proposed to be cleaned of the organic staining and repainted. The inner wall is proposed - as with the rest of this elevation - to be hacked off and a new, lime render applied.

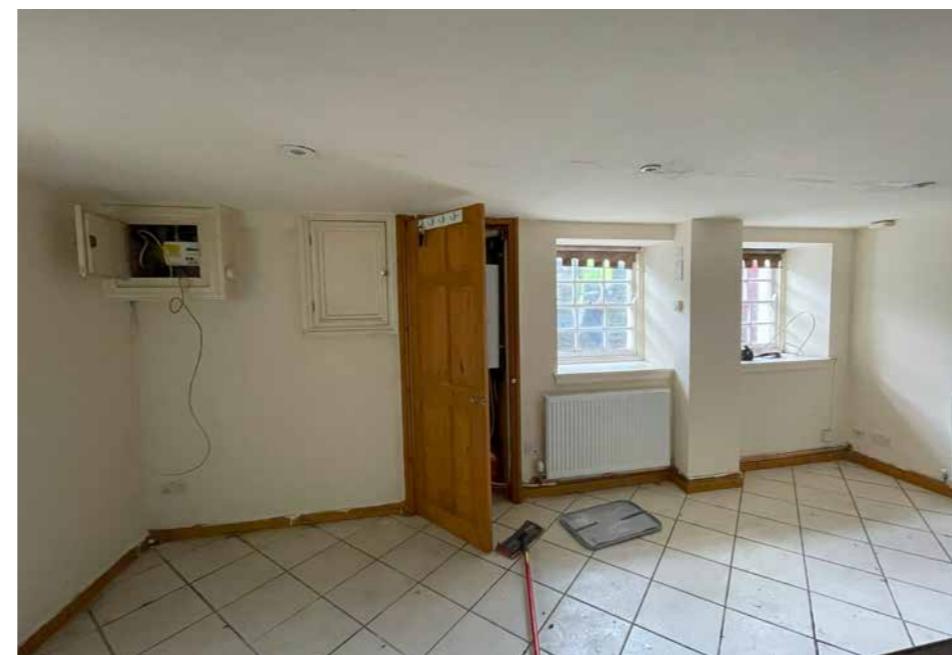
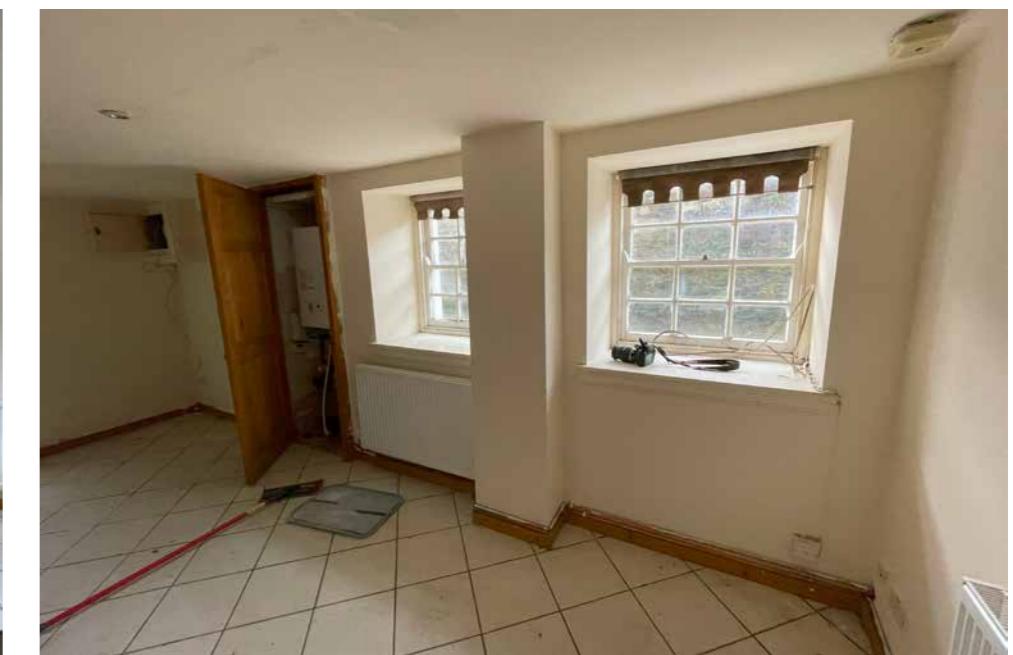
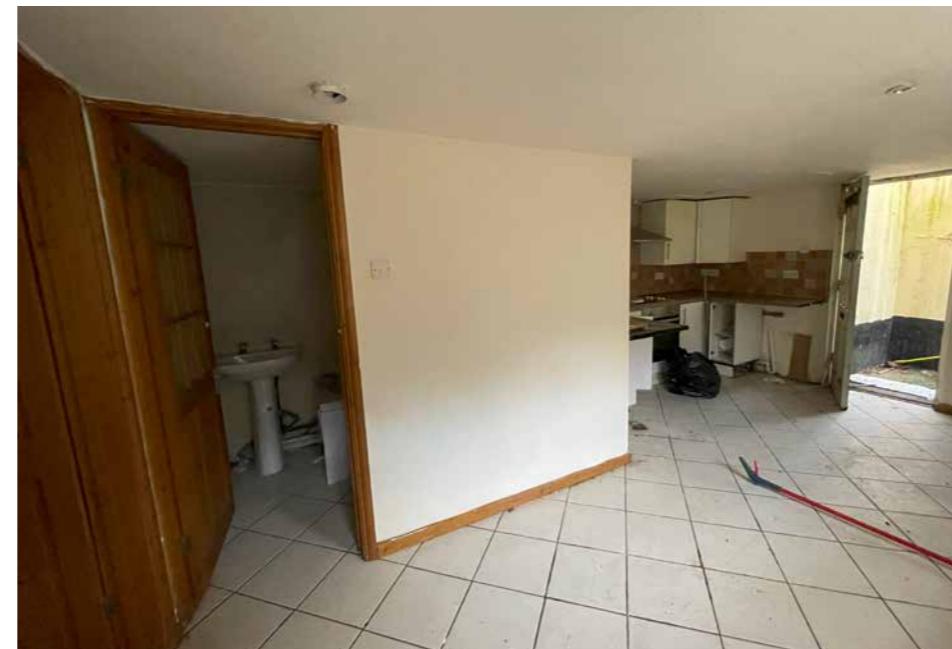
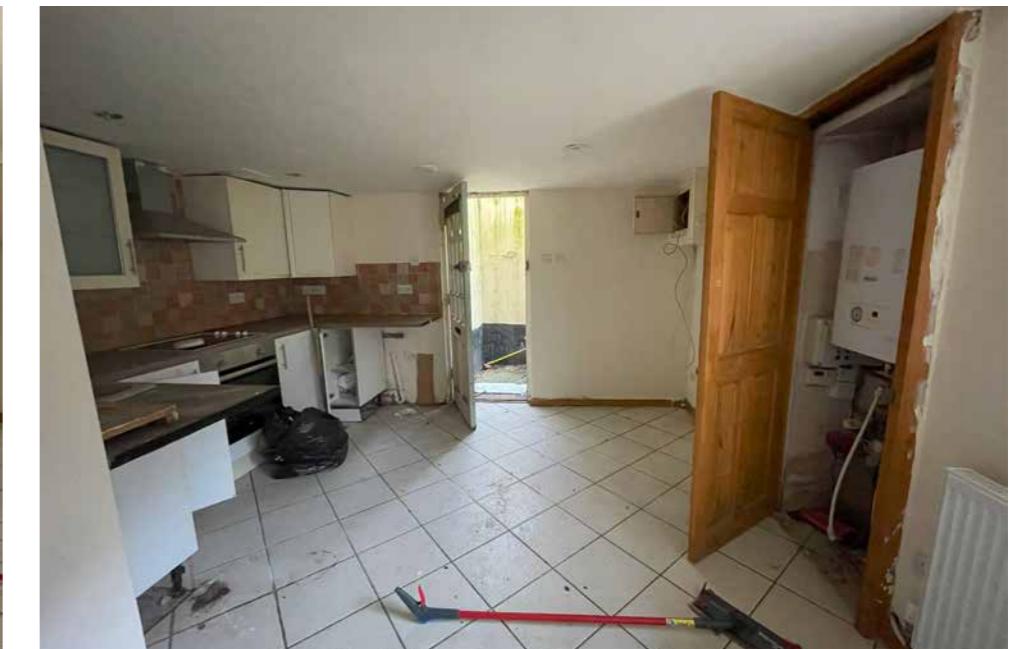
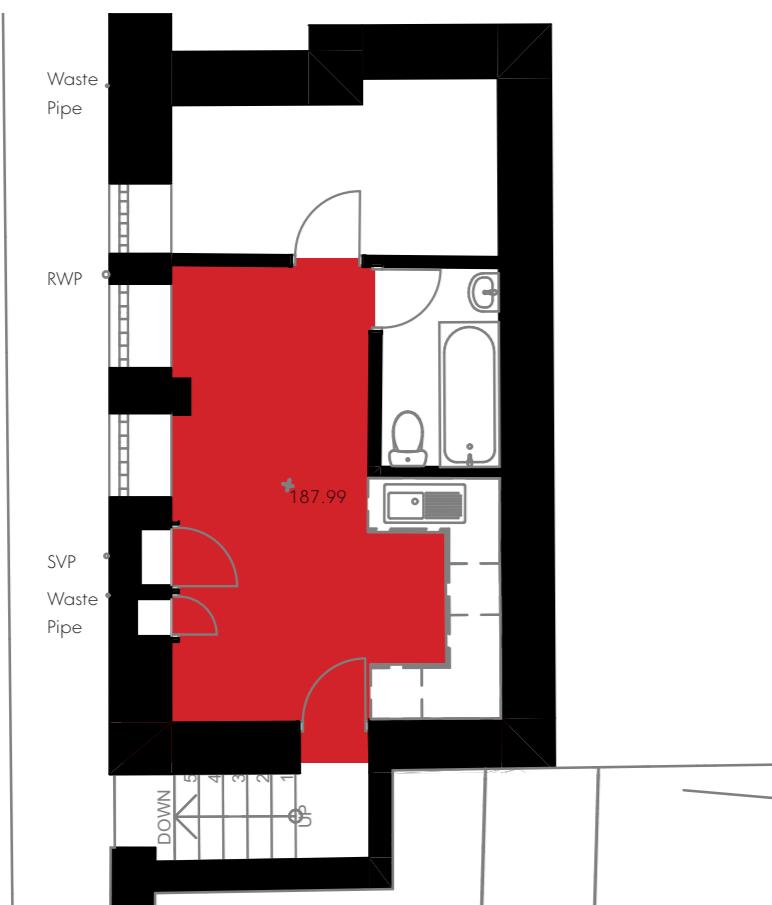
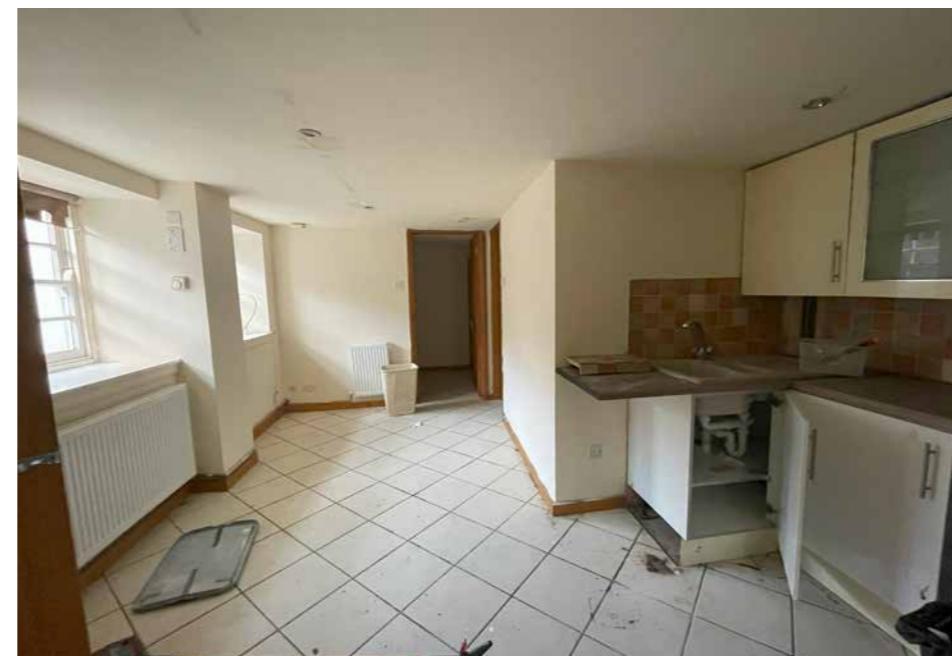
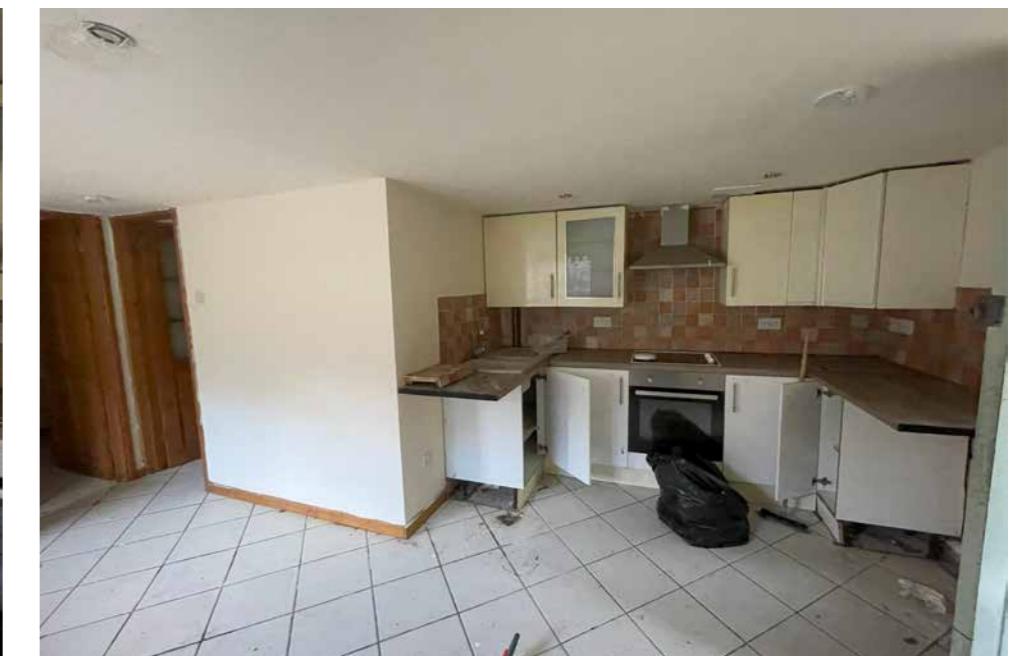
13.0 Interior - Lower Ground Floor - Main Space

The condition of the space is reasonable; however, in order to make this flat suitable for lease, the proposals seek to install new kitchen and bathroom and provide the interior with a full refurbishment, without any re-planning. It is also proposed that the small pane windows are all upgraded with Slimline double glazed units.

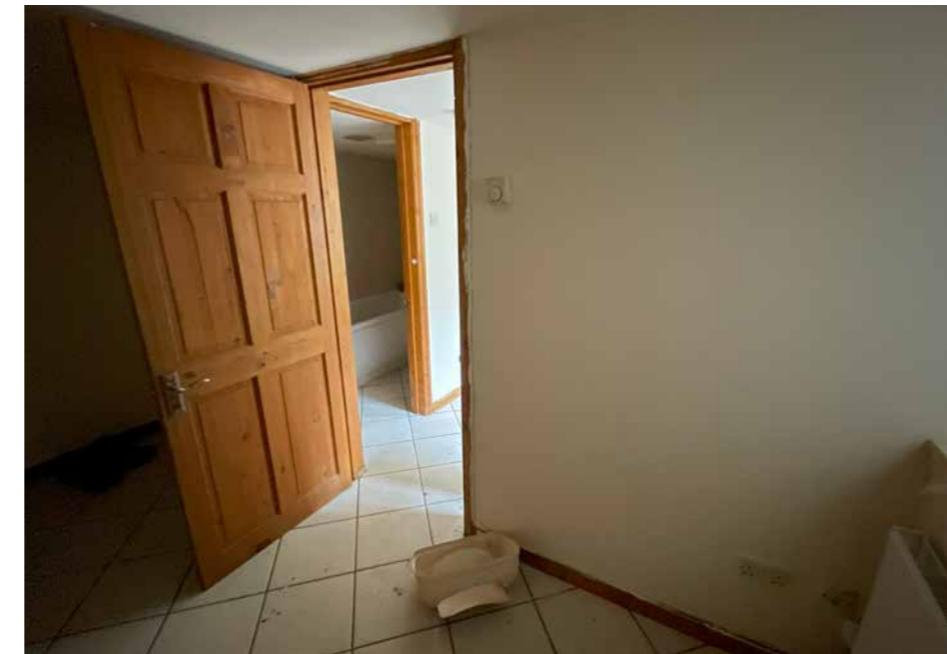
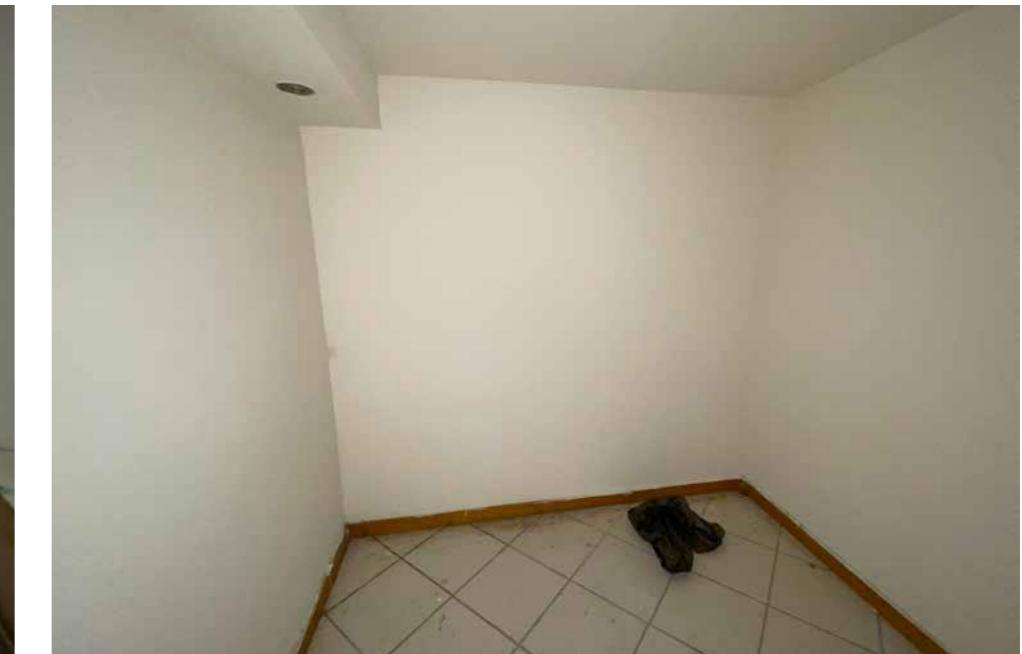
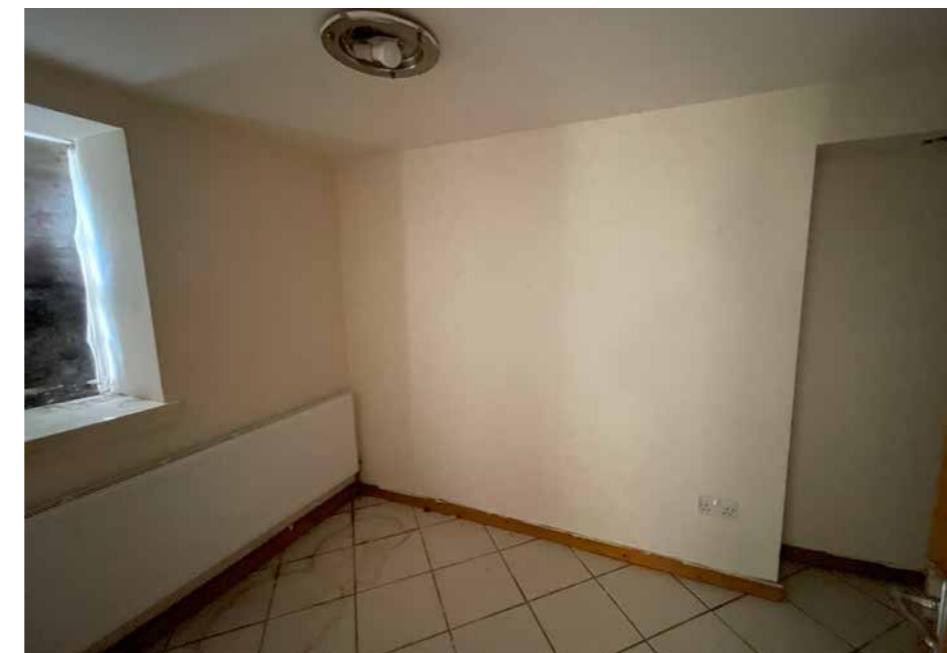
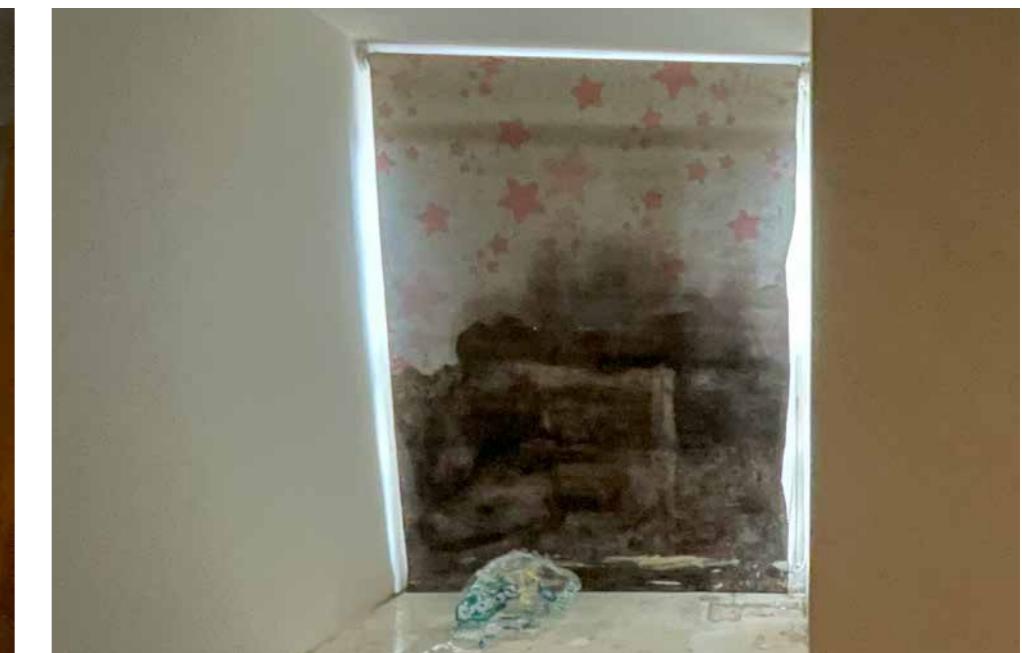
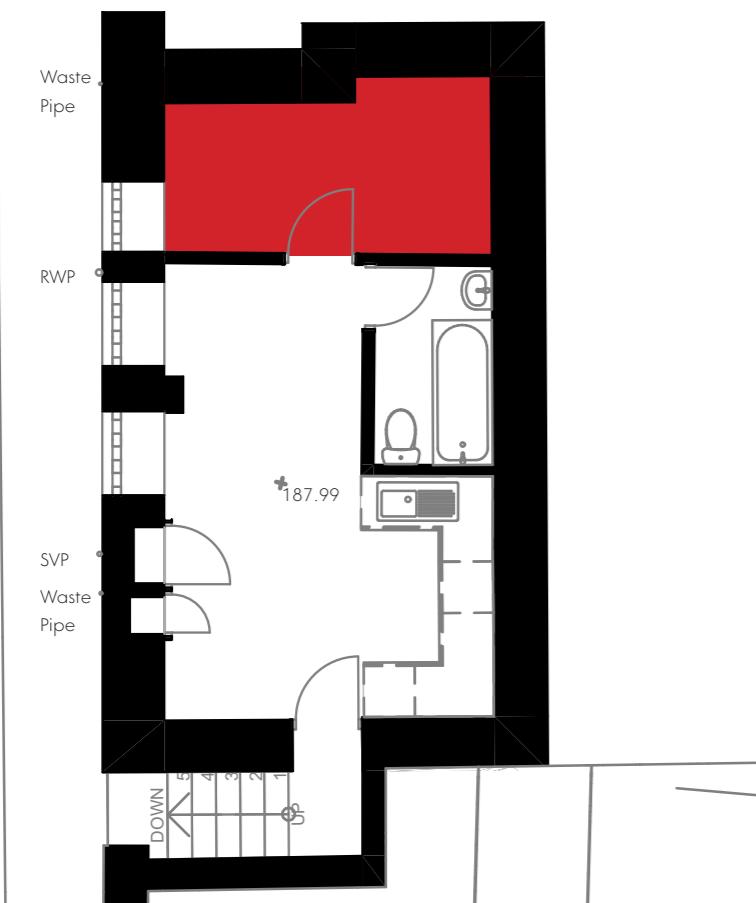
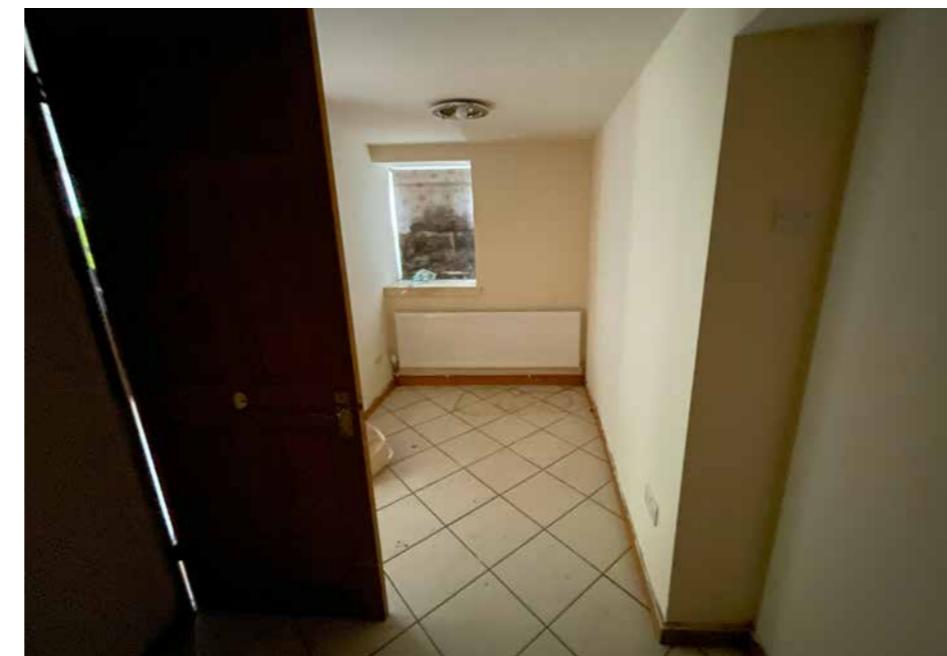
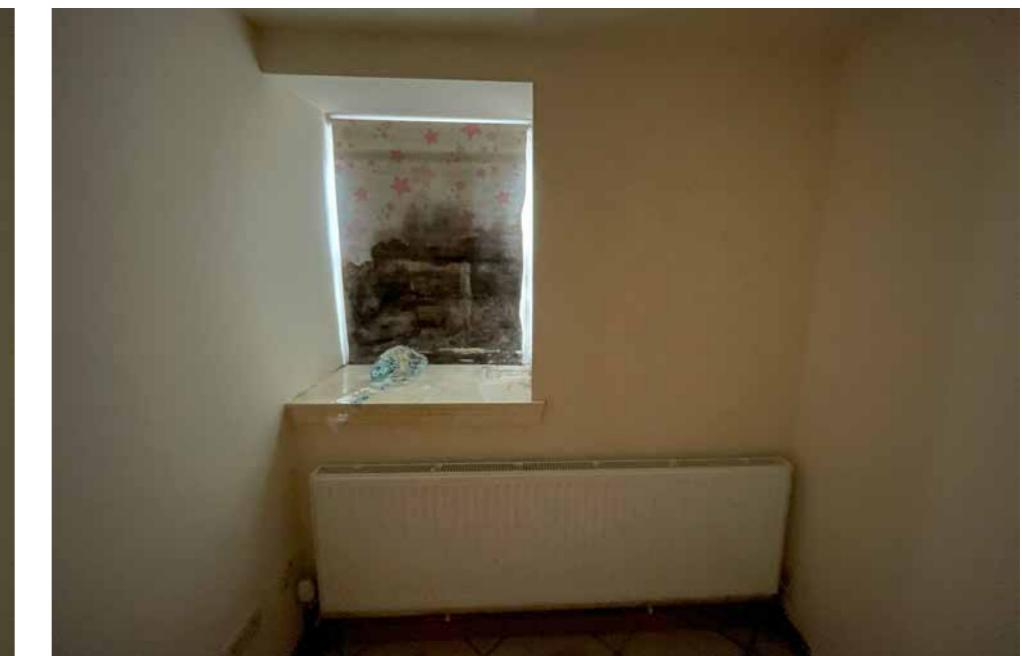
13.0 Interior - Lower Ground Floor - Bedroom

This room is the same as the main room in terms of nature and condition and proposals.
