Primrose Hill, Merthyr Tydfil

RECORD OF BUILDING AND CONDITION ASSESSMENT REPORT, WITH REPAIR PROPOSALS

.....(449)2503-GVWP-A-HIS-P01

Date: 05.03.25

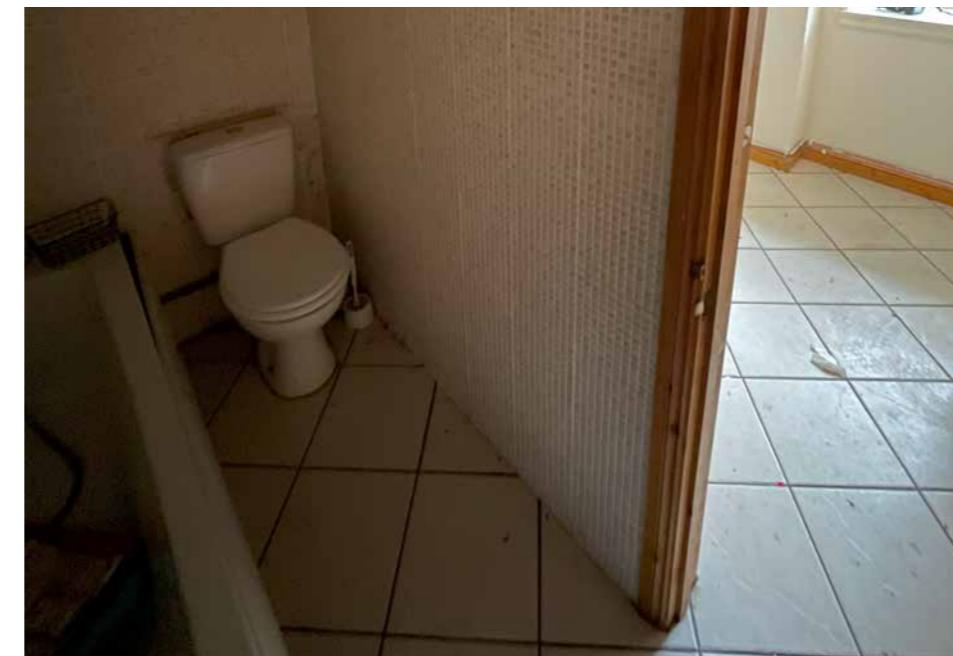
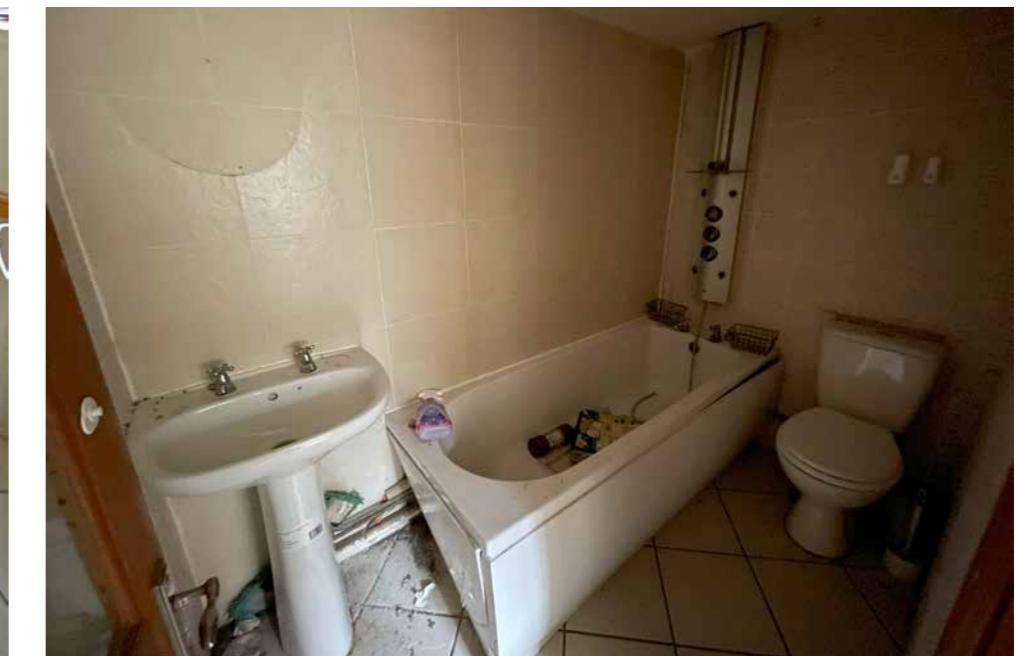
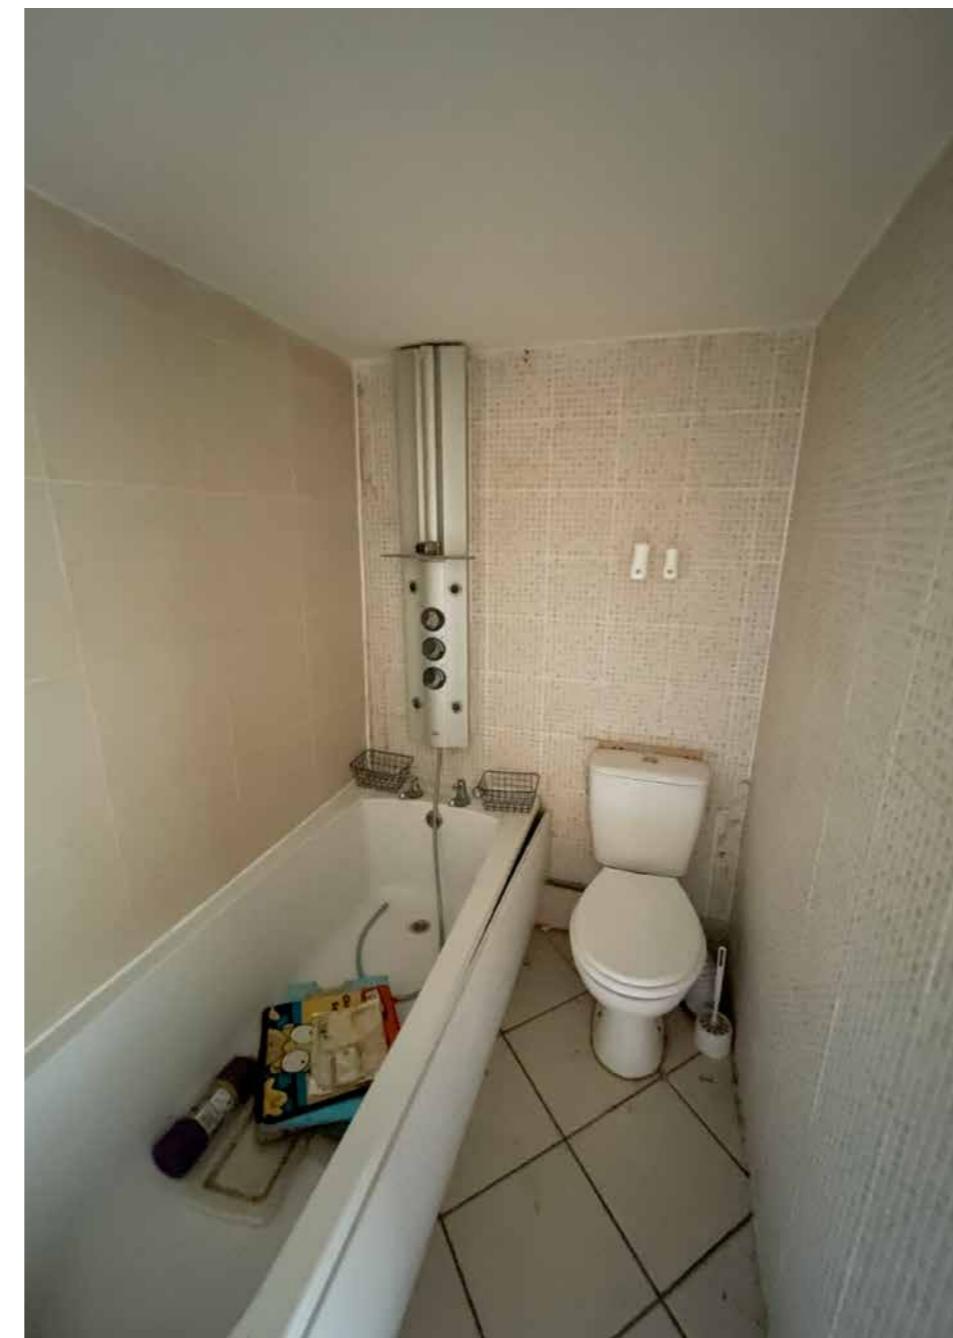
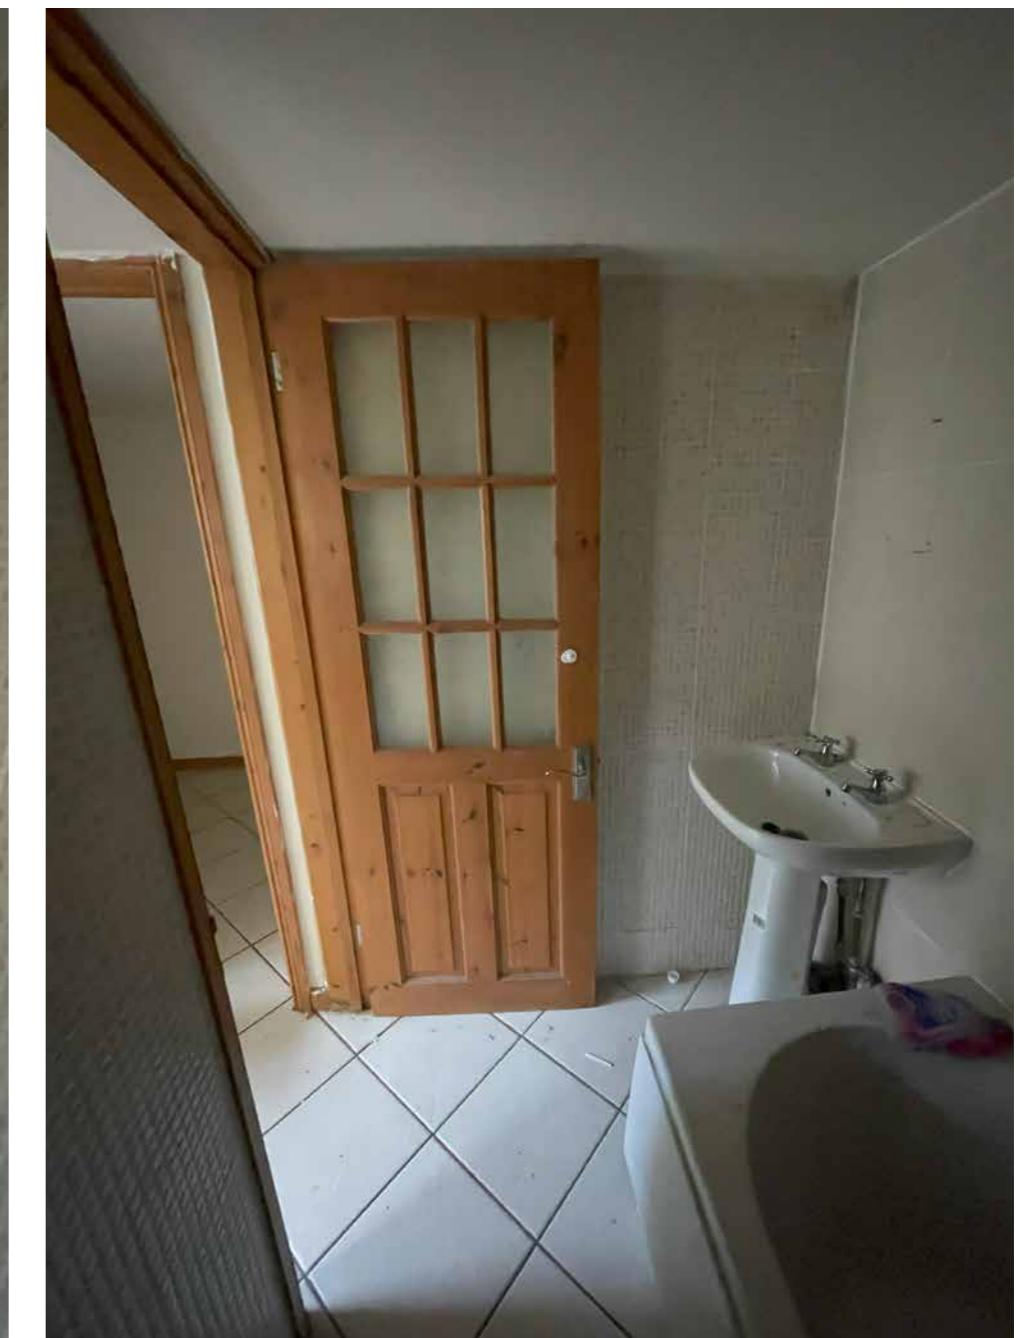
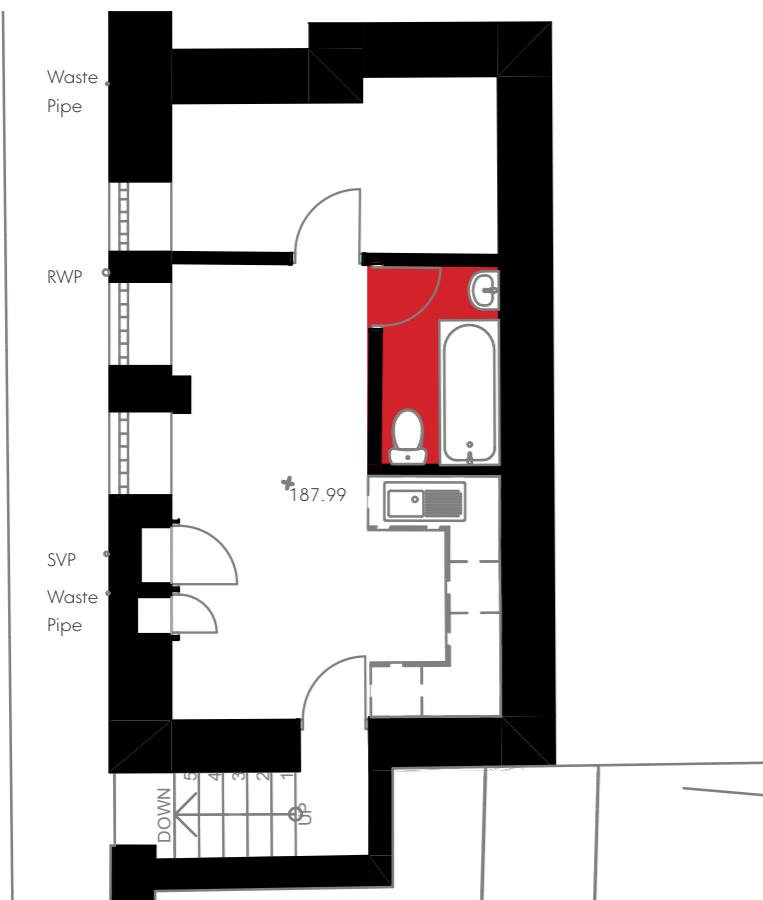
13.0 Interior - Lower Ground Floor - Bathroom

The bathroom is ceramic tiled to the walls and plastered on the ceiling, with no cornice or skirting. There is a partially glazed stained timber panelled door, a bath, toilet and pedestal basin.

The proposals seek to replace this bathroom suite.

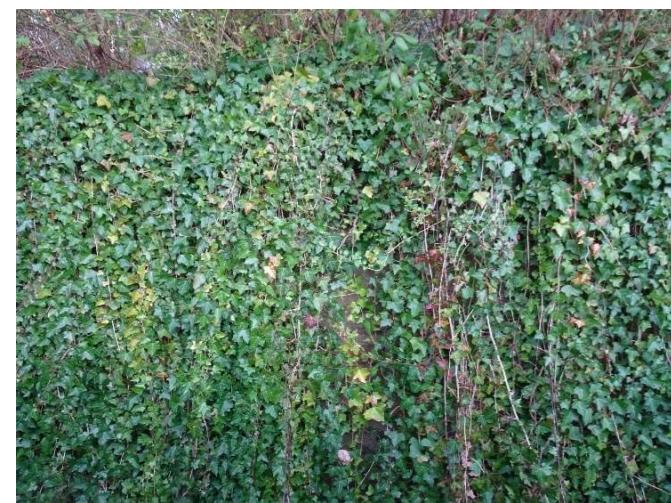
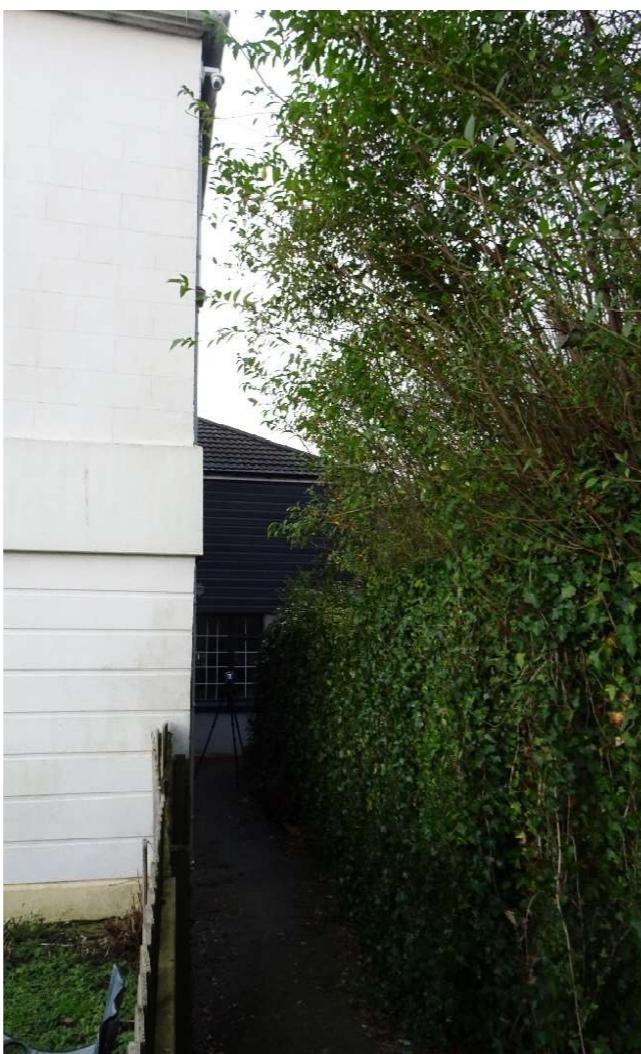
2.8.1 To the east of the building is an approx. 3m tall stone masonry retaining wall which is fully retaining an upper garden. The wall appears to comprise rubble stone masonry likely bound and originally pointed in lime mortar similar to the walls of the neighbouring Synagogue. The wall is currently covered with vegetation (ivy) and there is extensive vegetation / shrubs growing out of the head of the masonry therefore the wall was generally not inspectable.

2.8.2 The front elevation of the wall is heavily pointed in cement which is assumed to be a more recent repair.

3.5.1 The eastern retaining wall appears to be in reasonable condition and seems reasonably plumb where locally visible through the vegetation, however the elevation is generally covered with vegetation. The exact extent of distress / deterioration is unknown.

4.5 For the existing retaining wall, ongoing vegetation growth puts the masonry fabric at risk of further deterioration if left unaddressed with the potential to cause structurally significant harm to the existing fabric. The shrubs growing out of the head of the wall have the potential to accelerate degradation and risk localised loss of masonry which could fall from height unpredictably. The wall is also heavily pointed in cement which has the potential to trap water and accelerate degradation particularly considering the wall is fully retaining the upper garden which naturally drains towards the rear of the wall.

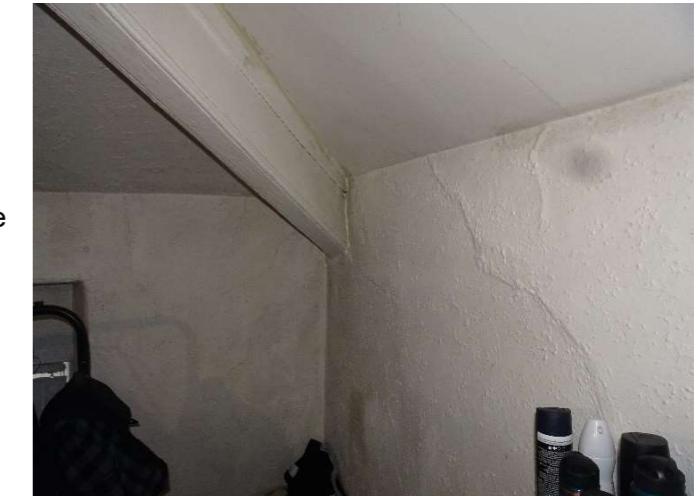
3.2.2 Minor but extensive cracking was observed to the plaster through the wallpaper in the rear bedroom 2F and there are signs that the walls have been replastered. This is not of immediate structural concern but warrants further investigation to confirm the condition of the underlying masonry fabric.

- Inspection of internal and external masonry walls. For the external walls, we recommend removing localised patches of existing plaster to expose the face of the masonry walls to help confirm construction and condition of the underlying masonry. We also recommend undertaking removal of finishes or localised opening up works to several of the internal walls

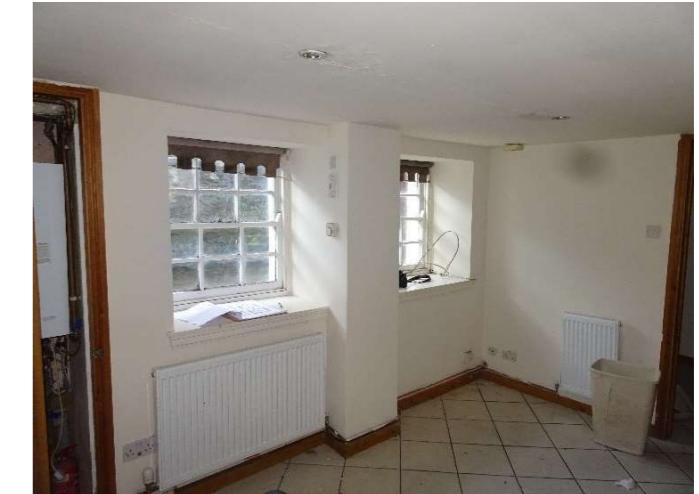
3.2.3 At basement level we anticipate that part of the masonry spine wall has been removed with an assumed steel lintel built into the ceiling / ground floor. The arrangement and condition of this beam are unknown.

- Inspection of the assumed steel beam in the basement where we suspect the historic spine wall was removed to inform details, specification and condition of the beam.

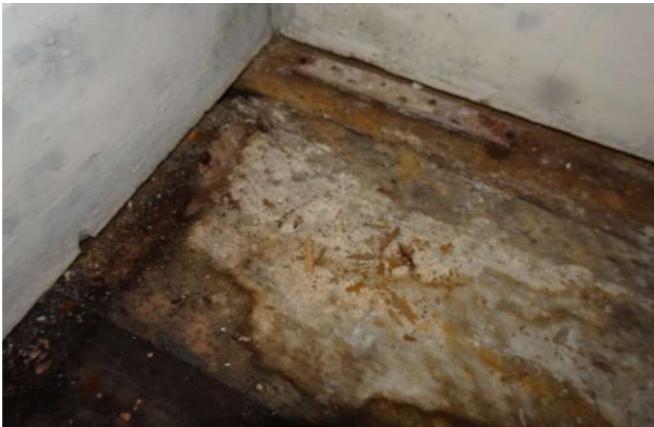
3.3.2 The floor joists in the front rooms (1F) were noticeably livelier than in the rest of the building the reasons of which were not confirmed on site.

3.3.3 In room 1F where the floorboards were uncovered, there is localised evidence of minor decay to the floorboards in the southeast corner of the room. It is possible that this may also have affected the floor joists which are assumed to be built into the external wall in this location.

- Inspection of the existing timber floor buildups at all levels, in particular along the internal faces of the external walls where damp is most significant. This would require floorboards to be lifted in a couple of the rooms at each level by a contractor which would permit inspections by the structural engineer to confirm condition (degradation of the joists and bearings) and capacity of the existing joists to help inform future uses. Floorboards would then be reinstated following the works.

5.2 As part of the refurbishment, we recommend allowing for localised repair and replacement of timber joists if found to be in a decayed state.

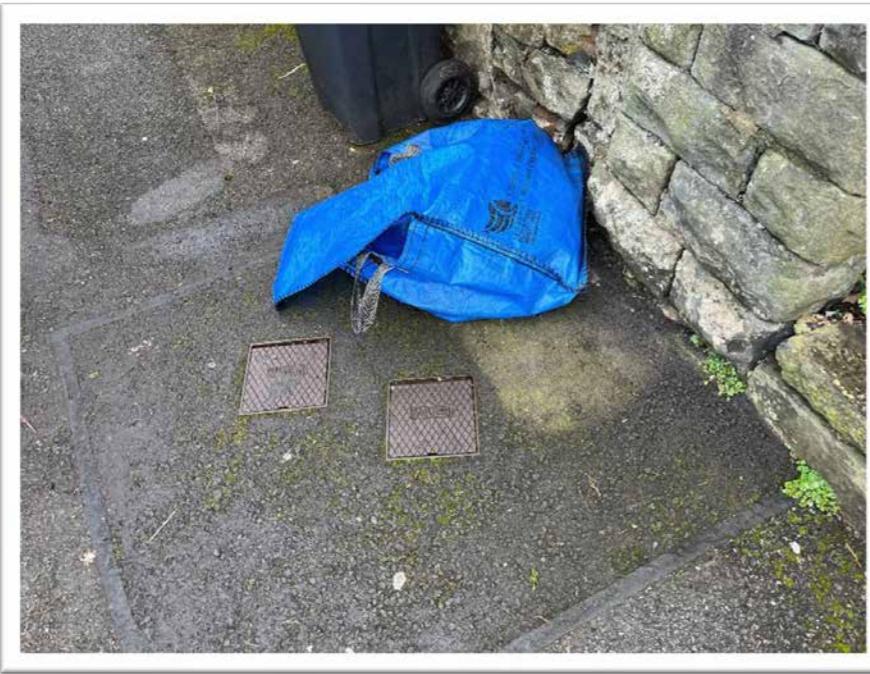
Cold Water Mains Stop Cocks

Overall, the condition of installation was found to be in a fair condition throughout.

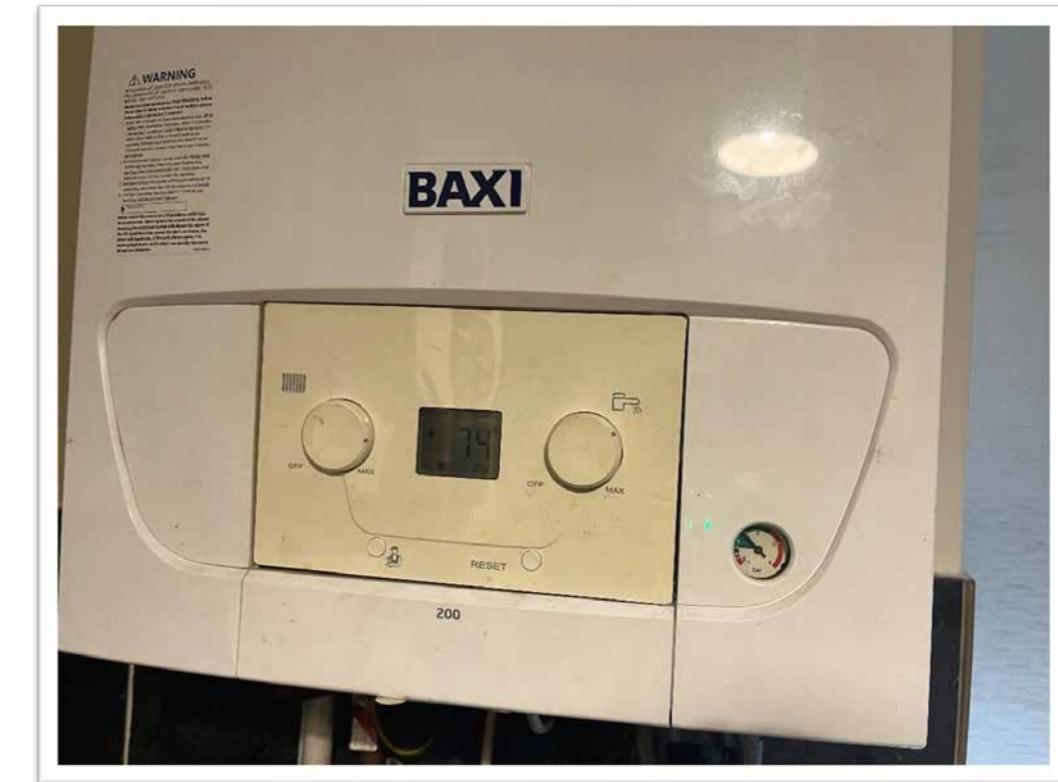
Baxi Combi Boiler

We estimate that a large amount of the mechanical infrastructure is in a fair condition. The main items of plant are nearing or past their working life expectancy and recommend they be replaced.

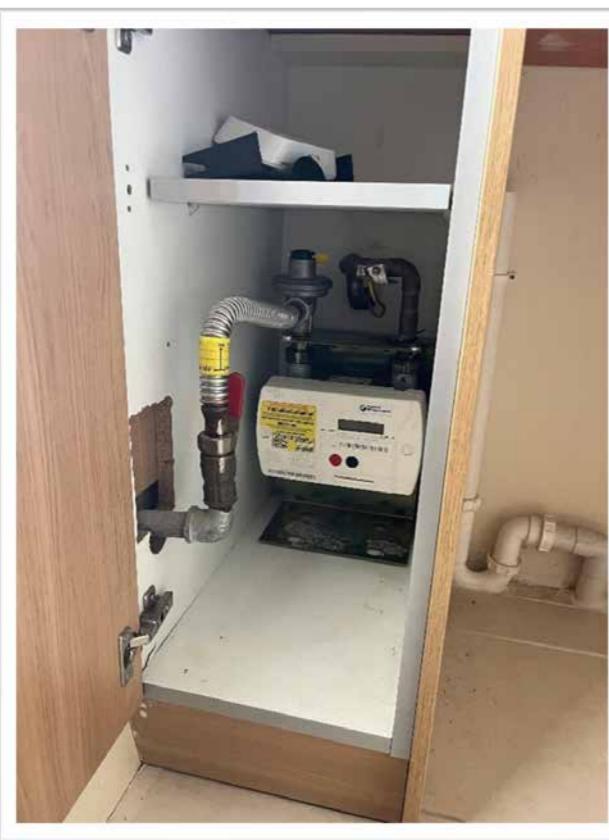
Gas Meters

Overall, the condition of the installation was found to be fair.

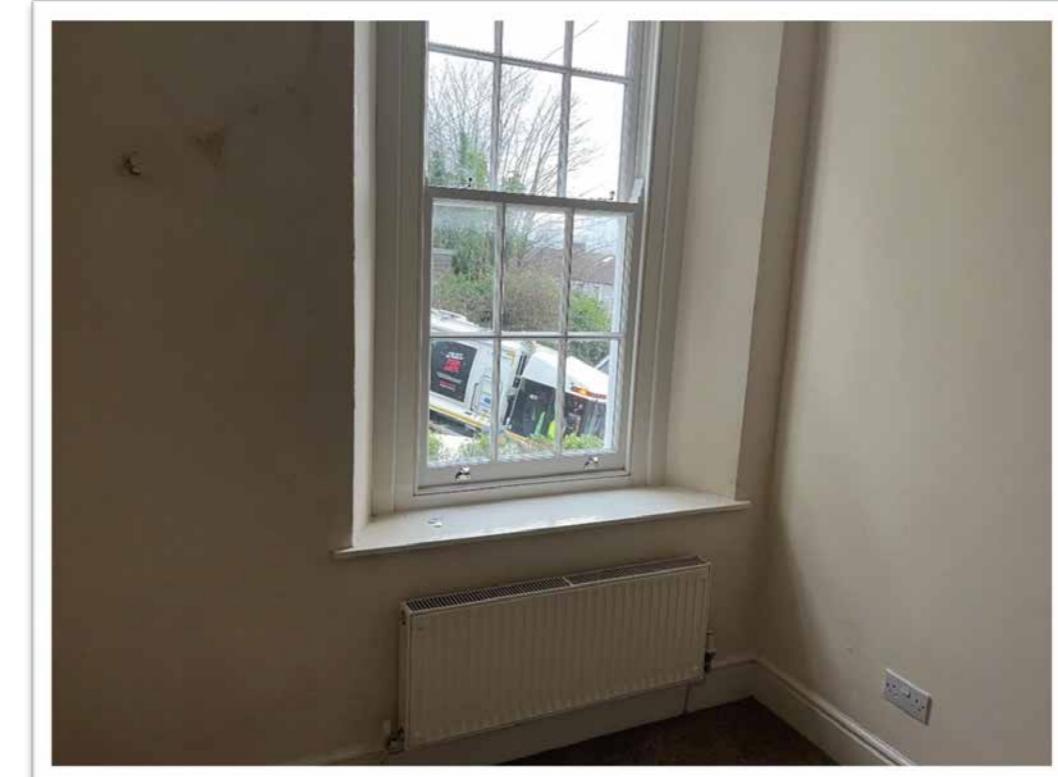
Steel Panel Radiators

The heating system and associated controls appears in the most part sufficient to satisfy the needs of the apartments. There are some areas that do not have radiators installed, additional radiators are recommended to avoid cold spots.

The steel panel radiators were generally in fair condition.

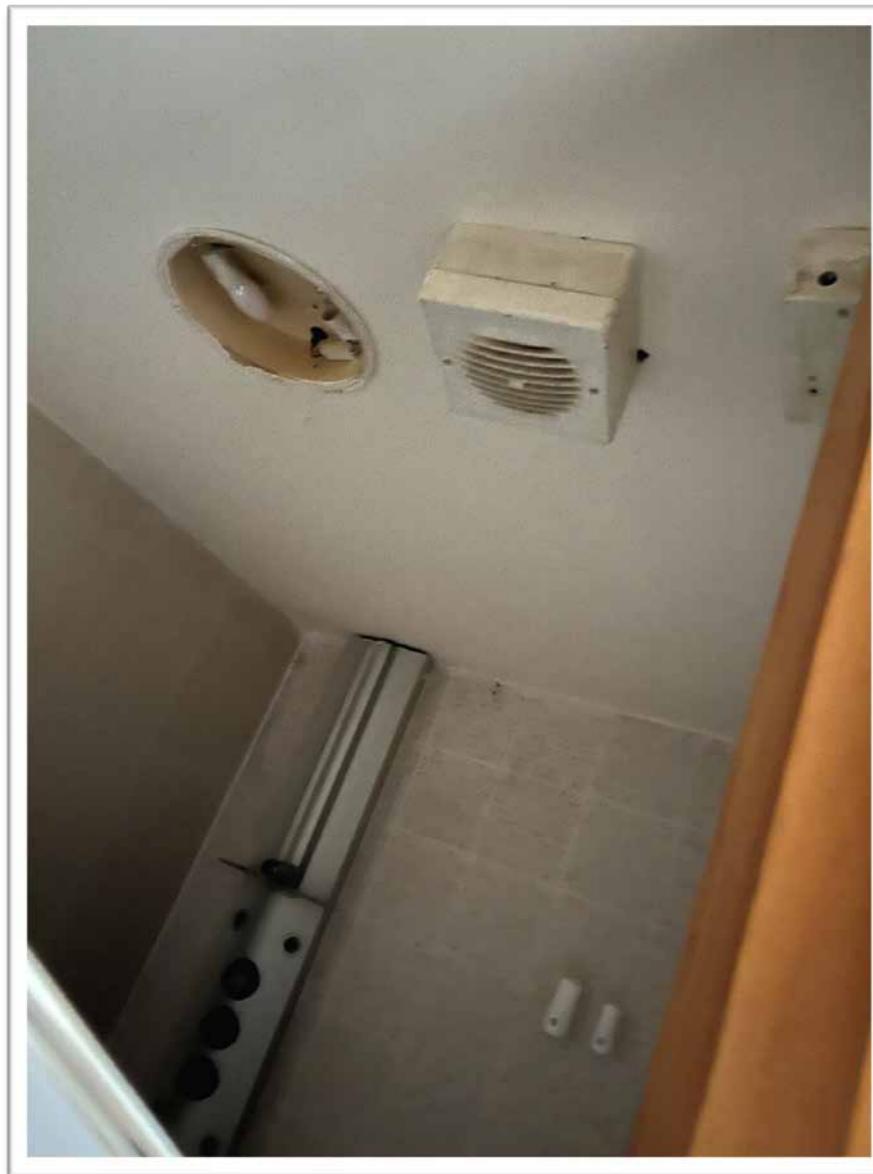
Bathroom Extractor Fan

Mechanical ventilation generally is in very poor condition.

Replace all mechanical ventilation.

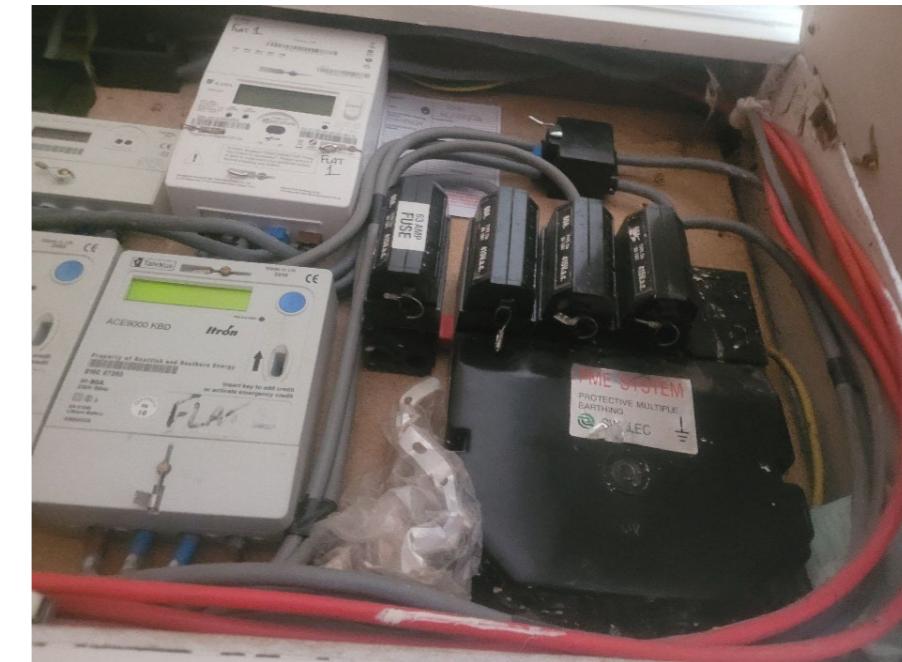
The main house is supplied by an underground National Grid service cable which terminates in a Three Phase and Neutral Cut Out unit as shown in the image below:

The despite being more than 25 years old incoming DNO service cut out is in a satisfactory condition, the Energy meters are in a good condition and a future life span of 15– 20 years can be expected from this equipment.

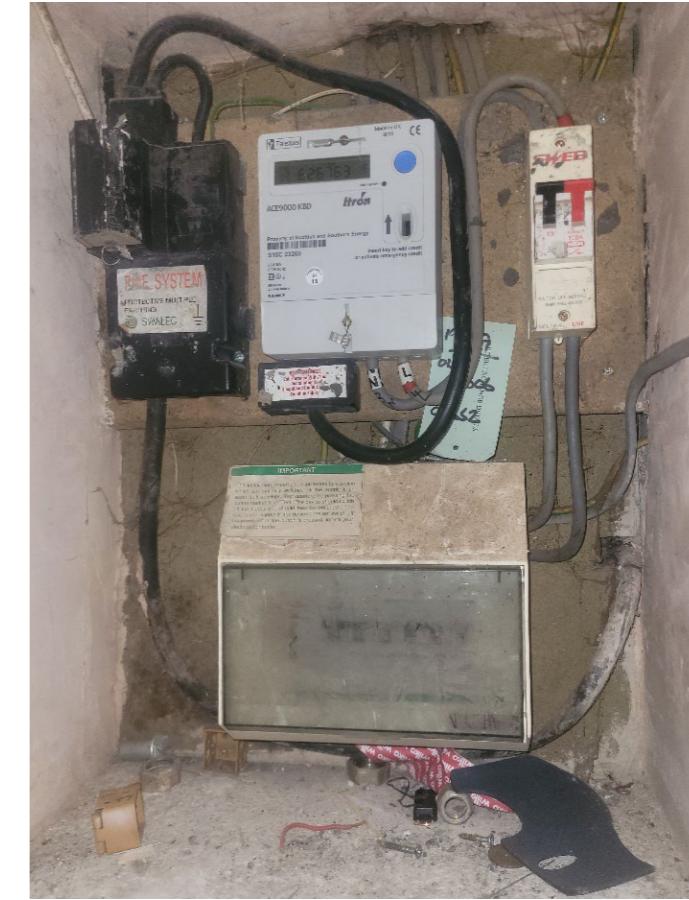
The basement flat is supplied by an underground National Grid service cable which terminates in a Single Phase and Neutral Cut Out unit as shown in the image below:

The electrical supply is a 60 Ampere single phase 2-wire TN-S 230-volt 50Hz. PME (TN-C-S) and there are no visual signs of any thermal damage or stress to the conductors.

The despite being more than 25 years old incoming DNO service cut out is in a satisfactory condition, the Energy meters are in a good condition and a future life span of 10– 15 years can be expected from this equipment.

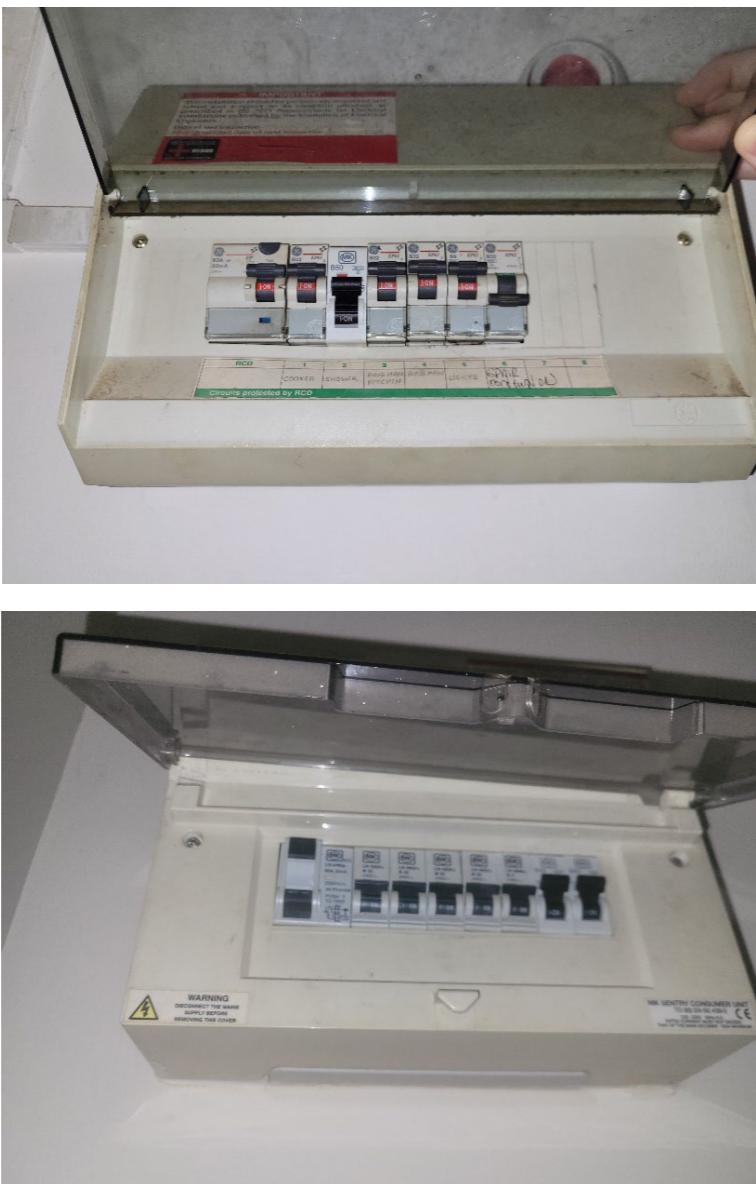
As stated above, each apartment is fitted with a dedicated Consumer Unit. Example images are included below:

Although in serviceable condition the consumer units do not comply with the requirements of the current version of BS 7671:2018. IET Wiring regulations 18th Edition – Requirements for Electrical Installations.

The current regulations require that distribution equipment located in escape routes are either manufactured from non-combustible materials or contained within an enclosure constructed from non-combustible materials.

Furthermore, a front end (main switch) Residual Current Device if activated due to an earth fault can cause inconvenience and possible danger in the event of a fault as the whole apartment will be plunged into darkness.

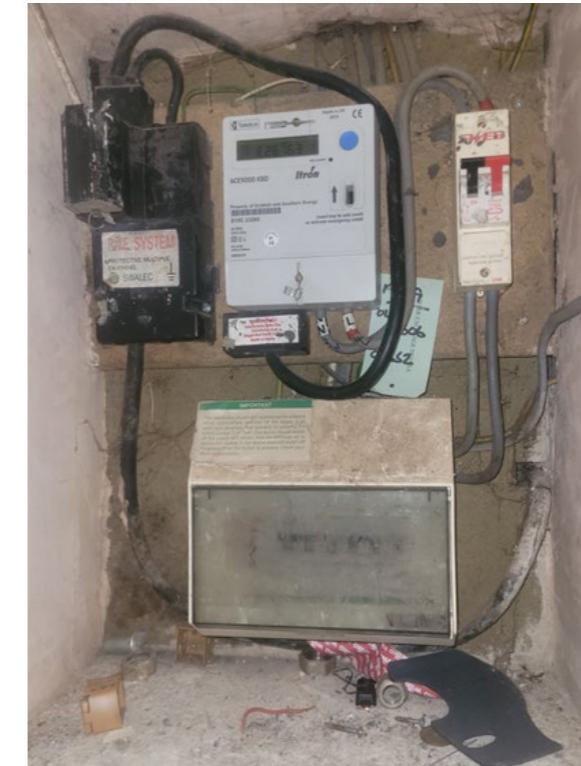
The basement is provided with a dedicated consumer unit located within the basement electrical cupboard along with the DNO cutout and energy metering equipment AS detailed in the image below:

The consumer unit is of the insulated type fitted with a 30milliamp Double Pole RCD Main Switch which provides additional earth fault protection which is required for all lighting circuits in a domestic type dwelling and socket outlet circuits rated at 32 amp or less. Miniature Circuit Breakers provide individual circuit protection against overload and short circuit faults between live conductors.

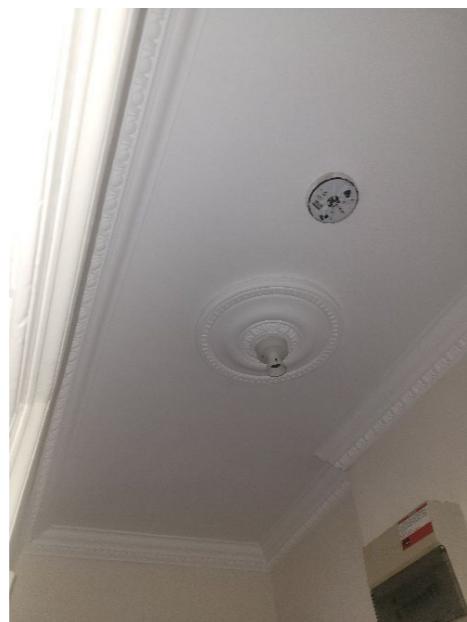
There are also instances where smoke/heat detection devices have been removed. See image below:

It is our considered opinion that based upon the visual survey undertaken that the Fire Alarm and Detection system does not comply with current British Standard requirements and a Fire Risk Assessment be carried out on the property as required by the Regulatory Reform Order (Fire) 2005.

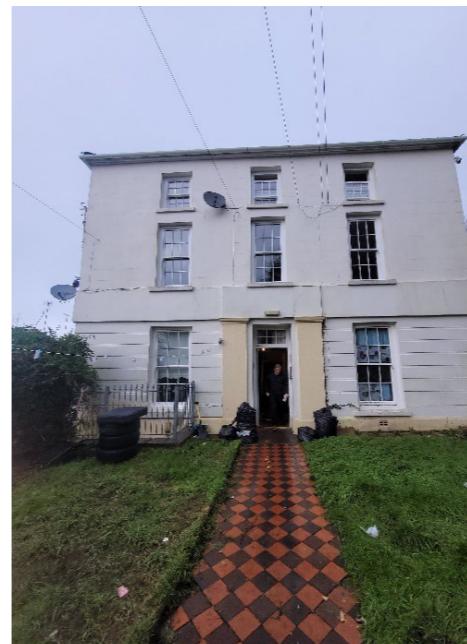
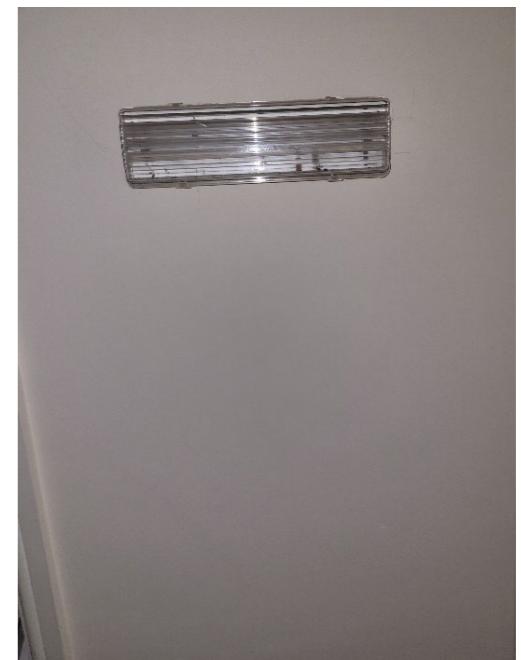
Emergency lighting is provided in the communal area and externally (above front door) by standalone non maintained bulkhead lighting, see image below:

The presence of emergency lighting test switches was not evident during our visit and there was no evidence that the system is being subjected to regular inspecting and testing as laid out in BS 5266 part 1 2016: Emergency lighting. Code of Practice for the Emergency Lighting of Premises.

Again, it is recommended that the emergency lighting system be reassessed following the undertaking of the Fire Risk Assessment mentioned in Section 3.
