Former St. Tydfil's  
Hospital

Listed Building Room Data &  
Photographic Record

Project Ref: 2447

21 September 2020

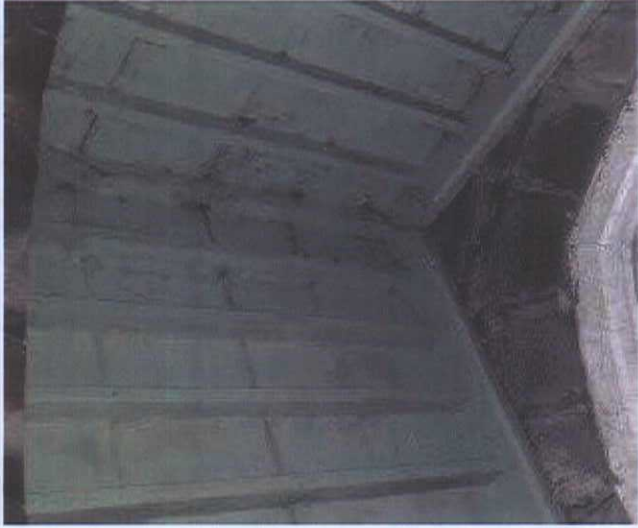
Ceiling

| Element | Condition (G/F/P) | Comments |
|---|---|---|
| Ceiling/Roof | G | Painted timber boarding |

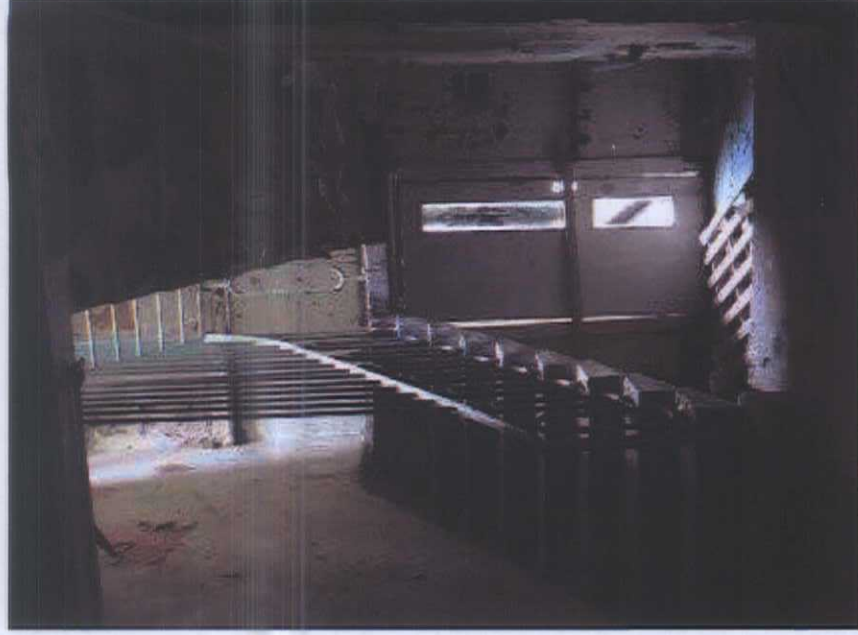
### East Wall

| Room Data | | |
|---|---|---|
| Walls | P | Peeling paint on plastered brick. |
| Doors | F/P | Internal doors & architraves missing. Arched timber double door to GF1 within simple rebated surround. Modern fire escape door in east wall. |

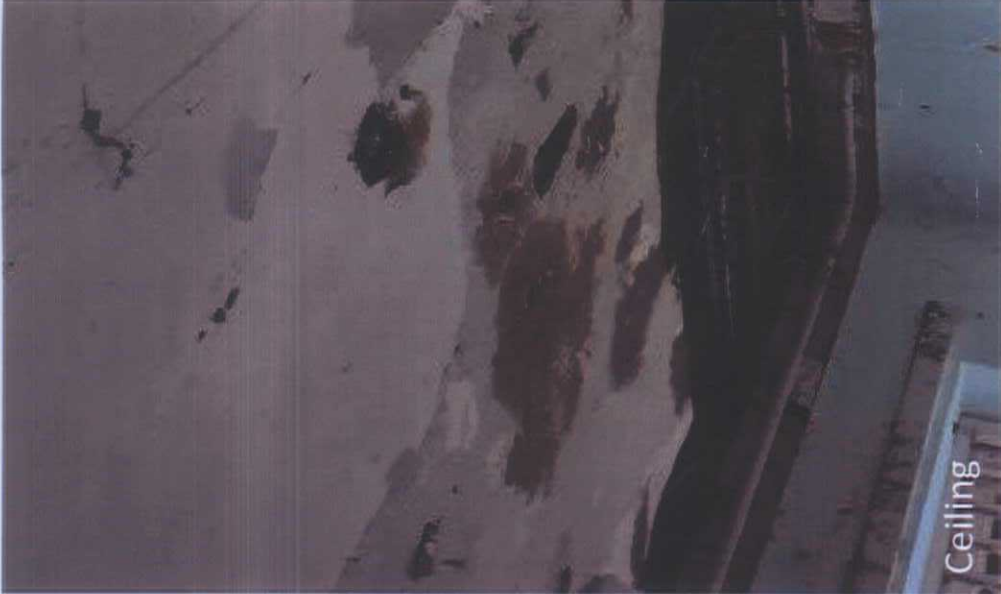
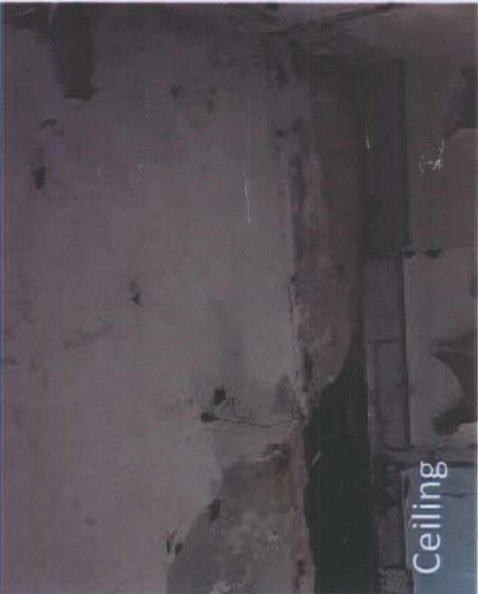
Ceiling

| Element | Condition (G/F/P) | Comments |
|---|---|---|
| Ceiling/Roof | P | Damaged lath and plaster above remnants of modern suspended ceiling |

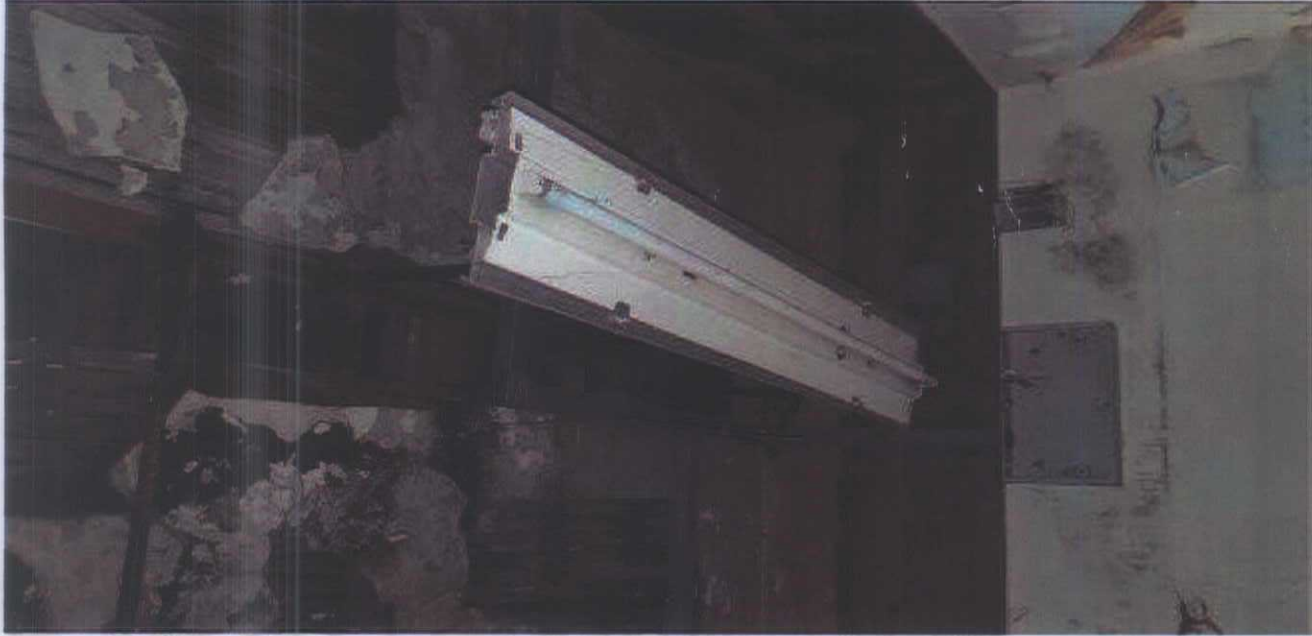
Ceiling

| Ceiling/Roof | P | Damaged lath and plaster above remnants of modern suspended ceiling |

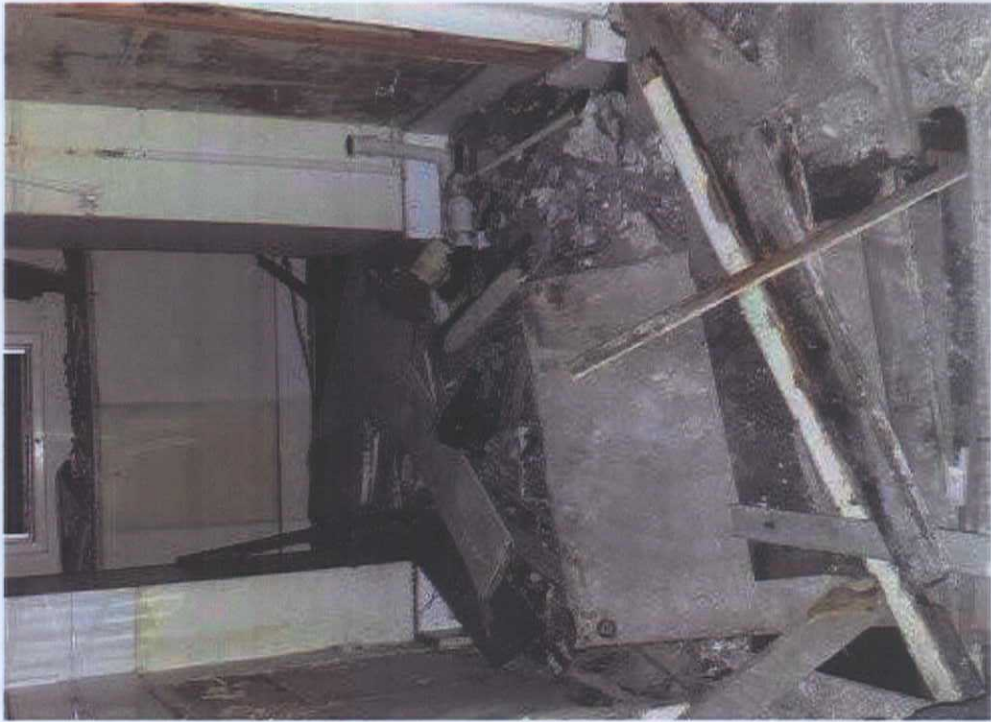
Collapsed drainage inspection chamber in floor

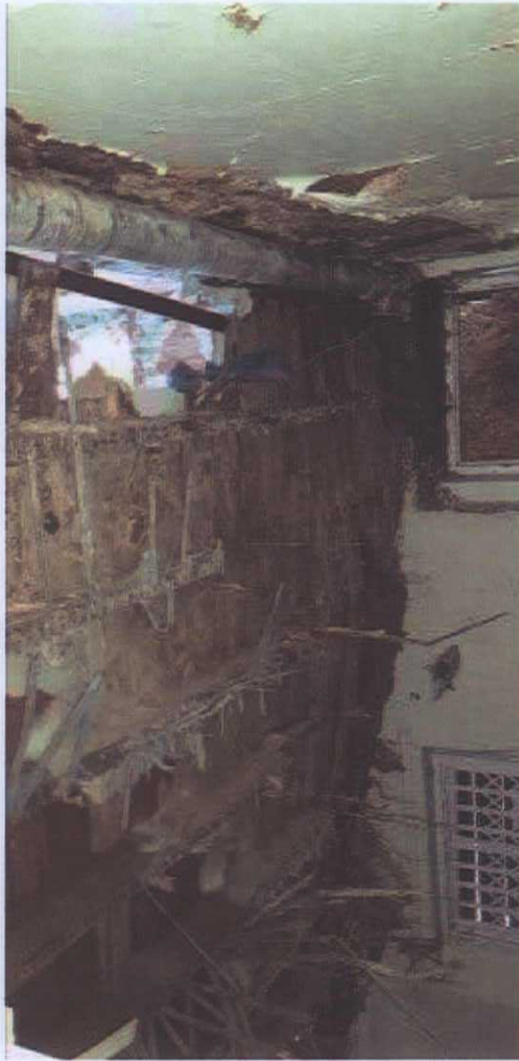
Collapsed ceiling & floor above

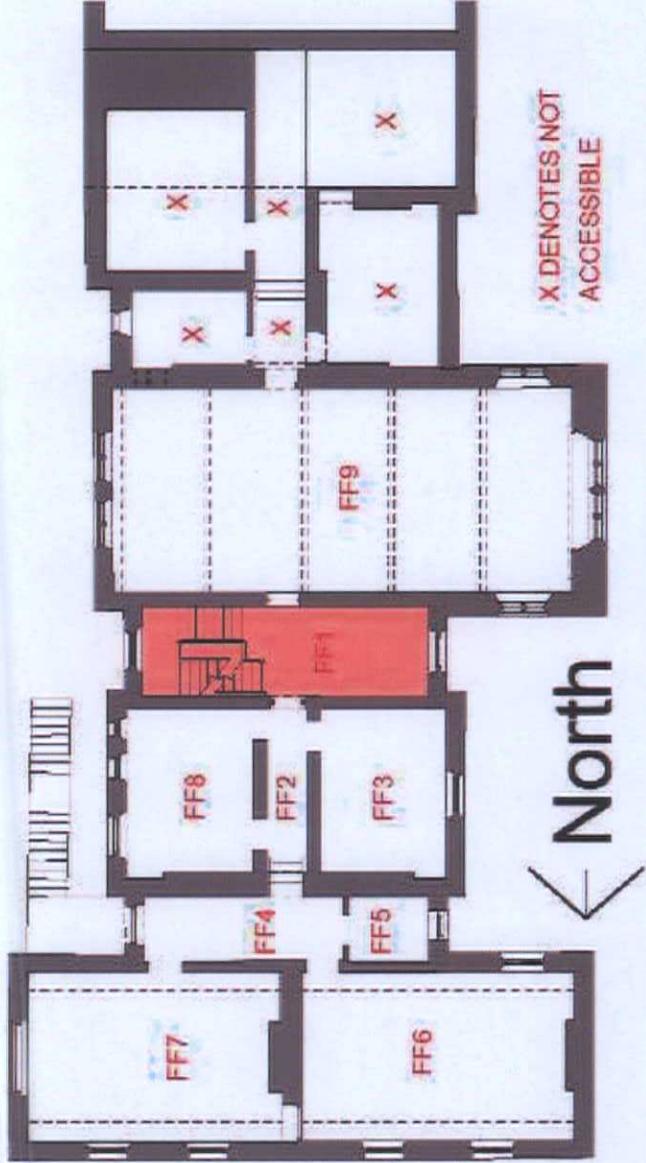
Room Number: FF1

| Room Data | | |
|---|---|---|
| Ceiling/<br>Roof | P | Lath & plaster ceiling entirely missing. Small areas of badly damaged painted plasterboard remain. |
| Doors | P | Internal doors & architraves missing. |
| Other | P | Timber staircase to second floor - clearly not original. Various skirting mouldings. |

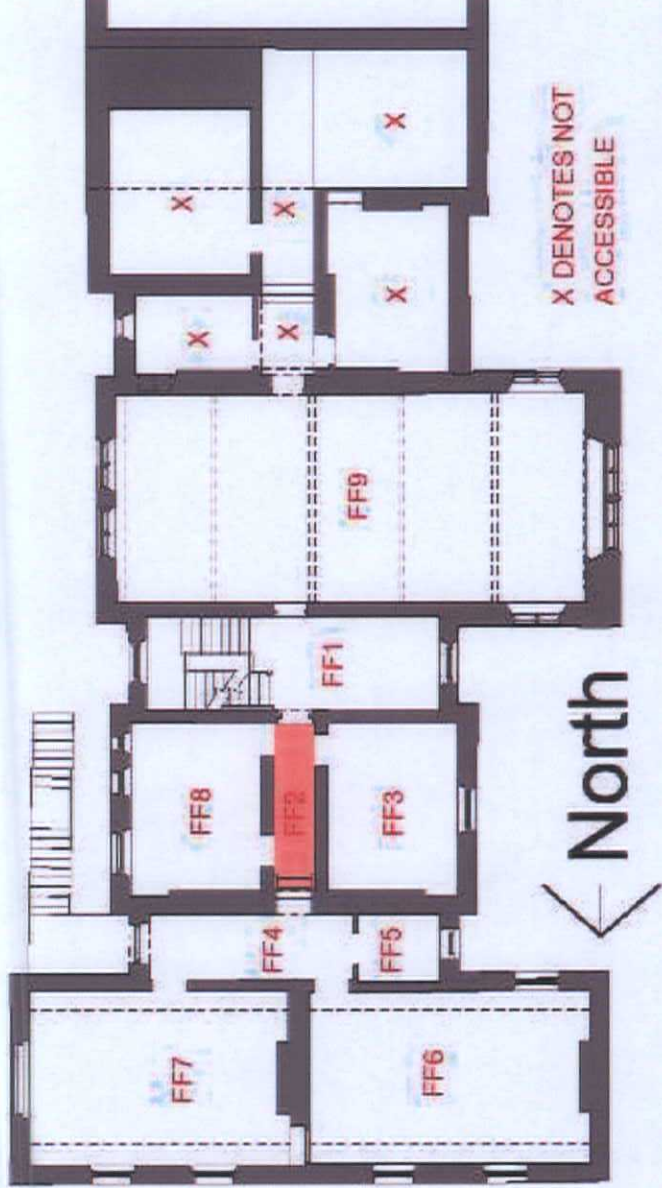
First Floor  
Room Number: FF2  
Room Description: Internal Corridor

| Room Data | | |
|---|---|---|
| Doors | P | Internal doors missing. |
| Other | F/P | Moulded skirting boards & architraves to archway and doorways - see detail photo |

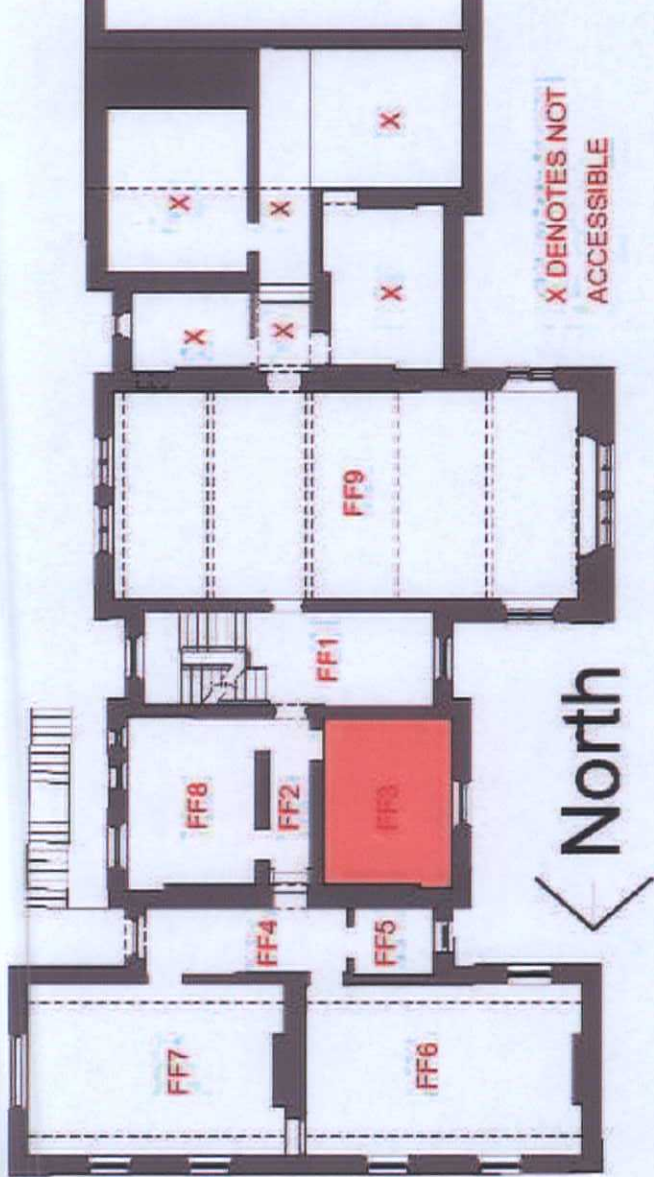
Room Number: FF3

| Room Data | | |
|---|---|---|
| Doors | P | Internal doors missing. |
| Other | F/P | Moulded skirting boards & architraves to doorway |

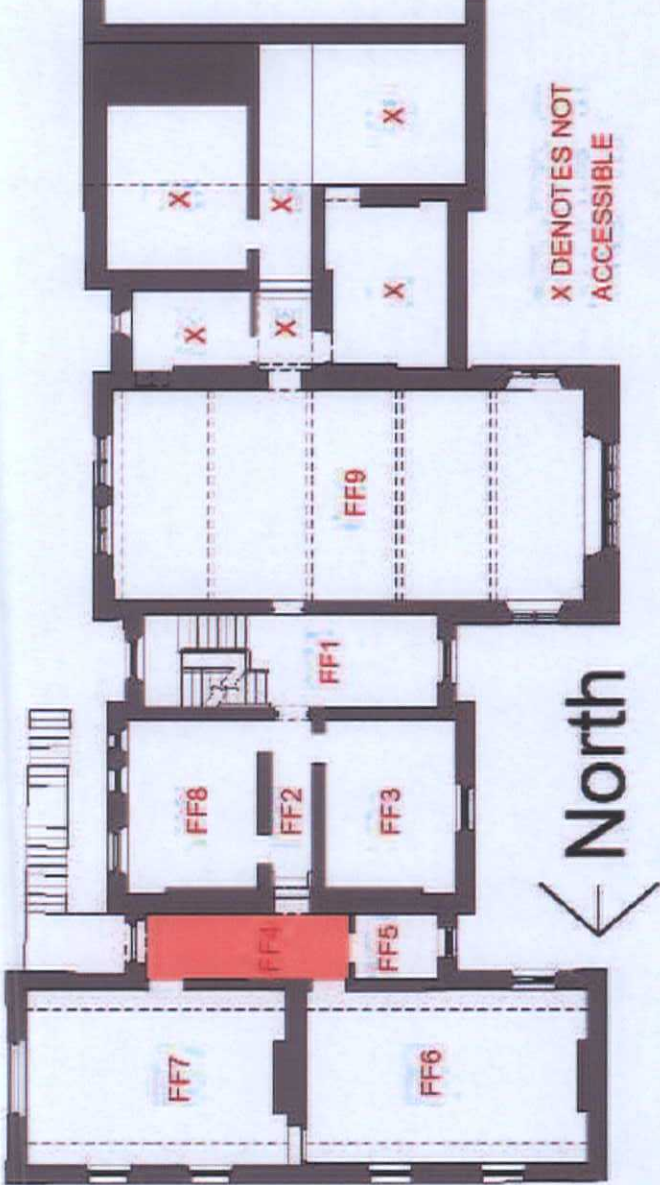
Room Number: FF4

| Room Data | | |
|---|---|---|
| Doors | P | Internal doors & architraves missing. Simple modern rebated frame to external door. |
| Other | F/P | Moulded skirting boards remain in places - See Detail |

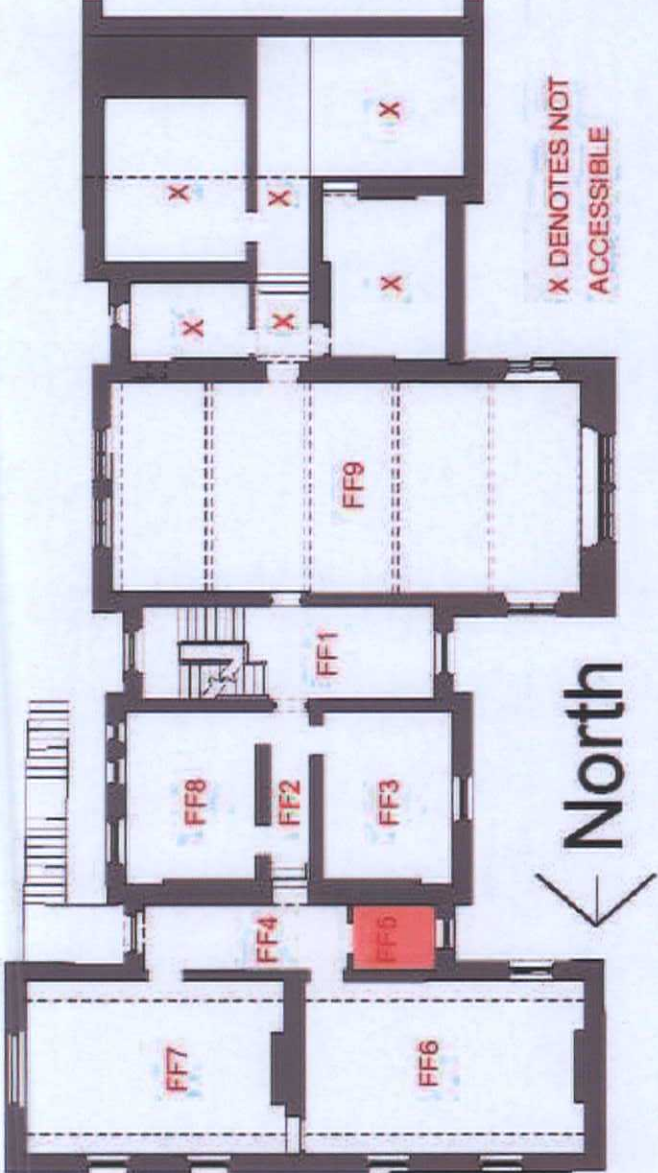
Room Number: FF5

| Room Data | | |
|---|---|---|
| Floor | P | Timber floor. Covering not visible due to collapsed ceiling debris. Room not accessible due to unsafe floor. |
| Doors | P | Door & architrave missing. |

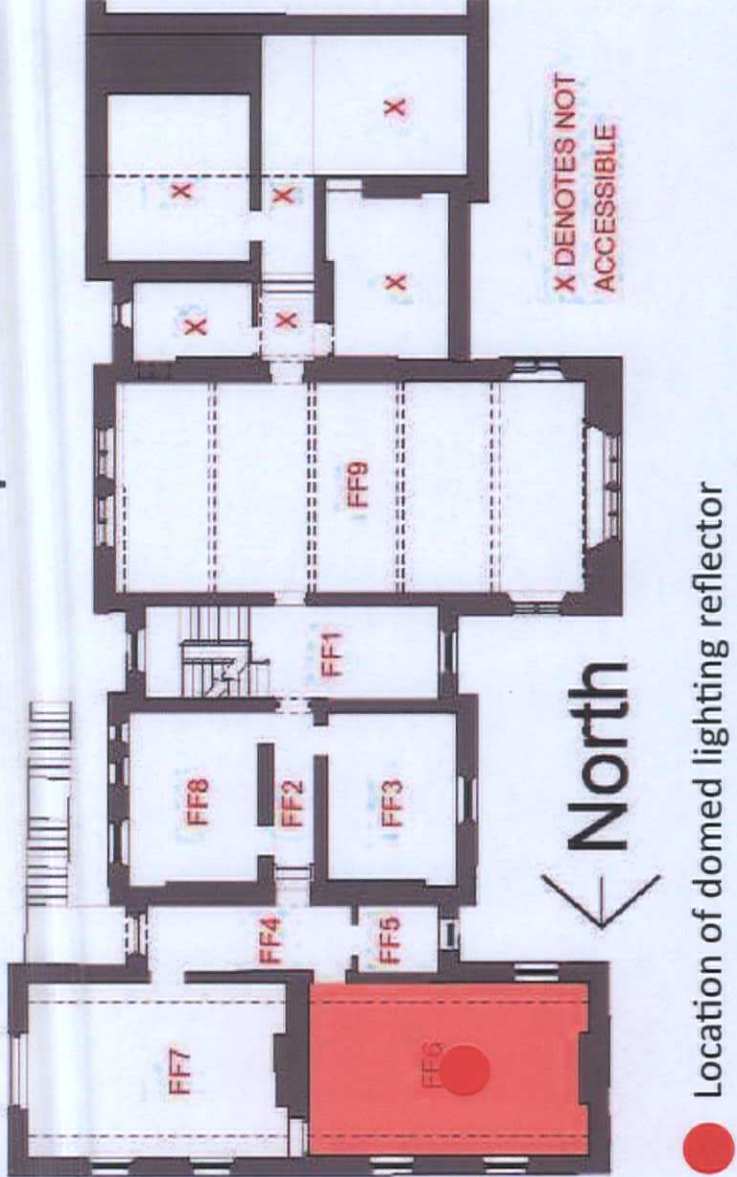
Room Number: FF6

| Room Data | | |
|---|---|---|
| Doors | P | Door missing into room but moulded architrave remains on internal side of door lining. Modern flush door and architrave to FF7 |

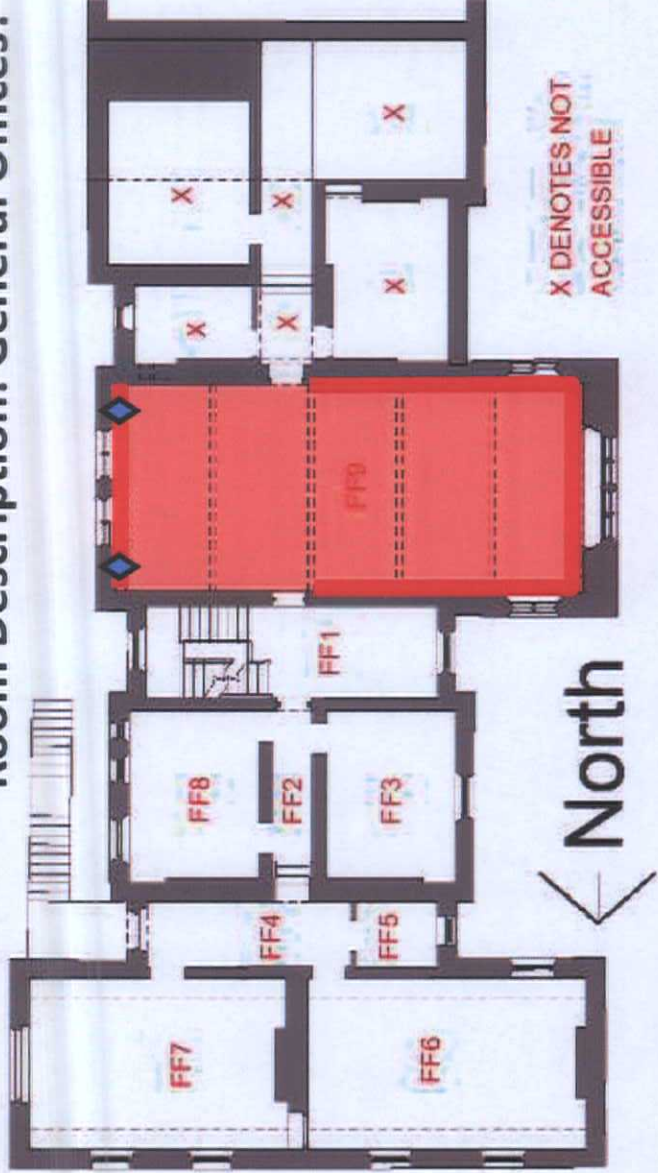
Location of extant timber panelling

Location of original vents

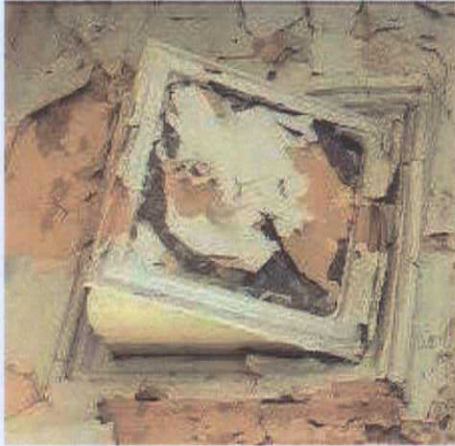
Vents in East Wall

| Element | Condition (G/F/P) | Comments |
|---|---|---|
| Fixtures & Fittings | F/P | Original ventilators in eastern wall - damaged |

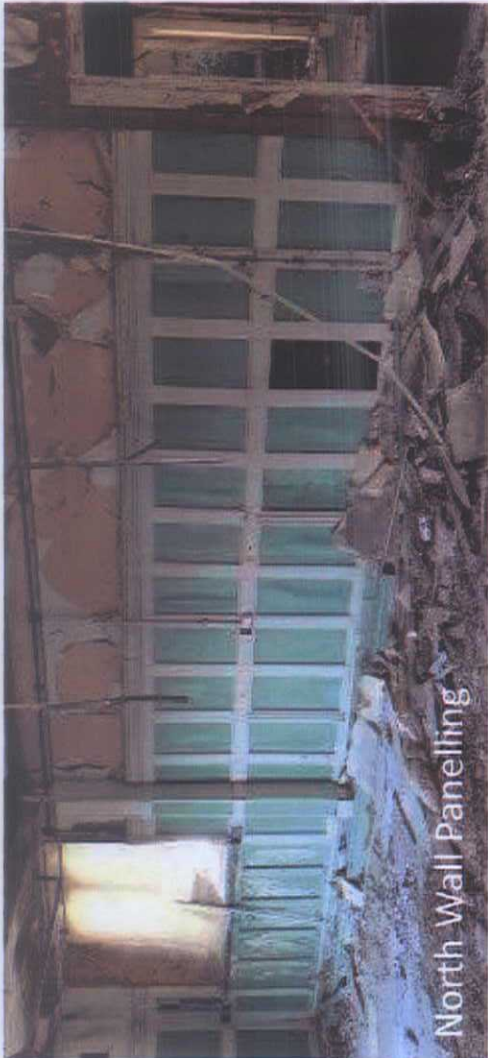
North Wall Panelling

| Element | Condition (G/F/P) | Comments |
|---|---|---|
| Walls | P | Peeling paint on plastered brick & stone. Timber panelling on all 4 walls in poor condition. Evidence of partitions now demolished. |

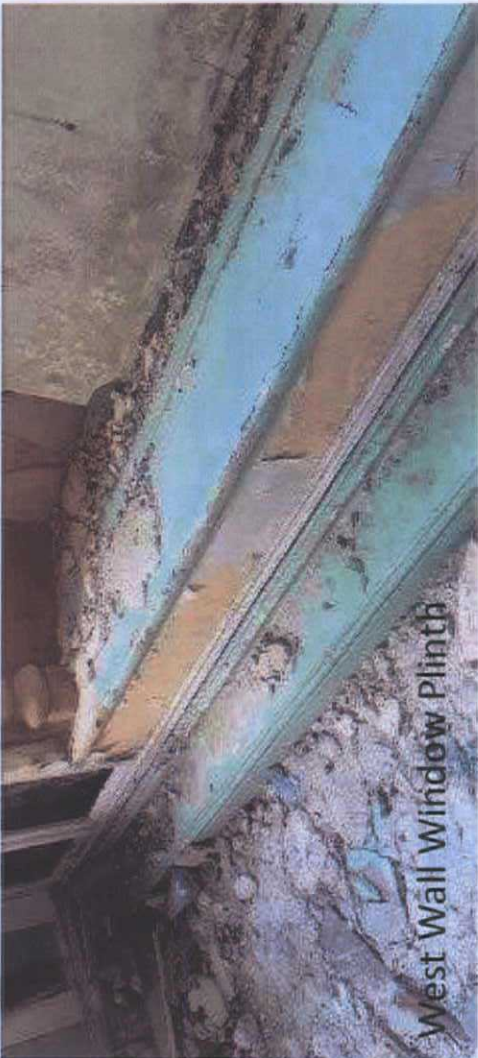
West Wall Window Plinth

| Element | Condition (G/F/P) | Comments |
|---|---|---|
| Other | P | Moulded skirting & window plinth in west wall |

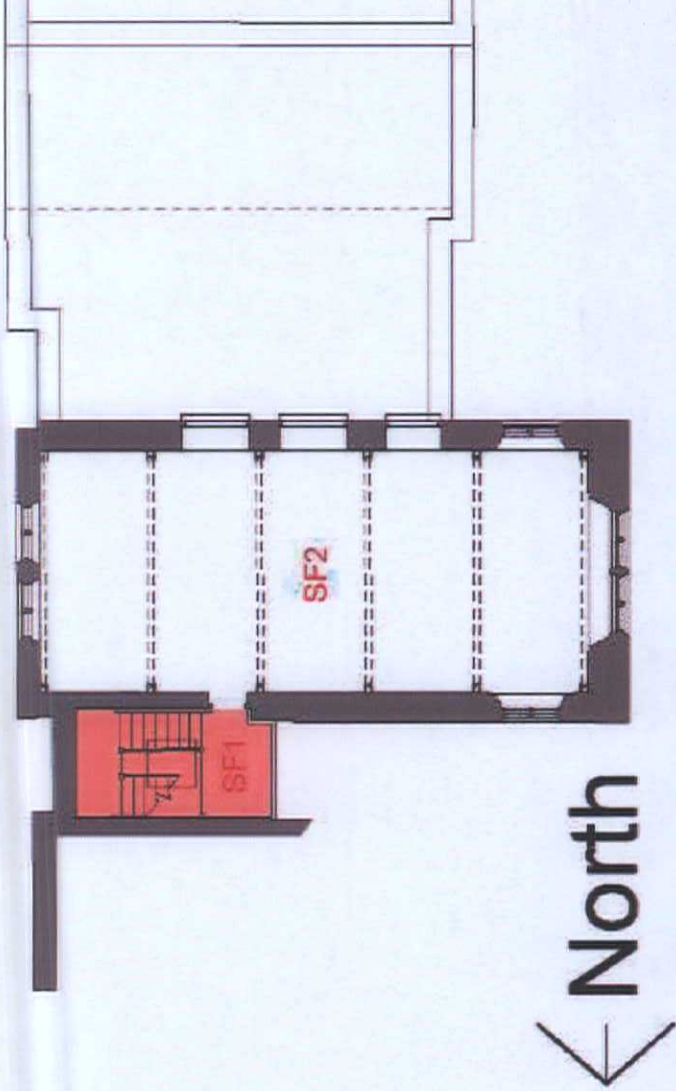
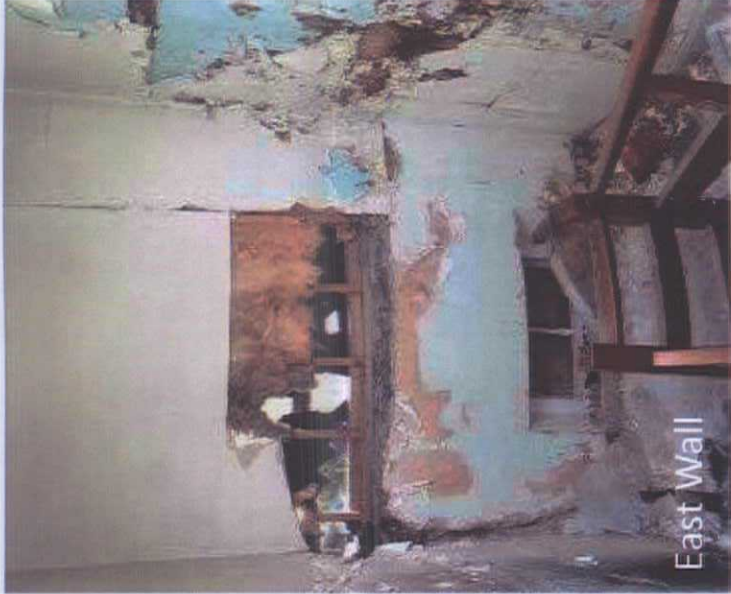
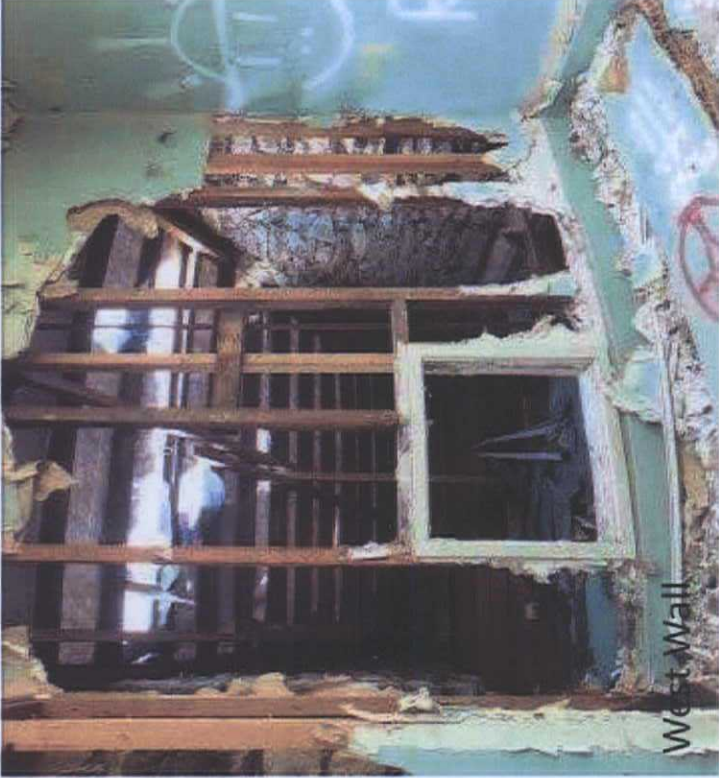
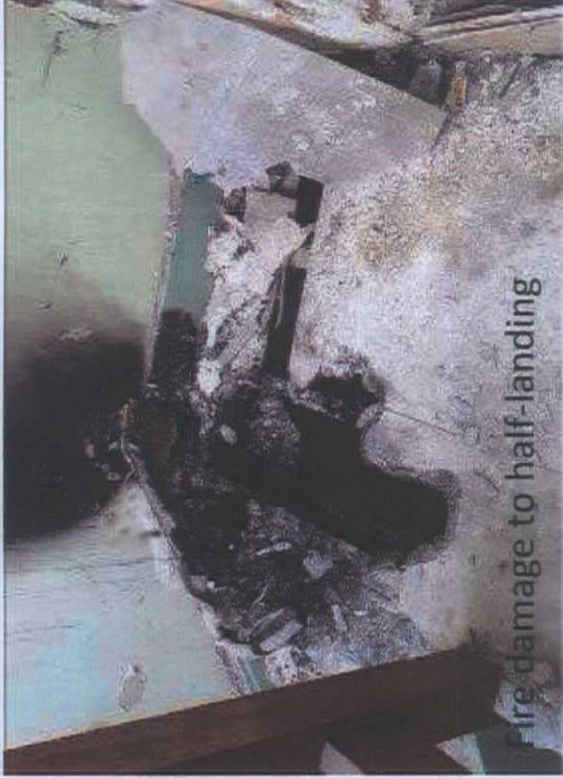
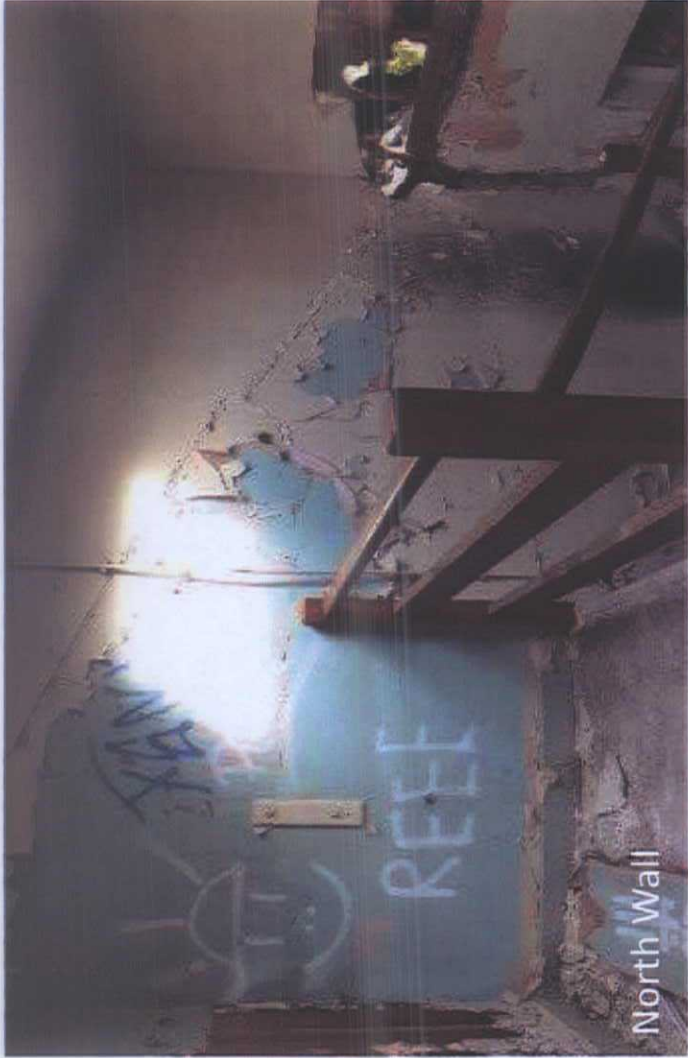
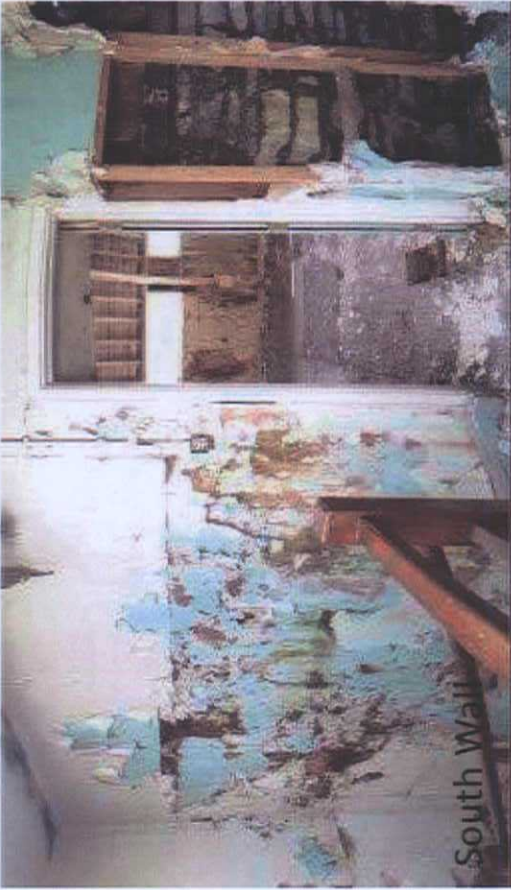
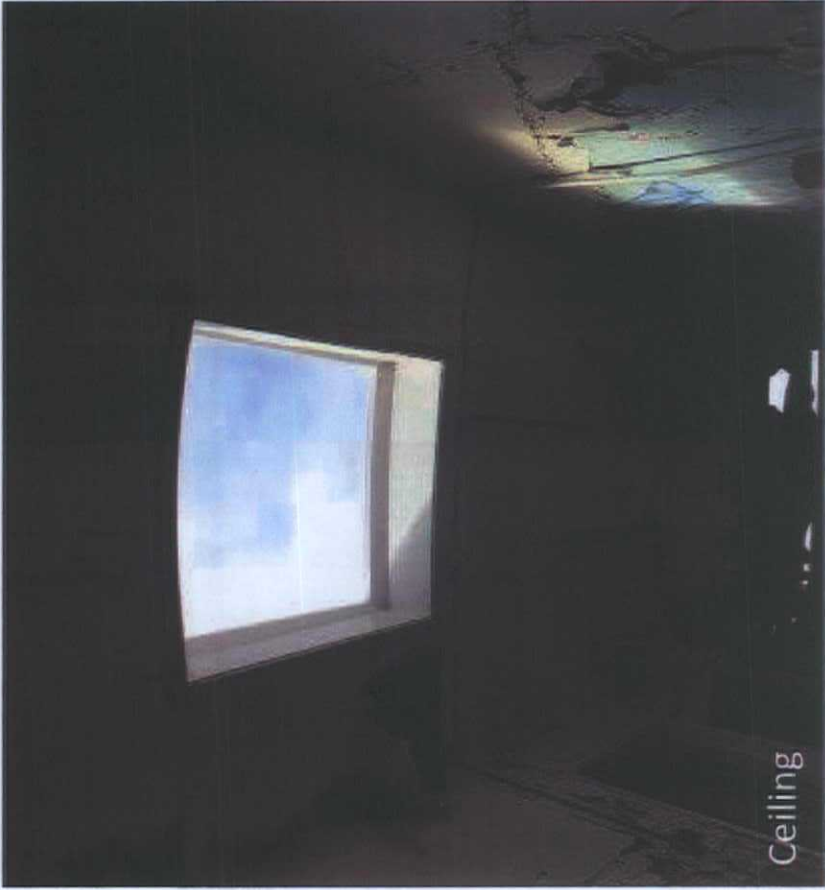
Room Number: SF1

| Room Data | | |
|---|---|---|
| Walls | P | Peeling paint on plastered brick & stone and to damaged timber frame flat-roof dormer addition. West wall partition heavily damaged. |
| Floor | P | Timber floor with ply boards & evidence of fire damage on stairs. |
| Doors | P | Internal door to SF2 missing. Modern bullnose architrave |

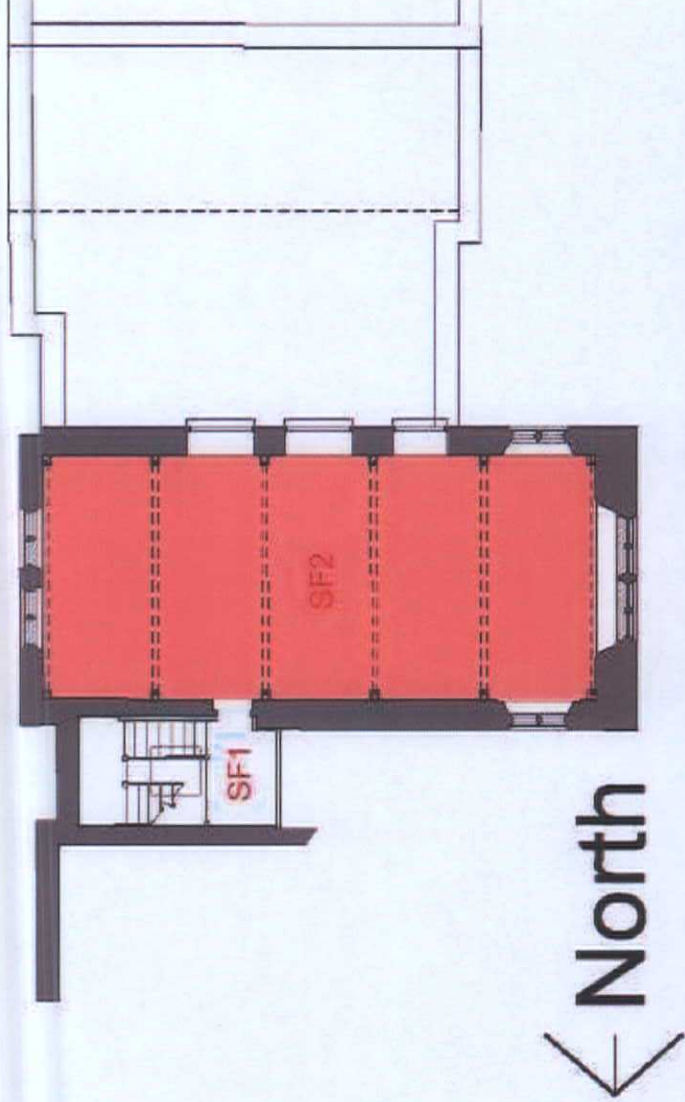
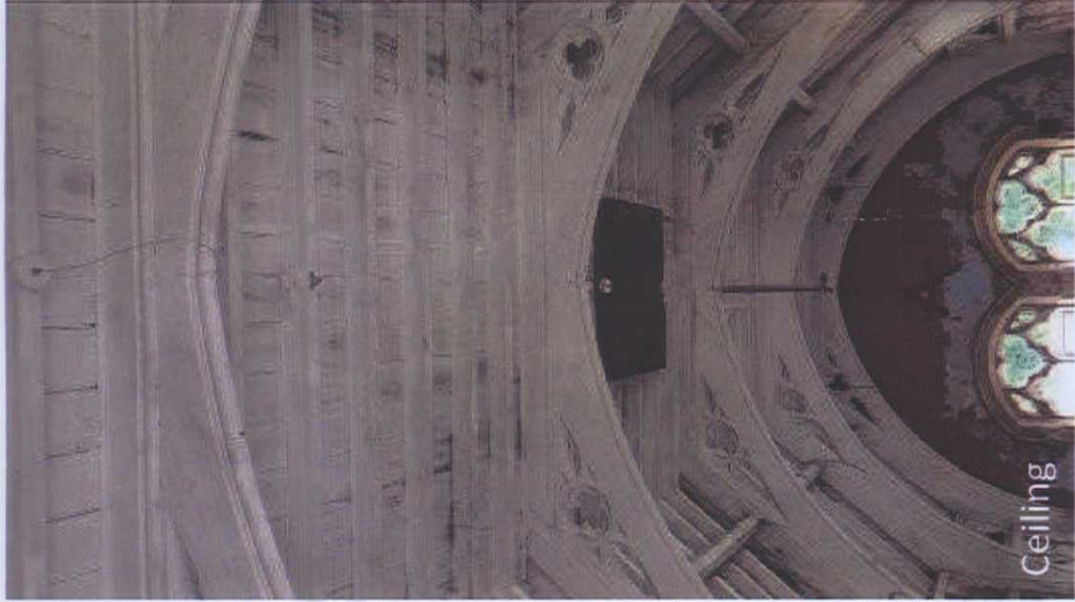
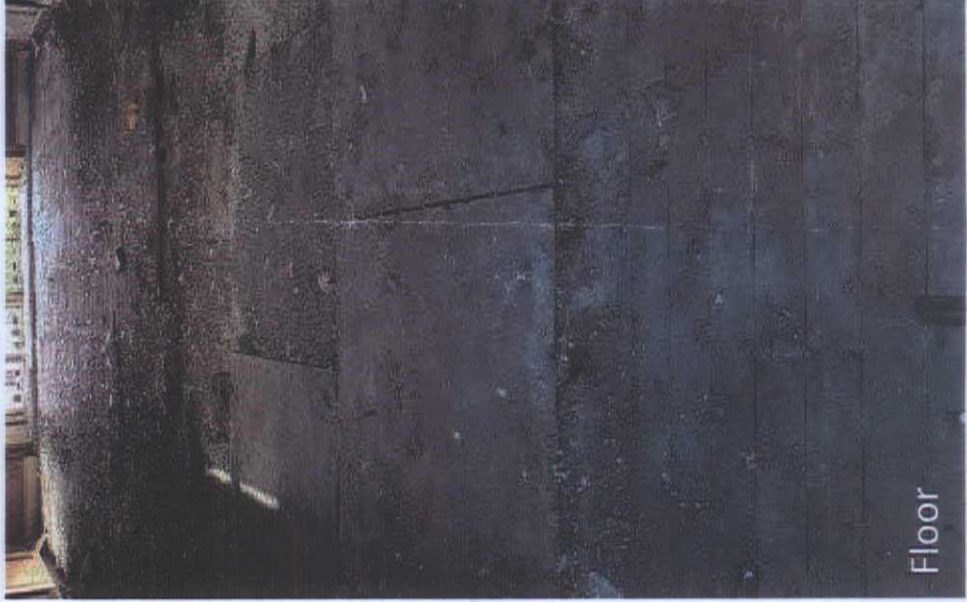
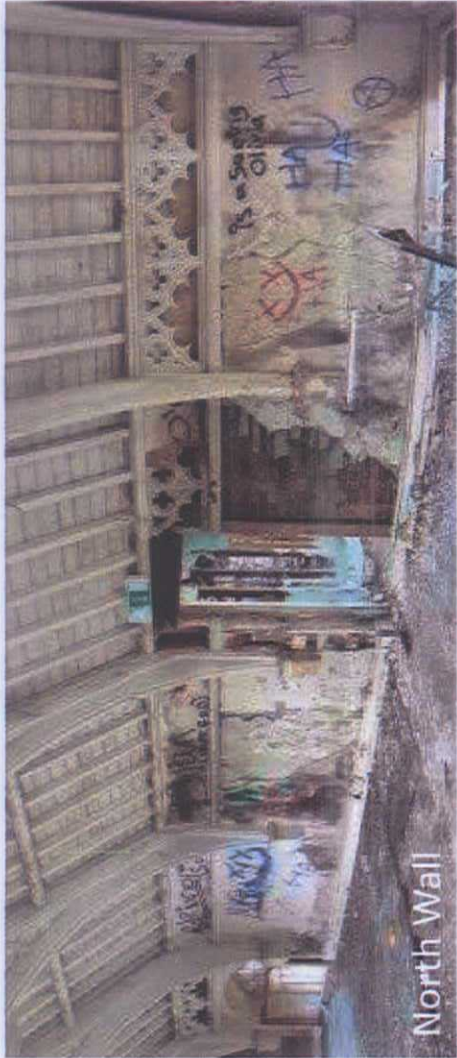
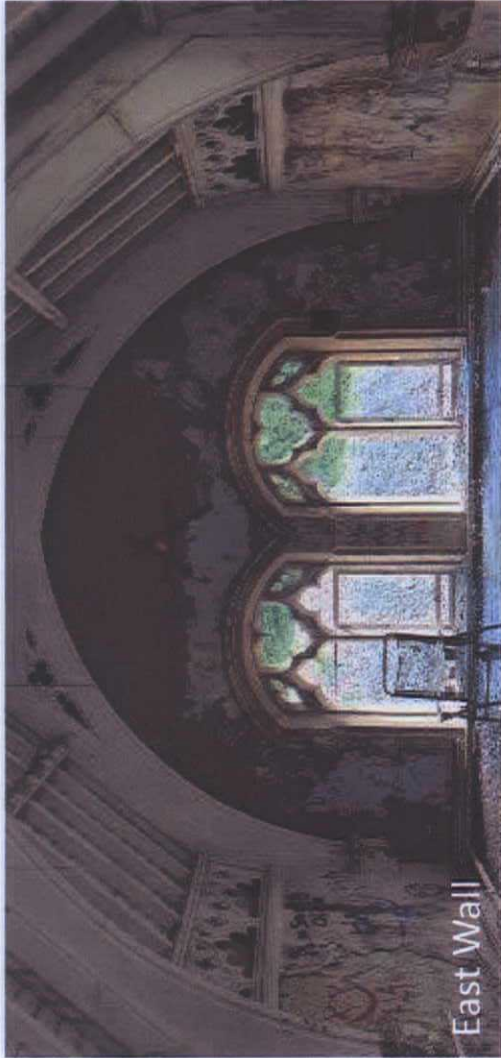
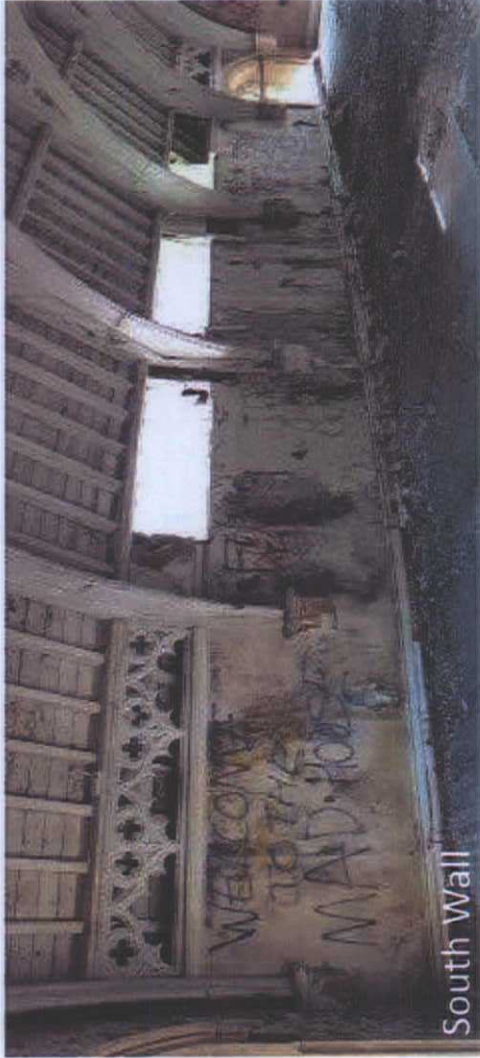
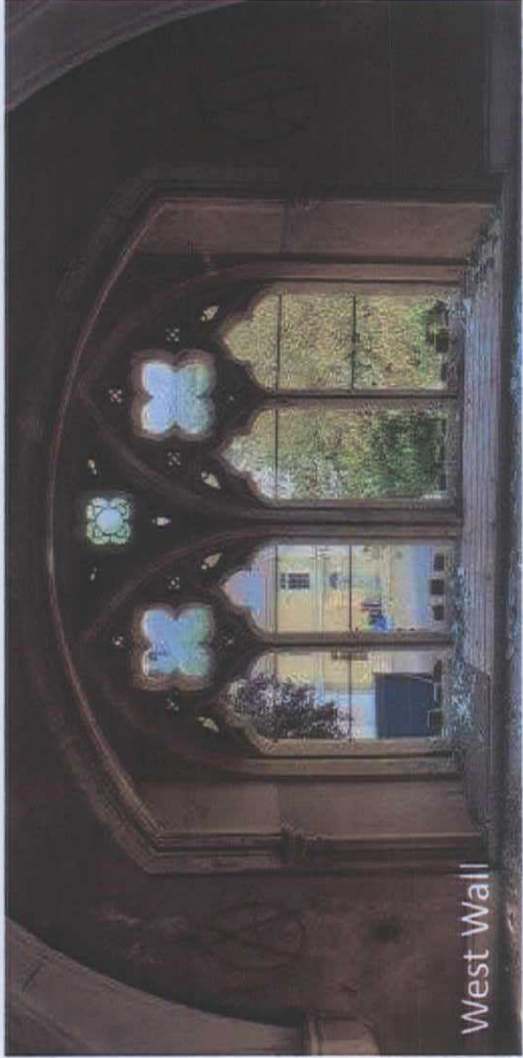
Room Number: SF2

| Element | Condition (G/F/P) | Comments |
|---|---|---|
| Floor | P | Timber floor with mixture of floorboards & replacement ply boards |
| Doors | P | Internal door & architrave missing. Door opening damaged. |
| Other | P | Moulded skirting & low window plinth in west wall |
